# Architectural Heritage Impact Assessment

for  
St.Coleman's Church Macroom  
Former Church of Ireland  
Community Hub Project

Prepared by Mary O'Brien,  
Architects Department  
09.12.2021

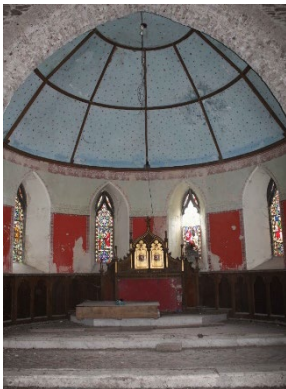
Apse - Main Space	<p>There are no changes proposed to the Apse save for light handed restoration works of plaster and crack repair and investigation of source of water ingress resulting in staining of some plasterwork and repair/repainting of same.</p>	Low	Use skilled trades with appropriate training.
<p>3</p>

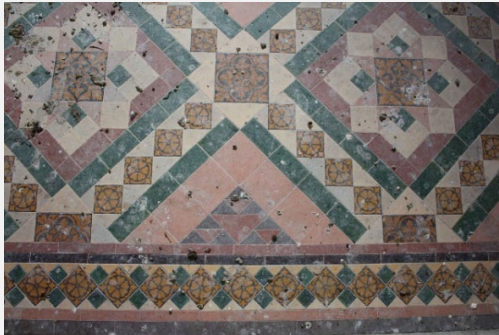
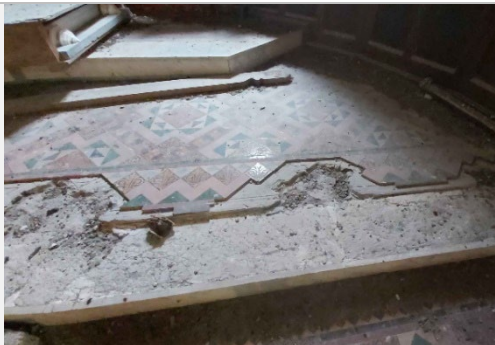
Apse - Floor	<p>The encaustic floor tiles of the apse, closest to the nave, are in good condition however many tiles are missing. The development intends to salvage the tiles on site and conserve the tiling in the apse as best as possible and as close to the original pattern.</p> <p>The large marble edge tiles will be replaced with as close to like for like as possible/ available. In general, the apse space will remain as is - open and directly connected to the nave with door connection through to the rear extension (annex).</p>	Low	Original tiles appear to be in a pile of rubble in the existing extension, perhaps from the 1994 works. Use skilled trades with appropriate training.

<p>Apse floor tiles, missing floor tiles, marble edging absent</p>				
<p>4</p>

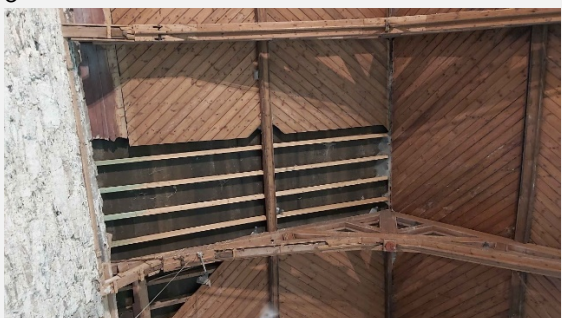
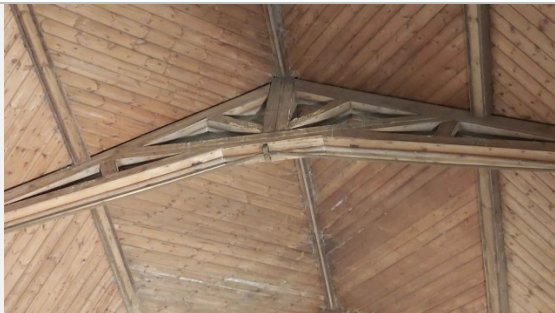
<p>View from the main nave looking up to the roof's underside.</p>	Roof	<p>The main nave roof is in fair condition externally. It is evident from the ground that rafters were recently replaced in the roof and that the roof is not insulated. This development will require measures to be put in place to offer a level of thermal performance and comfort.</p> <p>The unusual roof truss appears to be the original design and so the level of repair previously undertaken and now required needs to be ascertained. The condition of the wall plate also needs to be investigated further. Once funding is in place for the project, these surveys will be undertaken to inform the detailed design stage.</p>	Medium	<p>Various options will be considered during detail design stage, for agreement with the conservation officer.</p> <p>The timber panelling is suspected to be rotting in places, but further surveys will be required to ascertain the existing condition before seeking design remedy.</p>

<p>Existing roof truss</p>				<p>The condition of the wall plate also needs to be investigated further. Once funding is in place for the project, these surveys will be undertaken to inform the detailed design stage.</p>
<p>6</p>

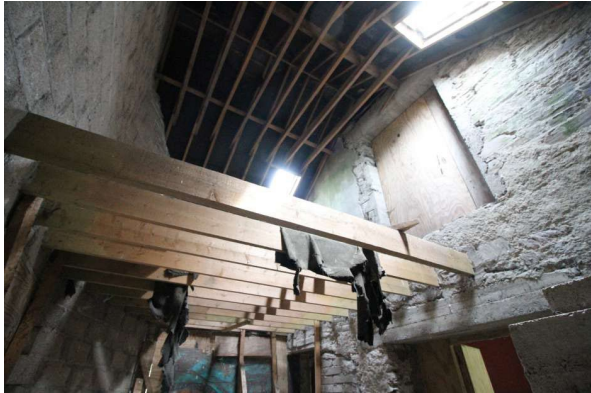
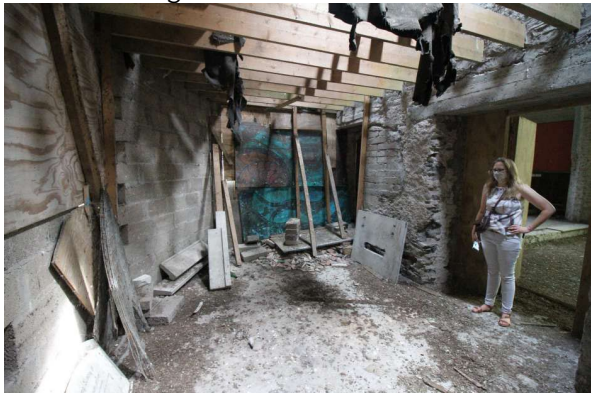
<p>Partially completed Annex building with mezzanine access landing.</p>

<p>Partially completed Annex building looking East.</p>	<p>Rear Extension (Annex)</p>	<p>The rear extension was construction in 1994 in a manner which does not align to best practice both in terms of design and construction, it appears.</p> <p>Discussions with the Heritage Unit of CCC, it was agreed that considering the damage already caused by the development, acceptance of same might be more appropriate in lieu of demolition and reconstruction of a new design. The development seeks to reconfigure the original internal layout to provide for new stairs, store and toilets on the ground floor, with tea station and meeting area on the upper floor which offers a view from a balcony down into the nave space.</p>	<p>Low</p>	<p>Treatment of historic fabric will be agreed with conservation officer at detail design stage. This section does not display architectural significance.</p>

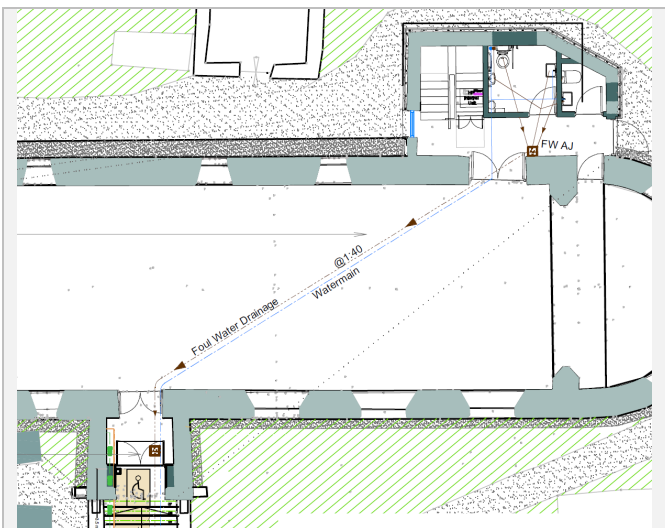
<p>Underground Services Connections</p>	<p>Attempts appear to have been made at the time of the construction of the rear extension to connect a foul drainage system to the east. These are suspected to be incomplete and sub-standard in design.</p> <p>The new proposal is to run a new route up through the external central path up to the porch. Foul and water routes are required diagonally across the 1990's concrete slab.</p> <p>Archaeological input has been sought to inform the route of foul and storm connections. Please refer to archaeological report in relation to this element.</p> <p>Refer to architectural drawings.</p>	<p>Medium</p>	<p>Further investigations and consultant civil design required.</p> <p>Treatment of fabric will be agreed with conservation officer at detail design stage. The intention is to not disturb the historically significant fabric beneath the concrete slab.</p>

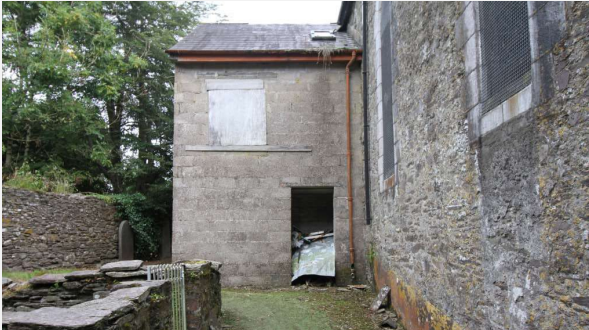
Existing extension - partially unfinished	Rear Extension (Annex)	The extension is currently unfinished with fair faced, un-weathered blockwork to the exterior. A slate roof was installed but with no ridge tiles and so also remains in an unfinished state. The development seeks to clad the external walls and roof with seamless and minimal larch timber cladding to aesthetically and sympathetically detach it from the historic fabric which forfeits any further construction disturbance. The exterior works seek to block up structural opes where they are no longer required and increase structural opes where appropriate in order to balance the external proportions of the external façade of the annex.	Low	Treatment of fabric will be agreed with conservation officer at detail design stage. This section does not display architectural significance.
2

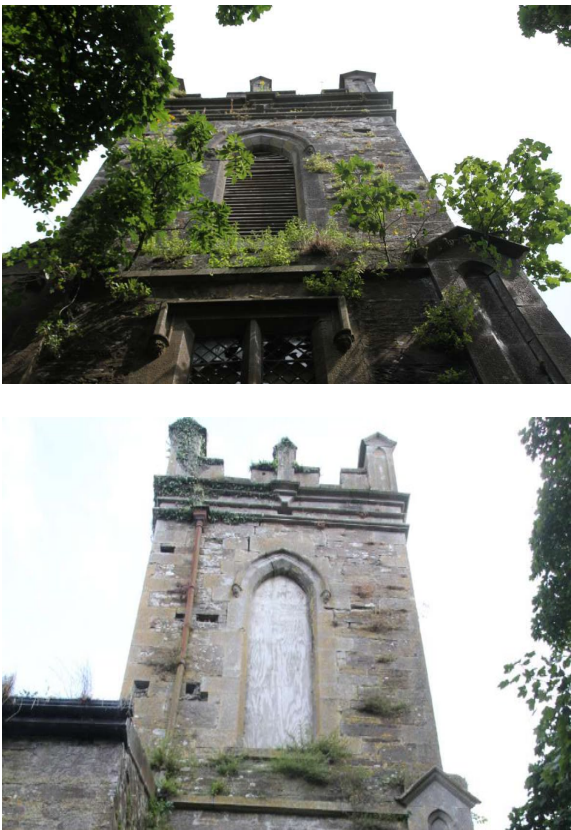
Tower	<p>The existing condition of the tower is poor, with significant vegetation destabilising the structure. These vulnerable stone details and their securing to the building will be addressed as part of the development by removal of growth and follow on re-pointing by appropriately qualified mason.</p> <p>There is evidence of slating inside the tower, we proposed to introduce counter flashings above stone banding details, with good depth of bedding. Where the tower meets the roof of the nave, these abutments need to be replaced and cement pointing above be removed and replaced with appropriate lime mortar and finish.</p> <p>Some stones which have fallen out over time due to weathering need to be reinstated.</p>	Medium	<p>Use skilled trades with appropriate training.</p> <p>Further investigations and close-up inspections required.</p> <p>Treatment of fabric will be agreed with conservation officer at detail design stage.</p>

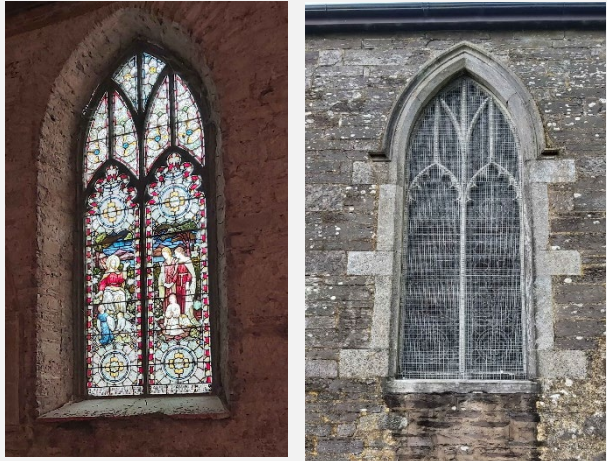
<p>Existing glazing in the south elevation of the nave.</p>	<p>External Windows and Storm Glazing</p>	<p>The existing windows to the south are in fair but vulnerable condition. The glazing to the east, north is in poor condition, but the tower is in extremely weak a condition. in smaller opes there is more damage, and repairs needed. Alter windows need to be protected. This development we propose to install ventilated storm glazing to the external side of the ope to protect the existing windows.</p>	<p>Medium</p>	<p>The poor windows will be repaired and/or replaced as appropriate, as recommended by a stained-glass specialist.</p> <p>A windows report will be procured at detail design stage where remedies will be agreed with the Conservation Officer.</p>
<p>6</p>

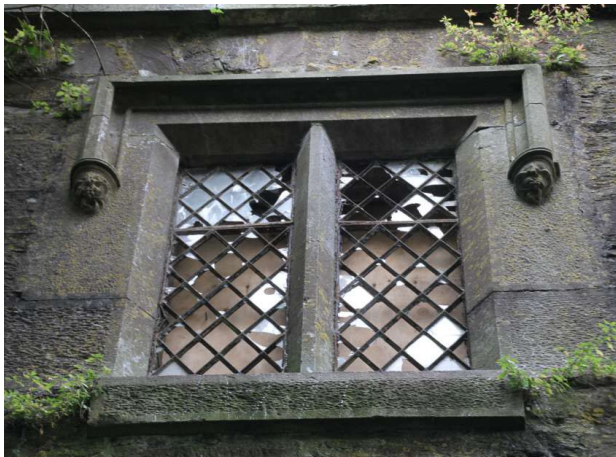
<p>Existing glazing to the tower, in irreparable condition</p>	<p>External Windows and Storm Glazing</p>	<p>Windows are intended to be repaired throughout where up to 50% damage has occurred. In windows where in excess of 50% damage has occurred (mainly all the existing diamond leaded glass windows), these windows are not proposed to be repaired but instead have a contemporary minimal glazed pane inserted in to the existing ope – distinguishable as a later addition.</p>	<p>Medium</p>	<p>A windows report will be procured at detail design stage where remedies will be agreed with the Conservation Officer.</p>

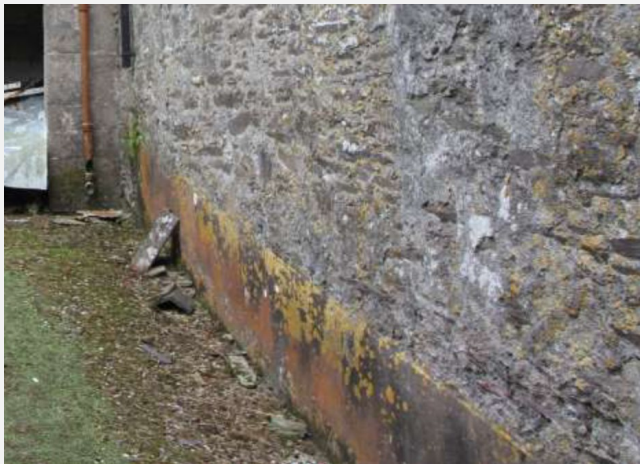
<p>General External Works – connections, RWOs, lead flashings</p>	<p>Please refer to the Condition Survey Report accompanying this planning application which highlights the requirement for the instruction (or reinstatement) of the French drain around the perimeter of the building.</p> <p>A 'French drain' around the perimeter of the building would aid removal/lowering of ground water immediately outside the building where elevated.</p> <p>General measures to improve drainage around the building and take off build up of water around the building can help significantly.</p>	<p>Low</p>	<p>Agree methodology prior to commencement.</p> <p>Use skilled trades with appropriate training.</p> <p>Treatment of fabric will be agreed with conservation officer at detail design stage.</p>
<p>8</p>

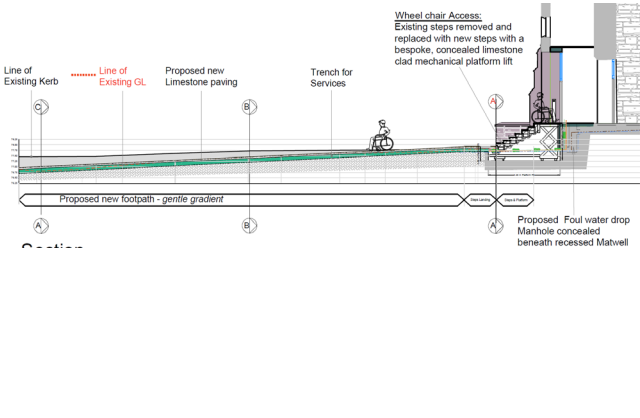
<p>General External Works – connections, RWOs, lead flashings</p>	<p>Attempts appear to have been made at the time of the construction of the rear extension to connect a foul drainage system to the east. A CCTV drains survey is required.</p> <p>Archaeological input has been sought to inform the route of foul and storm connections. Please refer to archaeological report in relation to this element.</p> <p>Refer to architectural drawings.</p> <p>The intention is to finish this new pathway in natural irish stone paving.</p>	<p>High</p>	<p>Agree methodology prior to commencement.</p> <p>Drains survey of existing is required but expected to be defective and partially complete.</p> <p>Route has been designed with minimal disturbance in mind.</p>

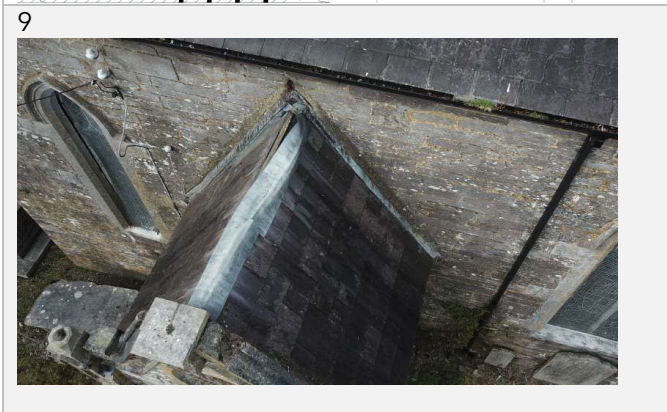
<p>General External Works – connections, RWOs, lead flashings</p>	<p>Local roof repairs will be required where lead flashing has lifted over time to maintain the weathering integrity of the external fabric. This will be done by way of re-dressing of lead.</p>	<p>Low</p>	<p>Agree methodology prior to commencement.</p> <p>Use skilled trades with appropriate training.</p> <p>Treatment of fabric will be agreed with conservation officer at detail design stage.</p>

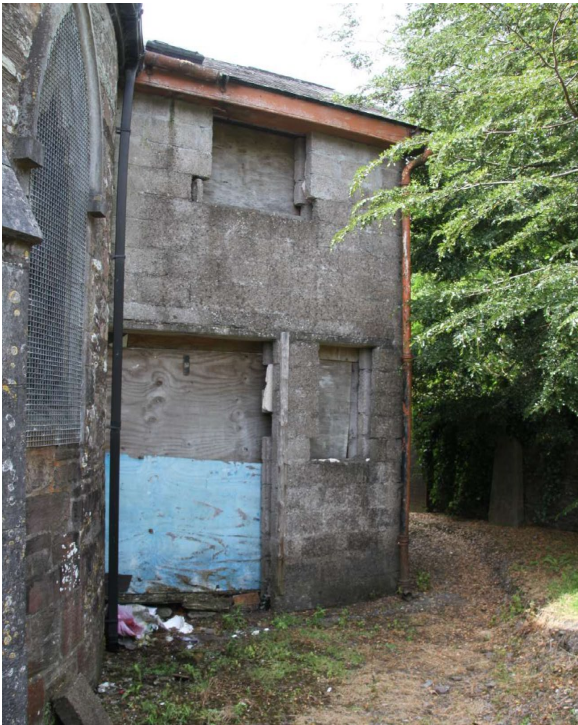
<p>The condition report also called for the replacement of the existing uPVC fascias and gutters to cast iron or new aluminium gutters, as appropriate.</p>	<p>Low</p>	<p>Treatment of fabric will be agreed with conservation officer at detail design stage.</p> <p>Specify appropriate materials.</p> <p>Use skilled trades with appropriate training.</p>
<p>11</p>

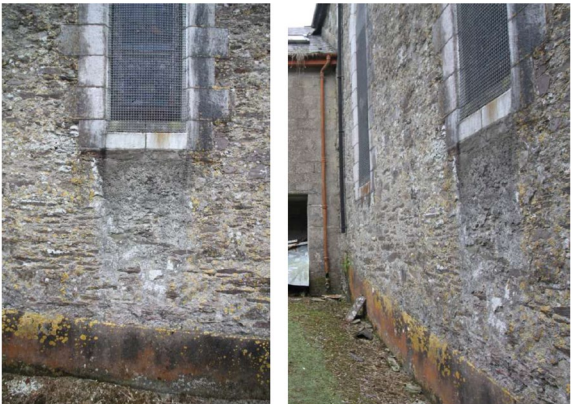
<p>General External Works - connections, RWOs, lead flashings</p>	<p>Sand and Cement mortar throughout has evidently failed (mainly south wall and all tower walls). The proposal requires the removal and repointing of failed areas by mason.</p> <p>The rear north wall had less pointing but has lost its earlier hauled lime wash finish coat. Repointing works are proposed to this elevation, as appropriate and as required.</p>	<p>Medium</p>	<p>Further investigations required. Extent of the repair and reinstatement would need to be reviewed by removal of a few sections.</p> <p>Use skilled trades with appropriate training.</p> <p>Treatment of fabric will be agreed with conservation officer at detail design stage.</p>
