St. Colemans Church,

Macroom,
Co. Cork.

Structural and Condition report :

Macroom Church Of Ireland,

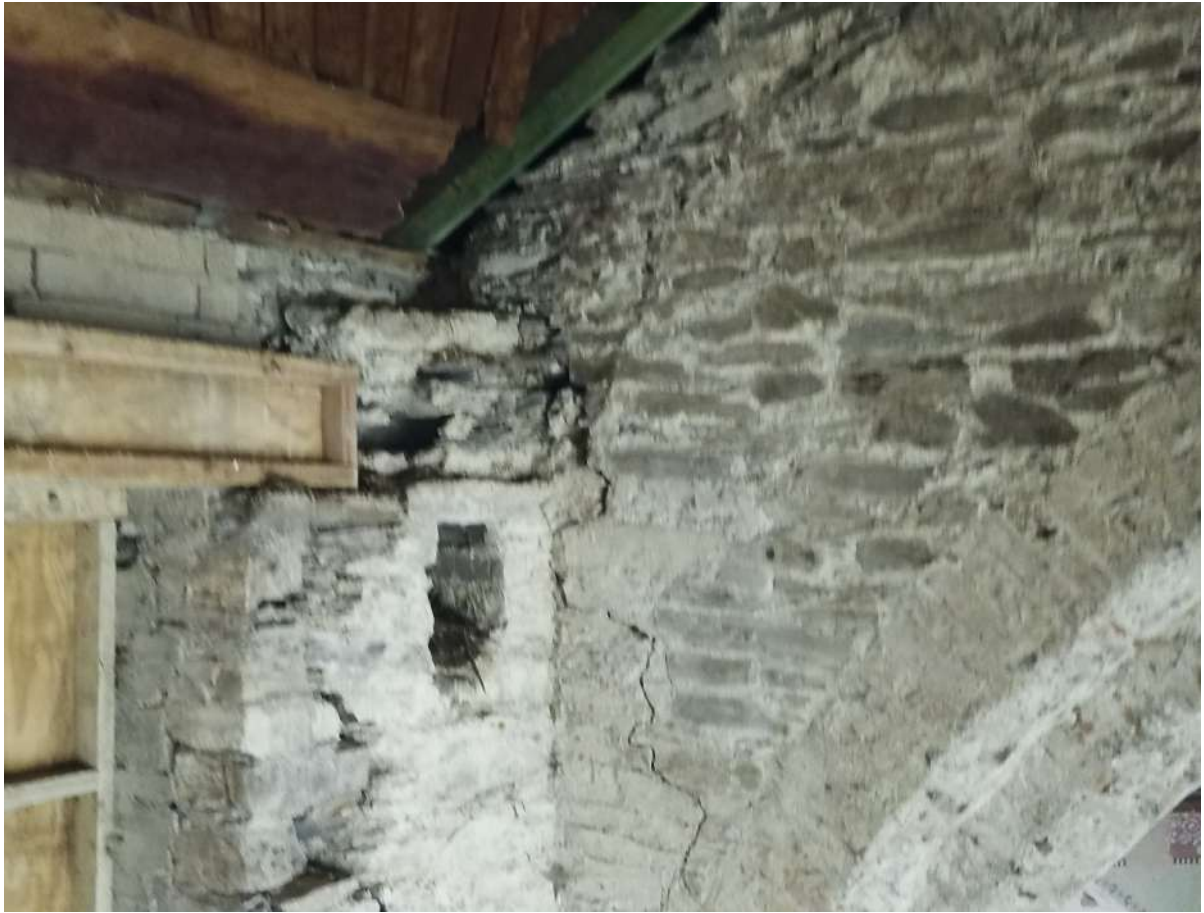
• Fig 61. Signs of movement to left of arch span.

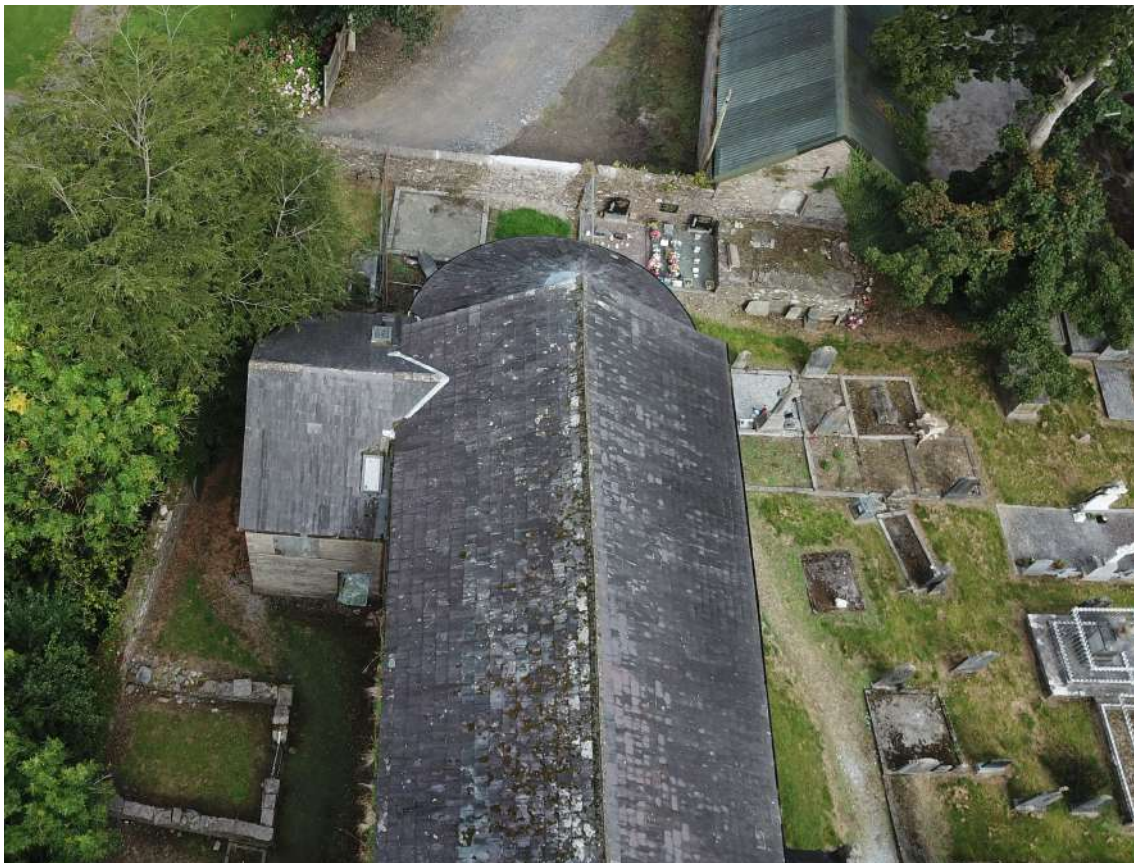
The building was re-roofed c1994. There may be some concern about the trusses and a slight dipping of the roof plane on both North and South sides of the main roof but this might be reviewed separately under RKA structural report.

Natural slates were used in the re-roofing and possibly an element of salvage of slates from the original roof. Slates appear basically sound across the roof generally, but there are certainly some slipped slates and some flashings in need of attention. Ridge flashings/ tiles to rear annex roof are missing and lead ridge flashing to entrance porch needs urgent attention.

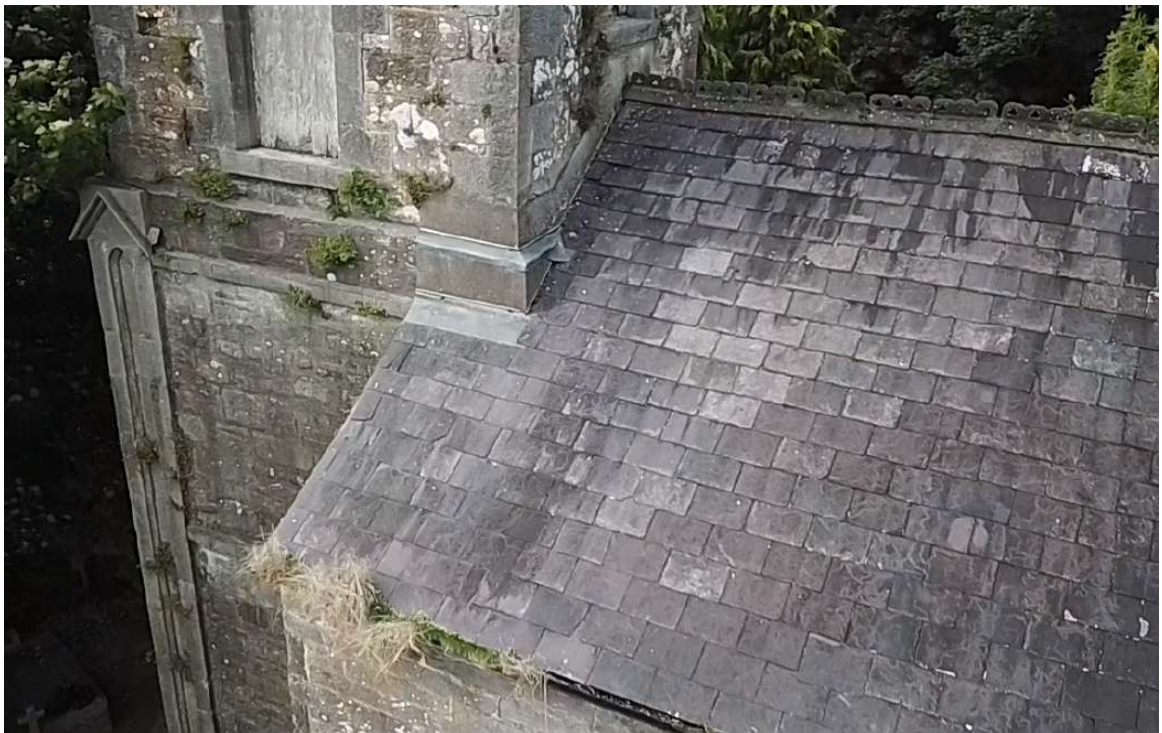
Where lead flashings meet masonry walls and are often dressed over with sand cement mortar this detail leads to its own difficulties, and should be addressed.

Roof gutters generally need urgent attention to maintain their operation in short term. This might be one priority action for the site.

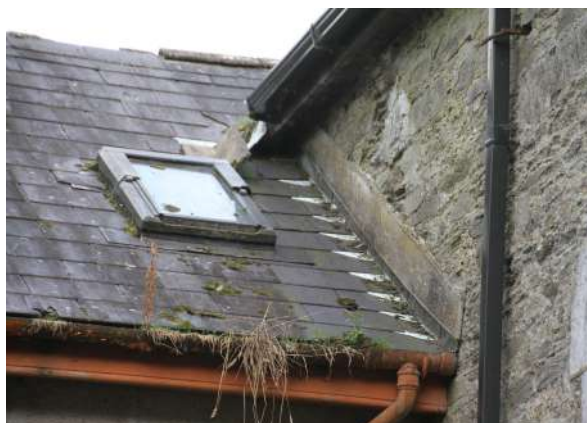
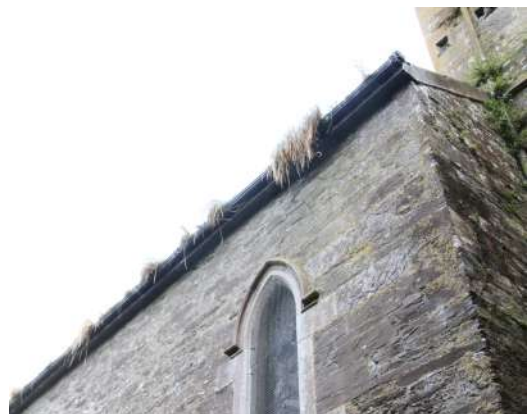
The same applies to Church and rear Annex roof gutters and down pipes, front and back of the building.

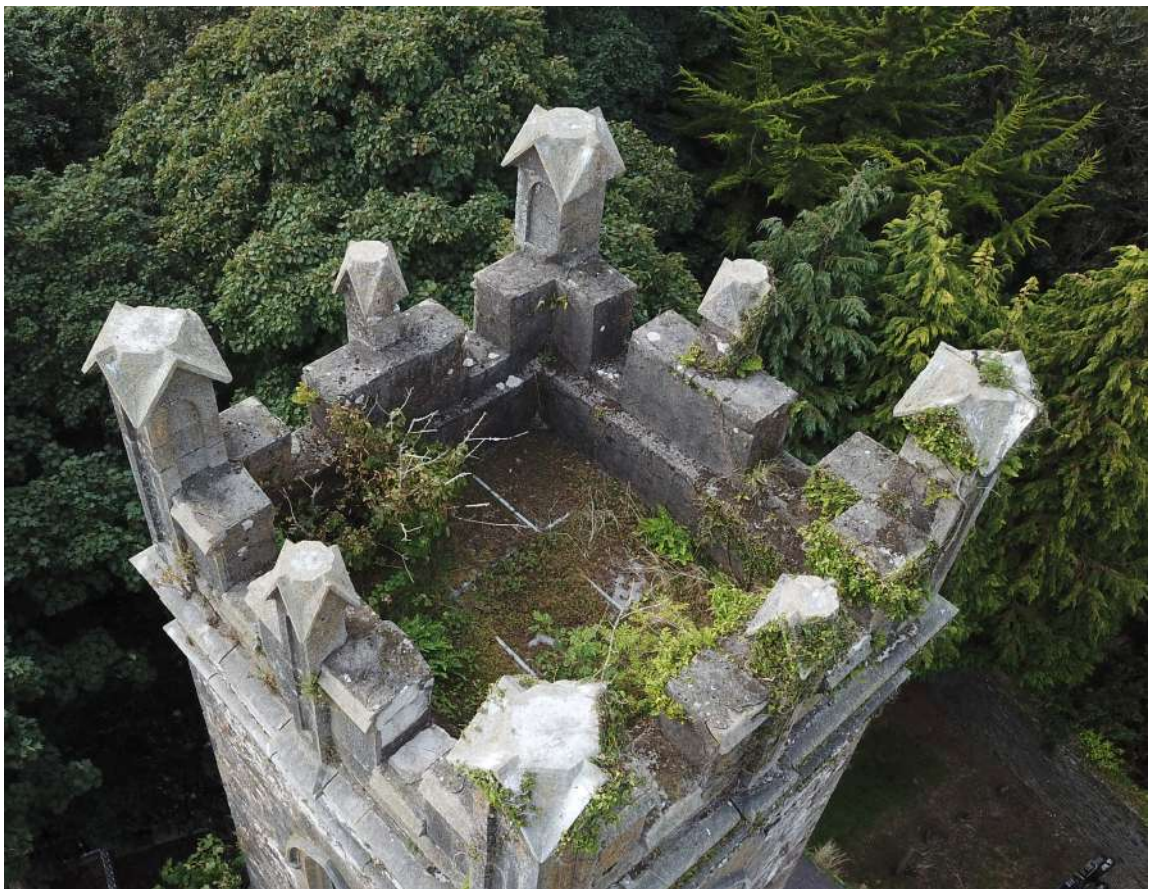
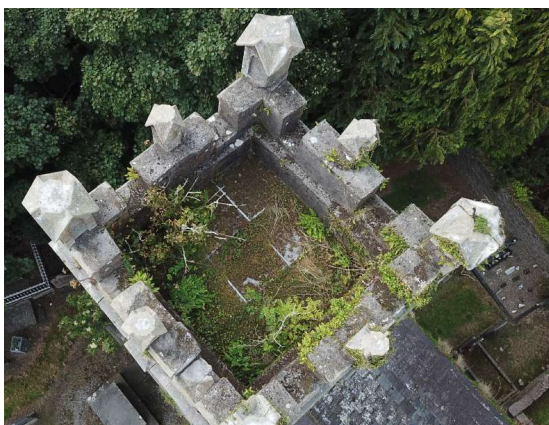
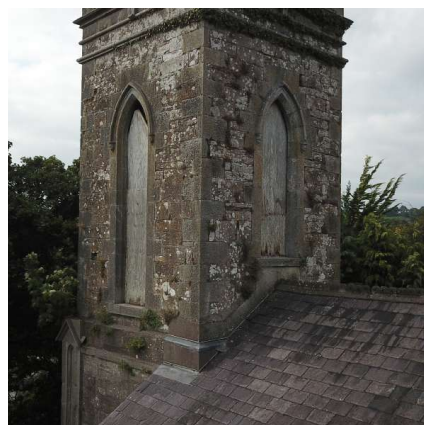
The roof of the tower of the Church also appears to have been addressed as part of the rest of the roof works. It looks like this may have had a lead roof repair at the time? Much sand cement mortar and render has been put on the upper level of the tower and it is possible that this may have been a part of creating a 'ring beam' to support the Castellations at the roof level.

Inevitably outlets out of reach become blocked up and growth is normal enough in these situations. The proximity to some fine surrounding trees is sadly another part of this problem, and some guided pruning would be no harm especially to trees in contact with the building.

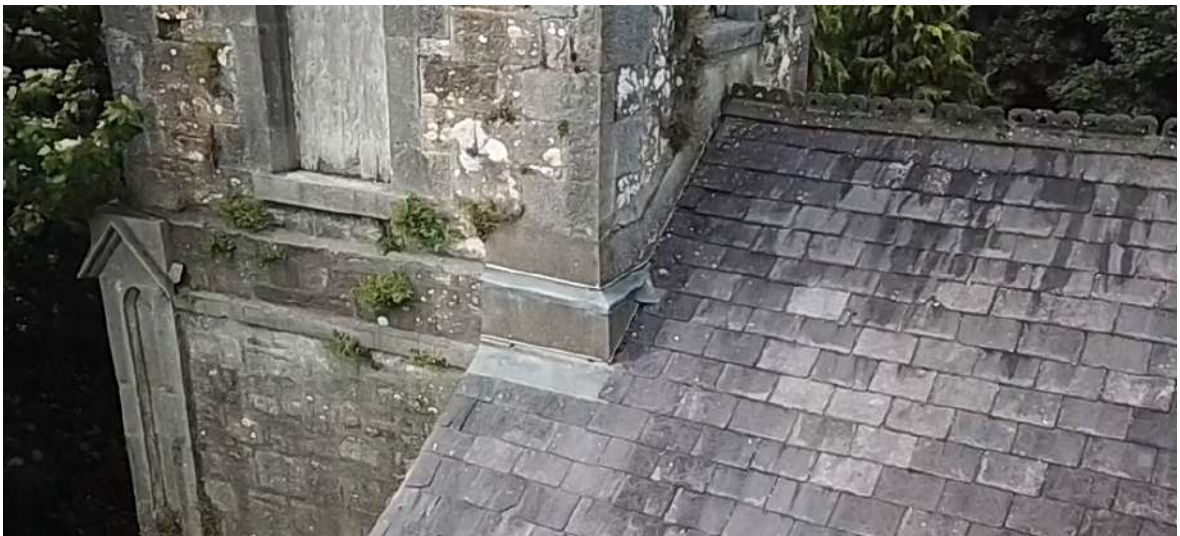
As mentioned above the counter render over and above flashings is one very specific issue, in that water above the flashing line cannot escape and effectively over time rendered the flashing ineffective.

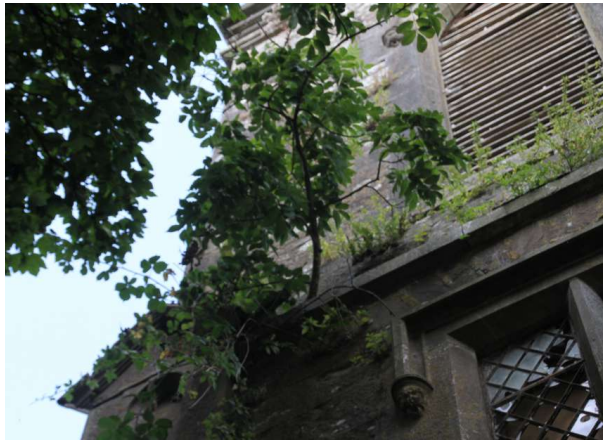
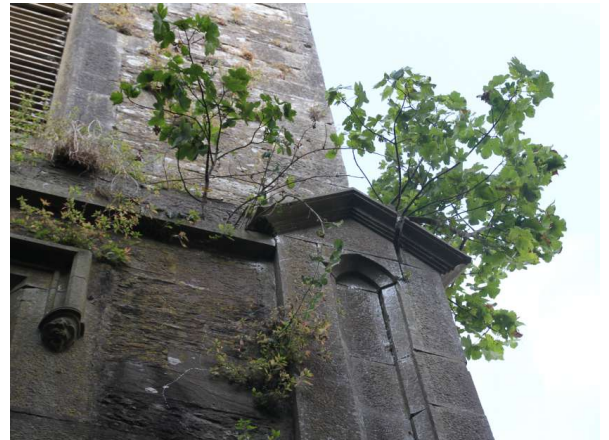
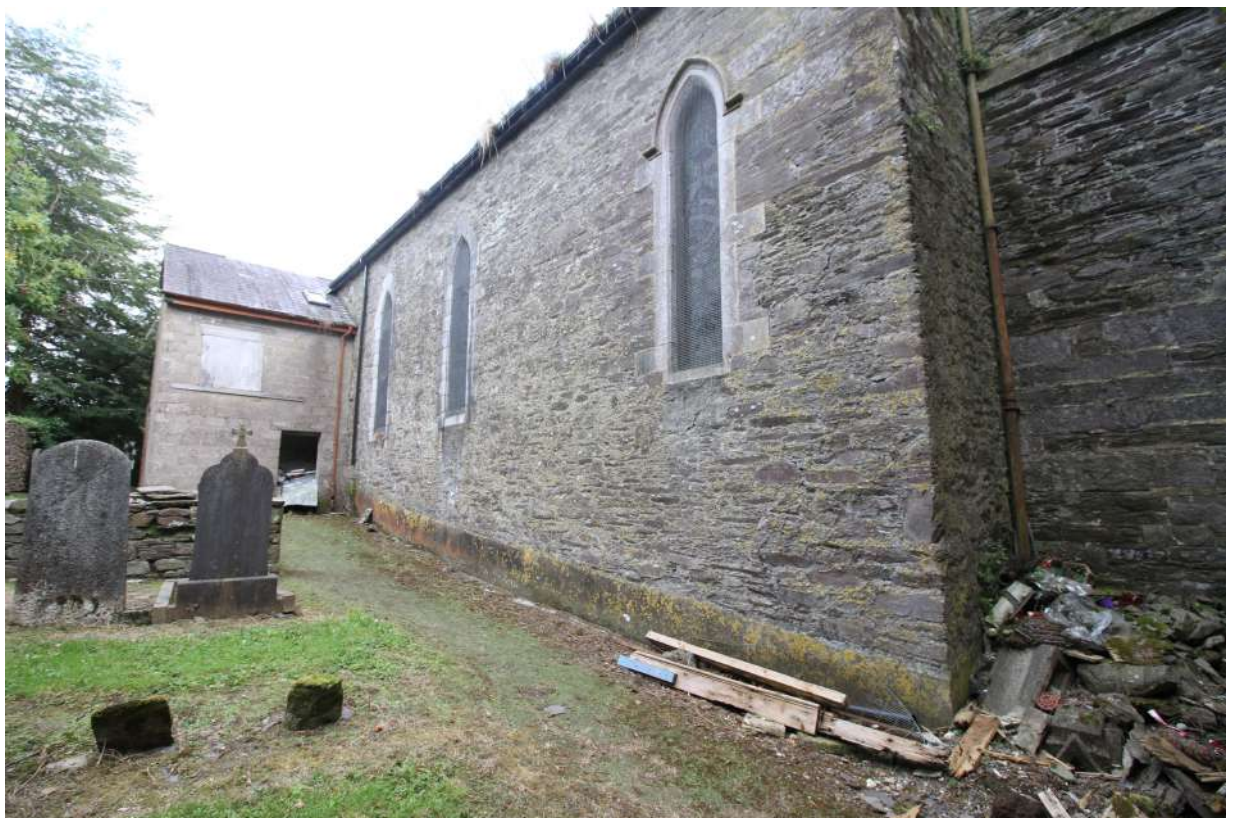
The other area of concern is the more vulnerable stone details and their securing to the building. Some have had pointing eroded over time and possibly corrosion of mounting dowels or similar underlying issues, and others are open joints now encouraging growth which in turn opens the joints further and adds to the issue.

Growth should be addressed and removed and follow on re-pointing to lessen possibility of re-growth.

Care would need to be taken to have this work carried out by mason as opposed to landscape crew/ tree surgeon!

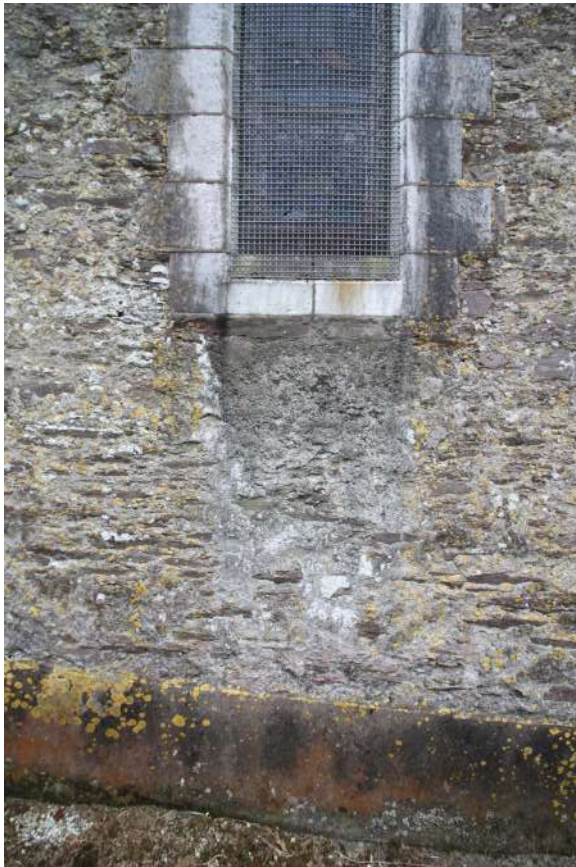
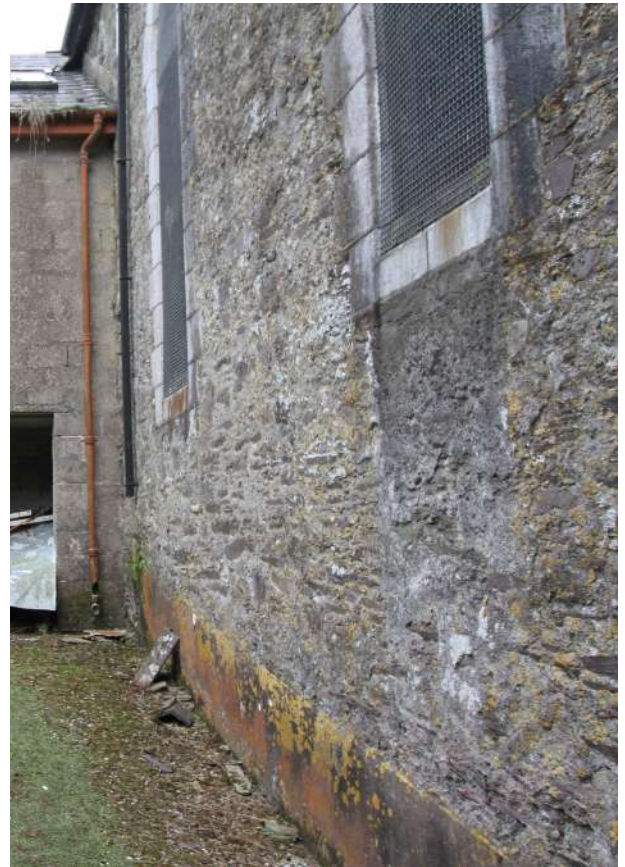
A concrete (cement based) plinth band has been introduced at the bottom of the rear (North) wall of the Church and may have been added relatively recently. This tends to make it harder for moisture travelling down the wall to escape, and has the opposite effect and drives rising dampness further up into the building. This should be removed in a few areas and wall examined behind. The objective should be its total removal.

Much of the North Facade has retained its lime pointing and remnants of its original render.

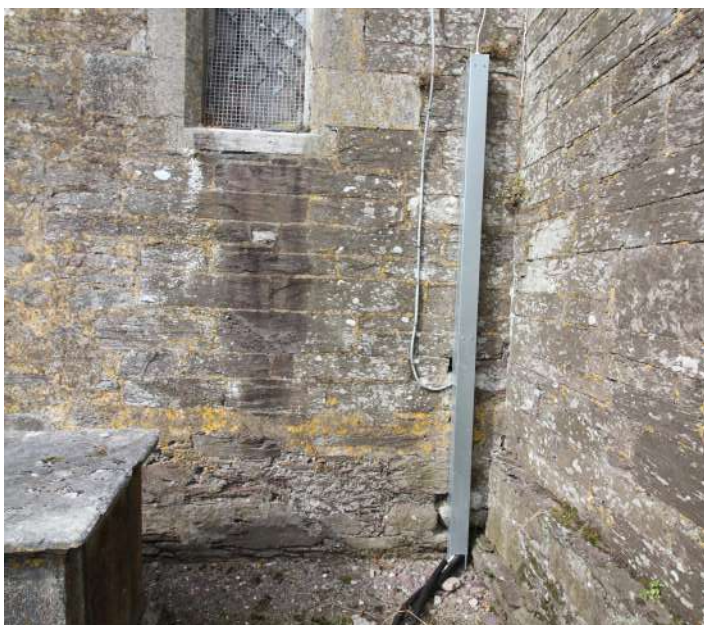
The South side of the building has been extensively re-pointed with S/C mortar which has in itself started to fail and needs remedial attention.

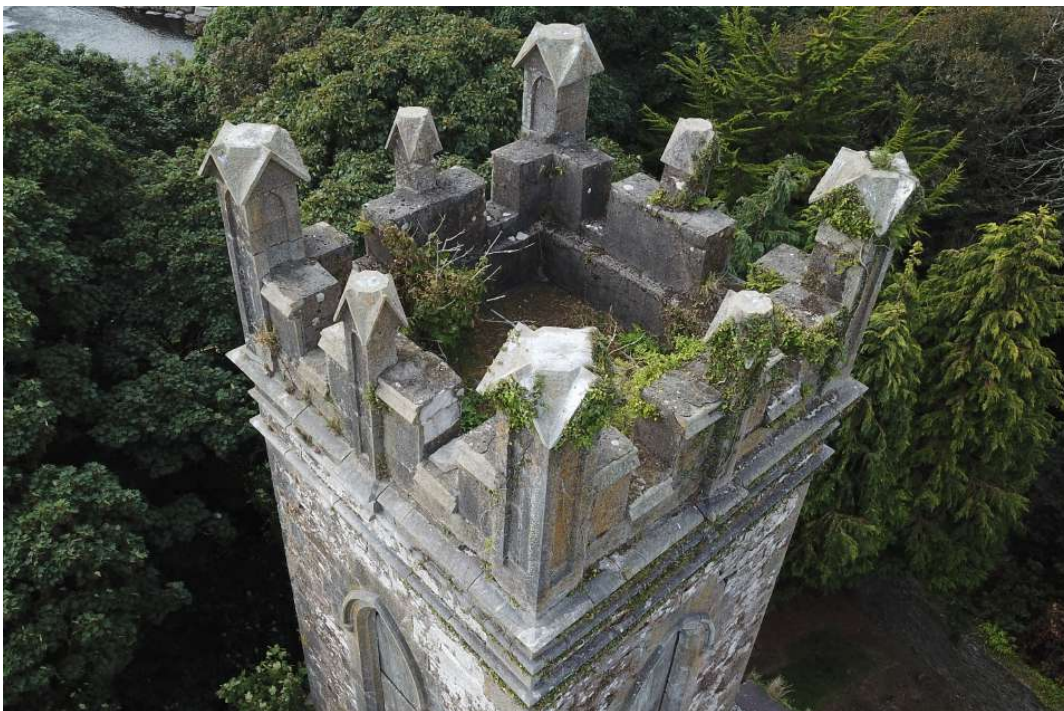
The Tower has fine Carved limestone corner pinnacles, crenellations and cornice, and dressed mixed stone walls with tooled limestone quoins, having tooled limestone string courses separating stages. Detail appears to have been lost and some further research may be needed to see what might have capped the pinnacles. While some work was clearly done at this level in recent years, with significant concrete internal parapet added, the point needs attention, and concrete condition needs survey.

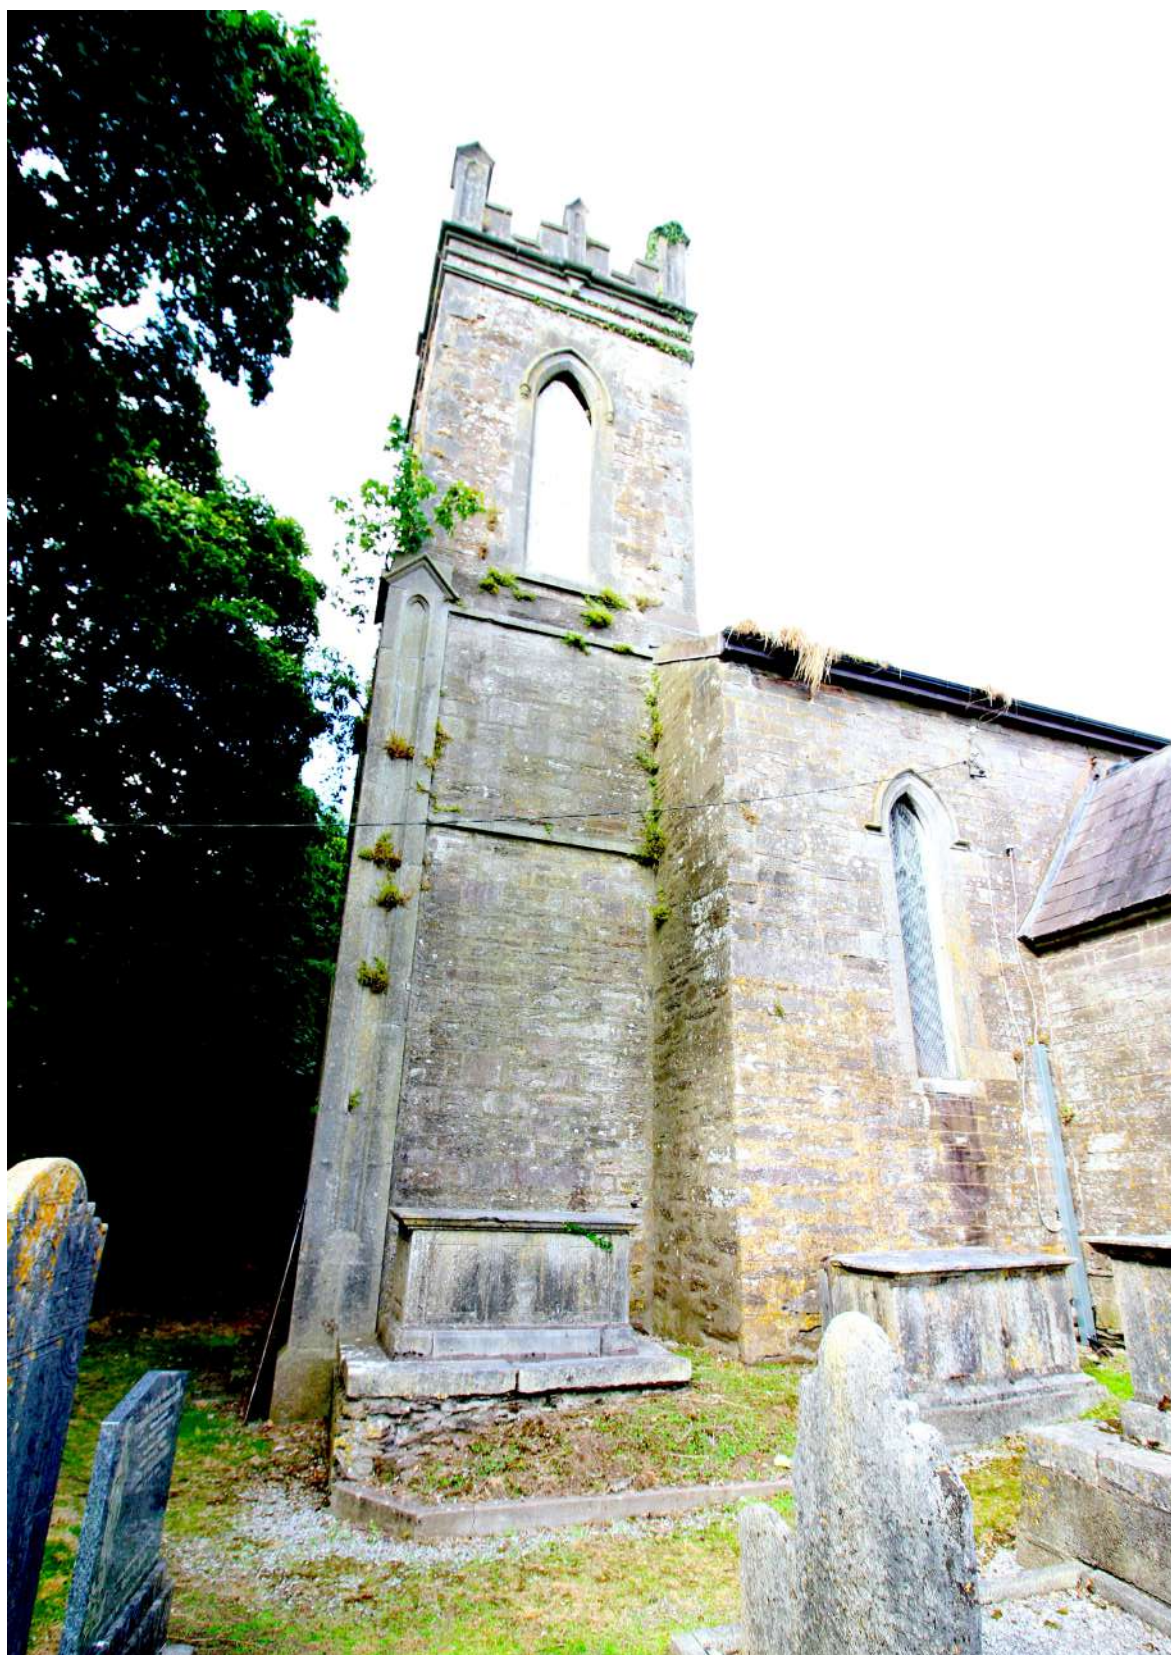
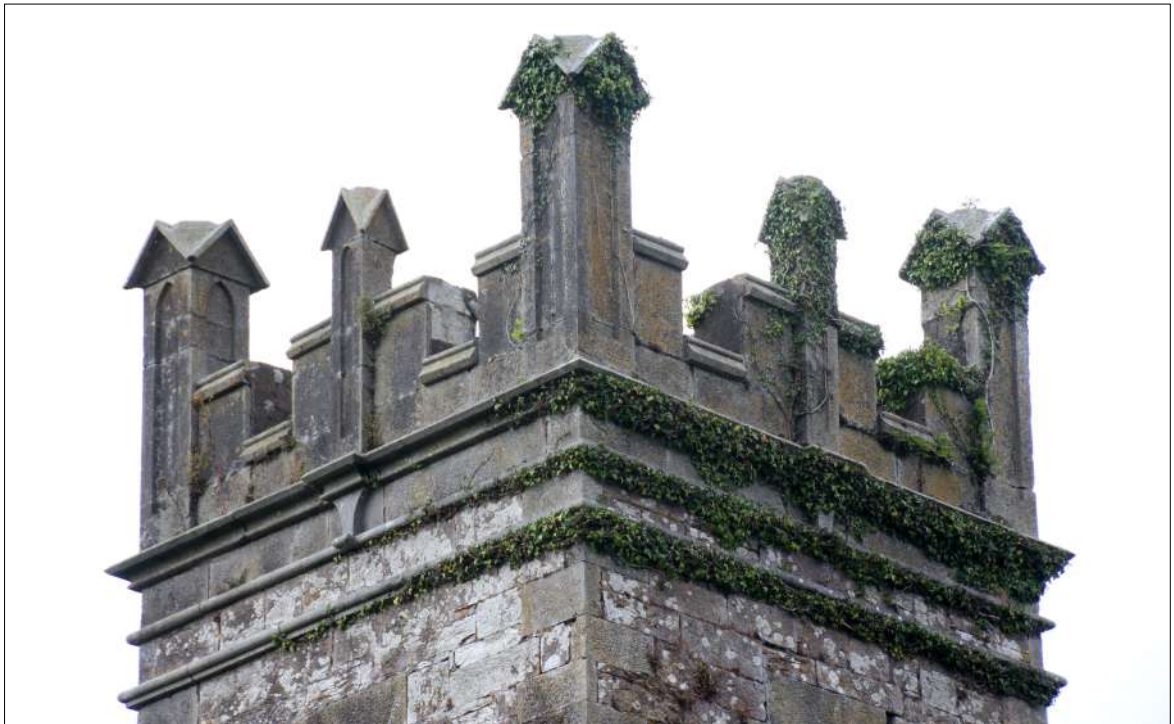
There are finely tooled limestone blocking buttresses to tower corners, having helmed coping and trefoil-headed panels. The level of growth in the tower indicates the amount of pointing required and moisture retention resulting from same.

The following image also indicates the amount of S/C heavy pointing to the SW corner of the Church and tower.

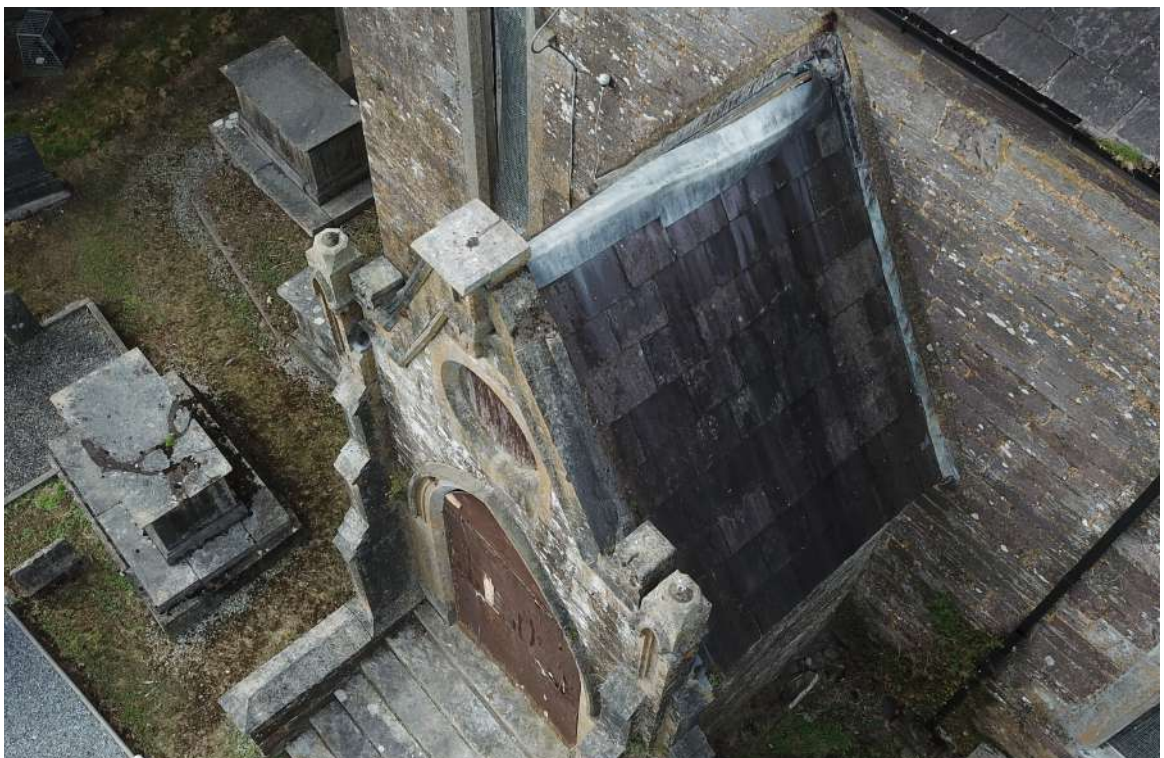
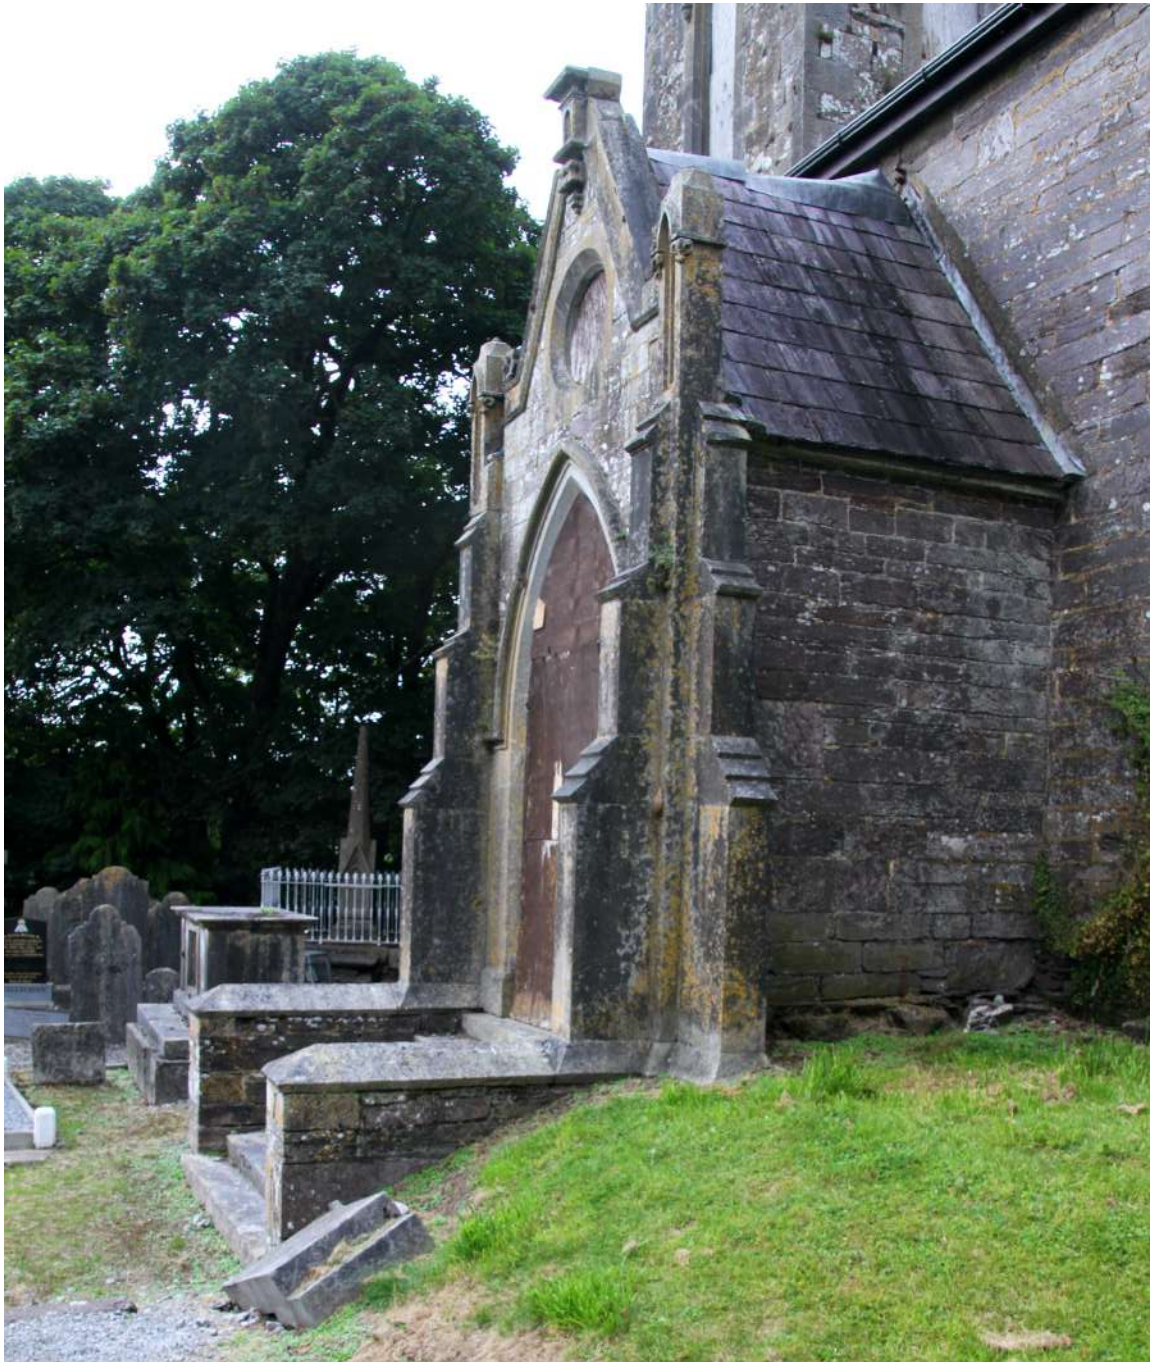
There is a tooled limestone gabled parapet with corner pinnacles to porch, along with carved limestone buttresses with pinnacles to porch. Sadly there is detail missing here too it would see, and a little research might uncover some evidence of what was there? Dowel fixing holes can still be seen.

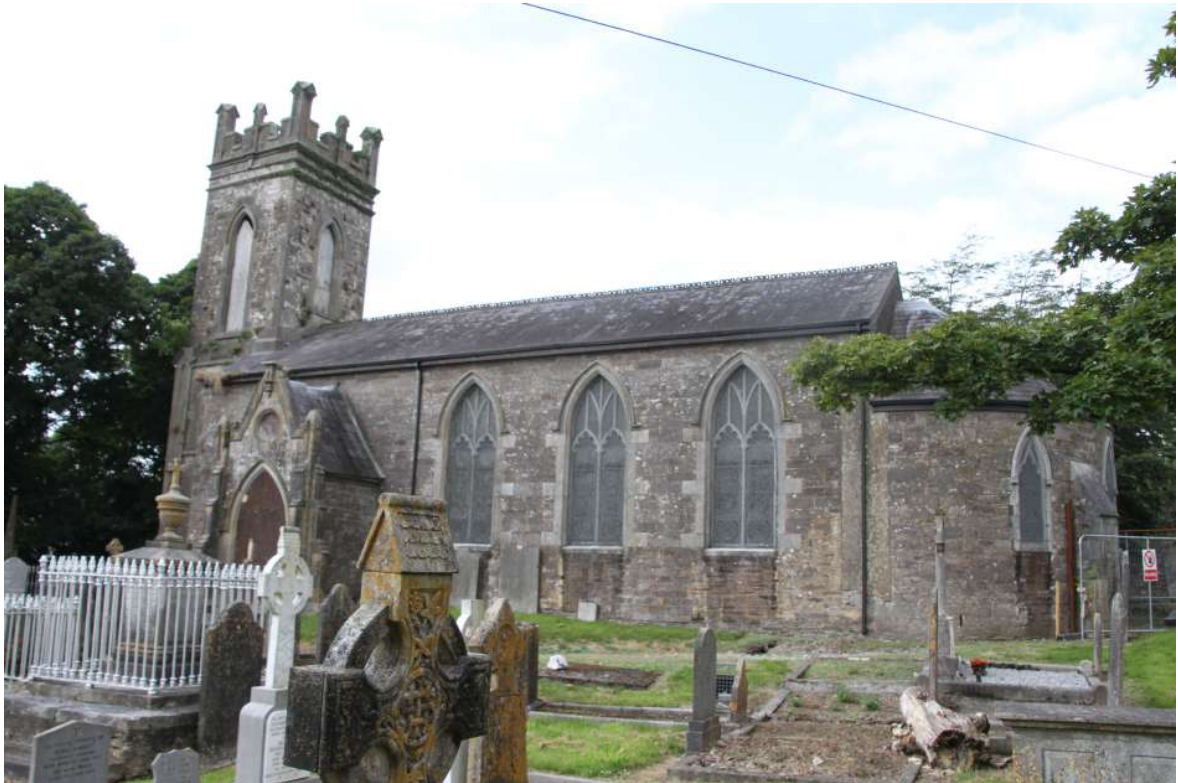
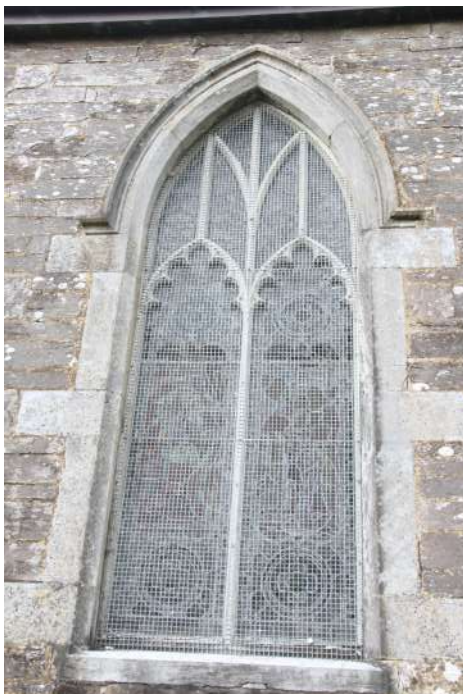
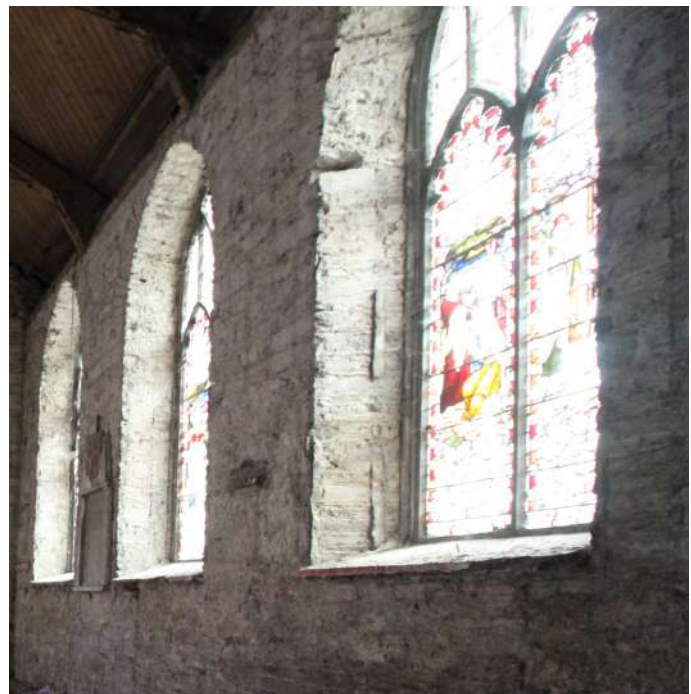
The windows themselves are removed in some areas and some are damaged in-situ.

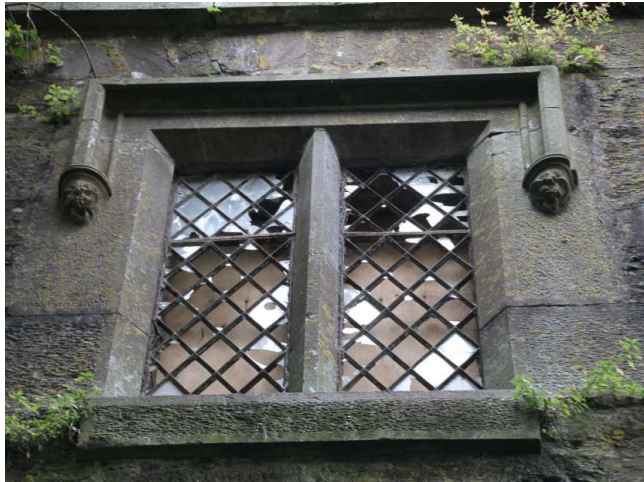
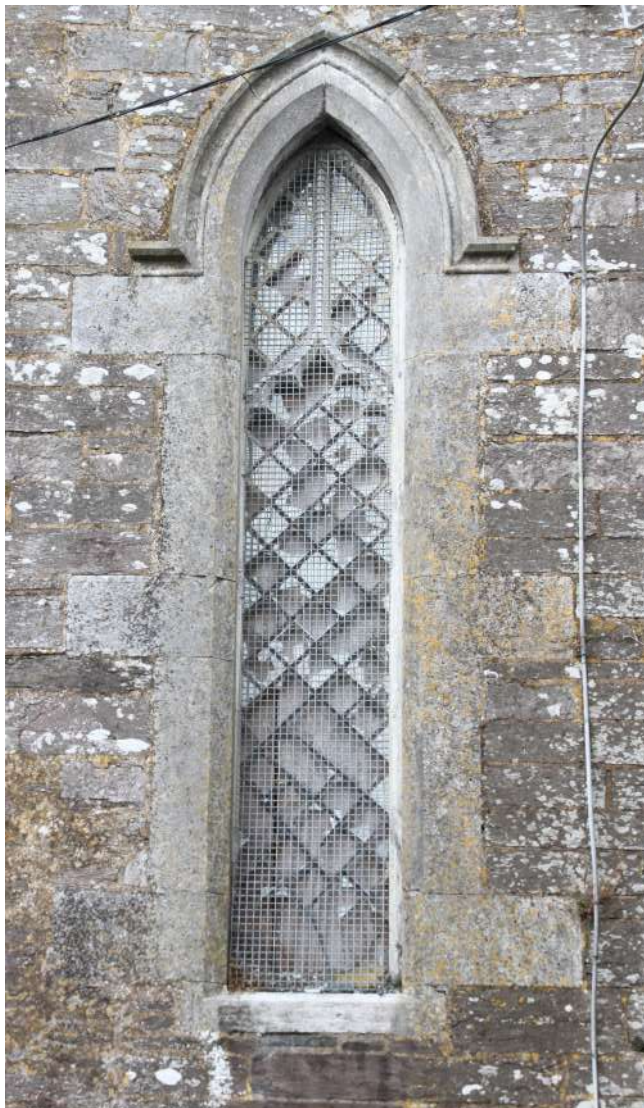
Externally windows are protected with steel mesh, and the main larger windows along Nave are reasonable safe and secure. In the less protected and smaller opes there is more damage, and repairs needed. Storm glazing/ secondary outer screen might be more appropriate in future?

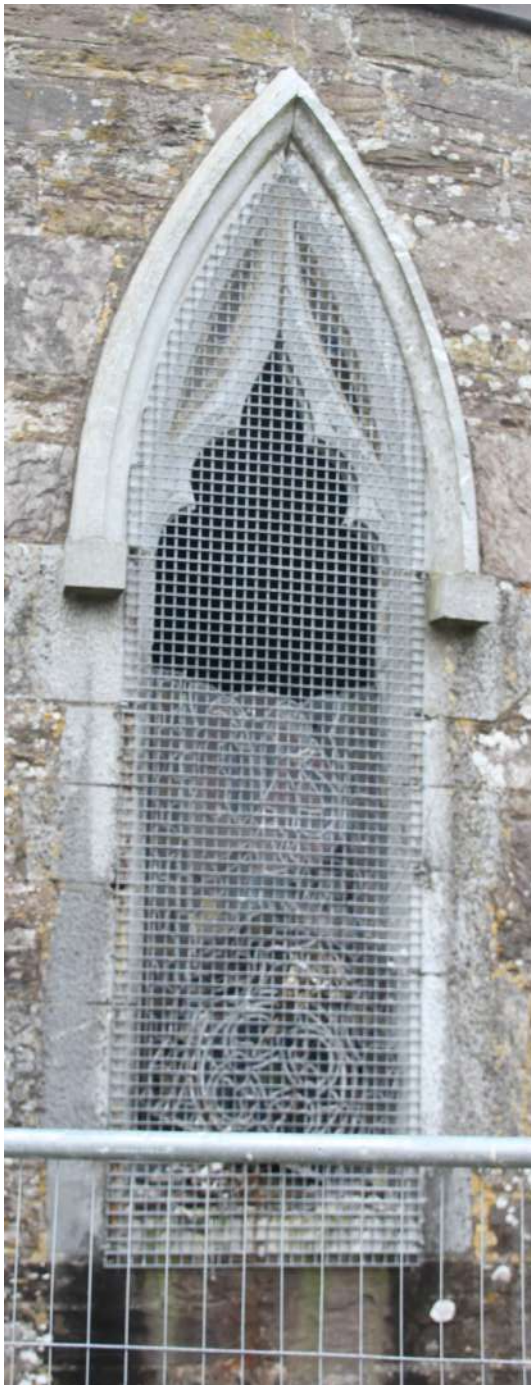
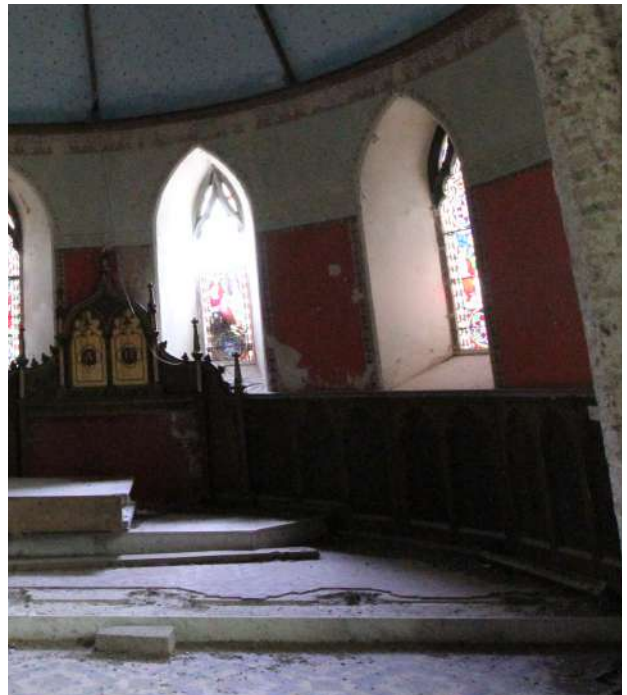
Damaged windows.

In order to conduct a full and detailed close-up survey of windows, including lead work and bedding of frames/ support structures, a platform/ ladder access would be required. We would like to see the general closer condition in due course and particularly where one of the stained glass windows behind the Alter in the Apse has been damaged and is in need of significant repair. This window should be better protected ASAP.

There are some damaged windows and they should be protected asap from further damage. The rear Chancel stained glass window that is damaged should be afforded support internally to prevent further collapse. Ideally the damaged windows should be restored and fully repaired. There are a few stained glass artists who could advise and make recommendations in this regard.

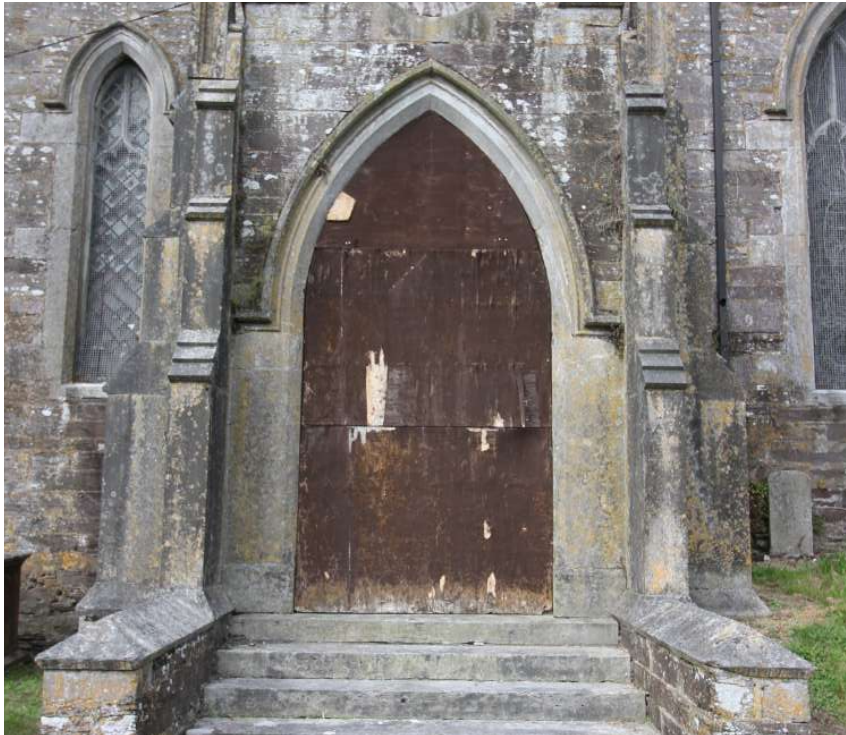
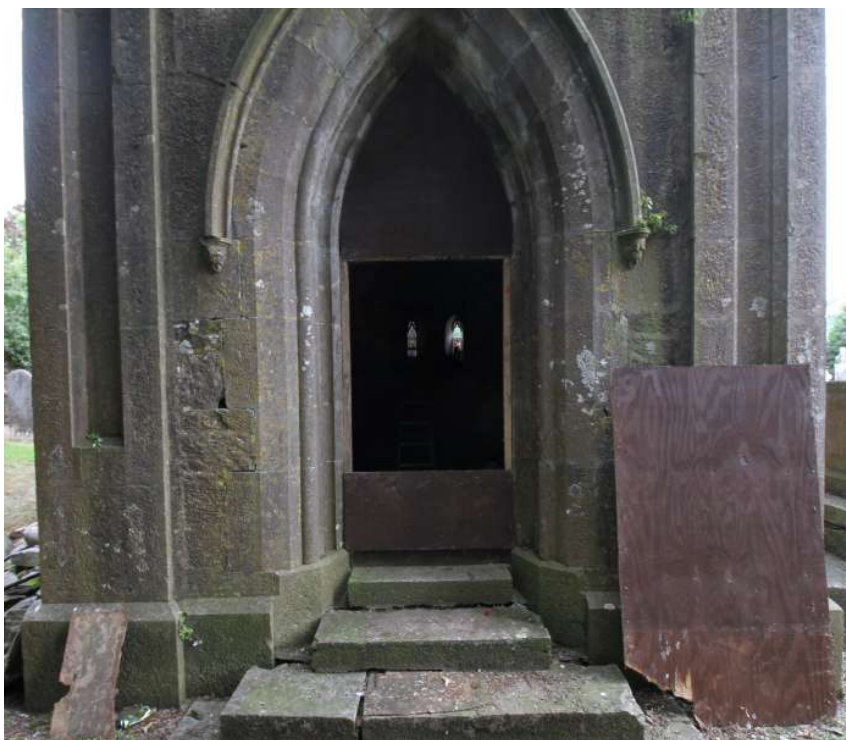
The doors have sadly all gone and will need replacement in due course. All door opes have been blocked up and secured.
