Gallanes Amenity Area (Phase 2)

Road Safety Audit Stage 1/2

**OCTOBER 2021**

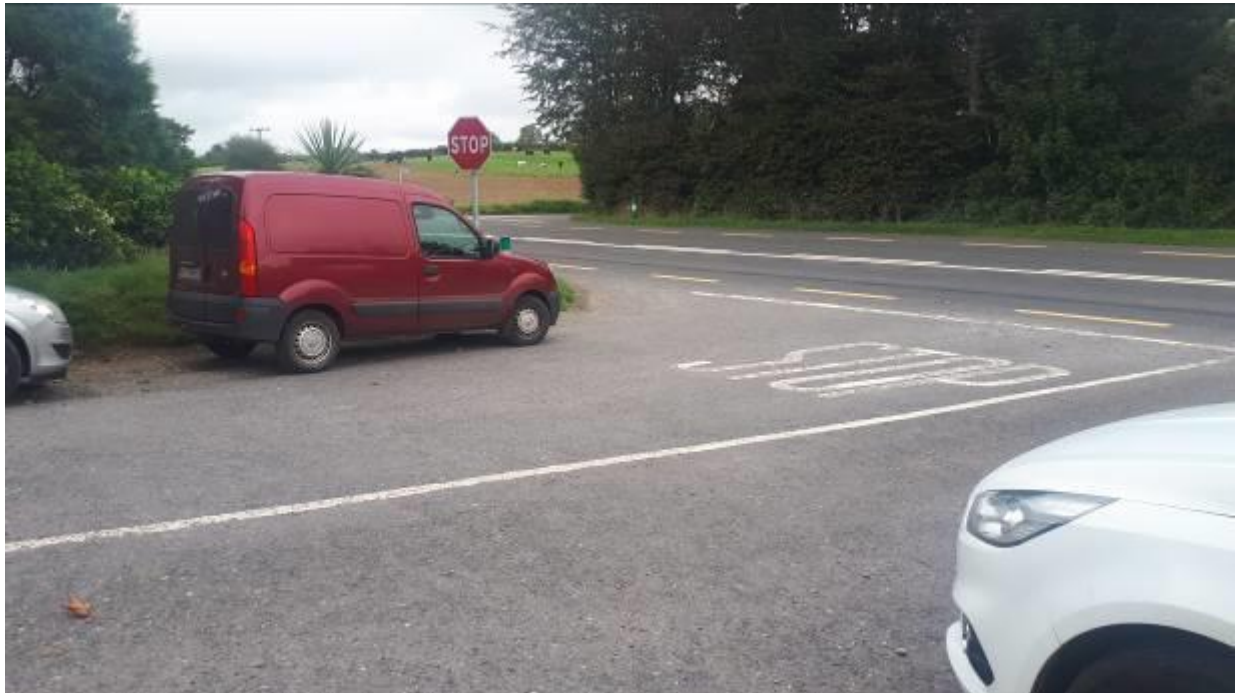
Visibility splays at the amenity walk tie in location are limited by its proximity to existing roadside parking. Failure to provide appropriate visibility at the junction may lead to collisions between passing vehicles and vehicles exiting the junction. See Photos A1 and A2 in Appendix A.

Figure 8.2 Photo A1 Parking in the vicinity of the proposed entrance (Looking north)

Provide parking enforcement control road markings with traffic management build-outs and double yellow road marking in the vicinity of the entrance to ensure that appropriate visibility is provided.

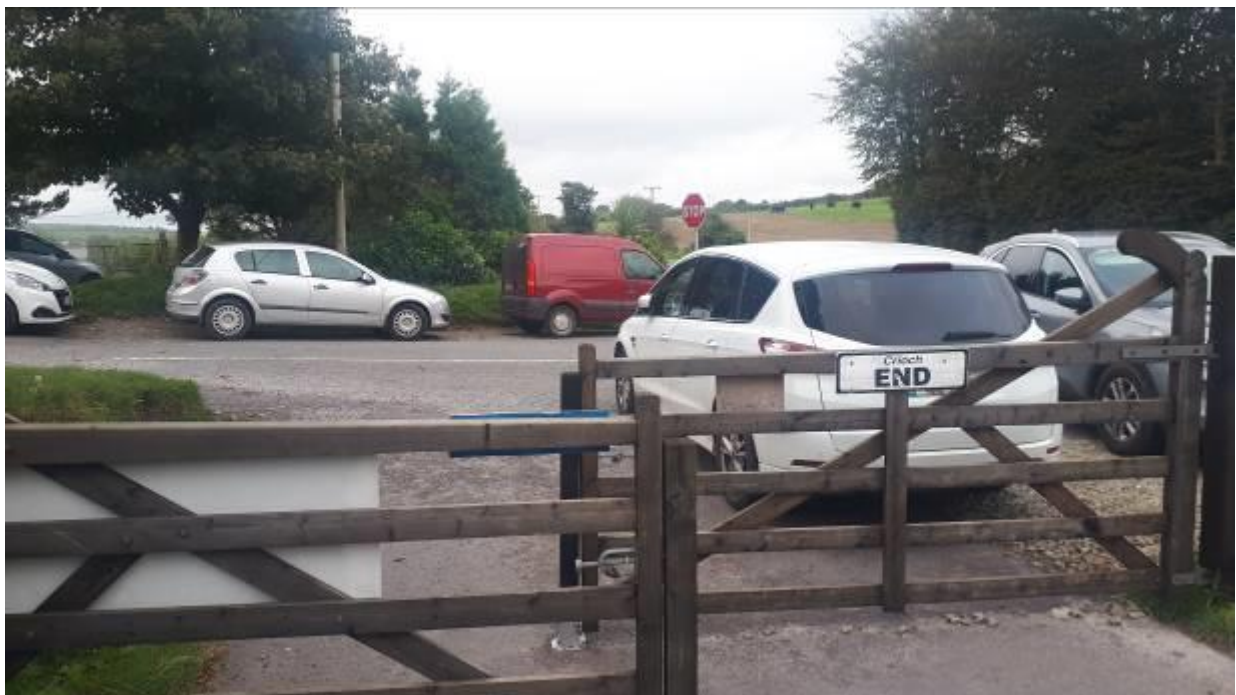
Figure 8.3 Photo A2 Parking in the vicinity of the proposed entrance (Looking north)

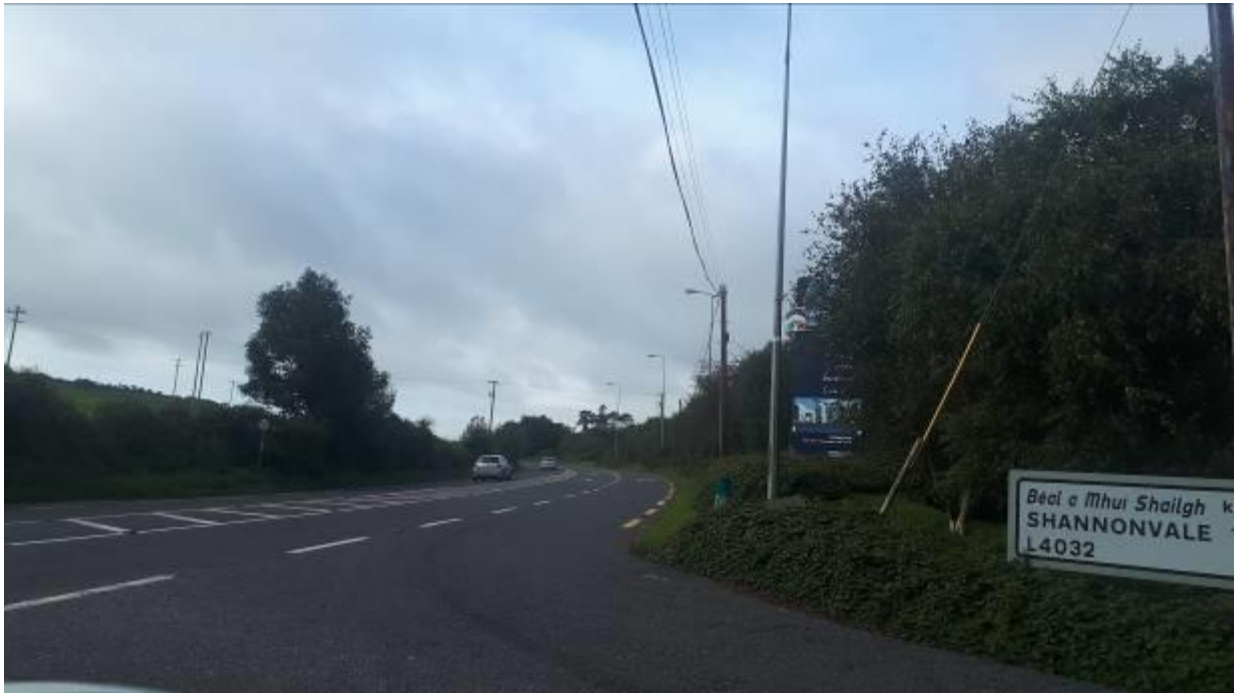
The proposed layouts do not show tactile paving at the proposed pedestrian crossing location. Failure to provide appropriate tactile paving may lead to visually impaired/vulnerable users walking onto the road carriageway. This could lead to collisions between vehicles and vulnerable users at this location. See Photos A3 and A4 in Appendix A.

Existing visibility splays at the N71 junction should not be hindered by any pedestrian crossing proposals. Failure to provide appropriate visibility at the junction may lead to collisions between passing vehicles and vehicles exiting the junction. See Photos A3 and A4 in Appendix A.

Existing visibility splays at the Clonakilty Rugby Football Club junction should not be hindered by any pedestrian crossing proposals, boundary treatment proposals or proposed amenity parking facilities. Failure to provide appropriate visibility at the junction may lead to collisions between passing vehicles and vehicles exiting the junction. See Photos A3 and A4 in Appendix A.

It is unclear if the sufficient forward visibility of approaching cars to the new pedestrian crossing is provided. Failure to provide appropriate forward visibility of the pedestrian crossing may lead to collisions between vehicles and vulnerable users at this location. See Photos A3 and A4 in Appendix A.

**Figure 8.4 Photo A3 Parking in the vicinity of the proposed entrance (Looking south)**

Provide appropriate junction tactile paving on both sides of the junction.

Provide appropriate junction offset for any pedestrian crossing proposals, inclusive of enforcement road markings with traffic management buildouts and double yellow road marking in the vicinity of the entrance to ensure that appropriate visibility is provided.

Provide appropriate setback of the car parking spaces from the rugby club boundary with the local road, ensuring junction visibility splay envelopes at the RFC entrance are appropriate to the relevant design speed.

Provide appropriate forward sightlines on all approach arms to the junction, ensuring crossing pedestrians can be clearly seen from the appropriate FSD.

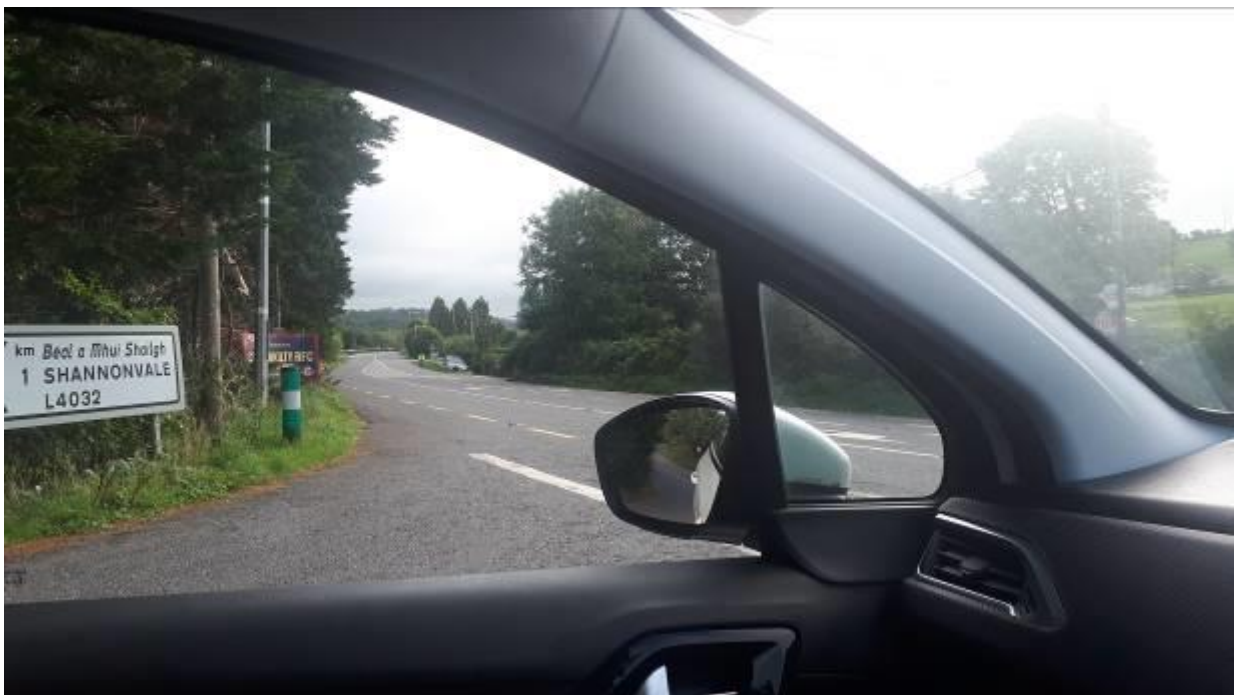
**Figure 8.5 Photo A4 Parking in the vicinity of the proposed entrance (Looking north)**

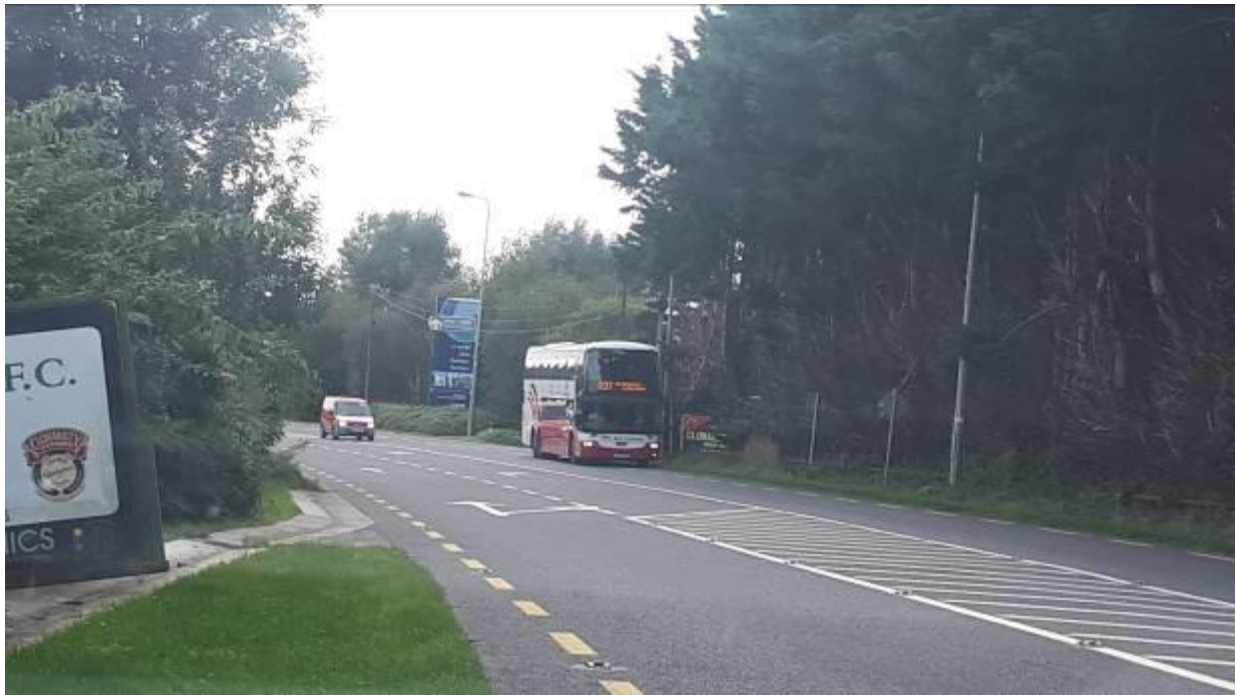
During the site visit, the daily Bus Eireann 237 service that passes the site was seen to stop directly at the N71/L4032 junction, creating a traffic hazard. This is noted in Photo A5. This led to diminished sightlines for existing traffic onto the N71 and unsafe pedestrian movements along the N71 carriageway road edge.

**Figure 8.6 Photo A5 Parking in the vicinity of the proposed entrance (Looking west)**

Provide appropriate bus set down facilities at this location to service the Business/Technology Park and rugby club, ensuring compliance with relevant design standards.

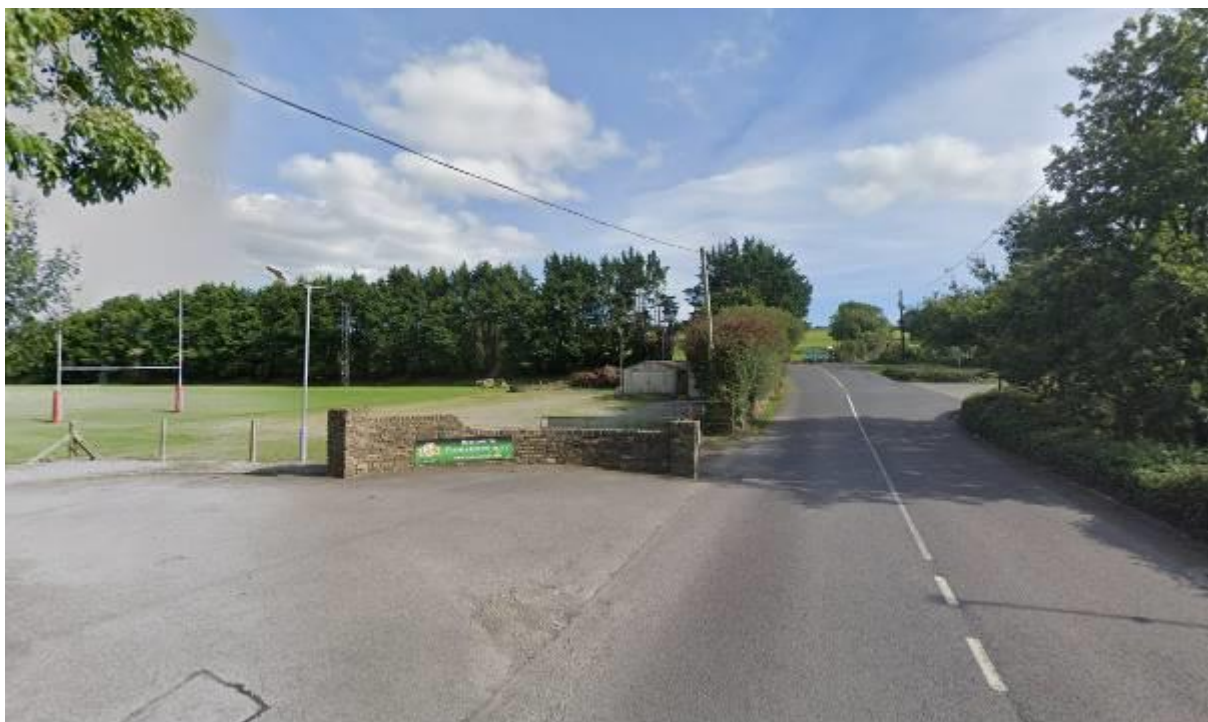
**Figure 8.7 Photo A6 Existing RFC junction entrance (Looking south)**

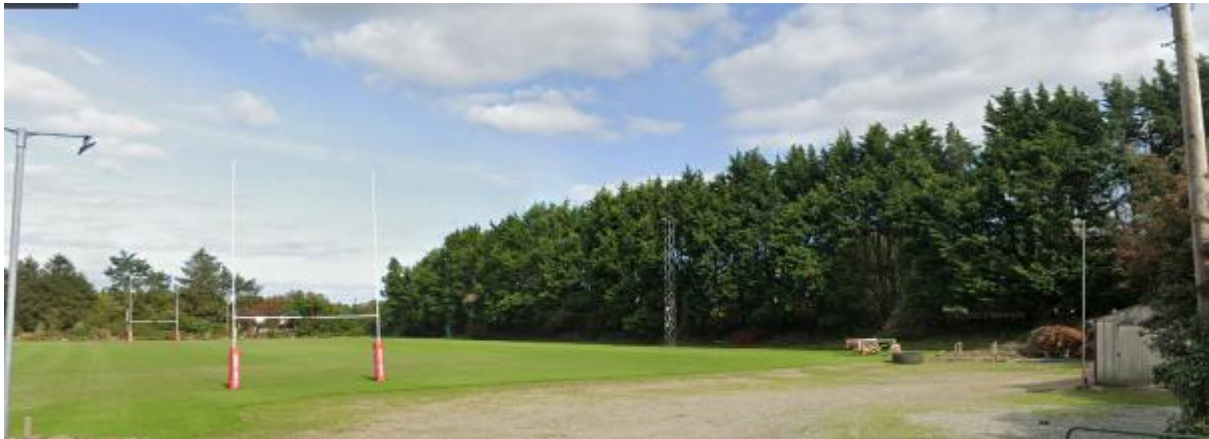
It is unclear from the layouts what boundary treatment is proposed along the section of amenity walkway that runs adjacent to the Rugby Club. Failure to provide appropriate boundary treatment provision may lead to trip/fall hazards to pedestrians travelling to/from this pedestrian route. See Photos A7, A8 and A9 in Appendix A.

It is unclear if the mature line that currently lines the boundary between the N71 and the Clonakilty RFC is to be removed. The existing mature trees block pitch flood lighting from entering onto the adjoining N71 carriageway. Failure to take account of obtrusive flood lighting dazzling passing traffic may lead to traffic collisions. See Photo A7 in Appendix A.

**Figure 8.8 Photo A7 Existing practice pitch flood lighting (Looking east)**

Provide appropriate boundary treatment provision along pedestrian walkway, ensuring compliance with relevant design standards.

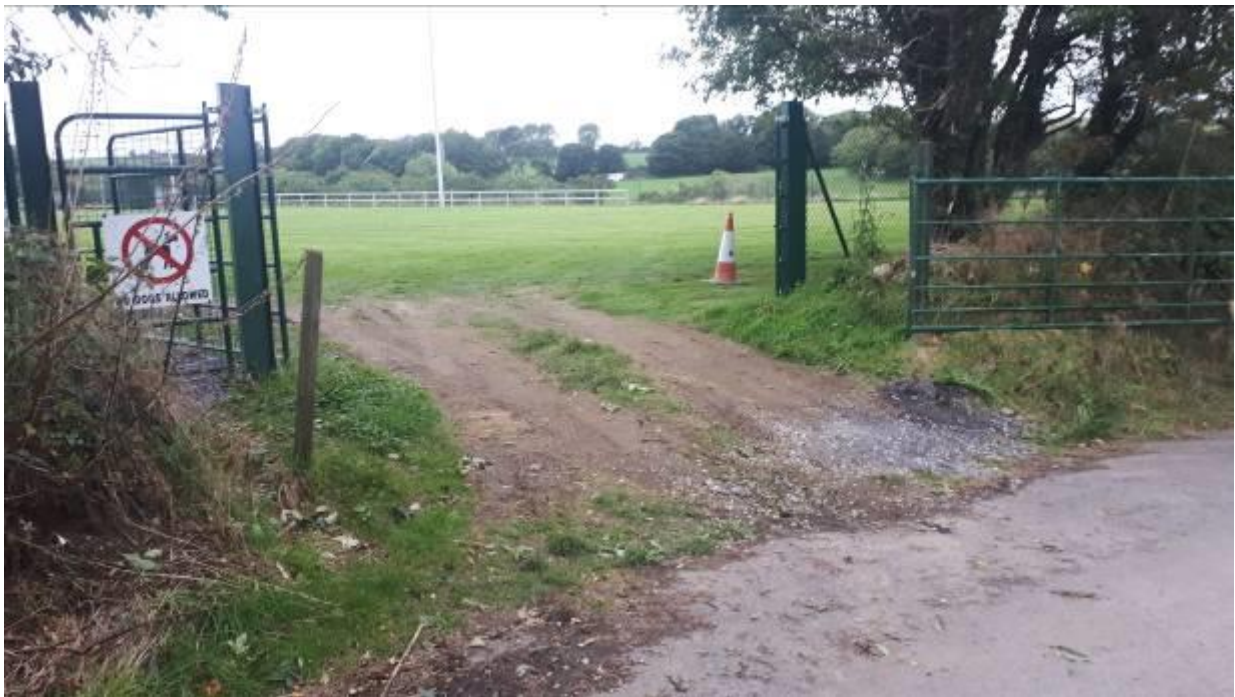
**Figure 8.9 Photo A8 Parking in the vicinity of the proposed entrance (Looking west)**

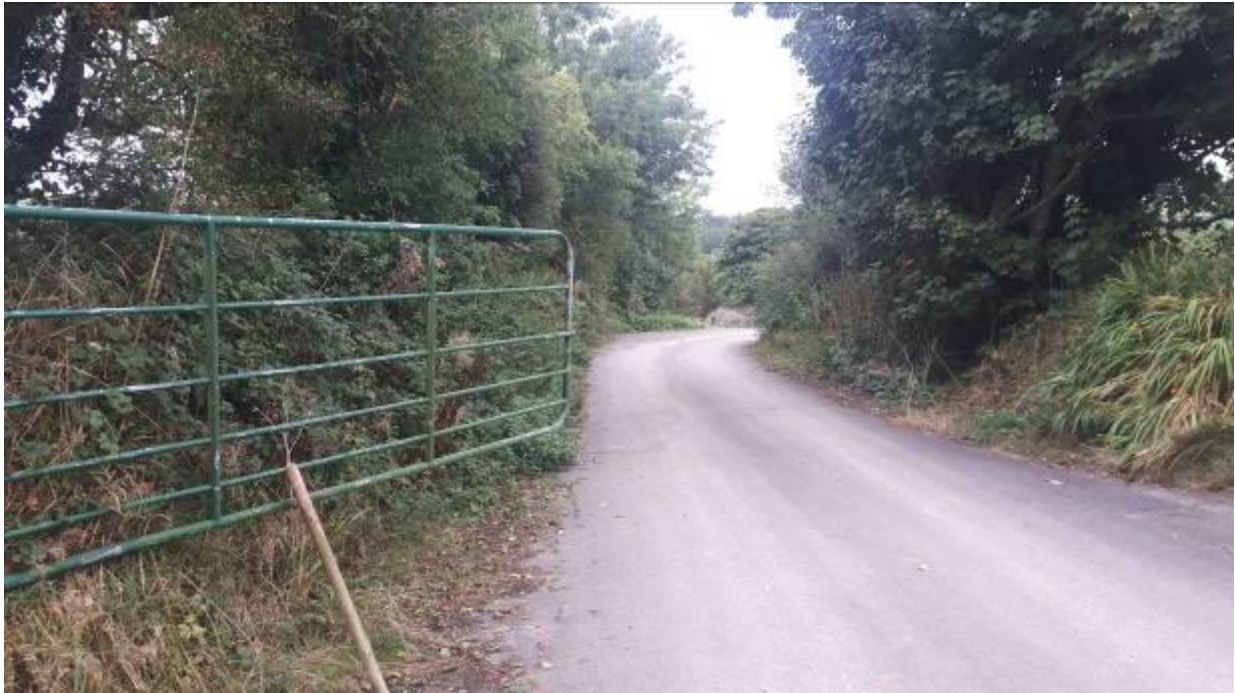
**Figure 8.10 Photo A9 Parking in the vicinity of the proposed entrance (Looking north)**
