7no. Coastguard Cottages at Lower Road, Crosshaven, Co. Cork

Conservation Report

14 October 2021- **P02**

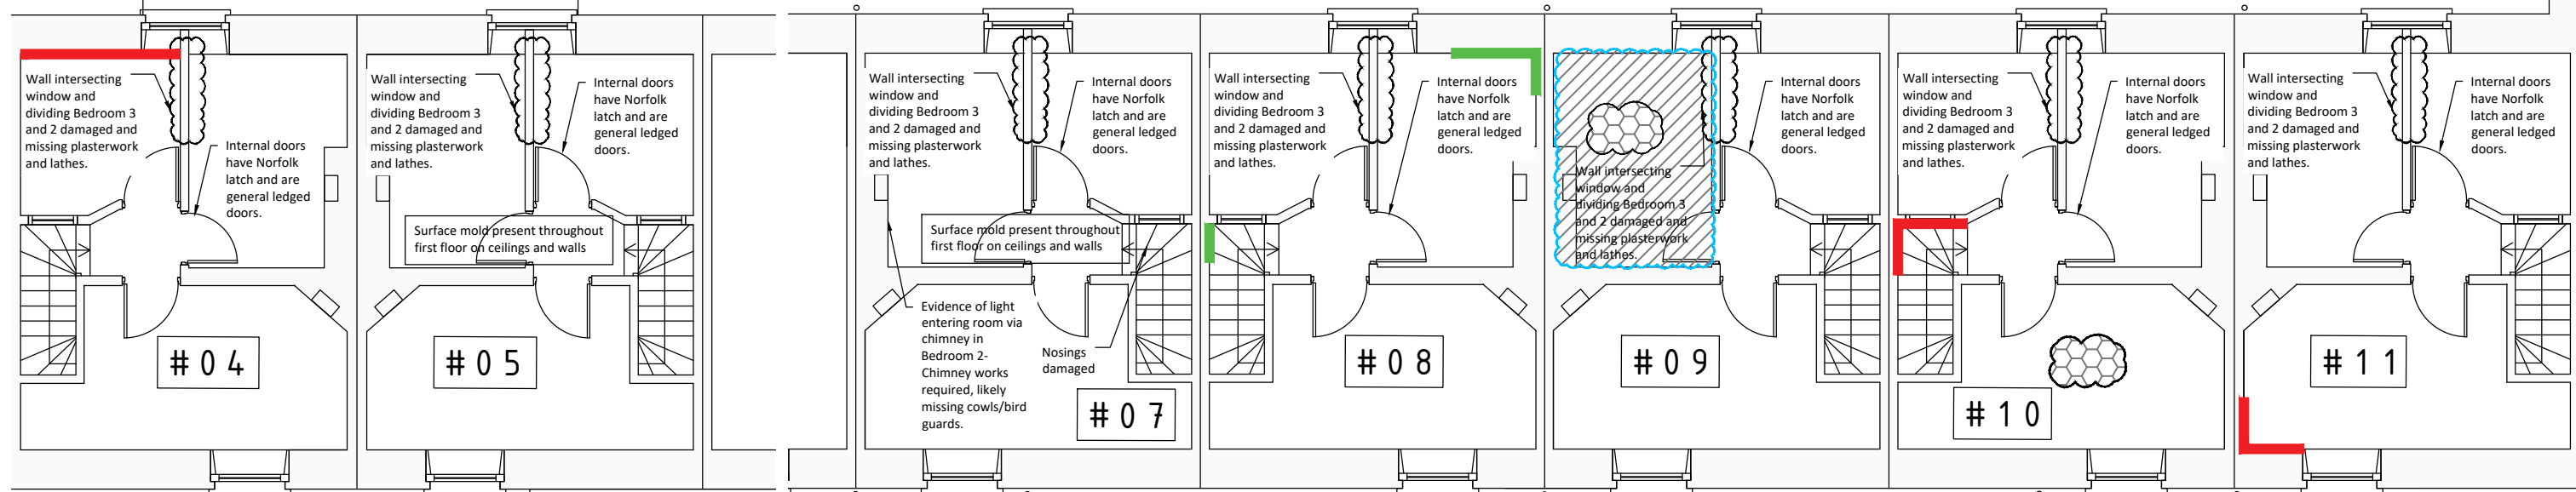
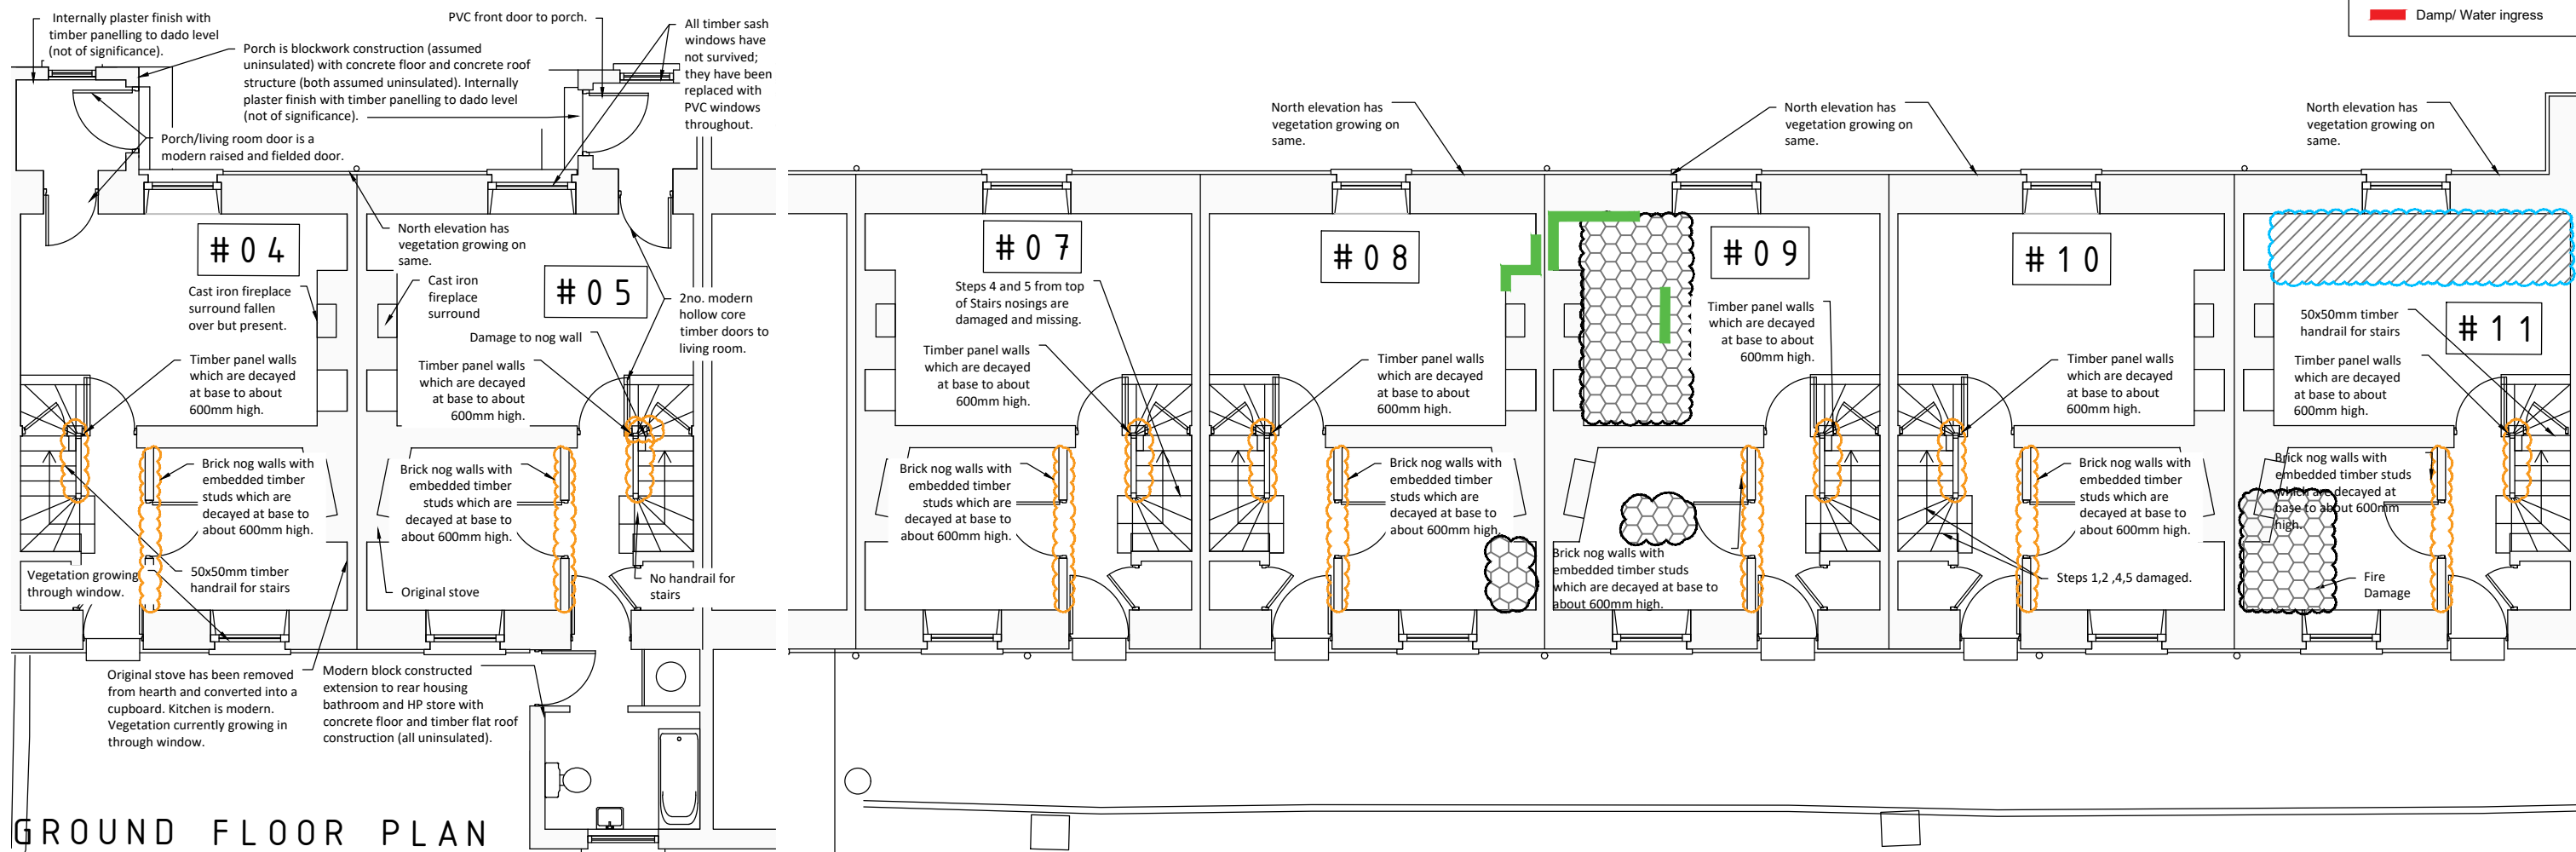
DWG TITLE
CONDITION SURVEY PLANS
SY_110

- Lathe and plaster ceilings though out generally in ok condition with exceptions as per (see SY_110).
- Rainwater goods in poor condition, down pipes missing and guttering damaged in parts (see SY_310 for locations).

- Closed string timber staircase on ground floor decayed due to rising damp.
- North room (living room) has a suspended timber joist floor assumed on sleeper walls (no access/ opening) with timber floorboard finish in poor condition (see SY_110 for locations).

- Cast iron fire surrounds have fallen over in some units (see SY_110 for locations).
- Original stove in kitchen hearth in poor condition.

- Walls between hall and kitchen and hall and store are brick nog walls with embedded timber studs which are decayed at base to about 600mm high due to rising damp (see SY_110 for locations).
- Walls between hall and stair are timber panel walls which are decayed at base to about 600mm high due to rising damp (see SY_110 for locations).
- Wall between kitchen and living room is assumed as solid brick structural walls supporting the floor joists above partially continuing to ceiling.
- Damages to first floor timber floors (see SY_110 for locations).
- Wall plates not visible- assumed damp/decayed.
- 150x50 Roof rafters with high collars @ 350 c/c supporting 50x12 battens @ 400 c/c supporting slate with lime parging between slate.

- Damaged area
- Damaged suspended timber floor
- Damaged lathe and plaster ceiling
- Dry/Wet Rot
- Damp/ Water ingress

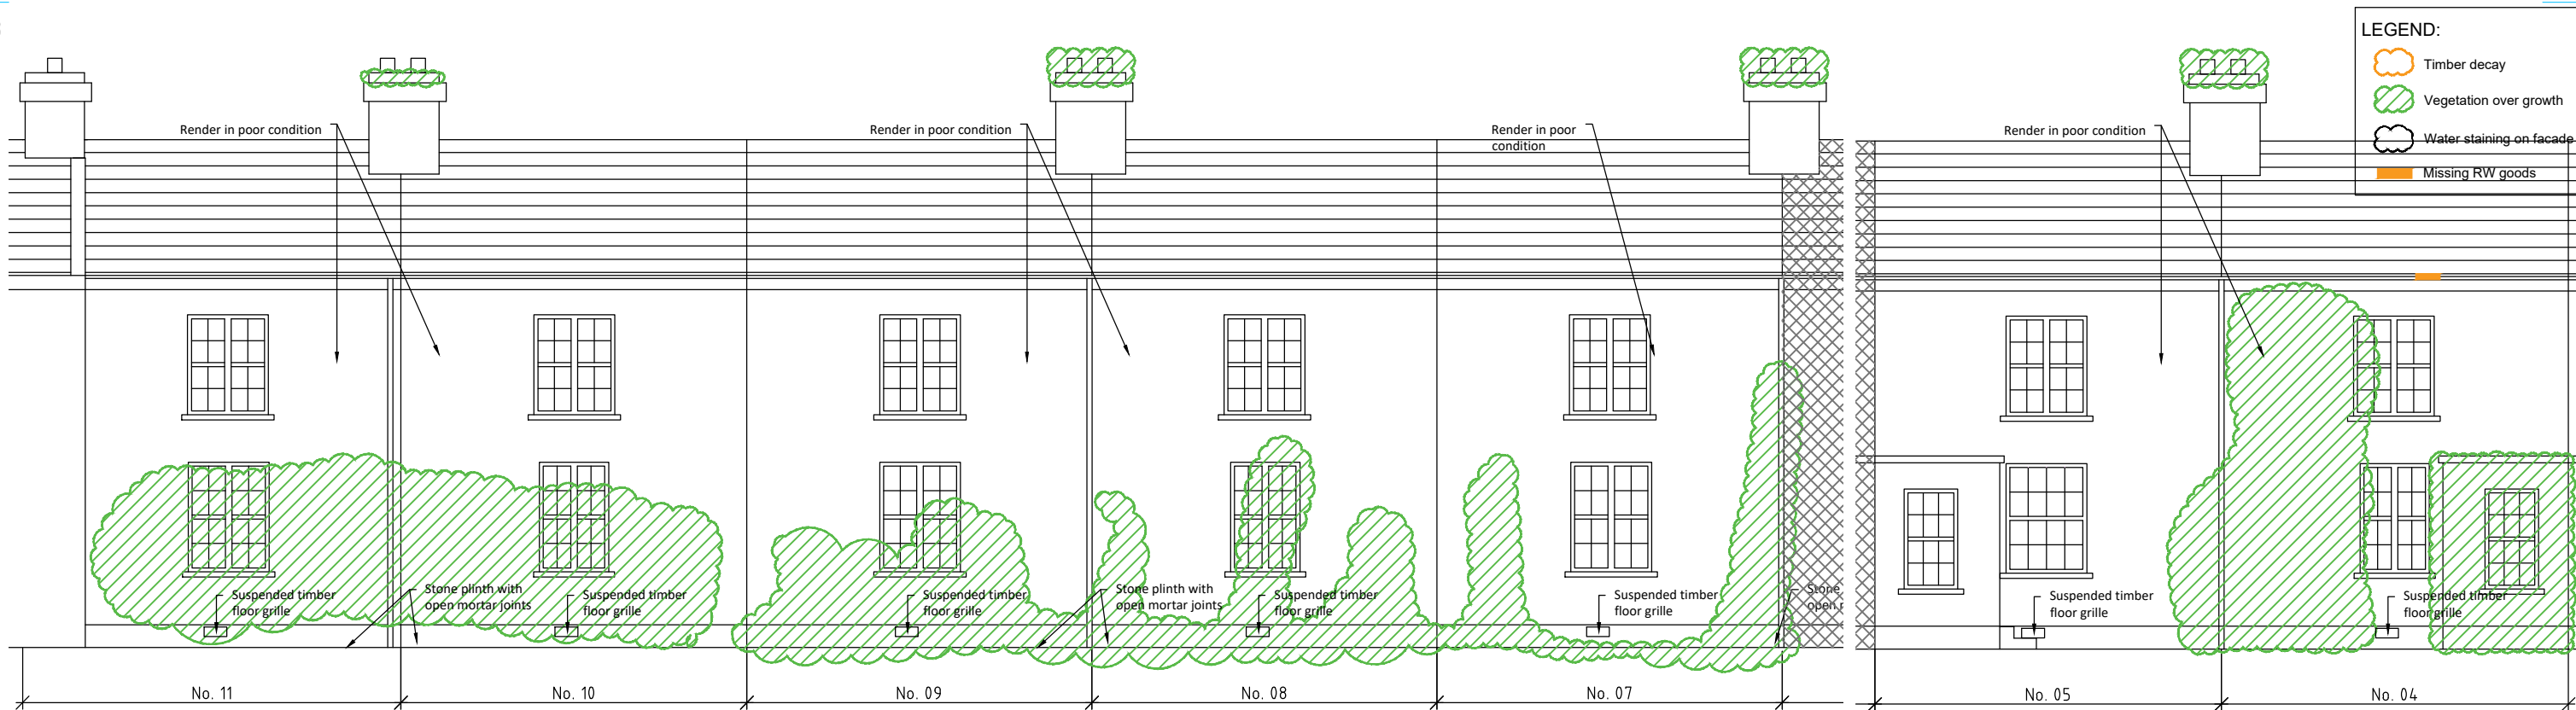
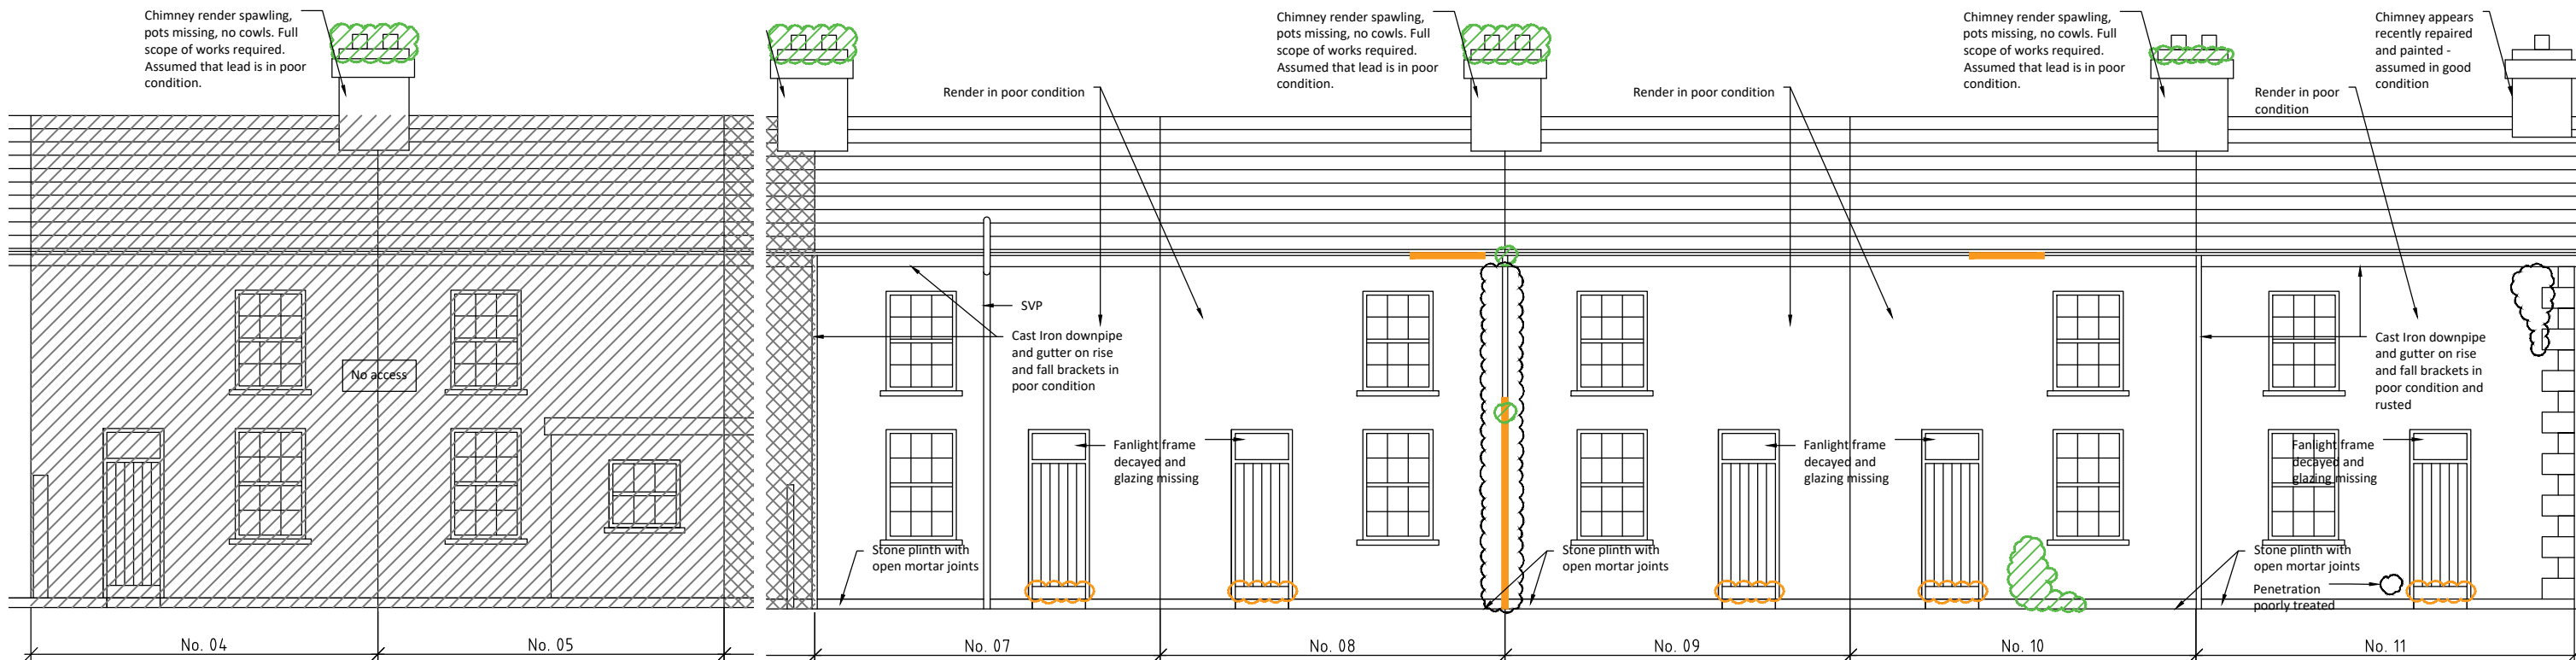
CONDITION SURVEY PLANS
SY_110

- Remnants of historic boot scrapes present for units 7,9,10,11 (see SY_110 for locations).
- Ledge and braced timber sheeted external door decayed at bottom- ditto for door frames, integrated clear glass over light with opening section in poor condition (see SY_310 for locations).

- Chimney flaunching, brickwork, and lead in poor condition, vegetation present (see SY_310 for locations).
- Eave's stone, corner quoin stones and stone plinth (180mm high) have open mortar joints (see SY_310 for locations).

- Existing rendered elevations in poor condition (see SY_310 for locations).
- North elevation overgrown with vegetation (see SY_310 for locations).
- Cast iron ventilation grilles are rusted but present for suspended timber floor (some have been blocked up) (see SY_310 for locations).
