Proposed Bantry Peace Park Playground,  
Glengarriff Road, Bantry

STAGE 1 & 2 ROAD SAFETY AUDIT

April 2023

<b>Client</b>	Cork County Council
<b>Project Title</b>	Proposed Bantry Peace Park Playground
<b>Document Title</b>	Stage 1 & 2 Road Safety Audit
<b>Document No.</b>	23030RS-Doc01
<b>Job No.</b>	23030RS

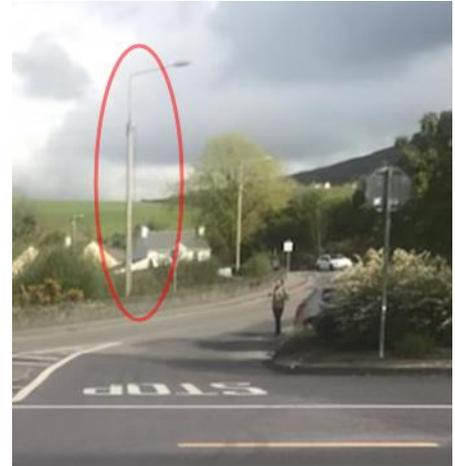
### 2.1 PROBLEM 1: Light Pole at Entrance to the Proposed Car Park is a Potential Obstruction

There is an existing street light on the Slip Road behind the stone boundary wall at the approximate location of the proposed entrance to the car park. This light pole has not been indicated for relocation on the design layout drawings. If not addressed this lighting column could be an obstructing hazard for road users accessing the car park, resulting in evasion manoeuvres and possible resultant collisions with the entry pillars, opposing vehicles or the pole itself. See photos A2 and A5 which both show this public light pole.

#### Recommendation 1

Check whether or not this pole might be an obstruction at the car park entrance, requiring relocation to a safer place.

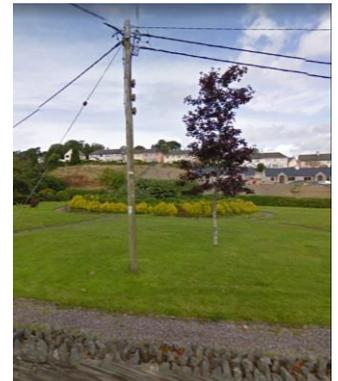
### 2.2 PROBLEM 2: Light Pole in Playground is a Potential Obstruction

There is an existing street light in the Peace Park behind the stone boundary wall that appears to clash with the playground proposals. This light pole has not been indicated for relocation on the design layout drawings. If not addressed this lighting column could be an obstructing hazard for children playing in the playground as they may run into the pole itself or trip over one of the cable stays, and there is a potential live electricity proximity danger also. See photos A1, A3, A4 and A6 which show this public light pole with numerous electric cables extending in all directions from it.

#### Recommendation 2

Consider relocating this pole a safe distance from the playground area.

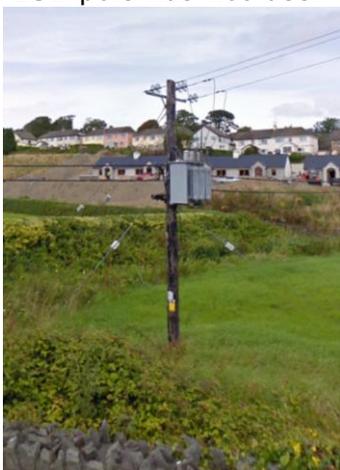
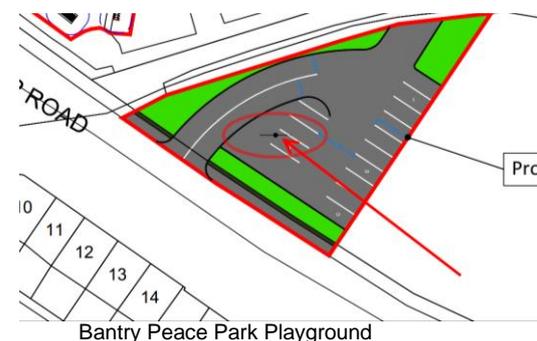
### 2.3 PROBLEM 3: ESB Electricity Network Pole is an Obstruction

There is an existing ESB network pole with a transformer on it behind the stone boundary wall in the middle of the proposed car park. See photo and sketch below. This ESB pole has not been indicated for relocation on the design layout drawings. If left in

position the pole and cable stays would obstruct at least 2 spaces and constitute an obstructing hazard for road users manoeuvring their vehicles in the car park, potentially resulting in evasion collisions with opposing vehicles or with the pole itself. See photos A2 and A5. And there is a potential live electricity proximity danger also for pedestrians.

**Recommendation 3**

Consider relocating this pole a safe distance from the car park vehicle and pedestrian circulation area.

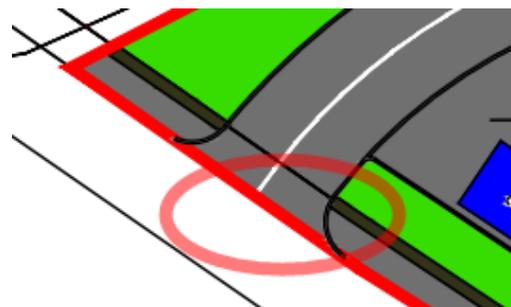
**2.5 PROBLEM 5: No Road Markings or Traffic Signs**

No road marking details or “Stop” traffic sign have been provided at the vehicular access from the car park onto the L-4711 Slip Road. Lack of regulatory road markings or signage could lead to collisions involving vehicles exiting the car park failing to stop at the public road resulting in collisions with vehicles passing by.

**Recommendation 5**

Provide adequate “STOP” road markings and sign at the proposed exit.

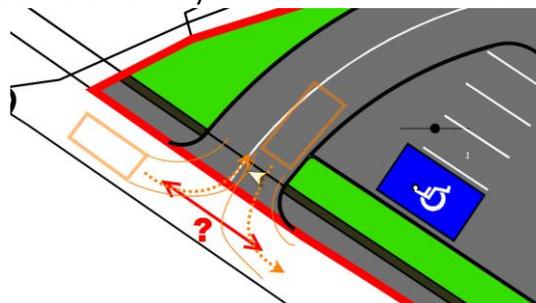
**2.6 PROBLEM 6: Narrow Entry/Exit Lanes at Car Park Junction**

The entrance width to the car park access appears very narrow at the bell mouth. There is a risk that vehicles entering and exiting at the same time may collide with each other.

**Recommendation 6**

Consider using a swept path analysis tool for the Design Vehicle such that the optimal entry/exit width can be provided.

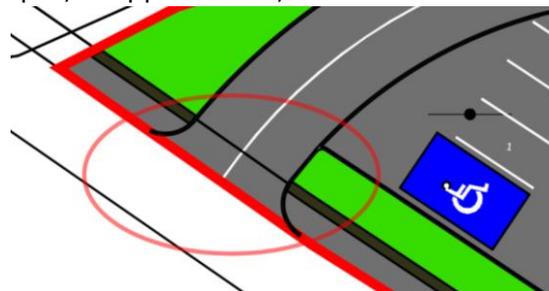
**2.7 PROBLEM 7: Lack of Tactile Paving at Proposed Development Entrance**

No tactile paving has been shown to be installed at the proposed entrance into the car park. Neither is there any reference made to “ramps”, dropped kerbs, dished footpaths or raised entry treatment at the junction. Failure to provide an appropriate pedestrian/vehicle interface with tactile paving may lead to collisions between visually impaired pedestrians and vehicles entering and exiting the proposed car park.

**Recommendation 7**

Provide the appropriate tactile paving at both sides of the development entry/exit point in accordance with the relevant guidelines. Further details should also be provided regarding proposals for ramps, drop kerbs etc. It may be more appropriate to provide a raised entry treatment across the entry/exit lanes as would be more comfortable for wheelchair users and the mobility impaired passing by on the footpath.

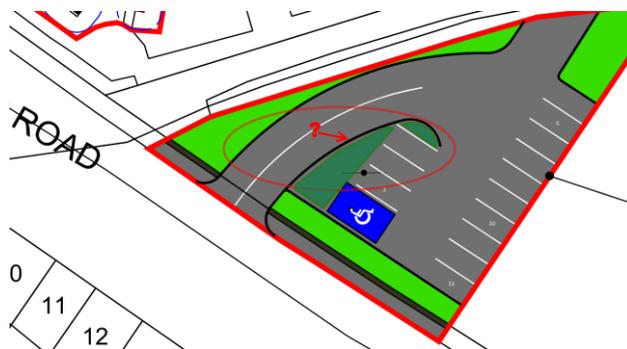
**2.9 PROBLEM 9: Lack of Clarity on Road Edge Proposals**

It is not clear from the design layout of the car park if the road edge will be defined by a kerb line or drainage feature as no construction details or cross section have been provided. In the absence of a hard kerb line defining the road edge there is the potential for vehicles to cross from the access road directly into the car park spaces near the entrance. This could result in incoming vehicles colliding with those carrying out parking manoeuvres or with pedestrians who are walking in the car park on the shared surface.

**Recommendation 9**

Provide a segregating road edge such as a precast concrete kerb or an alternative surface between the access road and the car park. Consider providing some landscape areas and pedestrian refuge between the access road and the car park in the area highlighted green in the adjacent sketch.

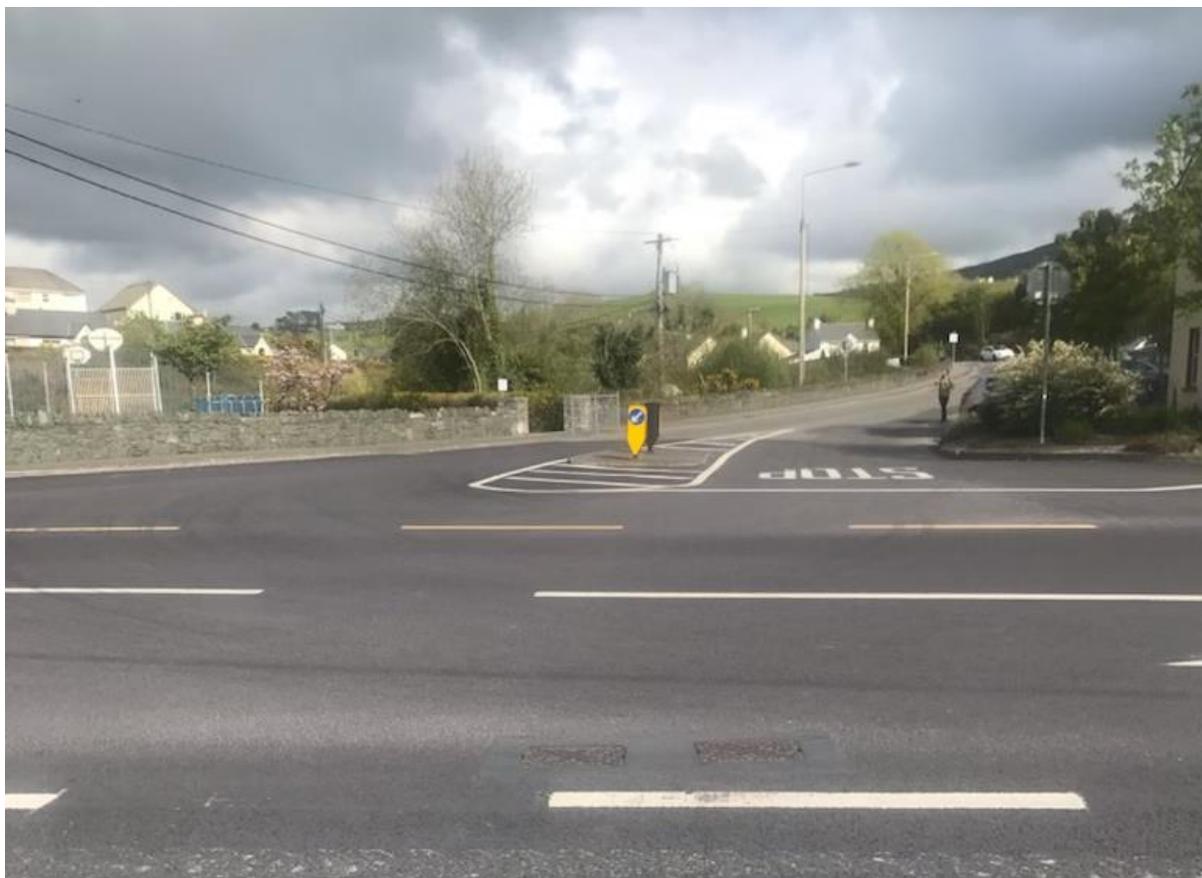
**Photo A2 – View East along Slip Road from N71 & View of Peace Park from West**

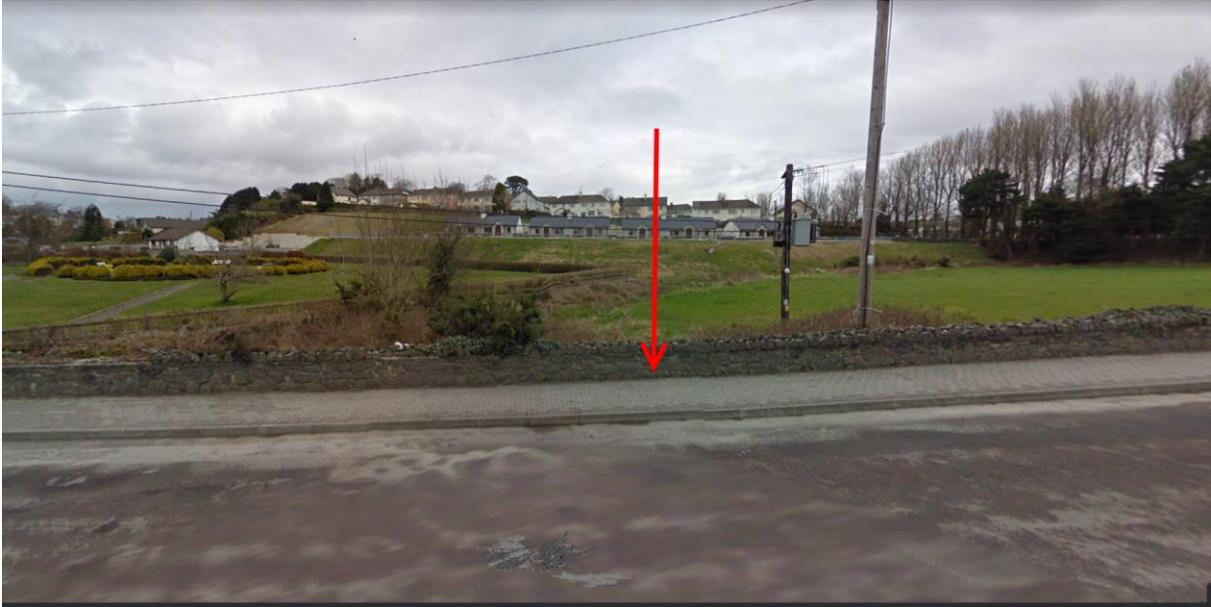
The ground level of the site for the proposed car park is much lower than the level of Slip Road. See Photo A5. As no vertical alignment information has been provided it is not clear if it is intended to fill the car park site or have a gradient on the access road to the car park to connect the level difference. A steep access gradient could cause issues for vehicles egressing the car park with potential for rear end shunt type collisions caused by roll back (handbrake release) of queuing vehicles waiting to exit the car park.

**Photo A5 –View of Site of Proposed Playground Car Park with Proposed Entrance Location Highlighted with Red Arrow**

Ensure there is a level plateau at the junction where the access road meets the public road footpath in accordance with the appropriate road design standards. This is important for junction sight lines too.

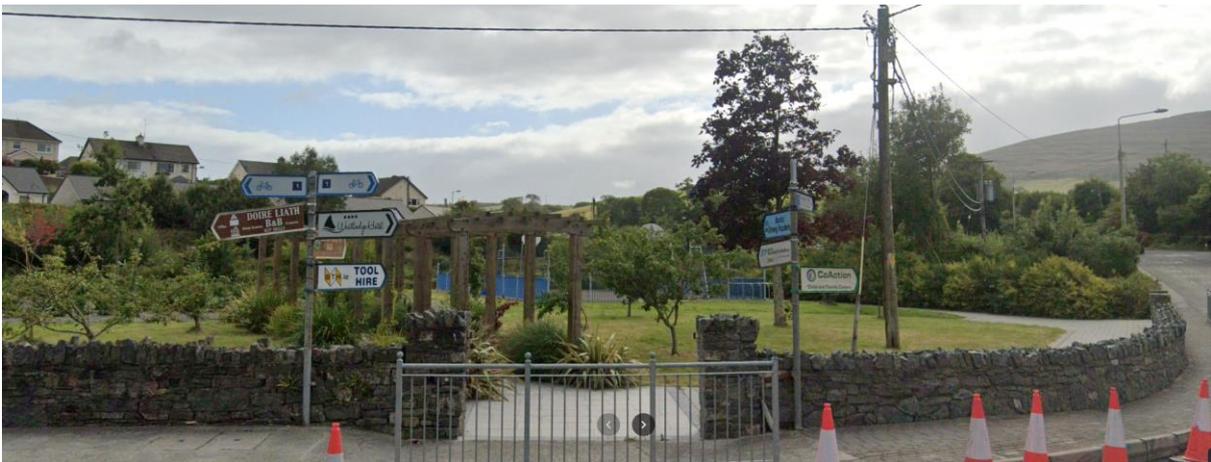
**Photo A6 – View of Peace Park from the N71 South West Entrance through Boundary Wall**
