Carrigaline UDF and Public Realm

Stage 1 - Road Safety Audit

Cork County Council

July 2023

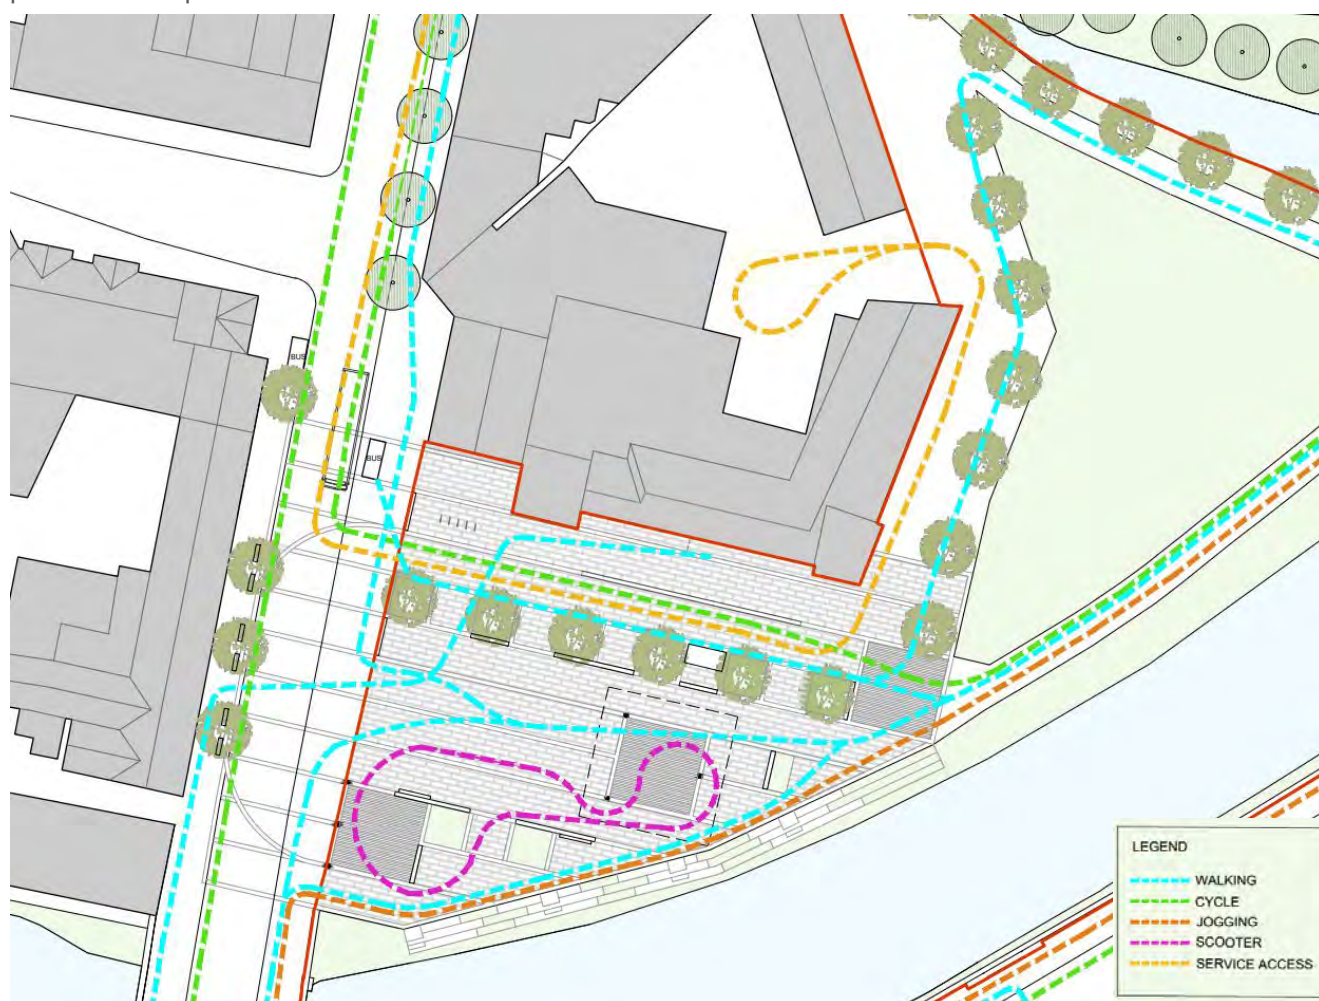
Figure 2-1 - Details of Service Access and Inter-Action with Other Users

The proposed service/delivery vehicle access route to the courtyard at the rear of the cluster of commercial buildings is not clearly defined, as the surfacing of the public plaza appears to be the same throughout. This could lead to a pedestrian or cyclist being unaware that the area is also shared with service/delivery vehicles, which could cause collisions between unsuspecting pedestrians/cyclists and service/delivery vehicles. Typically, service/delivery vehicles are large in nature which would exacerbate any potential collision.

Further to the above, the surfacing of remainder of the service/delivery vehicle access route, just north of the public plaza is not defined. It appears from the design drawings to be regular tarmac which would indicate vehicle priority. However, there are shop entrances accessed from this side of the building which would expose pedestrians to potential collisions with vehicles.

Pedestrian and cyclist safety should be prioritised in public/commercial areas such as this. If the service/delivery vehicles must use this route, then consideration should be given to the route being identifiable so as to inform both vehicle drivers and pedestrians and cyclists of the potential presence of vehicles in the area with the finishings being continued along the full length of the service access route.

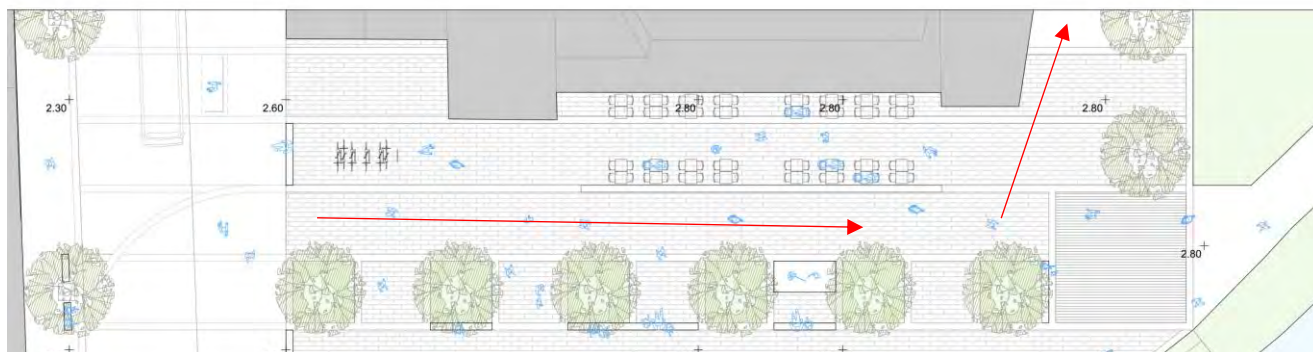
Figure 2-2 - Service Access and Adjacent Features

The proposed layout includes some features such as large trees and low walls/benches adjacent to the service/delivery vehicle access route which may cause an obstacle for the large service/delivery vehicles that will likely be using the route. The proposed layout also indicates that the service/delivery vehicles will be forced to turn and travel in very close proximity to the south-eastern corner of the cluster of commercial buildings with exits/entrances along this eastern side of the building block. These potential obstacles may lead to collisions causing material damage or injury.

The separation to entrances/exits and the selection and siting of trees and other physical features should be considerate of the likely traffic using the service/delivery route.

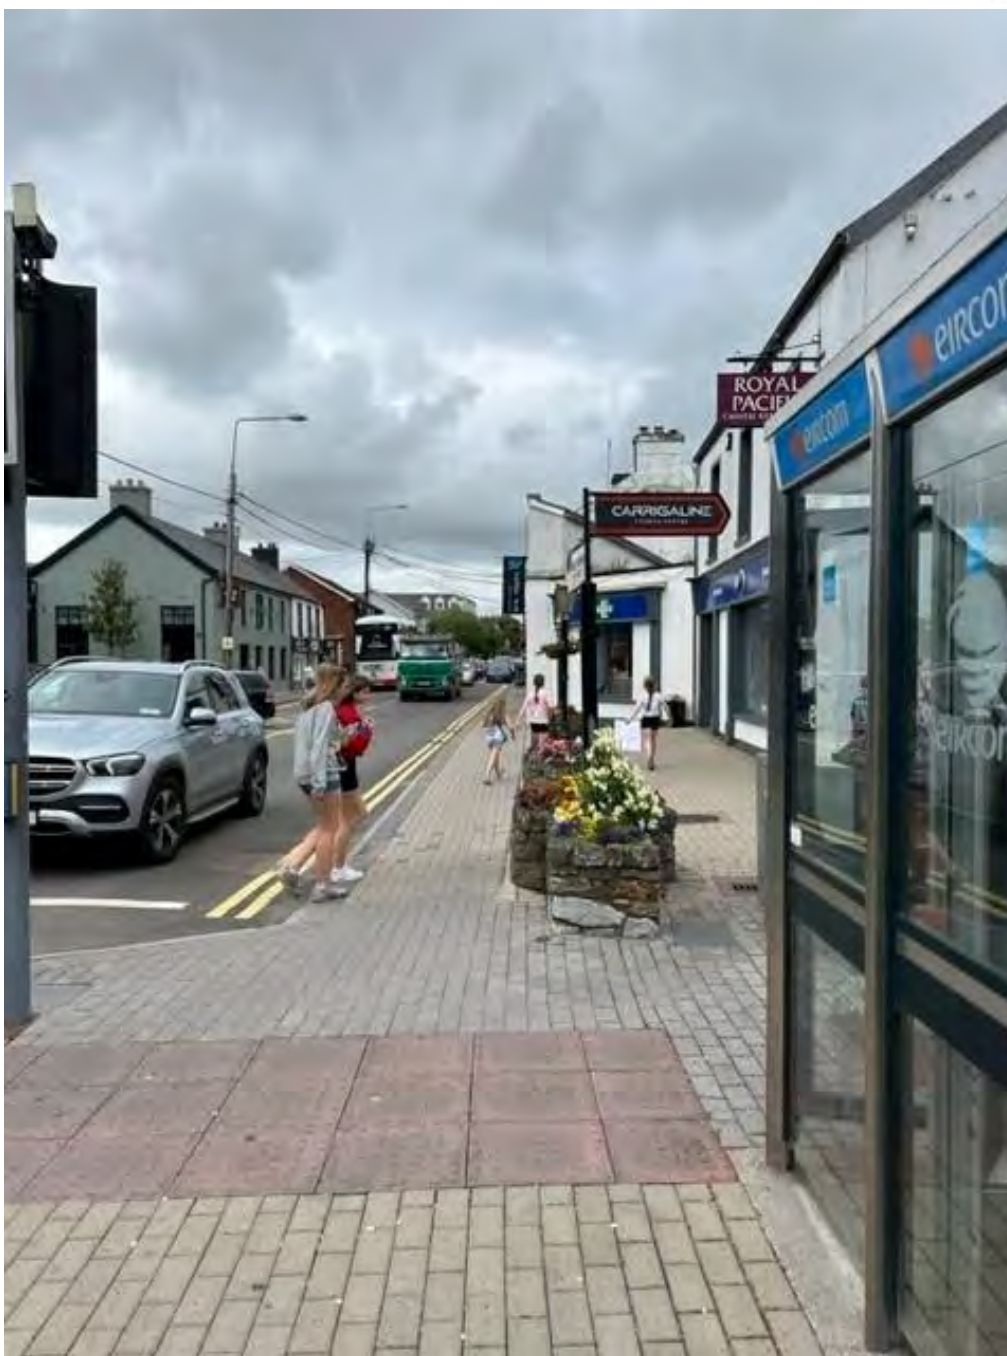
Figure 2-3 - View to the Right at Approximate Location of Proposed Service Vehicle Egress Point

It is not clear from the design drawings that adequate sightlines are being provided on egress from the service/delivery vehicle access route onto Main Street and also from the carpark onto the R612 on the eastern side of the site. Insufficient visibility splays could lead to side swipe type collisions.

Appropriate visibility splays should be provided on egress from both entrances.

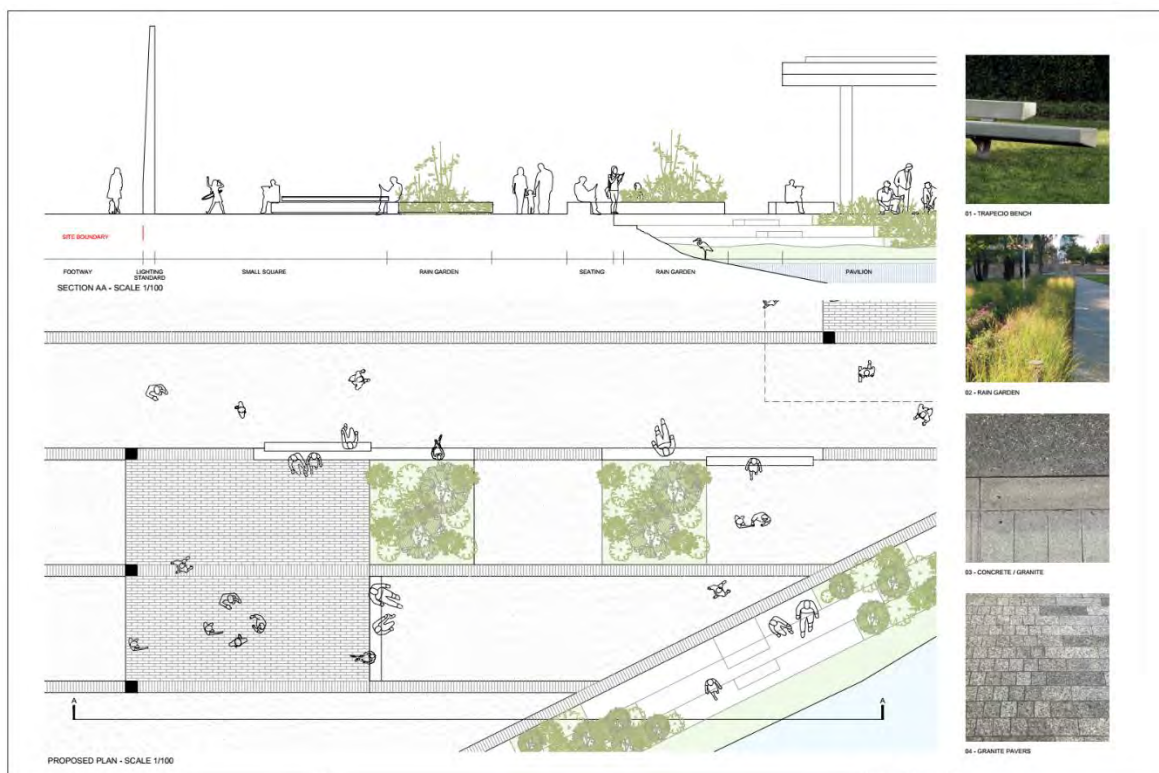
Figure 2-4 - Proposed Details of the Stepped Embankment

It is unclear from the drawings whether the stepped embankment is above the maximum tidal water level, if not the steps could become slippery from deposits of mud and algae resulting in slips trips and falls.

Ensure that adequate protection measures are in place to prevent falls into the river along the entire length of the scheme.

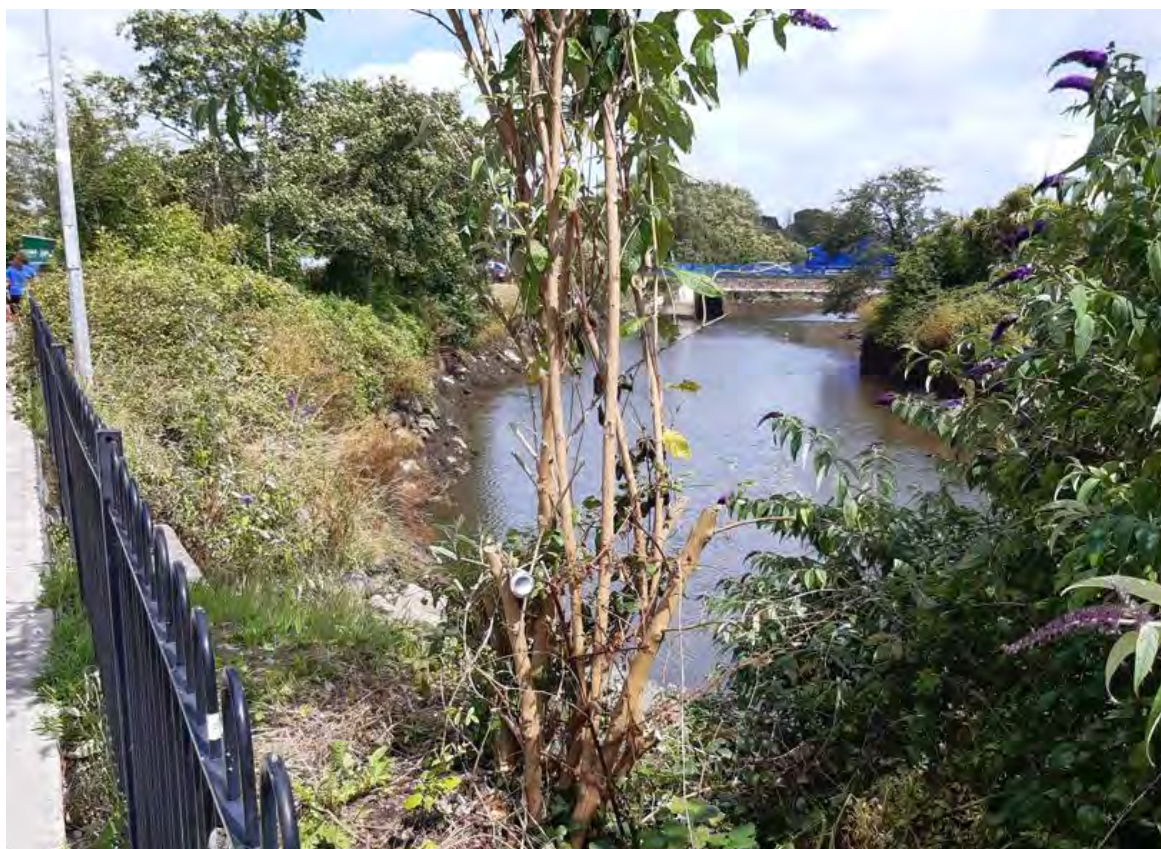
Figure 2-5 - Existing Railing and River Embankment

In addition, it is unclear from the drawing whether the existing railing along the south side of the existing footpath from beyond the proposed embankment area is to be removed or replaced. If no railing is provided this could lead to pedestrians or cyclist falling into the river. The Owenabue River is a significant width and depth, which would increase the severity of an incident such as this.

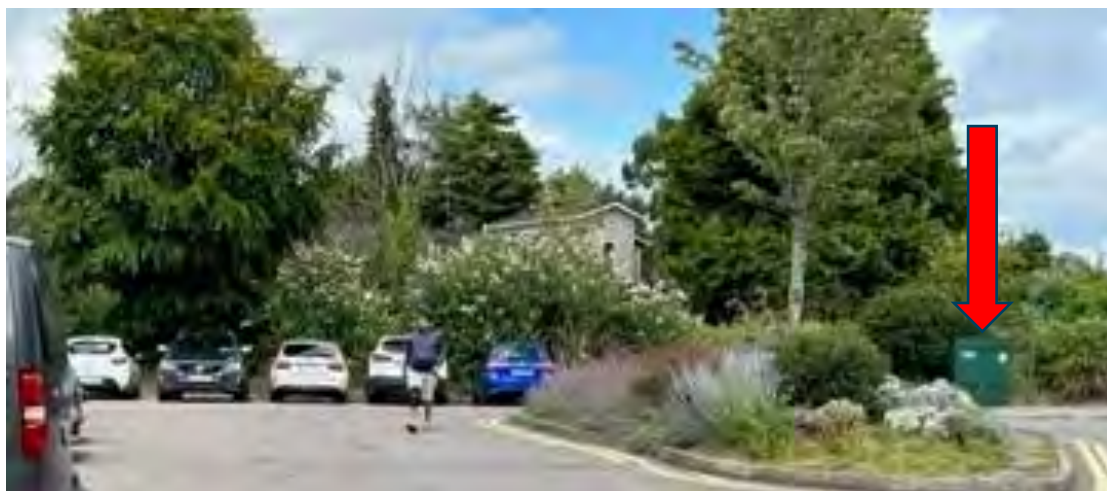
Figure 2-6 - Existing ESB Cabinet in Line of Proposed Parking

There are a number of utility services and chambers within the site, in particular one cabinet at the northern boundary of the western carpark. The scheme proposes to replace the existing road and carpark in this area with landscaping and a footpath/shared path. If the service is not being relocated as part of the development this may force maintenance personnel to use the footpath/shared path to access the service. This may lead to the footpath being obstructed which could cause passing pedestrians to slip, trip or fall.

Maintenance and access requirements of the existing service should be considered, and appropriate facilities should be provided to facilitate.

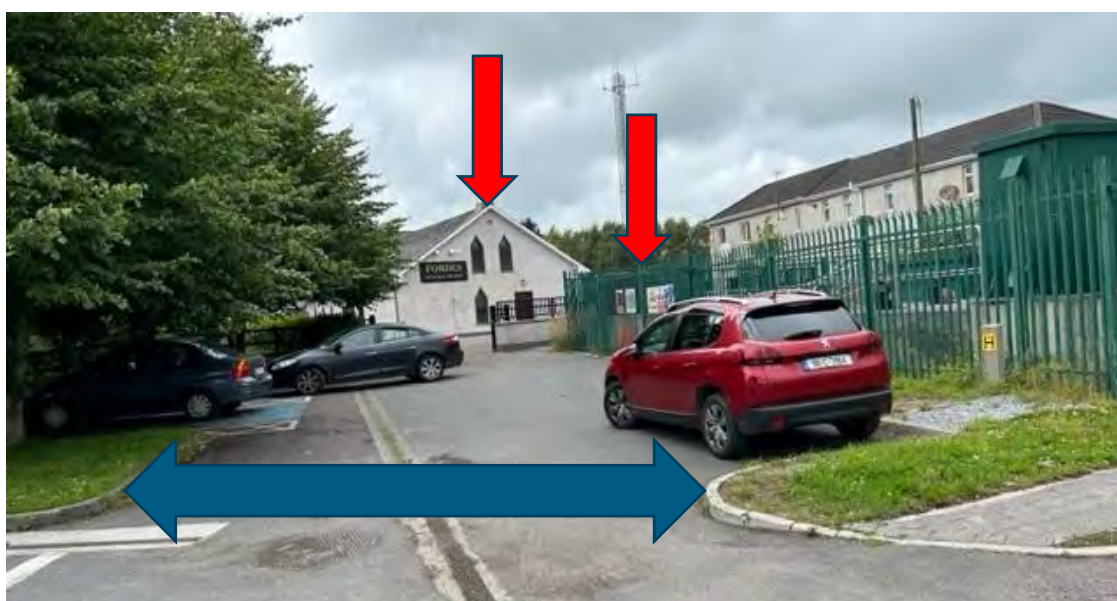
Figure 2-7 - Existing Access Point to Funeral Home and Pumping Station

There is an existing access to an Irish Water Pumping Station and Denis Forde & Sons Funeral Homes in the eastern carpark which is to be removed as part of the proposed scheme. The funeral home does have a second access point, from the Old Waterpark Road but it does not appear to be suitable as main access. However, the Irish Water Pumping Station has no alternative access route and would require access to be maintained. If adequate accesses are not provided to the existing facilities individuals may be forced to access the facilities in an unsafe manner.

Consideration should be given to retaining the existing access or providing an adequate alternative solution.

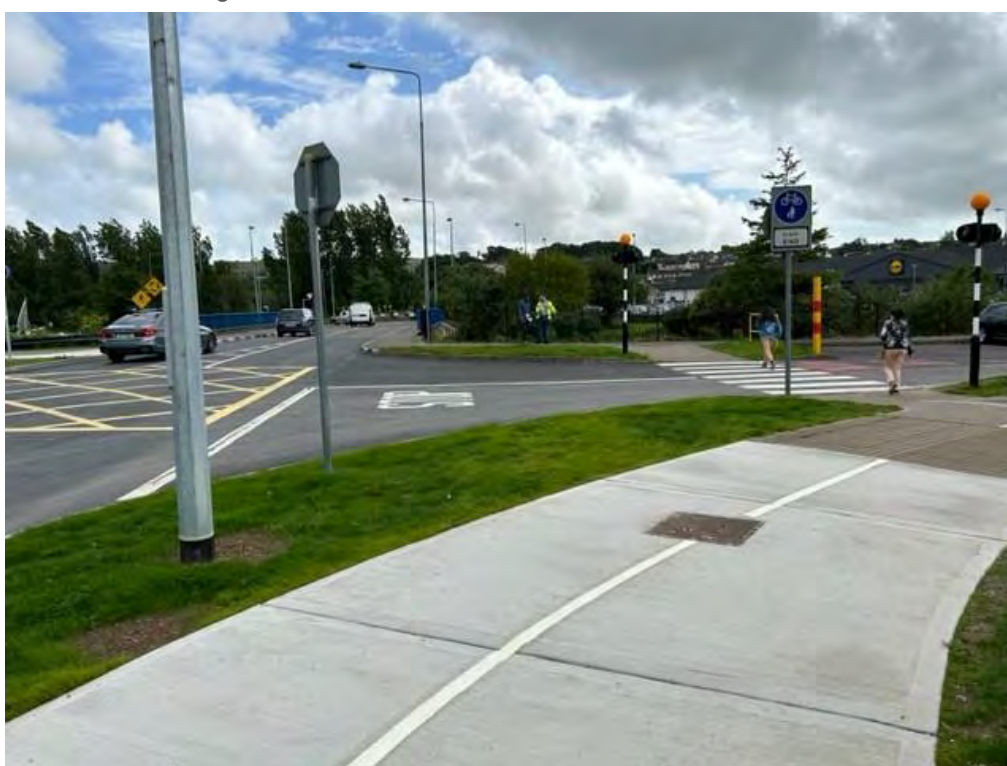
Figure 2-8 - Existing Cycle/Pedestrian Facility at the Car Park Entrance

There is an existing segregated pedestrian/cyclist facility running along the eastern side of the R612 which crosses to the western side via a controlled crossing to access the carpark. This pedestrian/cycle facility terminates at a setback uncontrolled crossing at the car park entrance road, at the eastern side of the site. The scheme will remove this uncontrolled crossing to facilitate a relocated entrance to the proposed carpark with a new layout of parking spaces.

The current cycle provision for northbound cyclists is on road with no delineation and southbound on an existing off road facility. The drawings indicate a proposed zebra crossing at the existing controlled toucan crossing and a proposed zebra crossing at the bridge.

The concern is that southbound cyclists may cross at the first crossing possibly resulting in them travelling through the carpark area and interacting with vehicles.

Consideration should be given to the routing and crossing facilities for southbound cyclists.
