Cobh Town Hall

Roger Casement Square, Ringmeen, Cobh, Co.Cork.

Conservation Report - Heritage Impact Assessment:

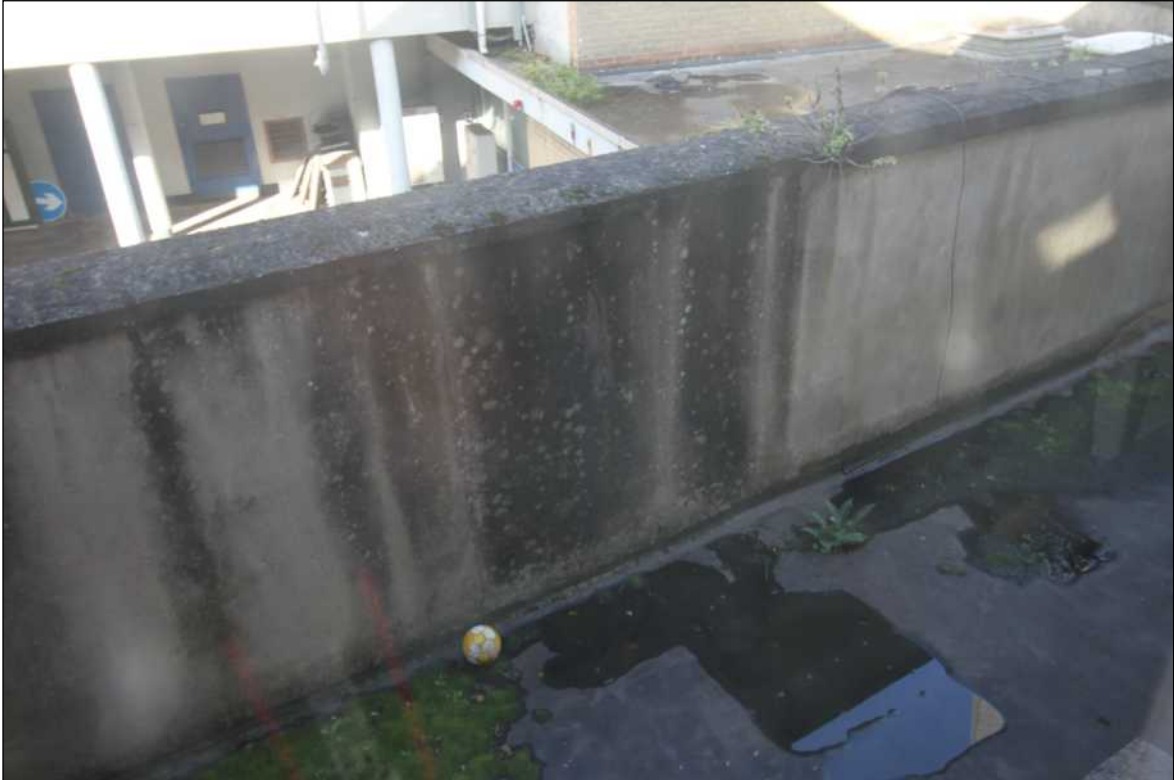
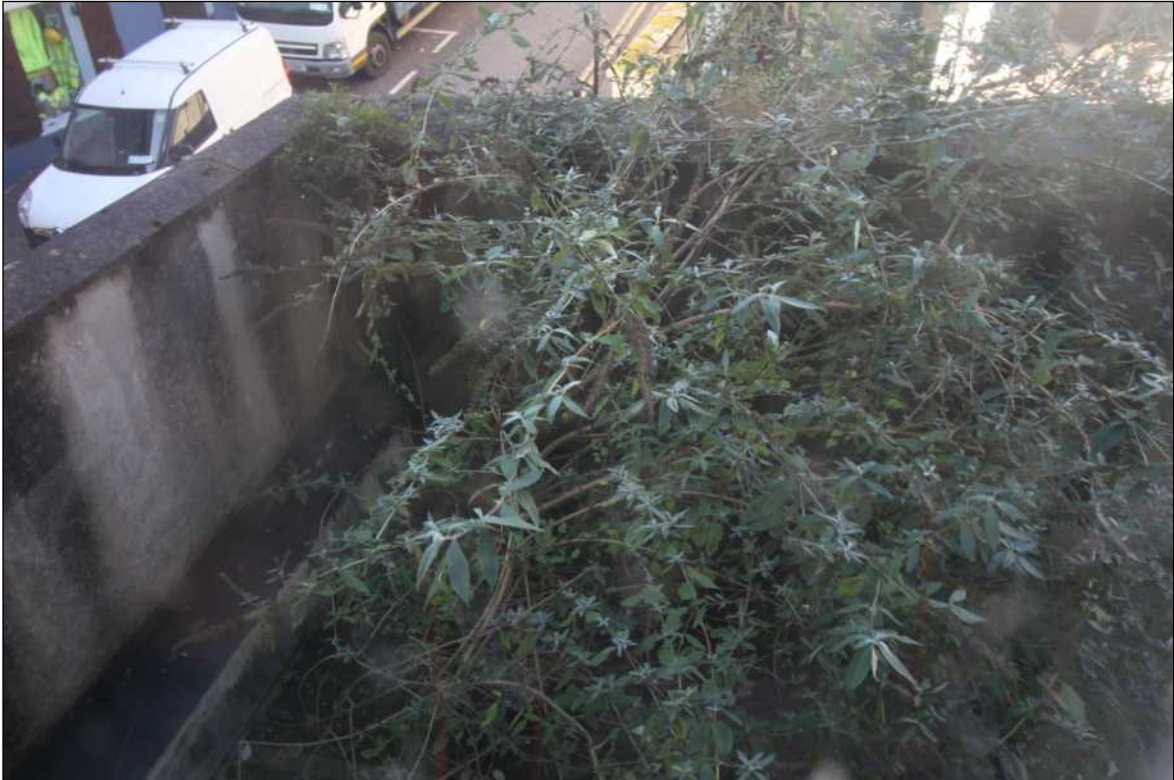
• Fig 76 & 77. Rear flat roofs.

The rear flat roofs are clearly in need of attention, as illustrated above. Much of the trouble is likely to stem from blocked outlets and build up of 'greenery' on the roof. It is assumed this roof is being replaced and as such less of a concern.

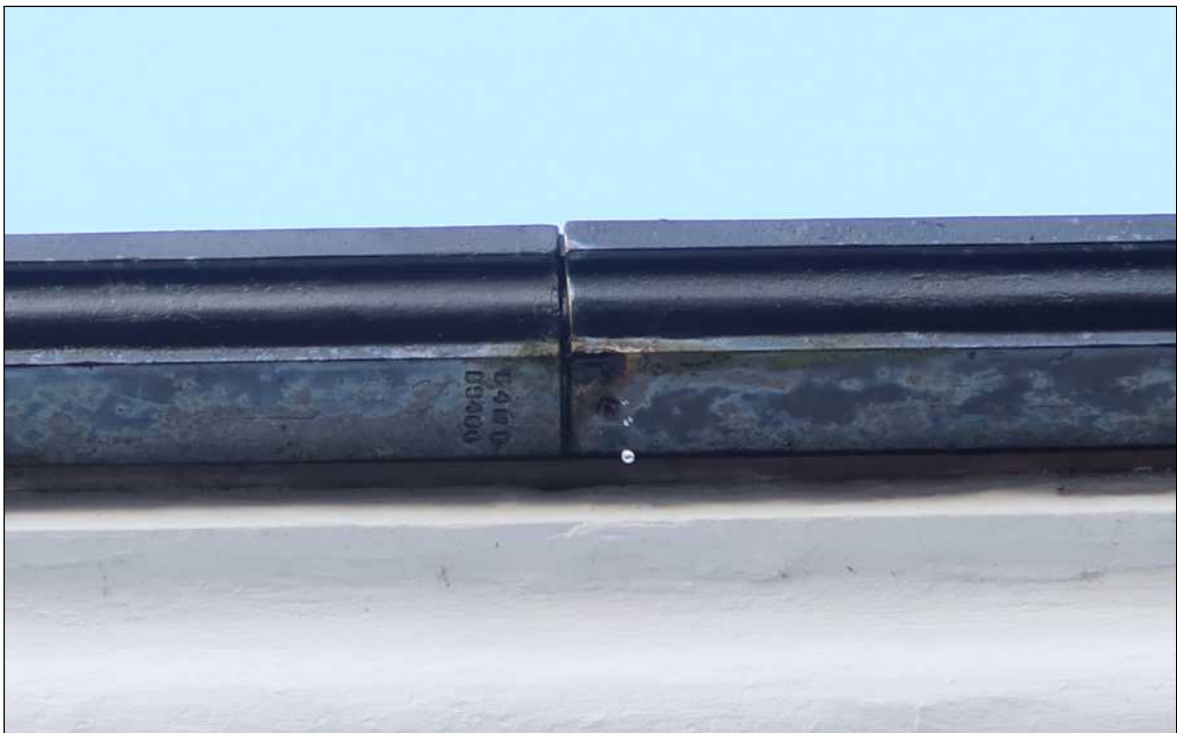
There is no clear evidence of any issue with the upper pitched roof, however there gutters are in need of attention and there are leaks from the joints in front gutters, and signs of other blocked gutters in areas very difficult to access because of boundary issues.

• Fig 78. Leaking gutter junctions in places (over Eastern wing South elevation.) Corrosion evident also.

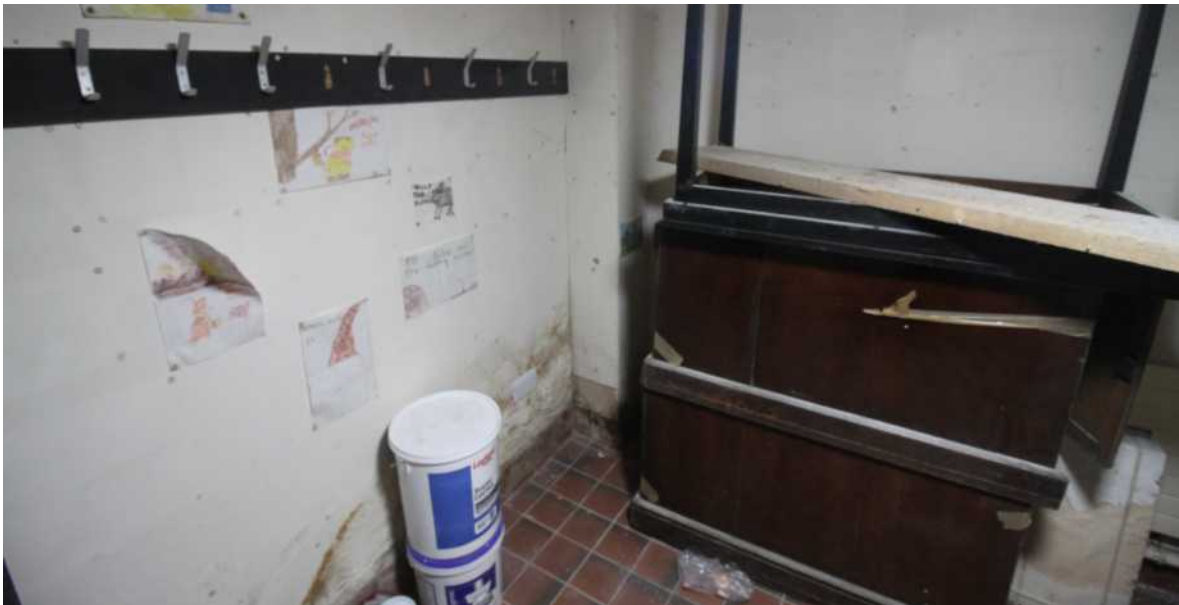
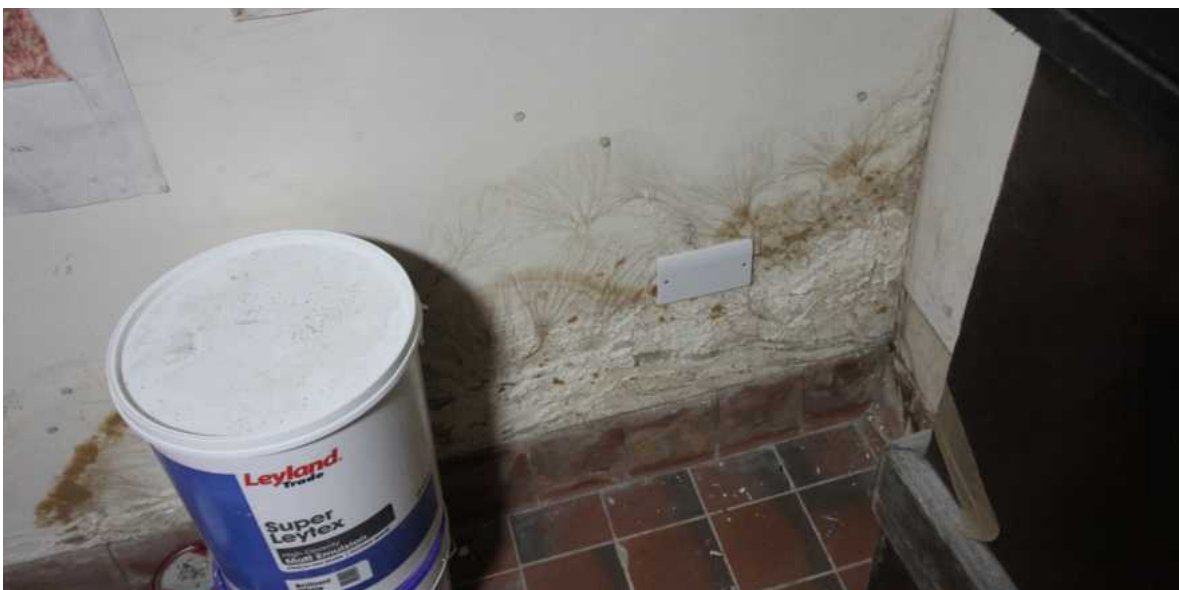
The walls of the building appear to be dry lined, which has the overall effect of maintaining dry insulated inside faces of walls, but preventing ventilation of the existing structure. The evidence in places of moisture in the internal plaster skin are slightly worrying signs that all might not be well in wall hidden cavity.

The biggest concern when this happens, is that embedded timbers within the walls can deteriorate significantly with permanent contact with dampness and areas of interstitial condensation.

• Fig 79 & 80. Rot indications in rear rooms to GF Eastern block.

If the new areas are to be re-lined, it would be worth considering a breathable insulation internally such as Cork, Calcium Silicate board, or cork lime insulation, to improved thermal performance and allow breathability of the fabric.

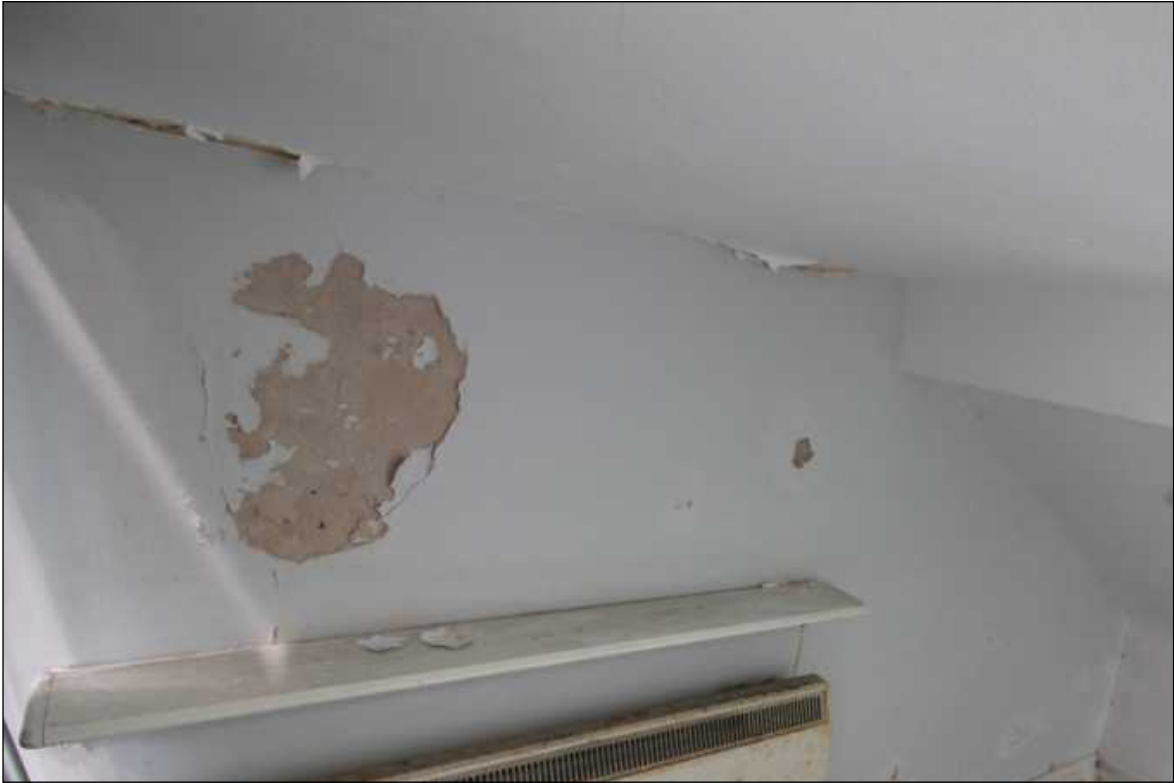
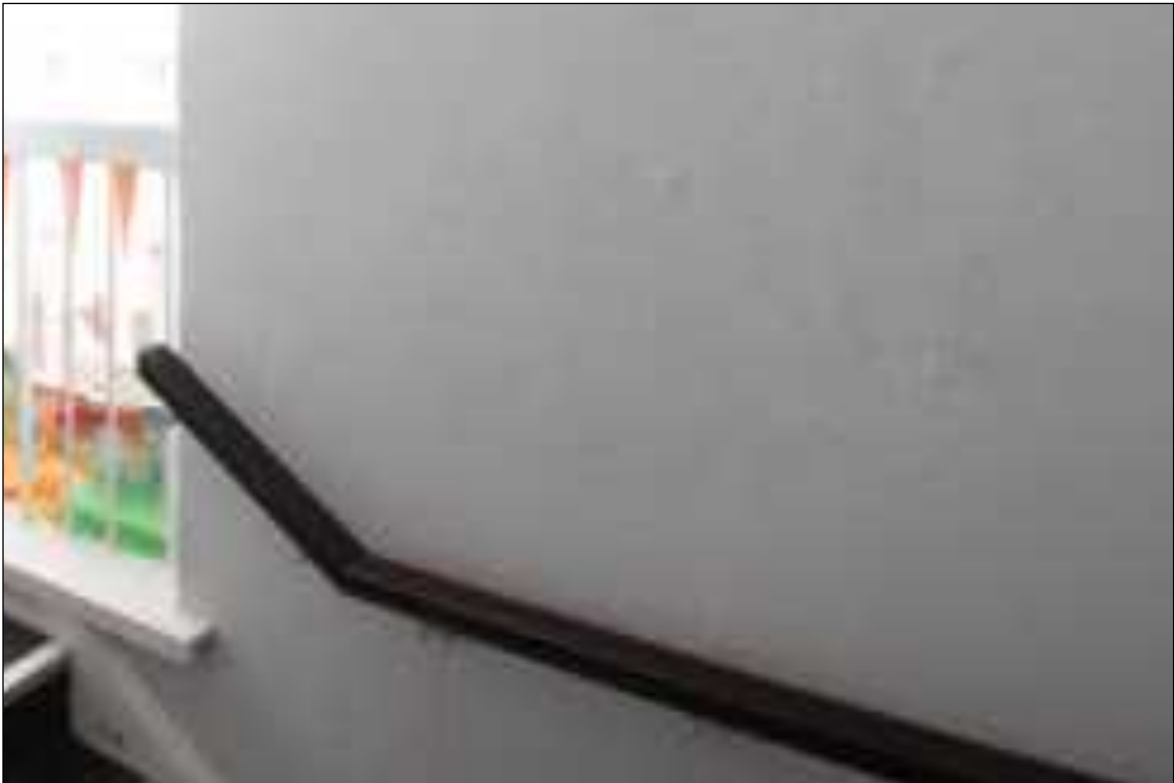
There are some indications of the potential wall condition in some areas like internal stairs which is not lined and dampness/ peeling wall finished in the area:

• Fig. 81 & 82. Stairs wall (unlined) problem areas.

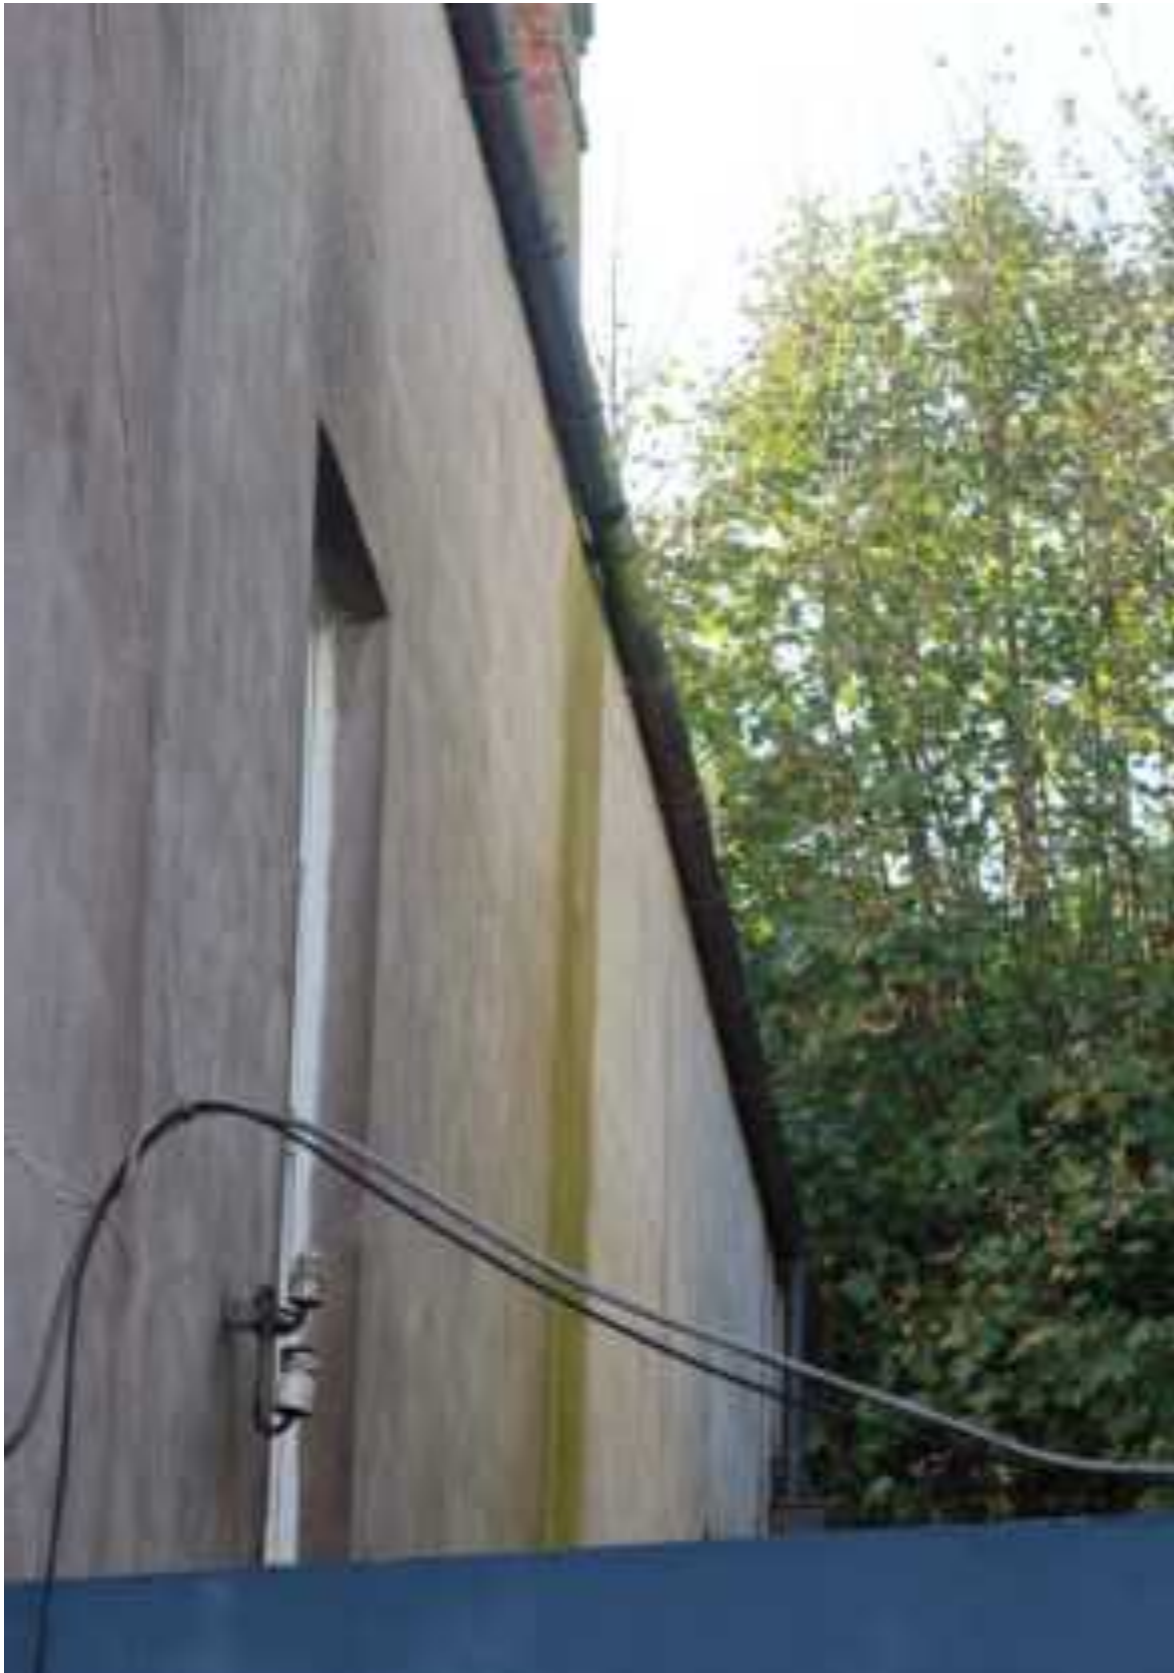
• Fig. 83. Leaking rear gutters.
