Carrigaline UDF and Public Realm

Stage 1 - Road Safety Audit

Cork County Council

February 2024

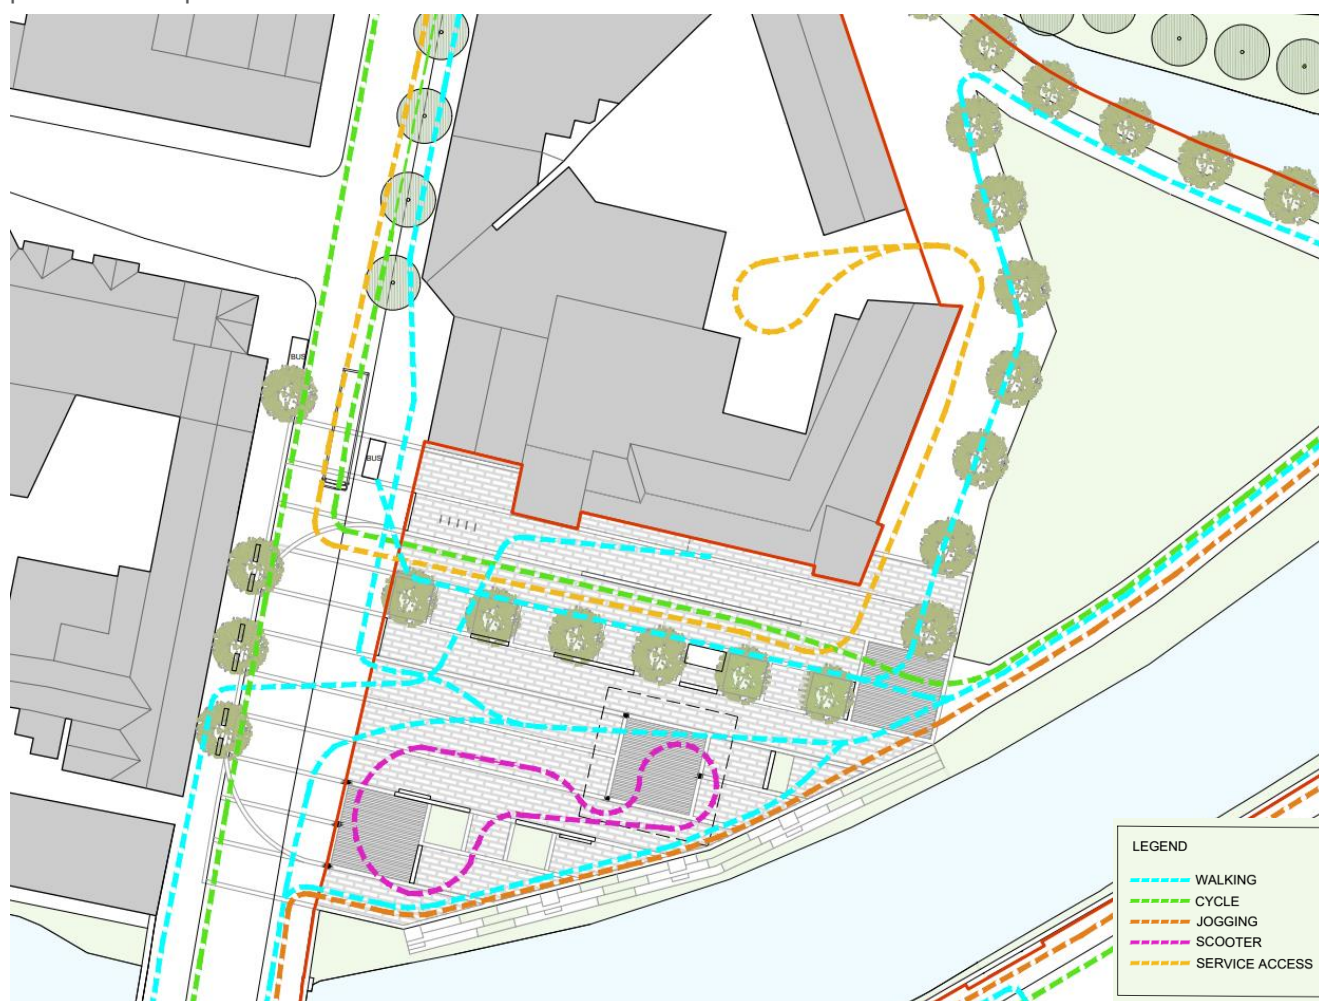
The proposed service/delivery vehicle access route to the courtyard at the rear of the cluster of commercial buildings is not clearly defined, as the surfacing of the public plaza appears to be the same throughout. This could lead to a pedestrian or cyclist being unaware that the area is also shared with service/delivery vehicles, which could cause collisions between unsuspecting pedestrians/cyclists and service/delivery vehicles. Typically, service/delivery vehicles are large in nature which would exacerbate any potential collision.

Further to the above, the surfacing of remainder of the service/delivery vehicle access route, just north of the public plaza is not defined. It appears from the design drawings to be regular tarmac which would indicate vehicle priority. However, there are shop entrances accessed from this side of the building which would expose pedestrians to potential collisions with vehicles.

Figure 2-1 - Details of Service Access and Inter-Action with Other Users

Pedestrian and cyclist safety should be prioritised in public/commercial areas such as this. If the service/delivery vehicles must use this route, then consideration should be given to the route being identifiable so as to inform both vehicle drivers and pedestrians and cyclists of the potential presence of vehicles in the area with the finishings being continued along the full length of the service access route.

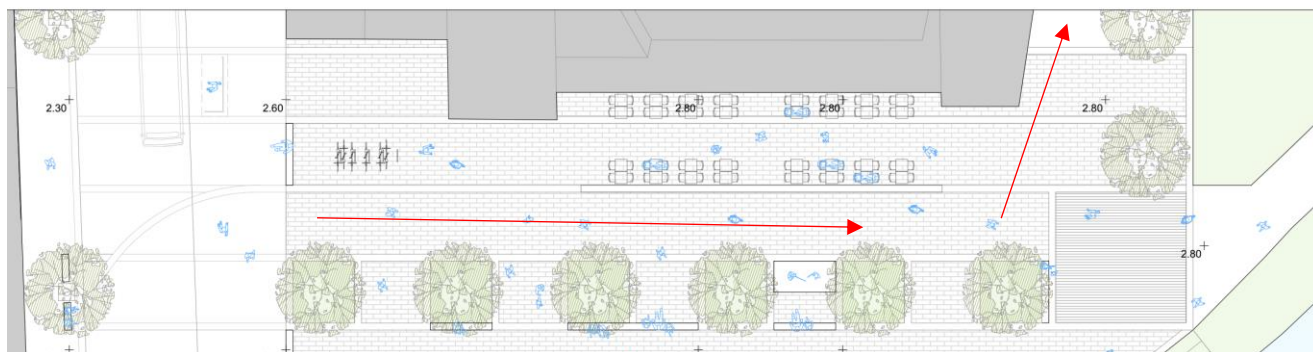
The proposed layout includes some features such as large trees and low walls/benches adjacent to the service/delivery vehicle access route which may cause an obstacle for the large service/delivery vehicles that will likely be using the route. The proposed layout also indicates that the service/delivery vehicles will be forced to turn and travel in very close proximity to the south-eastern corner of the cluster of commercial buildings with exits/entrances along this eastern side of the building block. These potential obstacles may lead to collisions causing material damage or injury.

Figure 2-2 - Service Access and Adjacent Features

The separation to entrances/exits and the selection and siting of trees and other physical features should be considerate of the likely traffic using the service/delivery route.

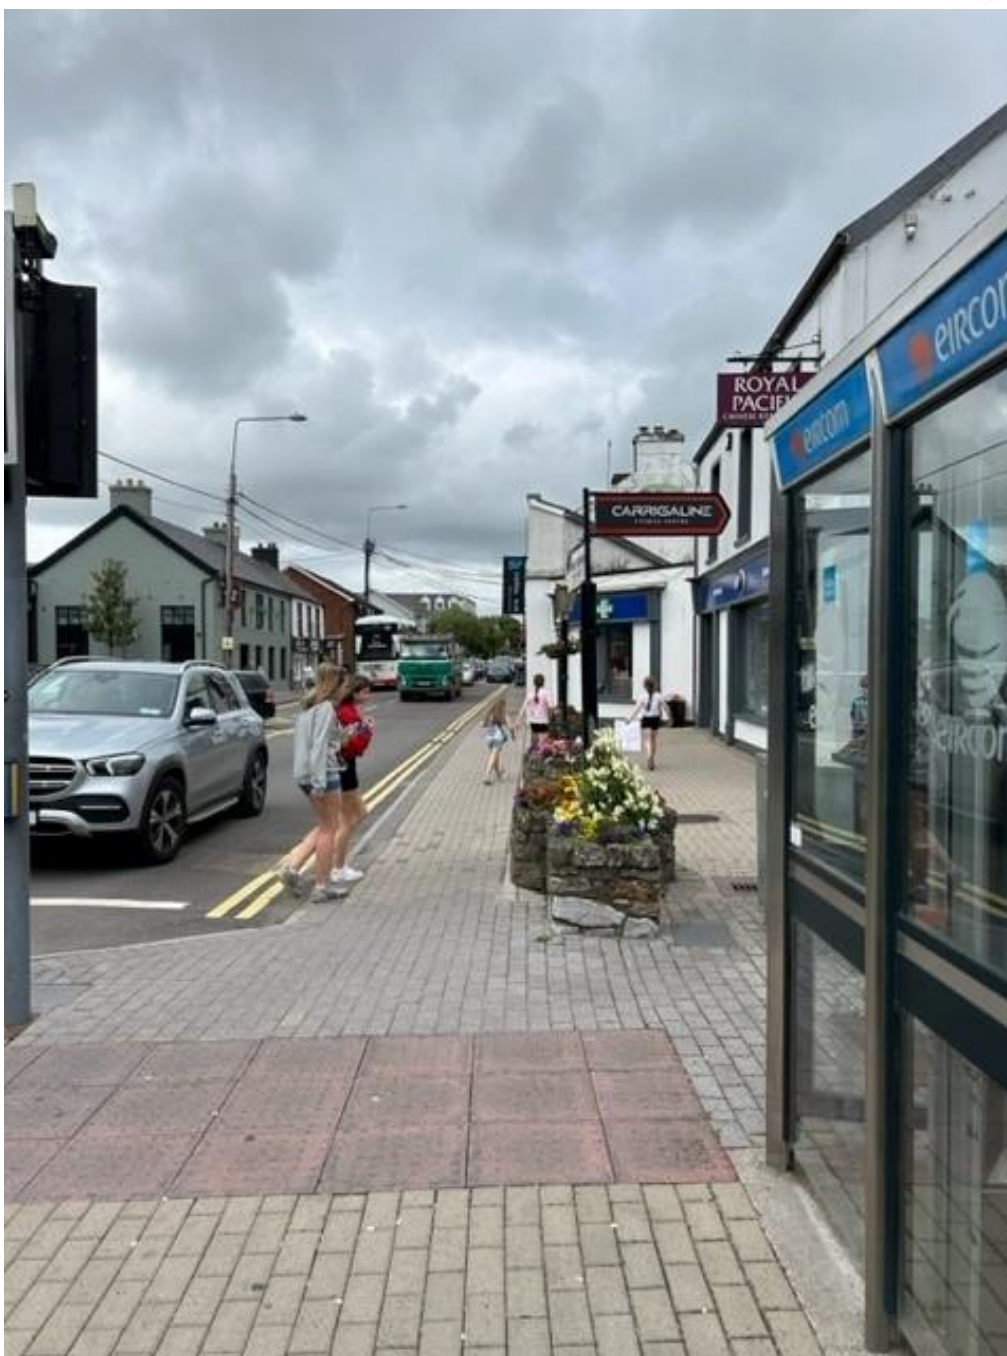
It is not clear from the design drawings that adequate sightlines are being provided on egress from the service/delivery vehicle access route onto Main Street and also from the carpark onto the R612 on the eastern side of the site. Insufficient visibility splays could lead to side swipe type collisions.

Figure 2-3 - View to the Right at Approximate Location of Proposed Service Vehicle Egress Point

Appropriate visibility splays should be provided on egress from both entrances.

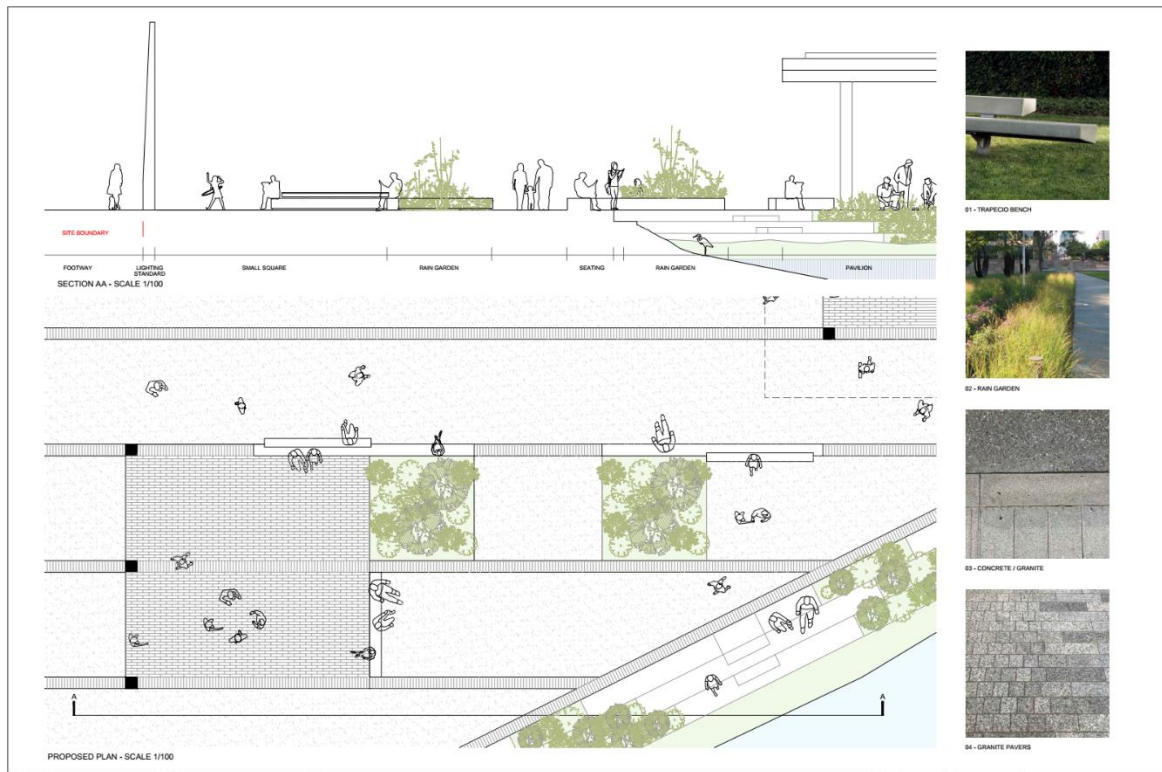
It is unclear from the drawings whether the stepped embankment is above the maximum tidal water level, if not the steps could become slippery from deposits of mud and algae resulting in slips trips and falls. In addition, it is unclear from the drawing whether the existing railing along the south side of the existing footpath from beyond the proposed embankment area is to be removed or replaced. If no railing is provided this could lead to pedestrians or cyclist falling into the river. The Owenabue River is a significant width and depth, which would increase the severity of an incident such as this.

Figure 2-4 - Proposed Details of the Stepped Embankment

Ensure that adequate protection measures are in place to prevent falls into the river along the entire length of the scheme.

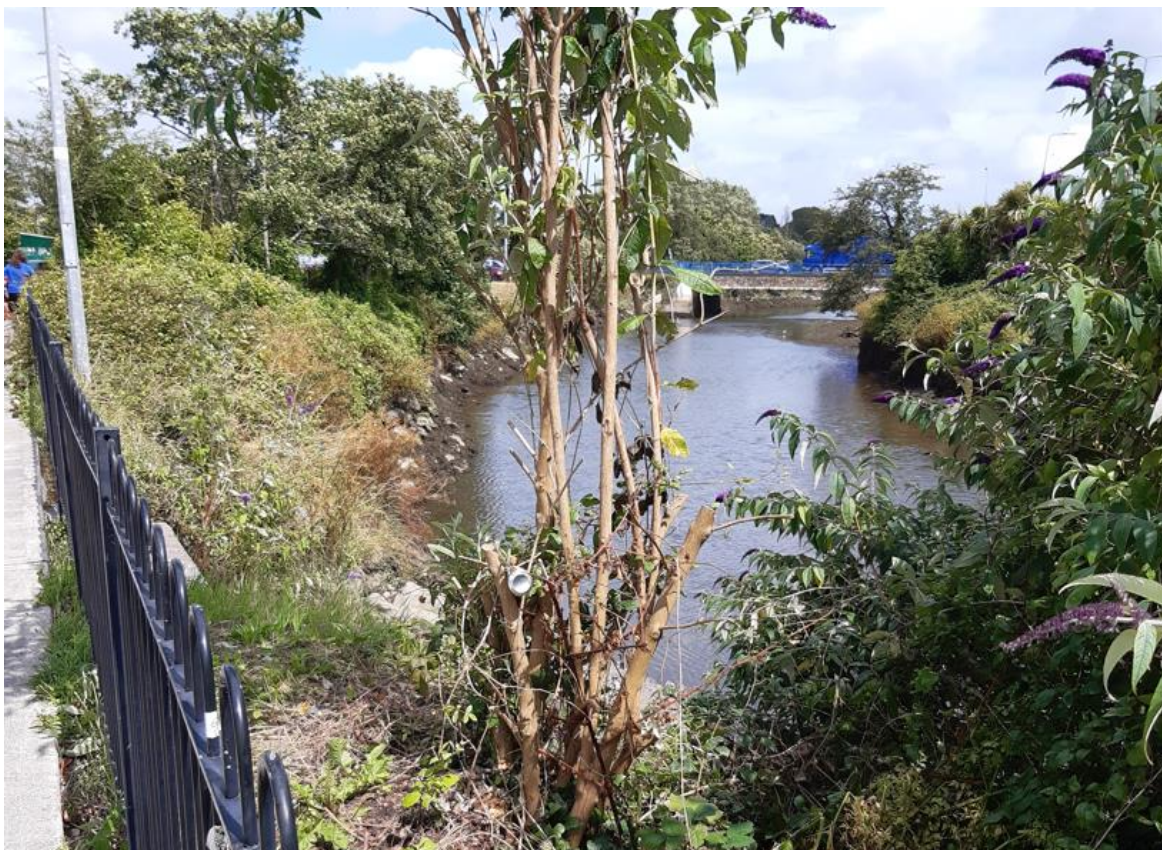
Figure 2-5 - Existing Railing and River Embankment

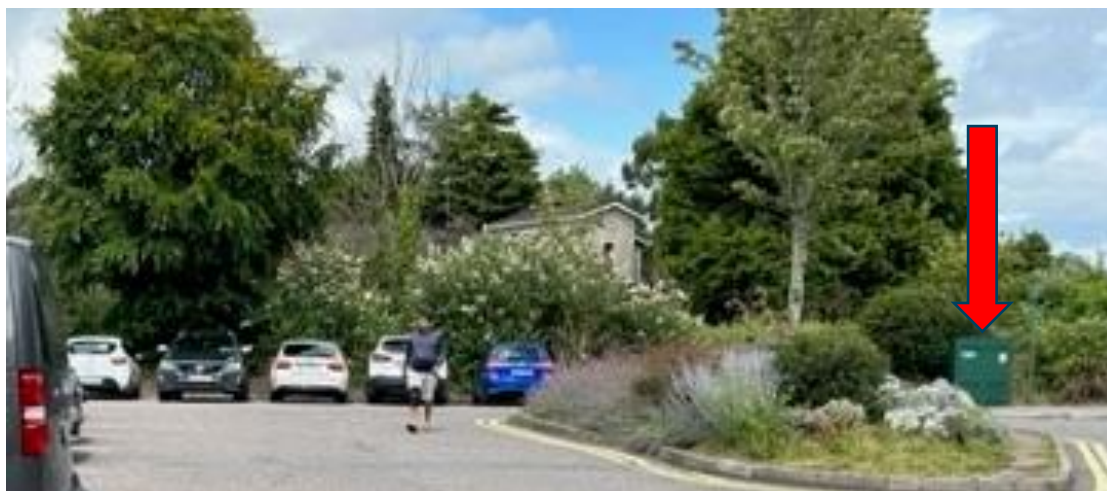
There are a number of utility services and chambers within the site, in particular one cabinet at the northern boundary of the western carpark. The scheme proposes to replace the existing road and carpark in this area with landscaping and a footpath/shared path. If the service is not being relocated as part of the development this may force maintenance personnel to use the footpath/shared path to access the service. This may lead to the footpath being obstructed which could cause passing pedestrians to slip, trip or fall.

Figure 2-6 - Existing ESB Cabinet in Line of Proposed Parking

Maintenance and access requirements of the existing service should be considered, and appropriate facilities should be provided to facilitate.

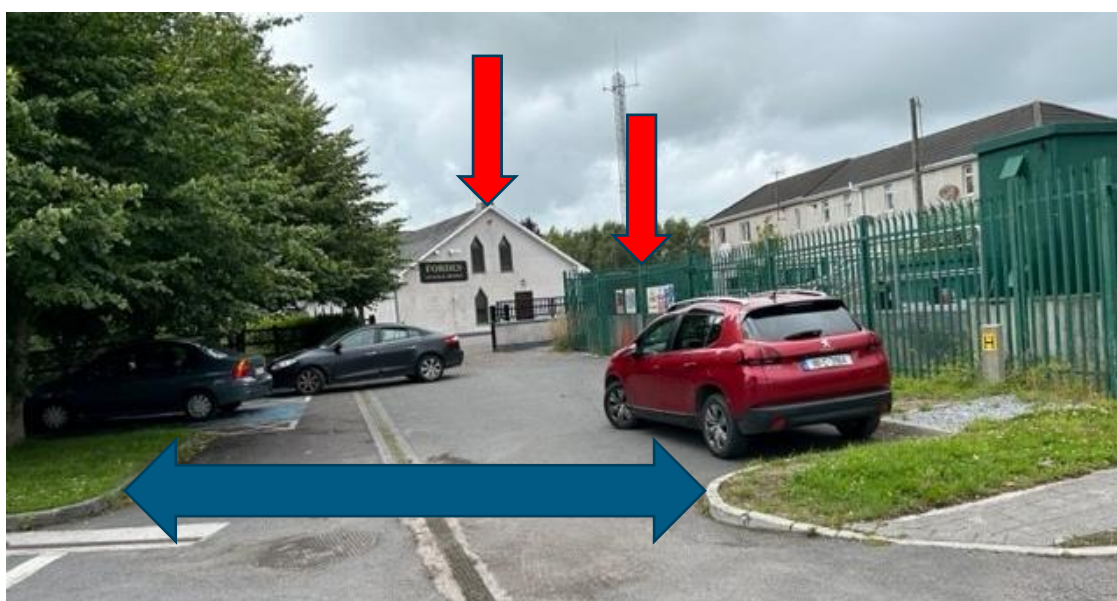
There is an existing access to an Irish Water Pumping Station and Denis Forde & Sons Funeral Homes in the eastern carpark which is to be removed as part of the proposed scheme. The funeral home does have a second access point, from the Old Waterpark Road but it does not appear to be suitable as main access. However, the Irish Water Pumping Station has no alternative access route and would require access to be maintained. If adequate accesses are not provided to the existing facilities individuals may be forced to access the facilities in an unsafe manner.

Figure 2-7 - Existing Access Point to Funeral Home and Pumping Station

Consideration should be given to retaining the existing access or providing an adequate alternative solution.

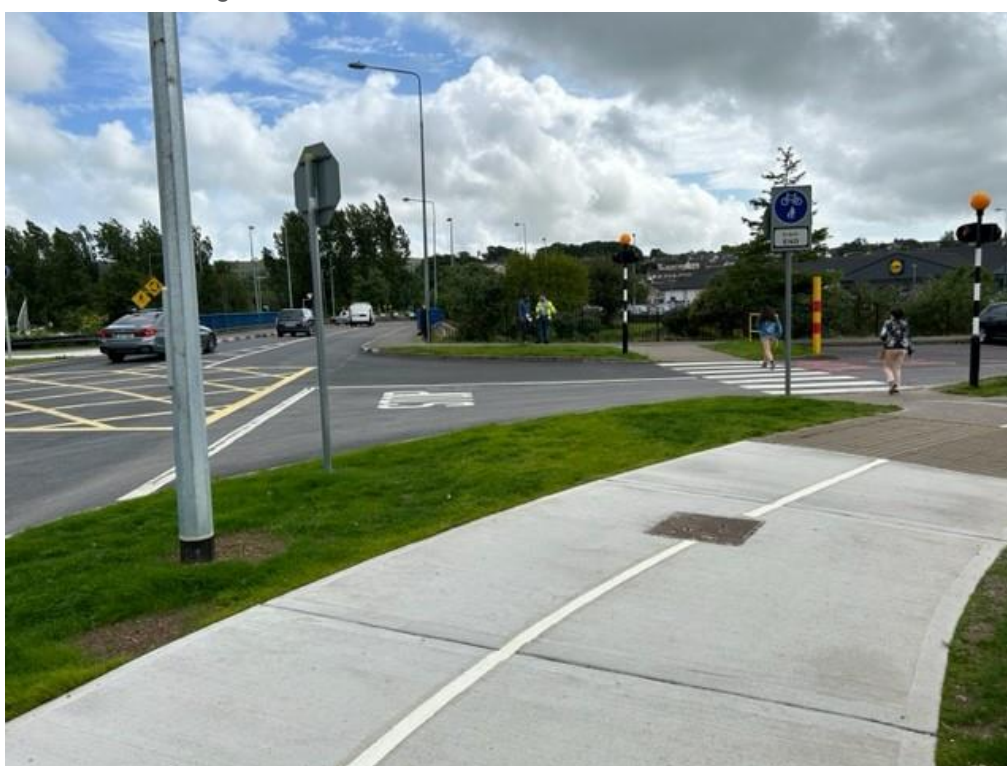
There is an existing segregated pedestrian/cyclist facility running along the eastern side of the R612 which crosses to the western side via a controlled crossing to access the carpark. This pedestrian/cycle facility terminates at a setback uncontrolled crossing at the car park entrance road, at the eastern side of the site. The scheme will remove this uncontrolled crossing to facilitate a relocated entrance to the proposed carpark with a new layout of parking spaces.

The current cycle provision for northbound cyclists is on road with no delineation and southbound on an existing off road facility. The drawings indicate a proposed zebra crossing at the existing controlled toucan crossing and a proposed zebra crossing at the bridge.

The concern is that southbound cyclists may cross at the first crossing possibly resulting in them travelling through the carpark area and interacting with vehicles.

Figure 2-8 - Existing Cycle/Pedestrian Facility at the Car Park Entrance

Consideration should be given to the routing and crossing facilities for southbound cyclists.
