Inspection of Kinsale Town Car-Park Wall for Cork County Council

CONDITION REPORT

February 2023

Job No. 22150

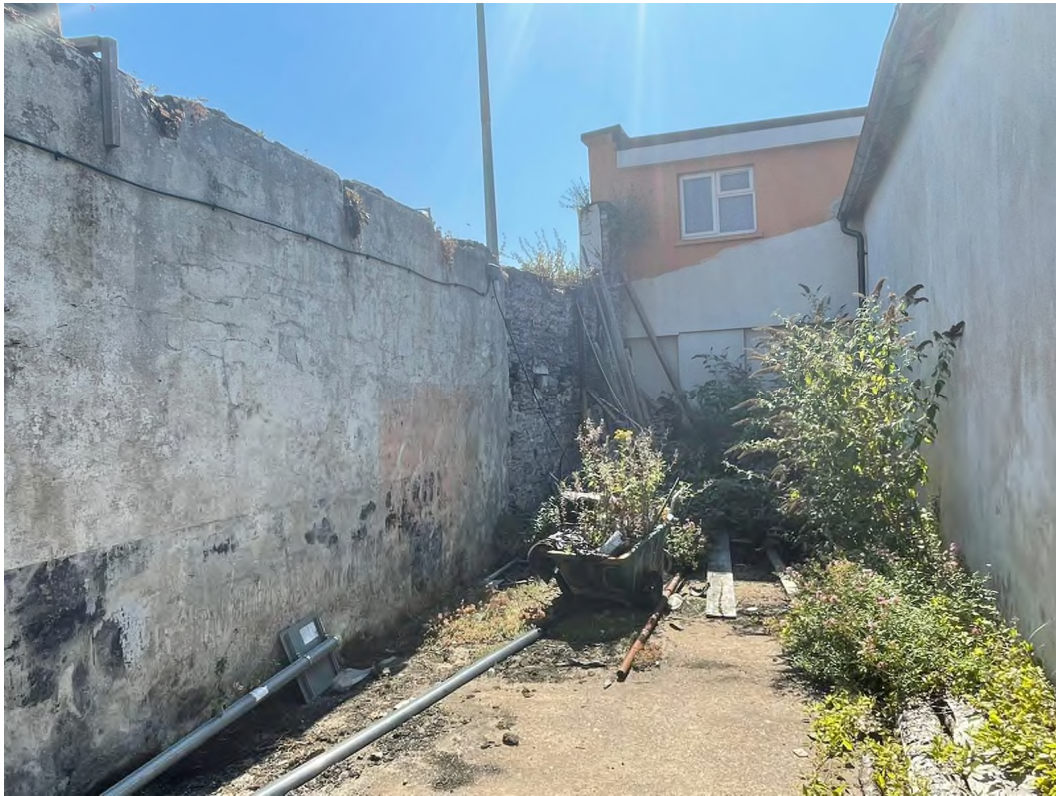
Building Components and Condition						
Component	Component Description (materials, construction and location)	Condition		Risk Assessment and Recommendation		
		Condition Description	CC	Probable Causes/Consequences	Recommended Measures	UC
North-West Face (The interior face of the wall was only accessible as far as the extension of the commercial hall which is the equivalent of the plastered area on the outer face.)	The northern end has a painted render finish	There is light cracking in the plaster.	CC 1	This is an internal plaster that is now on an external wall.	Remove any loose pieces in danger of falling and monitor until further works are carried out on the site.	UC 1
		The remains of the trusses from the roof that was removed in 2017 are still there.	CC 0	-	-	UC 0
	The middle section of the wall appears to have been limewashed.	It has large (1 foot approximately) square openings between 1 and 1.5m from ground level that may have been bearings for floor beam ends (Photograph No. 7). The stone in the middle is very shaley indicating it has been exposed in the past. The stone above it is smoother. Some cement repairs are also evident.	CC 1	The openings are vulnerable. They were a part of an indoor face of a wall that is now exposed.	Consolidate loose masonry around openings.	UC 1

Photograph No. 1 – Internal Face of Wall

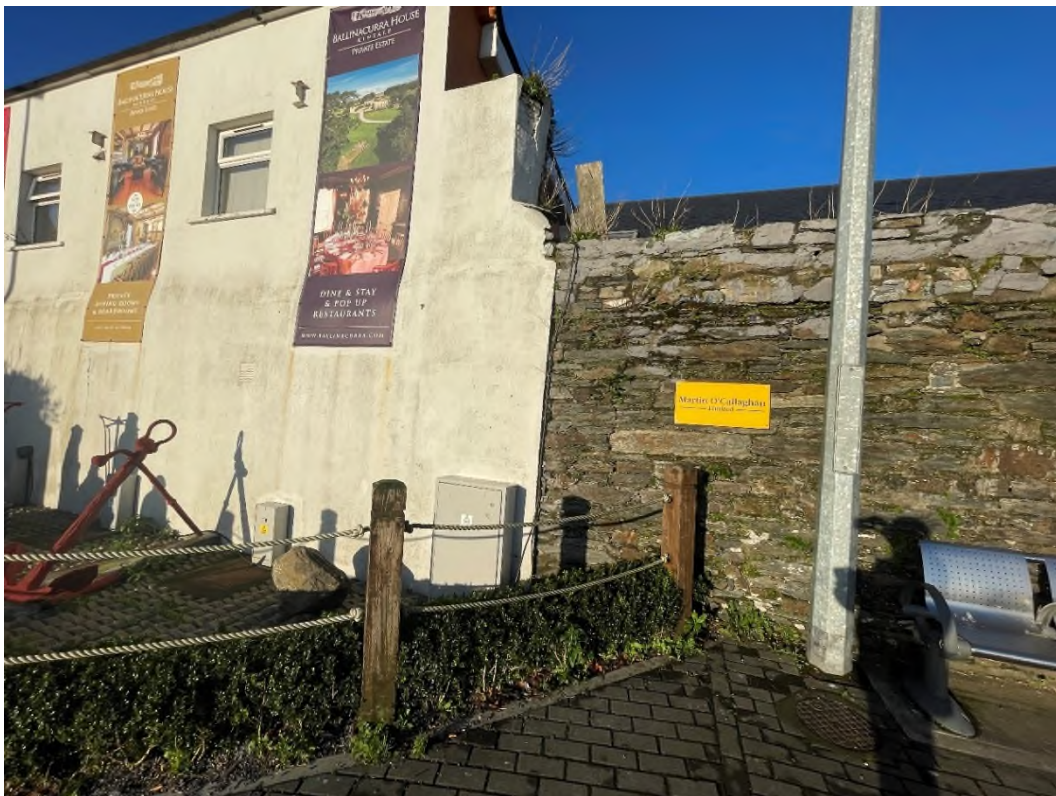
Photograph No. 2 – Short Quay End of Wall

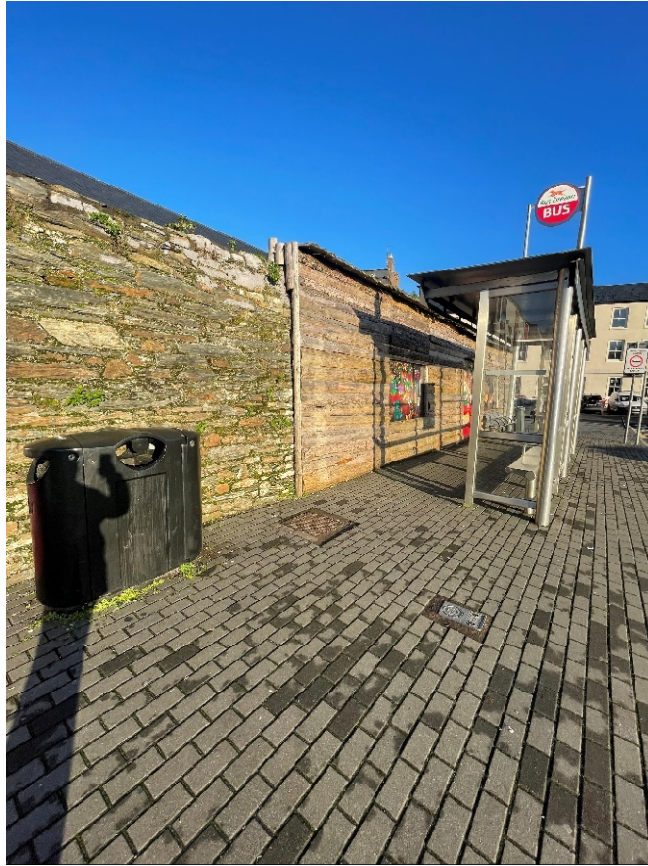
Photograph No. 3 – Long Quay End of Wall

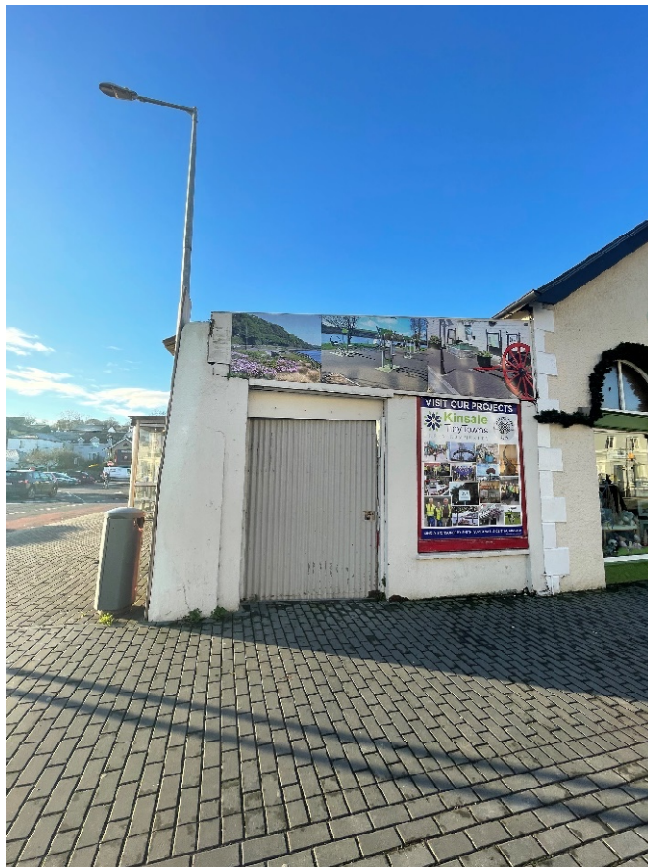
Photograph No. 4 – View from Long Quay

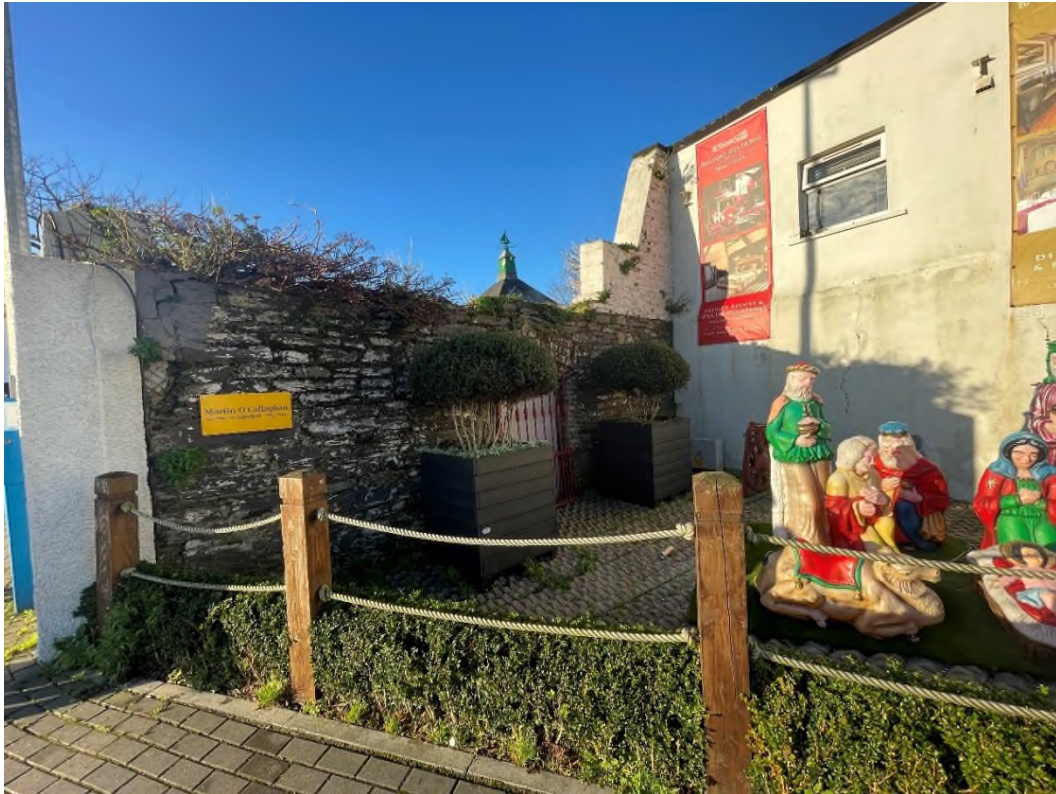
The lower section has had an extension of the commercial hall built on top of it. The two-storey southwest end of the wall incorporates a buttressing return that may be part of the former gable of the storage building.	This section has a plaster finish and has some cracking in the plaster	CC 1	This may have been caused by a cementitious render or the newer building built above it.	Monitor it and seal crack to prevent water ingress.	UC 1

Photograph No. 5 – Southwestern return wall

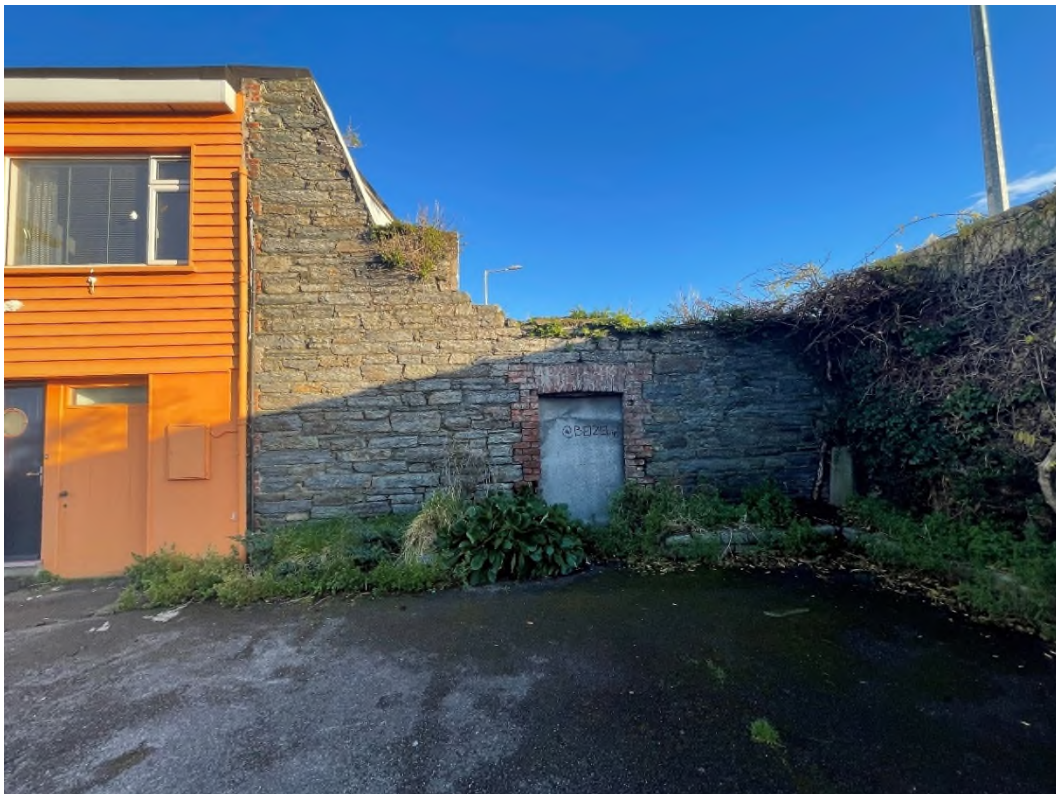
Photograph No. 6 – View from Short Quay Side

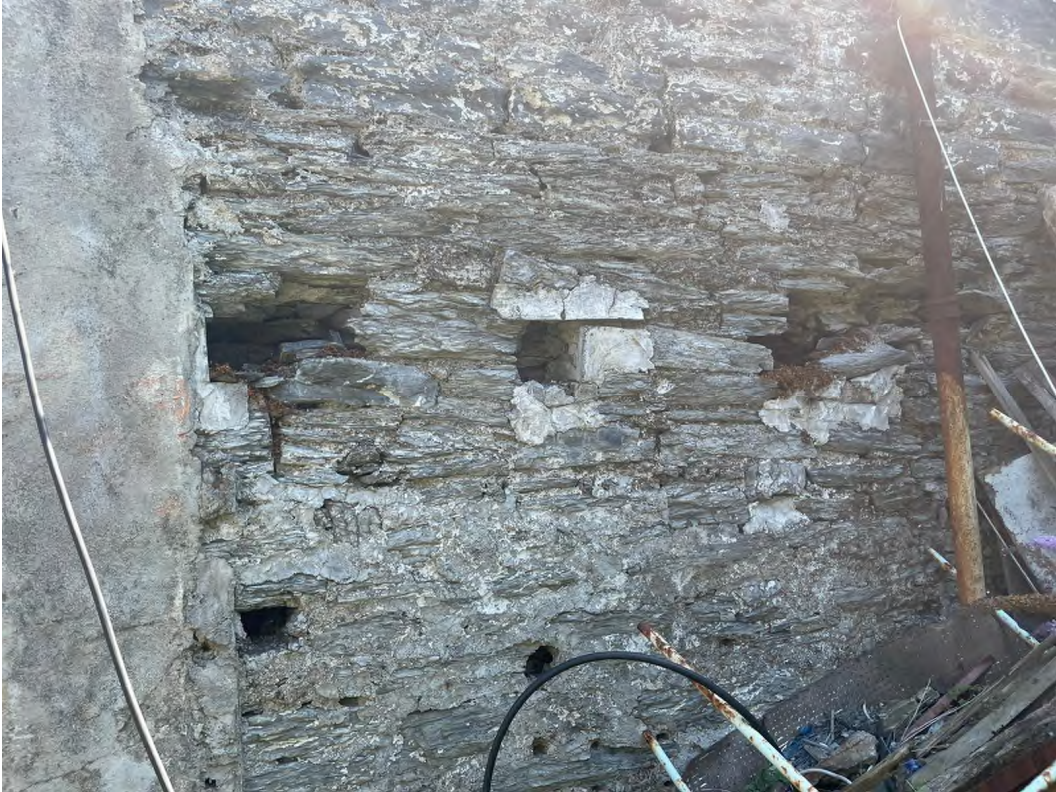
Photograph No. 7 – Lintel Openings

Repair masonry around lintel openings
