Charleville Court and Market House

Architectural Heritage Impact Assessment

January 2022

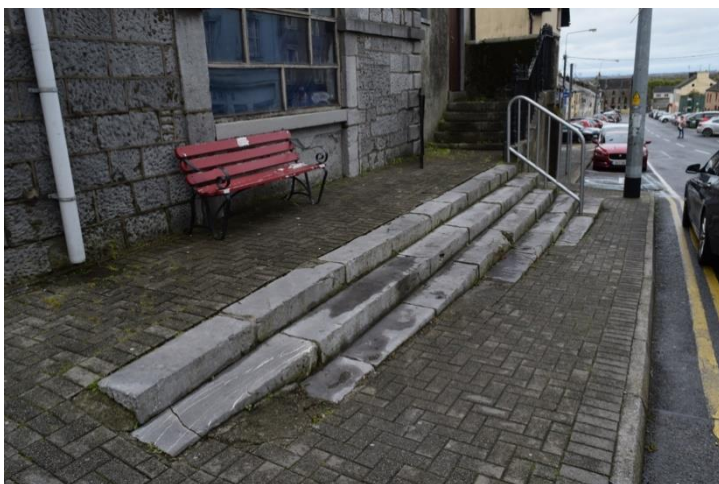
Image 6: Existing Limestone Steps

The repair of the external staircase will have a positive impact on the building's appearance, historic character, and sustain this original point of access, which would have led to the Court Rooms in the building.

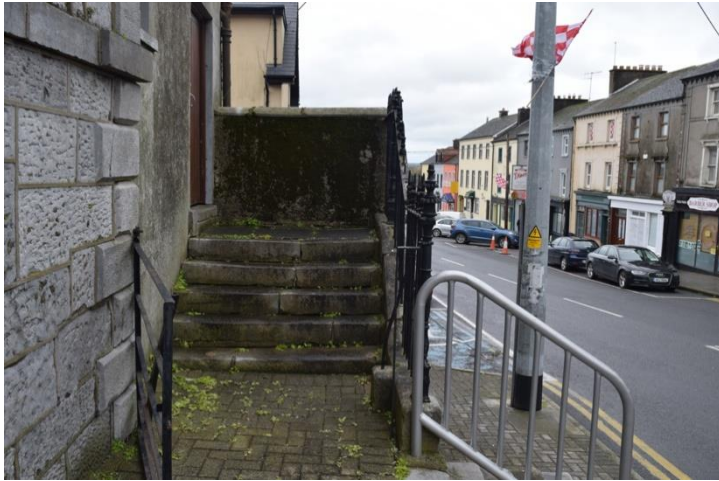
Image 7: Existing steps to Courtroom Entrance

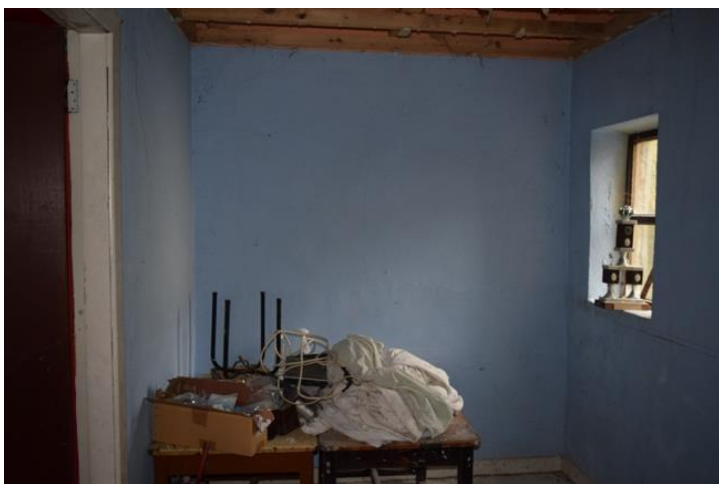
- 1.5 The section of lean to roof to rear of building and structure below, infilling area between the two returns is in very poor condition and should be fully replaced. This is the area identified for the potential installation of lift.

Image 18: Vacant room in later extension in poor condition.

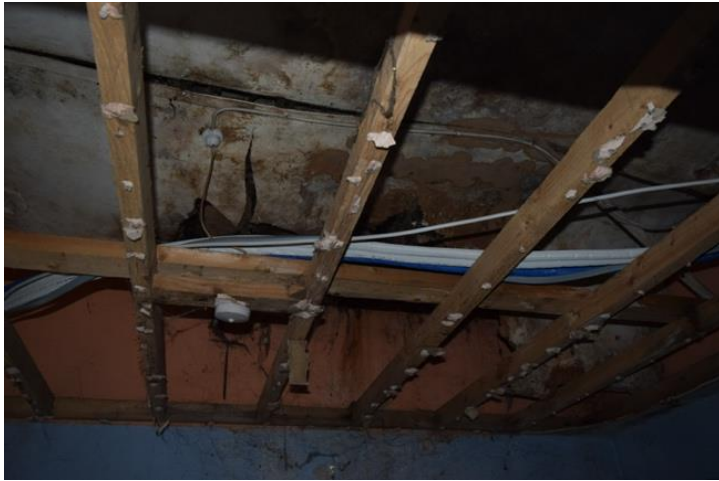
Image 19: Vacant room in later extension in poor condition.

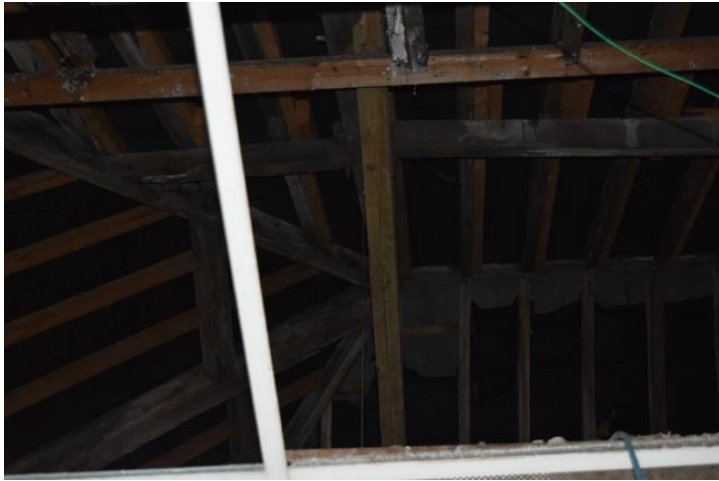
- 1.2 Much of the historic timber roof structure remains, including the queen post trusses, a significant number of rafters have been replaced / strengthened with new timbers alongside.

Image 22: Hipped roof timbers over Court Room.

Roof: The existing historic Queen Post roof timbers are to be retained and repaired, with a timber decay study to inform further repairs. The existing modern artificial slate roof covering remains functional, though areas to be re-slatted are to use an appropriate natural slate. Existing cast-iron rainwater goods that are suitable for re-use will be retained, with new rainwater goods to be cast-iron rather than the existing uPVC. This will have a positive impact on the historic character of the roof.

- 1.3 Following further inspection with the input of a timber decay specialist it may be necessary to carry further timber repairs to facilitate a new use below.

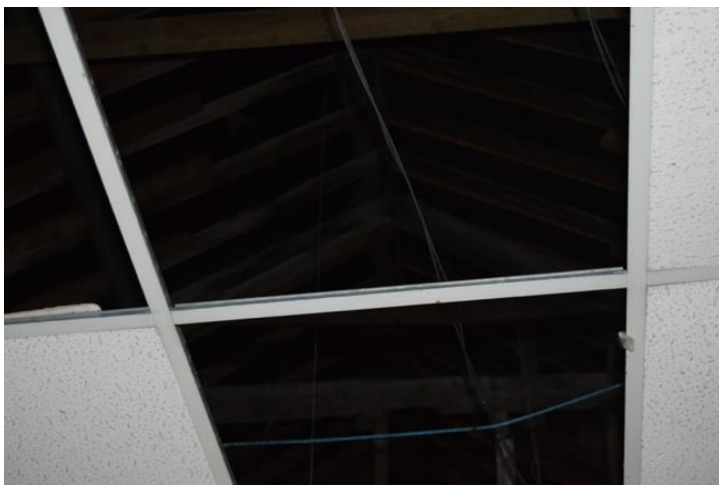
Image 23: Hipped roof timbers over Court Room.

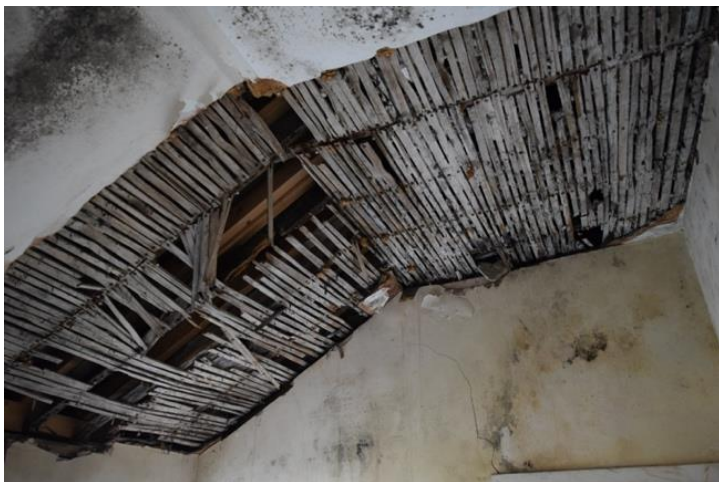
Image 27: Lath and plaster ceiling exposed in later extension. Poor condition.

- 7.1 Existing modern suspended grid ceiling to be removed, there are remnants of a lath and plaster chamfered ceiling at first floor which should be reinstated following works to roof.
- 7.2 Allow for repairs / replacement of regular damaged ceiling and decoration throughout

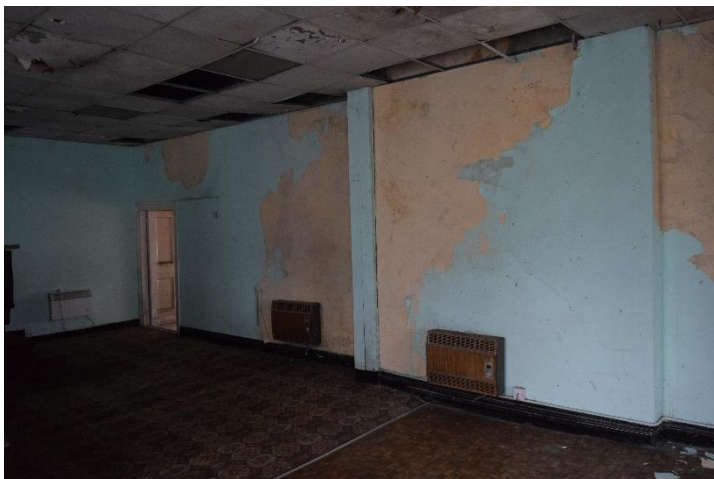
Image 30: Court Room. Location of new ope to provide universal access to first floor.

The provision of fully accessible entry to and from the new lift will necessitate the removal of a section of the existing rear masonry wall. At present, this area of wall has a modern internal lining, but it is possible that there may have been a chimney flue in this area. It may already have been altered following the removal of the original cupola. While it is necessary in order to create a fully accessible first floor, the removal of masonry here will have a minor negative impact on historic building fabric.
