# East Tip, Haulbowline Island

## Factual Report

## East Tip, Haulbowline Island Factual Report

Márta 2012

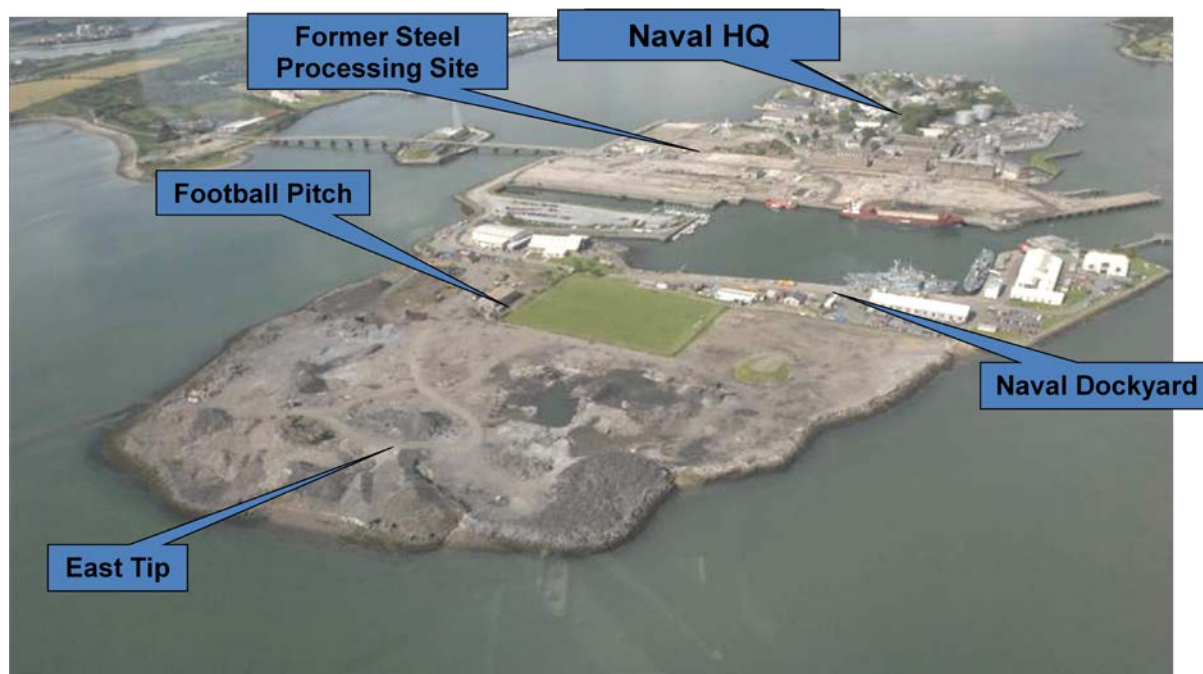
Plate 2.1: Site Layout

The Headquarters of the Irish Naval Service is situated on the western portion of the Island with the Naval Dockyard to the east. Separating these is the site of former Irish Ispat Steelworks. The majority of buildings associated with the steel production have been demolished and cleared from the site since 2005. A number of listed buildings were retained. To the east of the Naval Dockyard is the East Tip, an area of land reclaimed from the Spit Bank by infilling with processing waste from the steelworks. A site layout is presented in Plate 2.1. The Coastal and Marine Research Centre (CMRC) which is part of University College Cork is accommodated within Naval Headquarters.

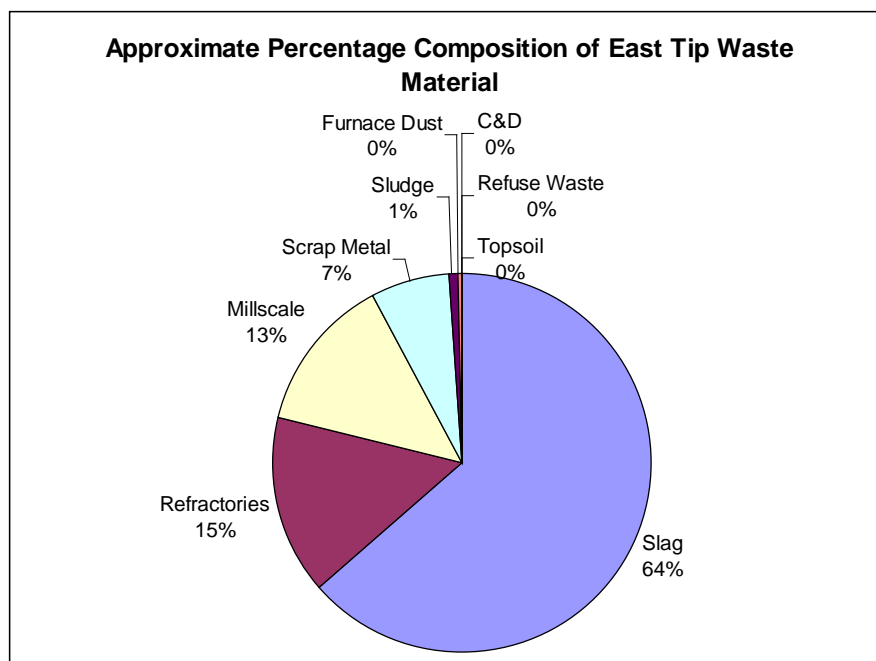
Figure 2.3: Approximate percentage composition of East Tip Waste Material (WYG, 2008)

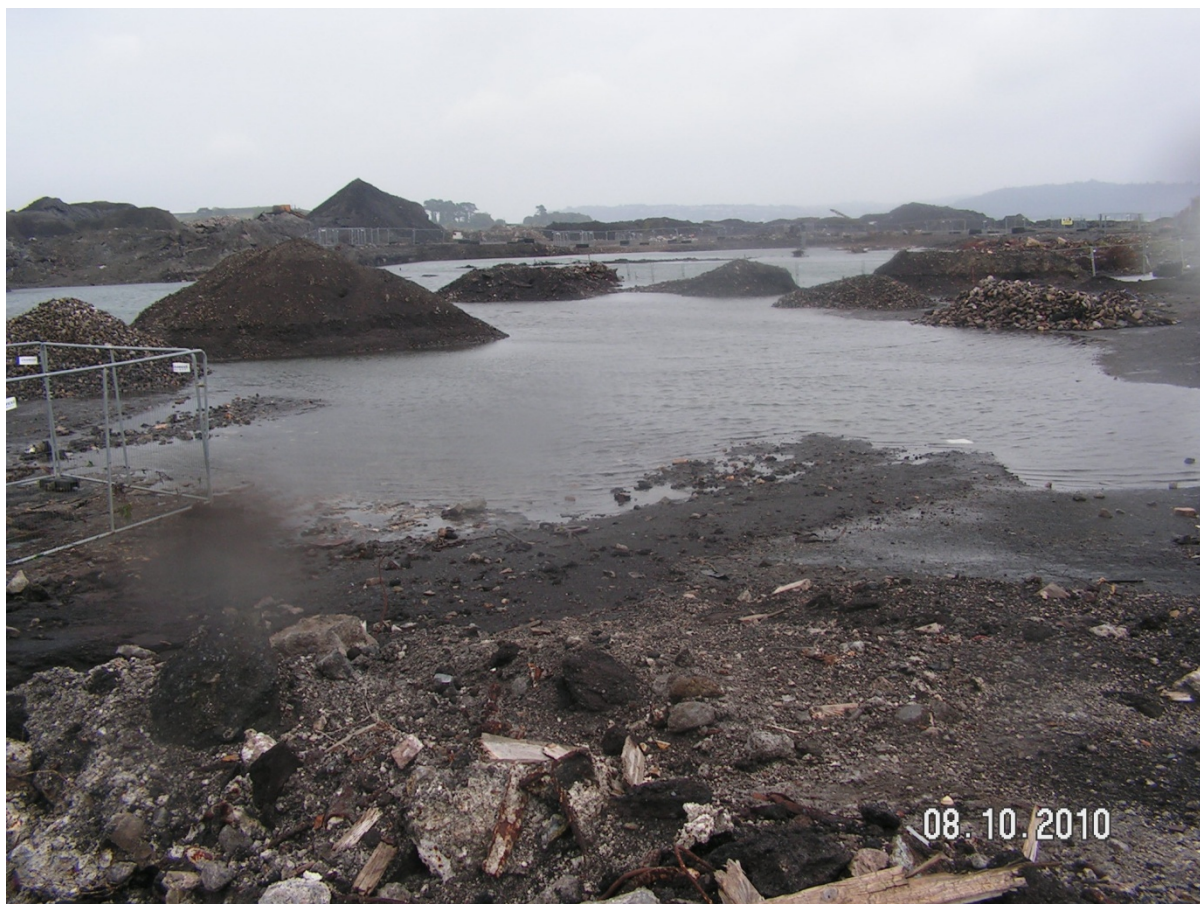
Plate 2.2: East Tip Inundated with Seawater

material remains on site but the majority was exported for disposal. As can be seen from the survey the main excavation is divided into two areas which are excavated to differing depths. The northern section of the excavation has an elevation of approximately 0mOD with the southern section having a depth of in excess of -2mOD in places. From 2008 groundwater level monitoring data, it can be seen that the groundwater level is generally in excess of 1mOD at high tide indicating a water depth of approximately 1m and 3m in the northern and southern excavation areas, respectively. The survey information also indicated that breach along the northern perimeter had resulted in the previous ground level being lowered by approximately 2m. This resulted in an area of the site becoming inundated with sea water under certain tidal and climatic conditions (Plate 2.2). This breach was repaired in November 2011.

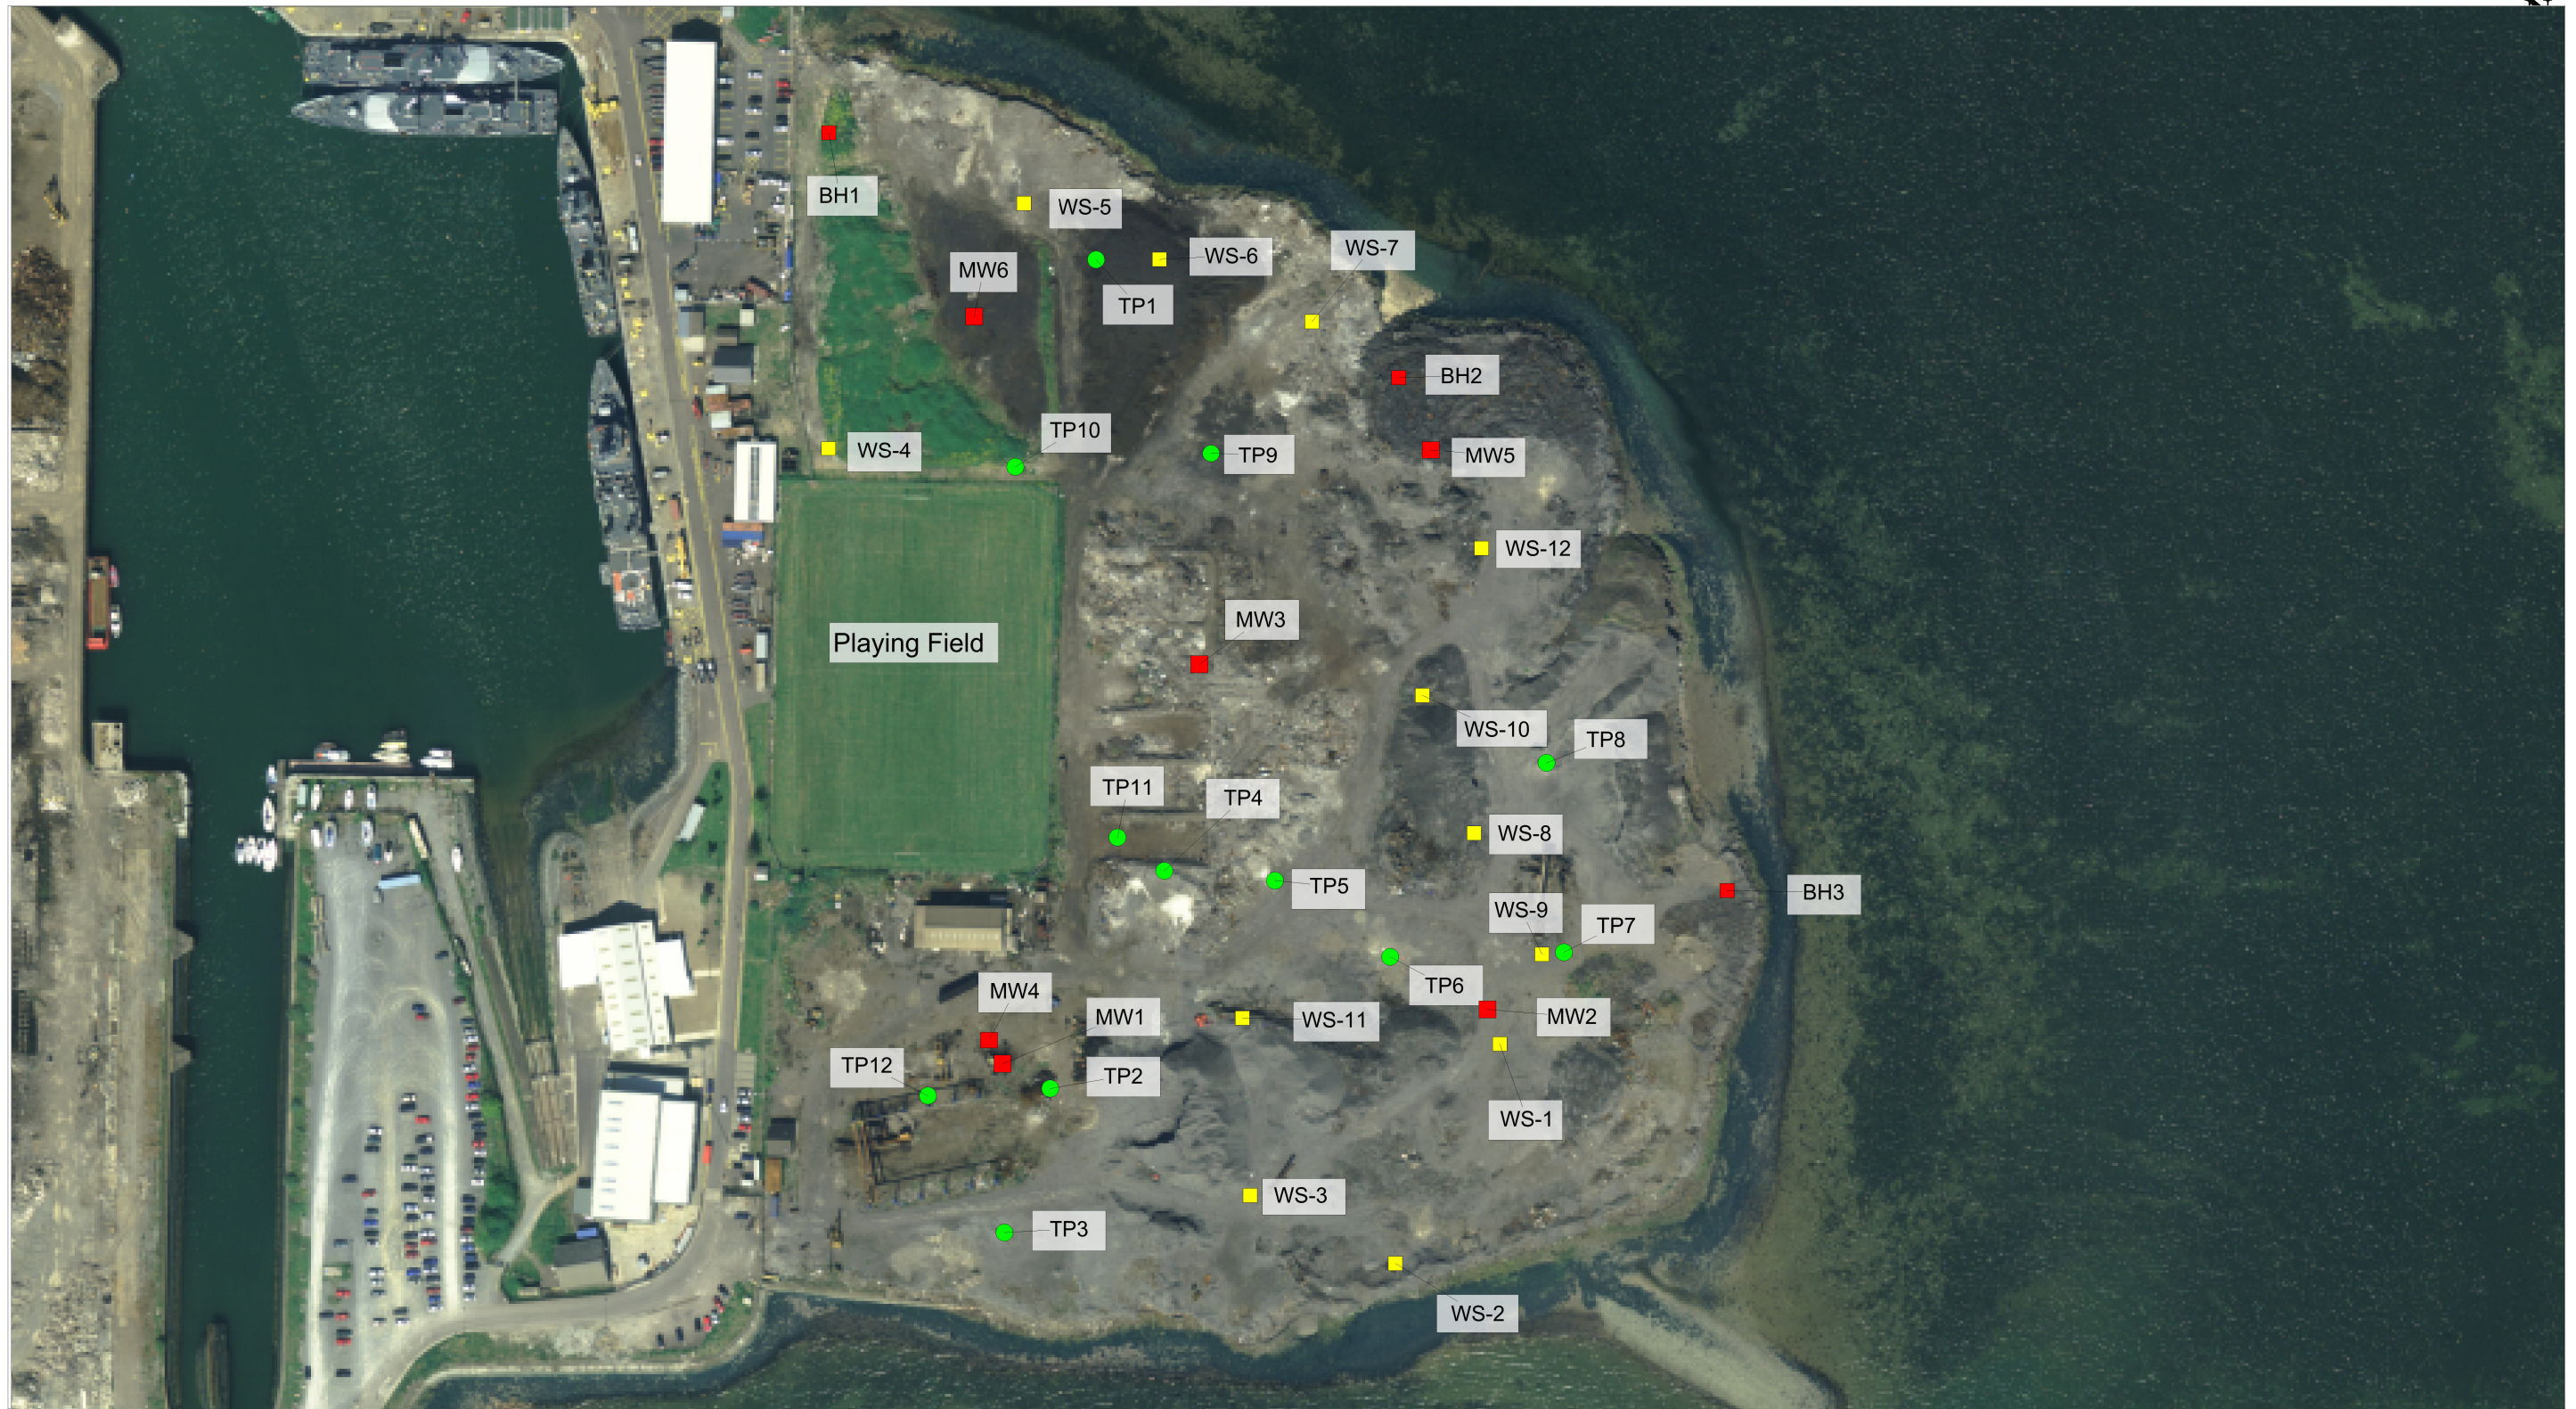
Title: **Figure 2.4:  
Borehole And Trial Pit  
Locations (1995,1998)**

<sup>2</sup> 3 no. additional boreholes (BH1 – BH3) had been previously drilled around the tip edge in May 1995 by Site Investigations Ltd.

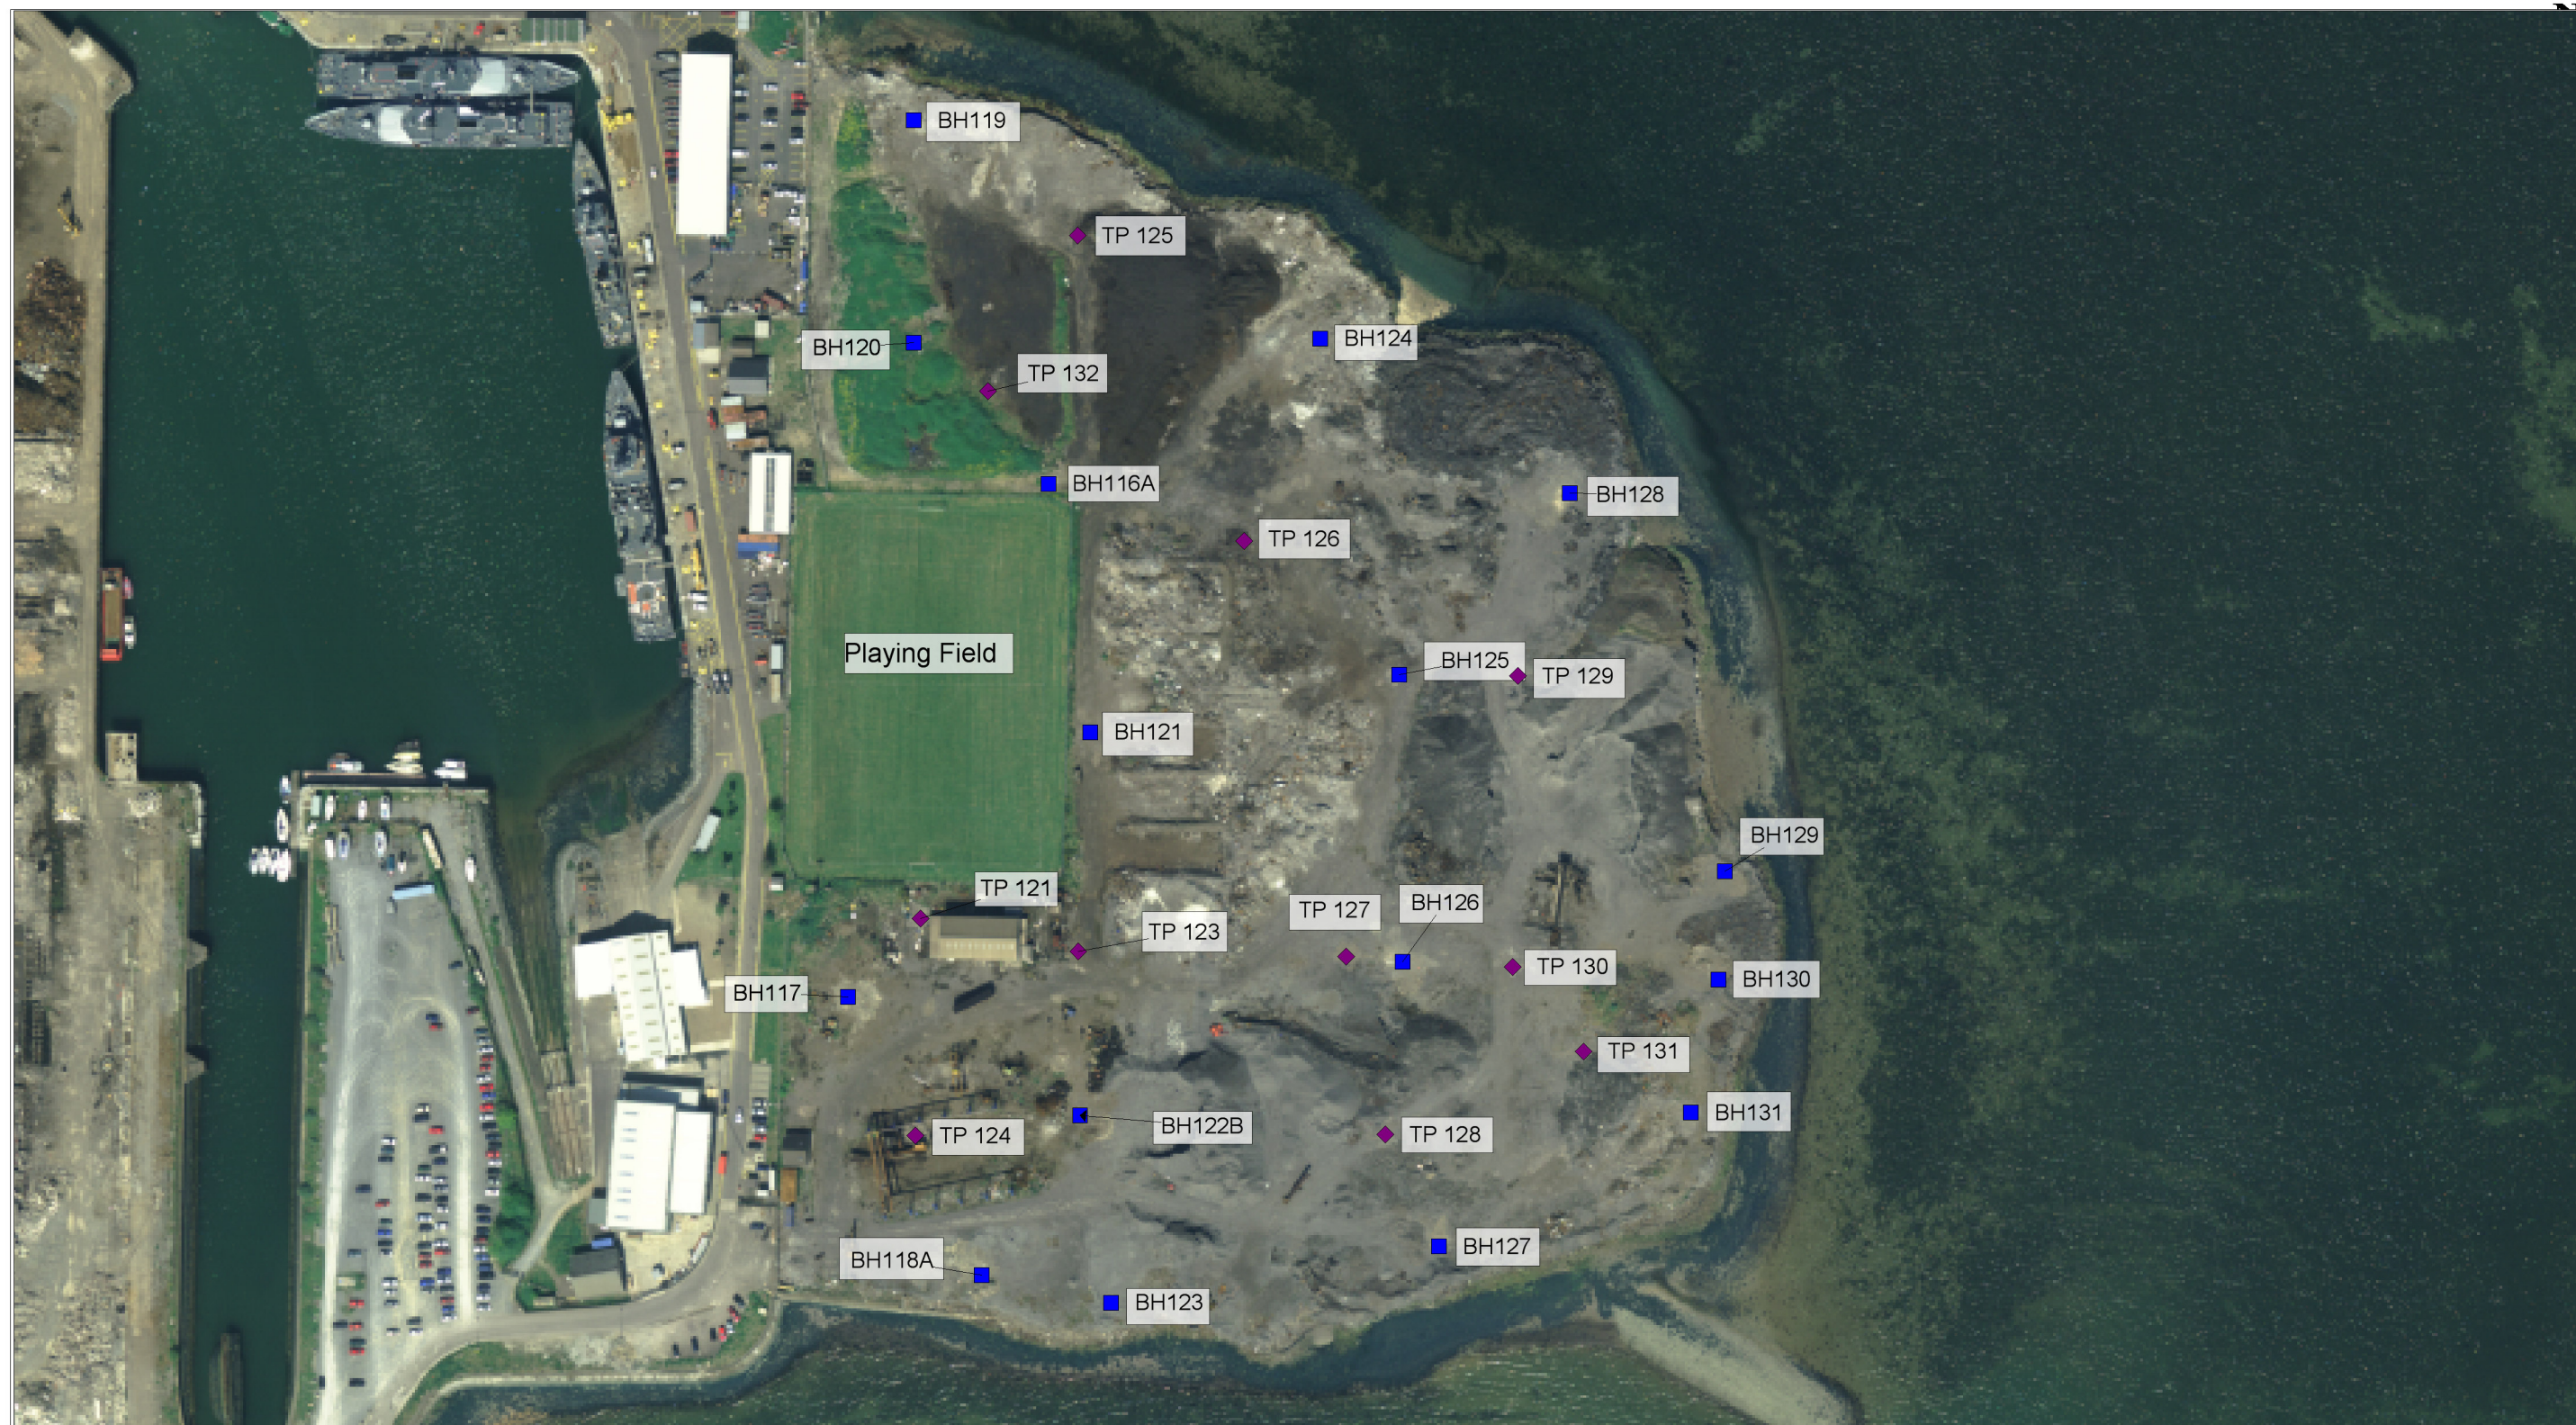
Title: **Figure 2.5:  
Borehole And Trial Pit  
Locations (2005)**

In 2005, WYG & Glovers were retained by Hyder, on behalf of Cork County Council to undertake an extensive subsurface investigation on the former Irish Steelworks site encompassing the East Tip and the main steelworks site. This report only references the site investigations carried out on the East Tip. The aim of the investigation was to provide an assessment of the geotechnical and environmental subsoil conditions (WYG A, 2005). In total 16 no. boreholes (BH116 – BH131) were installed and 11 no. trial pits (TP121, TP123-TP132) excavated within the East Tip. The 2005 borehole and trial pit locations are illustrated in Figure 2.5. Borehole logs and trial pit records are provided in Appendix D.

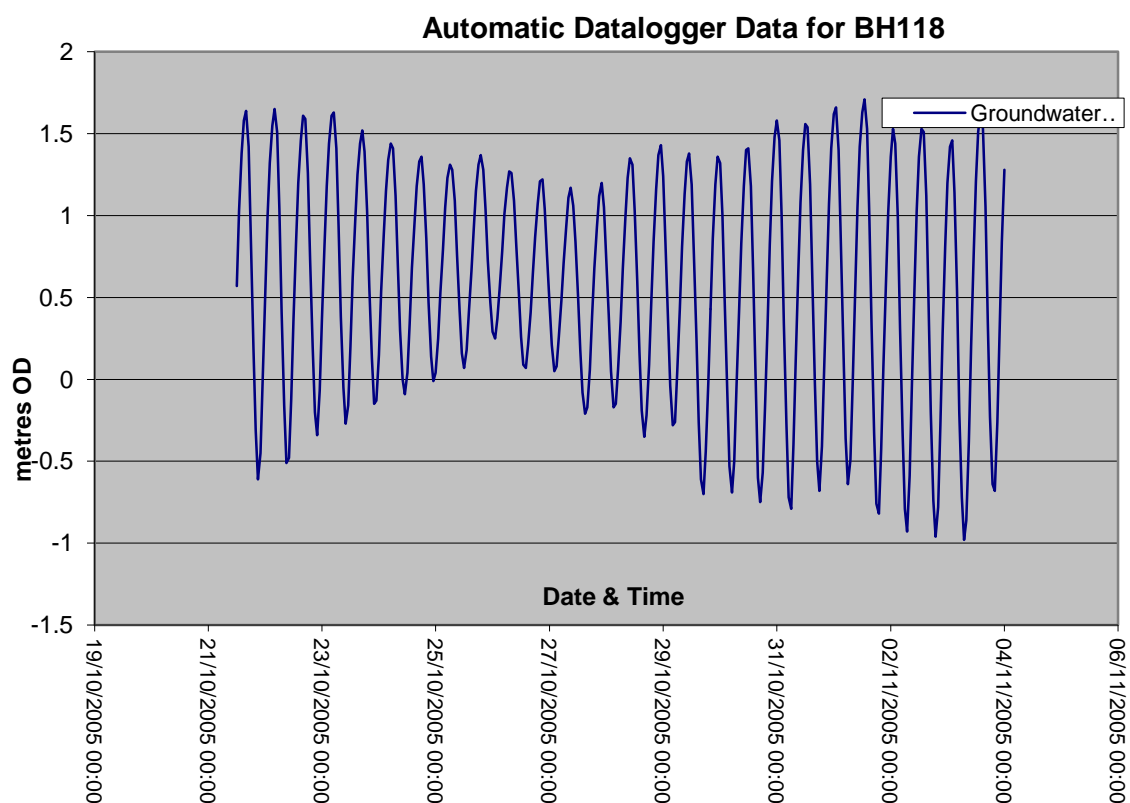
Figure 2.6: Automatic Datalogger Data for BH118 (WYG A, 2005)

The perched groundwater on the site has been found to be tidally influenced although due to the heterogeneity of the waste mass this is not constant across the site. Groundwater level measurements were taken from the monitoring wells at both high and low tide on 05/09/08 and 08/09/08, respectively, and are presented in Table 2.3 below. The groundwater level data was converted to Malin Head Ordnance Datum using levels obtained from a topographic survey (WYG A, 2008).

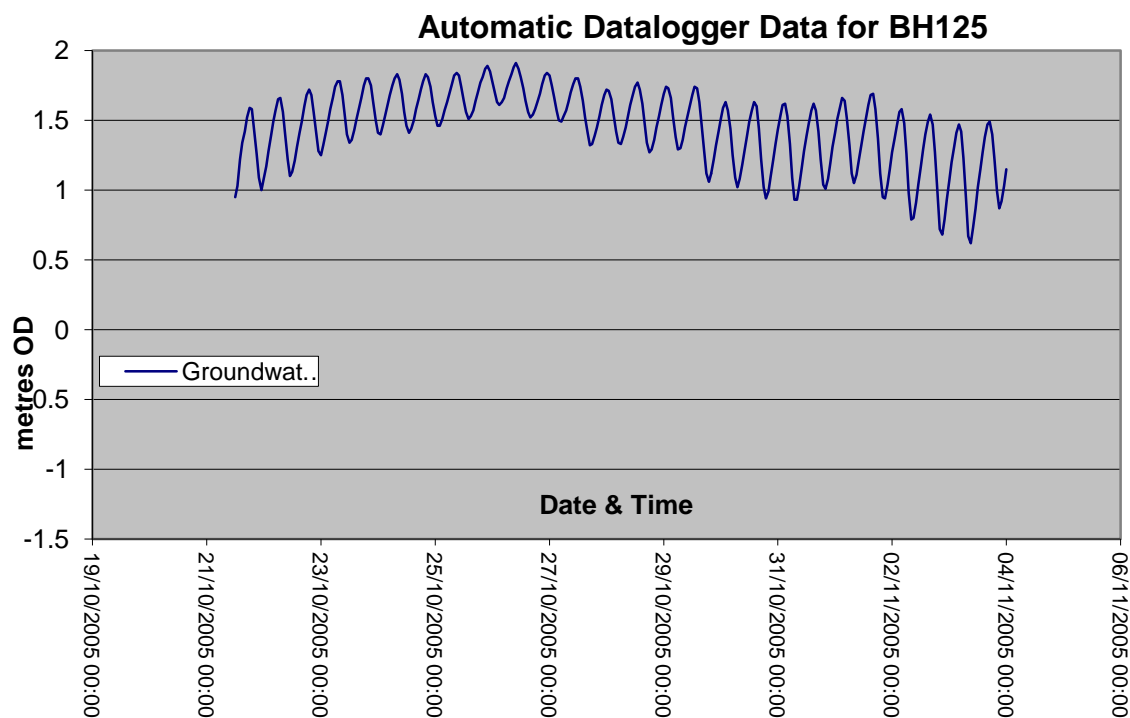
Figure 2.7: Automatic Datalogger Data for BH125 (WYG A, 2005)

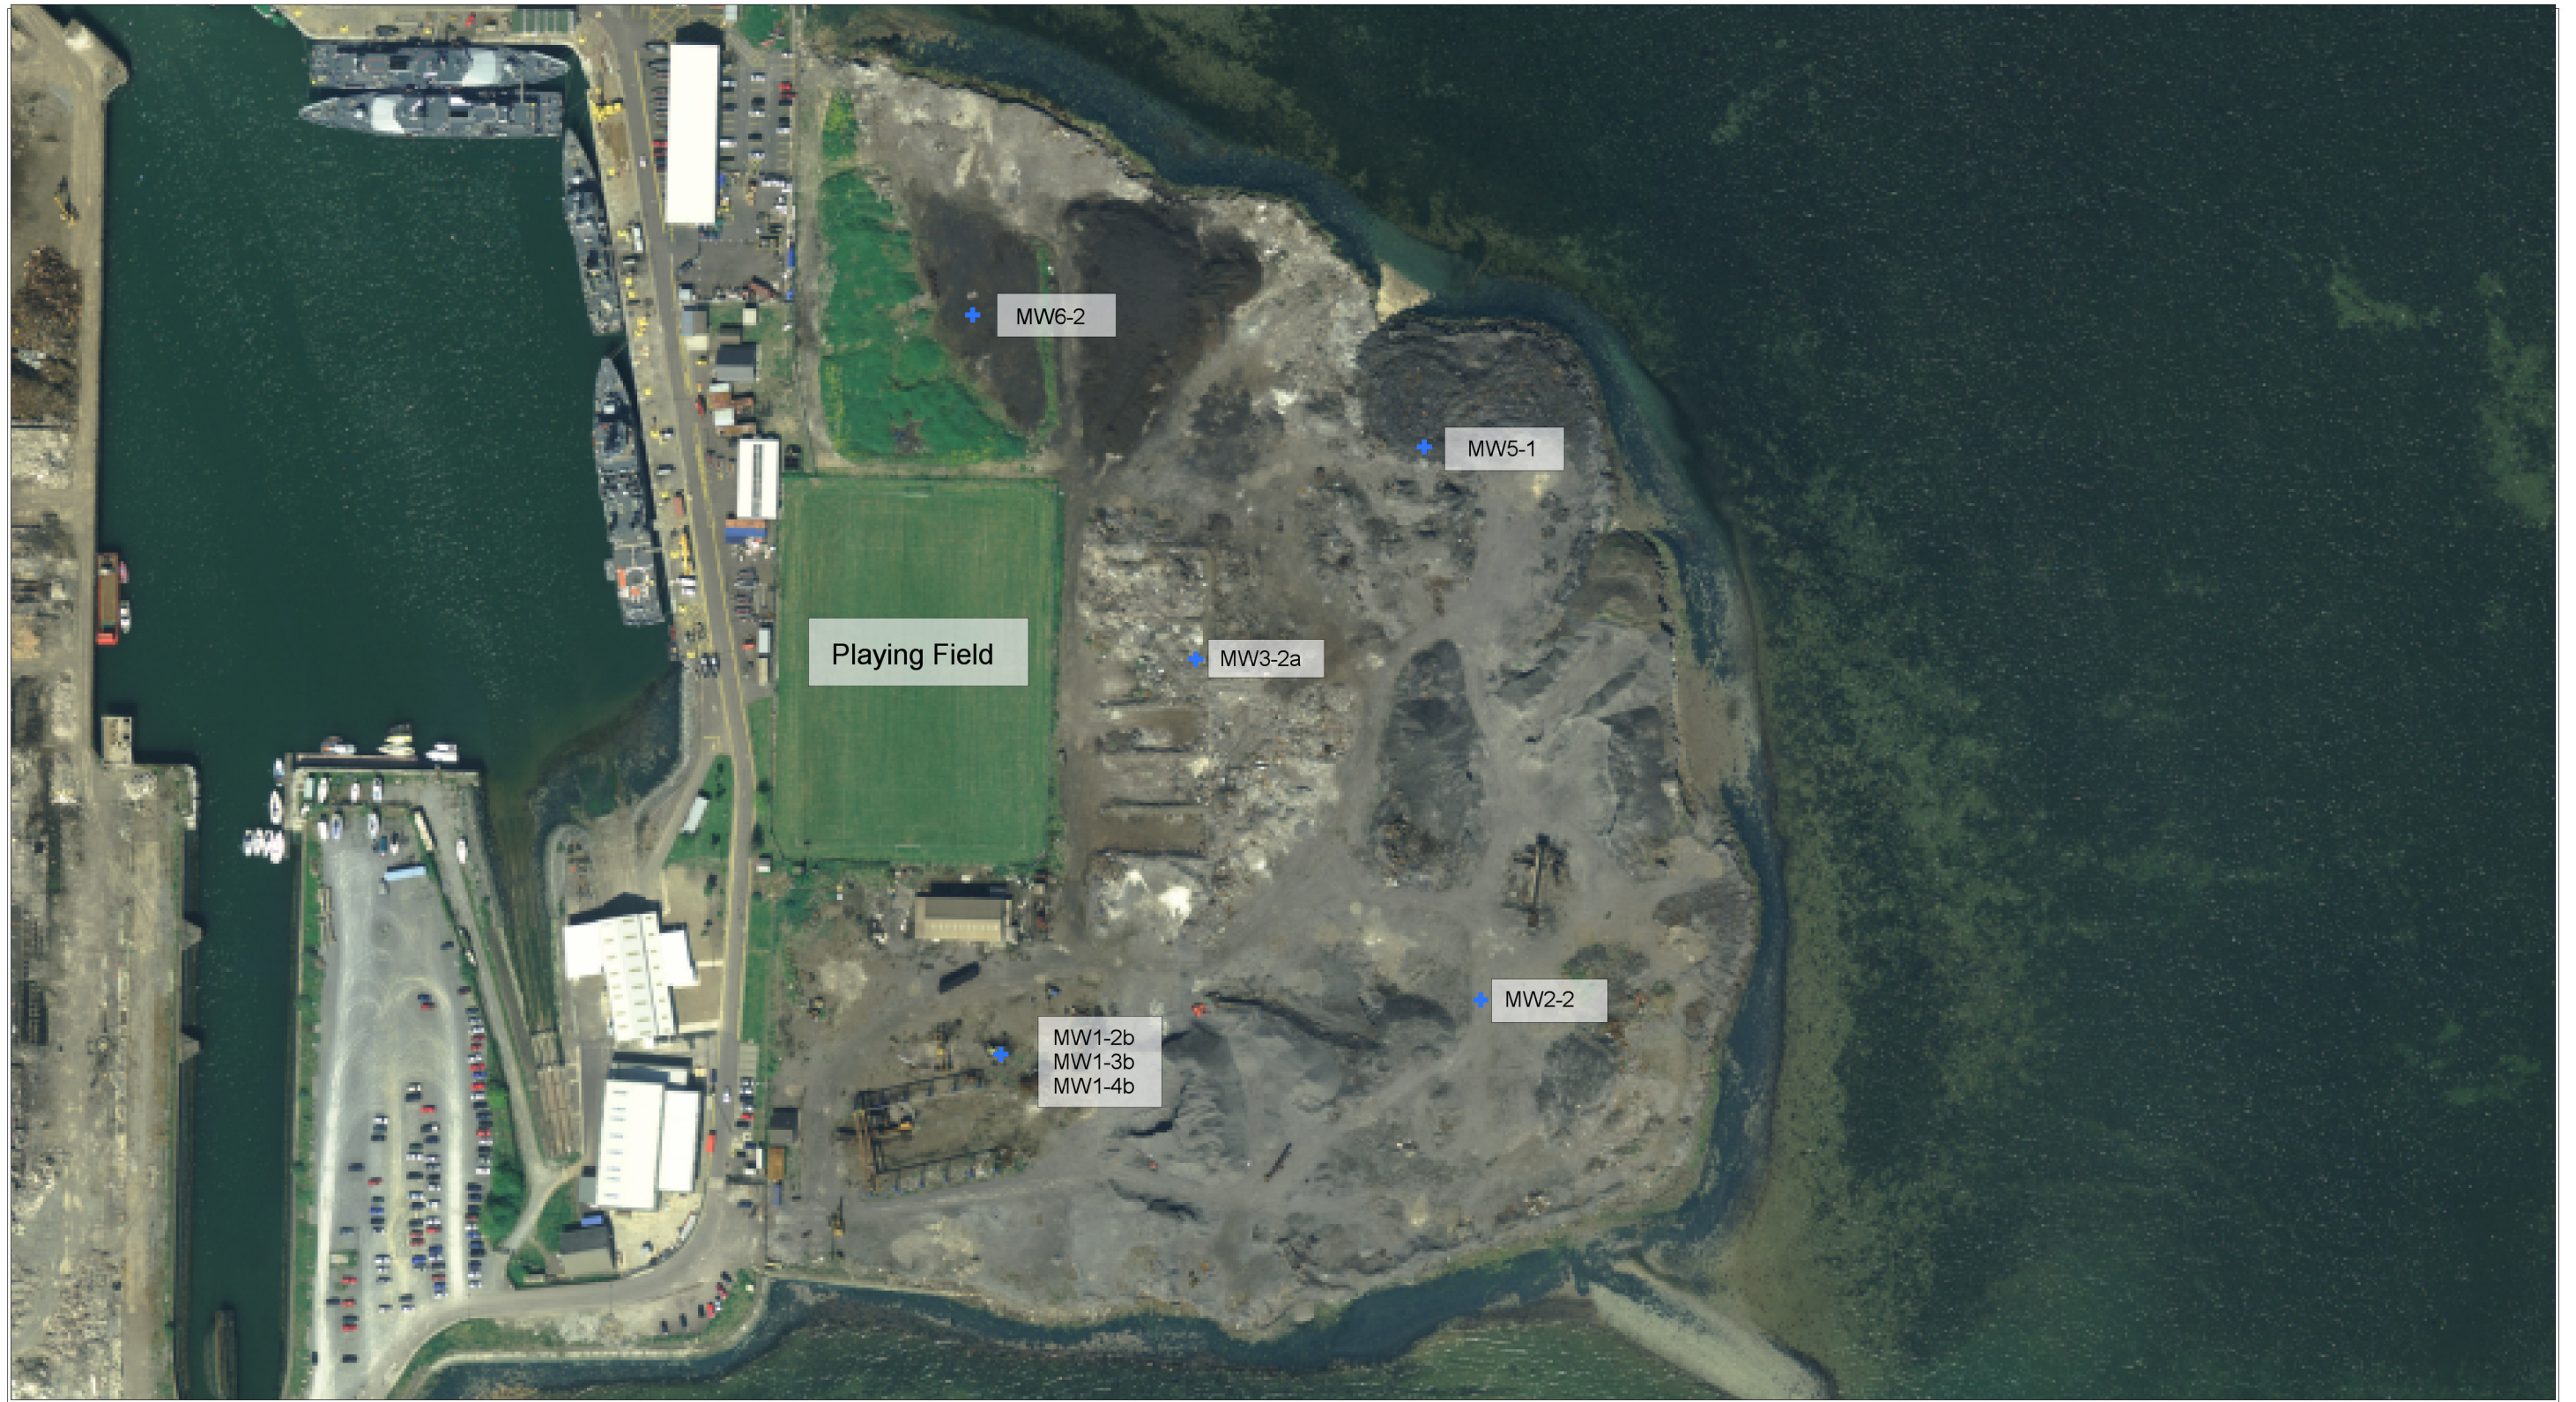
Title: **Figure 3.1;  
Silt Sediment Samples  
(1995 KT Cullen Report)**

The sample locations are presented in Figure 3.1. Results of the analysis determined that the natural water content of the silt varied between 21% and 46%. Particle size distribution charts are provided in Appendix H.

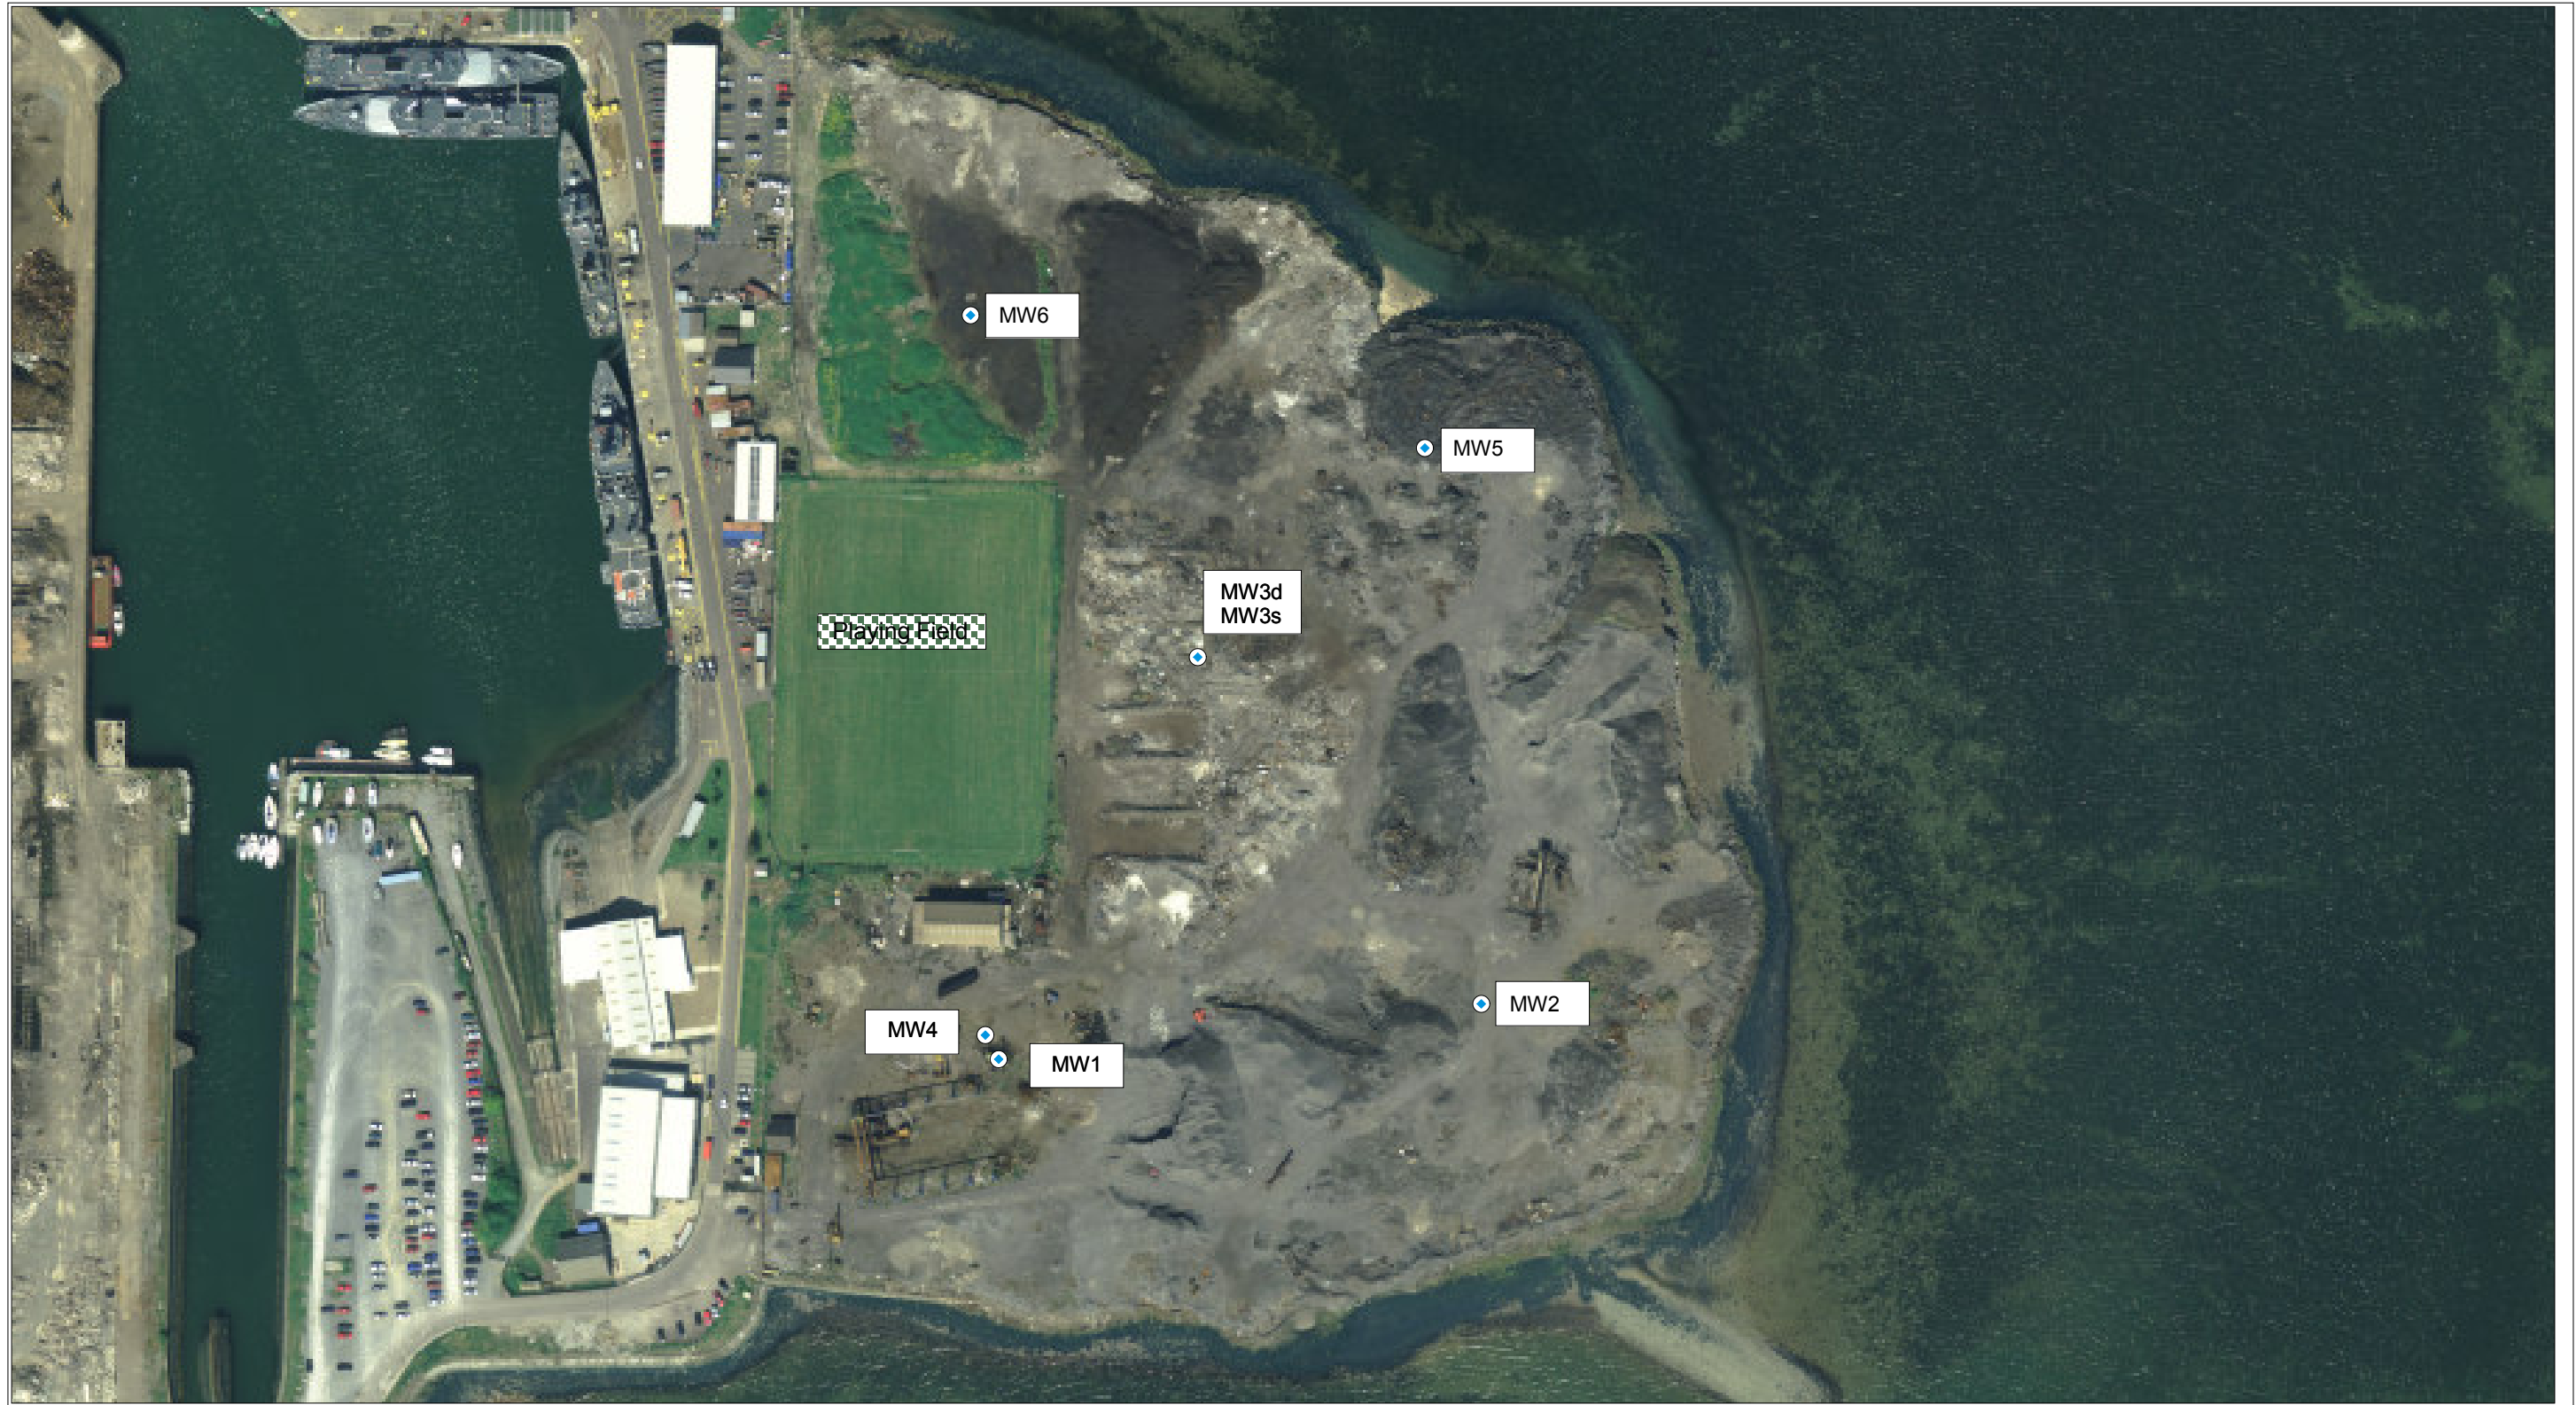
Title: **Figure 4.1:  
Groundwater Sampling  
Locations (1995)**  
Project: **Haulbowline Project**  
Drawn by: HaulbowlineTeam  
Date: 07/11/2011

The site investigation carried out by K.T. Cullen & Co on the East Tip in 1995 included groundwater monitoring. Six boreholes were drilled and seven monitoring wells were installed in order to establish the hydraulic regime of the tip head and to sample water entrained in the sediments. MW-3(s) and MW-4 were installed in the waste body and were thus in hydraulic connectivity with the sea water while MW-1, MW-2, MW-3(D), MW-5 and MW-6 were sealed within the sediments (CCC interpret this sediment to be the alluvium). Sampling of the seven monitoring wells was carried out on 28<sup>th</sup> August 1995 with samples being sent for analysis for a suite of inorganic parameters, TPH and phenol. Results were compared against available environmental quality criteria for water to determine the degree of impact and potential risks in addition to the Dutch Intervention levels. The 1995 groundwater sampling locations are presented in Figure 4.1 and the results of the analysis of the groundwater are presented in Appendix I.
