# East Tip, Haulbowline Island

## Factual Report

## East Tip, Haulbowline Island Factual Report

Márta 2012

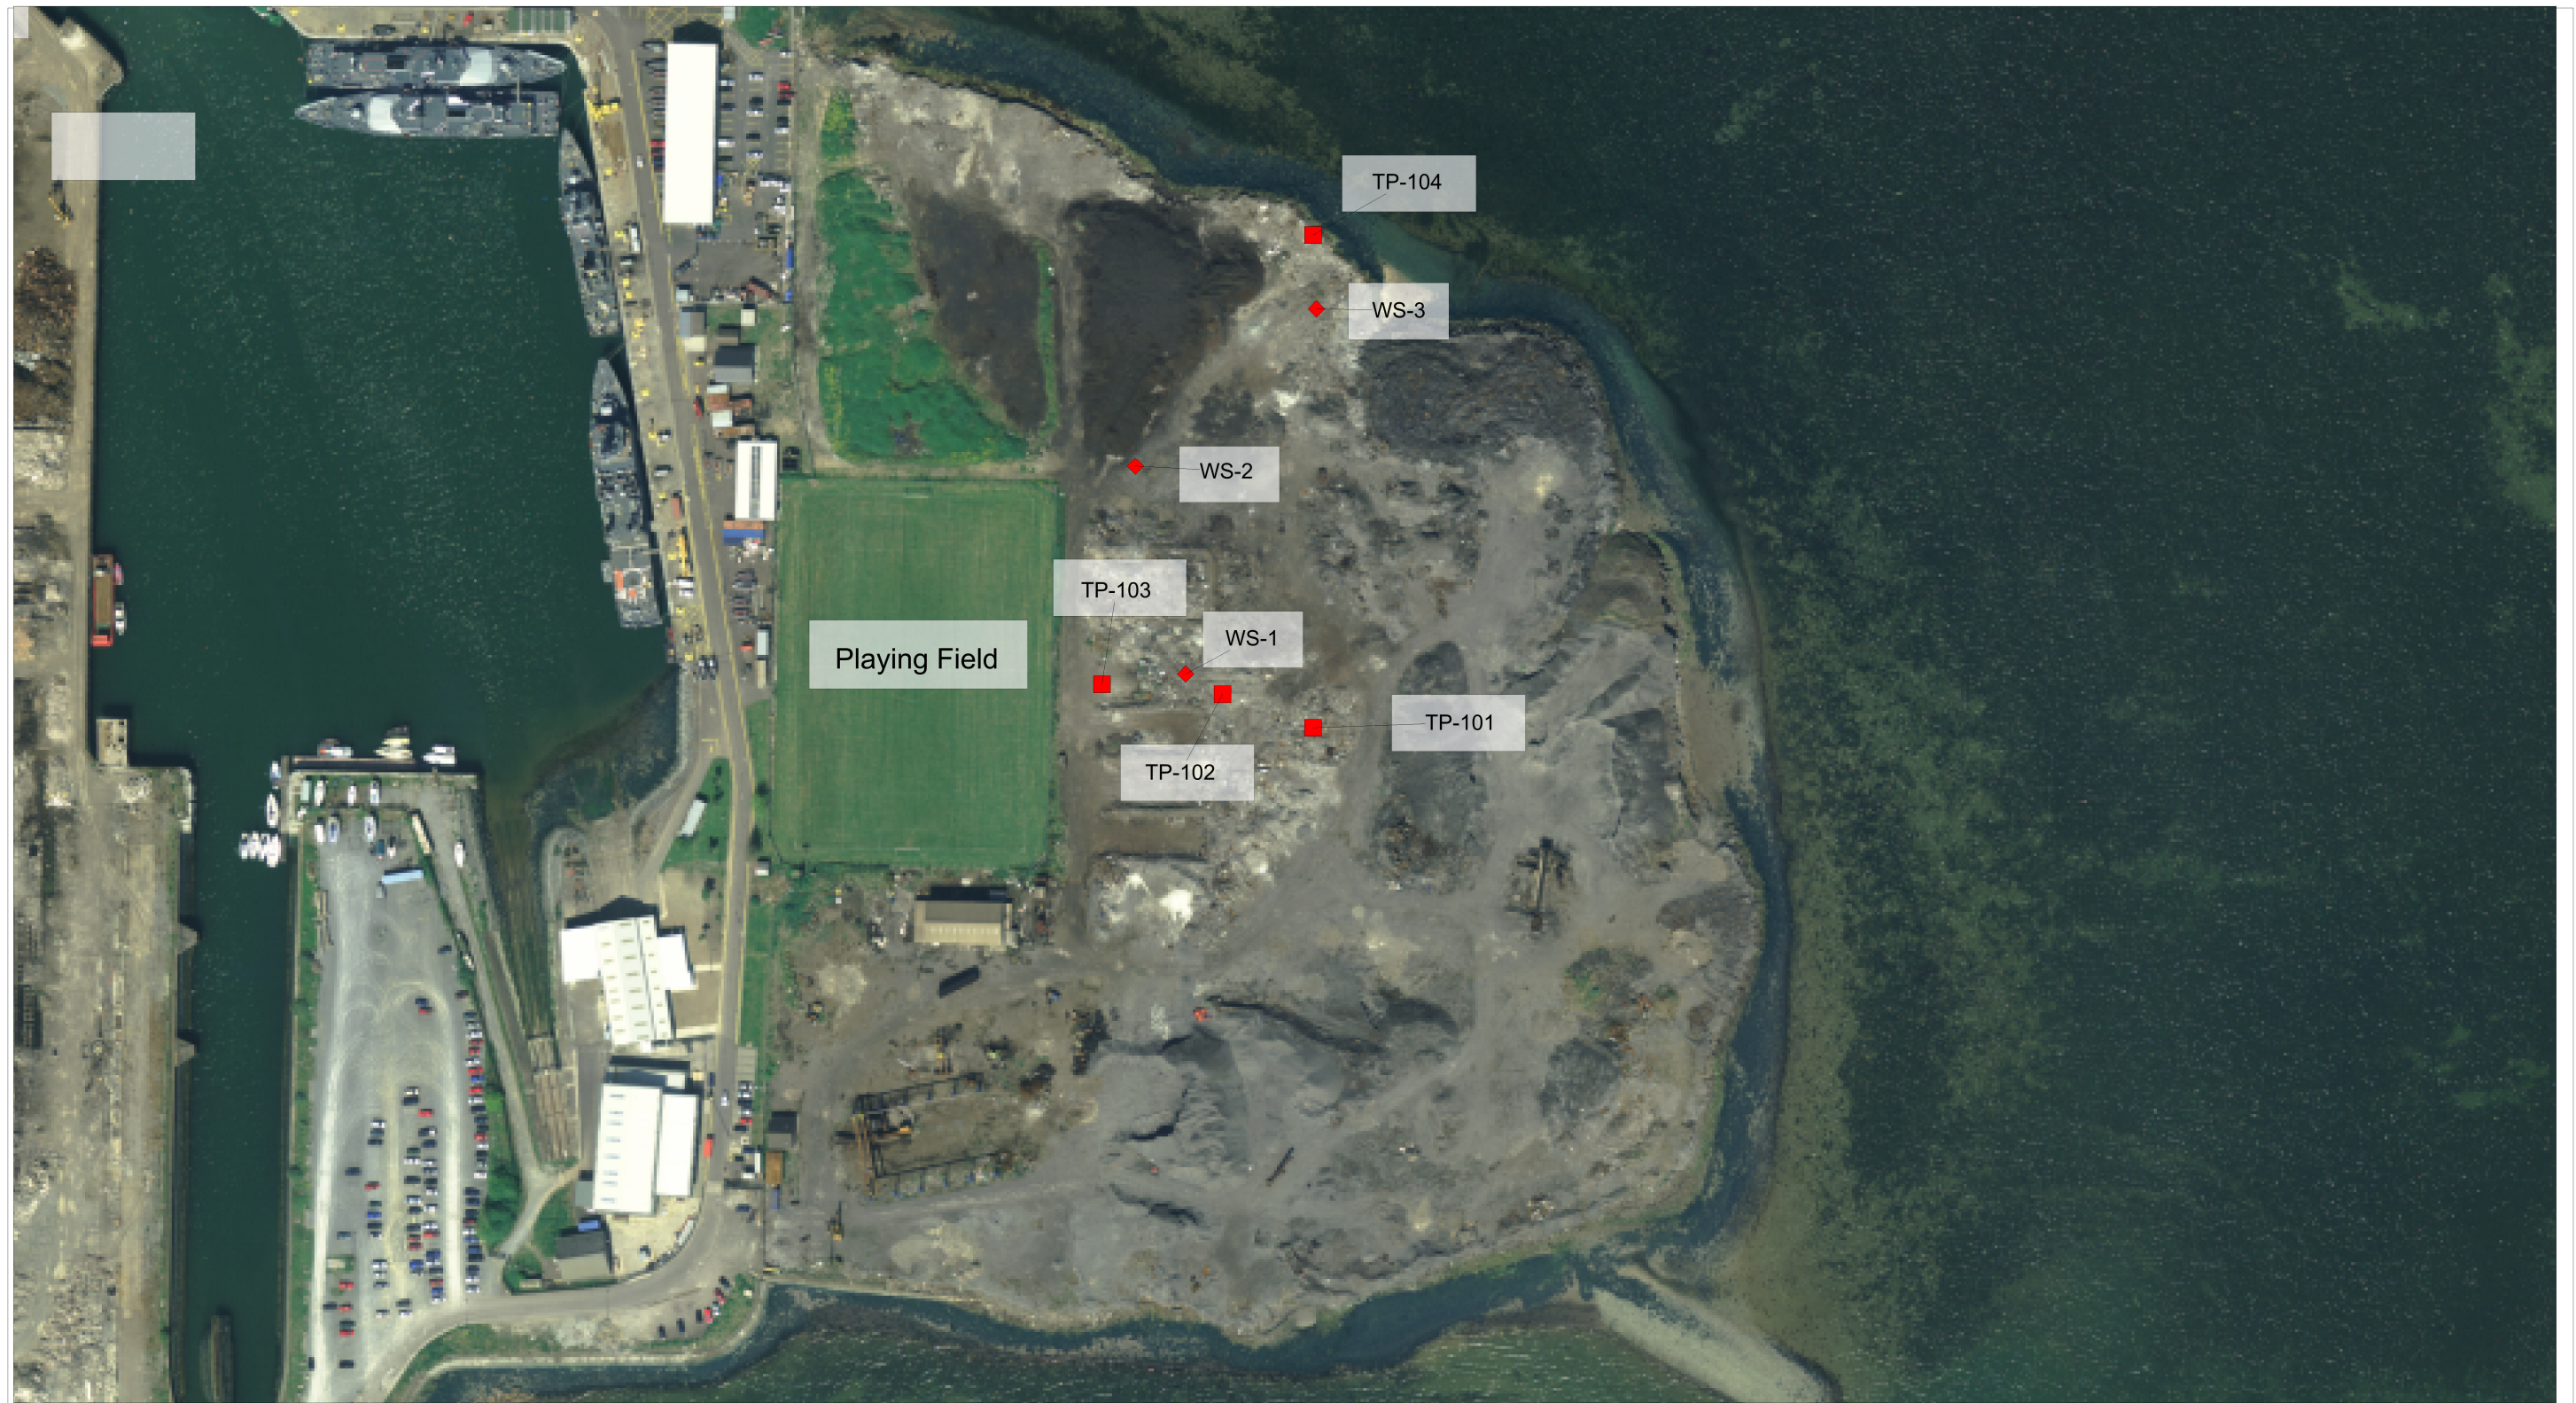
Title: Figure 4.4:  
Surface Water Sampling Locations  
From Contractor Excavations  
And Trial Pits (2008)

Three water samples (WS-1 to WS-3) were taken from the surface water on the East Tip at locations shown in Figure 4.4. Samples WS-1 and WS-2 were taken from the main contractor excavation and WS-3 was taken from an area of the site that is normally dry and above the water level in the main excavation. Four of the fifteen contractor trial pits on the East Tip were also sampled (TP101, TP102, TP103 and TP104). Figure 4.4 presents the location of these trial pits. The water in the trial pits was similar to the excavation in that it contained both groundwater and surface water from the seawater that encroached onto the East Tip together with any collected rainfall. Water samples were obtained by taking a grab sample directly from the trial pit. The surface water samples were analysed for a broad suite of chemical parameters and the results are presented in Appendix I. Results were compared against the UK EA coastal and estuarine Environmental Quality Standards (EQS) and the annual average and maximum allowable concentration Environmental Quality Standards sourced from the Draft European Communities Environmental Objectives (Surface Water) Regulations 2008. These regulations have since come into effect on 30 July 2009 (European Communities Environmental Objectives (Surface Water) Regulations 2009). The analytical results were compared to the draft regulations 2008.

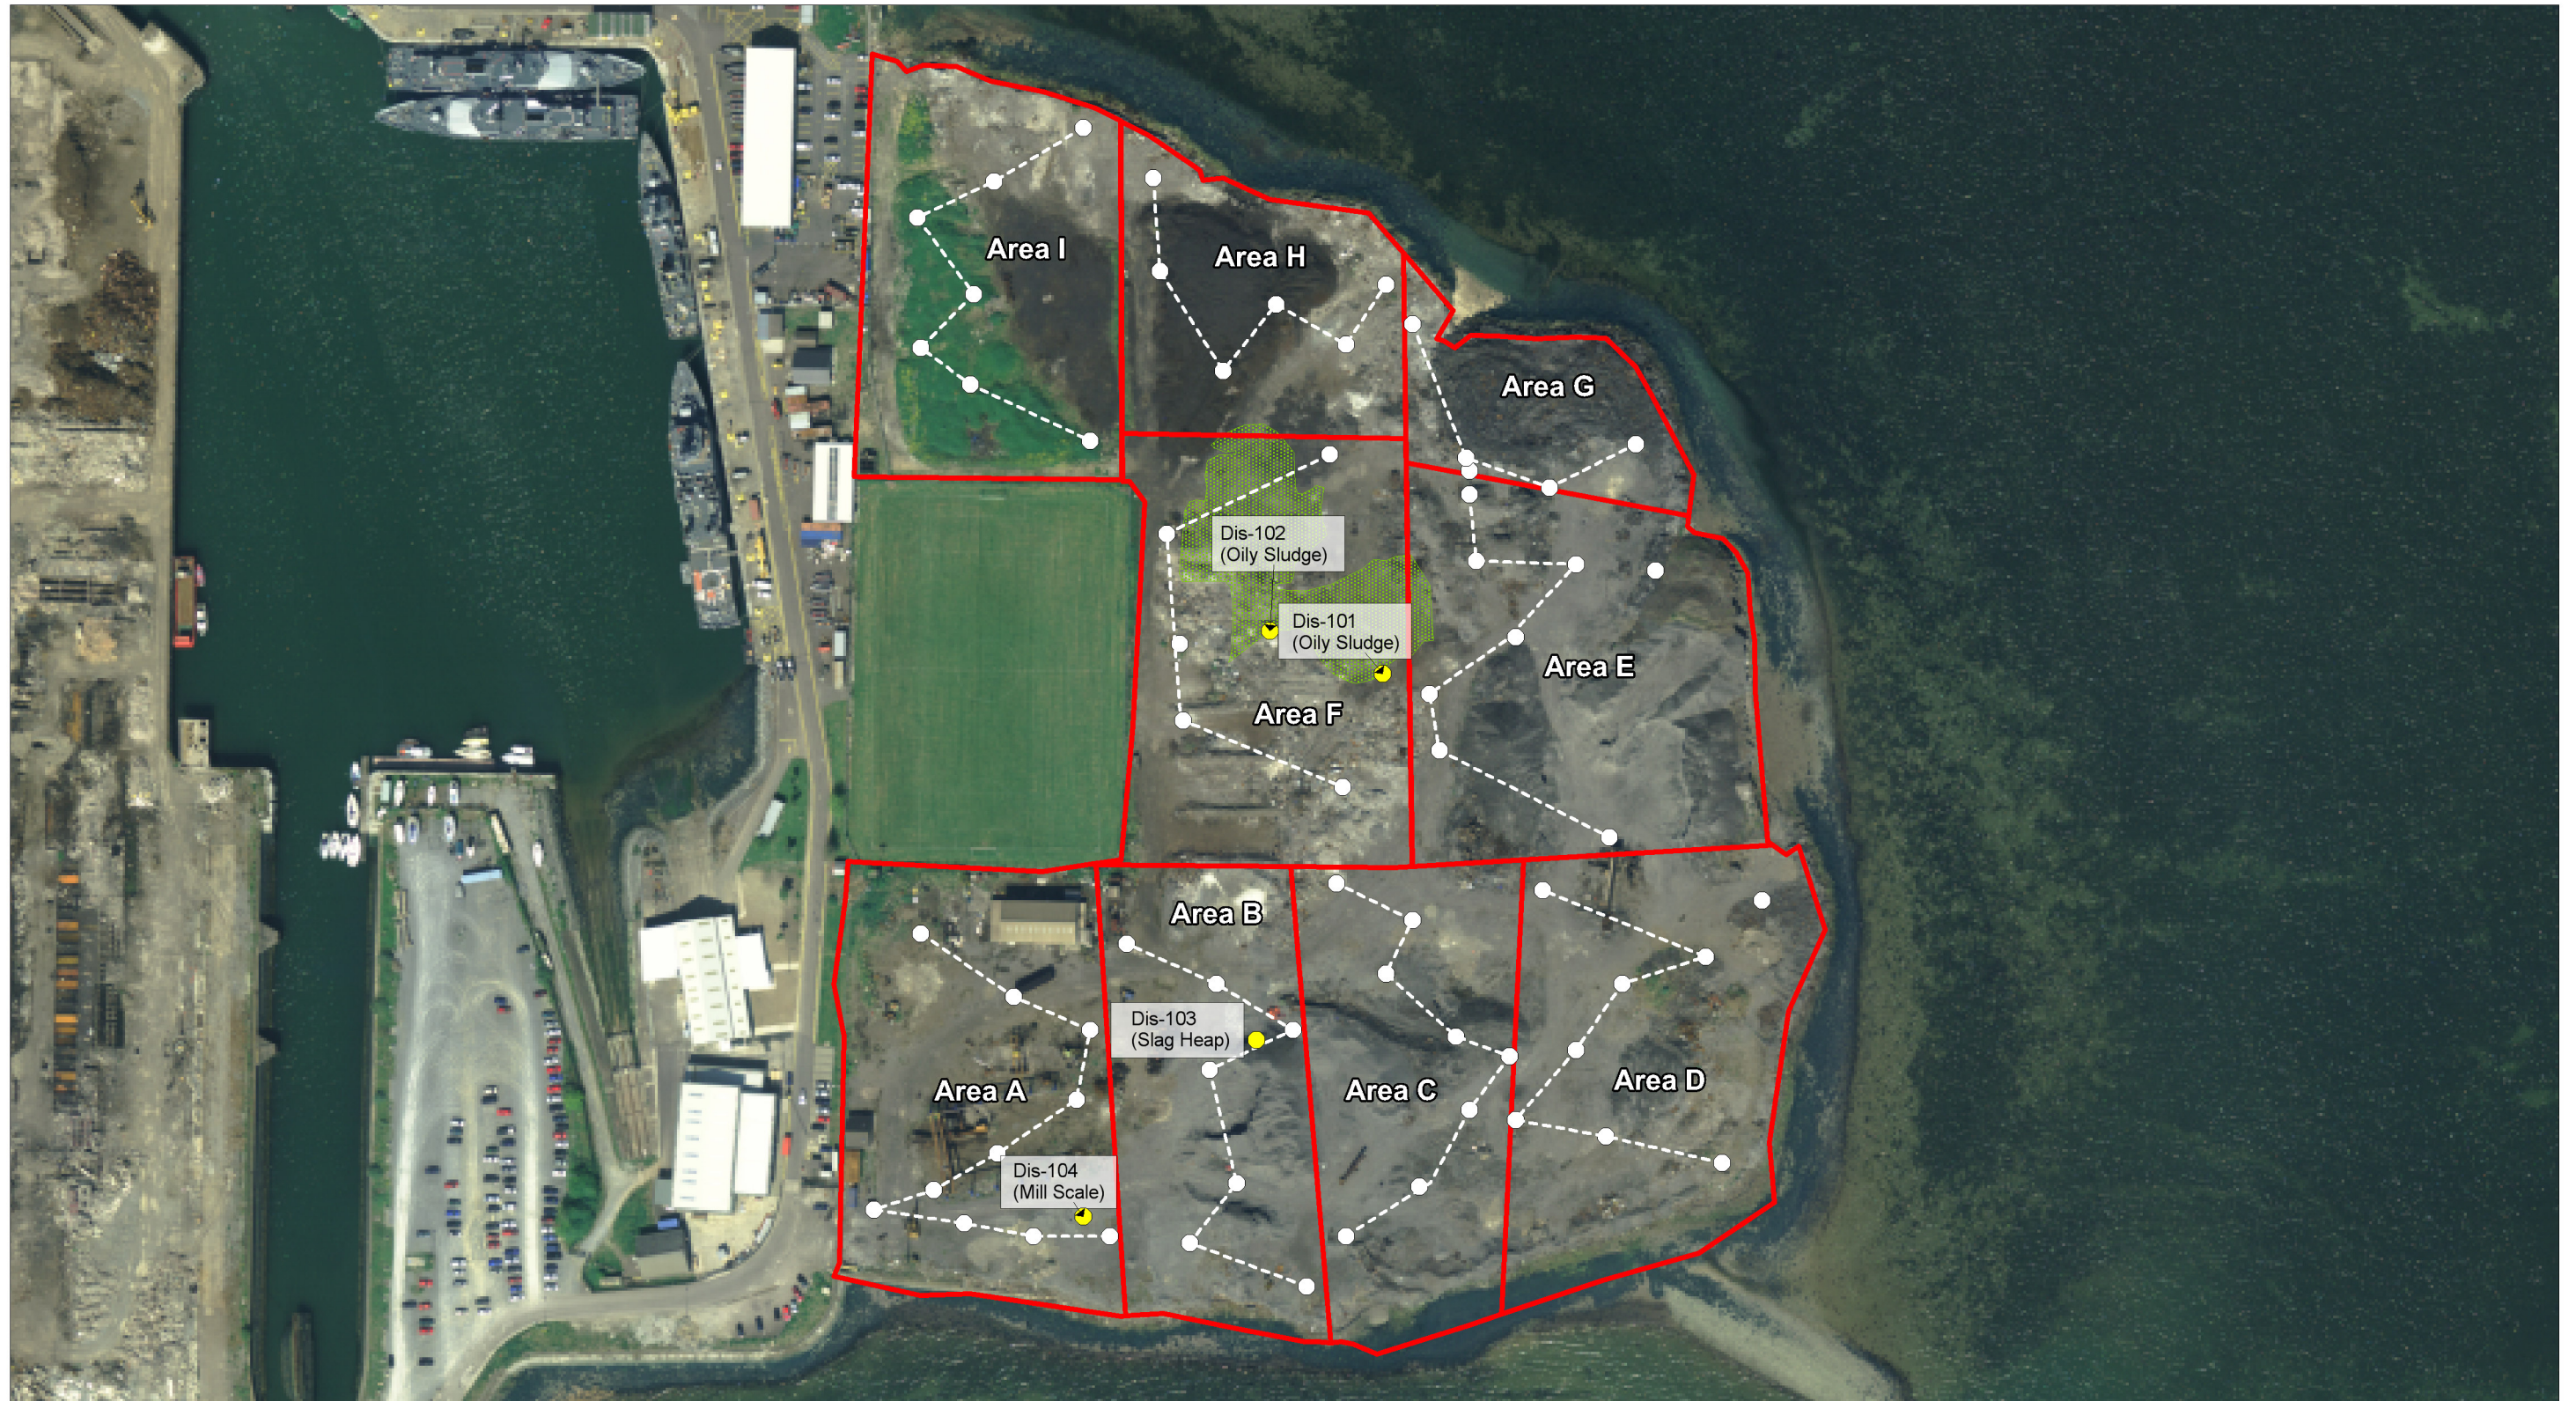
Title: **Figure 5.3 Surface Waste Sampling Locations (WYG 2008)**

During the 2008 site investigation 4 no. discrete samples and nine composite samples were obtained from the East Tip (Figure 5.3); composite samples were taken from a grid of nine areas of approximately one hectare (Area A to Area I). The four discrete samples and two composite samples were also subjected to leachability analysis to determine the potential impact on surrounding waters (Section 5.2.2). Table 5.6 below presents a list of the waste analysis undertaken as interpreted from WYG, A, 2008. The results of the laboratory analysis are provided in Appendix K.

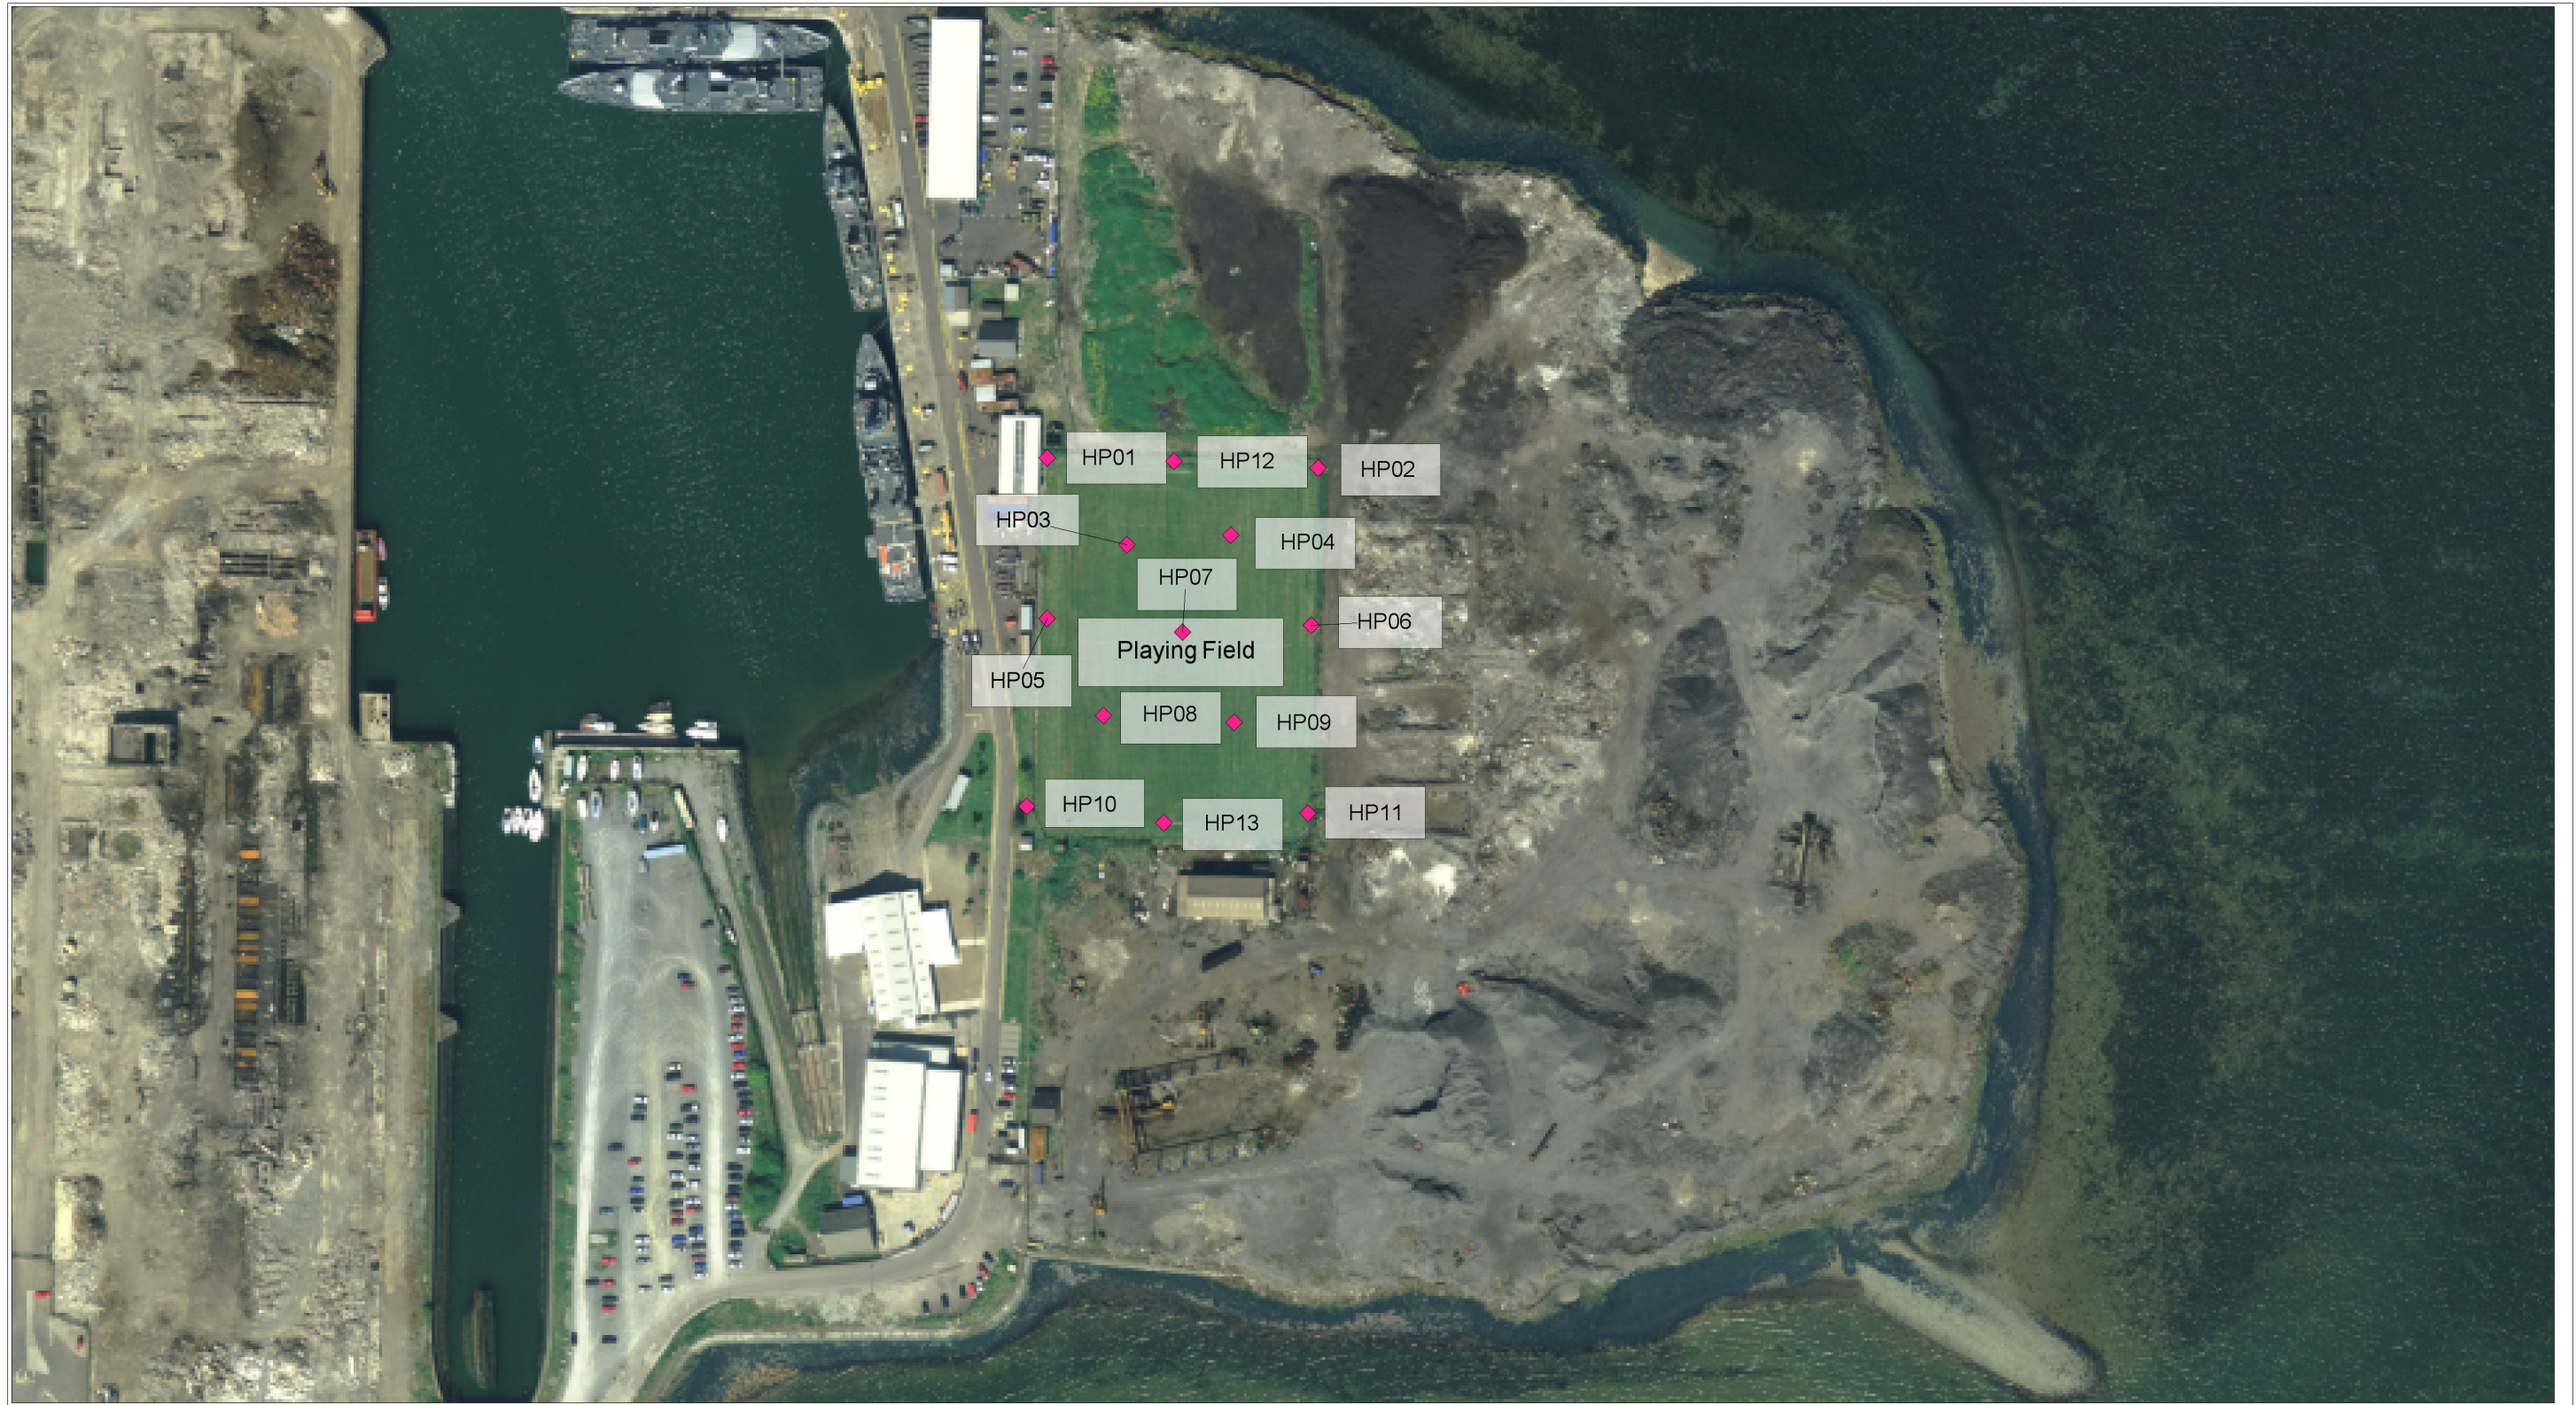
Title: **Figure 5.4: Shallow Soil Sample Locations (RPS 2008)**  
 Project: **Haulbowline Project**  
 Drawn by: HaulbowlineTeam  
 Date: 07/11/2011

A shallow soil investigation was carried out by RPS in July 2008 which consisted of the analysis of hand-dug surface soil samples of the Naval football pitch on the East Tip. 18 no. soil samples were taken from 13 no. locations (HP01 to HP13) and sampling locations are presented in Figure 5.4. Samples were collected from two horizon depths; ground level to 0.01mbgl and 0.01mbgl to 0.05mbgl. The following information was recorded during the excavation of the hand-dug pits:

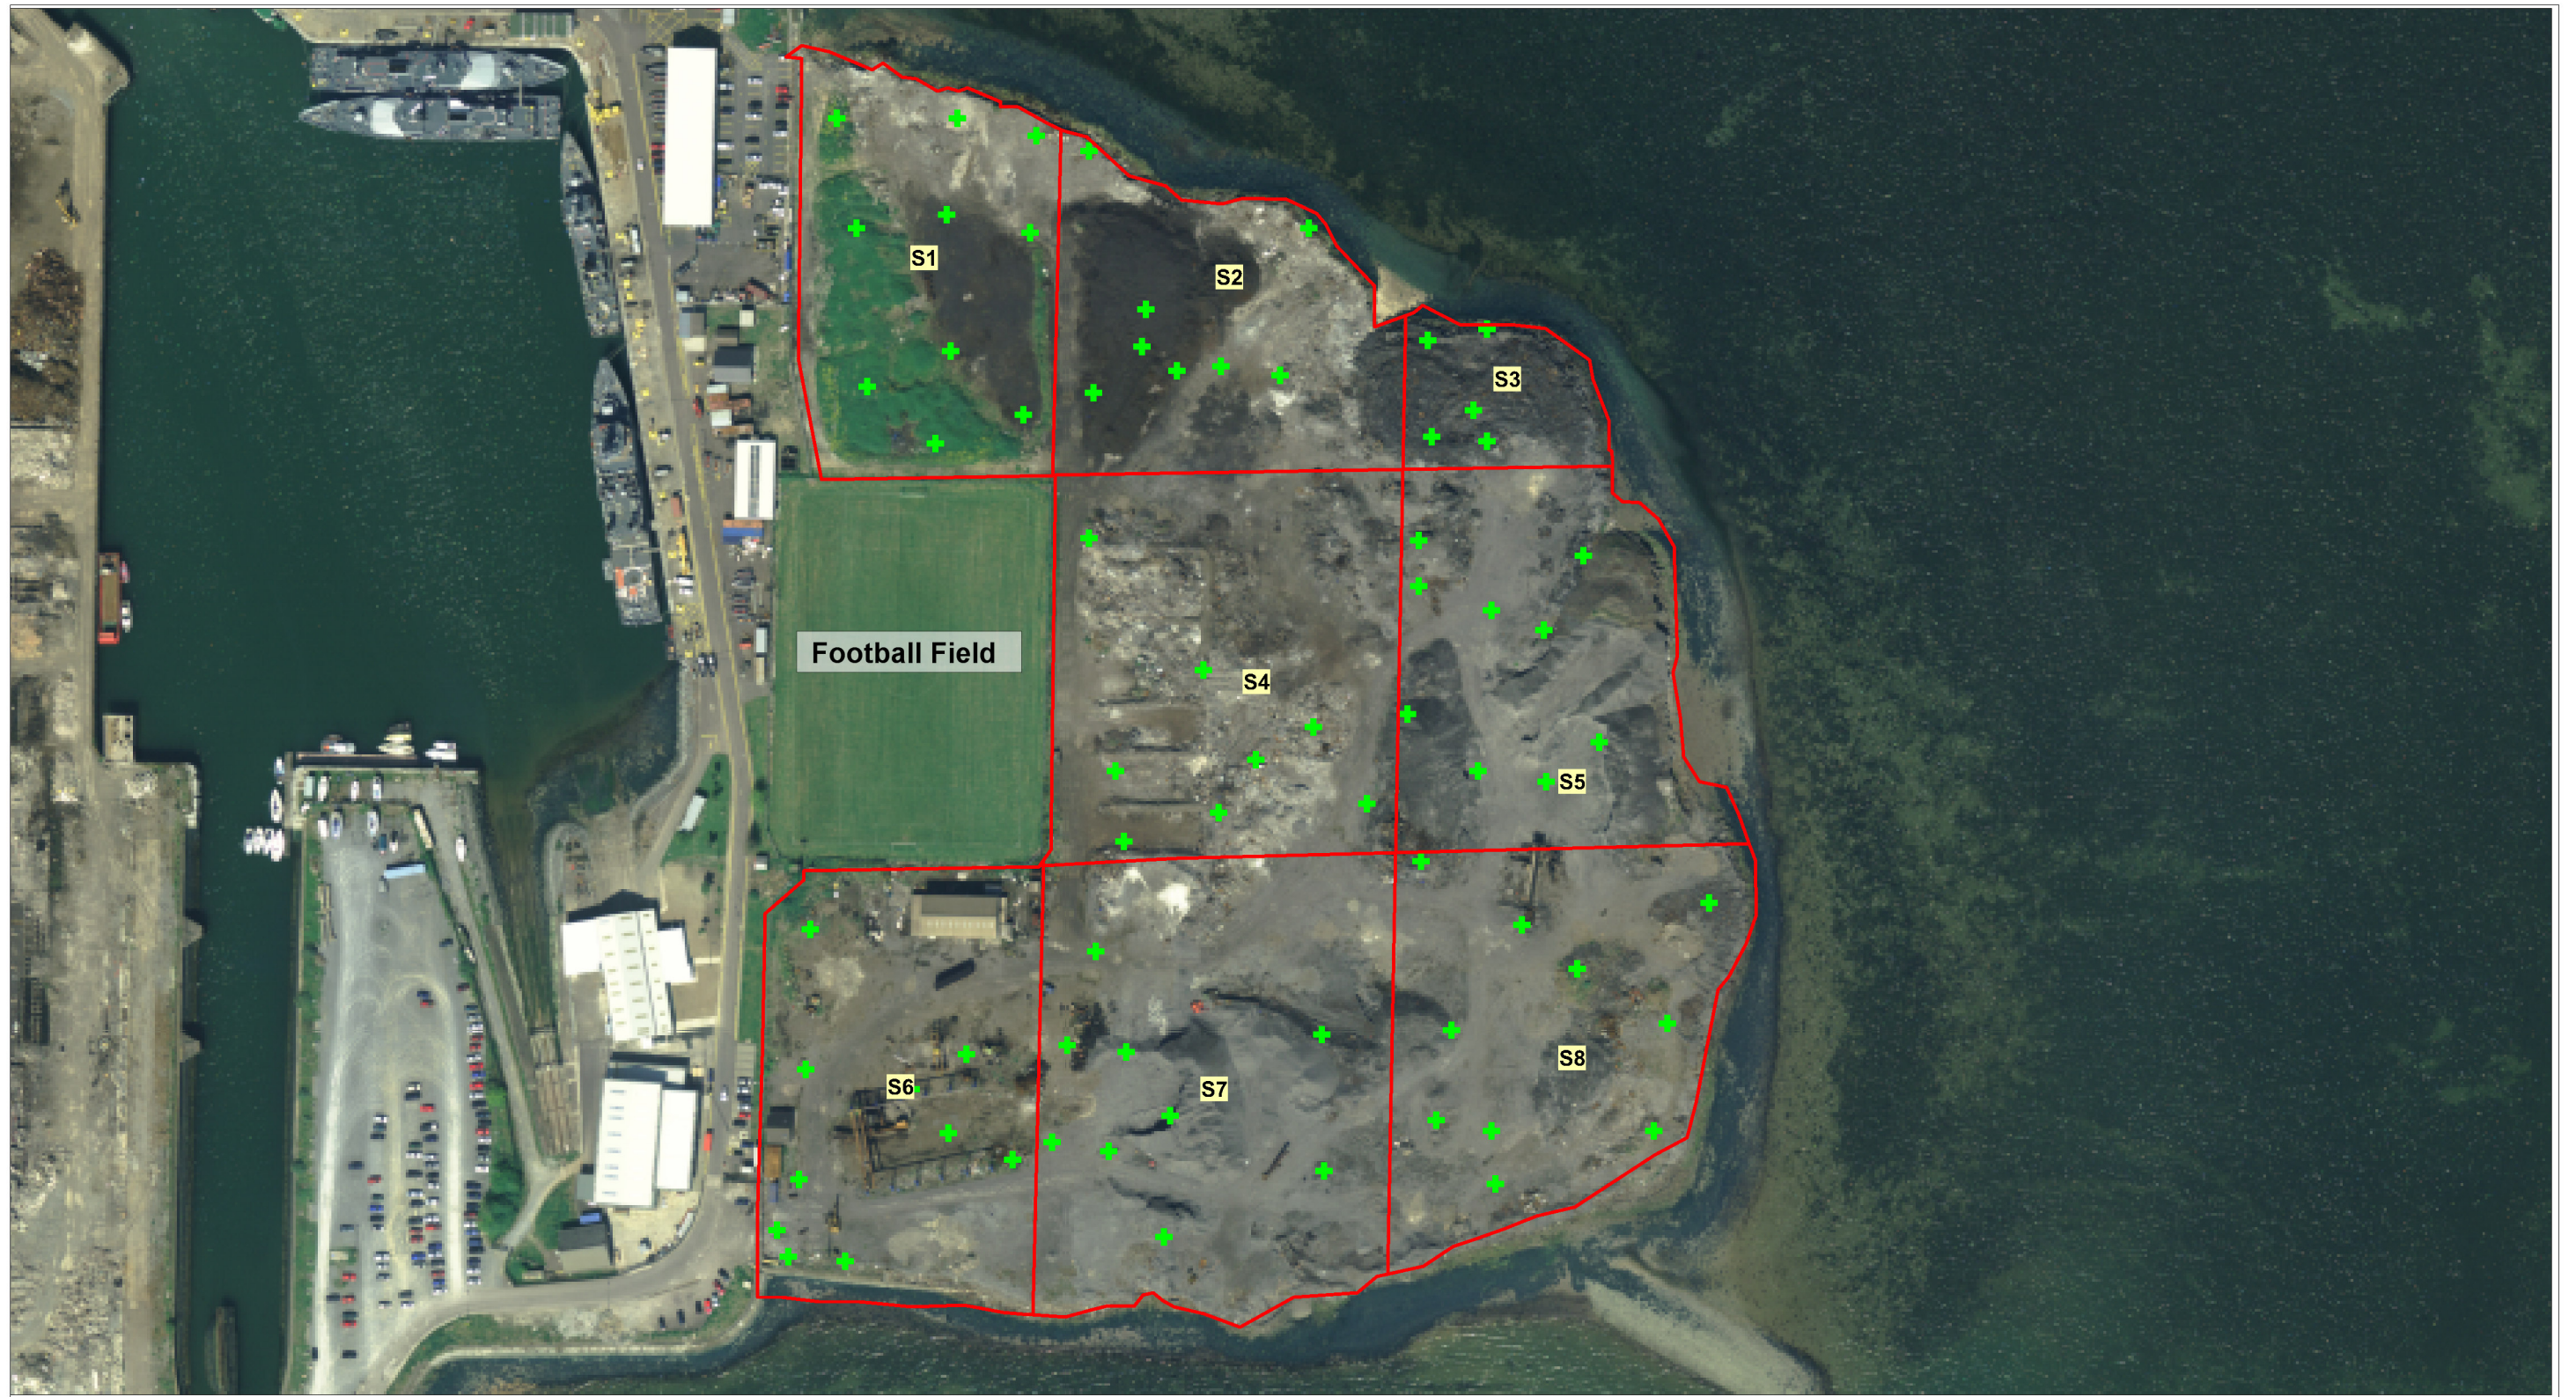
Title: **Figure 5.5:  
Slag Waste Stockpile  
Sampling Locations**

A total of eight composite slag samples (S1 – S8) were taken by WYG in July 2008 from the near surface slag wastes material across the East Tip (Figure 5.5) and underwent analysis in accordance with the CEN leachability test.
