Remediation of the East Tip, Haulbowline Island

Results of Detailed Quantitative Risk Assessment

Remediation of East Tip – Update on EIS, Statutory Consents, Appropriate Assessment & Outline Design

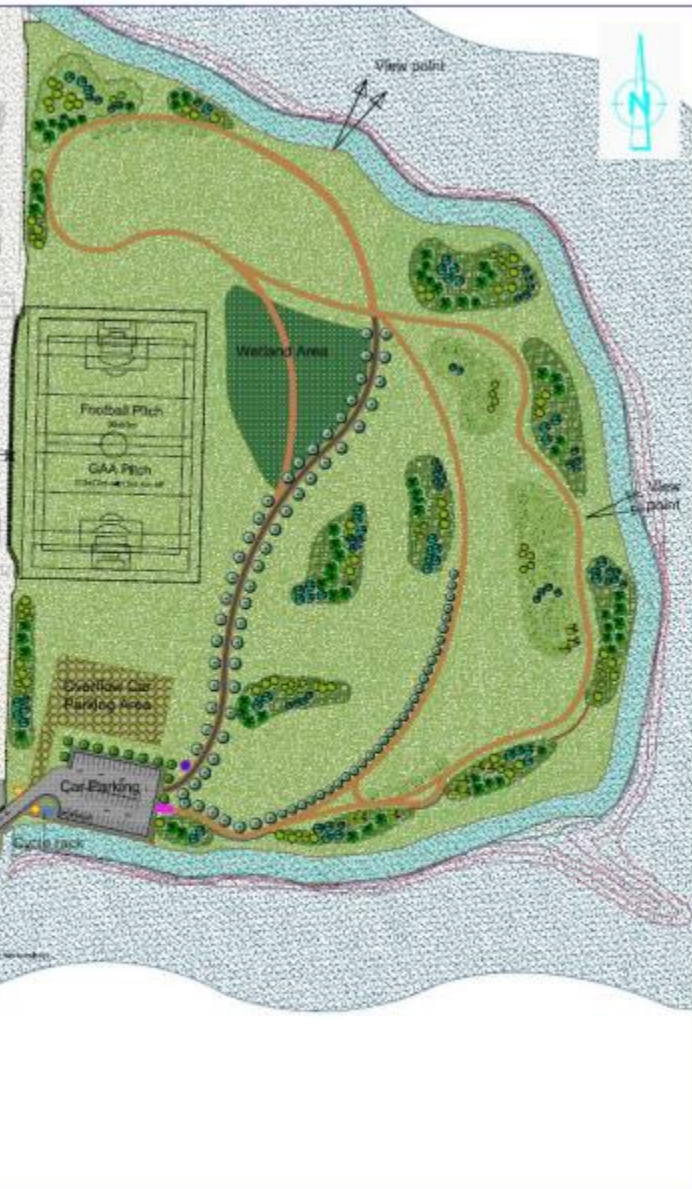
Páirc Áineasa Inis Sionnach
Landscape Masterplan
1:1,000@A1
Figure X.XXX

PÁIRC ÁINEASA INIS SIONNACH LANDSCAPE MASTERPLAN

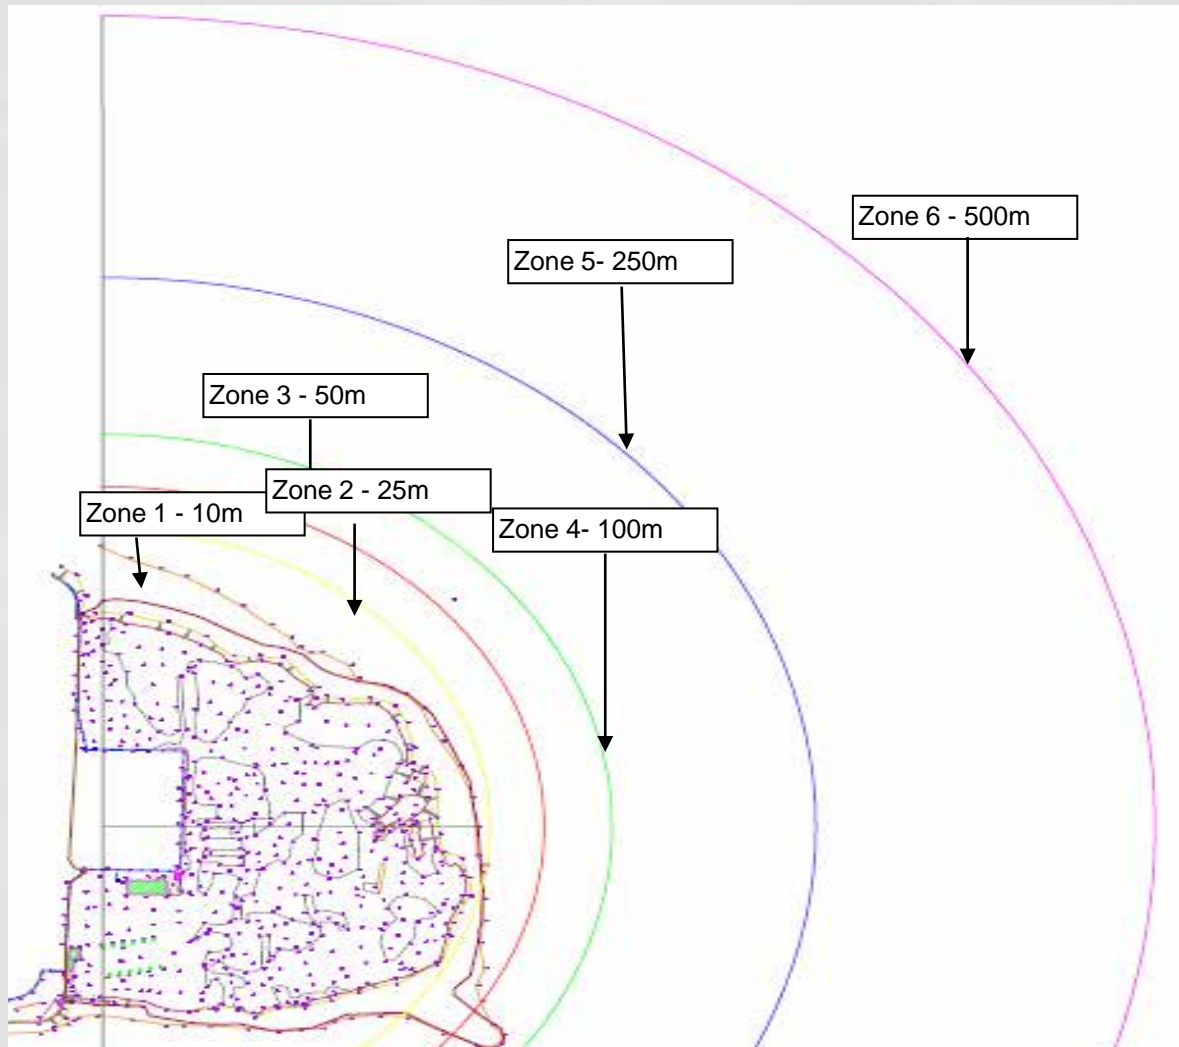
DQRA Modelling Output

- Generic QRA -
 - Basic comparison of soil and leachate data to Water Quality Standards (WQS)
- Detailed QRA
 - Considering contaminant flux and from the site and dilution model in the receptor

- Potential human health risk for site users in it's current state.
- Potentially leachable contaminants remain in the waste.
- Groundwater impacted with heavy metals and hydrocarbons, and in direct hydraulic continuity with Cork Harbour.
- Model predicts limited impact to near shore waters (<25m) although no measurable impact to water was observed.
- Contaminant contribution from erosion and sediment transport is likely to be more important than dissolved contaminant transport.

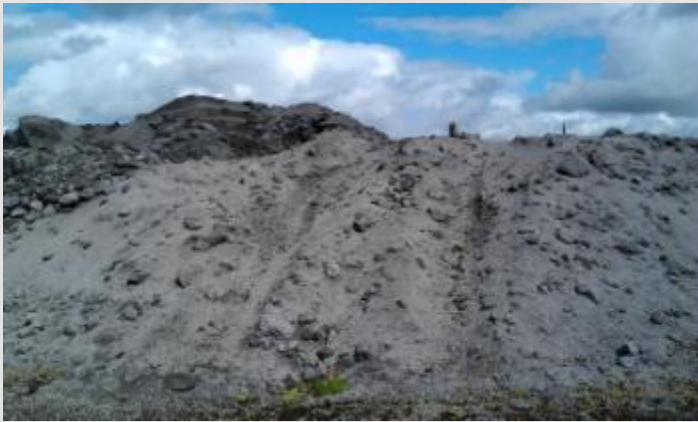
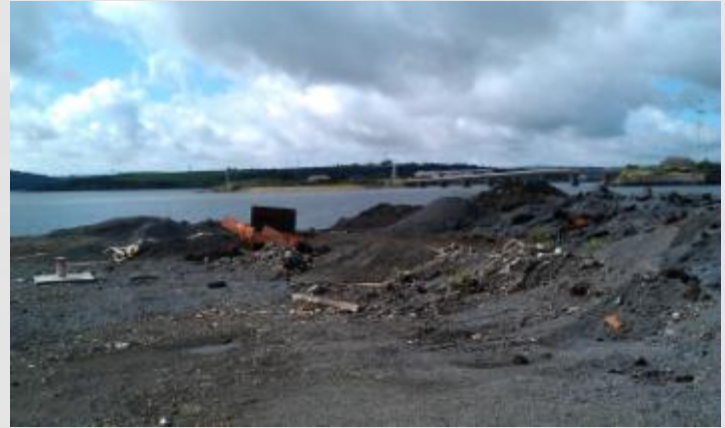
Basis of Design

- Design developed for the proposed remediation of the site
- Design informed by results of Detailed Quantitative Risk Assessment
 - Capping or cover system across the top of the landfill
 - Installation of a perimeter engineered structure (to decrease lateral permeability along the shoreline)
