# Ecological Impact Assessment

R605 Ship Pool Bends Improvement Scheme

January 2022

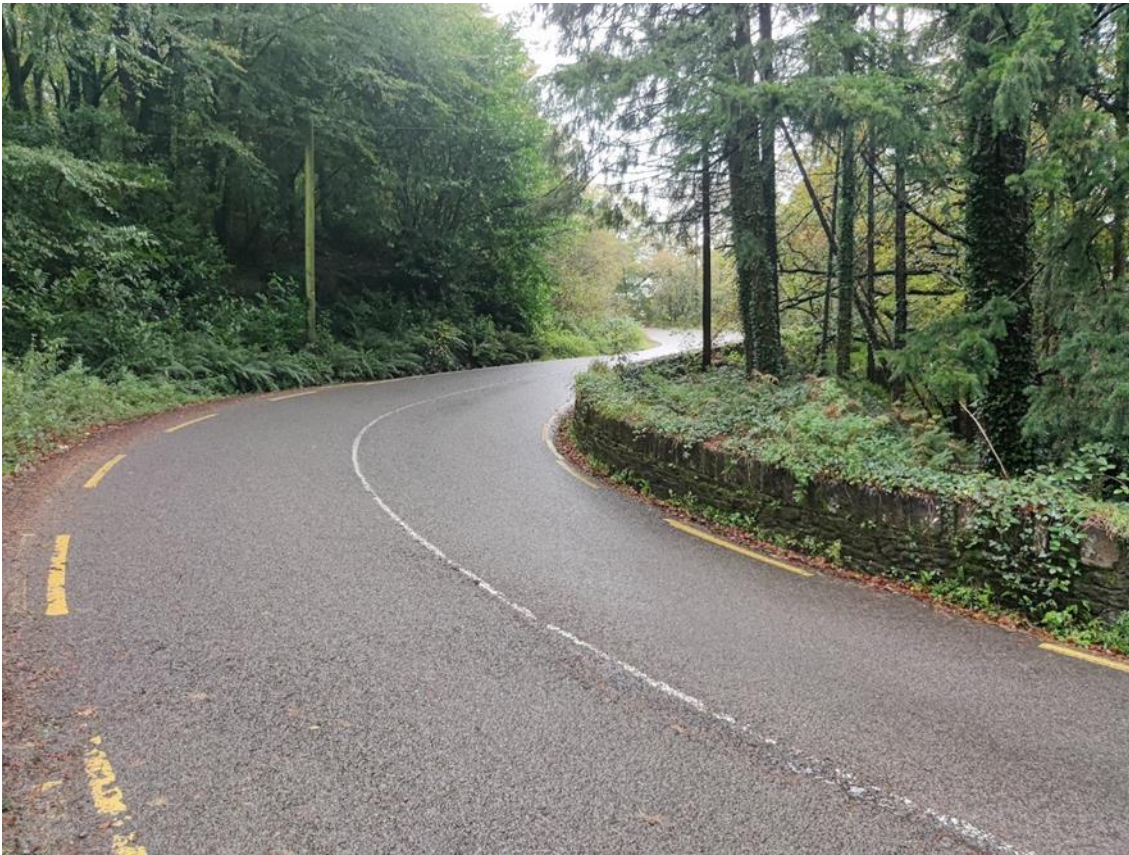
**Photo 4.1: Existing R605 Road Layout**

As previously noted, the majority of the works area is comprised of the existing road, the culvert over the stream, and roadside walls (Photo 4.1).

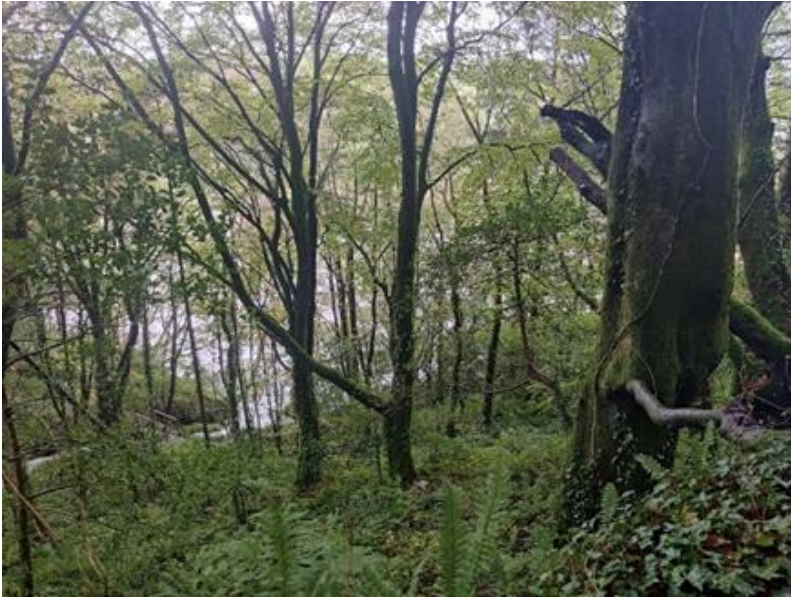
**Photo 4.2: Mature Broadleaf Woodland**

To the west of the existing road the woodland was sloped steeply down towards the Bandon River (Photo 4.2). To the east of the road the woodland was more level but contained exposed earth banks where earth slippage had occurred (Photo 4.3). In places the woodland was perched above the existing road level with the banks interfacing with the road. The woodland forms part of the greater Ship-Pool woodland, which is used recreationally for walking. It also provides connectivity to wooded areas along the Bandon River to the north and south of the works area.

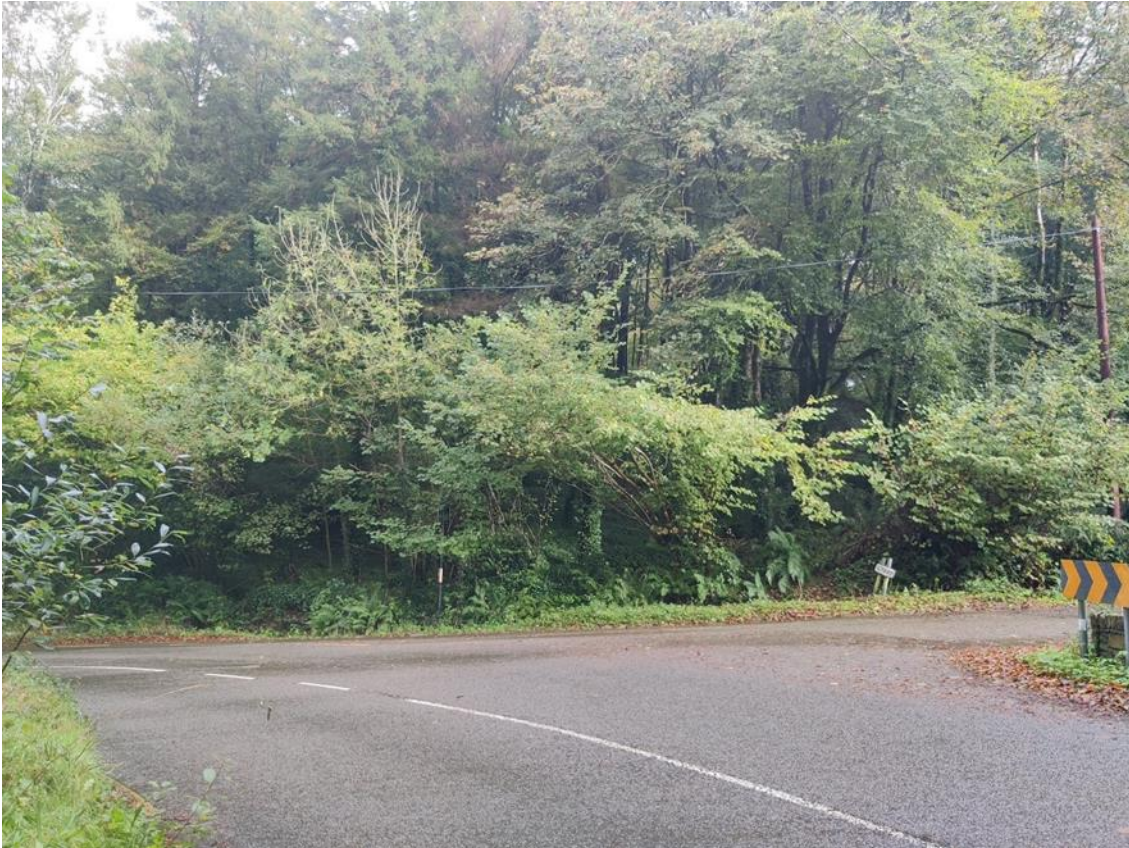
**Photo 4.4: Scrub Fringing Road with Mature Woodland Behind**

In small sections scrub was present fringing the road (Photo 4.4). This thin line of scrub was likely the result of maintenance along the road. The scrub was typically dominated by hazel, but generally contained a similar species composition to the woodland. Other species recorded within the scrub included sessile oak, ash, birch, laurel, bramble, nettle (*Urtica dioica*), yellow archangel (*Lamium galeobdolon*), meadowsweet (*Filipendula ulmaria*), and woodrush.

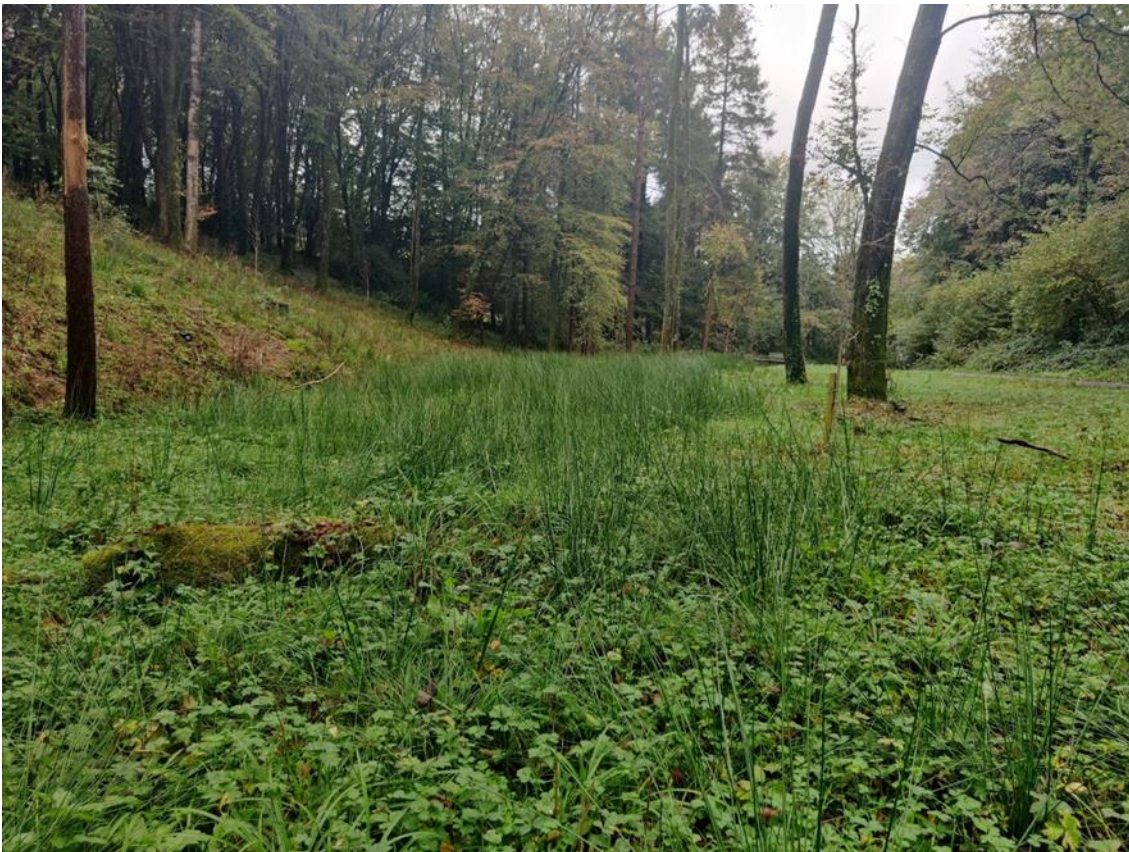
**Photo 4.5: Managed Verge**

In the eastern section of the works area, the lands to the south of the existing road have historically been cleared and managed to create an area of green verge (Photo 4.5). The area was likely re-seeded as amenity grassland (GA1) however, at the time of survey it showed an affinity towards wet grassland (GS4) but contained a number of species more readily associated with woodland habitats. Fallen branches which had become overgrown were noted within the area. Several mature trees were retained within the grassland, with young alder (*Alnus glutinosa*) trees also planted.

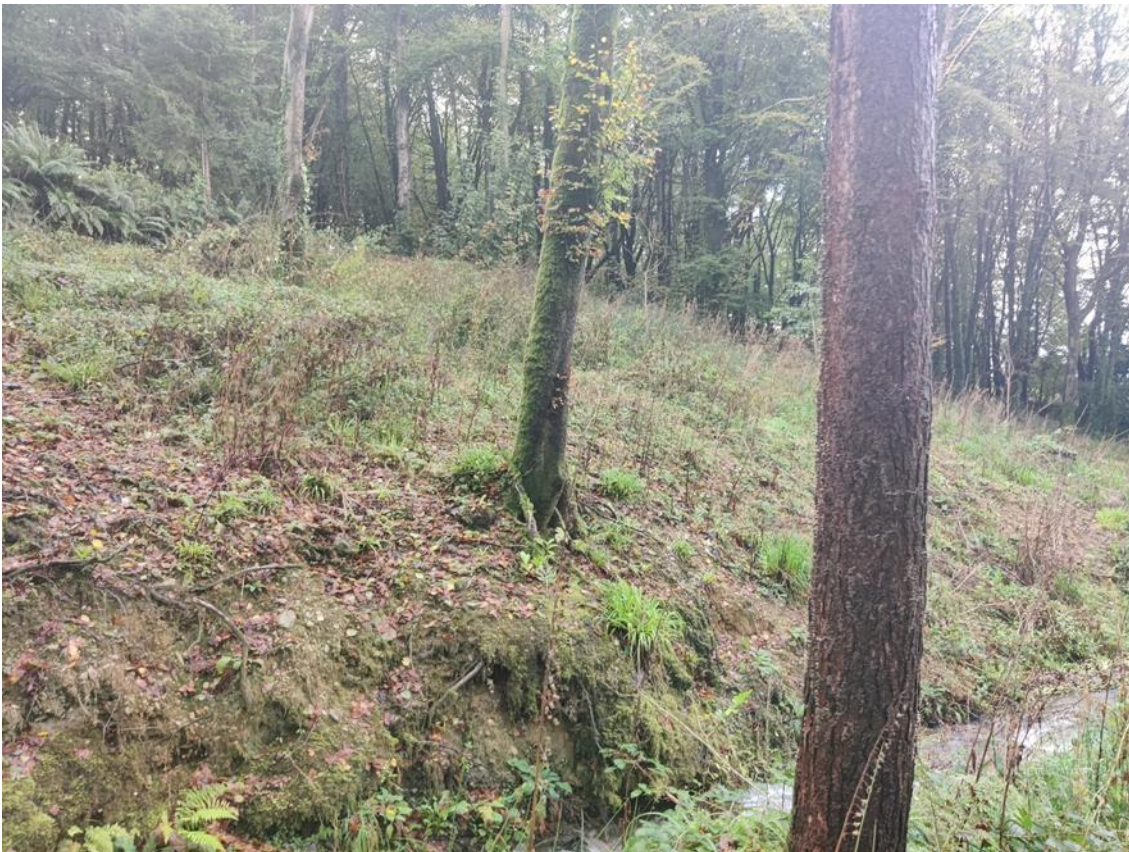
#### Photo 4.6: Cleared Land on Southern Stream Bank

Some areas of land on the southern bank of the stream, within managed verge habitat, had also recently been cleared and vegetation is recolonising. This area sloped steeply down towards the stream and contained a large proportion of exposed soil (Photo 4.6). The majority of the land had been cleared, with mature tree retained. Species recorded within this habitat included foxglove, bramble, woodrush, willowherb (*Epilobium spp*), laurel, beech, and sycamore.

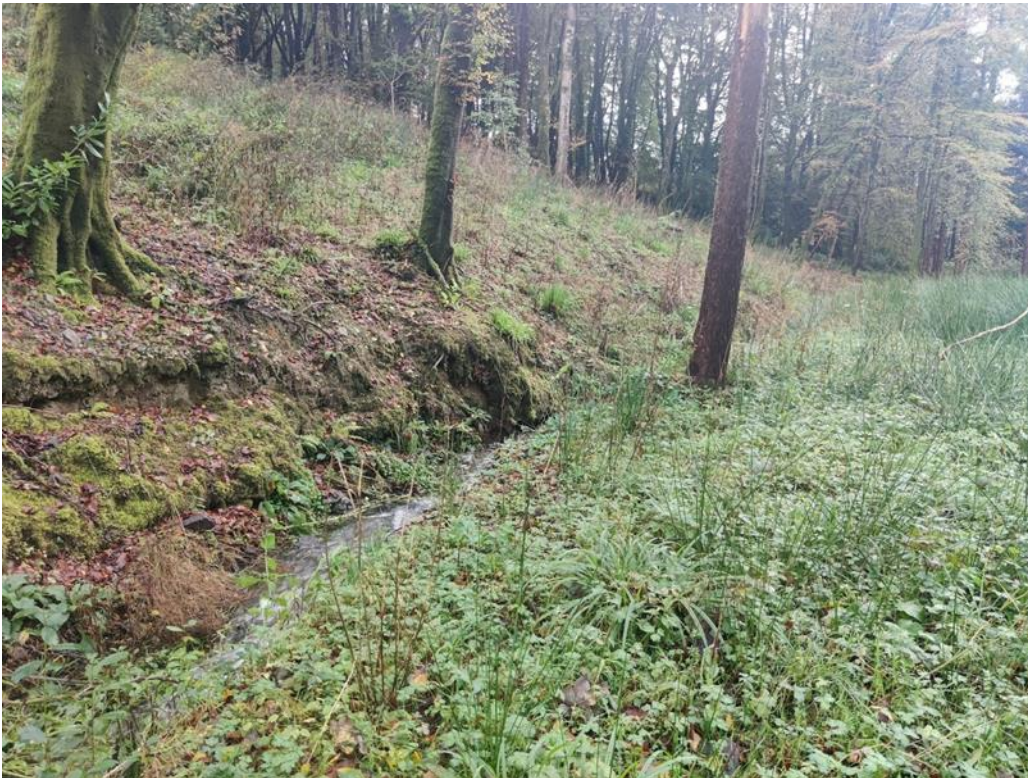
#### **Photo 4.7: Riverbank Upstream of Culvert**

As previously noted, a stream (FW1) bisects the site, flowing to the west into the River Bandon. The gradient of the stream upstream of the existing culvert is relatively flat. As previously noted, the lands surrounding the stream upstream of the culvert had been cleared and so little in terms of bankside vegetation was recorded, with areas of bare earth banks recorded (Photo 4.7).

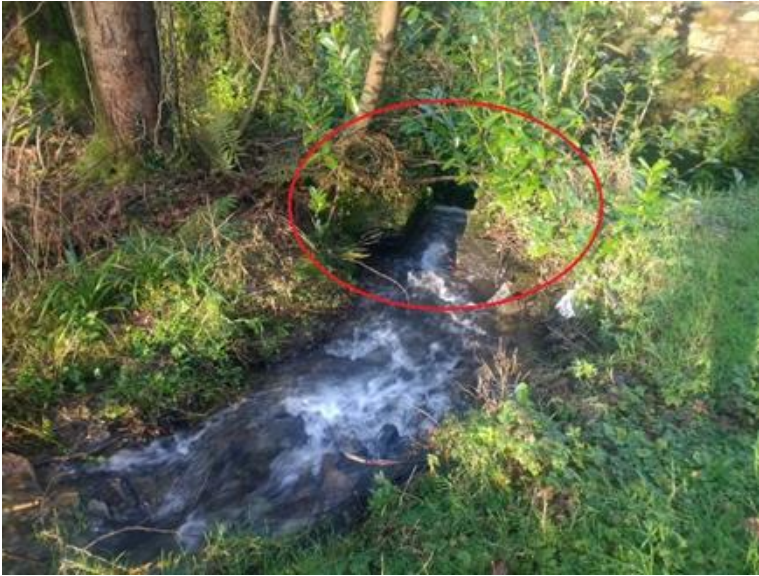
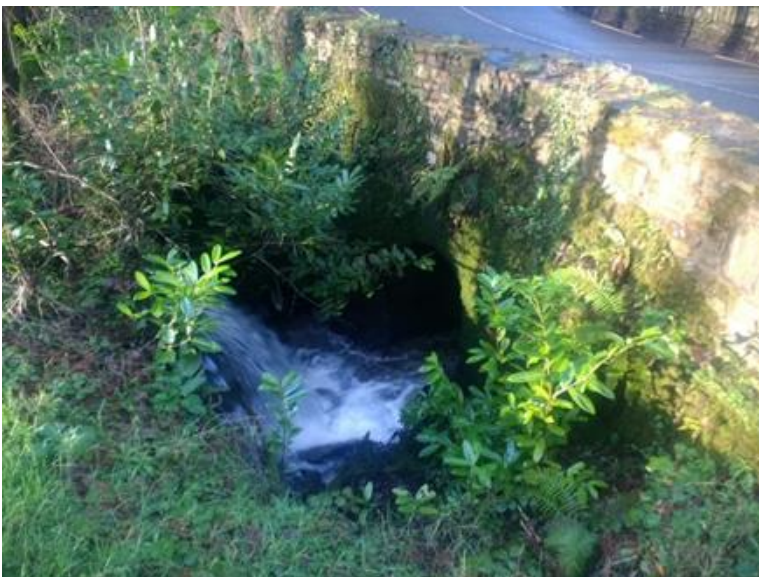
The stream crosses a stone weir directly upstream of the culvert, with a steep drop into the stone culvert beneath the road (Photo 4.8 and Photo 4.9).

**Photo 4.8: Stream and Top of Weir (Circled)**

**Photo 4.9: Culvert face and Stream Immediately Downstream of Weir**

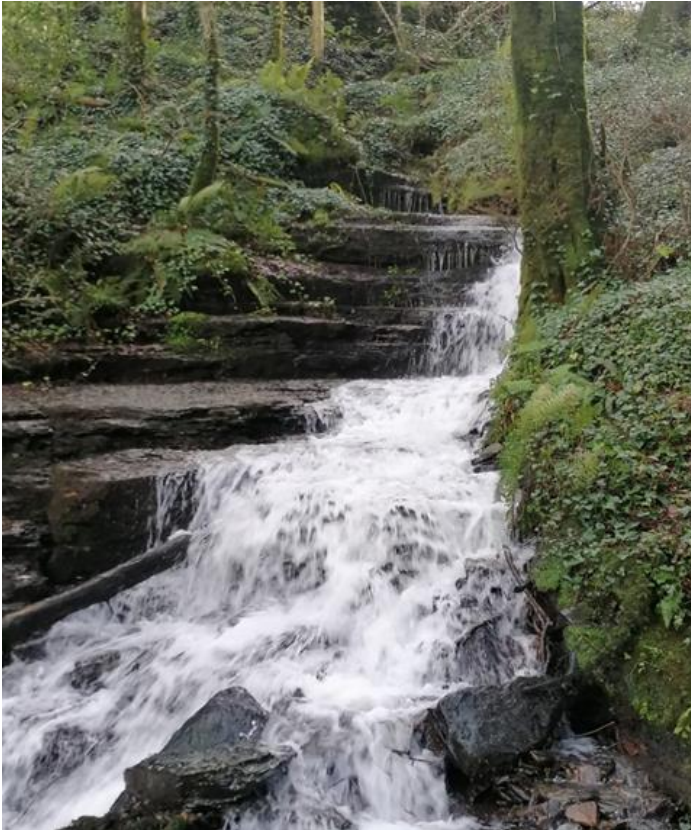
**Photo 4.10: View of Stream Downstream of the Culvert**

Downstream of the culvert the gradient of the stream was steep, with a high velocity in terms of flow. The substrate was comprised of large cobbles and stone slabs. As the gradient was steep these slabs had become exposed creating steps in the stream (Photo 4.10). Given these features, the gradient of the stream and the presence of the weir upstream of the culvert, fish passage is not likely to take place moving upstream of the Bandon River. Likely as a result of the velocity of the water within the stream, no instream vegetation was recorded.
