Heritage Impact Assessment

Proposed Bridgemount link, Carrigaline, County Cork

Prepared by
John Cronin & Associates
3A Westpoint Trade Centre
Ballincollig
County Cork

June 2022

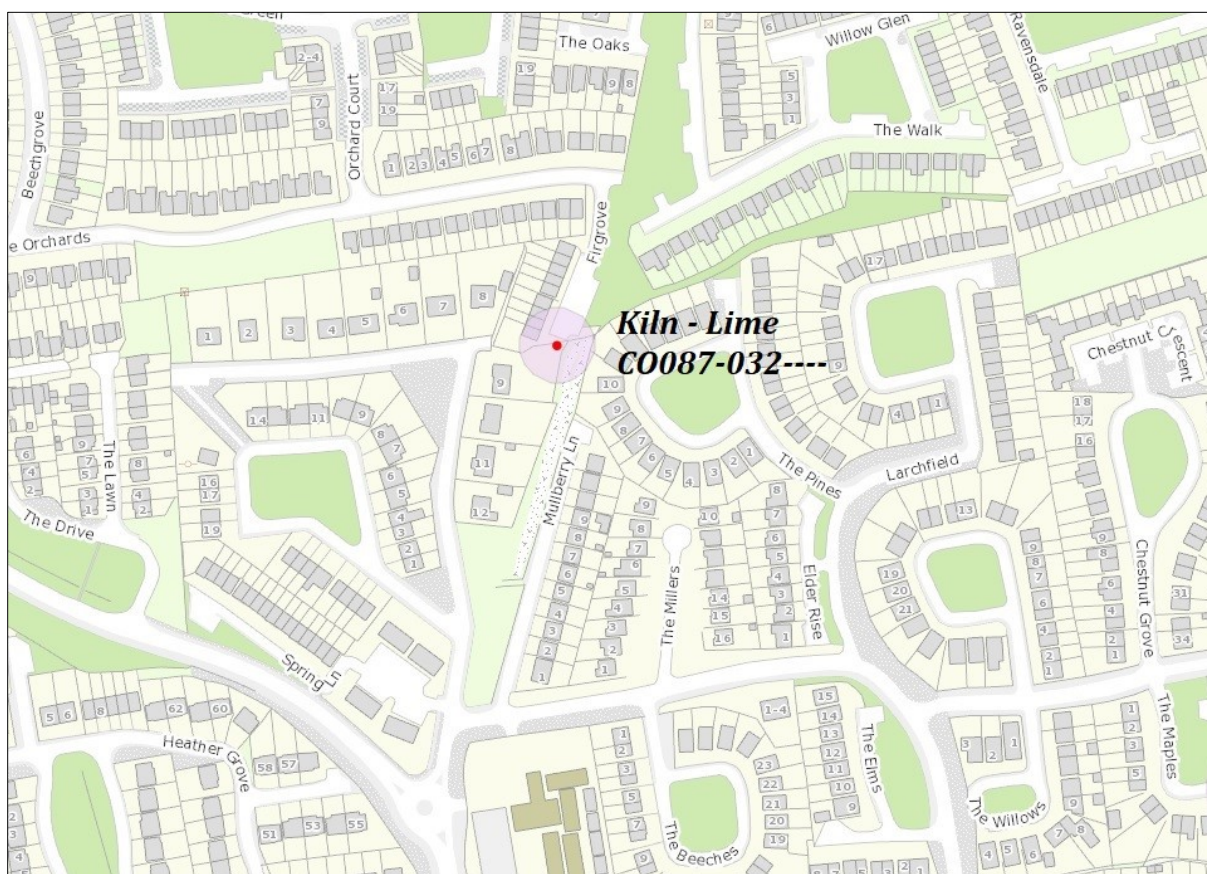
The subject site is located within the townland of Carrigaline-Middle on a section of the disused Cork, Blackrock and Passage Railway line extension which ran to Crosshaven. The former railway cutting is secured to the south by a palisade fence and to the north by a high boundary wall and is surrounded by modern housing estates. There are no protected structures or NIAH structures within 300m of the subject site. One “recorded monument” (protected under the National Monuments Code). A lime kiln located immediately adjacent to the west of the former railway cutting is a “recorded monument” protected under the National Monuments Code and included in the Record of Monuments and Places (RMP); the monument’s reference number is CO087-032- --- (see **Figure 2** below).

Figure 2: Extract from Historic Environment Viewer (Source: Government of Ireland). The red dot indicates the recorded location of the lime kiln and the pink-shaded circle indicates an associated zone of notification for the monument.

It is recommended that vegetation clearance or ground disturbance work within the *zone of archaeological notification* for the lime kiln (RMP No. CO087-032----) should be supervised/monitored by a suitably qualified archaeologist to ensure that any surviving fragmentary remains of the former lime kiln are not impacted by the proposed works.

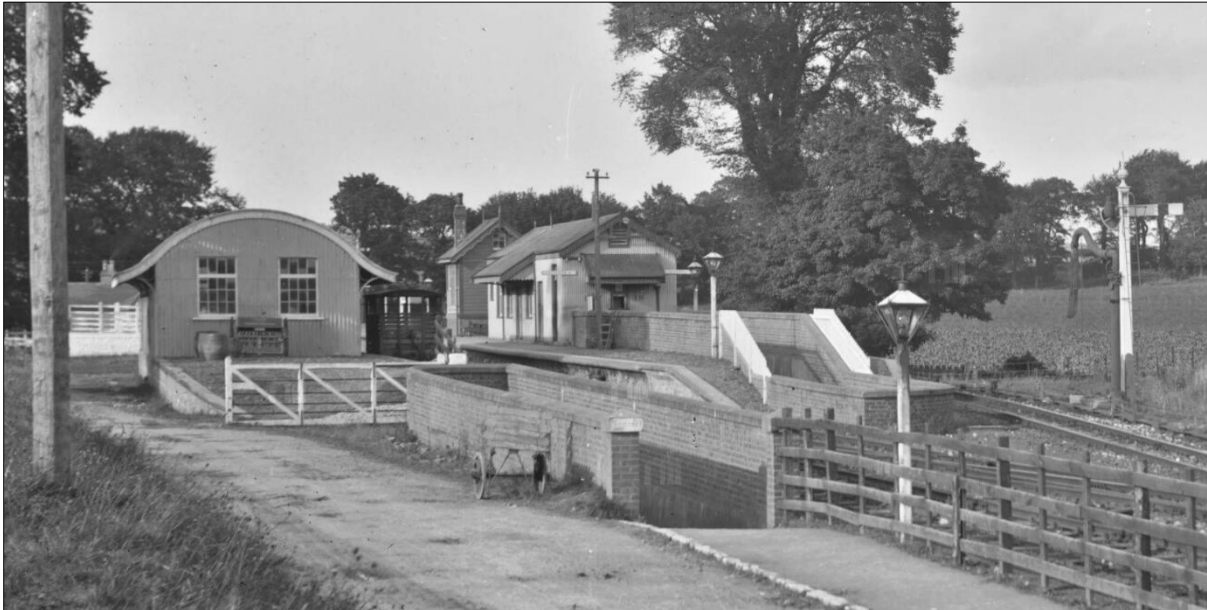
Figure 3: Historic photograph of Carrigaline railway station c. 1900 (Source: National Library of Ireland) – this former railway station is located approximately 400 metres to the south-south-west of the proposed Bridgemount Link

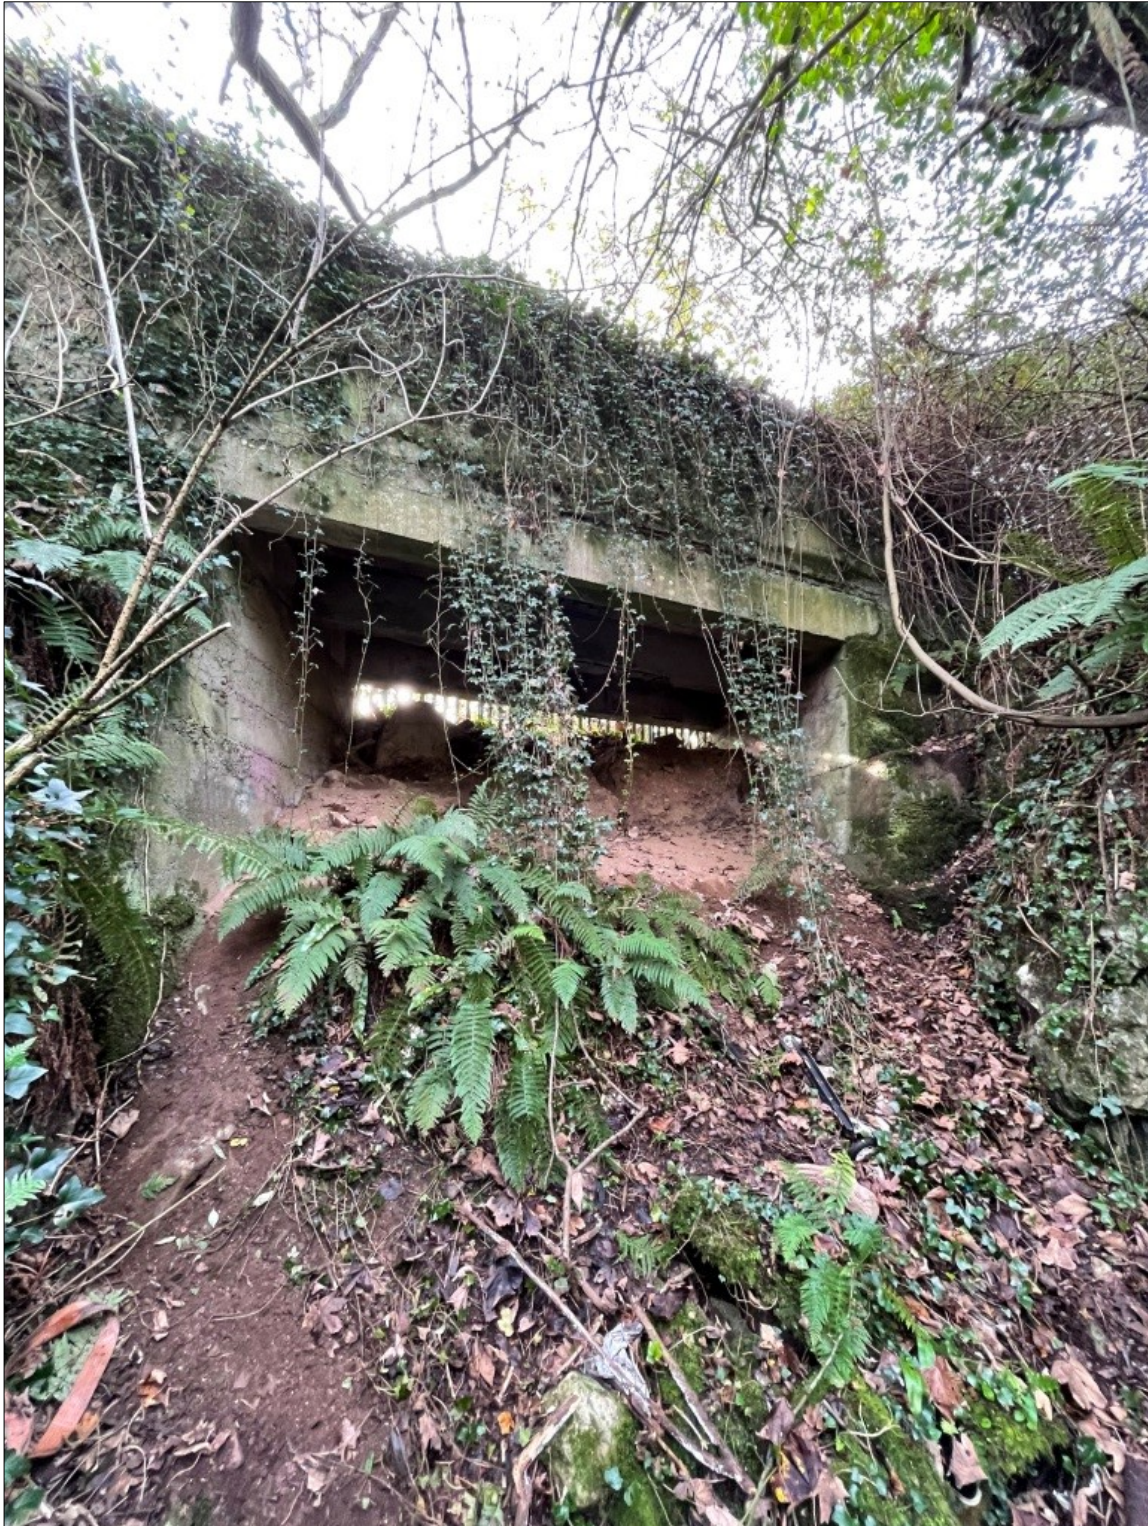
At the southern end of the section of railway cutting is a narrow concrete agricultural overpass (see **Appendix**). This appears to date from the beginning of the twentieth century when the railway connection to Carrigaline was constructed. The structure consists of two concrete

abutments placed either side of the cutting; these support three reinforced concrete beams, 300mm x 500mm, which in turn support a flat reinforced concrete slab c. 3300mm x 4500mm. The bridge/overpass has a concrete parapet wall c. 100mm in thickness and c. 9300mm in length.

Plate 1: View to overpass from within cutting with the ground below having been infilled.

If the concrete overpass is to be removed, it is recommended that prior to demolition that a scaled, drawn and measured survey of the structure be prepared. The survey should include ground plans, elevations, and representative sections. The resultant survey should be retained by the Traffic and Transportation Section of Cork County Council for archival purposes.

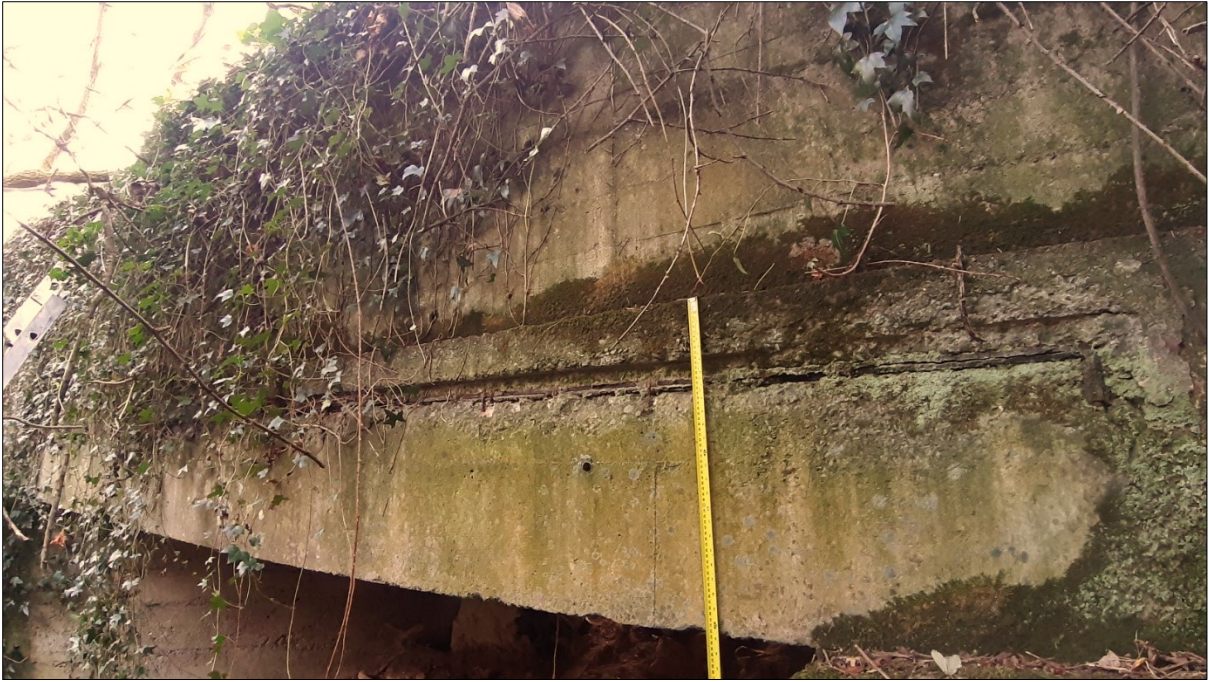
The overpass dates to the beginning of the twentieth century, is utilitarian in nature and of no particular heritage significance. It is noted that this section of the former railway line is the only segment that was not along the coast and/or alongside a public road; therefore, there was a requirement for localised agricultural access across the cutting in this inland area. The structure was likely built by the railway company for the exclusive use of an individual farmer/landowner and not built as an embellishment or feature to adorn the local landscape. The structure is of basic construction. Due to the obvious deterioration of the concrete (see photographic record contained within the appendix of this document), the structure may be unsuitable for retention. The structure is considered to be of negligible heritage significance.

Plate 2: Northern elevation of overpass

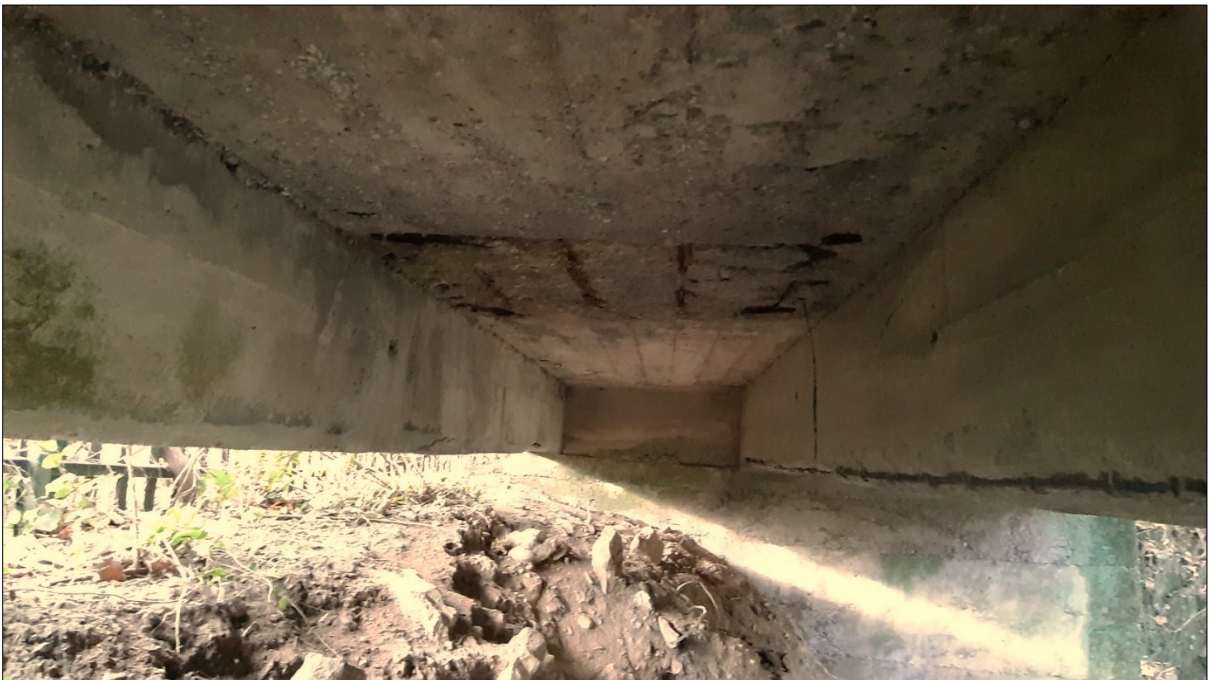
Plate 3: Underside of overpass looking west

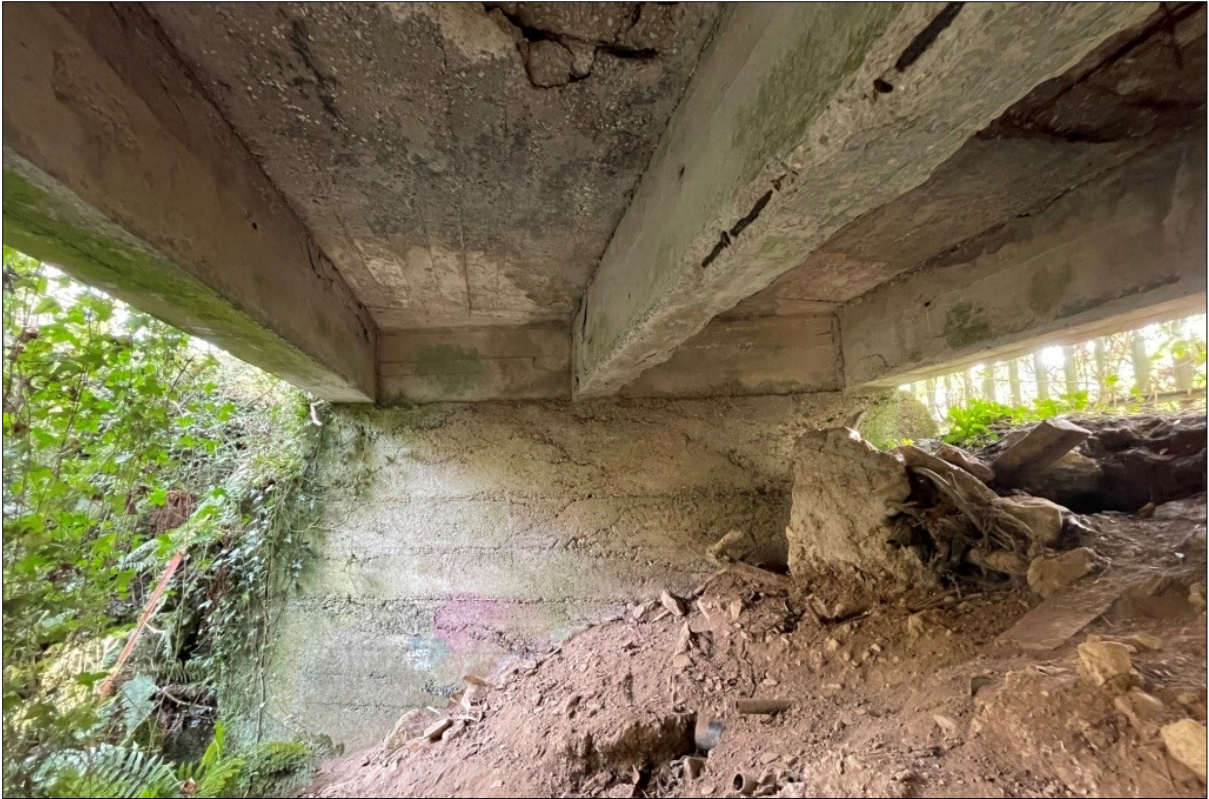
Plate 4: Underside of overpass looking east

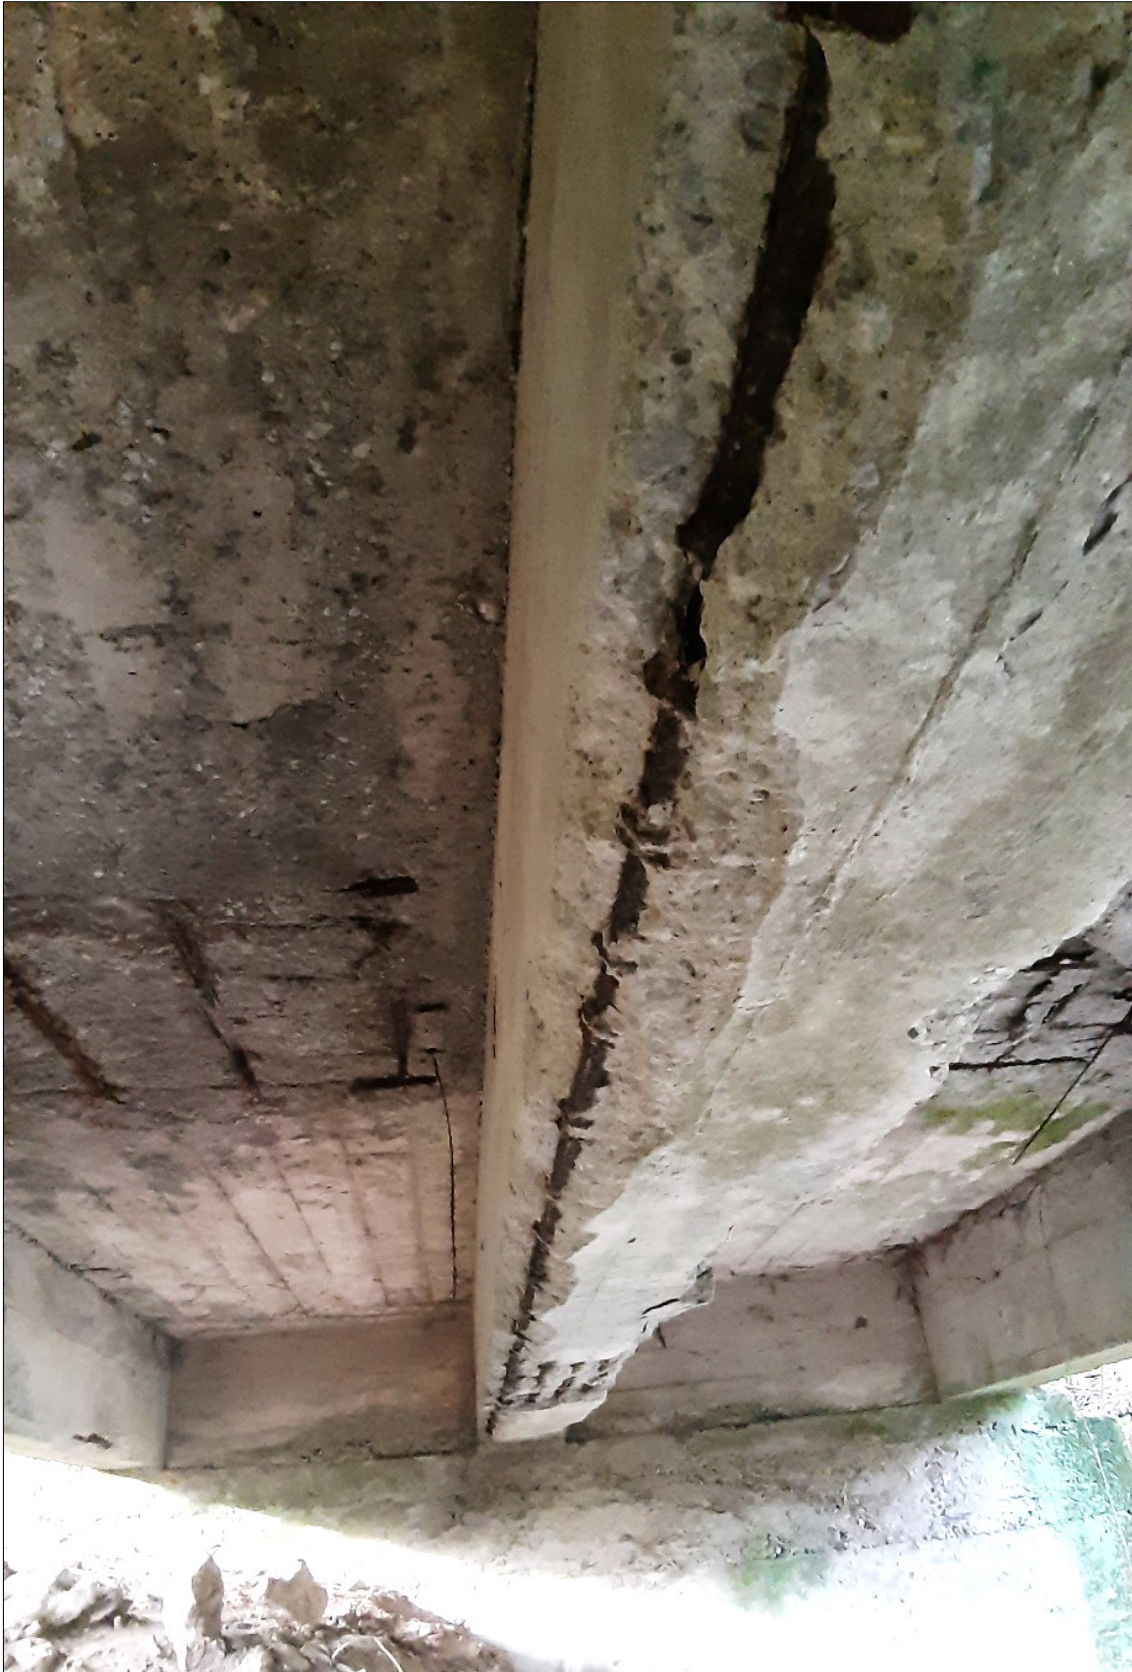
The overpass is an early twentieth-century reinforced concrete structure which has been disused for many years. The structure was for agricultural use as a cattle overpass. The structure is of little or no heritage significance and displays no inherent architectural qualities or design significance. It is noted that there appears to be significant structural decay in the support beams as the concrete is spalling and delaminating, and many of the metal reinforcement bars are exposed and heavily corroded. The structure is not identified in any heritage inventory or survey as a feature of archaeological, architectural, civil engineering, or technical significance. The removal of the structure would not represent a significant loss to the built and railway heritage of Carrigaline and environs.

Plate 5: Decayed concrete and exposed reinforcement bars
