# FERMOY WEIR REMEDIATION AND FISH BYPASS CHANNEL

## Engineering Technical Report to Accompany Planning Application

JUNE 2022

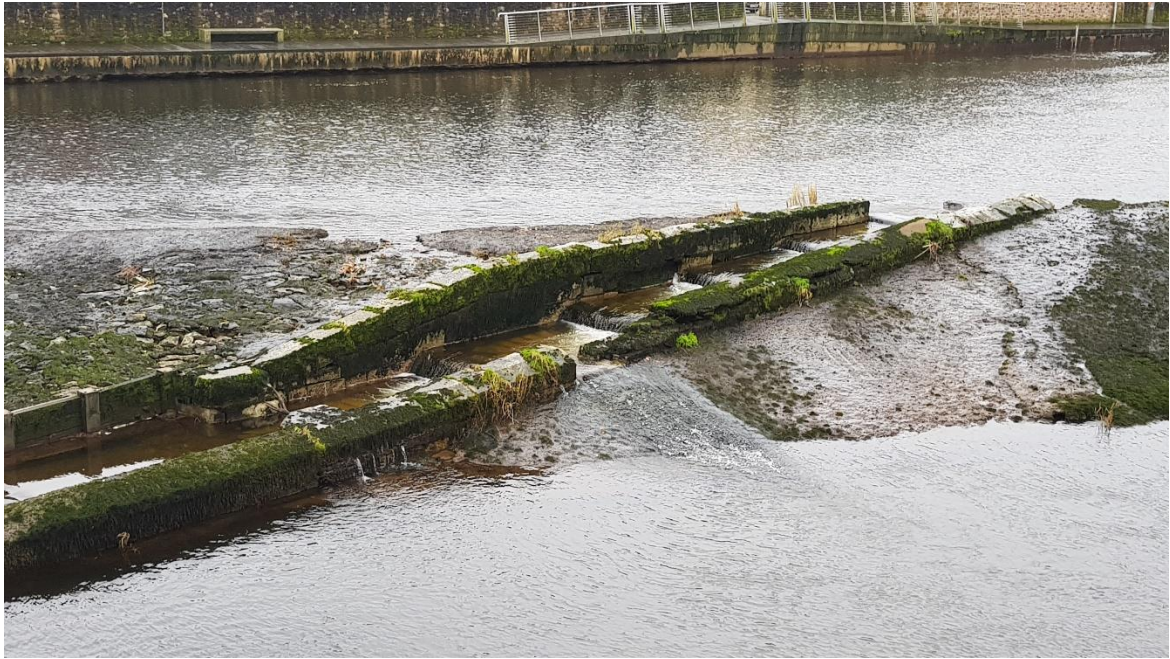
This option consists of repairing the existing fish pass. The existing fish pass is a technical type fish pass, comprising a masonry stepped structure located within the weir structure close to the midpoint of the river. The fish pass crosses the weir on a diagonal to decrease the gradient and increase the number of steps in the structure. Damage to the lower part of the structure was repaired in 2013. Since then, further damage has occurred and part of the side wall of the pass, on the downstream facing side of the structure, has been breached.

**Figure 3-1: Existing Fish Pass at Fermoy Weir - November 2019**

It had been proposed to retain the upper section of the fish pass structure and demolish and replace the lower section with a new in-situ concrete structure. A new channel was proposed to be created in the river bed to create an attraction flow in the river at the entrance to the fish pass.

IFI have advised that the location of the existing fish pass is contrary to basic fish pass design guidance. Guidance advises that the entrance should be located where migrating fish naturally congregate which is generally as far upstream along a weir structure as possible. The existing fish pass entrance is halfway along the weir and is too far downstream to be found by all migrating fish. In addition to this, the entrance will not ensure the free run of all fish at all periods of the year.

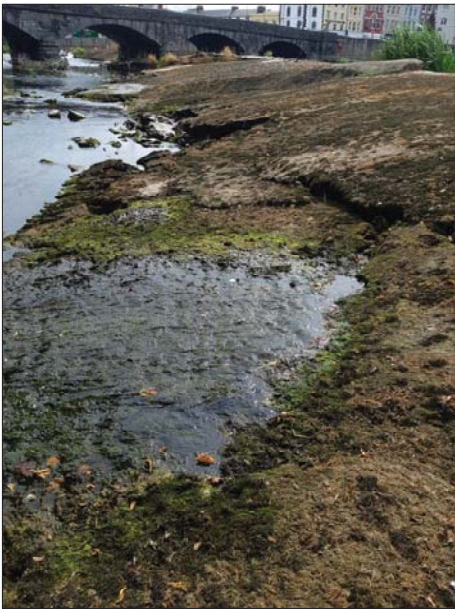
D 0074 CONCRETE APRON OF WEIR HAS DISINTEGRATED AND WASHED AWAY IN PLACES

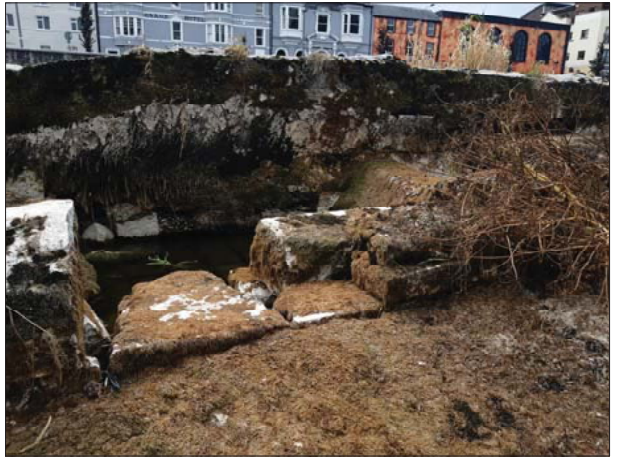
F  
0075  
VIEW OF DAMAGE TO FISH PASS WALL

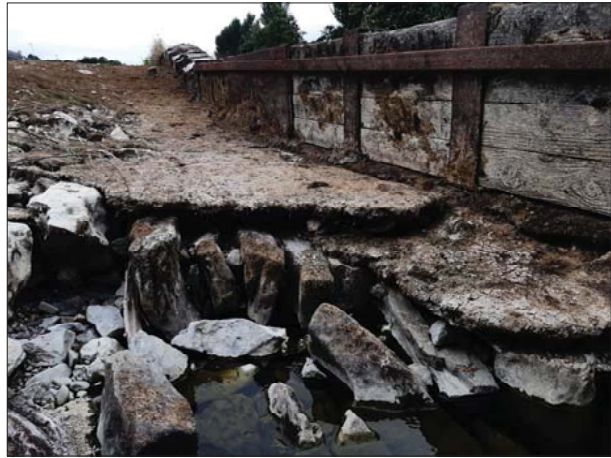
G  
0075  
WEIR APRON HAS DISINTEGRATED AND WASHED AWAY

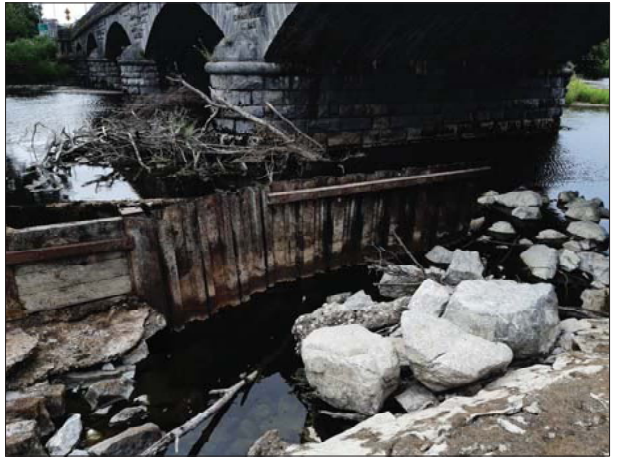
H  
0075  
VIEW OF TEMPORARY REPAIRS TO FISH PASS AND  
DISLODGED MATERIAL FROM WEIR

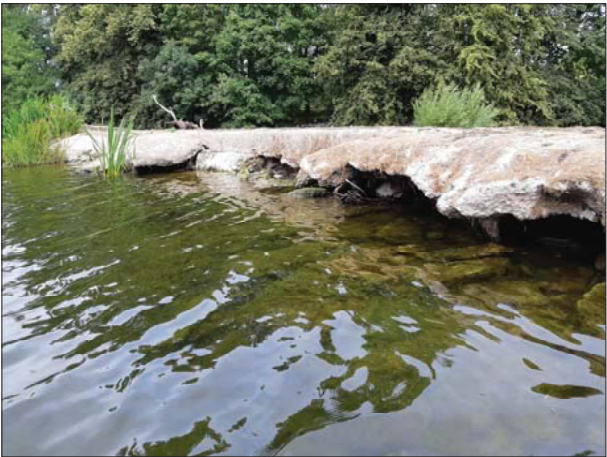
L  
0076  
PART OF WEIR WALL WASHED AWAY UNDER  
WEIR CREST

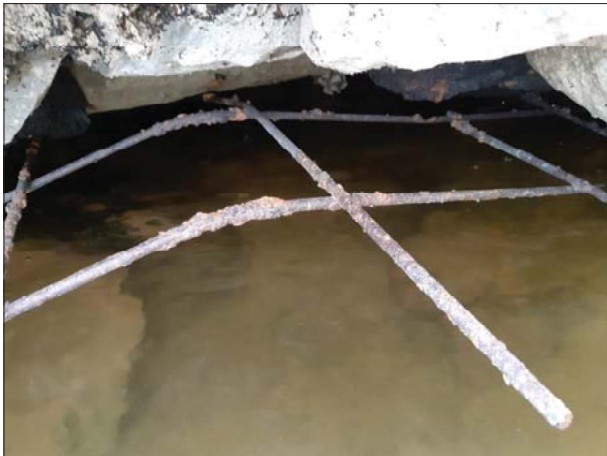
S REINFORCEMENT EXPOSED AND CORRODED  
UNDER WEIR APRON

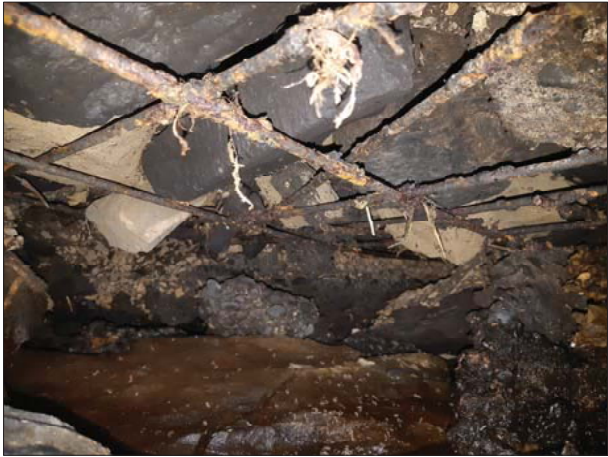
T LARGE VOIDS UNDER CONCRETE WEIR APRON,  
REINFORCEMENT EXPOSED AND CORRODED

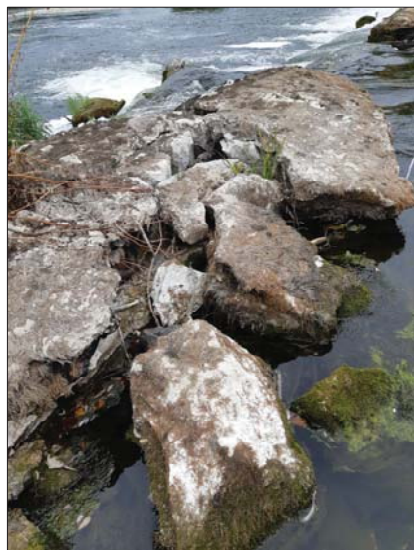
X  
0078  
VIEW OF WEIR CREST CONDITION

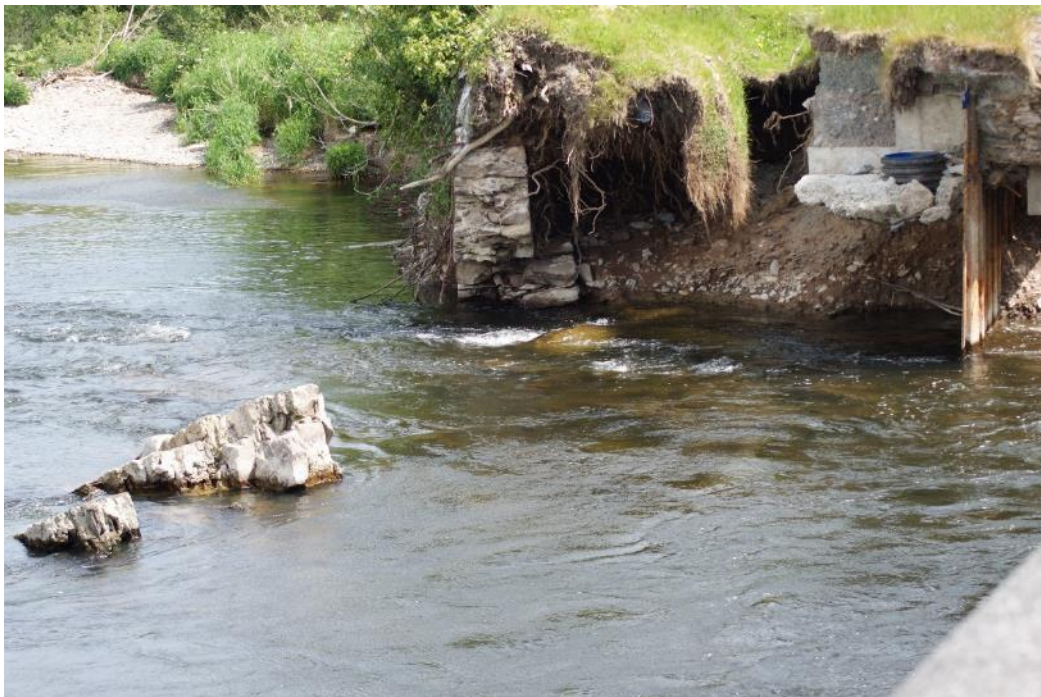
**Photograph 6: Breach in weir and damage behind flood defence works**

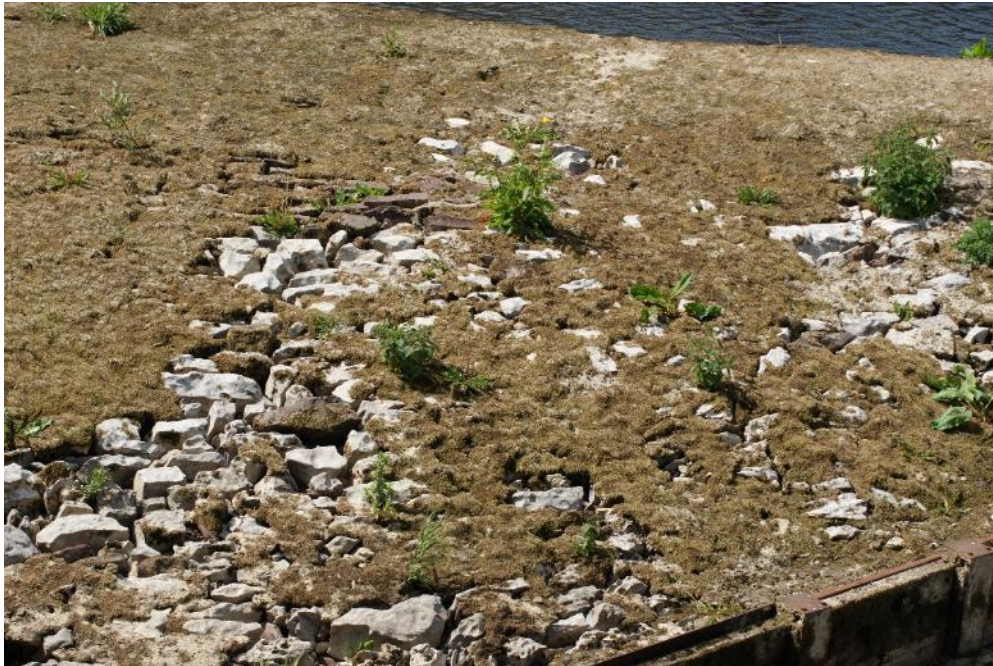
**Photograph 7: View of part of back slope to Crump Weir section showing spalled concrete apron exposing original Limestone blockwork under**

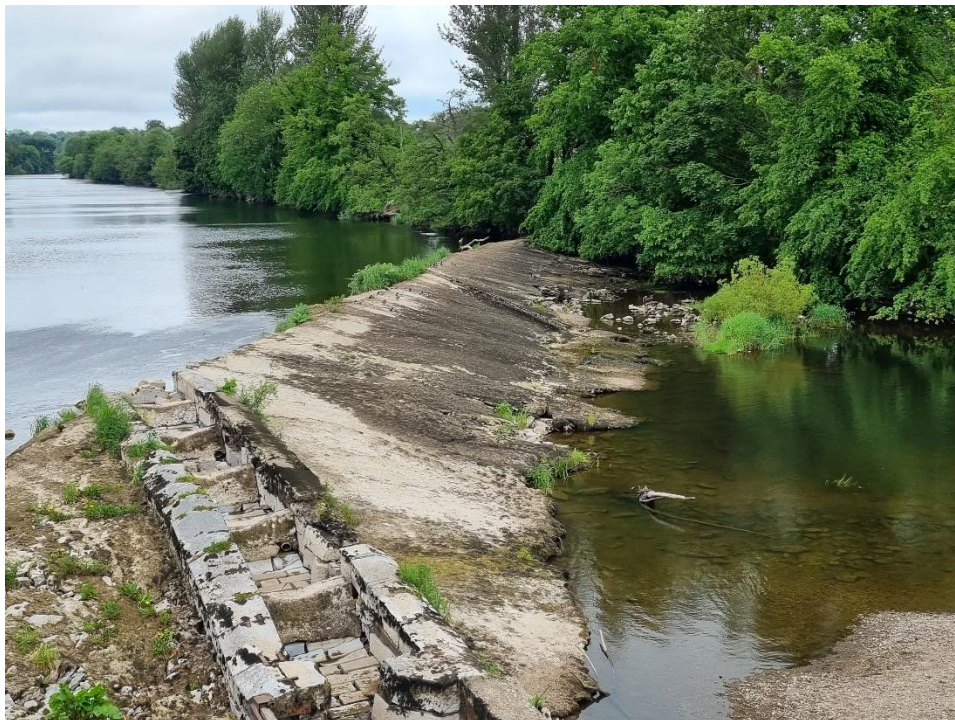
Figure 1-2: Embankment Section of Weir & Existing Fish Pass – June 2021 (Looking Upstream)

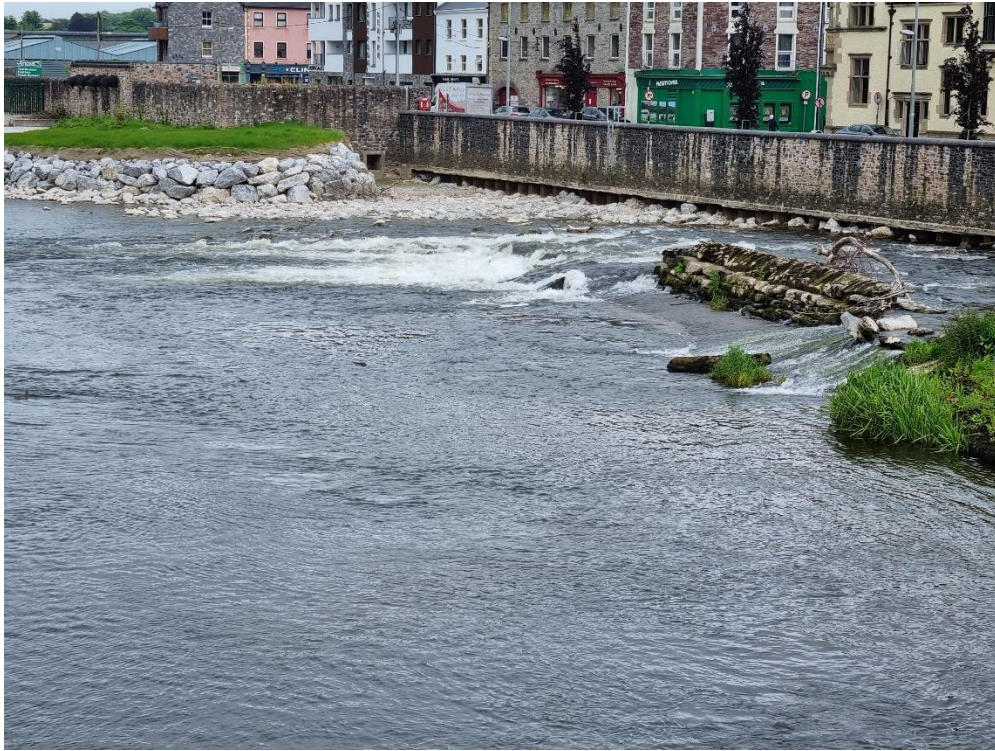
**Figure 1-3: Mill Race Section of Weir & Breaches – June 2021 (Looking Downstream)**
