19011-TJOC-PL-XX-DR-C-0052

19011-TJOC-PL-XX-DR-C-0074

TJ O connor & Associates Fermoy Mill Race River Bed Survey

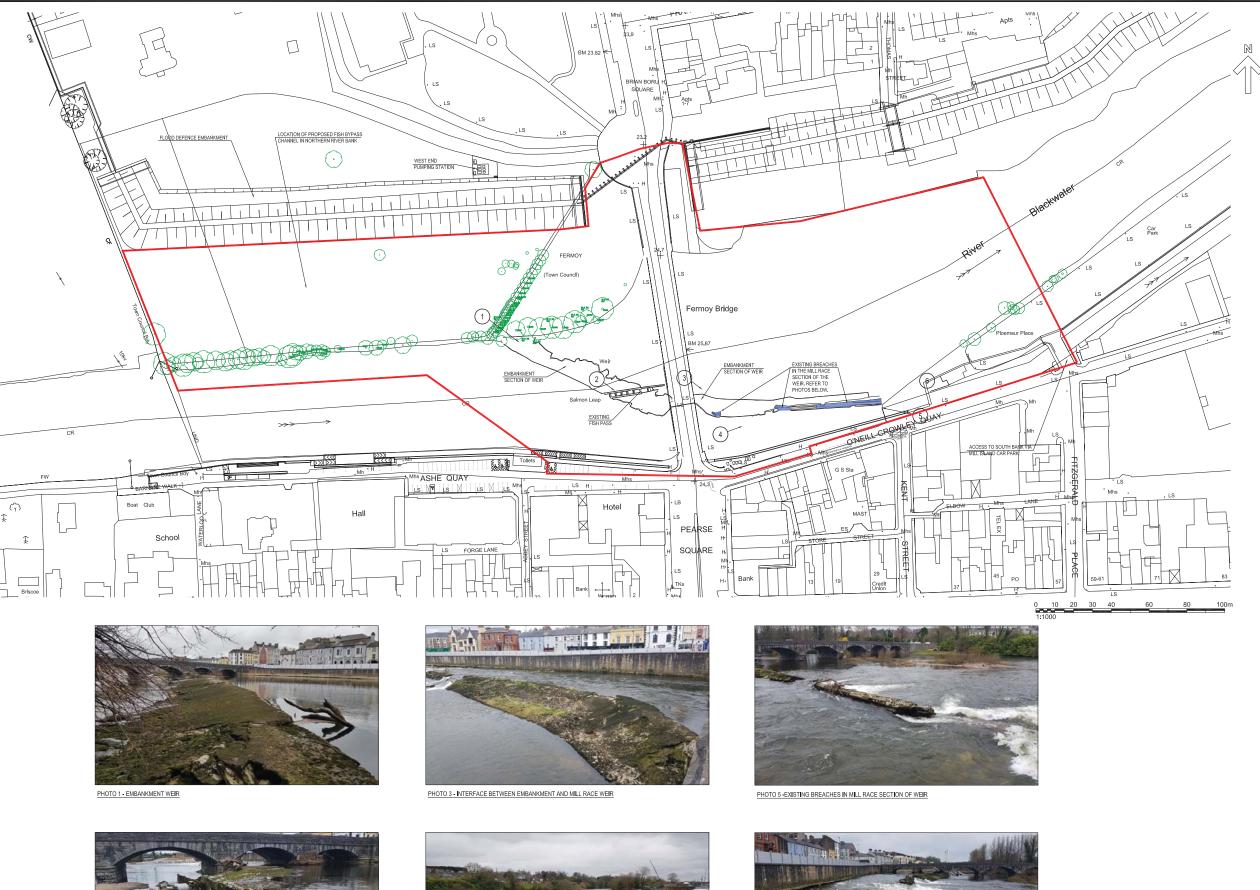
PHOTO 2 - EXISTING FISH LADDER

PHOTO 6 -EXISTING BREACHES IN MILL RACE SECTION OF WEIR (LOOKING UPSTREAM)

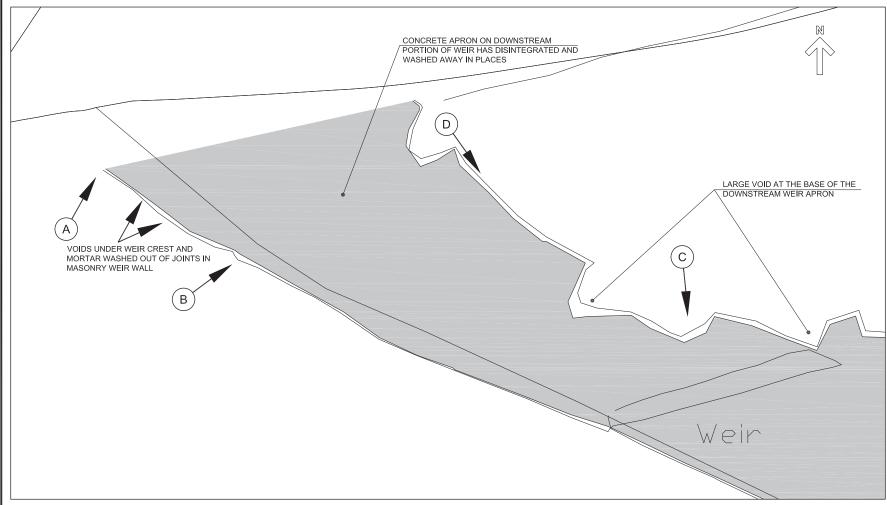
$\underbrace{ \overset{\text{B}}{\text{0074}}} \underbrace{ \overset{\text{MORTAR AND FINES WASHED OUT OF}}{\text{JOINTS IN MASONRY WEIR WALLS}}$

C LARGE VOID AT THE BASE OF THE DOWNSTREAM WEIR APRON

$\frac{\text{D}}{\text{0074}} \underbrace{\frac{\text{CONCRETE APRON OF WEIR HAS DISINTEGRATED}}{\text{AND WASHED AWAY IN PLACES}} }$

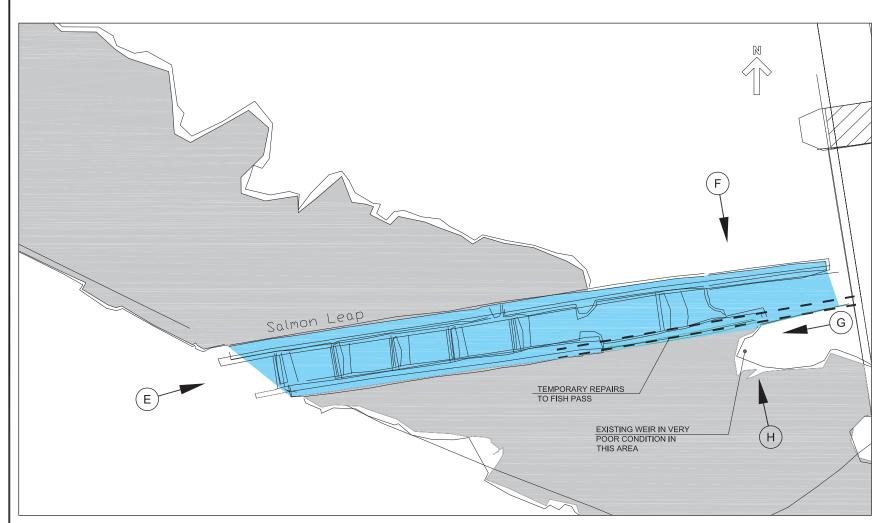
VIEW OF UPSTREAM END OF FISH PASS

© WEIR APRON HAS DISINTEGRATED AND WASHED AWAY

$\frac{\rm _{H}}{\rm ^{0075}} \frac{\rm VIEW~OF~TEMPORARY~REPAIRS~TO~FISH~PASS~AND}{\rm DISLODGED~MATERIAL~FROM~WEIR}$

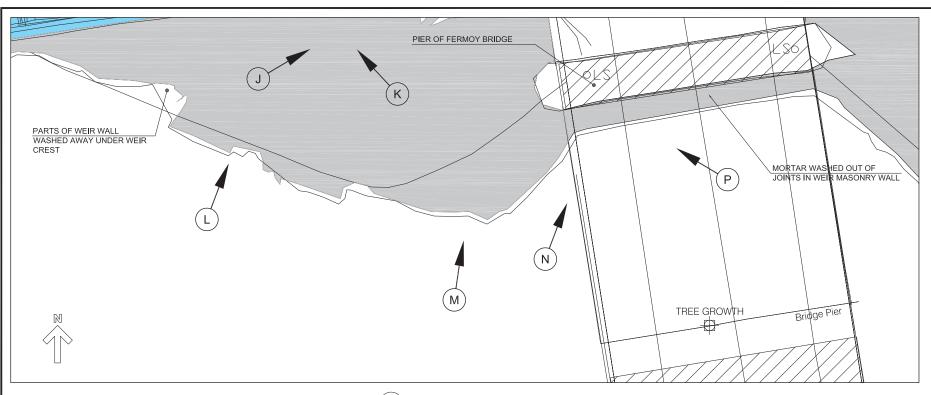
MORTAR AND FINES WASHED OUT OF MASONRY WEIR WALL ADJACENT TO FERMOY BRIDGE

$\underbrace{ \begin{array}{c} \textbf{J} \\ \textbf{0076} \end{array} }_{\textbf{0076}} \underbrace{ \begin{array}{c} \textbf{WEIR APRON DISINTEGRATED AND WASHED} \\ \underline{\textbf{AWAY AT JUNCTION WITH FISH PASS}} \end{array} }_{\textbf{1}}$

WEIR APRON DISINTEGRATED AND WASHED AWAY AT JUNCTION WITH FISH PASS

L PART OF WEIR WALL WASHED AWAY UNDER WEIR CREST

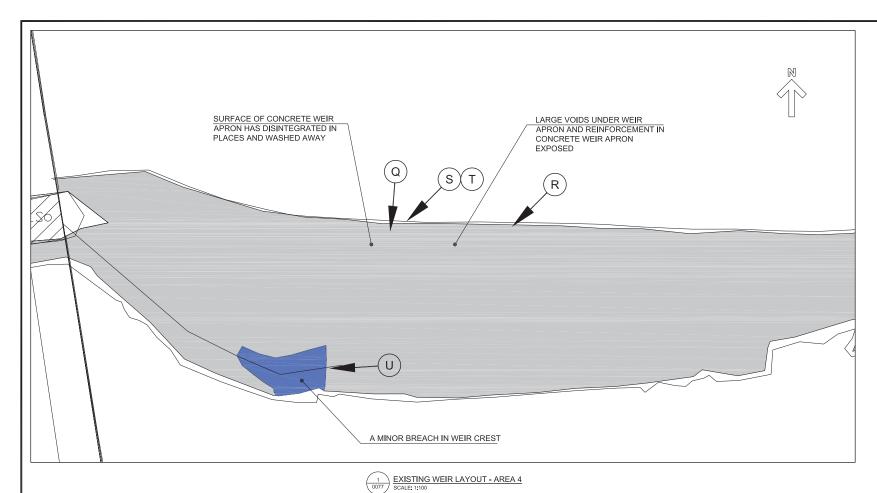
LARGE VOIDS UNDER CONCRETE WEIR APRON, REINFORCEMENT EXPOSED AND CORRODED

SURFACE OF CONCRETE WEIR APRON HAS DISINTEGRATED IN PLACES

$\overbrace{ ^{R}_{0077} }_{\textbf{R}} \, \underline{ \text{LARGE VOIDS UNDER CONCRETE WEIR APRON} }$

$\underbrace{\frac{\text{s}}{\text{0077}}}_{\text{UNDER WEIR APRON}} \underbrace{\text{REINFORCEMENT EXPOSED AND CORRODED}}_{\text{UNDER WEIR APRON}}$

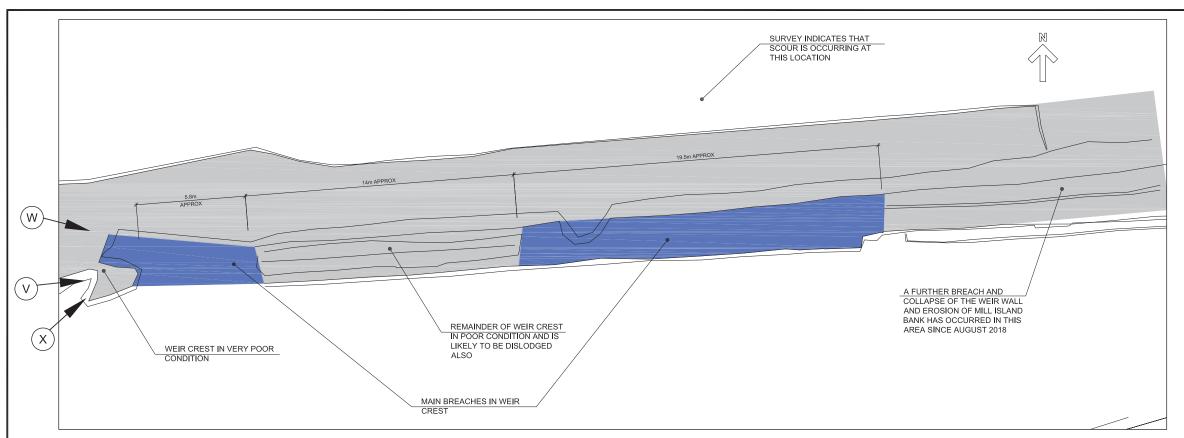
1 0078 EXISTING WEIR LAYOUT - AREA 5 SCALE: 1:100

W VIEW OF WEIR CREST AND DOWNSTREAM APRON

X VIEW OF WEIR CREST CONDITION

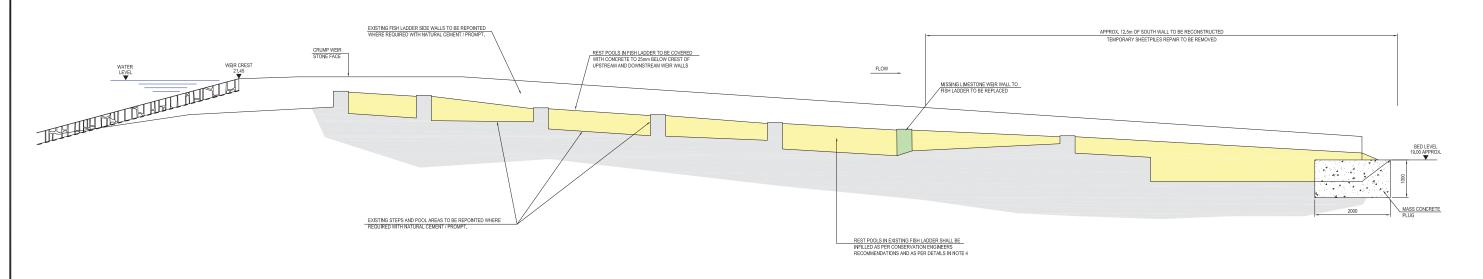
PROPOSED FISH LADDER SECTION
SCALE: 1:50

- 5. ALL LEVELS AS PER MURPHY SURVEYS 2018 SURVEY OF WEIR STRUCTURE.
- EXISTING FISH LADDER SHALL BE INFILLED IN ORDER TO AVOID WHITE WATER CREATED BY THE STEPS IN THE LADDER ATTRACTING FISH FROM DOWNSTREAM OF THE WEIR.

- 3. PROPOSED REMEDIAL WORK DETAILS AS PER CONSERVATION ENGINEER, TREVOR WOODS CONSULTING ENGINEERS, DETAILS.
- COVERING
 DPM 1500 GAUGE TO BE LAID UP PASS INSIDE WALLS OVER BASE AND LAPPED MIMMUM 1m BETWEEN SHEETS / JOINTS.
 TYPE 6F FILL WITHIN 300mm EXISTING CAPPING.
 150mm CLAUSE 304 BLINDED WITH LEAN MIX CONCRETE.
 150mm CONCRETE EXLA (FIBER BESH POLYPROPYLENE FIBRES)
 SURFACE TO BE STAMPED WITH RANDOM STONE PATTERN.
