Fermoy Weir, Fermoy, Co. Cork

Underwater Archaeological Impact Assessment (UAIA)

Julianna O'Donoghue and Caitlyn Haskins

DATE: September 2020

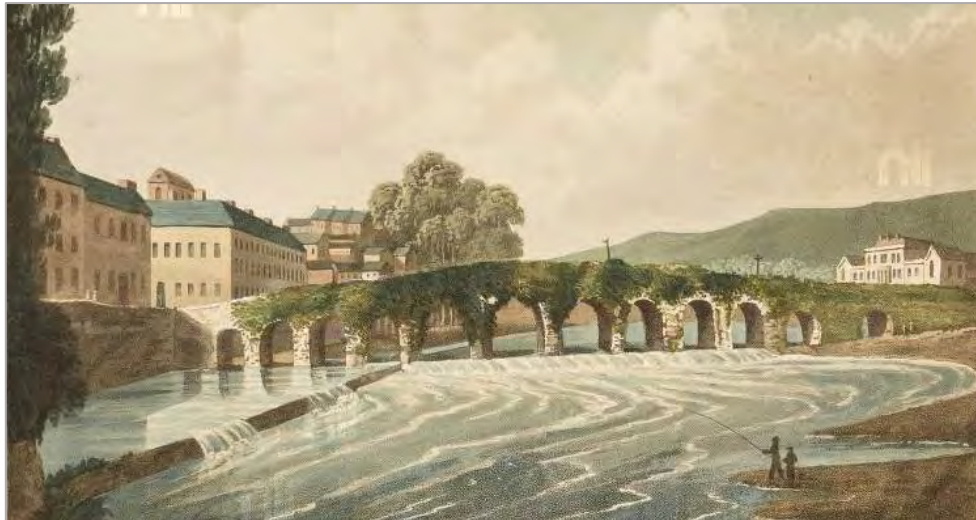
Figure 3: Fermoy Bridge, 1816- showing the weir and bridge prior to the replacement of the bridge in 1864/65 (NLI).

A sketch of Fermoy Bridge by Richard England in 1816 (Fig. 3) shows the version of the bridge as expanded by Anderson in 1799. The weir is clearly shown in this sketch. Interestingly, the southern portion of the weir, which runs almost east-west, appears to be in the same position as the corresponding portion of the upstanding weir today. This is the same section where the breach has occurred. However, the northern portion of the weir runs roughly N-S at the downstream side of the bridge. This is opposed to running on a NW-SE curve on the upstream side of the bridge, as it does today. It is possible that this was an artistic error, however, as the only known photograph of the earlier bridge shows the weir passing underneath the bridge, as it does today (Plate 1).

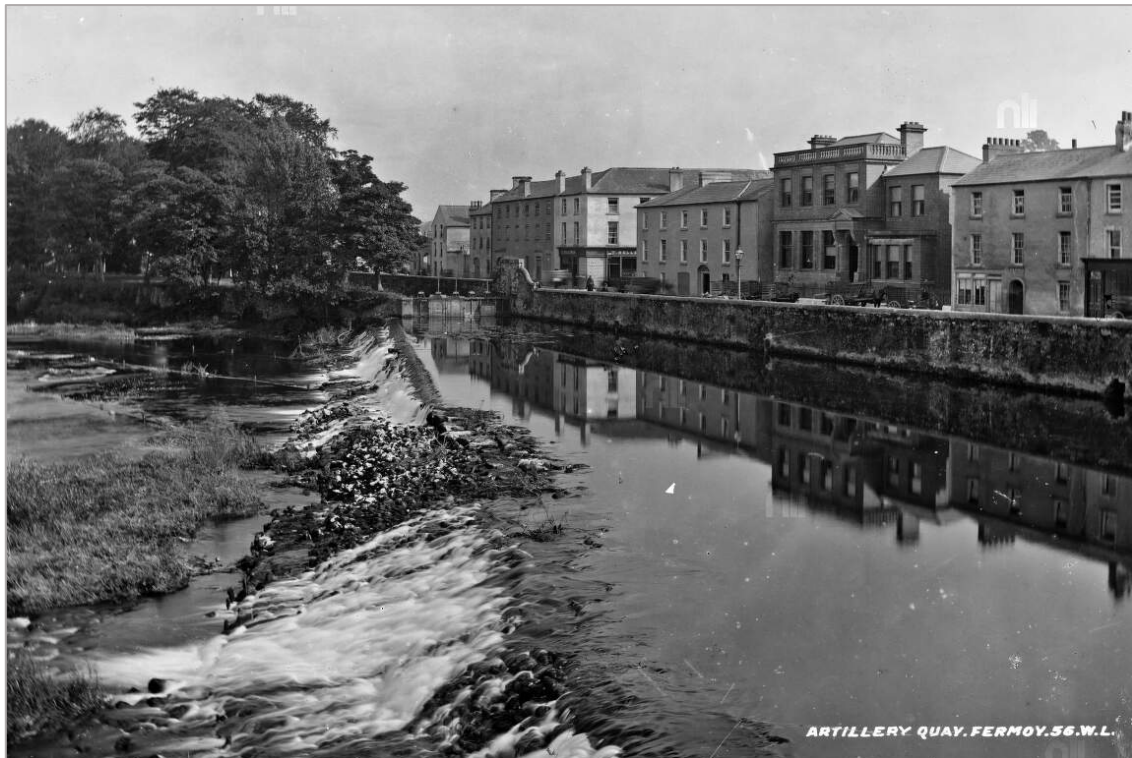
Plate 2: Artillery Quay, Fermoy, Co. Cork by R. French, c. 1865-1914 (The Lawrence Photograph Collection: NLI).

The weir at Fermoy Bridge was constructed as a component of the nearby mill complex in order to increase the waterpower (Plate 2). It stretches across the river diagonally in a NW-SE orientation encompassing the two southern most arches of the bridge which supply water to the mill race. A fish-pass is incorporated into the weir extending through the third (from south) arch (Plate 3). The mill race runs parallel to O’Neil Crowley Quay (formerly Artillery Quay) and still contains the sluice gates.

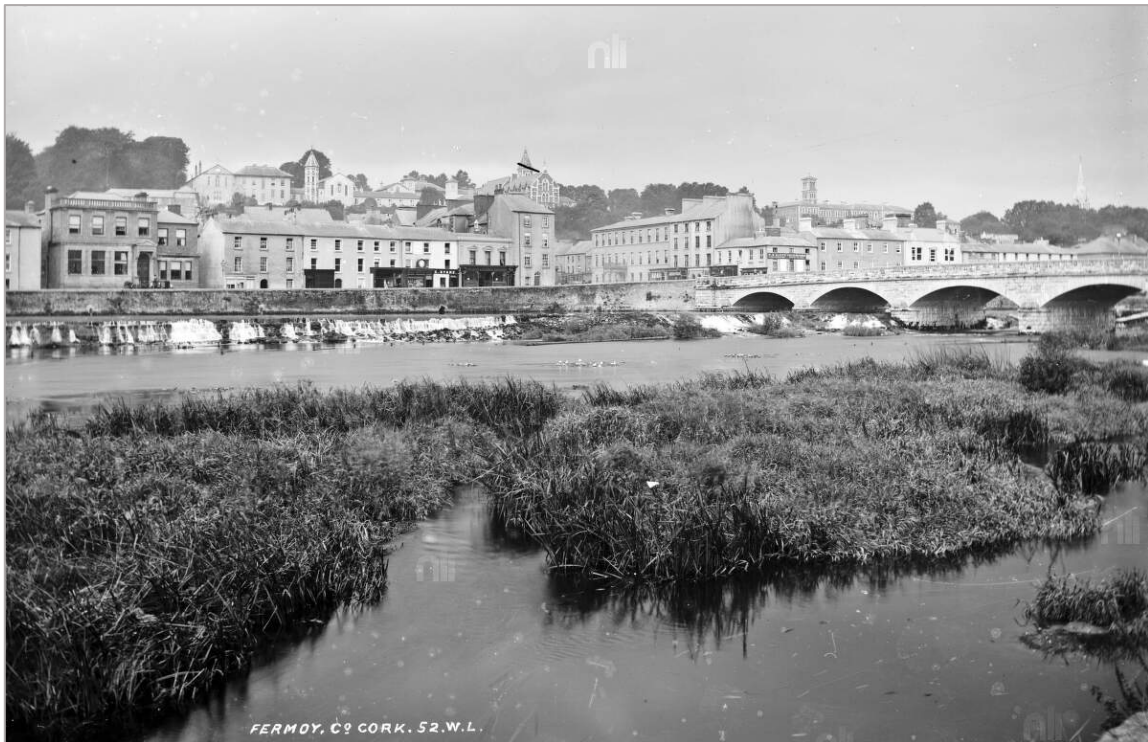
Plate 4: General View, Fermoy, Co. Cork by R. French, c. 1865-1914- showing the weir and the bridge constructed in 1864/65 (The Lawrence Photograph Collection: NLI).

The present Fermoy Bridge was designed by A.O. Lyons and constructed in 1864/65 by Joshua Hargreave and funded by the County Grand Jury (Plate 4). It is constructed of well-dressed limestone ashlar masonry with rounded cutwaters and contains seven wide segmental arches varying between 11.58m and 14.63m. The 14.5m wide bridge is a designated archaeological monument (CO035-073). It is also a registered in Fermoy Town Council’s Record of Protected Structures (No. 199).

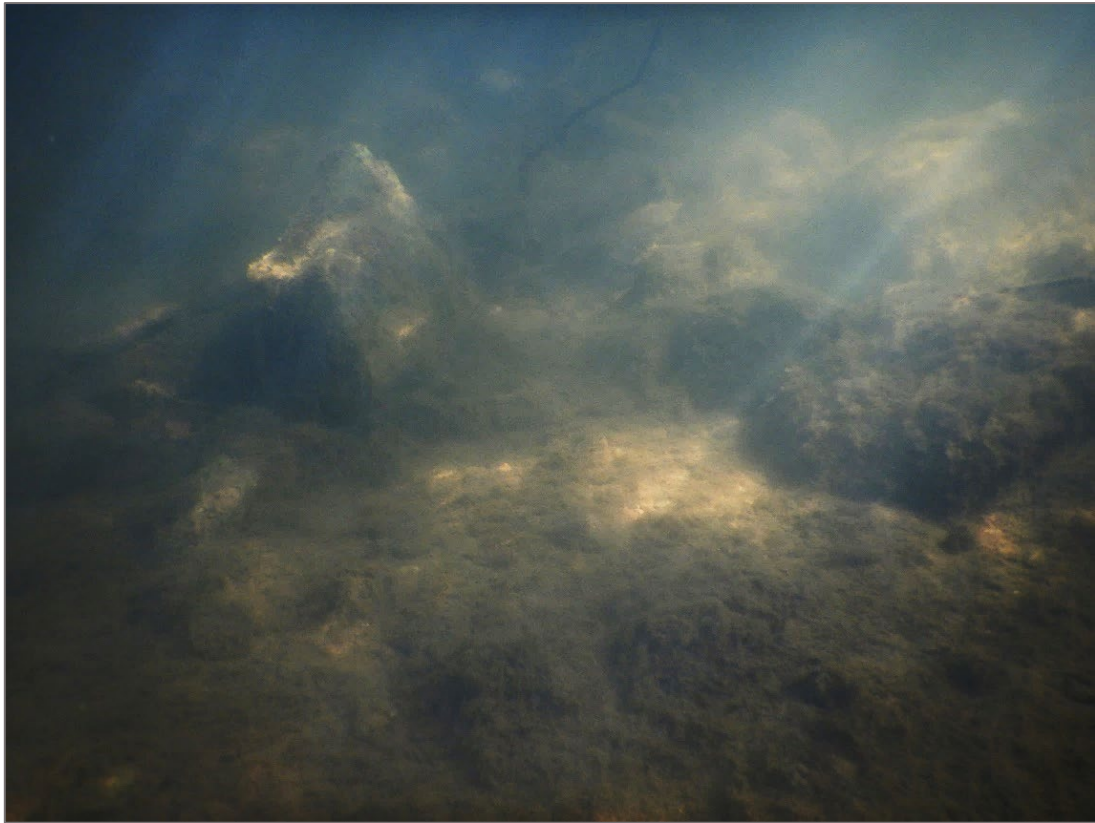
The riverbed upstream of the weir was silty with frequent stone inclusions averaging 0.25m x 0.12m x 0.16m (Plate 5). Downstream of the weir, the riverbed is composed of medium to large stones north of the fish pass. Under the bridge, the riverbed is sandy with fewer stone inclusions and is generally shallower. East of the bridge, on the downstream side of the weir, there are occasional collapsed stones from the weir visible up to 2m out from the weir, and the riverbed drops off sharply in many places.

Plate 5: Riverbed upstream of weir.

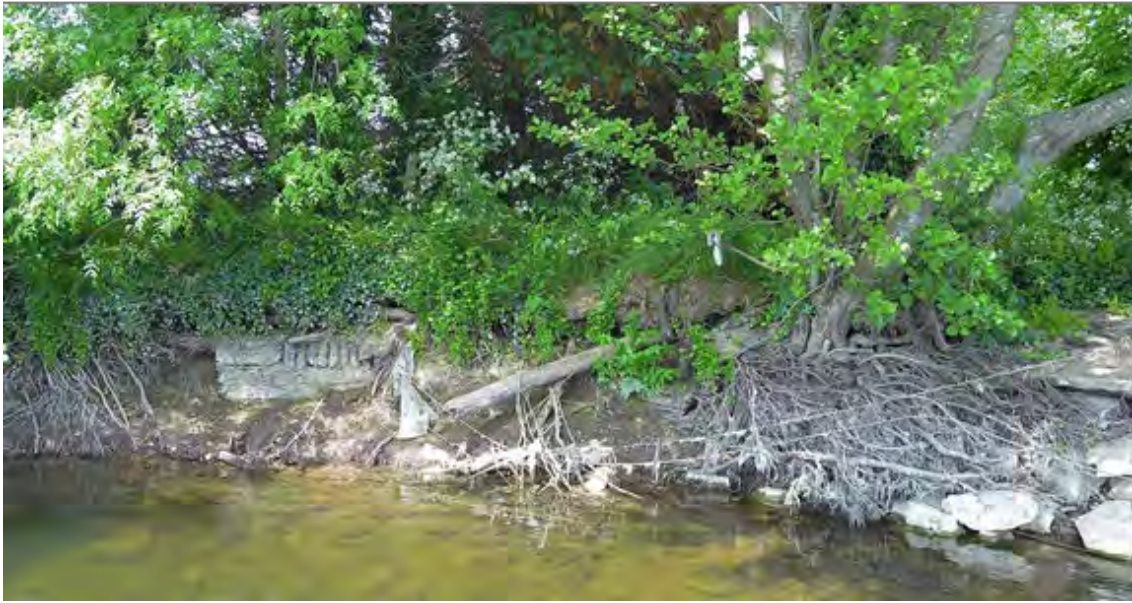
The north-western limits of the weir are connected to an earthen riverbank. Upstream of the weir a small section of stone revetment wall remains in the bank (Plate 6), while downstream a stone revetment wall survives in poor condition for c. 19m. At the opposite terminal, at the SE, the weir connects to a headrace that formerly served a substantial mill complex.

Plate 6 North bank with section of quay wall visible, face of weir to far right. Taken from south.

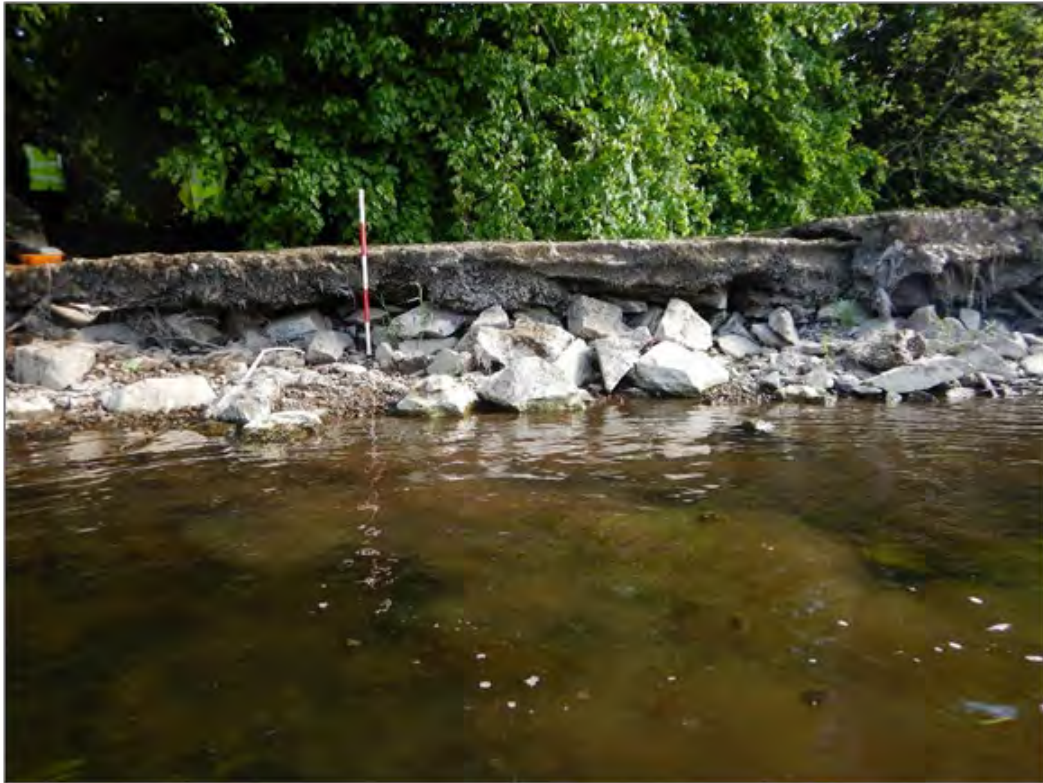
This part of the weir is triangular in profile having a vertical upstream elevation of up to 1m in height above the riverbed and a broad sloping glacis. Nothing of the original upstream face is visible, excepting a small section on either side of the fish pass. It has largely been replaced by hessian concrete bags (Plate 7). Limestone rubble which appears to have originated from the weir is strewn on the riverbed at the base of the upstream elevation.

Plate 7 Upstream face of western portion of weir, taken from south-west.

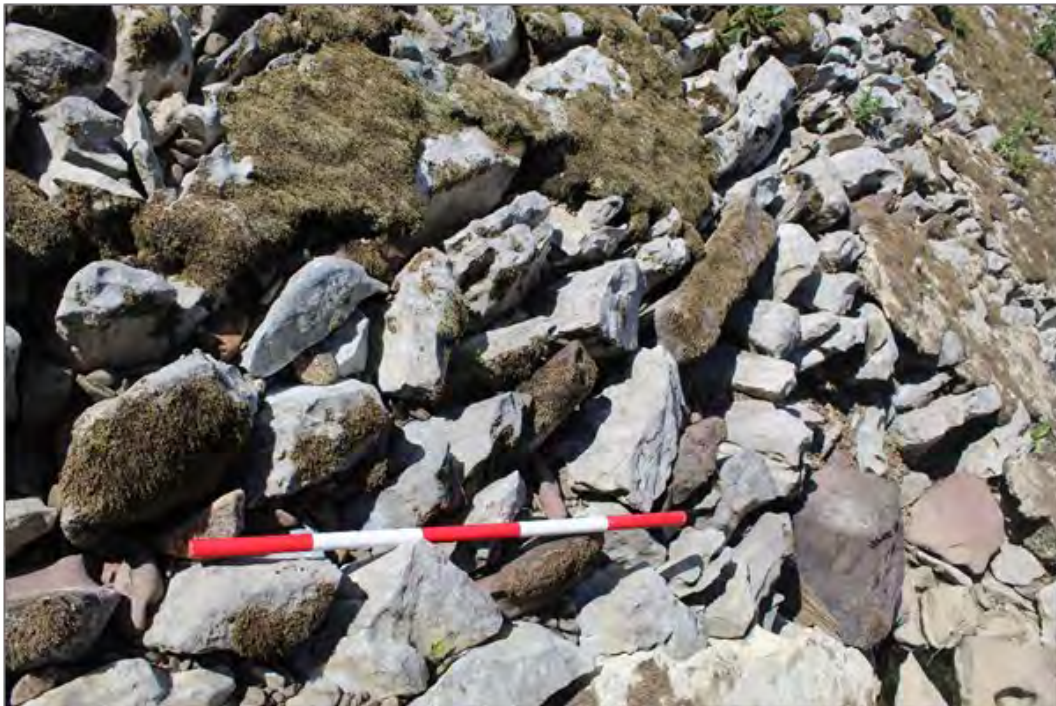
Plate 8 Exposed stone face of weir slope, located south of fish pass. Taken from east.

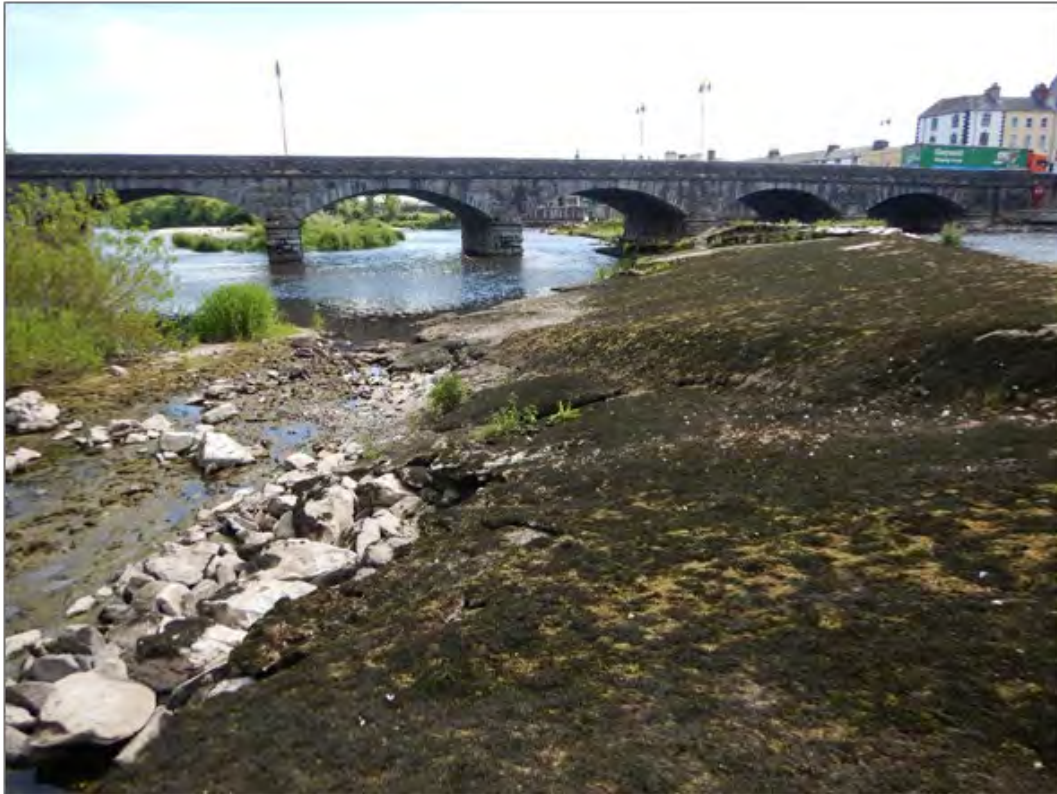
Plate 9 Concrete-covered slope of fish pass east of the bridge, showing paved stone area to the left. Taken from north-east.

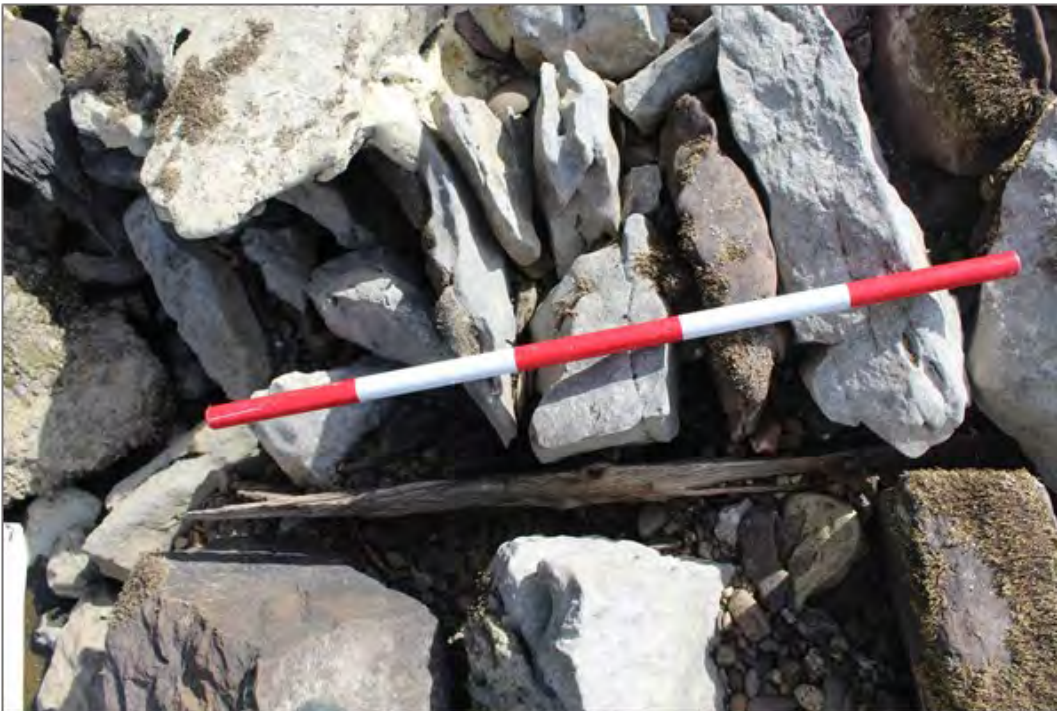
A thin horizontal timber fixed with metal stakes is visible among the stones in the eroded section (Plate 10). This was likely used during the construction to prevent stone slippage. Other timber uprights were noted beneath the concrete to the northwest of the fish pass but were barely discernible (Plate 11 & 12).

Plate 10 Timber with stake, placed with the exposed rock slope of the weir, to the south of the fish pass, taken from west.

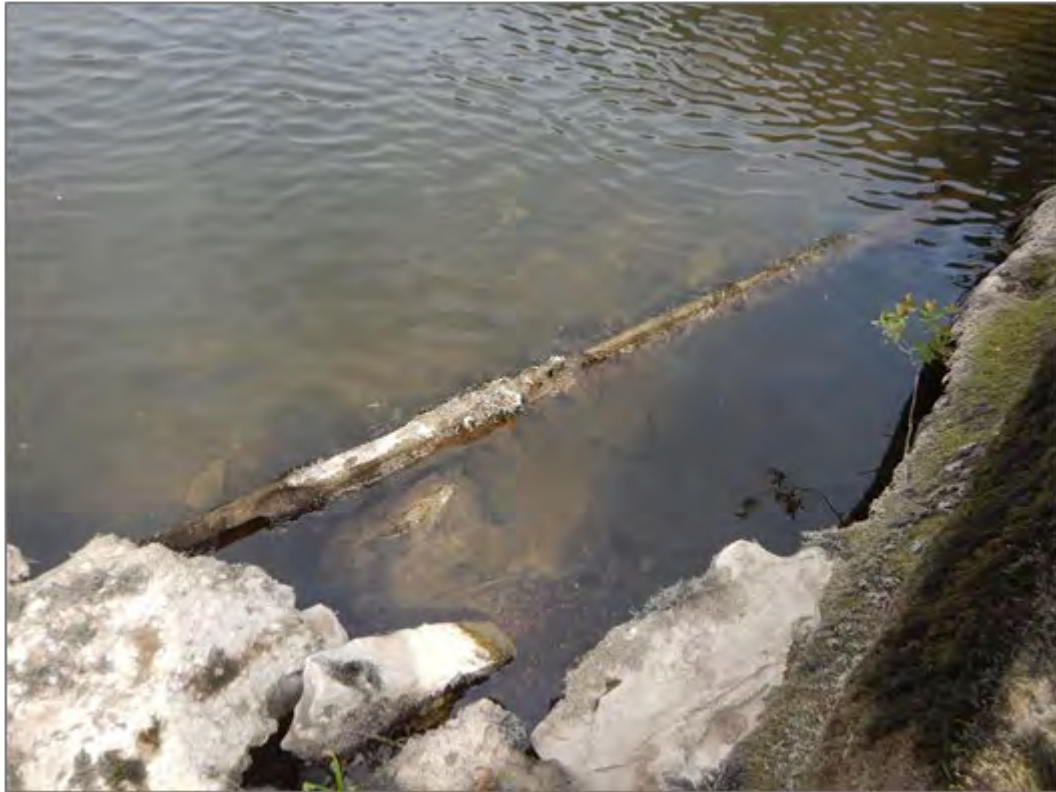
Plate 11 Timber connecting of the fish pass (right) and base of the weir (left). Taken from west.

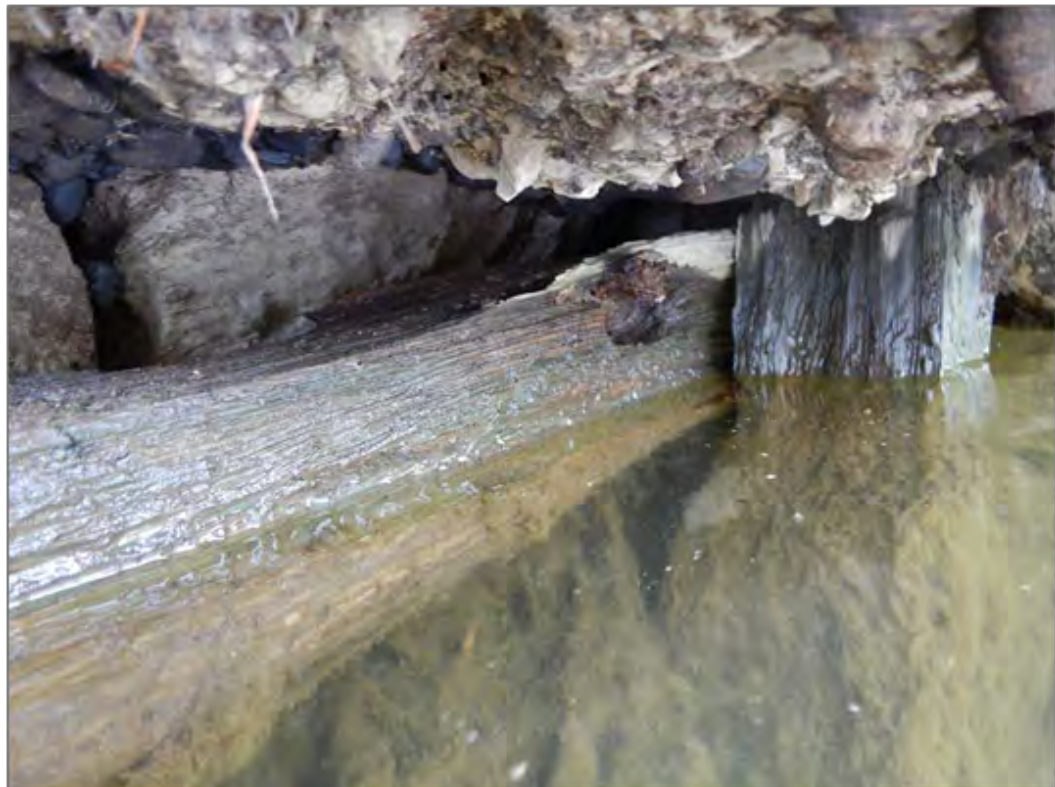
Plate 12 Timber baulk underneath concrete of weir slope, with stones visible behind (left) of the timber and upright timber (right). Taken from east.

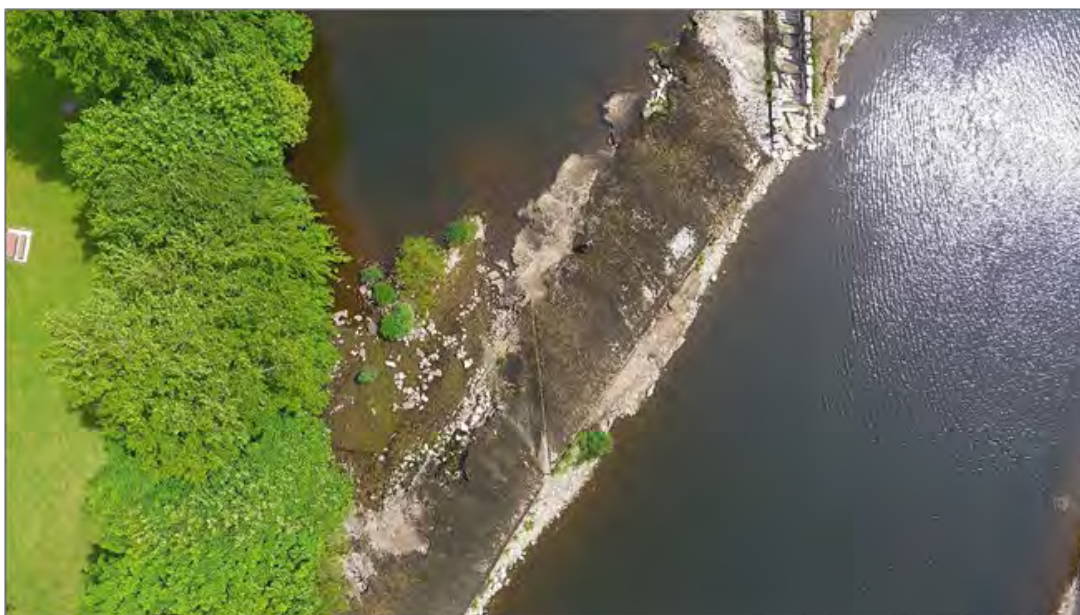
The riverbed is paved between the toe of the weir and north riverbank (Plate 13). It is constructed of vertically laid roughly hewn setts similar to those forming the glacis. The paving is coursed but displays different laying directions which are defined by thin timbers fixed with metal stakes (Plate 14 and 15). A distinct kerbing is visible to the east, marking the edge of the paved area.

Plate 13 Aerial photograph showing the western extreme of the pier, with paved area shown in the acute angle formed by the weir and northern bank.

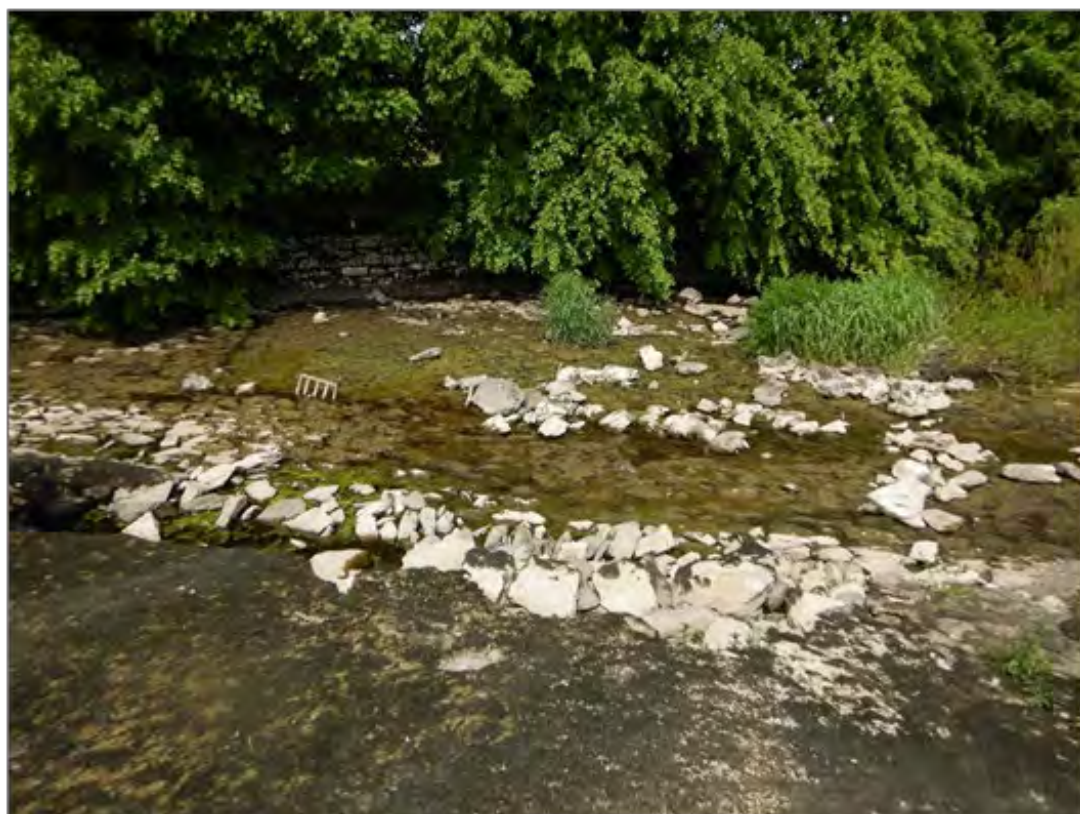
Plate 14 Paved area at base of weir, with quay wall in background behind vegetation. Taken from south.

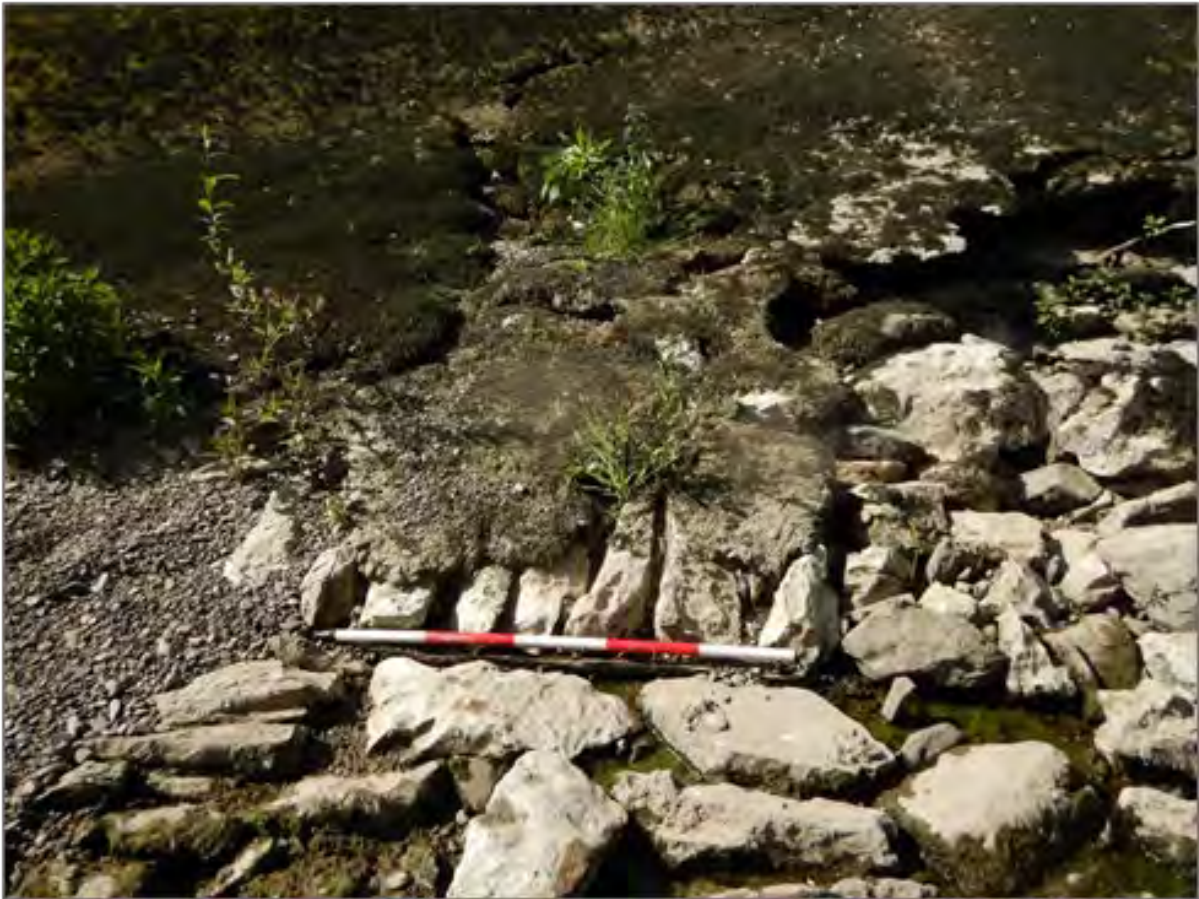
Plate 15 Timber separating end of weir and paving stones, taken from north-east.

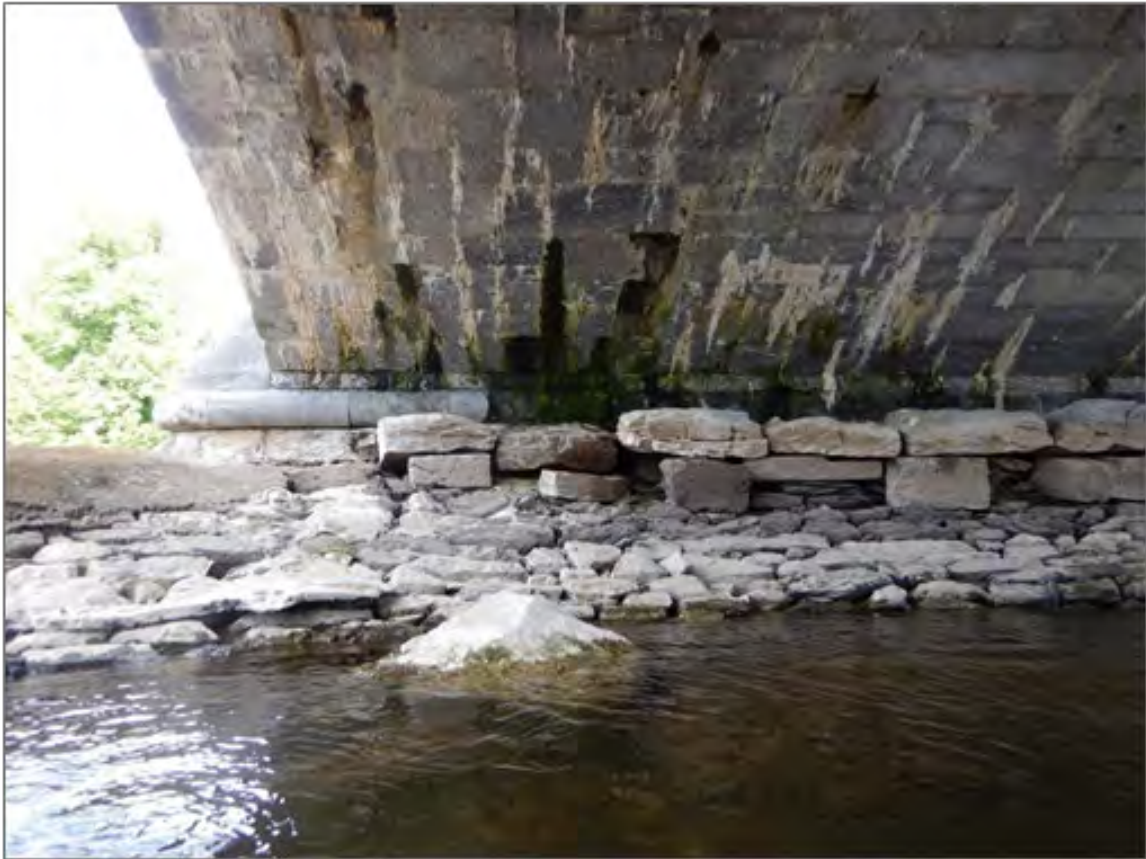
The weir was originally constructed in 1799, as part of the industrial development of the town and the bridge, at that time, was a stone 13-arch structure. This portion of the weir, and possibly upstream of the bridge was reconstructed at the time of the bridge replacement in 1854/5.

Plate 16 Original rubble stone slope of weir capped by two courses of large cut limestone, ending at the end of the pier of Fermoy Bridge. Taken from south.

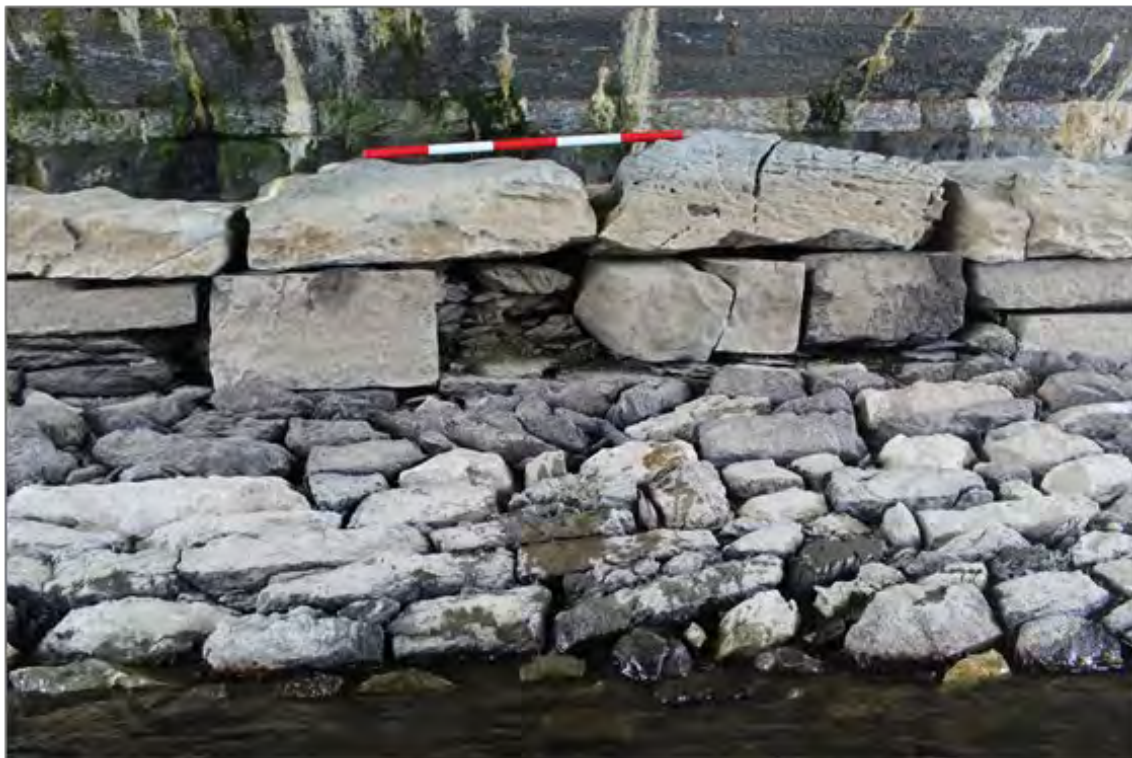
Plate 17 Original rubble limestone slope with two/three courses of large limestone cut stones overtop. Taken from south.

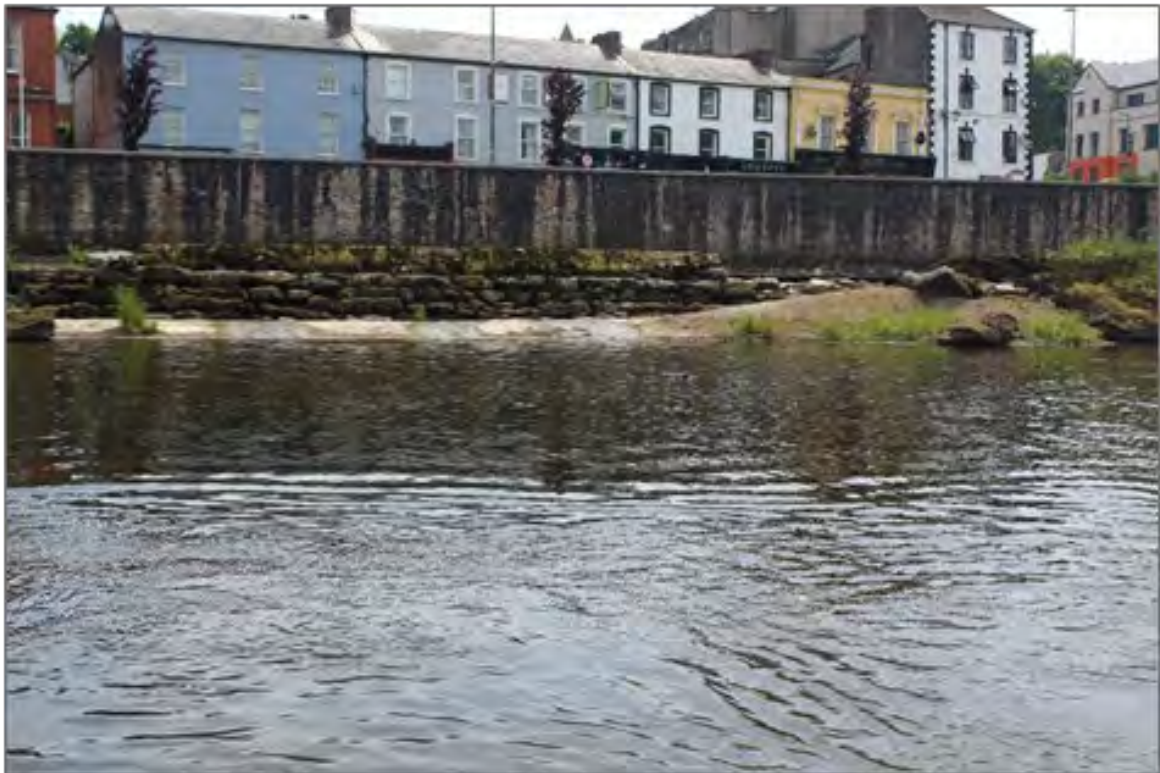
The weir is severely damaged at the eastern end and most of the fabric of the weir has washed away, but some rubble stone and concrete are visible in the surrounding riverbed. A small number of larger roughly hewn stones were also identified on the riverbed, though there were significantly less than would have formed the totality of the breached section.

Plate 18 Eastern end of weir, before breached area. Taken from north.

Where possible, the damaged sections of the historic weir should be rebuilt with the original construction materials and bonded with appropriate hydraulic lime mortar suitable for underwater. All historic weir repairs and reconstructs should be undertaken by those with a proven track record in historic building works. All proposed new sections of the weir should be designed and constructed to sensitively match the existing character of the protected structures.

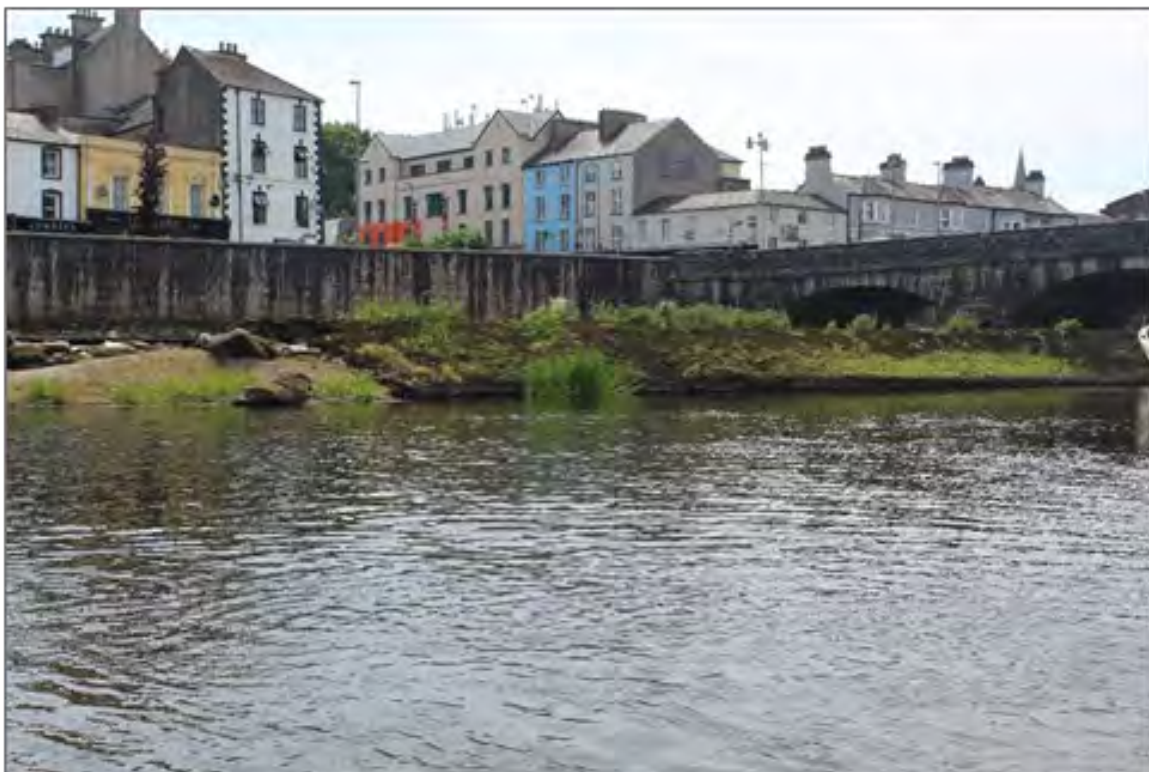
Plate 19 Eastern end of weir, east of bridge. Note difference in construction after above. Taken from north east.

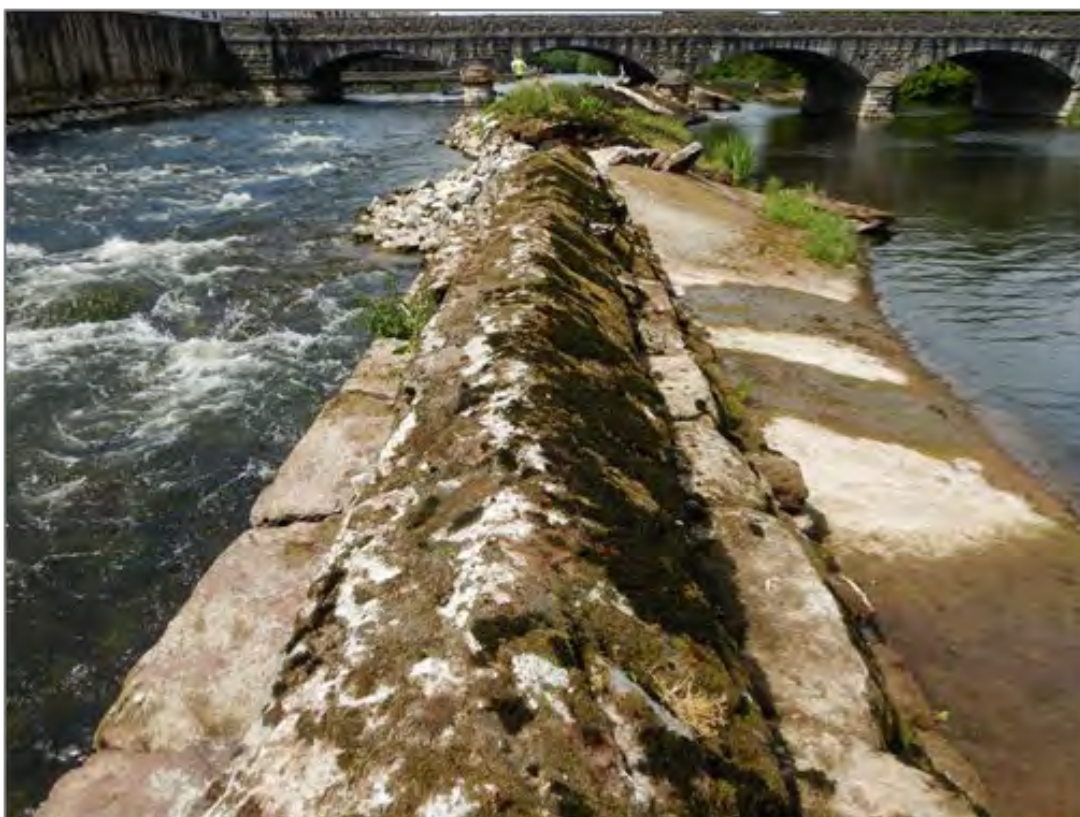
Plate 20 View from top of western end of weir, showing shaped concrete coping set back from stone courses. Taken from east.

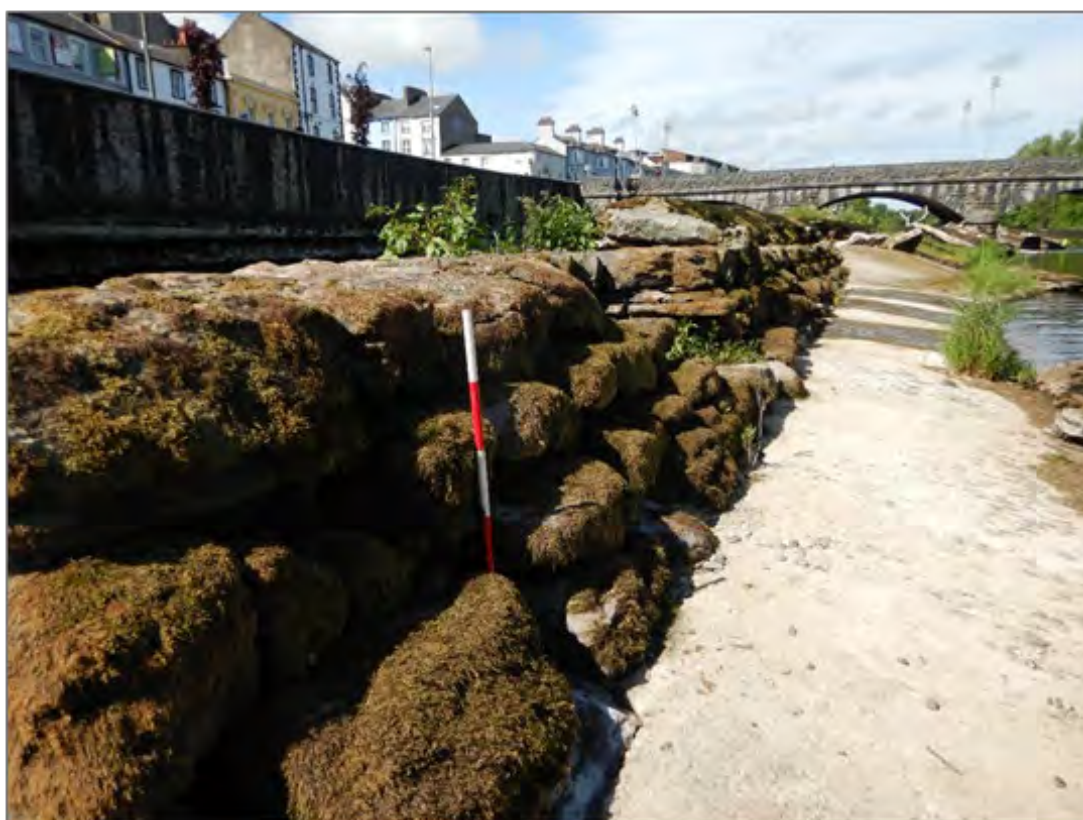
Plate 21 Stepped courses of stone on north face of western end of weir. Taken from west.

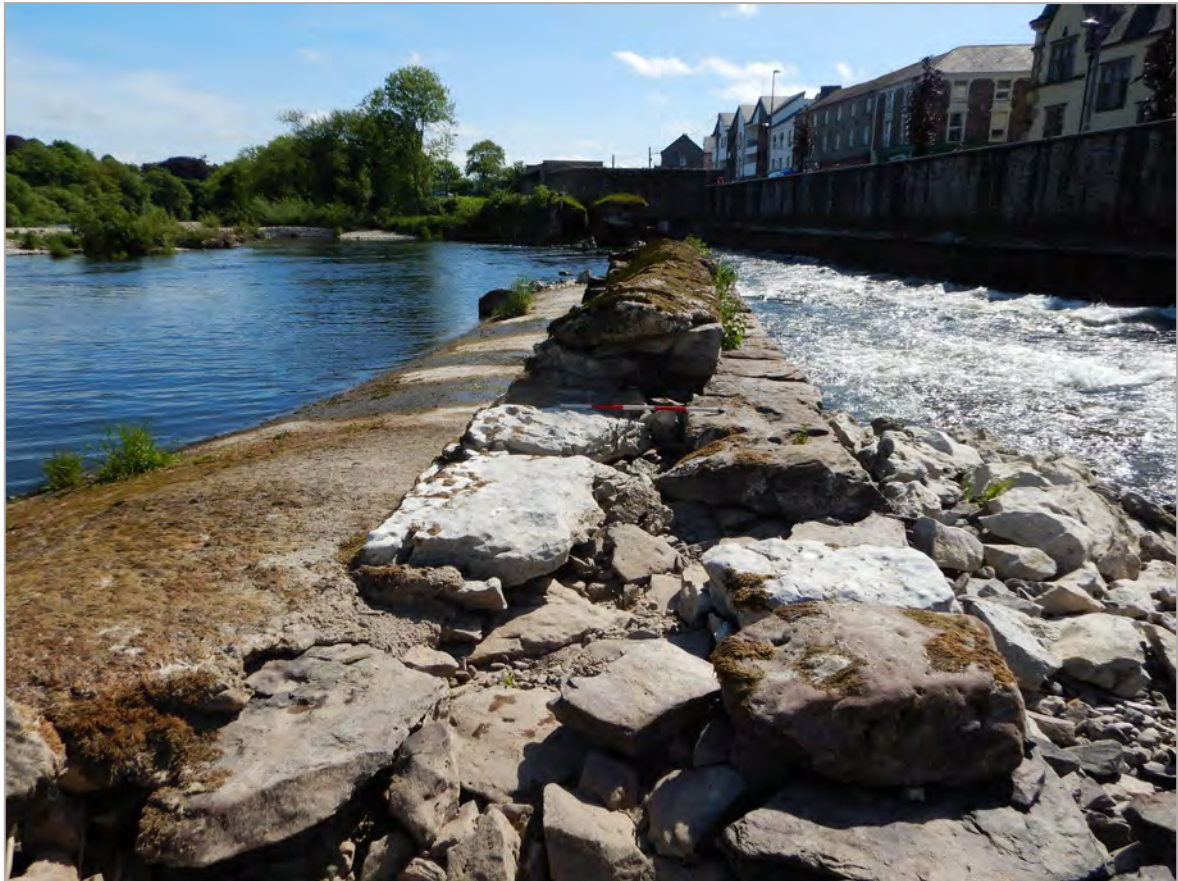
Plate 22 Random rubble fill visible at small breach. Taken from east.

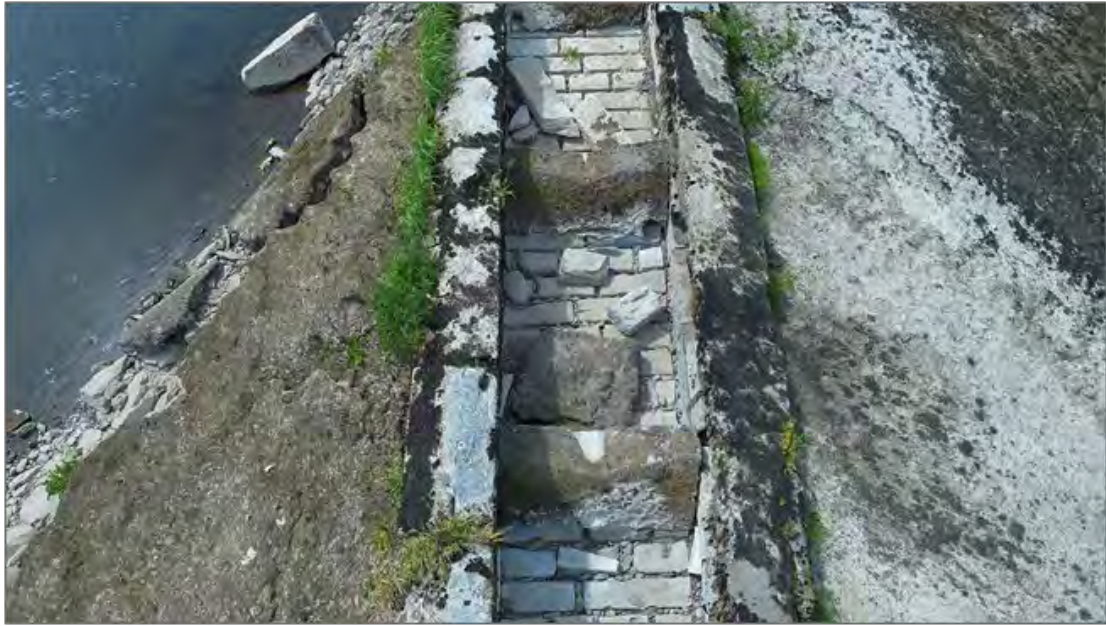
A pool-and-transverse fish pass is incorporated into the north-western part of the weir. Set at a 30° angle it measures 27m in length and c. 2.7m in width. The side walls are constructed of coursed, squared limestone blocks (avg. size 1.19m long x 0.43m high x 0.70m deep) and topped with wedge limestone coping on the south side wall and a concrete coping on the north side wall. The base is laid with slightly smaller cut stones (avg. size 0.77m long x 0.25m wide) (Plate 23). The fish pass is in poor repair with multiple areas of collapse, particularly at the western end and along the northern side wall.

Plate 23 Aerial of fish pass, showing paving stones at the base.

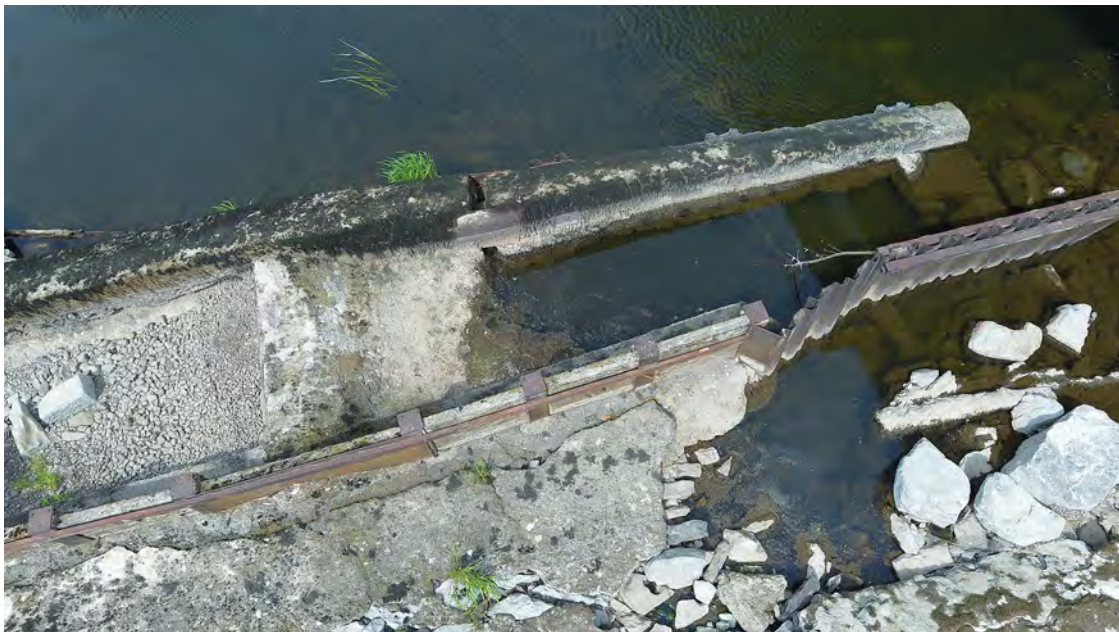
Remedial works have been carried out on the fish pass and are visible at its eastern end (Plate 24), where an extension of timber and metal forms the final 9.9m of the fish pass.

Plate 24 Aerial view of remedial works at eastern end of fish pass.

2. Proposed works to existing fish pass: temporary remedial works removed, section of side wall reconstructed with new limestone to match the existing, remaining side walls pointed with natural cement, any other missing stonework replaced with any out of position stonework reset. As a new bypass channel is to be constructed, this fish pass will need to be effectively decommissioned. It is intended to do this by installing stonework across the current channel to the same height of the stonework side walls, solid geotextile mat laid and fill material with limestone setts to match those of the main crump weir slope to create a smoother transition from the crest to the toe.

Likely Impact: The removal of the ad-hoc modern repairs to the fish pass will help restore the character/appearance of the weir. Although it will not be restored to its original design the preservation of its sidewalls will retain a vestige of its original form. The proposed works will have a moderate positive impact on the underwater cultural heritage of the area.
