Fermoy Weir, Fermoy, Co. Cork

Underwater Archaeological Impact Assessment (UAIA)

Julianna O'Donoghue and Caitlyn Haskins

DATE: September 2020

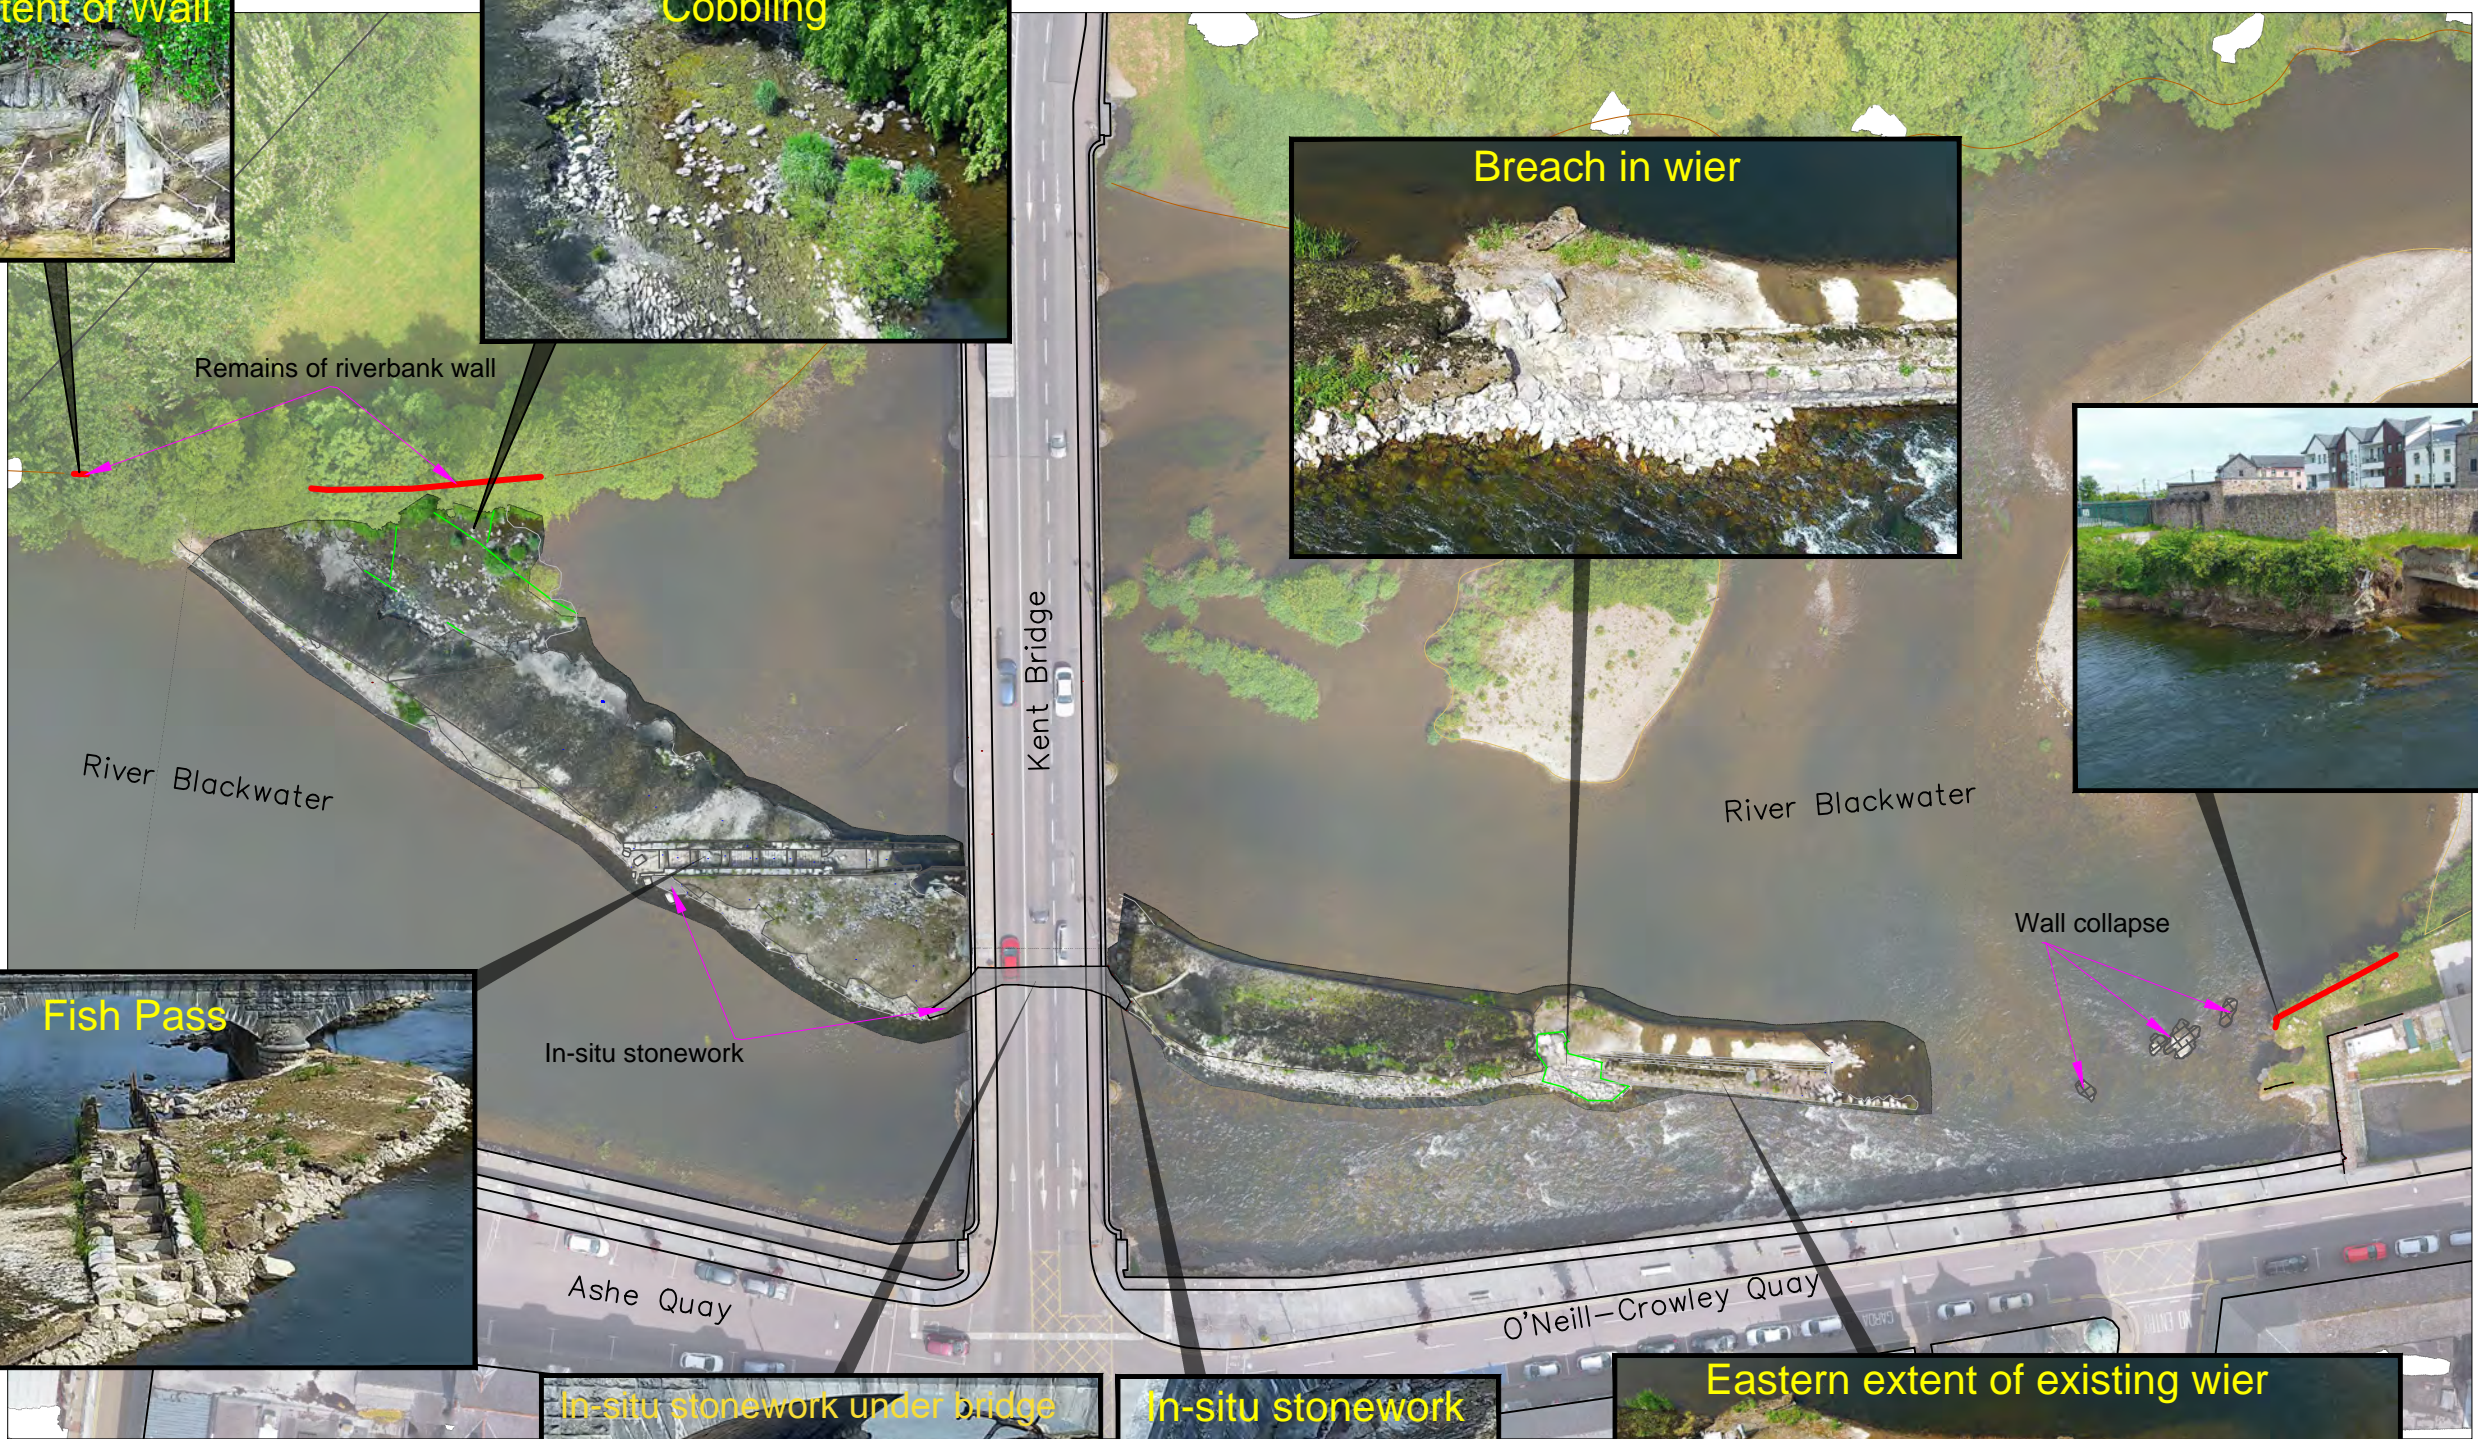
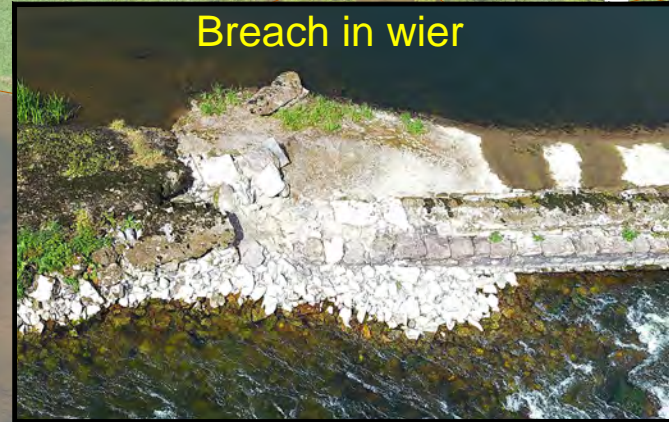
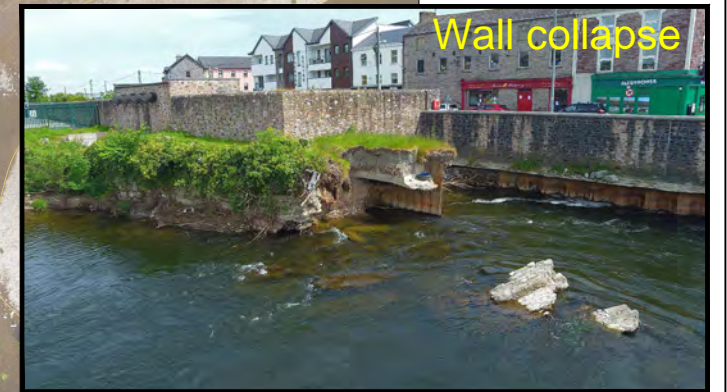
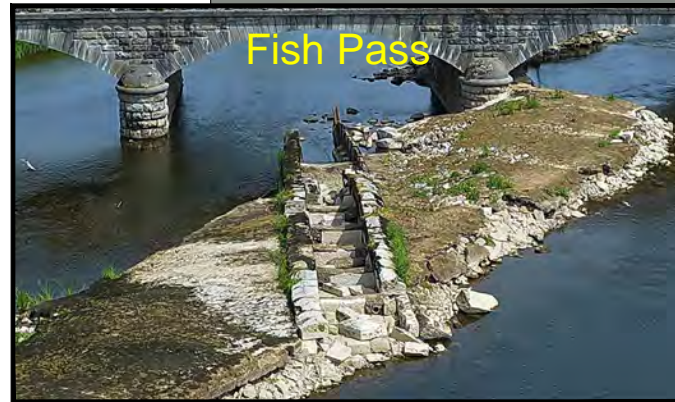
Western Extent of Wall

Cobbling

Breach in wier

Wall collapse

Fish Pass

In-situ stonework

In-situ stonework under bridge

Eastern extent of existing wier
