# Bat Survey and Assessment

Lower Road

Crosshaven

Final Report prepared for Cork County Council

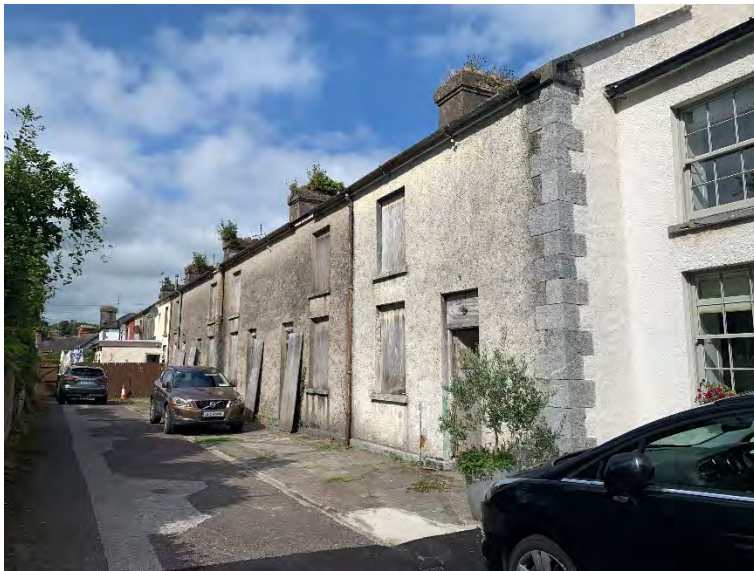
The dwellings comprise 7 no. terraced cottages (Plate 3-1). In relation to potential bat habitats within the buildings, the characteristics of the dwellings are the same and so are described as one in the following section.

The subject of the survey comprises 7 no. 2-storey terraced houses with rendered walls. The windows and doors of the properties have been boarded up. The roof is constructed of timber beams and slate roof tiles. There is no membrane to the roof tiles. The guttering is fixed to concrete coping stones; there are no soffits. Internally, no evidence of bats was recorded and the loft spaces contained many cobwebs.

*Plate 3-1: Row of terraced cottages.*

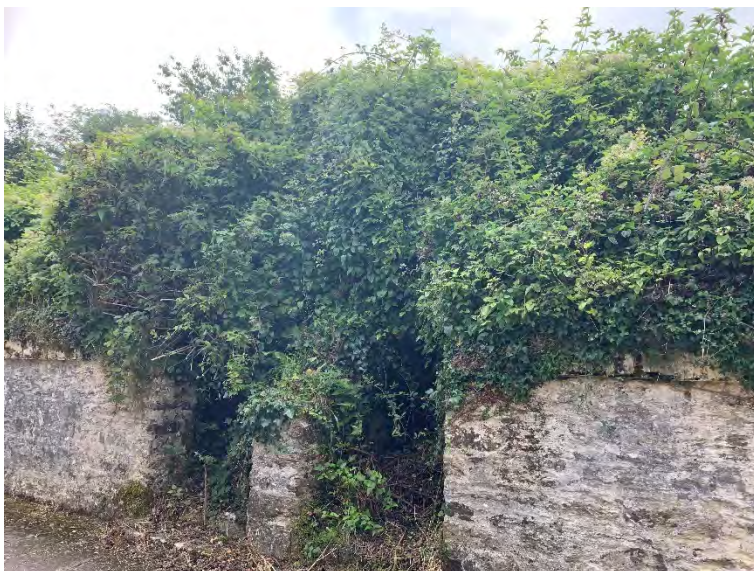
Outbuildings to the south of the dwellings are constructed of stone and are obscured by heavy growth of Traveller's Joy, Bramble and Himalayan Honeysuckle (Plate 3-2).

*Plate 3-2: Outbuilding overgrown with vegetation to the south of the dwellings*

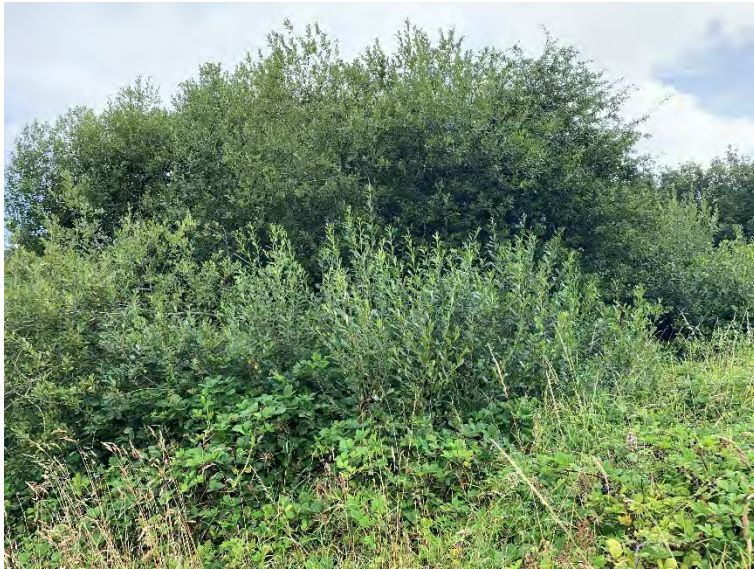
The land to the south of the dwellings is overgrown with Bramble, Himalayan Honeysuckle, Butterfly Bush and Willow scrub (Plate 3-3). Semi-mature Sycamore and Willow are present to the north and centre of the land to the rear of the dwellings. A linear band of semi-mature Beech, Sycamore and Hawthorn, and Birch saplings are present at the southern boundary of the site (Plate 3-4). One mature Hawthorn present on the southern site boundary supports lifting bark and Ivy growth and one Sycamore to the centre of the site supports Ivy growth.

*Plate 3-3: Willow scrub in vegetated area to the south of the dwellings*

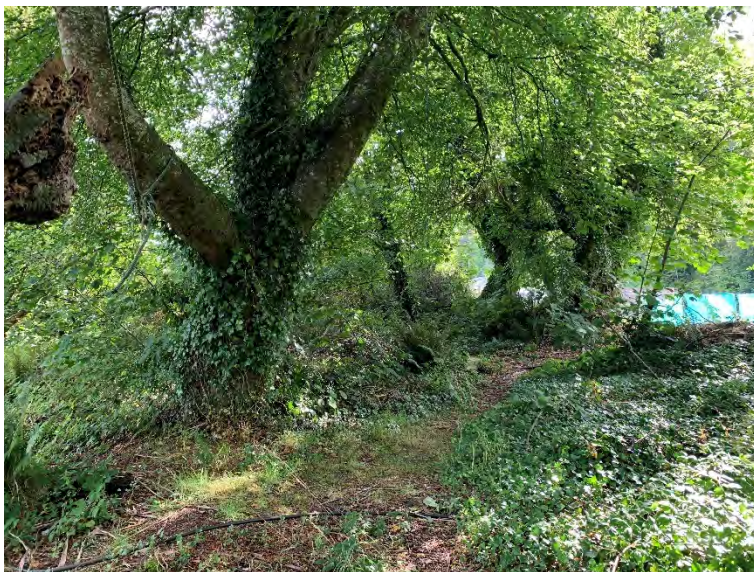
*Plate 3-4: Beech located on the southern site boundary*

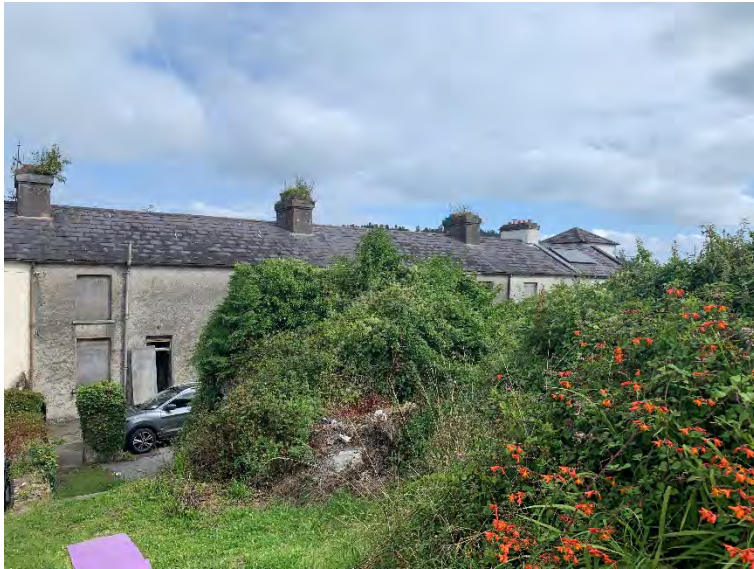
The slate roof tiles are generally in relatively good upkeep, however, there are some gaps between the roof tiles, under the ridge tiles and also under chimney flashing.

*Plate 3-5: Tiles in good condition over most of the roof*

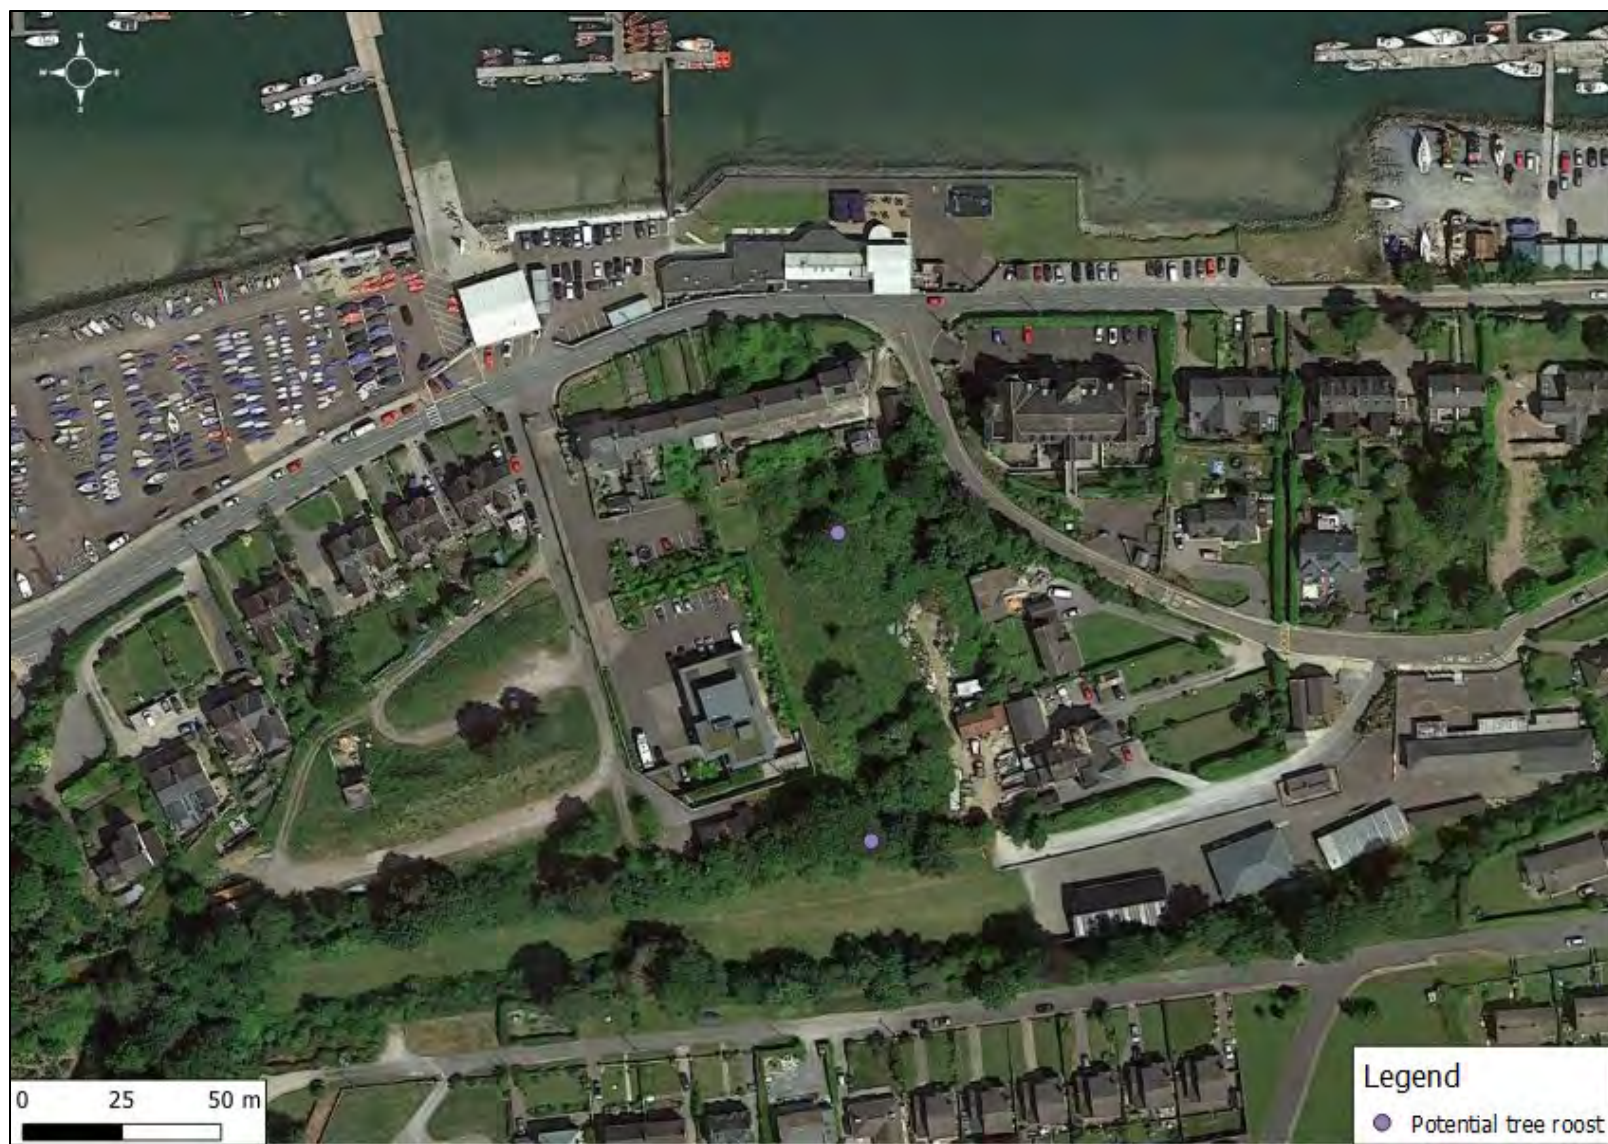
One mature Hawthorn present on the southern site boundary supports lifting bark and Ivy growth and one Sycamore to the centre of the site supports Ivy growth; these trees are considered to be of low suitability as roosting or resting places for bats. The location of trees with low roosting potential is illustrated in Figure 3-1.

Figure 3-1: Lower Road, Crosshaven- trees supporting low roosting potential

Landscaping of the lands to the rear of the dwellings should retain boundary trees and shrubs where feasible. Enhancement planting of native trees and shrubs is recommended where there are gaps in the existing site boundary. This would enhance the biodiversity of the site and provide foraging and commuting habitat for bats and maintain connectivity to the wider landscape.

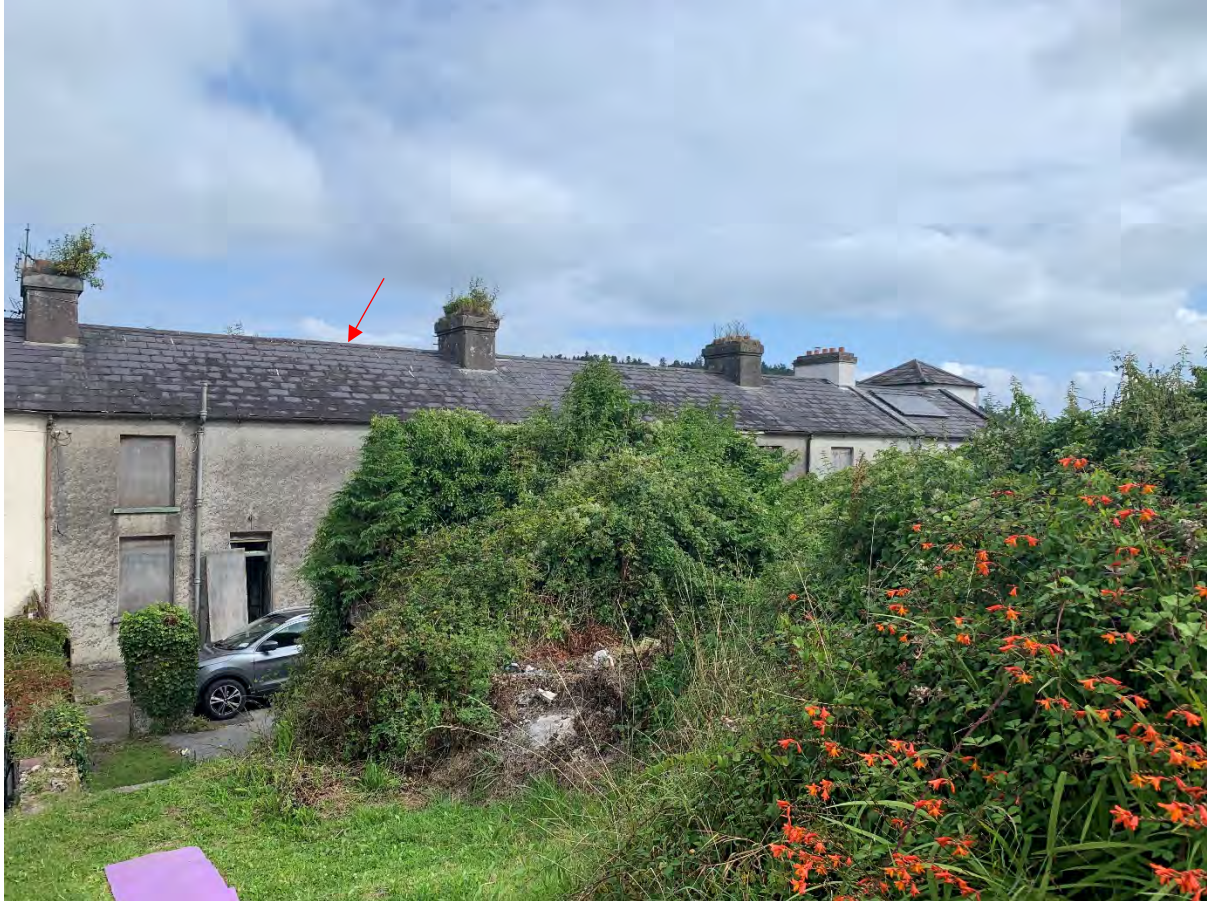
One common pipistrelle bat was recorded emerging from the roof of dwelling no. 8 (entry/ exit point illustrated in Plate 3-6).

Plate 3-6: Lower Road, Crosshaven- emergence/ re-entry point for single common pipistrelle

Works to the roof of dwelling number 8 shall occur between 1<sup>st</sup> September and 1<sup>st</sup> May.

Confirmed Roost: The building will be subject to a daytime inspection or dusk/ dawn survey (depending on season and weather conditions) for evidence of bat usage prior to the commencement of works. In the event that no evidence of bat usage is found during the inspection, renovation works can commence. Should bats be found within the building, works will be delayed until they are no longer present (i.e. they have naturally flown from the roost). Prior to commencement of works the bat specialist will brief contractors on the possible presence of bats on the site, the subsequent need to take appropriate care and attention whilst carrying out the works and the steps to take should bats be discovered at the site at any time (i.e. stop works and inform the bat specialist). Active bats will usually keep out of the way of any operations, but torpid bats may need to be gently temporarily placed in a box until dusk and released on site.

Where feasible, access to the roost space shall be retained. Access for crevice dwelling bats such as common pipistrelle can be as small as 15-20mm high x 20-50 mm wide and simple, for example the use of an adapted tile.<sup>2</sup>
