Thatched Houses of County Cork

A Survey
by Mary Sleeman
for the Heritage Unit

In 2001 Cork County Council commissioned the author, to carry out a follow-up survey of these 187 houses. The objective of the survey was to study the surviving thatched housing stock, assess its condition and identify its distribution and typology with a view to informing policy on future protection and conservation.

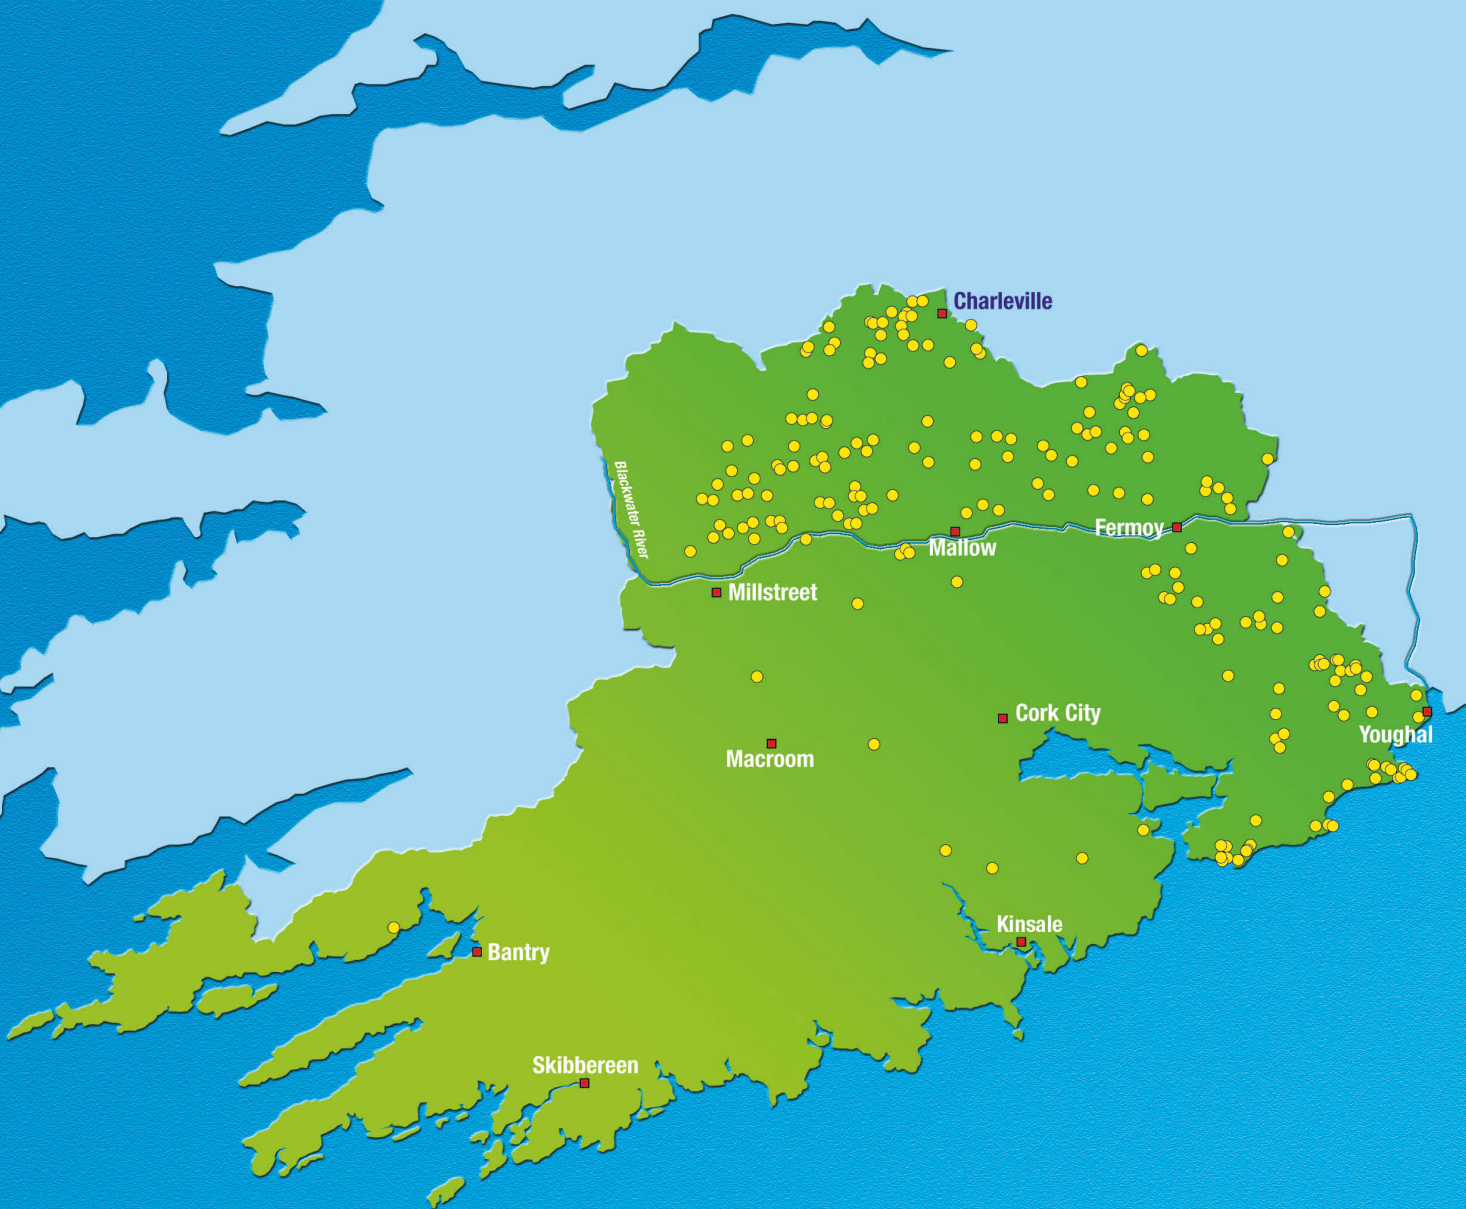
Figure 1. Distribution map of thatch houses in Co. Cork.

The 187 thatched houses catalogued by CAS were re-visited and recorded by the CCC survey over a six-week period in the summer of 2001. During the course of this work a further forty-seven examples were discovered and recorded, bringing the total of houses recorded by the CCC survey to 234. Whilst it is not claimed that this is a definitive catalogue of surviving thatched houses in the county, it is unlikely that a great number remain to be discovered. The geographic regions are defined for the purpose of this survey is as follows: North Cork - the area north of and including the Blackwater valley, East Cork as the area east of a line from Cork city to Fermoy and West Cork as the area west of a line from Kinsale to Millstreet, (fig. 1.)

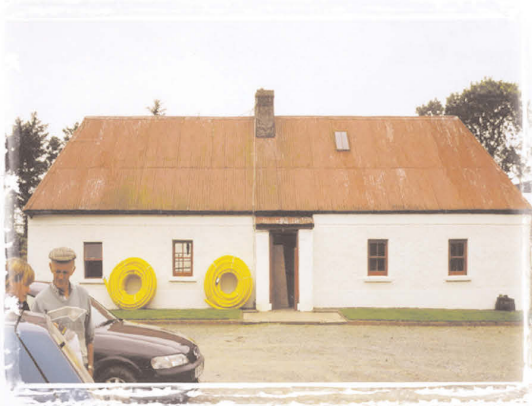
Figure 3. Corrugated former thatched house, Knockawillin. CCC No 34.

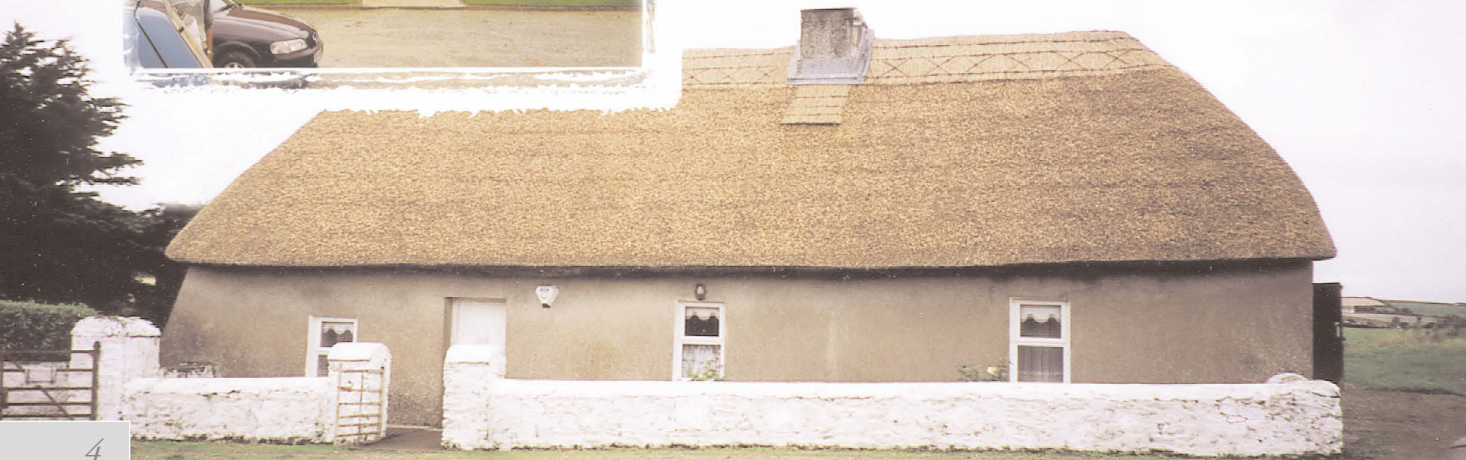
Figure 2. Typical thatched farmhouse, at Ballycrenane, Ballymacoda, East Cork. CCC No 149.

By and large the buildings that feature in this survey are rural farmhouses: 201 out of a total of 234, (fig. 2). Of the remainder, sixteen have a rural setting but no accompanying farm buildings and sixteen are located in some form of nucleated settlement of which five are public houses, (fig. 27), and there is one fisherman's house, (fig. 4). Whilst it will need a detailed examination of their interiors to determine whether there is a fundamental difference between a traditional thatched house in a rural and an urban setting, it is clear from the survey that all the structures recorded belong to the one vernacular building tradition, with little variation in appearance.

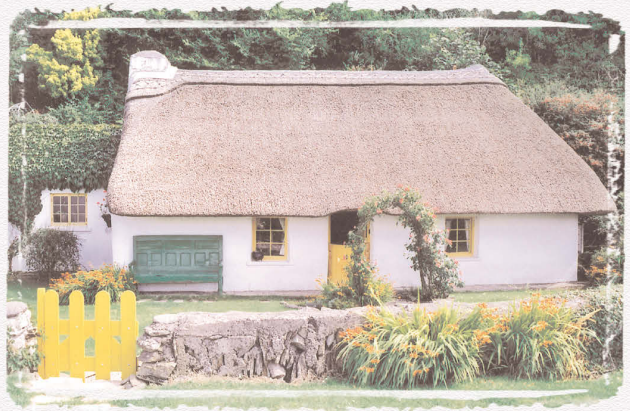
Figure 4. Thatched fisherman's cabin, Crosshaven, South Cork. CCC No 230

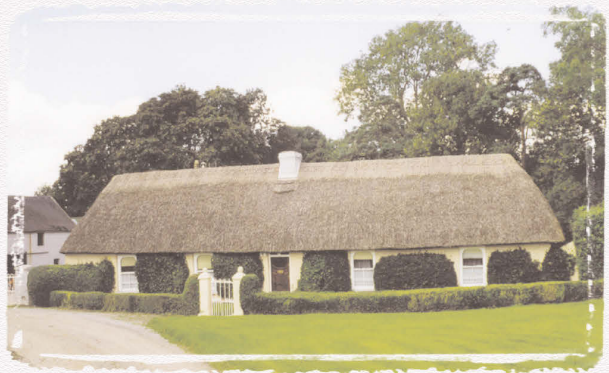
Figure 5. Typical thatched house, Dromaneen, Near Mallow, North Cork. CCC No 105.

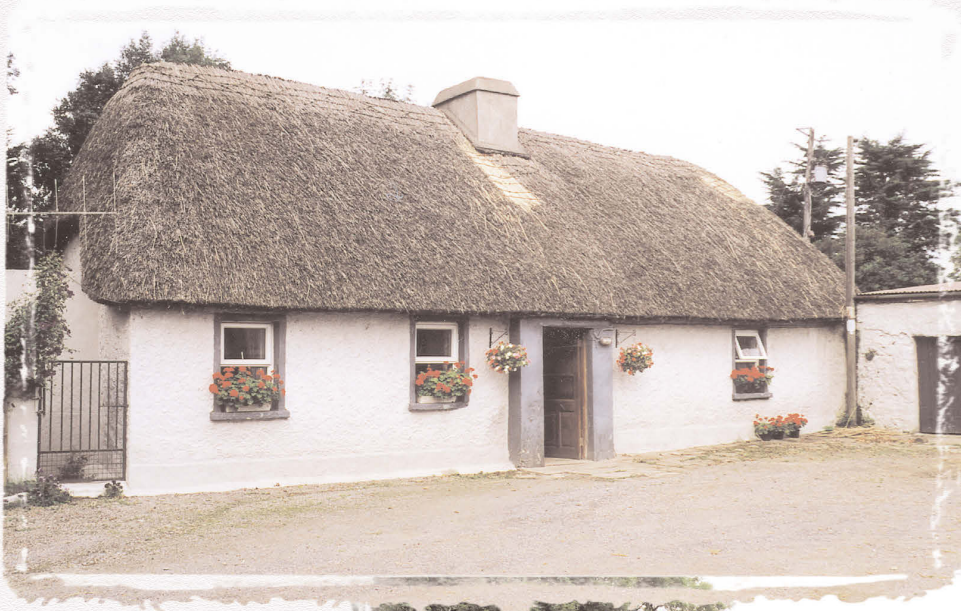
Figure 9. Example of lobby-entry thatch house, Glenabulla Cross, Mitchelstown, North Cork. CCC No 58.

Note relationship of door and chimney.

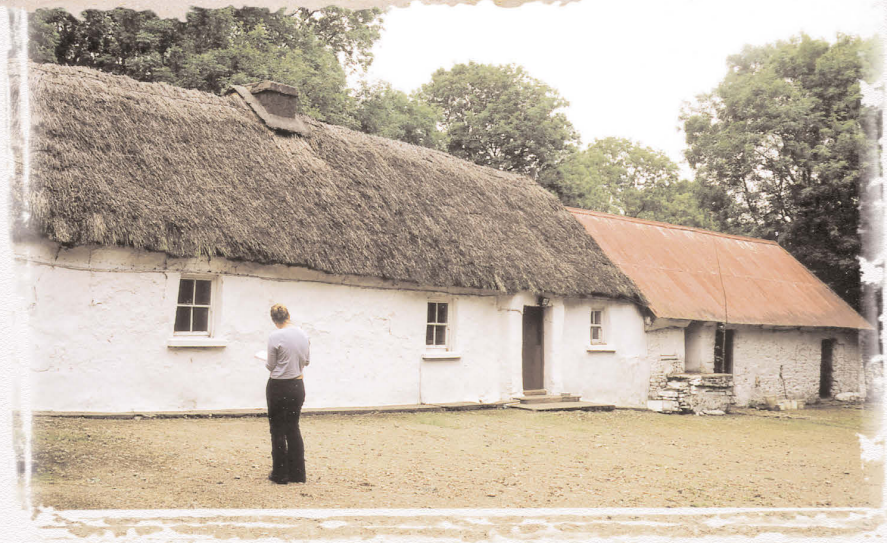
Figure 8. Example of a direct-entry thatch house, Tullylease, North Cork. CCC No 40.

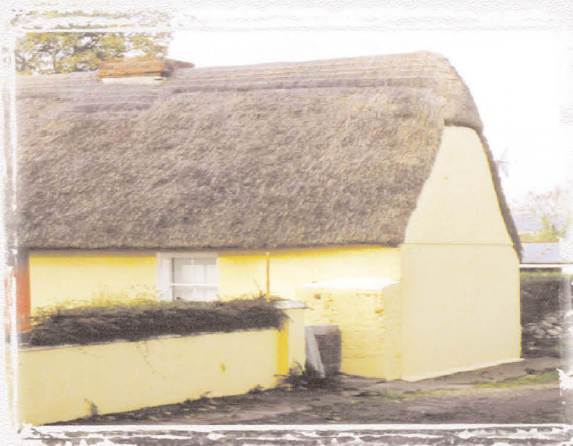
Figure 10. Detail of a gabled roof, Doneraile, North Cork. CCC No 45.

Two main roof types are characteristic of the thatched house: gabled and hipped, fig. 10 & 11. The gable-ended roof has two pitches that rise to the central ridge (back and front) with each end wall rising to an apex. A hipped roof curves around the end wall and the roof has four sloping sides (back, front and both ends).

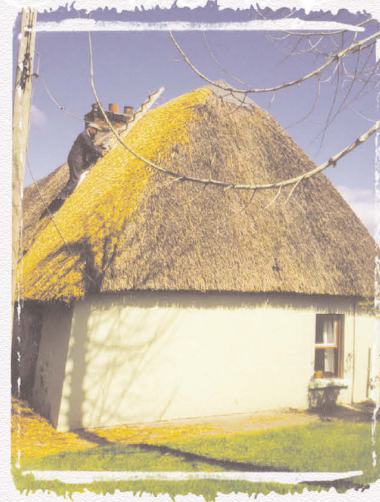
Figure 11. Detail of a hipped roof, Shandrom, near Charleville, North Cork. CCC No 5.

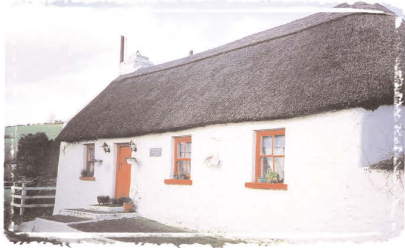
Figure 12. Example of a half-gabled thatched roof, at Knockmonalea West, Youghal, East Cork. CCC No 144.

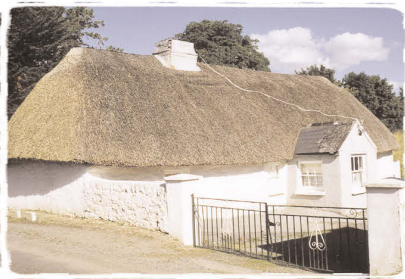
Figure 13. Example of a hipped roof, North Cork. CCC No 207.

Of the Cork houses with hipped roofs, 67 are lobby-entry whilst 55 are direct-entry. Those with gabled roofs divide between 26 that are direct-entry and 10 that are lobby-entry. And of those with a hip at one end and a gable at the other, 20 are direct-entry, and 9 lobby-entry. The remainder could not be classified.

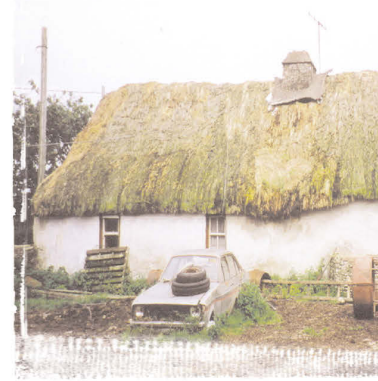
Figure 14. Wheaten straw roof, Balinure, Bartlemy, East Cork. CCC no 209.

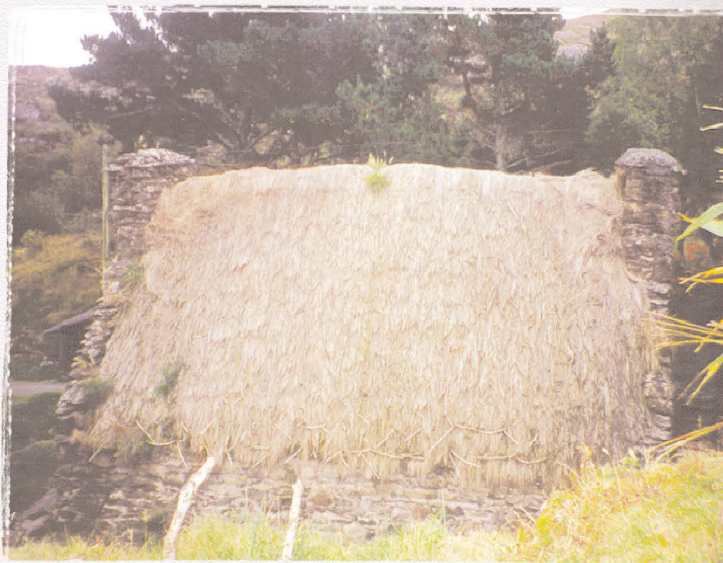
The one surviving thatched house in West Cork uses mountain grass, locally called 'ciób' or 'cib' (the Irish term for mountain grass), which is gathered off the mountain by the owner during the summer months, (fig. 15).

Figure 15. Ciób roof in sole remaining West Cork house, near Glengarriff, Coolieragh. CCC No 185.

Knockawillin, near Tullylease, (fig. 16). The third example is the sole house in West Cork (fig. 15 & 24). This house had two layers of scraw and, according to the owner, it was taken from the mountain in rolls roughly two feet wide and five feet long.

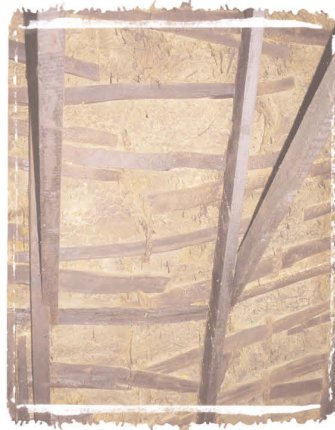
Figure 16. Detail of scraw, Lisnacore, near Kanturk, North Cork. CCC No 200.

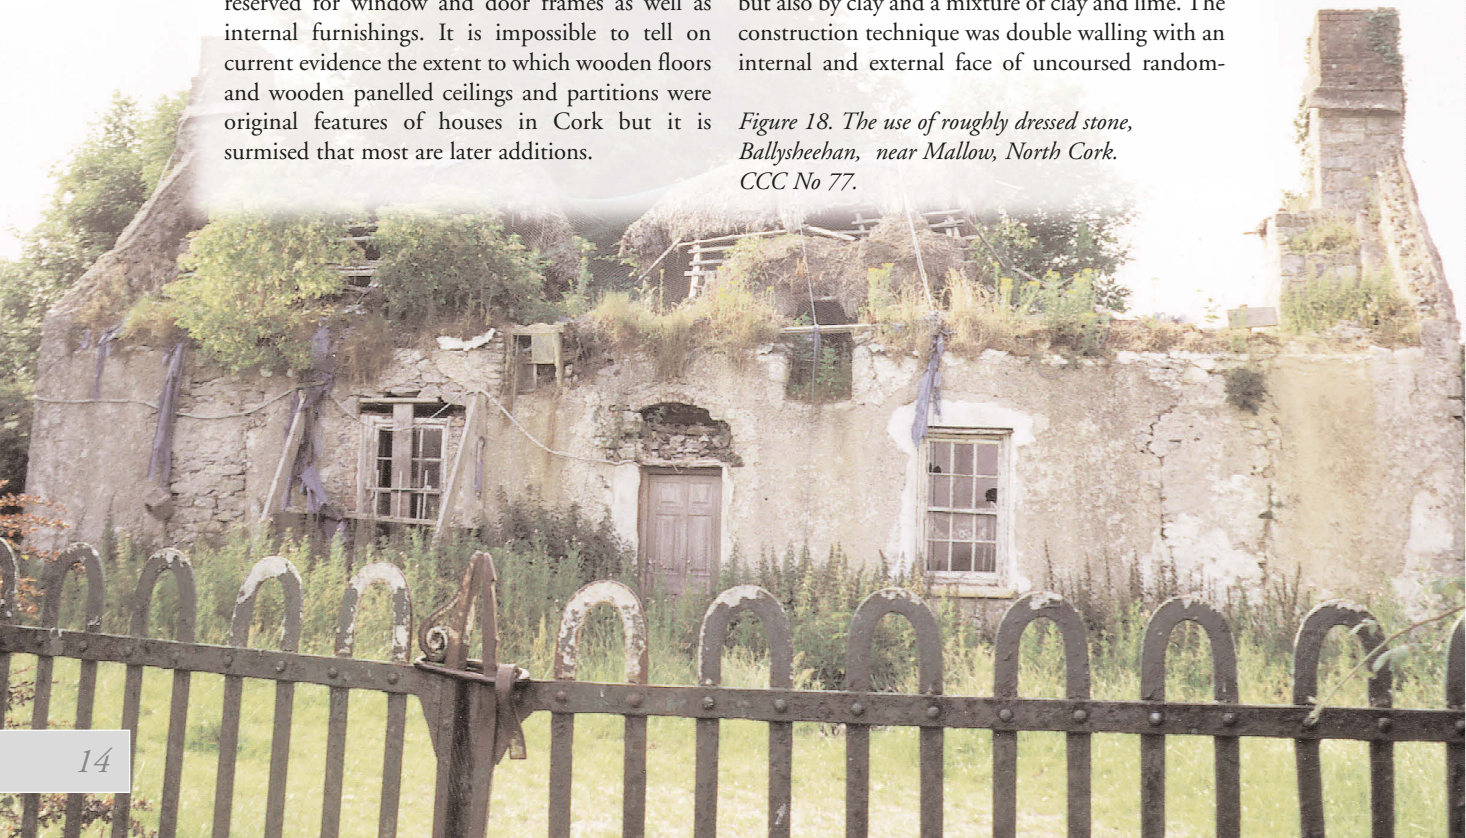
Figure 18. The use of roughly dressed stone, Ballysheehan, near Mallow, North Cork. CCC No 77.

rubble masonry. The thickness of the walls in the houses was quite consistent ranging from 0.52m - 0.7m. The wall height of the vast majority of houses was also quite constant ranging from 2m to 2.75m. Occasionally the stone was roughly dressed but this was confined to strategic structural points such as the corners of the house and above large openings, (fig. 18).

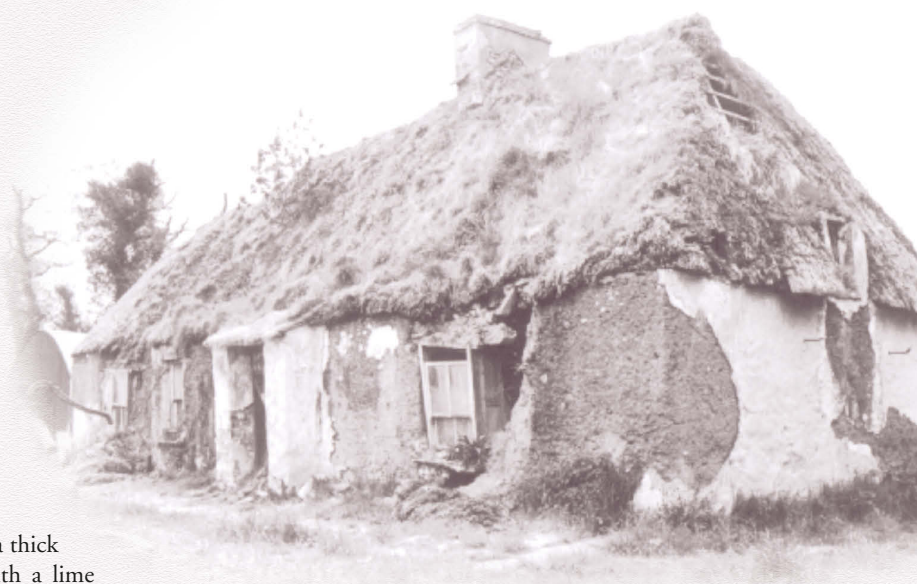
Figure 19. Exposed Clay in a ruinous thatched house, Milltown, near Charleville, North Cork. CCC No 21.

very rapidly once the render deteriorates. This is typified by the house at Milltown (CCC No. 21), (fig. 19). In 1984 the Cork Archaeological Survey recorded this house as recently abandoned and in poor repair. The owner had moved to a modern bungalow. He said his old thatched house had walls of clay which 'kept me warm in winter and cool in summer'. By 2001 the house had completely eroded back into the ground.

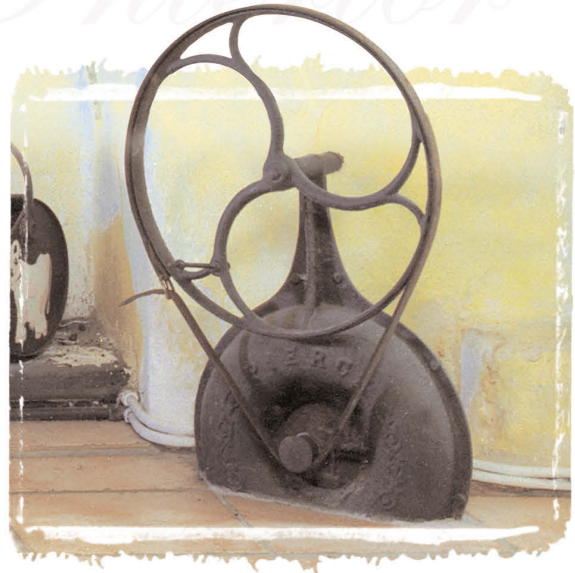
Figure 20. Cast-iron bellows, Ballymacoda. CCC No 161.

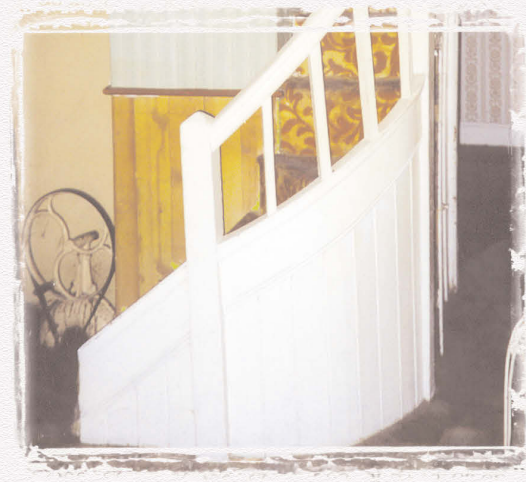
Figure 21. Narrow stairs, Rathmacarton, near Castletownroche, North Cork. CCC No 82.

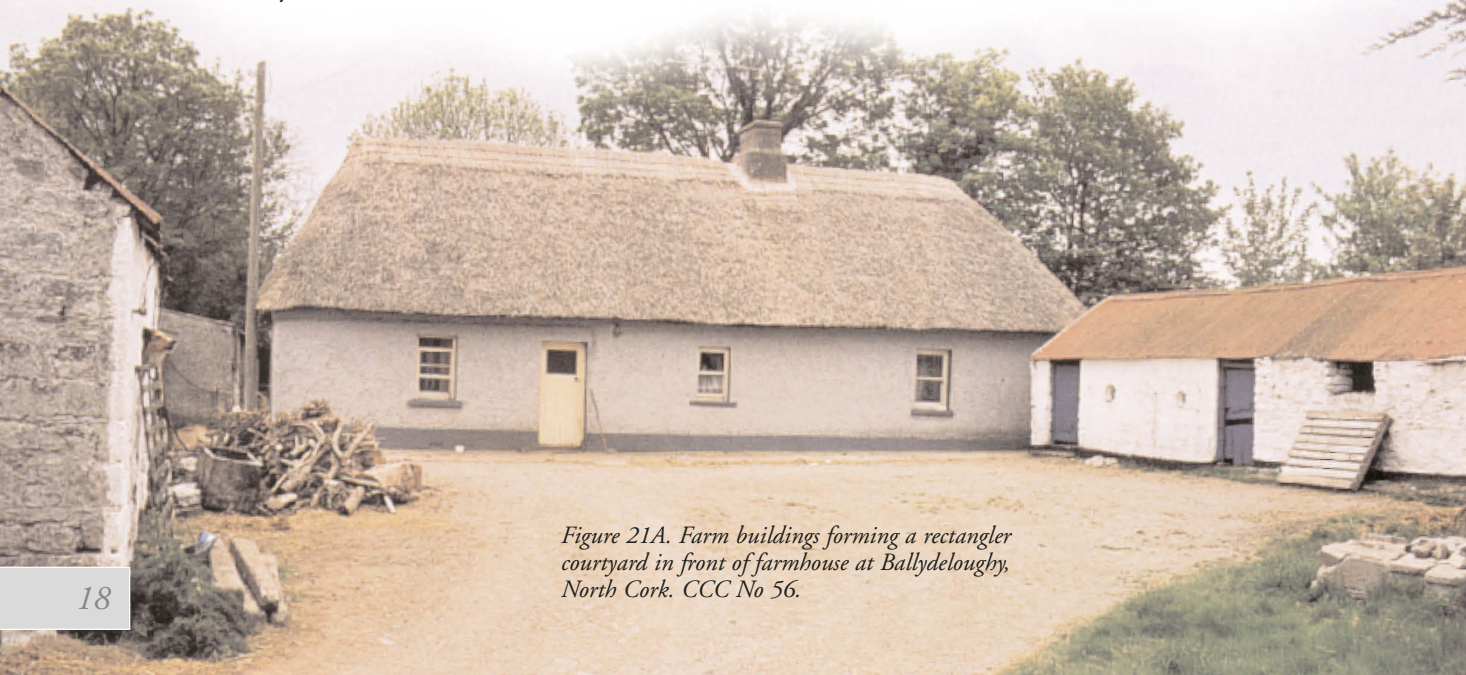
Figure 21A. Farm buildings forming a rectangular courtyard in front of farmhouse at Ballydeloughy, North Cork. CCC No 56.

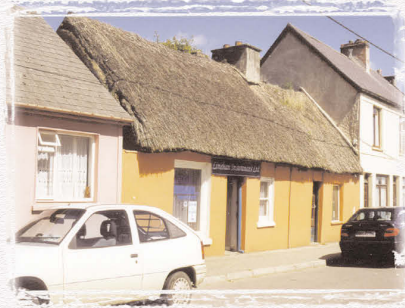
Figure 22. Thatched house in the streetline, Boherbue, North Cork. CCC No 190.

Thatched houses were once a common feature of towns and villages, both as part of the street line and scattered at the edge of the settlement. In North Cork two thatched houses still survive in a street line, in the villages of Boherbue (fig. 22) and Ballindangan. Somewhat more numerous are freestanding houses at the verge of village settlements. There are examples of the latter in the East Cork villages of Gyleen (fig. 23), Ballycotton (CCC No.228 & 229), Killeagh (CCC No. 217), Mountuniacke (CCC No. 218). A substantial number of houses with corrugated steel roofs covering the thatch did survive in most towns and villages in the county into the 1980s but these are now almost as scarce as the thatch.

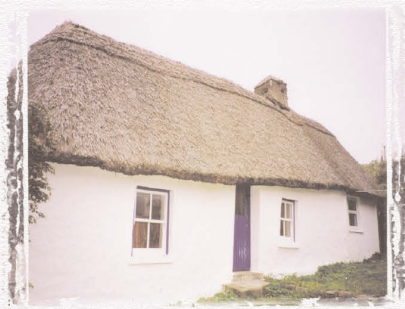
Figure 23. Thatched house at the edge of a village, Gyleen, East Cork. CCC No 224.

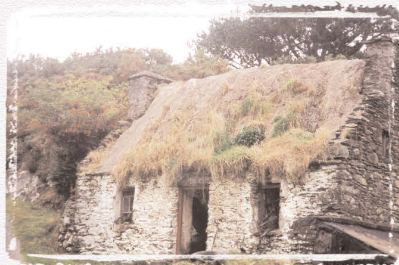
Figure 24. A rare example: the only recorded thatched house in West Cork, Coolieragh. CCC No 185.

The single remaining thatch in West Cork (CCC No. 185) is a small rectangular, one-storey gable-ended house with a loft, (fig. 24). It is a type that was once common in the coastal areas of West and South Cork, and similar buildings were noted on the Beara peninsula by Rosemary ffliott (1972, figs 3, 4 & 5). There is also evidence of them in the Ardfield/Rathbarry district near Clonakilty (Sleeman 1999-2000, 76) as well as in County Kerry (Ó Danachair 1975, 28). The West Cork house can also be compared with a number in East Cork, notably those at Knockadoon (CCC No. 168) and Gyleen (CCC No. 222).

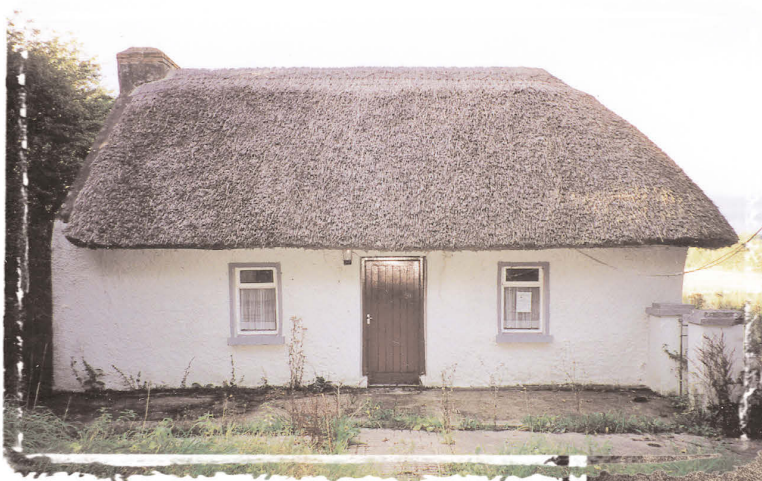
Figure 25. A rare example: a two-roomed thatched house, Ballywalter, near Shanballymore, North Cork. CCC No 79.

The once ubiquitous one- or two-roomed thatched 'cabin' has now almost entirely disappeared from the county. This reinforces the point made above that survival seems to be related to the relative prosperity of the house owner. The smallest of the few that do survive is at Ballywalter in North Cork, (fig. 25).

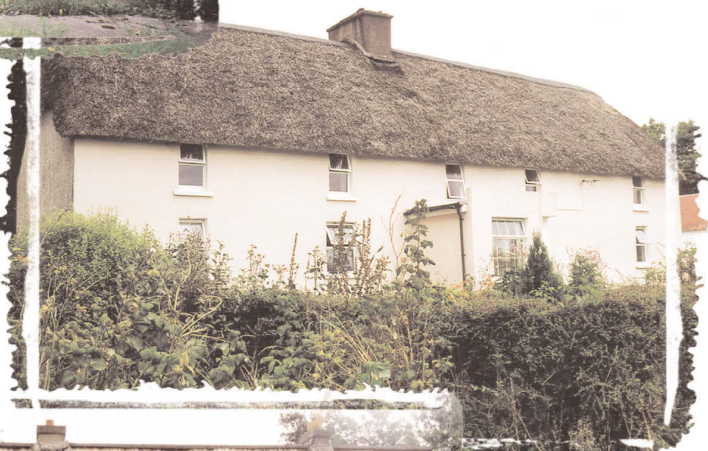
At the other end of the scale is the two-storey 'thatched mansion'. Four examples were recorded, all in north Cork. The substantial house at Curraheen, (fig.26), near Kanturk, is the only remaining example in good repair. Cloghanughera (CCC No. 14), near Charleville, lost its thatch in 1984, as did Fort William (No 76), near Doneraile (Grove White 1905-25, vol.3, opp. 320) at an earlier stage. The example at Ballysheehan, near Mallow, was intact in the late 1980s but is now a ruin (Sleeman et al. 1998), (fig's 18 & 28).

Figure 26. A rare example: a thatched mansion, Curraheen (near Kanturk), North Cork. CCC No 35.

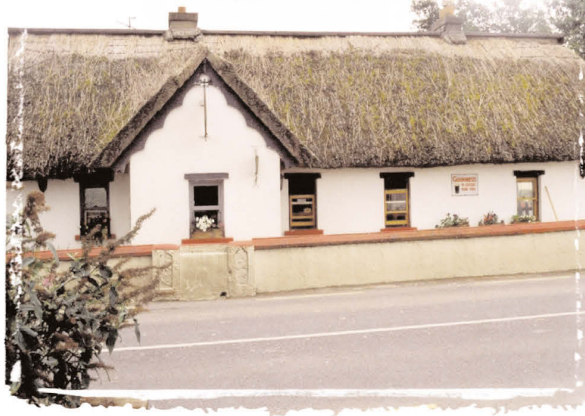
Figure 27. Thatch house in use as a public house, Dromina, North Cork. CCC No 187.

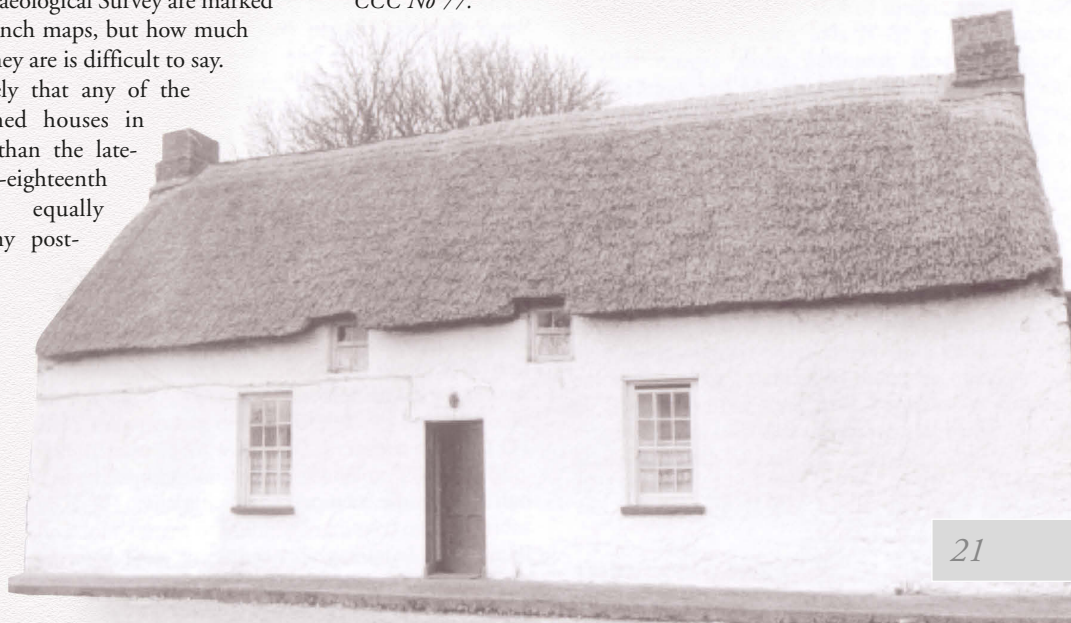
Figure 28. Ballysheehan thatched mansion near Mallow, North Cork (1984), before it fell into ruin (fig. 18). CCC No 77.

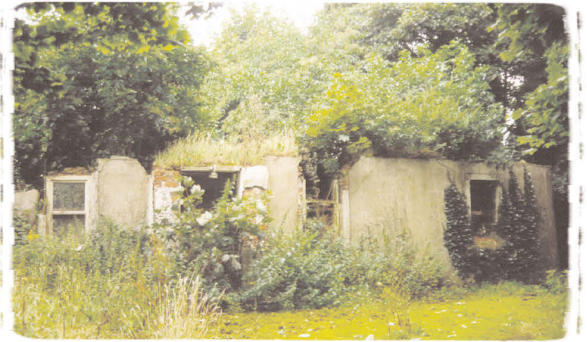
Figure 29. Thatched house in ruins, Farranshonikeen. CCC No 22.

The first obvious fact that emerges from these figures is that of the structures that were viable as traditional thatched houses in the mid-1980s, almost exactly 50% were still in that condition in 2001. The rest are either ruinous or have lost their thatched roof. The reasons why this is happening are discussed below, but what is clear is that to lose 50% of a building stock over fifteen years represents a serious and rapid decline. Given that the 2001 survey recorded a total of 93 houses in Excellent/Good condition, then it seems that at best there will be considerably less than fifty viable traditional thatched houses in the county by 2015 if nothing is done (fig's 29 & 30).

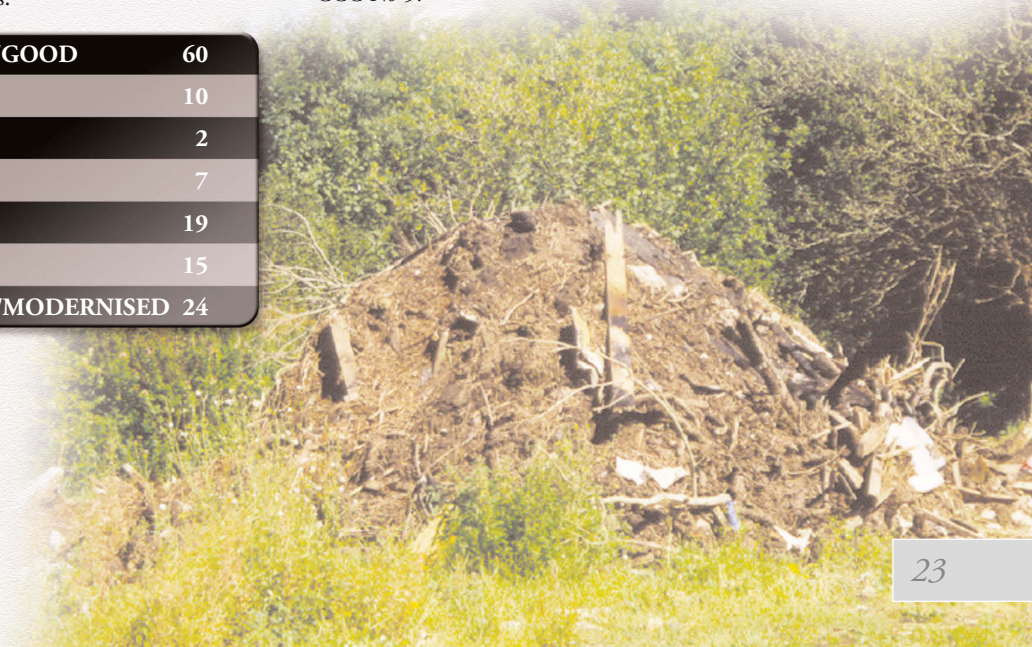
Figure 30. Disintegrated thatched house, Shandrum. CCC No 9.
