Mitchelstown Georgian Quarter Architectural Inventory and Assessment

October 2022

This report has been undertaken by James Bourke Architects as part of the proposed redevelopment of Mitchelstown's Georgian Quarter. The redevelopment project has been commissioned by Cork County Council. The design is being overseen by REDscape Design, and James Bourke Architects have been engaged on the project as conservation consultants for the design team. Our role is to identify any built fabric of particular historical significance within the site area of the Georgian Quarter, to provide a full record of these items, and to assess the conservation impact of the proposed works on the historic town.

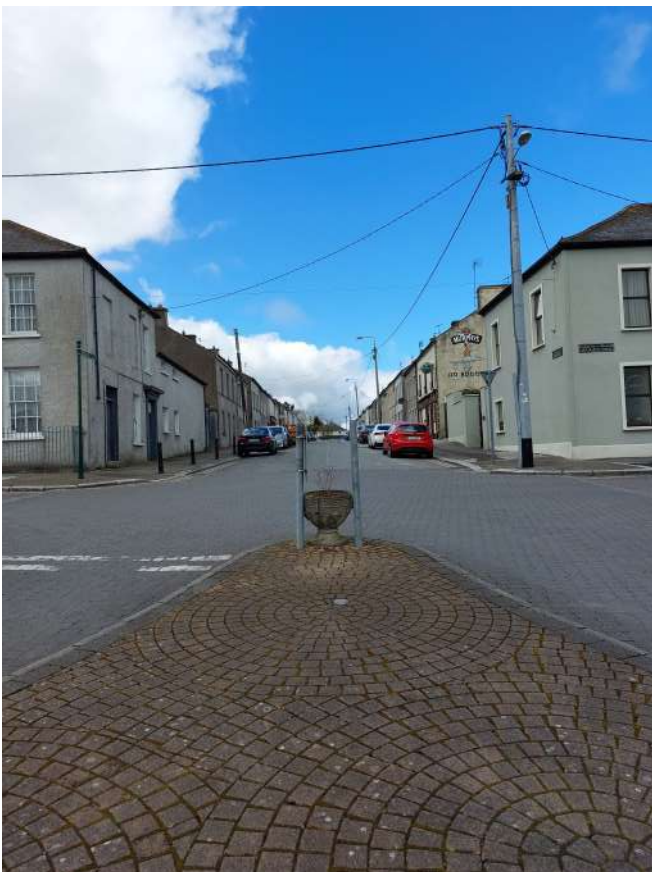
View of King Street facing west, from Market Square

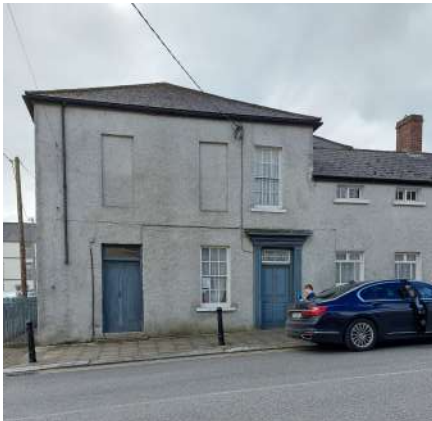
Reference A

It is noted on the NIAH record that *'The survival of limestone kerbs and paving in the vicinity also serves to enhance this building'*. The kerb in front of the house is generally intact, and as noted by the NIAH contributes to the overall character of the building. It is damaged locally, and the paving directly outside the house on King Street is concrete paving of low quality, with a manhole placed adjacent to the front door detracting visually from this historic element.

While this building is currently derelict, planning has recently been granted by Cork County Council for its restoration for use as a family home (planning ref 217163). The proposal does not significantly affect the external character of the building.

- Care should be taken to ensure that no historic fabric is damaged when undertaking the paving works. The limestone steps and doorcase should be retained and adequately protected as part of the works.
- Drainage should also be carefully considered to prevent possible water ponding adjacent to the building edge.
- If possible breathable external finishes should be used to this historic building.

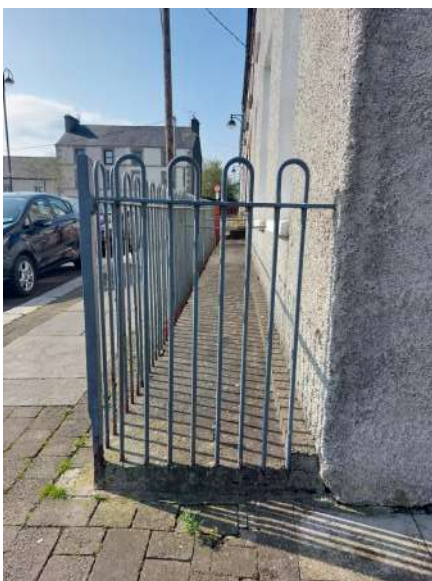
Record of Protected Structures ID No: 01089

Physical Impact: The laying of the new paths/ paving will be in directly adjacent to the building walls, and there is a risk of damage to the building walls/ stone steps and original doorcase.

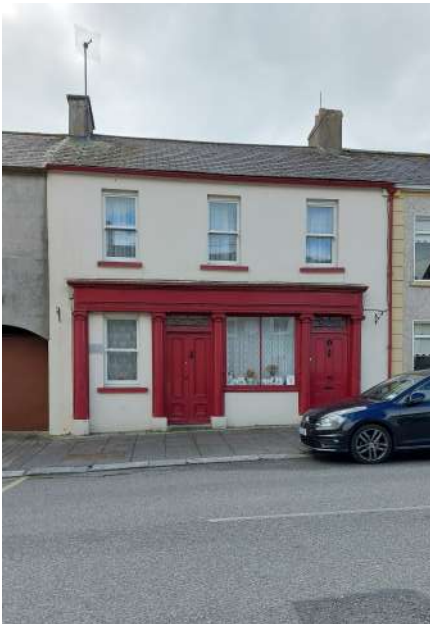
Reference B

It is noted on the NIAH record that *'This attractive house and shopfront...displays one of the finest shopfronts in the town, its neo-classical detailing with five ionic columns giving an elegance and grandeur to an otherwise simple and modest building. The retention of the fine timber panelled doors and decorative overlights, as well as its timber sliding sash windows, greatly enhances the building.'*

The fanlight to this building matches the one found to No.1 King street, and was presumably made by the same craftsman. The shopfront provides a sample of fine historic craftsmanship.

Physical Impact: The laying of the new paths/ paving will be in directly adjacent to the building walls, and there is a risk of damage to the building walls/ stone steps and original shopfront.

- Care should be taken to ensure that no historic fabric is damaged when undertaking the paving works. The limestone steps and shopfront should be retained and adequately protected as part of the works.
- Drainage should also be carefully considered to prevent possible water ponding adjacent to the building edge.
- If possible breathable external finishes should be used to this historic building.

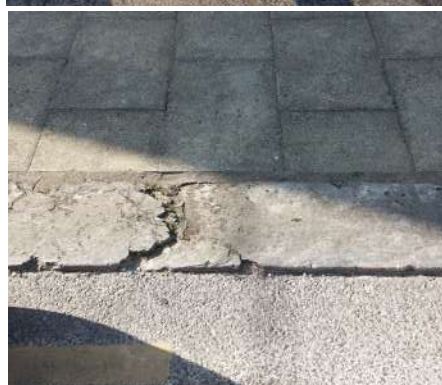
Reference 01A

1A: Section of kerb to south-east of street, to paths in front of numbers 1 to 3. Some damage was visible to the area in front of the front door of no.1.

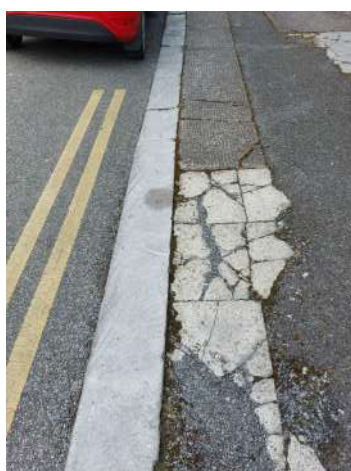
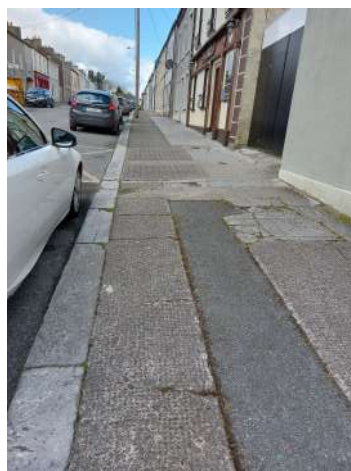
Reference 01D

1D: Section of kerb to south-west of street, to paths in front of numbers 12 and 13 and turning the corner onto Georges Street. This section of kerb is in reasonably good condition generally.

- Care should be taken to ensure that every possible care is taken to avoid damaging the kerbs in the process of moving them. A method statement for undertaking these works should be taken out in due course.
- Where feasible any kerbs which could be retained in situ as part of a detailed design should be (e.g. in sections at entrances to the gateways between the houses) This would allow the original layout of the street to remain legible.

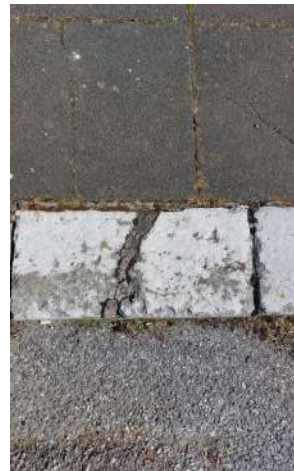
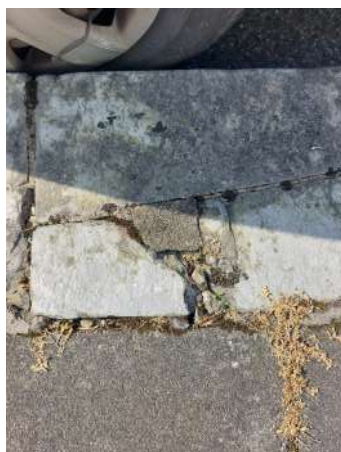
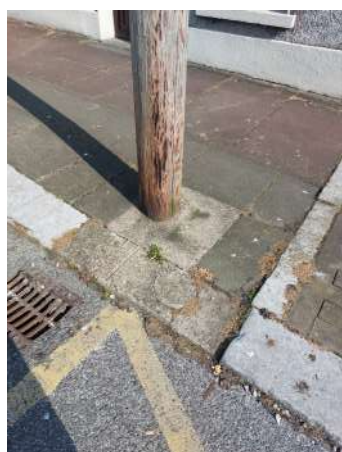
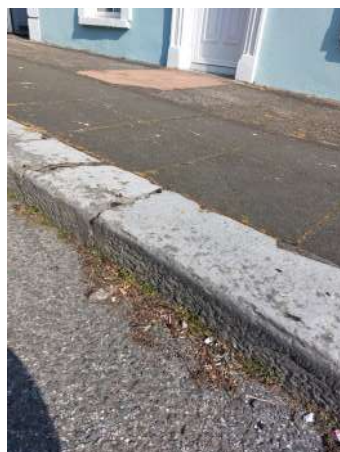
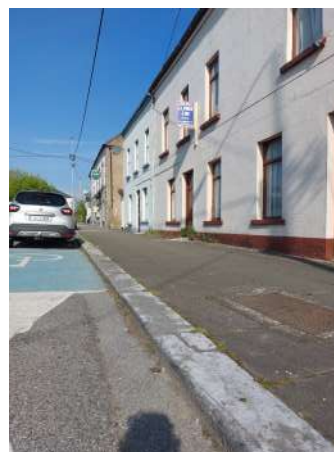
Reference 01E (top left to bottom right: : moving east to west)

1E: Section of kerb to north of the street, intact to almost full extent. Section at junction to Georges Street missing. Small section also missing in front of house 22 where a telegraph pole is present. The kerb is in a good condition generally, but cracking and damage is visible locally,.

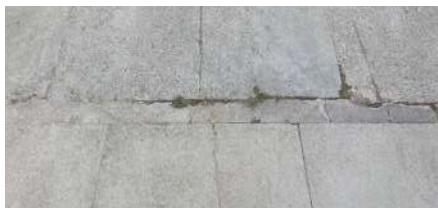
Reference 02A

The paving strips are approximately 150mm wide, with lengths varying. The distance from the houses to the kerb on the north side of the road is generally around 2.9m and the width between strips varies from 2.6-3.6m. They are in a reasonable condition generally, although some cracking was noted locally.

- A detailed design for the paving should be provided as part of the next phase of works. This should include details of the proposed new strips which are suitable for use in this historic context and highlight elements of original fabric being retained/ reused as part of the design
- Care should be taken to ensure that every possible care is taken to avoid damaging the steps in the process of paving the street. A method statement for undertaking these works should be taken out in due course.

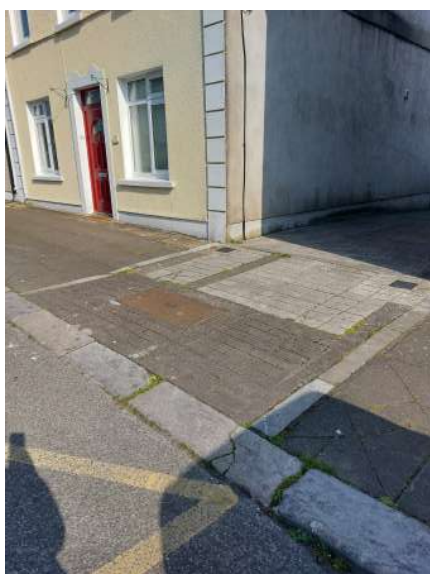
Reference 02C

2C: Paving strips to north side of street between numbers 18 and 19. One to either side of opening. 5 sections to the west which are laid unevenly but in good condition. 4 to the east, with the section closest to the road cracked and damaged.

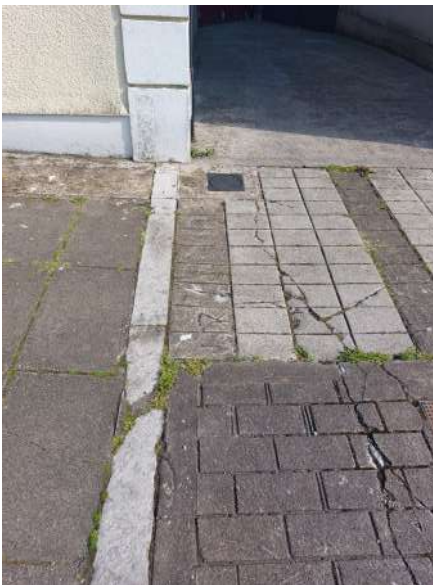
Reference 02D

2D: Paving strips to north side of street between numbers 20 and 21. One to either side of opening. 4 sections to the west which are in good condition. 3 to the east, with one large crack in the section closest to the road.

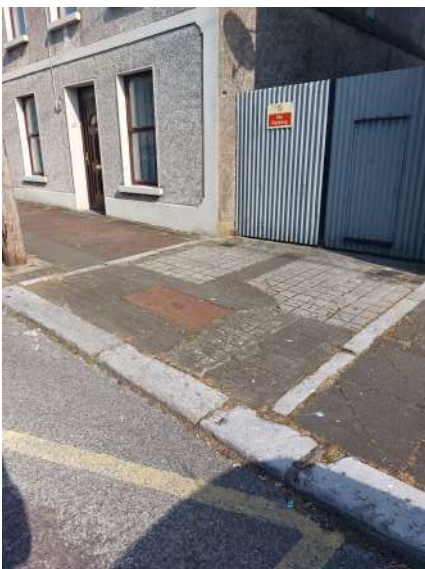
Reference 2E

2E: Paving strips to north side of street between numbers 22 and 23, one to either side of gate. 4 sections to the west and 3 to the east, all in reasonable condition.

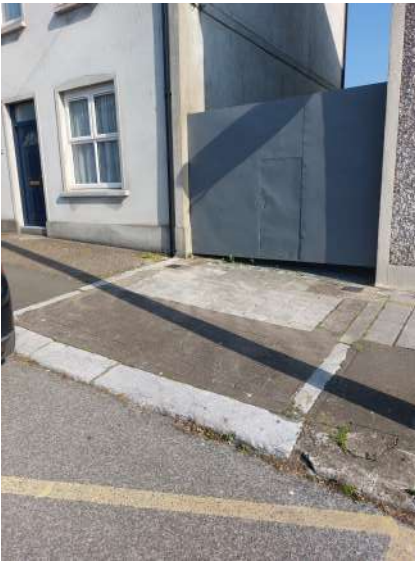
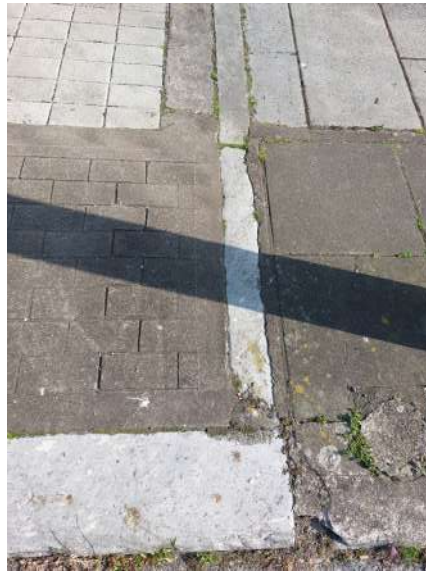
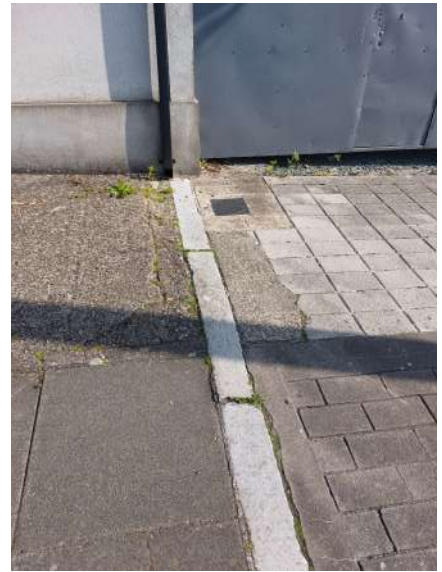
Reference 2F

2F: Paving strips to north side of street between numbers 27a and 28, one to either side of gate. 3 sections to the west and 3 to the east, in reasonable condition generally. Some damage visible adjacent to house number 28.

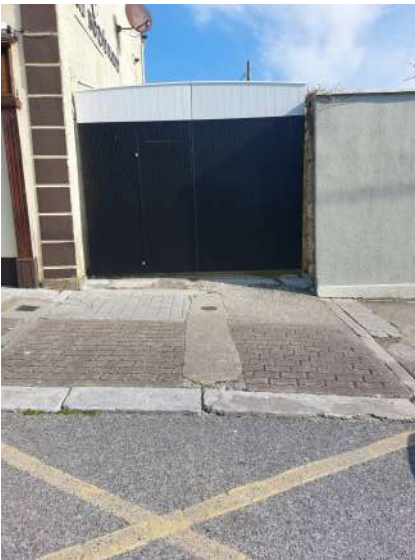
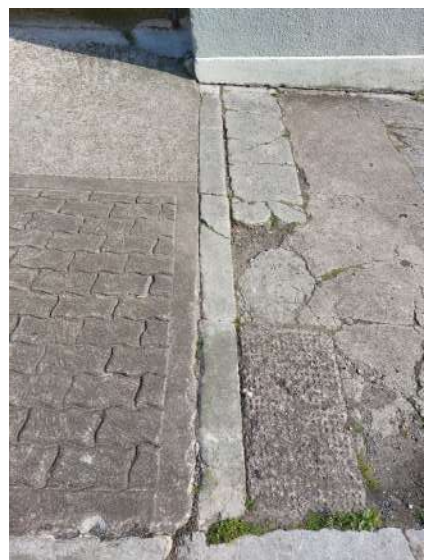
Reference 2G

2G: Paving strips to north side of street to east of number 29 (An Bodhron). One to either side of the gateway. The one to the east has minor cracking visible. The one to the west has a section missing where an access junction has been inserted.

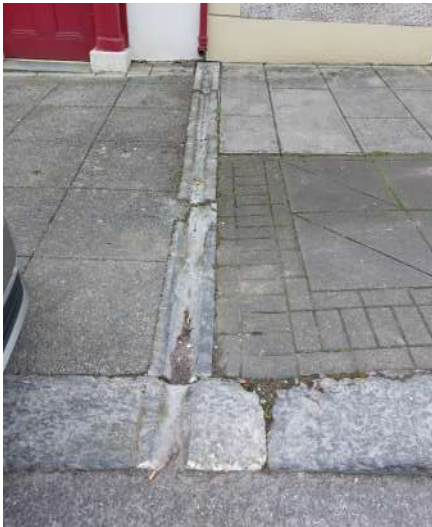
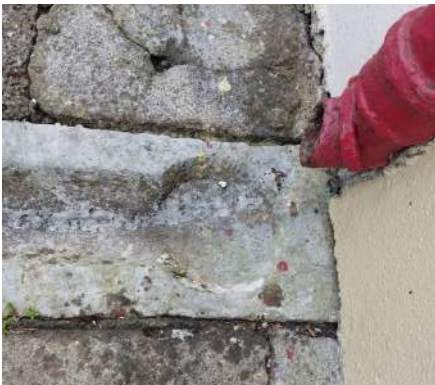
Reference 03A

3A: Gully to south side of street between numbers 6 and 7. 4 sections present, with some damage visible to the east edge of the section closest to the street. 1 cast iron downpipe discharges to the gully.

- Care should be taken to ensure that every possible care is taken to avoid damaging the gullies in the process of paving the street. A method statement for undertaking these works should be taken out in due course.
- A proposal should be put forward regarding the reuse of the off-cut sections of the gullies. It is noted that additional gullies are shown on the proposed drawings, and consideration could be given to forming new gullies using these offcut sections.

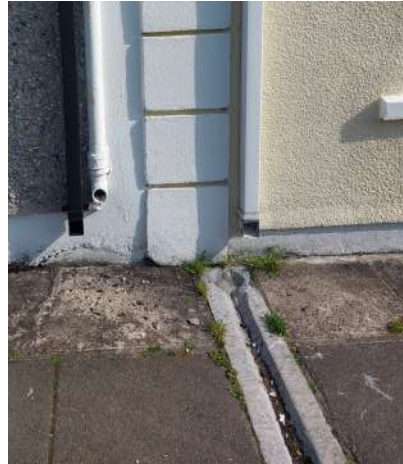
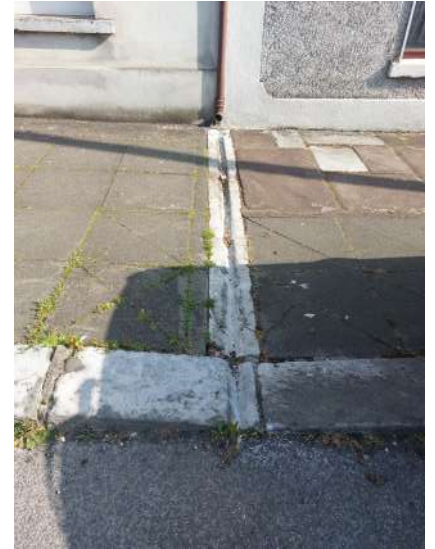
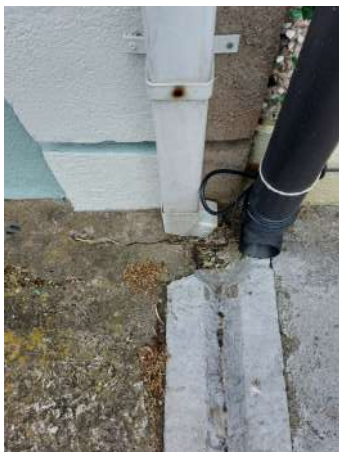
Reference 03E

3E: Gully to north side of street between numbers 23 and 24. 3 sections present, some damage visible to circular indent adjacent to houses. 2 PVC downpipes discharge to gully.

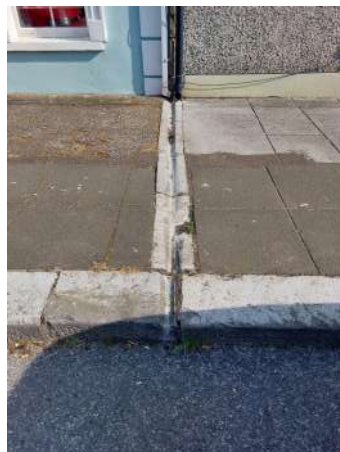
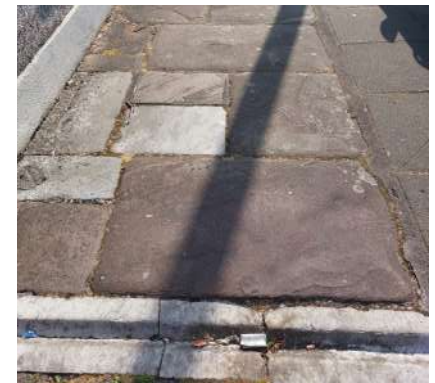
Reference 03D

3D: Gully to north side of street between numbers 21 and 22. 3 sections present, all in good condition. One cast iron downpipe discharges to gully. Stone paving to east of gully enhances its gully (see reference 5).

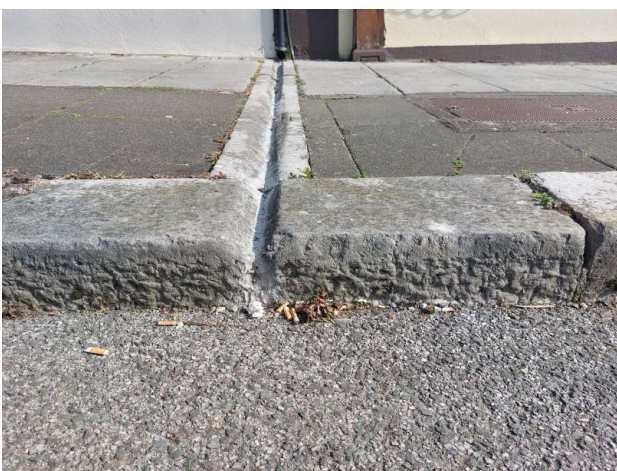
Reference 03F

3F: Gully to north side of street between numbers 28 and 29. 2 sections present, in good condition. 1 PVC downpipe discharges to gully.

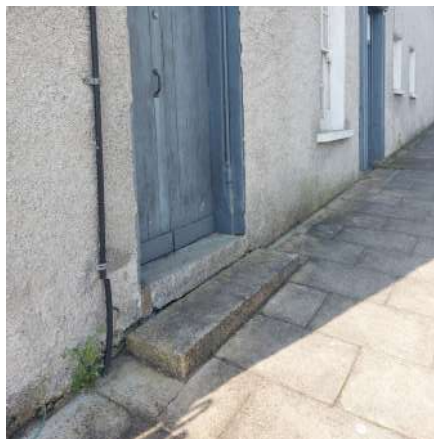
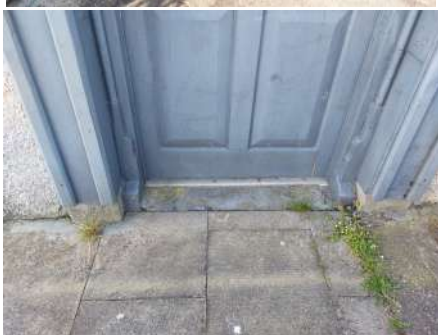
Reference 04A

Description: Steps/ level thresholds in limestone generally. These vary in size to suit the relevant door opening. All appeared to be in good condition.

- Care should be taken to ensure that every possible care is taken to avoid damaging the thresholds in the process of paving the street. A method statement for undertaking these works should be provided in due course.

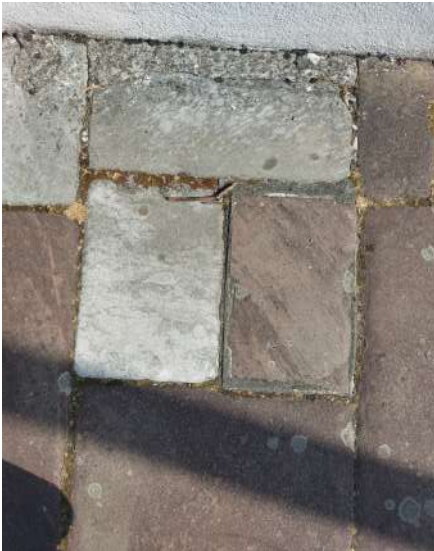
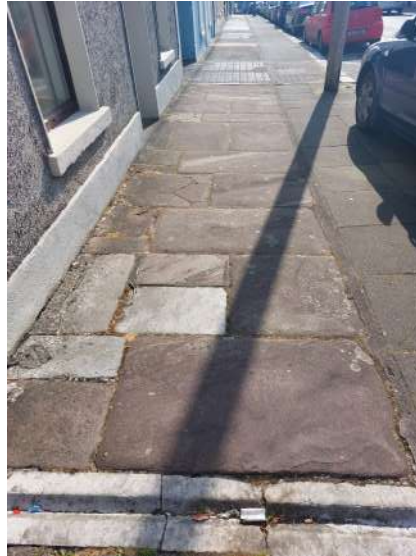
Note however that the proposed layout shows the larger paving slabs central on the pathway, with smaller paving units adjacent to the houses. This is contrary to the layout found in front of house 22, which has the large paving slabs of particular historical interest directly adjacent to the house. This was the threshold area traditionally in the control of the owner of the house, and historically the treatment of these areas would have varied between houses.

- These slabs should be either retained in situ or re-laid as part of the proposed paving layout. A detailed design for this should be provided as part of the next phase of works.
- Care should be taken to ensure that every possible care is taken to avoid damaging the paving slabs in the process of paving the street. A method statement for undertaking these works should be taken out in due course.

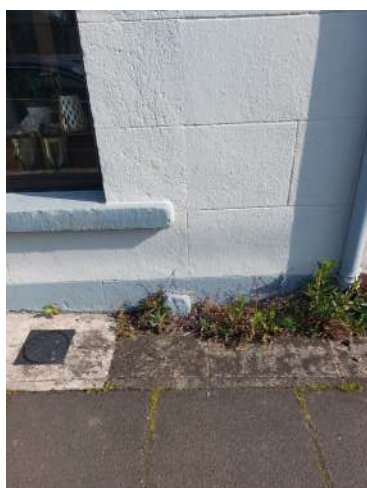
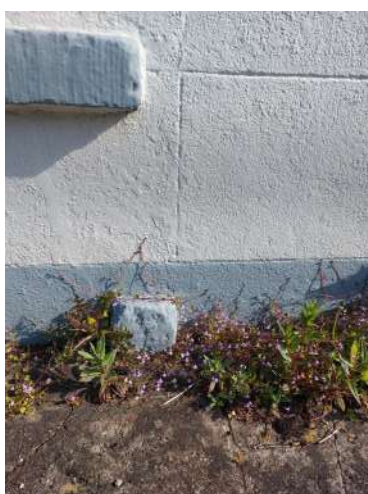
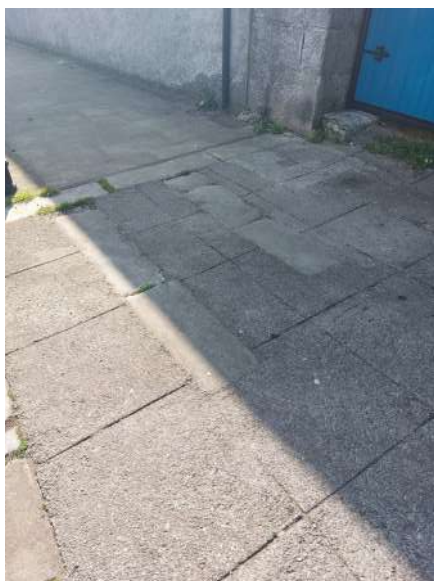
Physical Impact: The laying of the new paths/ paving will be in directly adjacent to the historic fabric, and there is a risk of damage to the corbels.

- Care should be taken to ensure that every possible care is taken to avoid damaging the corbels in the process of paving the street. A method statement for undertaking these works should be provided in due course.

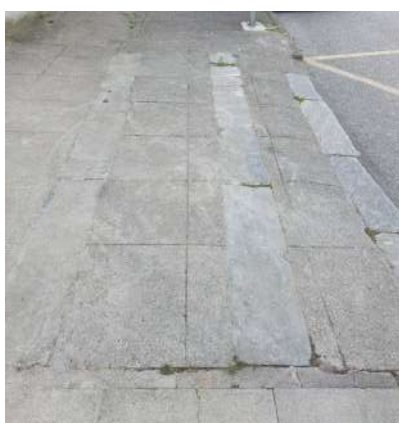
Reference 7B

7B: 2 strips to full length of opening in good condition generally.

- Care should be taken to ensure that every possible care is taken to avoid damaging the paving slabs in the process of paving the street. A method statement for undertaking these works should be taken out in due course.
- Consideration could be given to reinterpreting these strips in a more modern manner as part of the detailed paving design in the future.

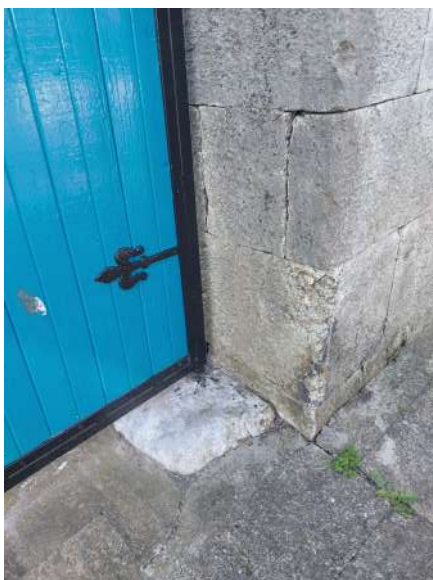
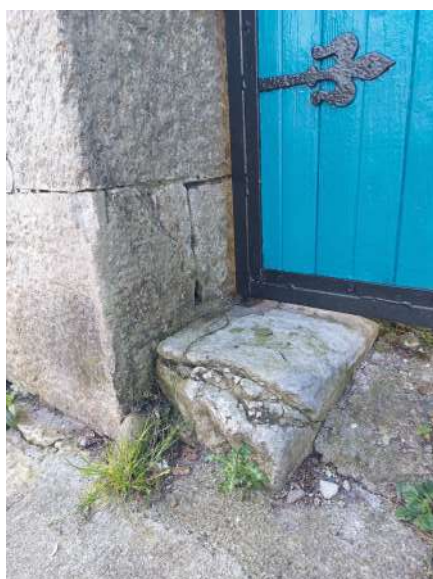
Physical Impact: The laying of the new paths/ paving will be in directly adjacent to the historic fabric, and there is a risk of damage to the building walls/ stone steps

- Care should be taken to ensure that every possible care is taken to avoid damaging the piers/ gateposts in the process of paving the street. A method statement for undertaking these works should be provided in due course.

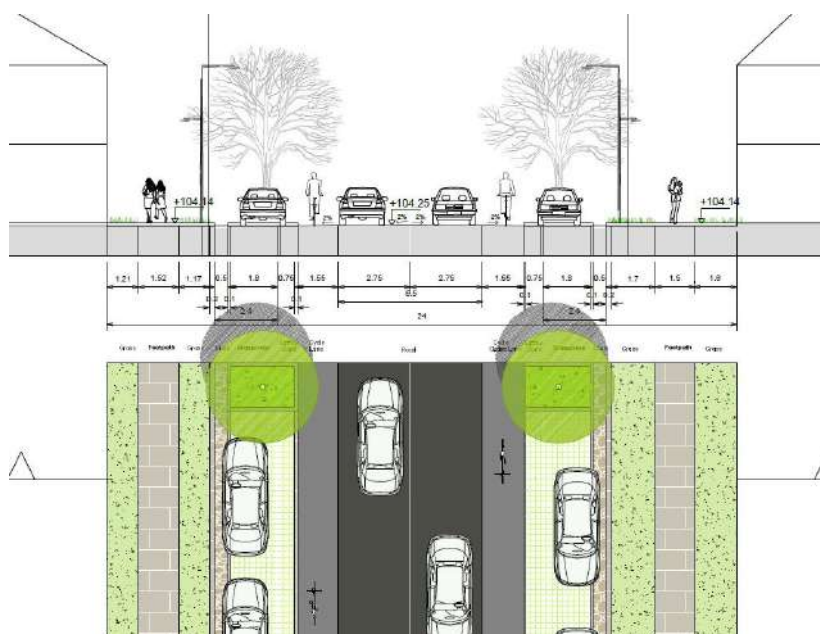
Relatively few alterations are proposed towards the north of the street, with the existing open drains, trees, kerbs, grass verges, and location of pathways being generally retained. The main north-south axis and vistas are retained. The proposal is based on the original street layouts and will significantly enhance the character of the street. It is noted that proposed drawings currently do not include details of a number of items of historical interest, but it is assumed that these items could be retained or reused as part of the detailed design.

Proposed layout to south end of street © REDscape

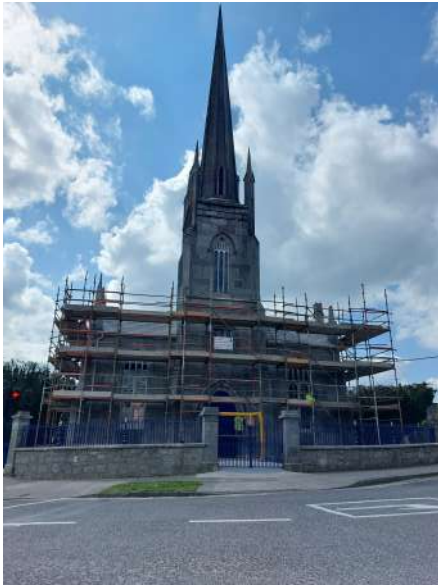
Reference C

St. George's Arts and Heritage Centre.

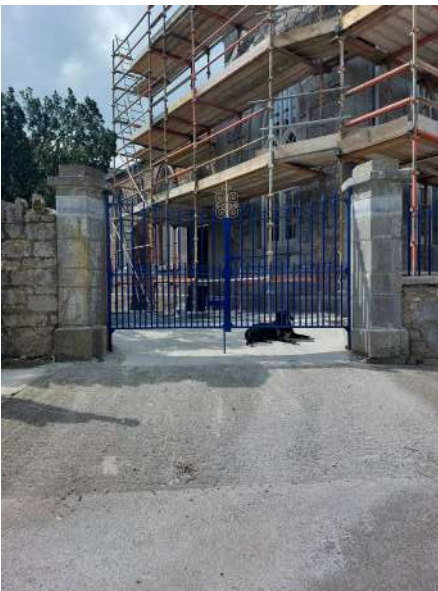
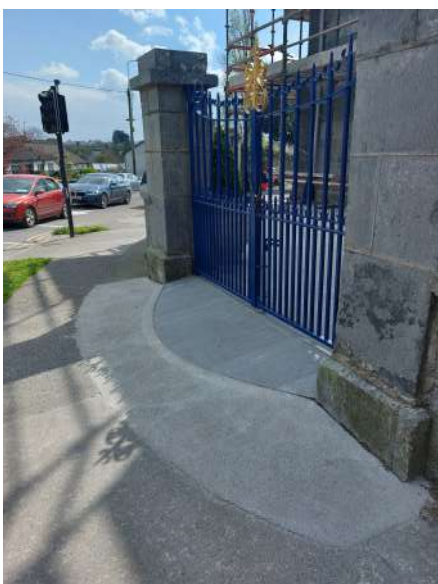
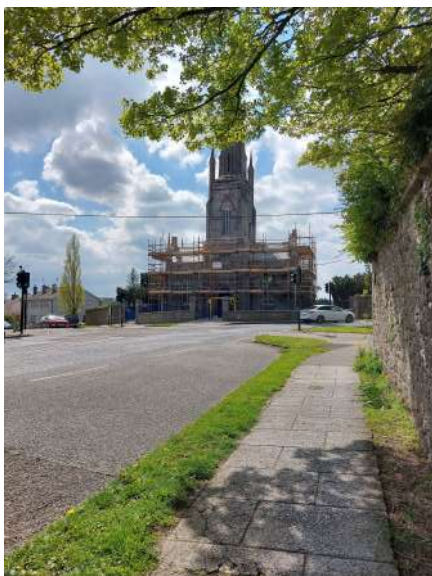
Reference C

Visual Adjacencies: The existing paving adjacent to the stone walls in front of the building is concrete and is cracked in places. The introduction of a new surface treatment to the paths will impact visually on the existing situation. This has the potential to be a positive impact, subject to a finish appropriate to the historic location being selected.

Physical Impact: The laying of the new paths/ paving will be in directly adjacent to the building walls, and there is a risk of damage to the building walls/ stone steps and original doorcase.

- Care should be taken to ensure that no historic fabric is damaged when undertaking the paving works. The rubblestone boundary wall should be retained and adequately protected as part of the works.

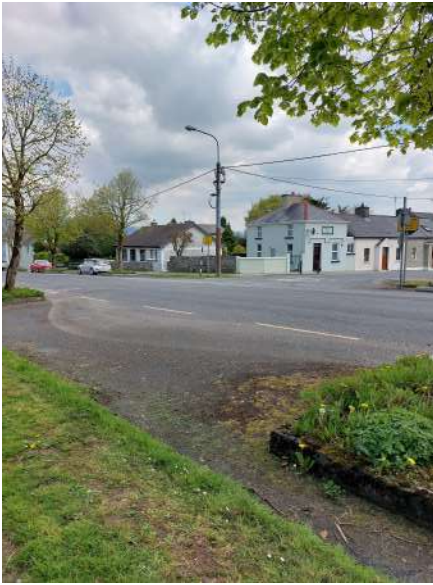
Reference D

16 James Street

Visual Adjacencies: The introduction of a new surface treatments and green areas will impact visually on the existing situation to the side elevation of the building (facing Georges Street). This is anticipated to be a positive impact and will be an improvement on the existing condition generally.

Physical Impact: As the building is set back from Georges Street no significant physical impact is anticipated.

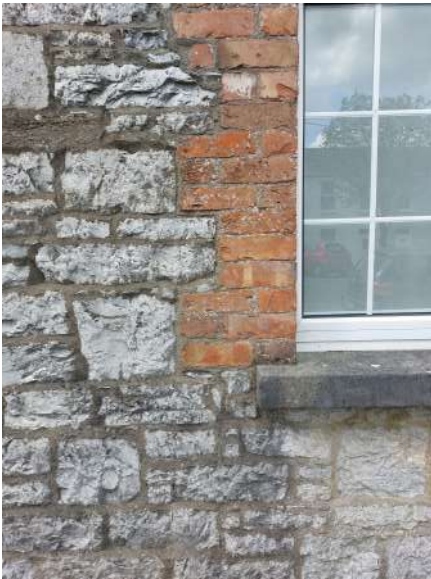
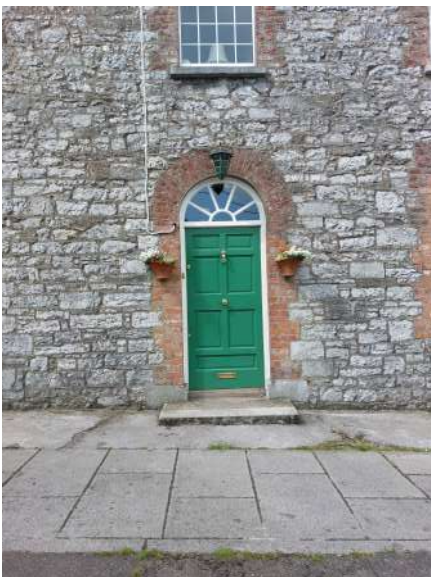
Reference E

Former School

Visual Adjacencies: The introduction of new surface treatments and green areas will impact visually on the existing situation to the front of the building. This is anticipated to be a positive impact and will be an improvement on the existing condition generally.

Physical Impact: The laying of the new paths/ paving will be directly adjacent to the building walls, and there is a risk of damage to the building walls/ threshold.

- Care should be taken to ensure that no historic fabric is damaged when undertaking the paving works. The rubblestone boundary wall should be retained and adequately protected as part of the works.
- Drainage should also be carefully considered to prevent possible water ponding adjacent to the building edge.

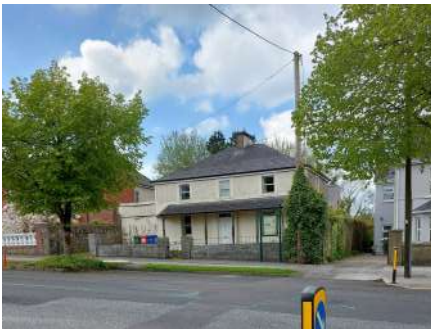
Reference F

Former Bridewell

The walls are rendered. Render is plain to the ground floor with a roughcast finish to the upper floor and plain moulded render surrounds to the windows. The windows are square headed with replacement pvc windows present. The front door is also pvc.

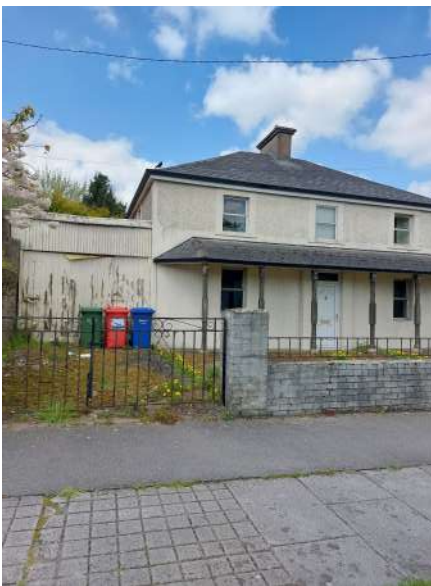
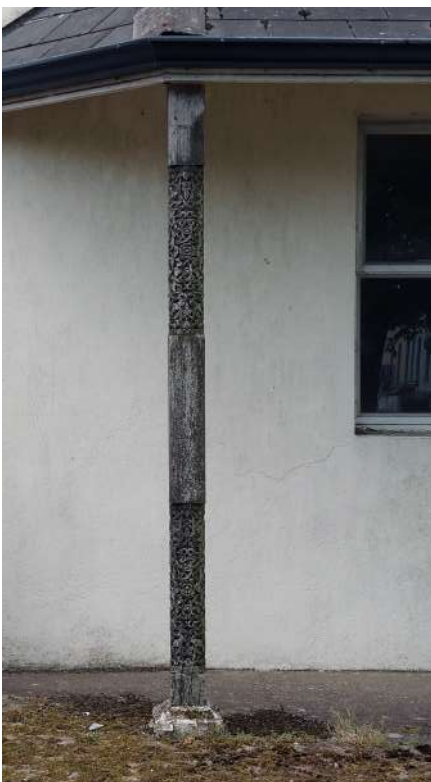
Reference F

Visual Adjacencies: The introduction of a new surface treatments and green areas will impact visually on the existing situation to the front of the building. This is anticipated to be a positive impact and will be an improvement on the existing condition generally.

The introduction of trees will also have a visual impact on the building. It is noted that the area in front of this building is of particular significance as it terminates the east-west axis of King Street. The introduction of a tree in front of this building is therefore deemed to of relatively high impact. However, the building and front yard is in need of repair and has an air of neglect to it at present, which lessens its presence on the street and contribution to built environment.

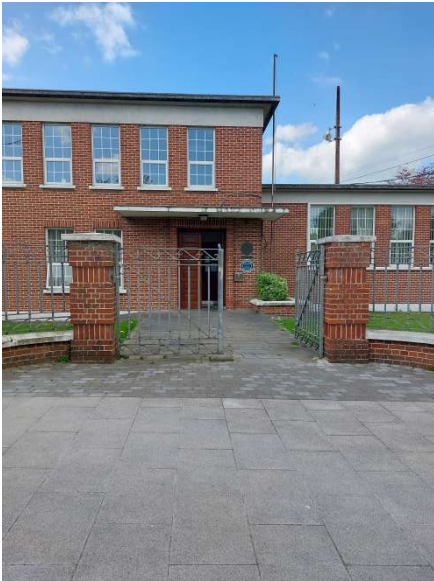
Reference G

Visual Adjacencies: The introduction of a new surface treatments and green areas will impact visually on the existing situation to the front of the building. This is anticipated to be a positive impact and will be an improvement on the existing condition generally. Further consideration could be given to mark this as a public accessibly building in the design of the paving/ streetscape.

The introduction of trees will also have a visual impact on the building, making it slightly less visible.

Physical Impact: The laying of the new paths/ paving will be in directly adjacent to the boundary, and there is a risk of damage to the building walls/ threshold.

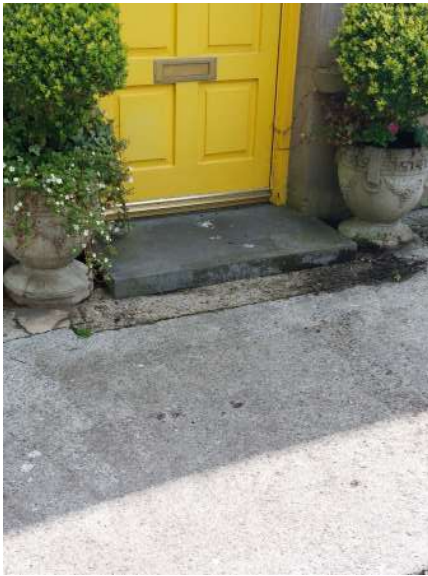
Reference H

Visual Adjacencies: The introduction of a new surface treatments and green areas will impact visually on the existing situation to the front of the building. The proposal is not radically different from the existing situation, and is anticipated to be a positive impact and will be an improvement on the existing condition generally.

Physical Impact: It is proposed to remove the existing concrete path adjacent to the building/ boundary walls and grass this area. There is a risk of damage to the building walls/ threshold over the course of this work.

Recommended Mitigation Measures:

- Care should be taken to ensure that no historic fabric is damaged when undertaking the paving works. The rubblestone boundary wall should be retained and adequately protected as part of the works.

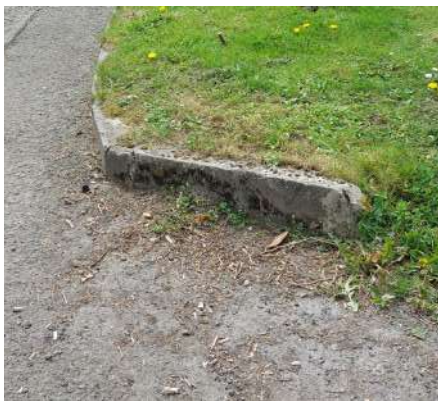
Reference 01

Limestone Kerbing

Physical Impact: The lifting and relaying of the kerb is of notable impact to the historic fabric and there is a n associated high risk of damage or loss of original building fabric.

Recommended Mitigation Measures:

- Care should be taken to ensure that every possible care is taken to avoid damaging the kerbs in the process of moving them. A method statement for undertaking these works should be taken out in due course.

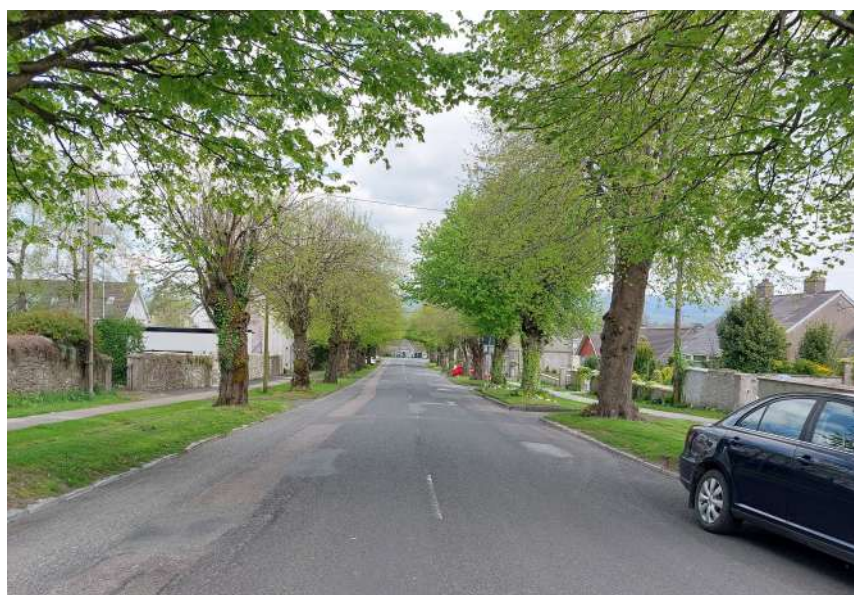
General view of Kerbing toward north of Georges Street

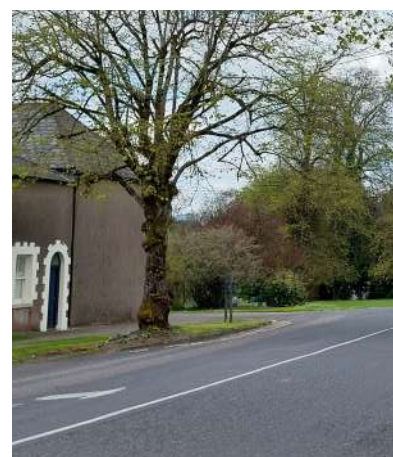
Reference 1Q

1Q: Section of kerb to west side of street, just south of King Square

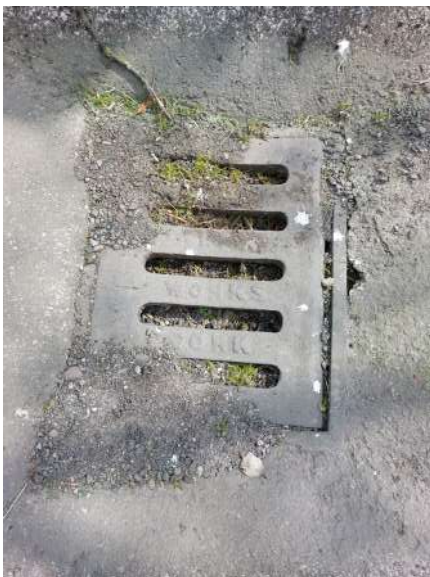
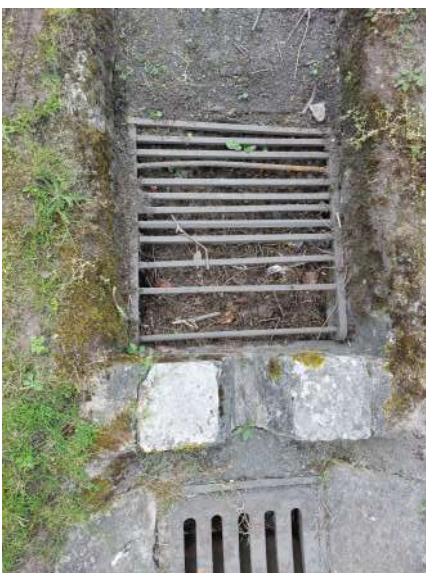
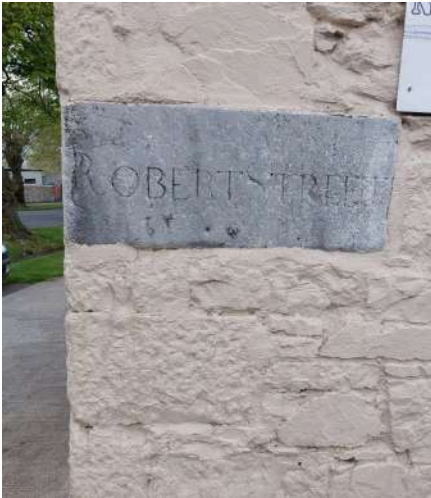
Reference 14

Limestone Plaque

No significant impact anticipated

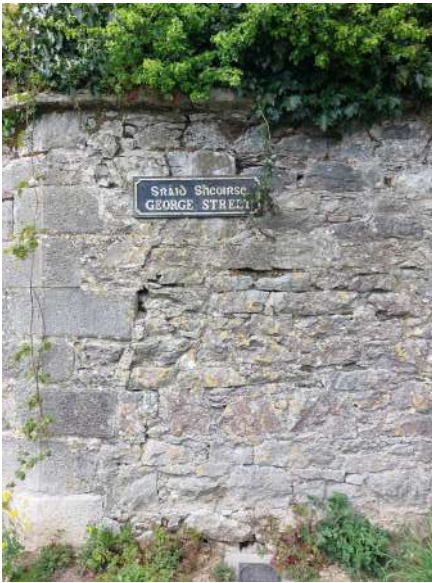
Reference 15 (a)

Metal Street Sign

No significant impact anticipated

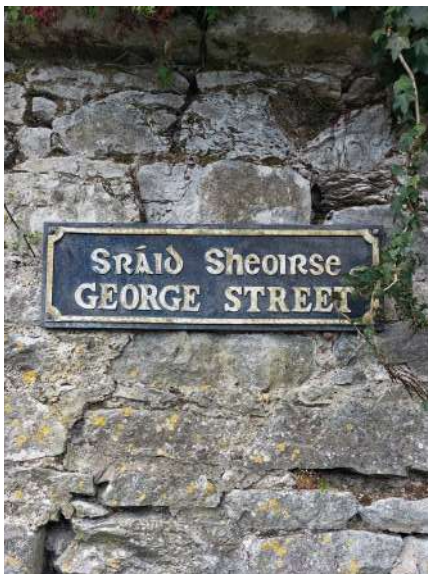
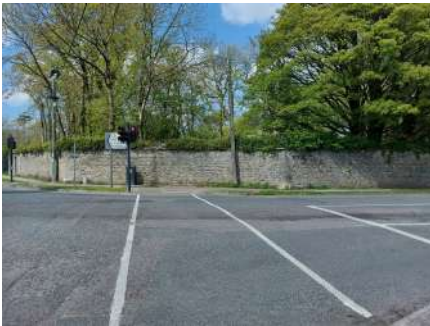
Reference 16 (a)

Demense Walls

Physical Impact: It is proposed to remove the existing concrete path adjacent to the walls and grass this area. There is a risk of damage to the walls over the course of this work.

- Care should be taken to ensure that no historic fabric is damaged when undertaking the paving works. The rubblestone boundary wall should be retained and adequately protected as part of the works.

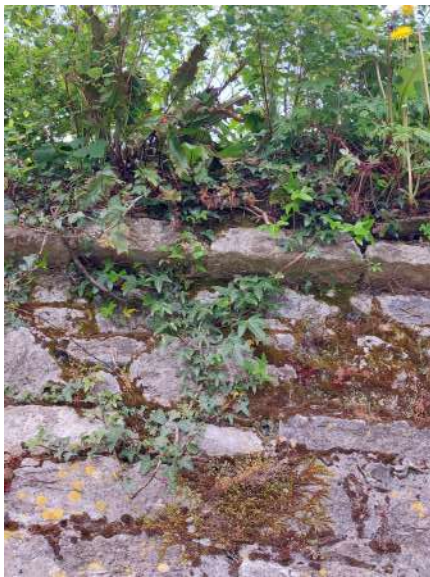
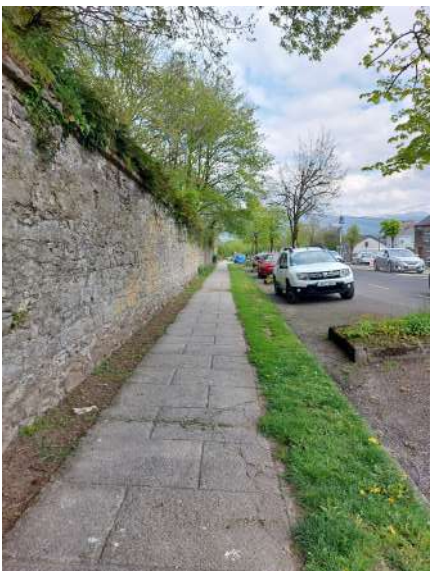
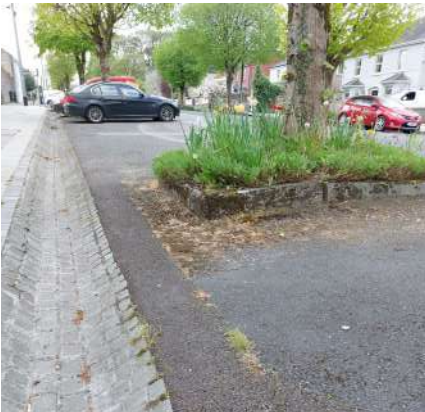
Reference 17

Open Drain

- While the majority of the drains have a concrete finish of limited value, where original cobbles are present these should be protected (see item 12).
- The selected finish of the drains should reference the original cobble finish throughout.

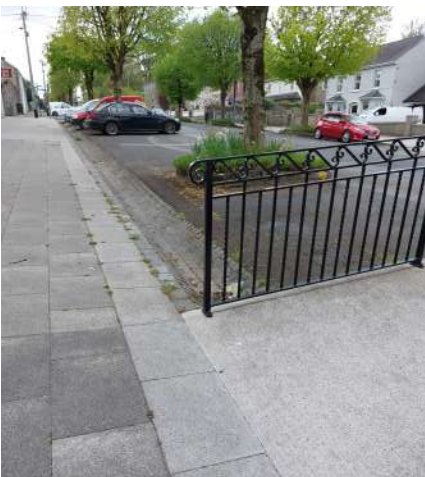
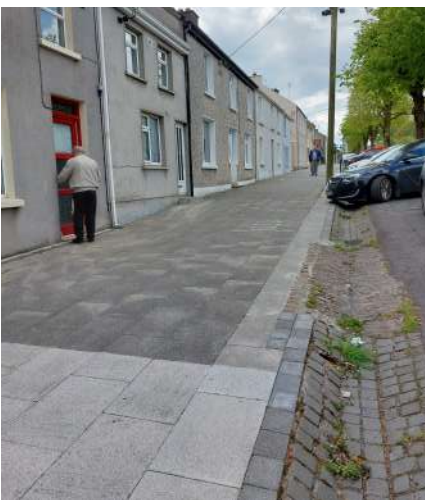
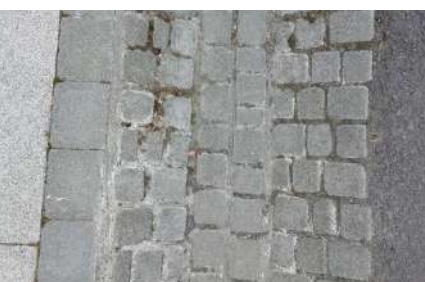
Reference 17A

17A Sections of open drain running to east side of Georges Street from King Street to Robert Street. This section is a replacement following the precedent of the original design, with small modern concrete paving slabs referencing the previous cobblestones. A cobblestone section does survive as previously described (reference 12A). There are some issues with accessibility, and a concrete section with metal railings bridges the open drain locally to allow for access across it.

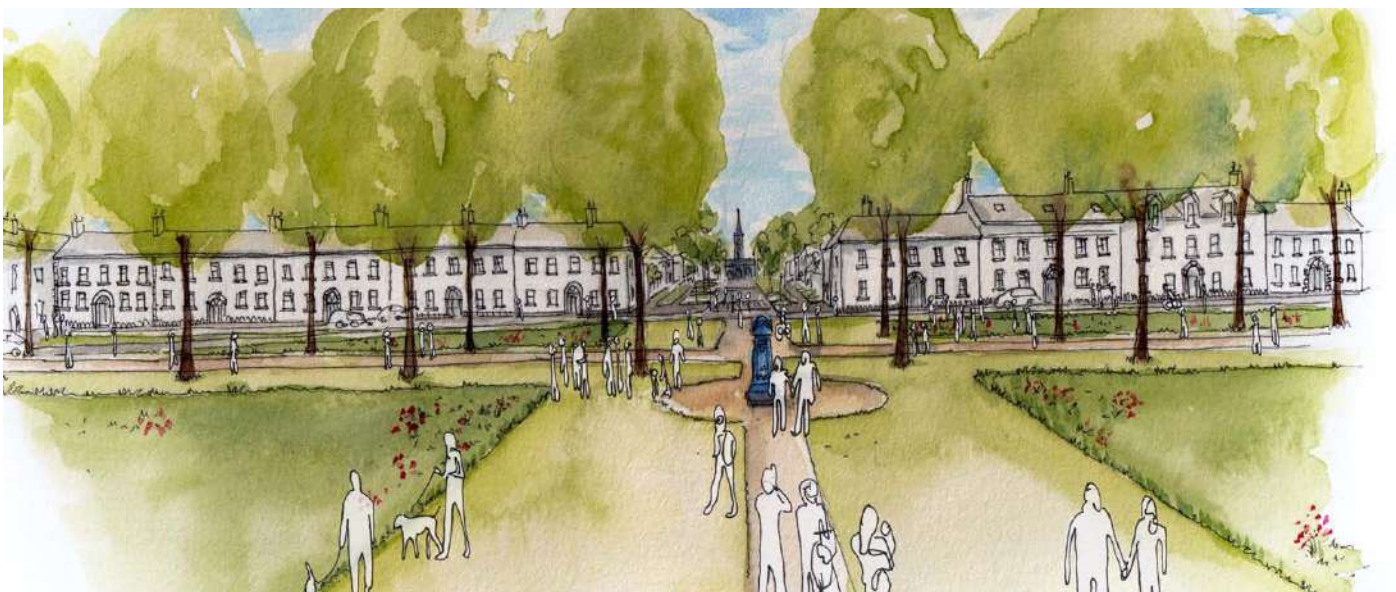
Initial Sketch Proposal © REDscape

It is proposed to install a simple chain fence to the edge of the square. This will serve to define the edge of the space while still retaining the open feel of the square and the proposal is thought to be appropriate to the historic context of the square. The proposed resurfacing of the paths and roads will have very limited impact as very little of the original fabric to these areas remains. Care should be taken to ensure that no walls of existing buildings are damaged when undertaking this works, and that existing railings, boundary walls, and stone thresholds and steps in the area are adequately protected. Care should also be taken to select finishes in keeping with this historical context.

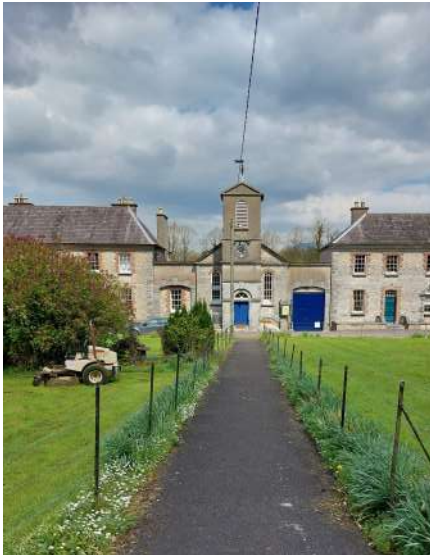
The houses were subdivided in the 1890s, and there are now 31 dwellings incorporated in the complex. There is external evidence of the subdivision, and the overall character of the building is shaped by the impression of changing use over time and a patina of age. The buildings are two storey over basement houses with pitched slate roofs with hips to the ends. There are low rendered walls, sometimes topped by iron railings, several feet from the front of the buildings, access to which is often gained by a couple of steps and a small bridge.

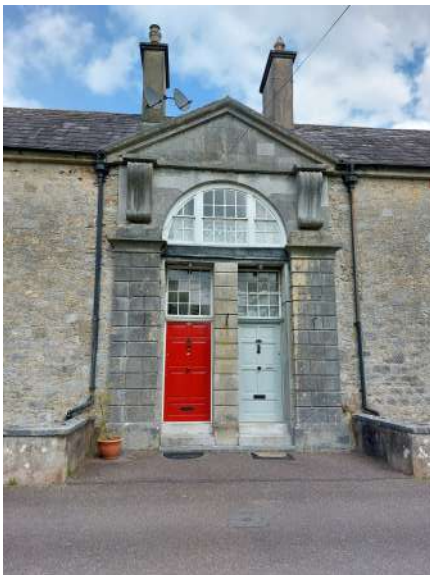
The walls are rendered coursed stone with red brick detailing around the windows. The houses include fine detailing such as stone quoins, round topped blind brick niches, brick window-cases filled in with rubble, timber sliding sash windows, and timber panel front doors. While some joinery appears to consist of replacement sections, much of the joinery appears to be original. The middle of the ranges to the east and west of the chapel are broken by the incorporation of two-storey pedimented stone breakfronts with piers topped by corbels and a Diocletian window below the pediment: the lower section is then split to provide admission to two houses. The houses to either side of the chapel incorporate cut limestone Gibbsian doorcases, and the one to the east has been subdivided to form a window.

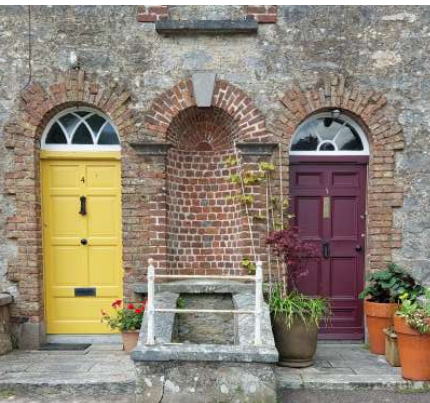
Kingston college is centred around the chapel, a pedimented building with projecting three stage entrance tower. Walls to the tower are lined and ruled on the upper levels and cut tooled limestone walls to lowest stage. There is a clock to the middle stage and louvered arched headed opening with keystone details above. The tower incorporates cut limestone string courses to each of the stages. There is a weather vane to the top of the tower. The tower is flanked by a slightly recessed gables to the east and west which have coursed stone walls with carved limestone eaves and string course and a round headed window opening with brick detailing. There is a segmental-headed carriage arch opening to the east with cut limestone voussoirs and jambs and moulded limestone parapet above.

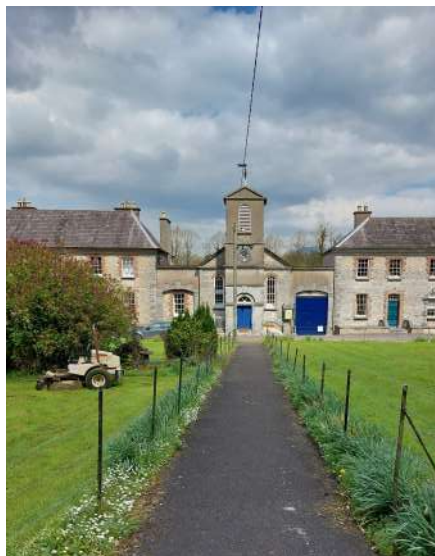
There are cut limestone steps up to the chapel to ground floor level, with a square-headed door opening to tower with cut limestone surround, projecting keystone, spoked timber fanlight and double-leaf timber panelled doors. There are secondary timber doors to either side of the tower, facing east and west. The Kingston Vault, in the crypt underneath the chapel, is the final resting place of members of the King (Earls of Kingston) family.
