Mitchelstown Georgian Quarter Architectural Inventory and Assessment

October 2022

This report has been undertaken by James Bourke Architects as part of the proposed redevelopment of Mitchelstown's Georgian Quarter. The redevelopment project has been commissioned by Cork County Council. The design is being overseen by REDscape Design, and James Bourke Architects have been engaged on the project as conservation consultants for the design team. Our role is to identify any built fabric of particular historical significance within the site area of the Georgian Quarter, to provide a full record of these items, and to assess the conservation impact of the proposed works on the historic town.

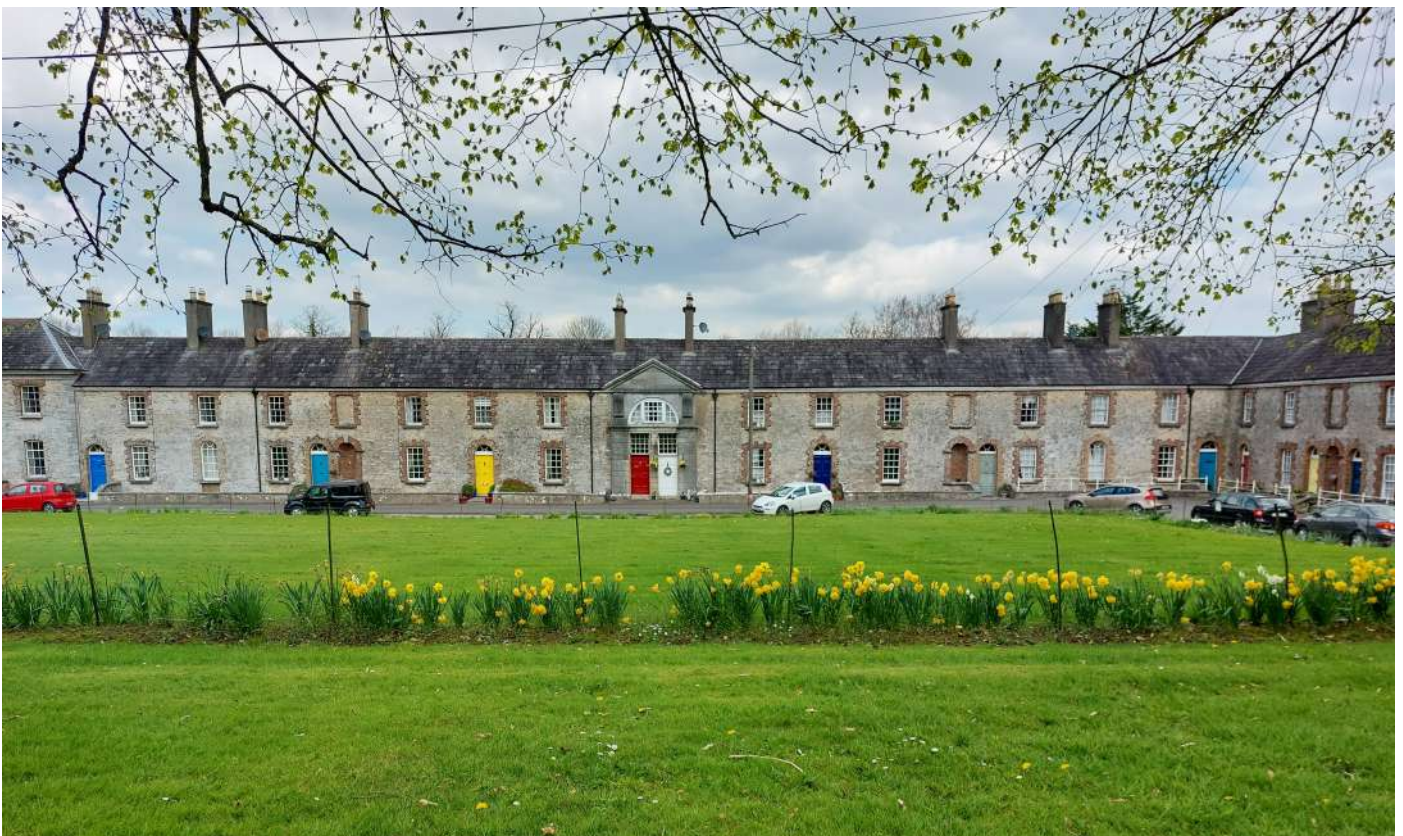
Reference I

Kingston College

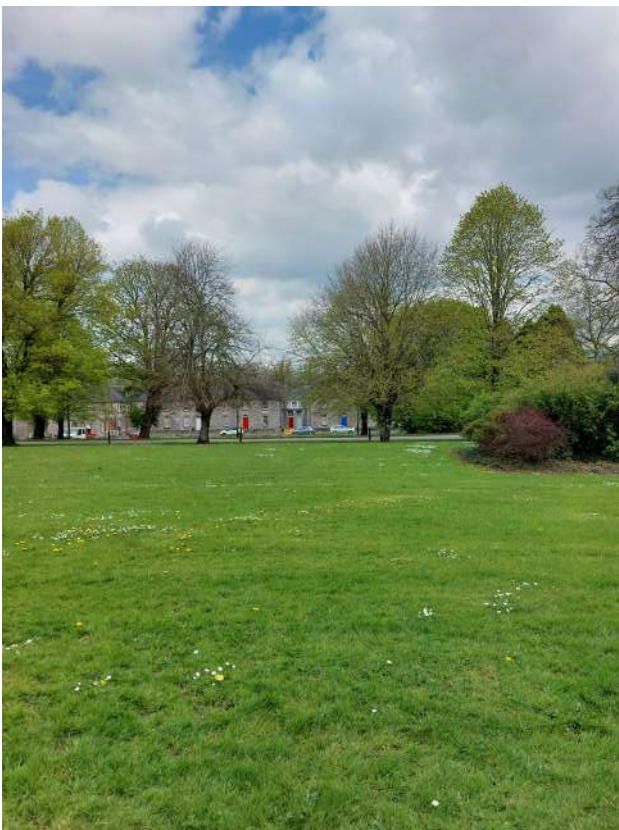
Visual Adjacencies: In general the proposed works have a limited visual impact on the buildings of Kingston College. The north-south vista from George's street terminating in the chapel is maintained as part of the works. It is not proposed to build any new structures or plant any new trees which would alter the existing views in the square, with the existing square being maintained as an open green space.

The existing pathways and paving adjacent to the houses of Kingston College consists of a plain tarmac roadway. The introduction of a new surface treatment will be an improvement visually on the existing situation, subject to a finish appropriate to its historic location being selected.

Physical Impact: The new surface treatments will be laid adjacent to the historic walls, railings, steps and thresholds of Kingston College.

- Care should be taken to ensure that no walls are damaged when undertaking the paving works and that existing historic fabric (historic walls, railings, steps and thresholds) are adequately protected
- It is proposed that the existing mature trees be retained, and a maintenance plan for these would be beneficial to ensure that the tree canopy is maintained at a height to allow for views of the buildings of Kingston College from the square.

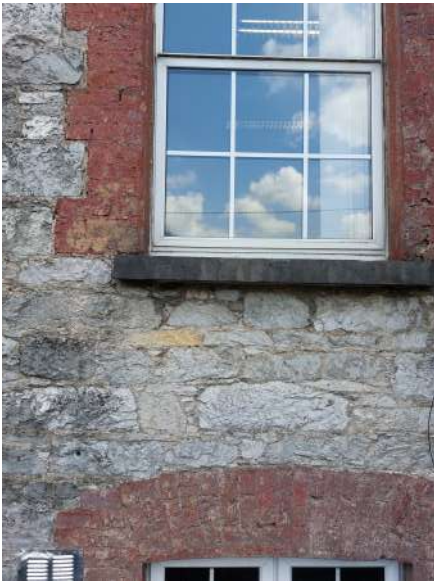
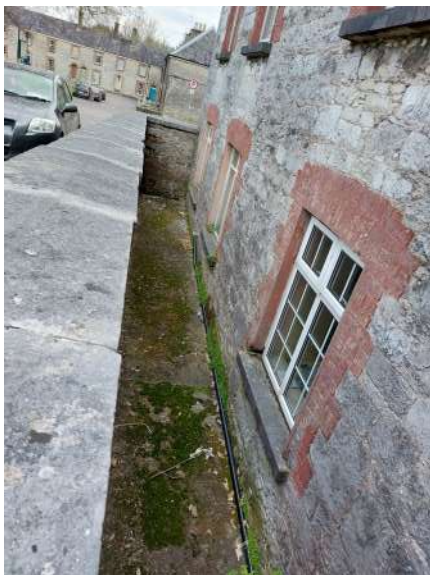
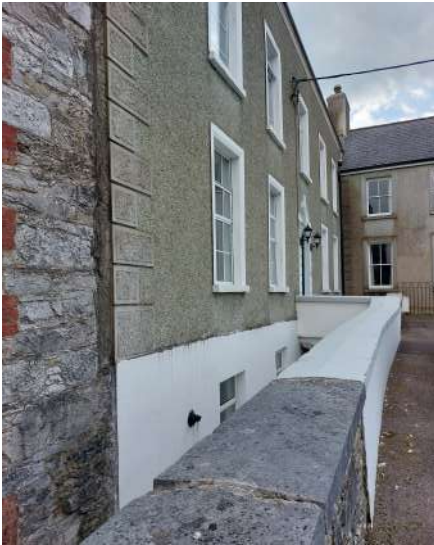
Reference K

Description: This building consists of a terraced five-bay two-storey over basement house, built circa 1780. It has a pitched artificial slate roof with skylights indicating attic accommodation, brick chimneystacks, terracotta chimneypots and ridge tiles, and rendered parapet. Walls are roughcast render, with painted rendered walls to basement. There are quoins to the north of the building, adjoining the former Kingston Hotel. Window openings are square-headed throughout with chamfered render surrounds and painted stone cills. Windows are replacement uPVC. The front door is a round-headed opening with painted stone pilaster and moulded cornice detail. There is a round, traceried fanlight above with moulded render surround with key stone details. The door is timber panel with limestone steps up to ground level. There is a retaining wall to the space in front of the basement, with painted render walls to the street with stone cappings.

Physical Impact: The laying of the new paths/ paving will be directly against the existing historic fabric, and there is a risk of damage to the boundary wall/ steps.

- Care should be taken to ensure that no historic fabric is damaged when undertaking the paving works. The boundary treatments should be retained and adequately protected as part of the works.

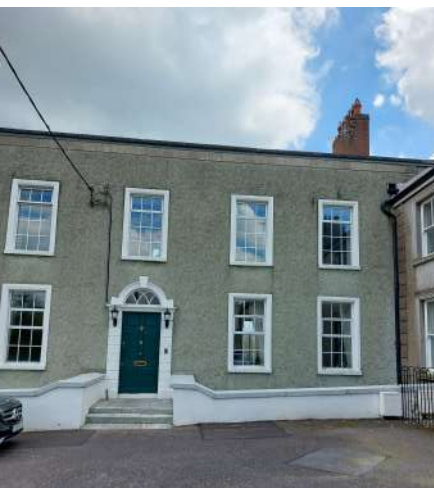
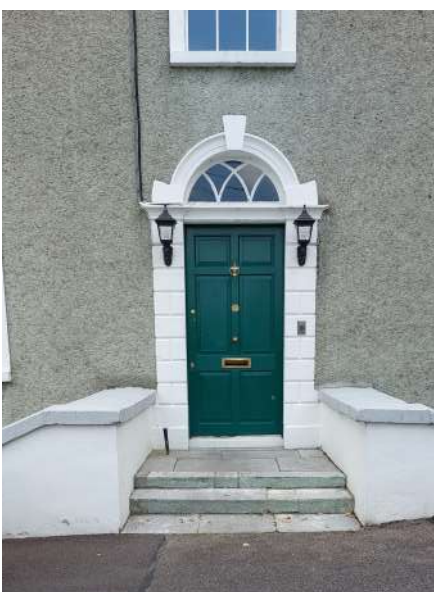
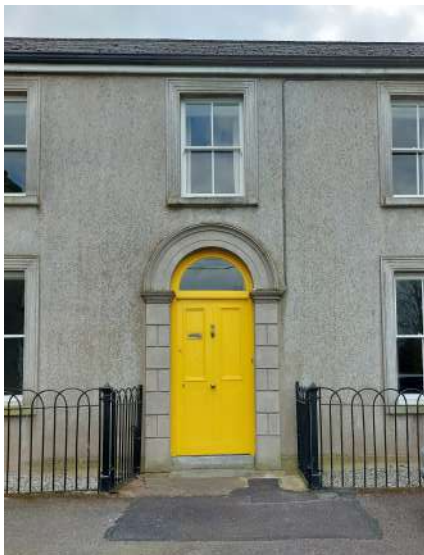
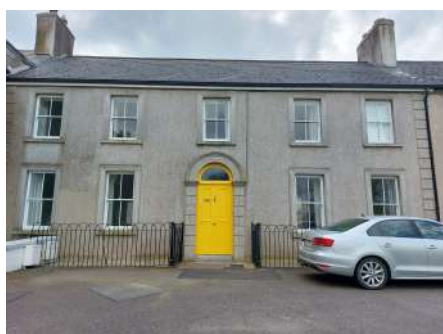
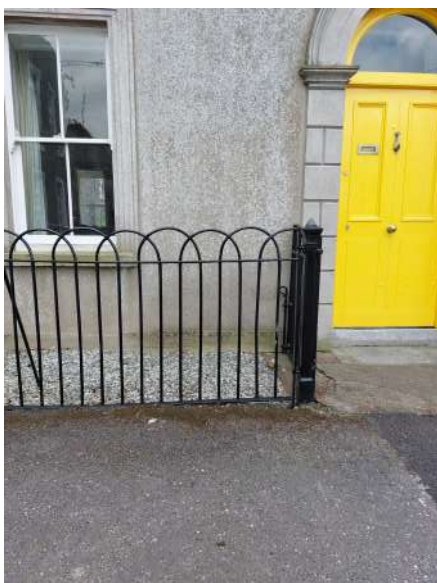
Reference L

Physical Impact: The laying of the new paths/ paving will be in close proximity to existing historic fabric, and there is a risk of damage to the railings/ stone threshold

- Care should be taken to ensure that no historic fabric is damaged when undertaking the paving works. The boundary treatments should be retained and adequately protected as part of the works.

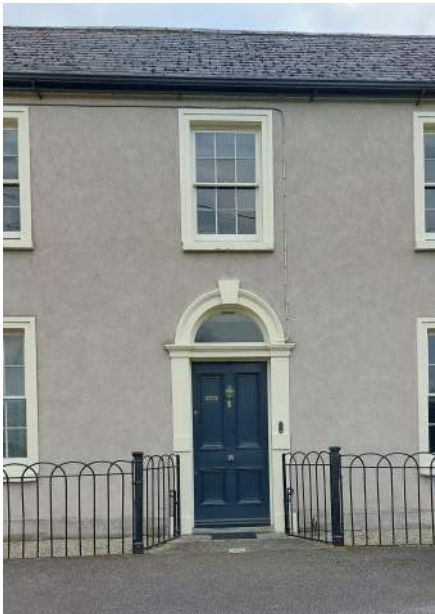
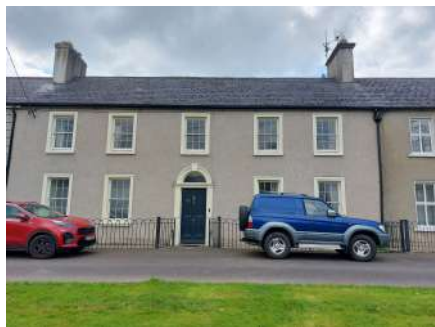
Reference M

Physical Impact: The laying of the new paths/ paving will be in close proximity to existing historic fabric, and there is a risk of damage to the railings/ stone threshold

- Care should be taken to ensure that no historic fabric is damaged when undertaking the paving works. The boundary treatments should be retained and adequately protected as part of the works.

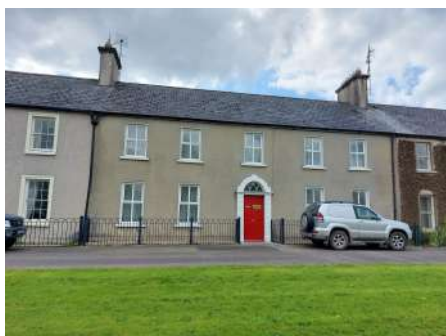
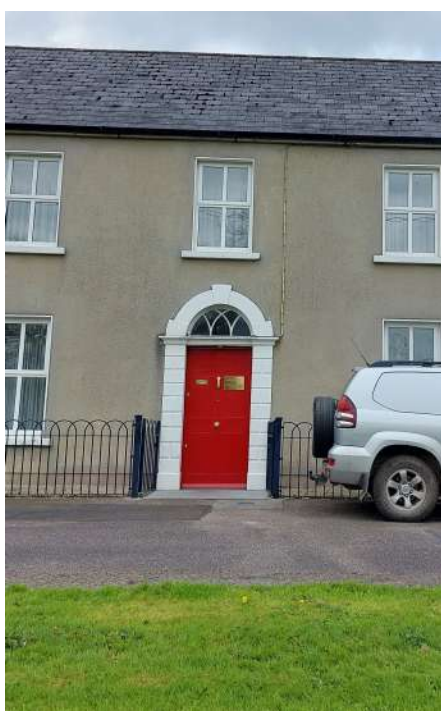
Reference N

Physical Impact: The laying of the new paths/ paving will be in close proximity to existing historic fabric, and there is a risk of damage to the railings/ stone threshold

- Care should be taken to ensure that no historic fabric is damaged when undertaking the paving works. The boundary treatments should be retained and adequately protected as part of the works.

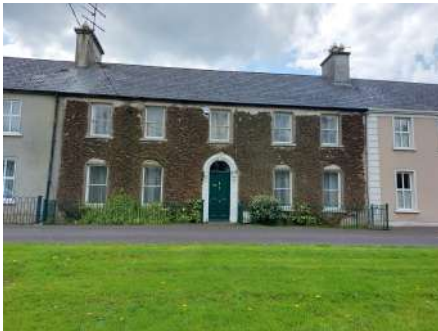
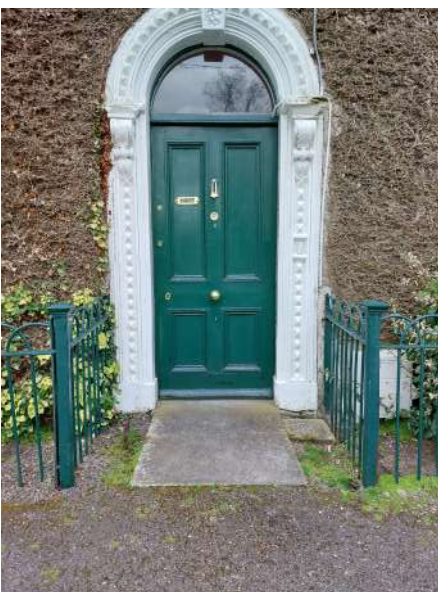
Reference O

Physical Impact: The laying of the new paths/ paving will be in close proximity to existing historic fabric, and there is a risk of damage to the railings/ stone threshold

- Care should be taken to ensure that no historic fabric is damaged when undertaking the paving works. The boundary treatments should be retained and adequately protected as part of the works.

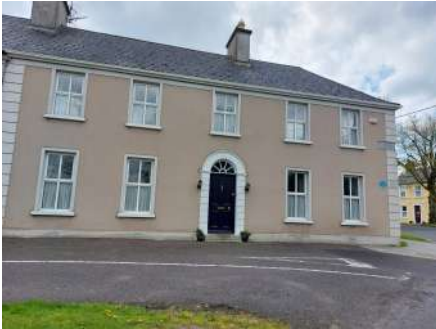
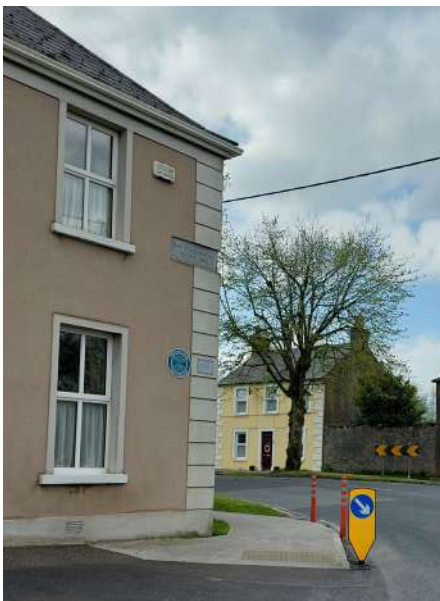
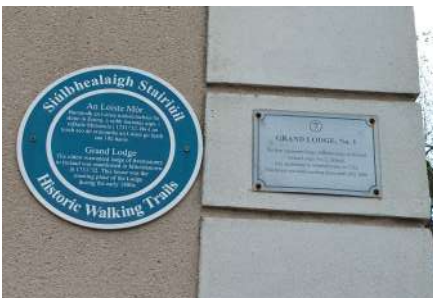
Reference P

Physical Impact: The laying of the new paths/ paving will be in close proximity to existing historic fabric, and there is a risk of damage to the railings/ stone threshold

- Care should be taken to ensure that no historic fabric is damaged when undertaking the paving works. The boundary treatments should be retained and adequately protected as part of the works.

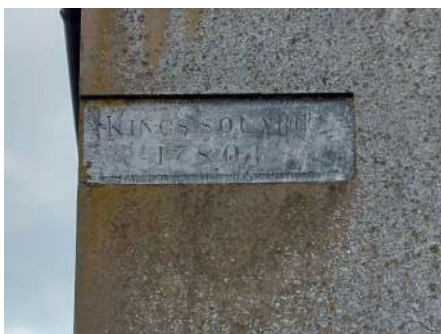
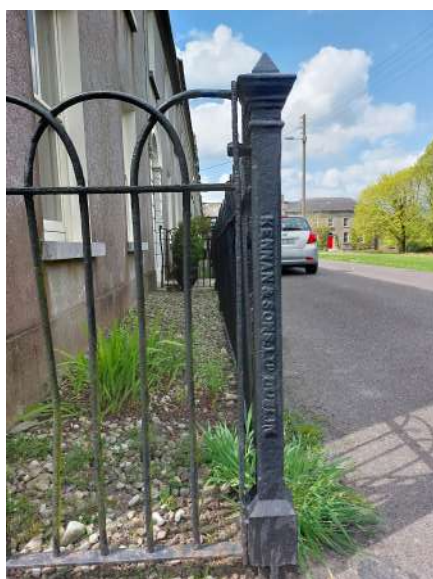
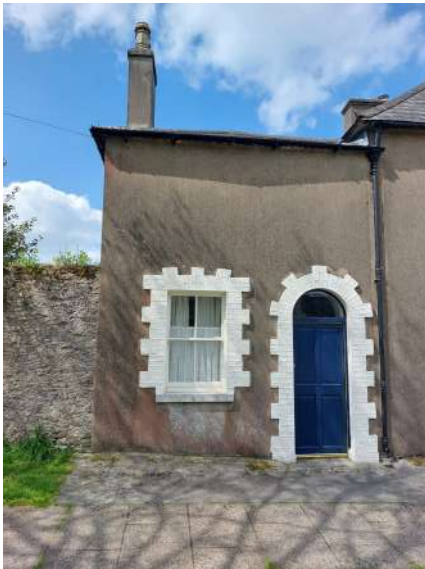
Reference Q

Physical Impact: The laying of the new paths/ paving will be in close proximity to existing historic fabric, and there is a risk of damage to the railings/ stone threshold

- Care should be taken to ensure that no historic fabric is damaged when undertaking the paving works. The boundary treatments should be retained and adequately protected as part of the works.

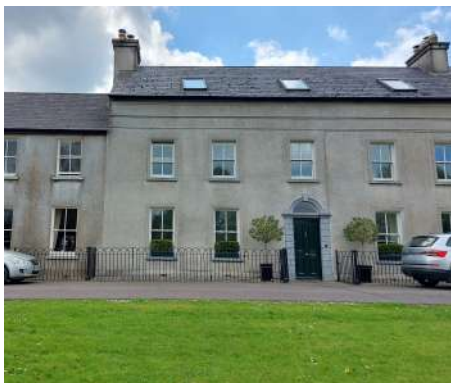
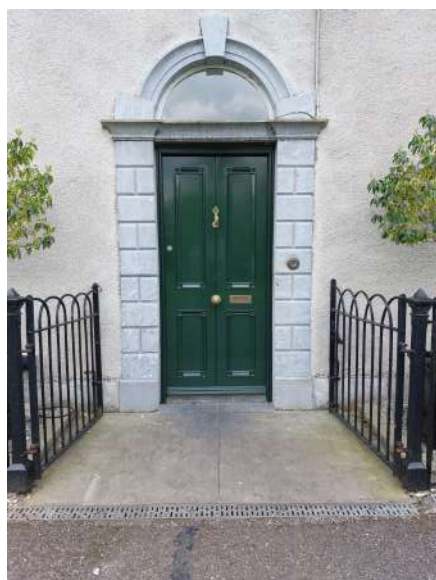
Reference R

Physical Impact: The laying of the new paths/ paving will be in close proximity to existing historic fabric, and there is a risk of damage to the railings/ stone threshold

- Care should be taken to ensure that no historic fabric is damaged when undertaking the paving works. The boundary treatments should be retained and adequately protected as part of the works.

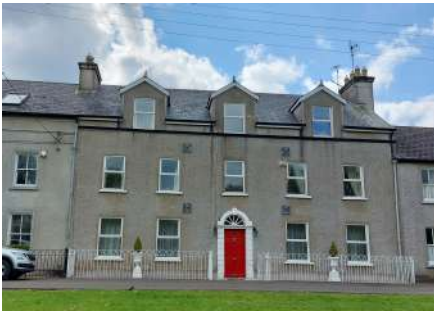
Reference S

A part of a terrace of 5 dwellings of varying design to the south side of King's Square dating to around 1780. No. 10 is a two storey dwelling with pitched slate roof with an additional dormer level. There are three gabled ended dormers with timber bargeboards. The front elevation is a five-bay elevation. Walls are roughcast render with metal pattress plates. Cast-iron down pipe present. The window openings are square-headed with plain render reveals and painted limestone cills. Windows are replacement uPVC. There is a round-headed door opening with painted channelled limestone pilasters with plinths, dropped keystone, moulded cornice, timber panelled door and spoked fanlight, with limestone threshold. There are cast-iron railings to front of house with double-leaf gate having square-profile chamfered cast-iron piers with moulded capitals.

Physical Impact: The laying of the new paths/ paving will be in close proximity to existing historic fabric, and there is a risk of damage to the railings/ stone threshold

- Care should be taken to ensure that no historic fabric is damaged when undertaking the paving works. The boundary treatments should be retained and adequately protected as part of the works.

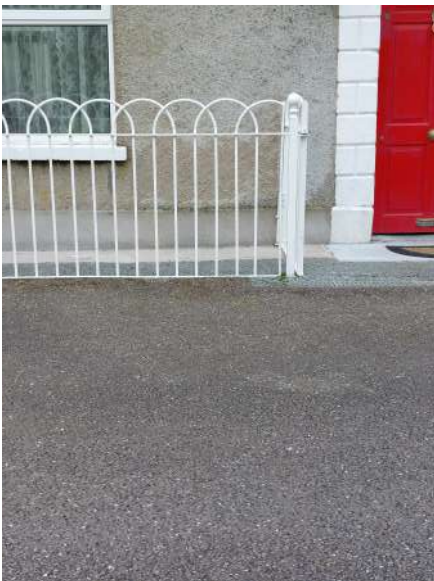
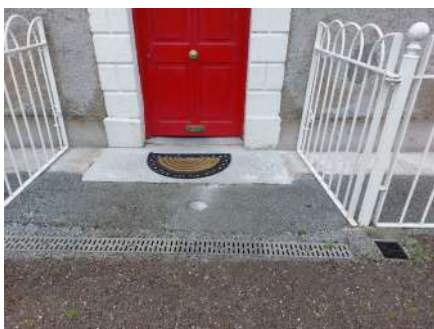
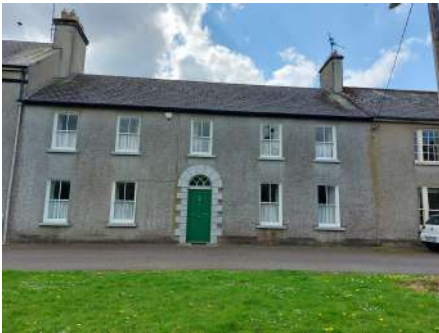
Reference T

Physical Impact: The laying of the new paths/ paving will be in directly adjacent to the building walls, and there is a risk of damage to the walls/ stone threshold.

- Care should be taken to ensure that no historic fabric is damaged when undertaking the paving works. The boundary treatments should be retained and adequately protected as part of the works. Drainage should also be considered to prevent possible water ponding adjacent to the building edge.

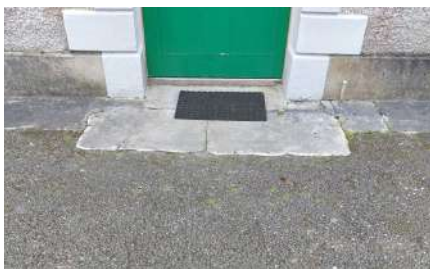
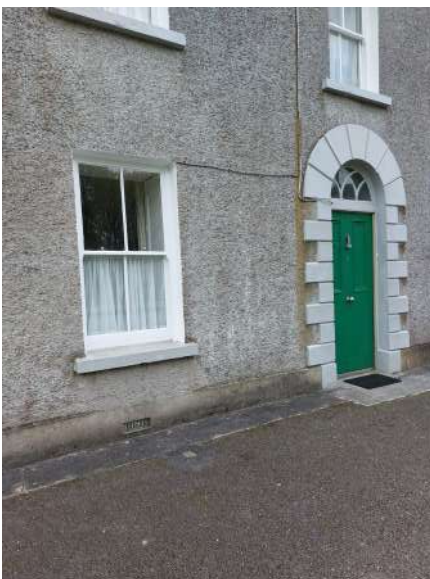
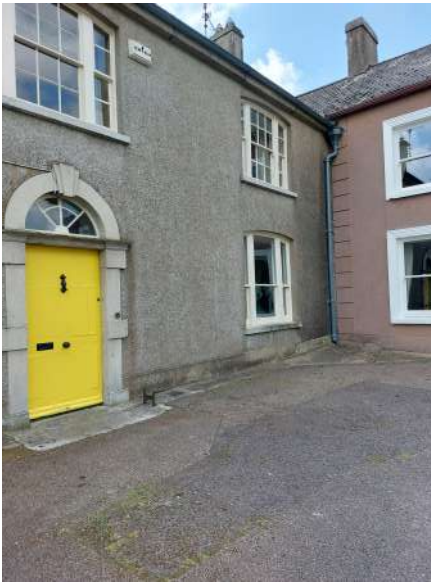
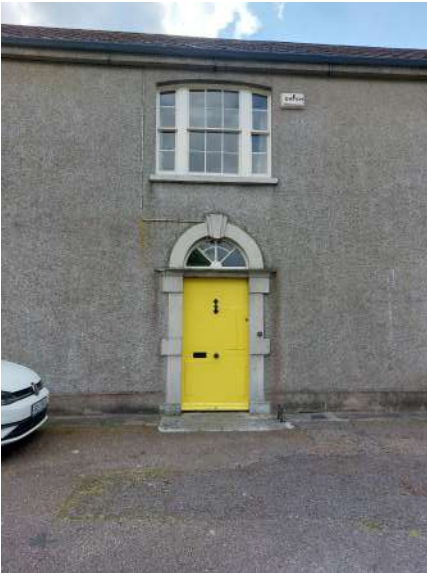
Reference U

Physical Impact: The laying of the new paths/ paving will be in directly adjacent to the building walls, and there is a risk of damage to the walls/ stone threshold.

- Care should be taken to ensure that no historic fabric is damaged when undertaking the paving works. The boundary treatments should be retained and adequately protected as part of the works. Drainage should also be considered to prevent possible water ponding adjacent to the building edge.

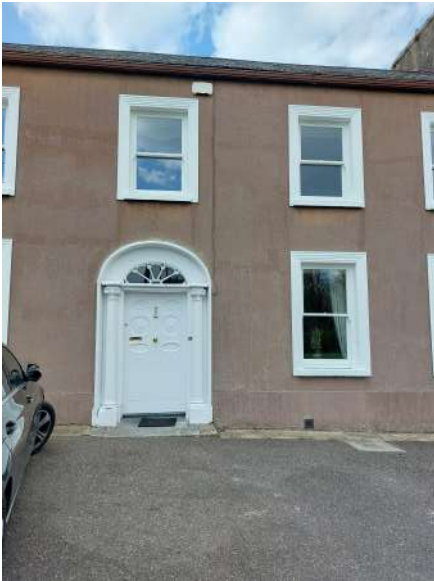
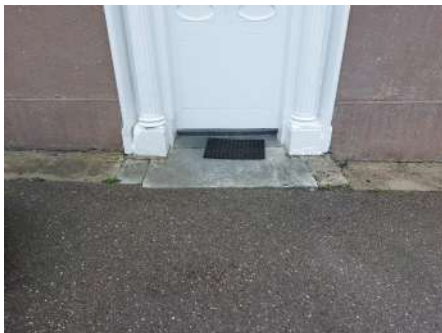
Reference V

No 13 King's Square.

The NIAH appraisal of the building reads as follows (note that uPVC windows were replaced with timber ones since the time of the NIAH report).

Physical Impact: The laying of the new paths/ paving will be in directly adjacent to the building walls, and there is a risk of damage to the walls/ stone threshold.

- Care should be taken to ensure that no historic fabric is damaged when undertaking the paving works. The boundary treatments should be retained and adequately protected as part of the works. Drainage should also be considered to prevent possible water ponding adjacent to the building edge.

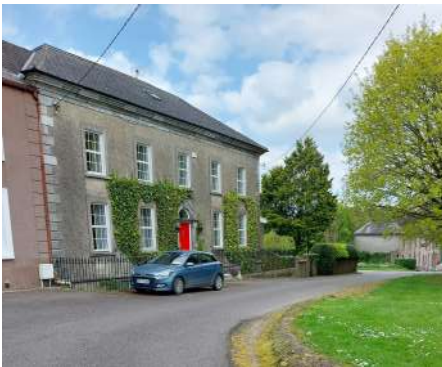
Reference W

No 14 King's Square.

Walls are roughcast render with chamfered limestone quoins, a limestone eaves course, a limestone platband below eaves, and a limestone plinth course. Window openings are square headed with moulded render surrounds and limestone cills. Windows are uPVC replacements to the upper stories, with six-over-six timber sliding sash windows being present to basement level. There is a round-headed carved limestone Gibbsian doorcase with triple keystone, timber panelled door and replacement fanlight. There is a flight of limestone steps up to ground floor level. There are cast-iron railings to site on limestone plinths to the front elevation.

There is a pedimented timber doorcase to the projecting north facing porch,. This has a double-leaf timber panelled door surmounted by cobweb fanlight, flanked by engaged columns with limestone plinths, moulded capitals and caps above with triglyphs, surmounted by open-bed pediment,. It is approached by flight of splaying limestone steps with rendered parapets which have limestone copings.

Adjacent to the north elevation of the house is a single storey rubblestone wall of unknown date with former pointed arch openings

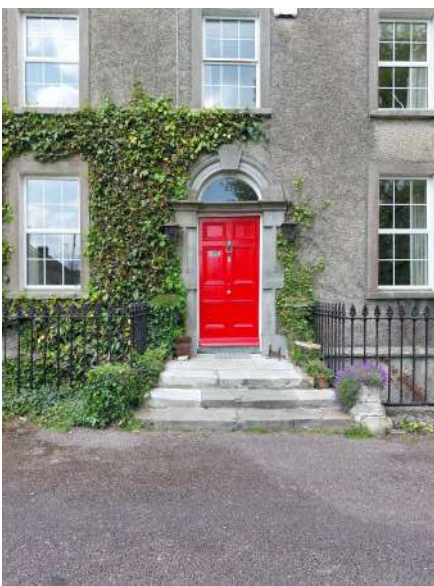
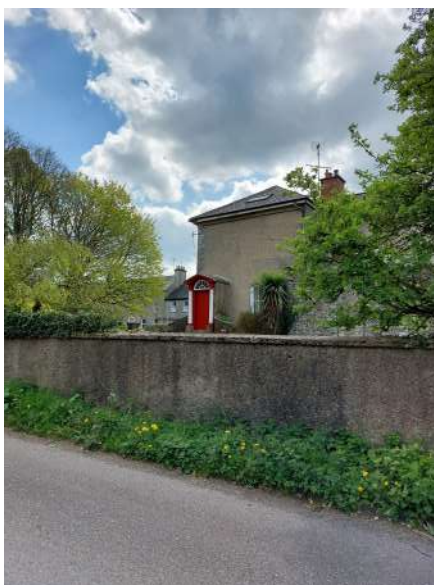
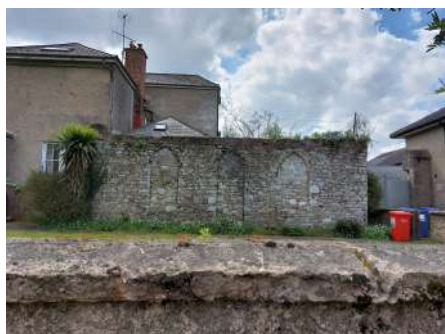
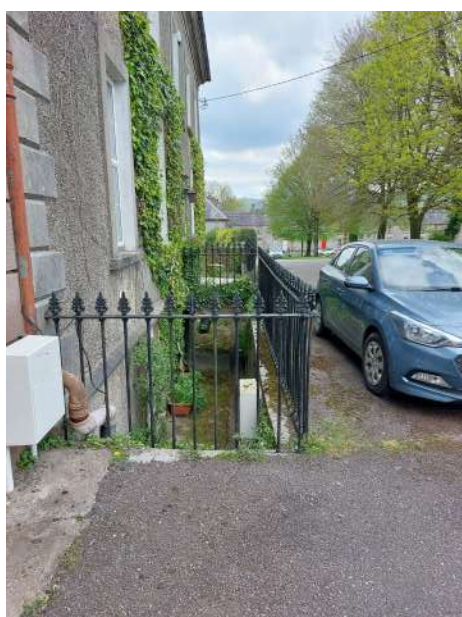
Reference W

No 14 King's Square.

Physical Impact: The laying of the new paths/ paving will be in directly adjacent to the building railings/ basement and there is a risk of damage to the limestone steps/ railings

- Care should be taken to ensure that no historic fabric is damaged when undertaking the paving works. The boundary treatments should be retained and adequately protected as part of the works.

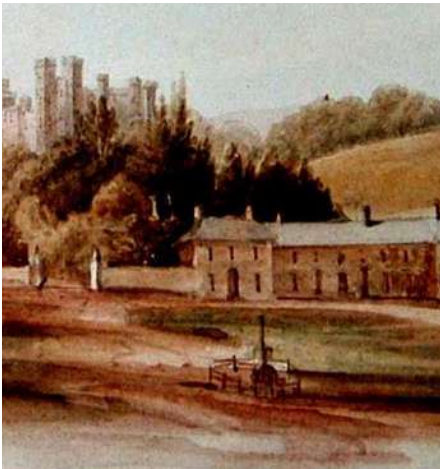
Reference X

Drinking Fountain

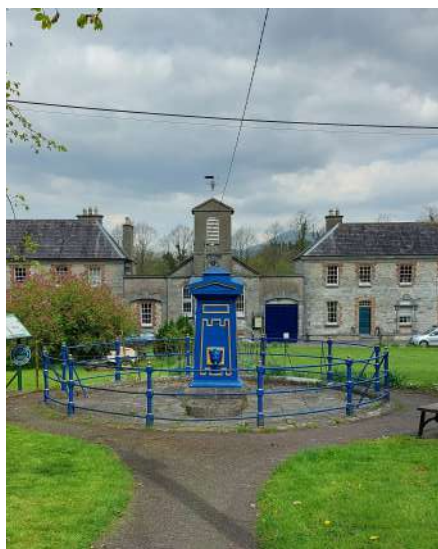
Reference X

Drinking Fountain

The proposal appears to show the railings around the fountain removed which have a significant visual impact and cannot be recommended from a conservation perspective.

Physical Impact: The laying of the new paths/ paving will be in directly adjacent to the fountain and there is a risk of damage to the original building fabric.

The possible removal of the railings would have a significant physical impact and cannot be recommended from a conservation perspective.

- Care should be taken to ensure that no historic fabric is damaged when undertaking the paving works. The fountain and railing should be retained and adequately protected as part of the works.
- A more detailed proposal should be put forward for this area to ensure that the design is appropriate to this historic context in due course, including clarification regarding the railings.

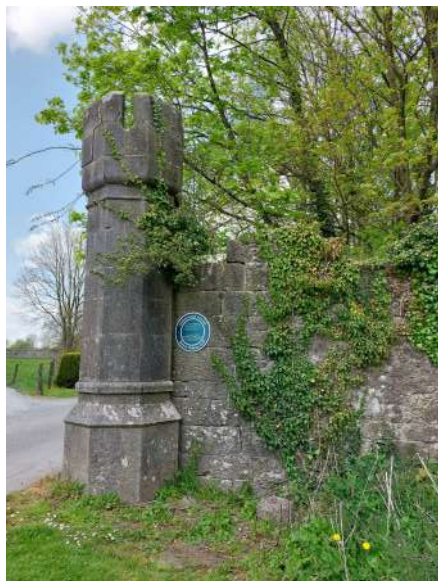
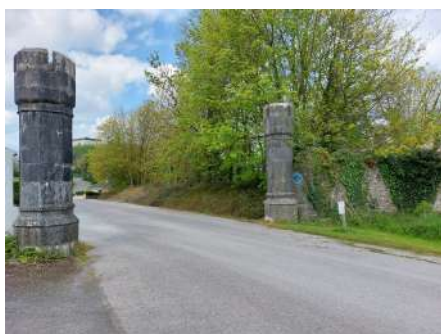
Reference Y

Former entrance to Mitchelstown Castle and demesne

Note: this area falls outside the boundary of the site, although it is noted in the design that it could be the area for an art projection

Visual Adjacencies: The existing tree-lined east-west vista will be maintained and the piers will continue to book-end this view. No significant visual impact is anticipated. An art projection would of course have a visual impact, but a carefully planned one could enhance the space.

Physical Impact: None anticipated.

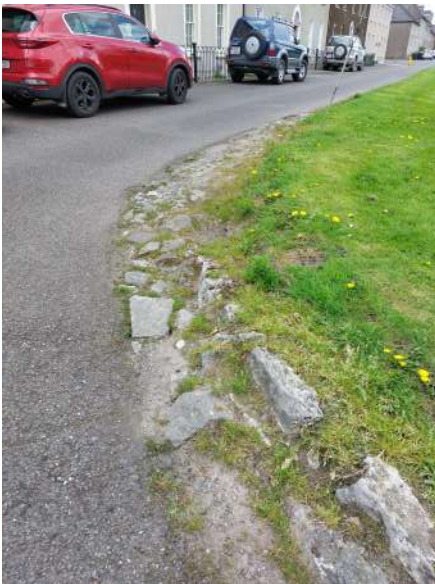
Reference 1Q

Limestone kerb with cobbles

- It would be preferable from a conservation perspective to retain this section of paving in situ as a record of what may have been here before.

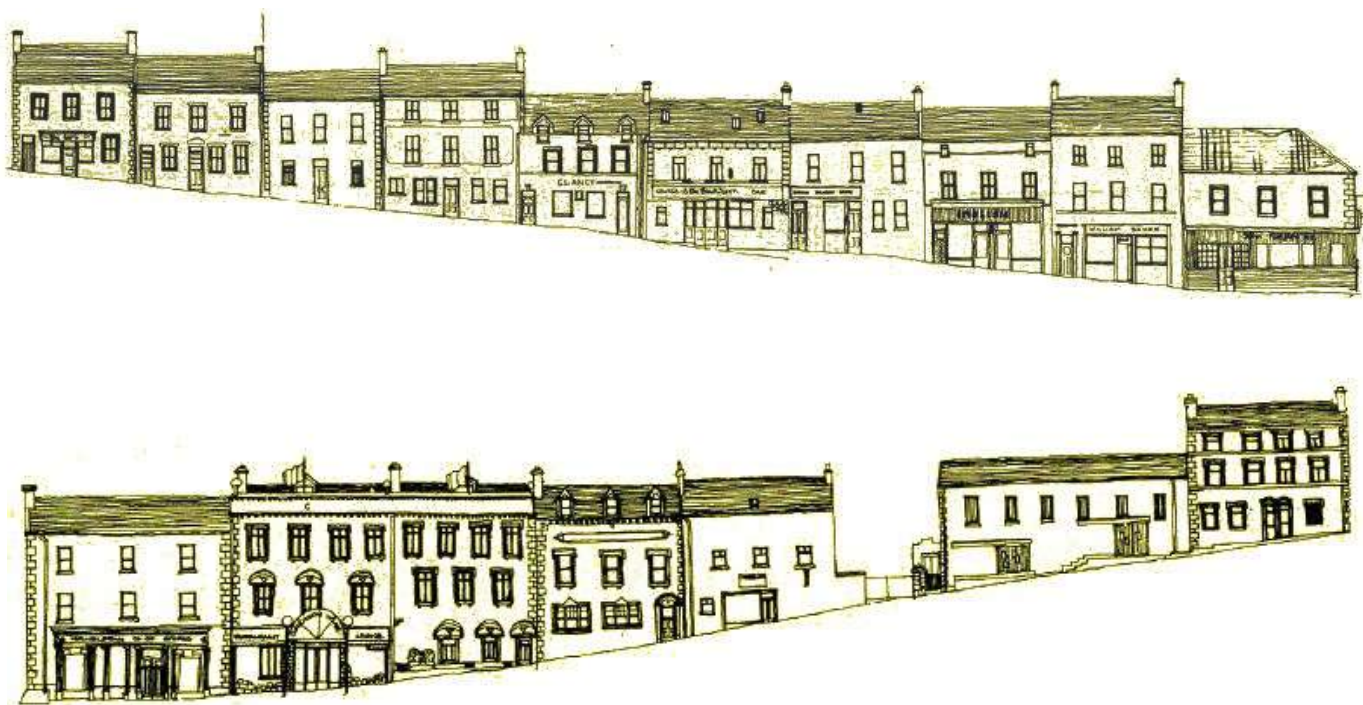
North (top) and South (bottom) street elevations of New Market Square from 1984 Heritage Plan

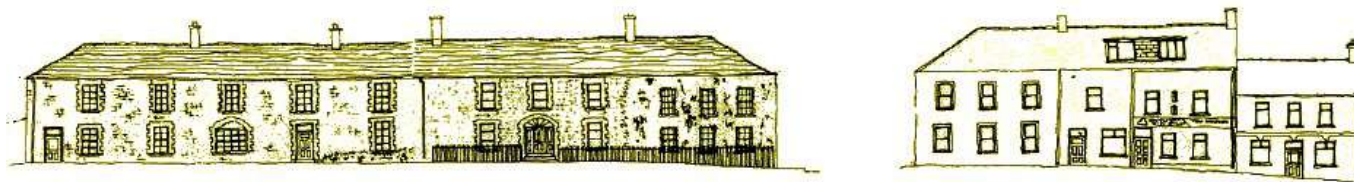
West side of square- street elevation of New Market Square from 1984 Heritage Plan

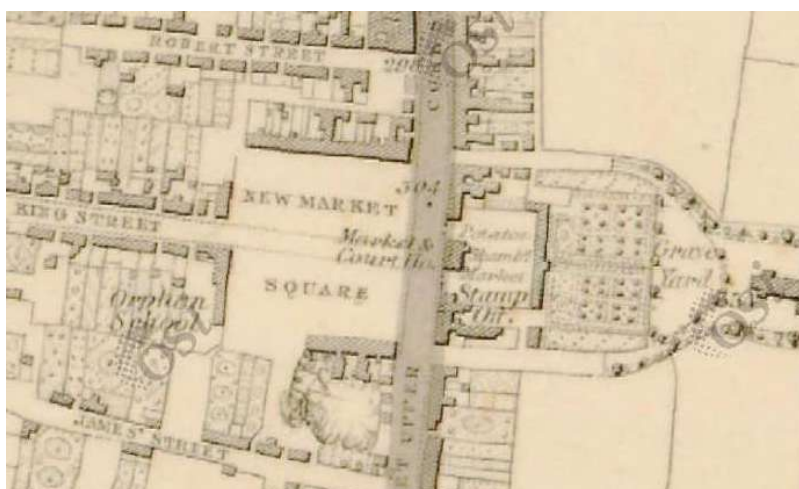
There is a very clear east-west axis set up in the layout of the square. In the earliest edition of the OSI maps there is a slightly more open edge to the space, to the south-west and north-west corners in particular. Historically the court-house was a detached building with openings to either side providing access to the market area to the rear. A large number of the buildings visible on the 6" map are narrower than those seen on the 25" one with a large portion of the building fabric appearing to have been rebuilt since the 6" series.

New Market Square - 6" OSI Map, 1837-1842.

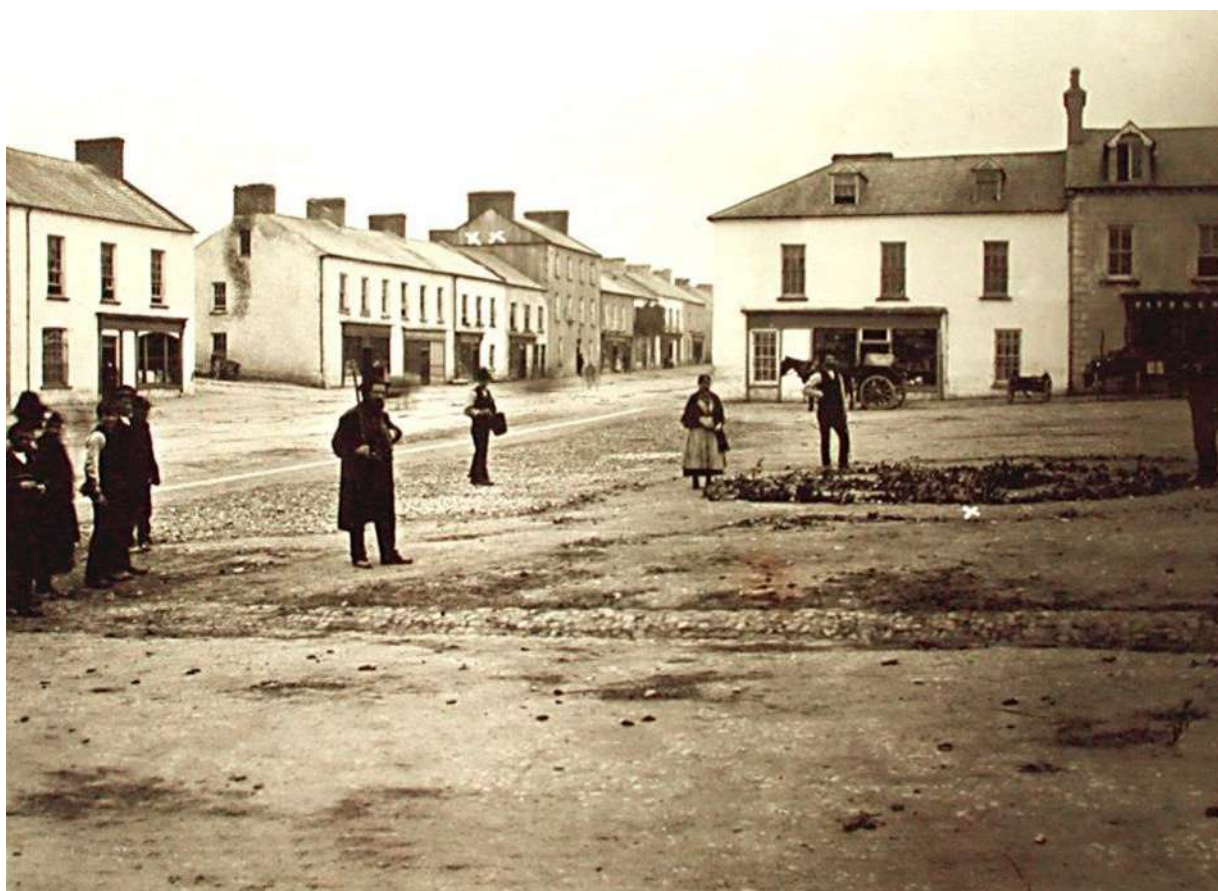
There have been various changes to the buildings and surface treatments of New Market Square over the past 200 years. The earliest photos of New Market Square show a rough mud/ cobblestone finish with open drains. The historic image below (© Bill Power) appears to date to the late 1880s, with a buildings to the south-east corner of the square differing significantly from what is visible on site today. Attractive and simple vernacular style buildings are present in the photo, two stories generally with dormer storey to the buildings to the south. A range of attractive timber shop-fronts are also visible . The surface of the square is rough, with cobbles visible, and an open cobble drain running east-west. A kerb appears to define the edge of Cork Street to the east side of the square. The square is very open, with no vegetation visible. The roads are not distinguished from the open space, with the exception of a simple kerb to Cork Street.

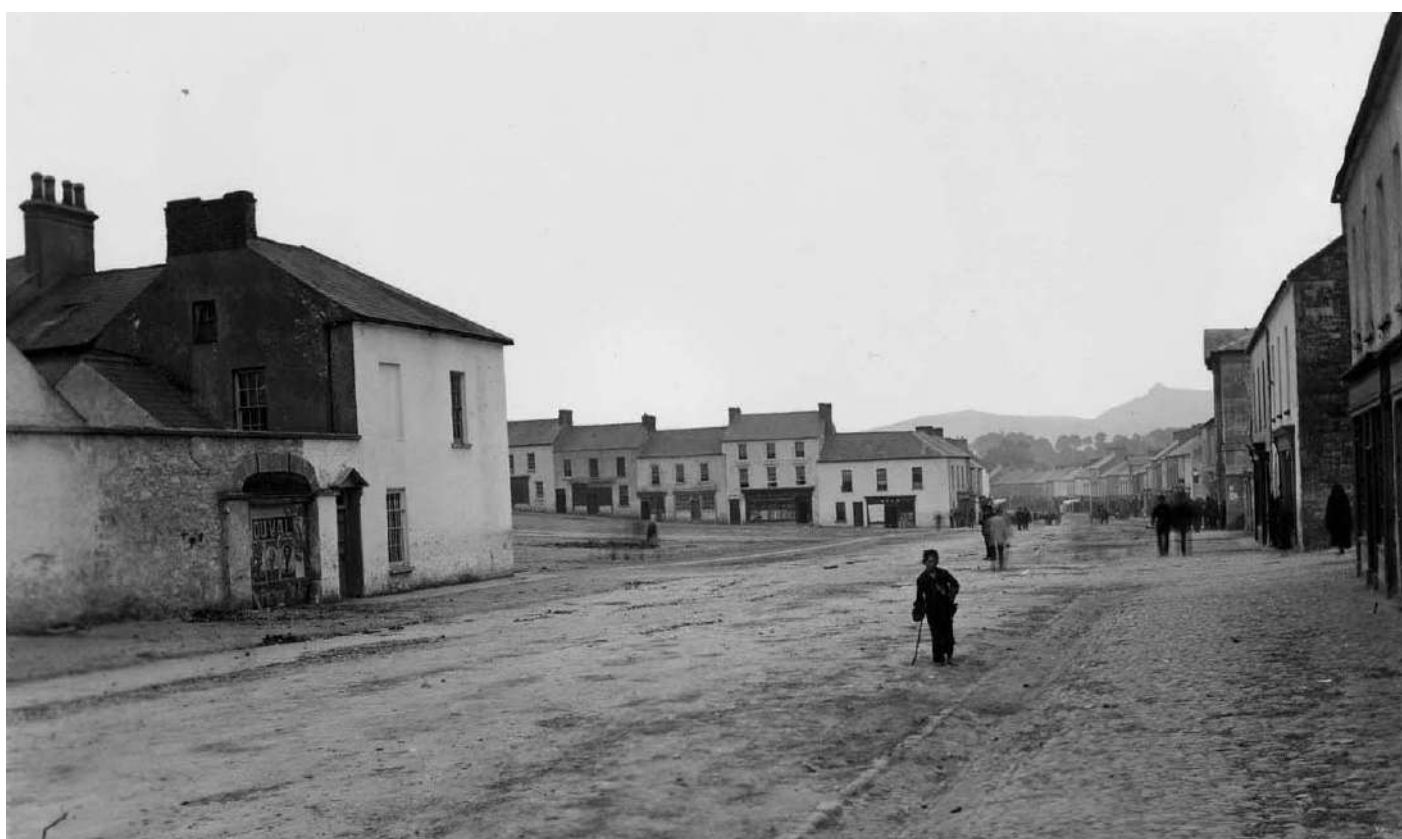
This is another photo dating to the late 1880s (© Bill Power), This photo predates the erection of the Mandeville statue (1906) and is taken along Cork Street facing north, into the square. The cobblestone finish to the pathway to Cork Street is of note, along with the open cobble stone drain adjacent to this. While the building in the foreground has altered significantly since the time this photo was taken, the stepped profile of the buildings along the north side of the square today is largely in keeping with the form and character of the street visible in the late 19th C. This photo, along with the one from the previous page, are thought to date from around the time of the Mitchelstown shootings (1887).

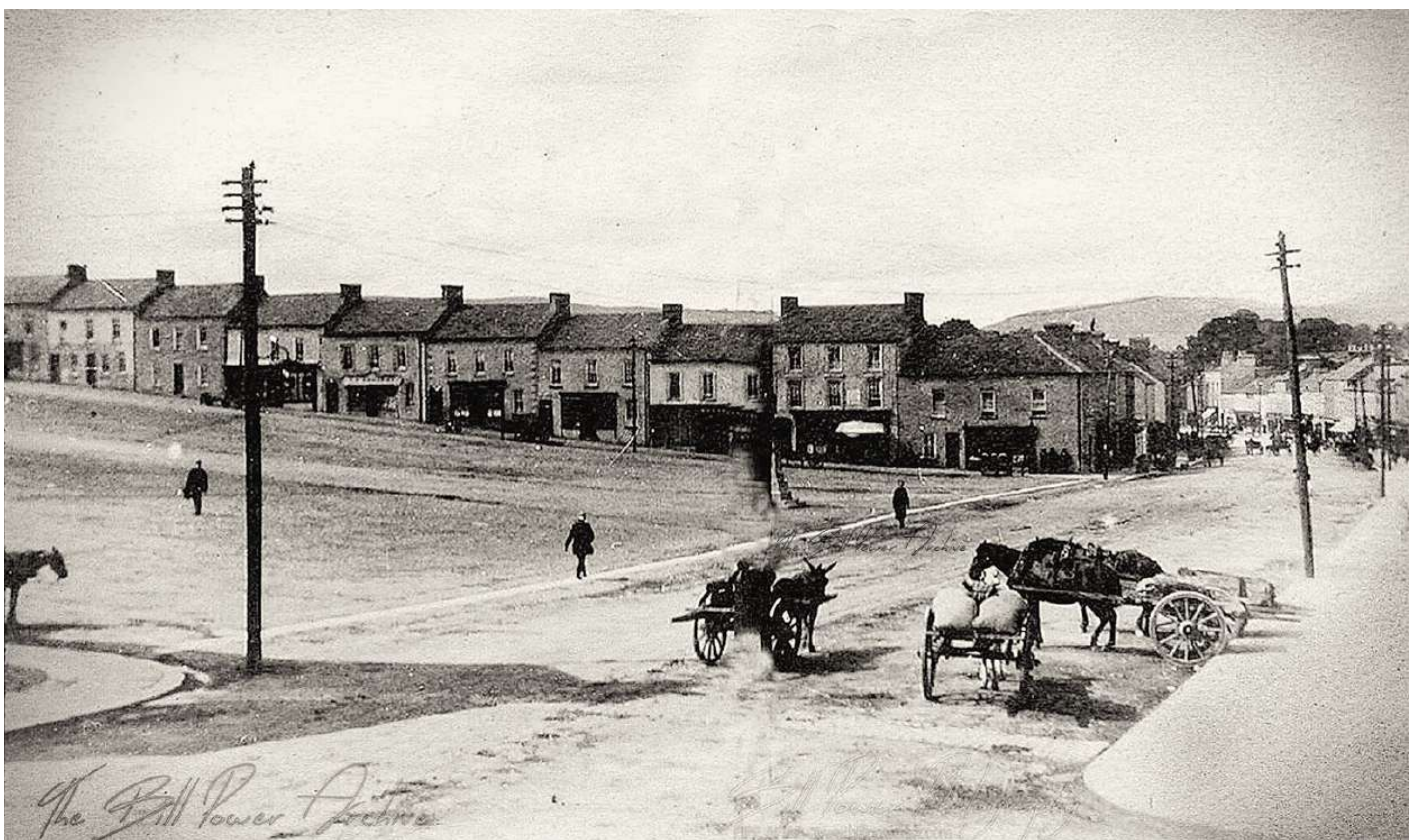
The image below dates to perhaps the early-mid 1900s (© Bill Power). and shows the stepped profile to the buildings along the north side of the square largely in keeping with the buildings present today. The Mandeville statue is present, along with telegraph poles which were erected throughout Mitchelstown by 1955. The areas to the perimeter of the square are paved, while the square itself is a large open space with no real variation visible in the surface treatment.

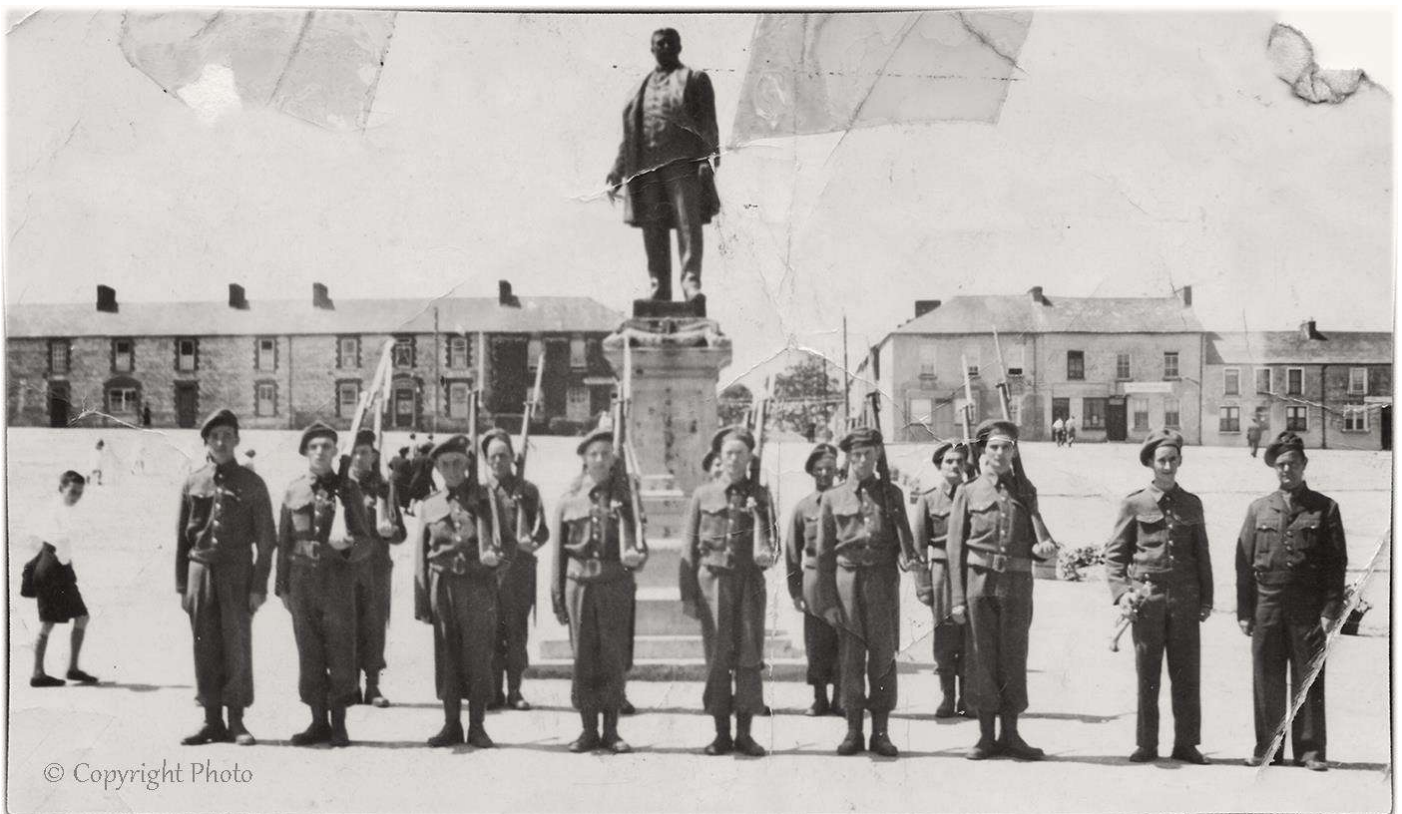
The image at the bottom of this page dates to around 1940 and was obtained from Maria O'Dwyer via the Mitchelstown Facebook page. It shows members of the Local Defence Force which was formed in Mitchelstown at the outbreak of World War II. The Mandeville statue is visible in its current location. The square itself appears to be a very plain and open space with no steps visible or vegetation present. The buildings to the west side of the square are visible in the background. The stone terrace towards the south appears largely unchanged since this time, with more alterations visible in the ones to the north, where ridges have been raised, dormers added, and fenestration patterns altered.

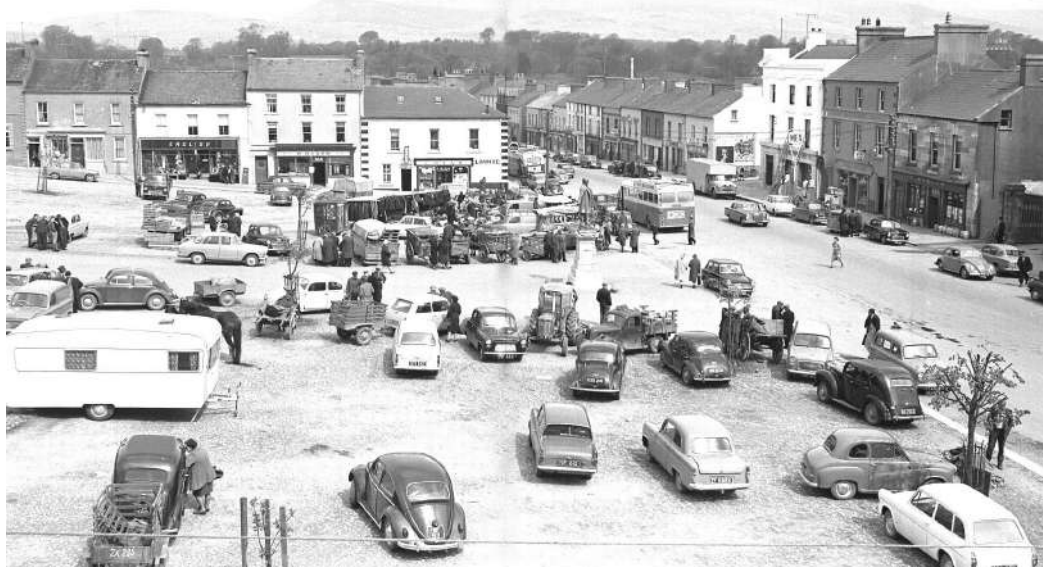
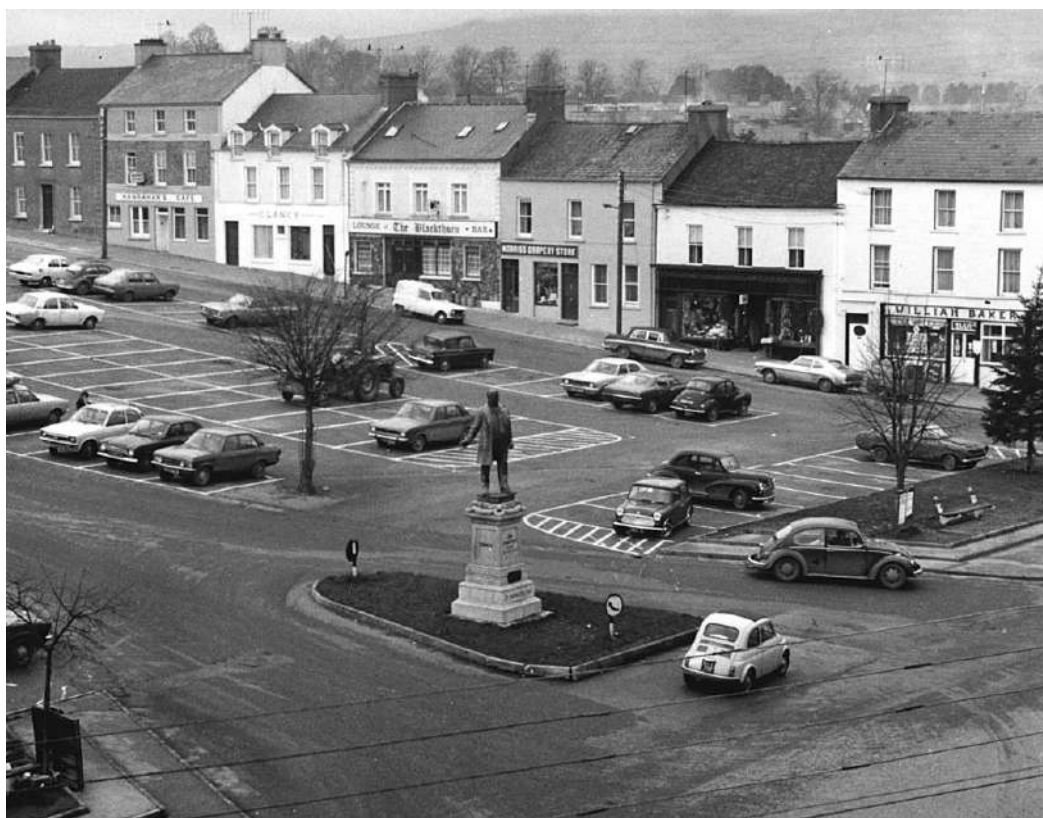
The images below show the more recent development of the square during the mid-late 1900s and the increasing dominance of cars in the space. The top image (© Ben Corbett) shows the space on market day. The space is quite open, with newly planted trees visible. There are no designated parking spaces with cars being parked haphazardly throughout the space. The second photo (© Bill Power). Shows the square with a paved surface with marked parking abys throughout the space. The trees have grown slightly, and telegraph poles have been added along the north side of the square.
