Mitchelstown Georgian Quarter Architectural Inventory and Assessment

October 2022

This report has been undertaken by James Bourke Architects as part of the proposed redevelopment of Mitchelstown's Georgian Quarter. The redevelopment project has been commissioned by Cork County Council. The design is being overseen by REDscape Design, and James Bourke Architects have been engaged on the project as conservation consultants for the design team. Our role is to identify any built fabric of particular historical significance within the site area of the Georgian Quarter, to provide a full record of these items, and to assess the conservation impact of the proposed works on the historic town.

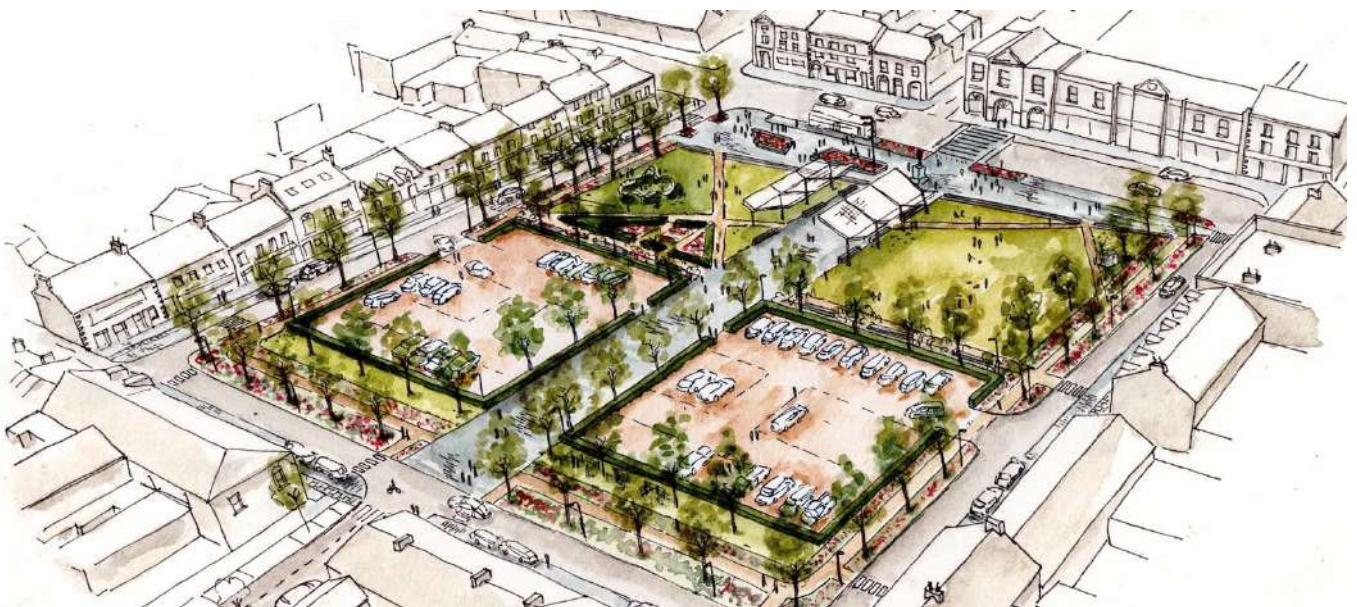
Concept Sketch © REDscape

The proposed works for New Market Square involves the reconfiguration of the square to allow it to become a multifunctional public space and to engage with people at a human scale. It is proposed to reconfigure the road layouts and to confine parking to the upper half of the square, with an open green space including a play area being located towards the lower half. The proposal has a strong east-west axis, which is in keeping with the planned town layout. It is proposed that this axis be defined as a paved route with trees and canopies to its edge. Trees are also proposed to wrap the edges of the square to the north, south, and west, with the space remaining open toward Cork Street. It is proposed to widen footpaths to the south and west of the square to allow for outdoor eating areas and an active edge. The proposal is tailored to allow for the continued use of the space as a place to host markets, which an essential part of the history and character of the space.

Originally this space was a simple open area. This character altered over the years, with the addition of soft landscaping in more recent years and an ever growing dominance of cars in the space. The proposal seeks to break the open space down into areas at a human scale and encourage social engagement. While the proposal is quite different from the original character of the space, it is considered to be a significant improvement on the current condition of the square. The proposal will result in a space much greener and softer than the original character of the square, and the views of the buildings from the square will generally be screened by trees. However, the proposal maintains and reinforces the east-west axis and has the potential to transform this public space in a positive manner.

Further details would also be required in the next stage of works to clarify where elements of historic interest will be incorporated in the detailed design, such as historic fragments of limestone steps, kerbs, and slate paving. It is noted that some existing items of significance are shown in the current proposed plan, such as the Mandeville Statue and William Trevor Memorial. However, additional items such as the sundial and limestone seat (references 20 and 22 on plan) should be indicated on the detailed plans in the future. Detailed design of the permanent canopy structures should include 3d views of the east-west axis to allow their impact on the space to be fully assessed. Further details and 3d views of the trees should also be provided to ensure their canopy does not impede the vista.

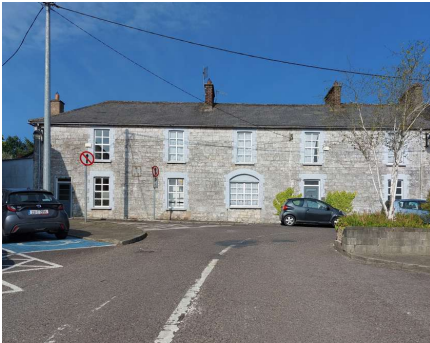
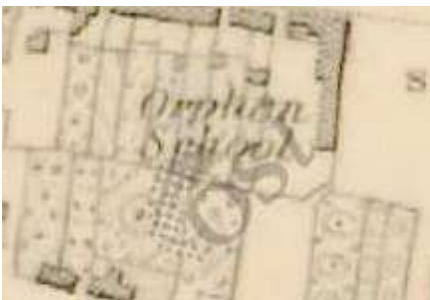
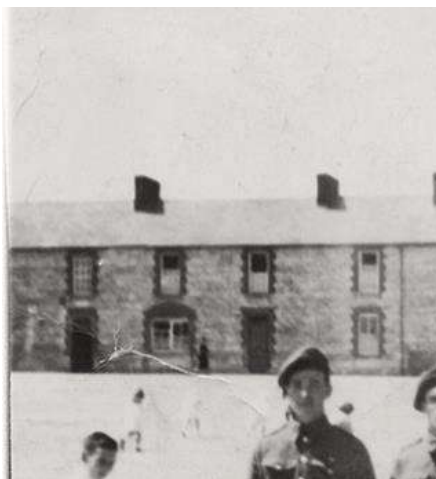
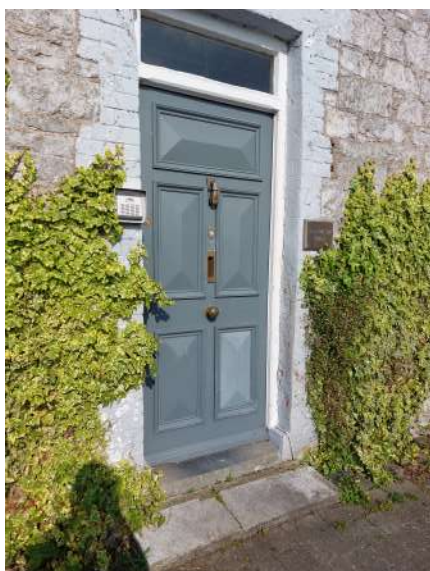
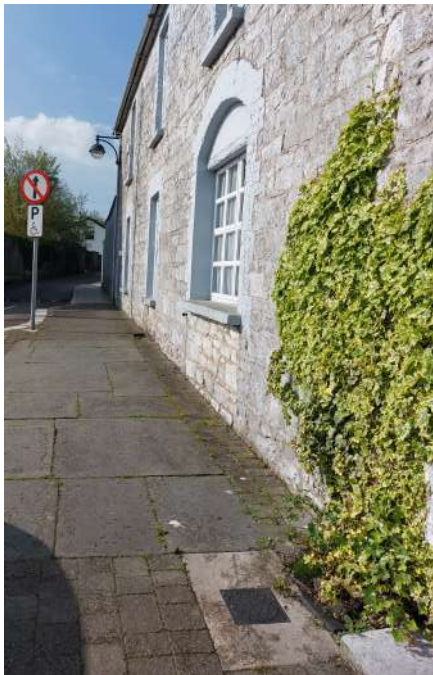
Reference Z

There window and door openings are square headed generally, with the exception of a larger round headed arch opening centrally on ground floor. There is painted brick surrounds to the openings throughout. Windows are uPVC replacements. The door towards the north is located under a window opening and is a modern timber panel door with a plain rectangular fanlight. The doorway to the south appears to be a relatively modern addition, with no window present above and no brick detailing. It has a modern timber door with glazed panels and plain rectangular fanlight.

Physical Impact: The laying of the new paths/ paving will be in directly adjacent to the building walls, and there is a risk of damage to the building walls/ threshold, as well as to the historic flagstones themselves.

- Care should be taken to ensure that no historic fabric is damaged when undertaking the paving works. The steps/ threshold should be retained and adequately protected as part of the works.
- Drainage should also be carefully considered to prevent possible water ponding adjacent to the building edge.

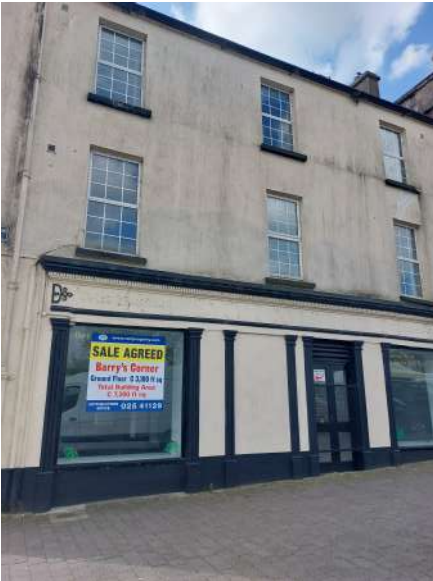
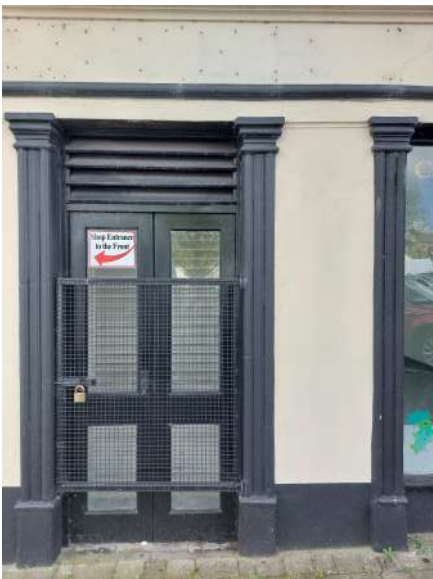
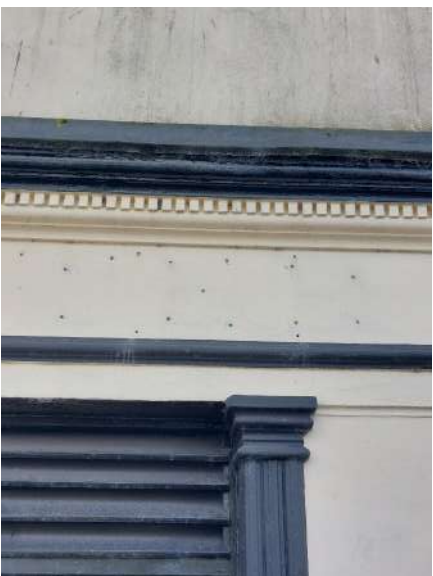
Reference A2

Shopfront has fluted pilasters with plinths and moulded capitals, moulded render courses to fascia, and dentillated moulded render cornice. Square-headed door opening with glazed timber panelled double-leaf door, flanked by plate glass display windows. Display windows also inserted to east gable and to extension....

The building itself is a three-bay, three-storey pitched roof house with a five-bay two-storey extension to rear. Early photographic evidence indicates that a smaller, two storey house was located in this site in the 1800s. This configuration appears to date to circa 1900, although the fabric from an earlier building may have been used in its construction. The current configuration has a pitched artificial slate roof, cast iron rainwater goods and square headed window openings with upvc windows and painted cills.

Also of note are limestone crosses at the foot of the wall, which the NIAH states is the site of killing of Land League patriots in 1887.

Physical Impact: The laying of the new paths/ paving will be in directly adjacent to the building walls, and there is a risk of damage to the historic shopfront.

- Care should be taken to ensure that no historic fabric is damaged when undertaking the paving works. The historic fabric should be retained and adequately protected as part of the works.

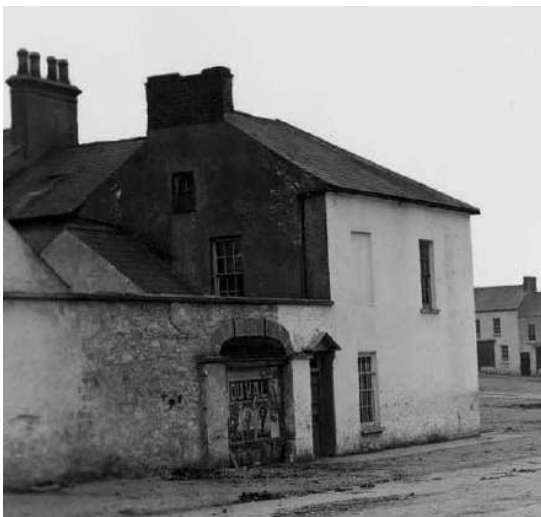
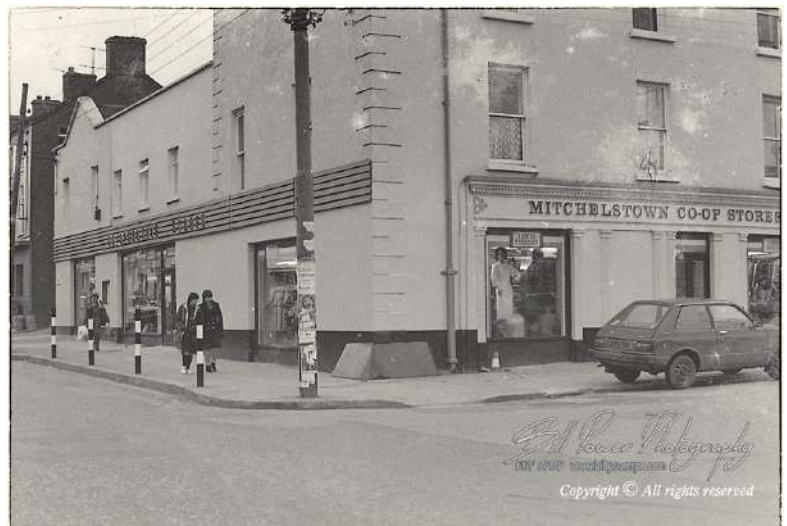
Historic Photos of the building showing its reconfiguration from a two storey hipped roof volume to the three storey volume currently present on the site today.

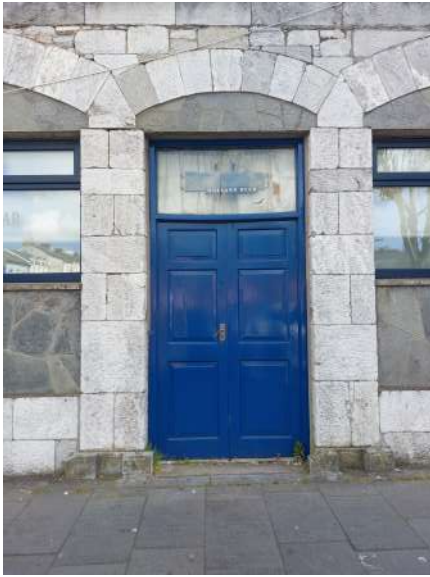
Reference C2

This building consists of a simple two-storey attached volume with a pitched slate roof and central rendered chimneystack to the gable end. The NIAH dates the building to c.1825. The front (west) elevation is a three-bay elevation with an ashlar stone finish. There are square headed window openings to the first floor with replacement timber windows, and limestone sills. There are segmental-arched openings to the ground floor which incorporate pilasters on plinths between the openings and ashlar voussoirs. Windows and door are modern. It is interesting to note that a photo from around 1920 shows a simple timber shopfront in place of the arched openings. It is assumed that the opening are nonetheless original, and that they were simply covered up by the shop-front. There is a gateway with a cut stone pier to the south of the building.

Physical Impact: The laying of the new paths/ paving will be in directly adjacent to the building walls, and there is a risk of damage to the building walls

- Care should be taken to ensure that no historic fabric is damaged when undertaking the paving works. The historic fabric should be retained and adequately protected as part of the works.
- A detailed design for the paving should be provided as part of the next phase of works.

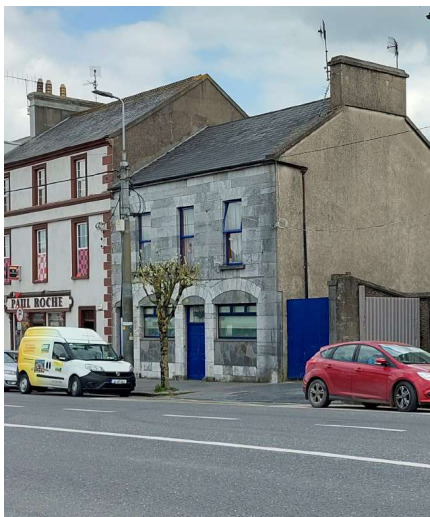
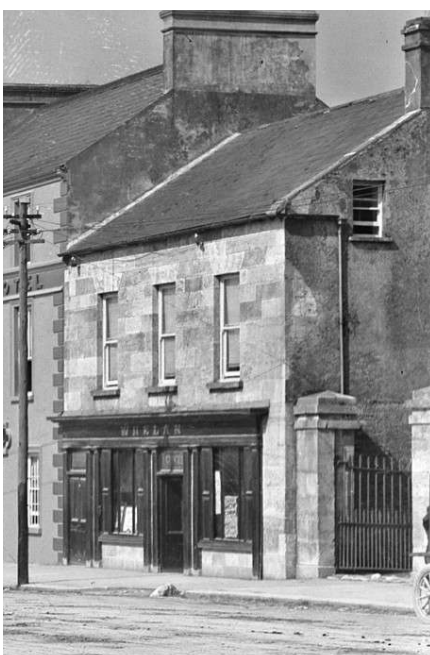
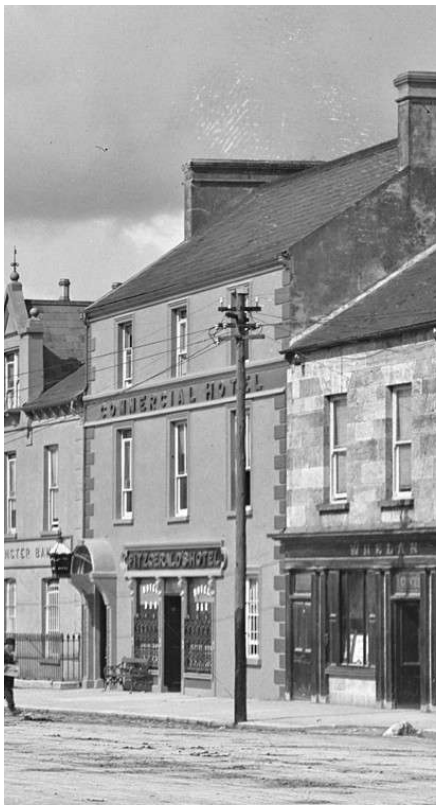
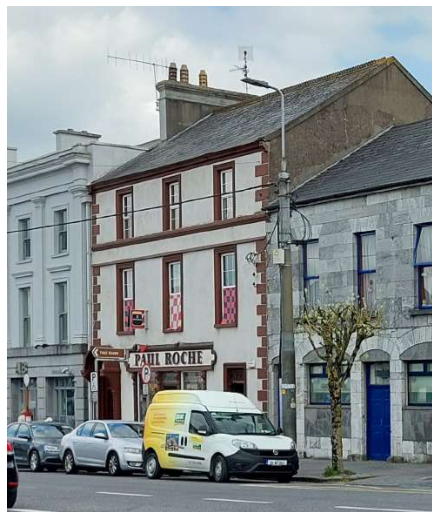
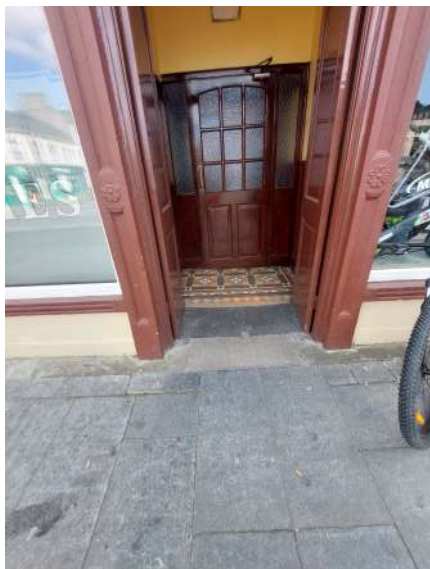
Reference D2

Terraced three-storey, three-bay building with render shopfront to ground floor. Pitched artificial slate roof present, with render chimneystack to north gable (note that earlier photo shows one to south also). Cast iron rainwater goods are present, along with a moulded render eaves course. Walls are painted render with render quoins. There is a painted render name fascia between the upper floors. The upper floors have square-headed window openings with replacement uPVC windows and painted moulded render surrounds.

Physical Impact: The laying of the new paths/ paving will be in directly adjacent to the building walls , and there is a risk of damage to the building walls/ shopfront/ mosaic thresholds

- Care should be taken to ensure that no historic fabric is damaged when undertaking the paving works. The historic fabric should be retained and adequately protected as part of the works.
- A detailed design for the paving should be provided as part of the next phase of works.

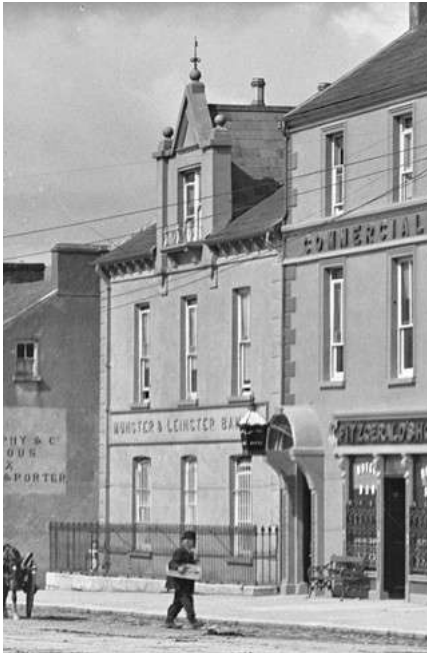
Reference E2

This fine building is a dominant feature of the streetscape in Mitchelstown, and its scale and notable features, such as the limestone cladding and the render mouldings cause it to stand out and add decorative interest to the streetscape. The retention of original features, such as the timber sash windows and panelled door and limestone steps, enhance the character and charm of the building.

Physical Impact: The laying of the new paths/ paving will be in directly adjacent to the building walls, and there is a risk of damage to the building fabric

- Care should be taken to ensure that no historic fabric is damaged when undertaking the paving works. The historic fabric should be retained and adequately protected as part of the works.

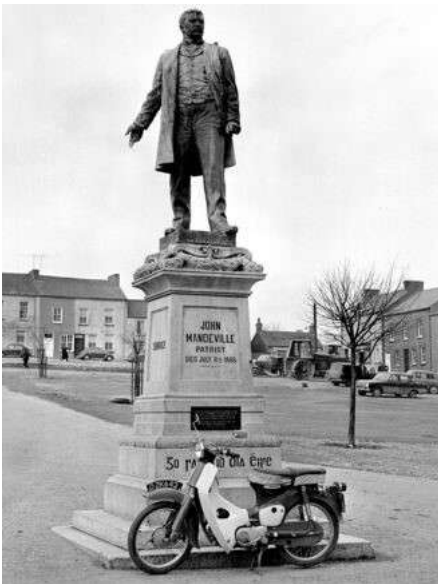
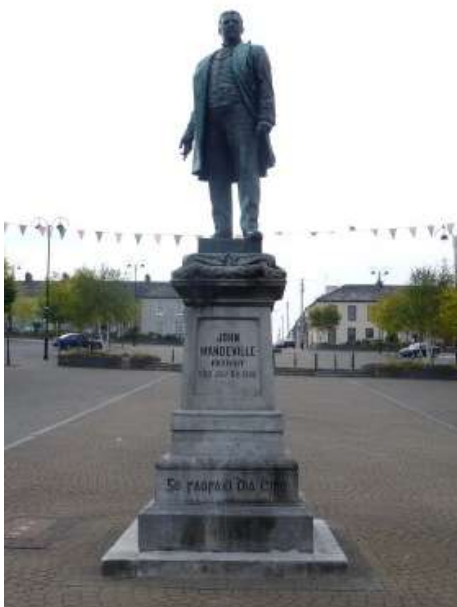
Reference ST

Visual Adjacencies: It is proposed that the statue retains its prominent location on the east-west axis of the square. The view of the statue should be framed by the proposed trees and canopies.

Physical Impact: The laying of the new paths/ paving will be in directly adjacent to the building walls , and there is a risk of damage to the building walls/ stone steps

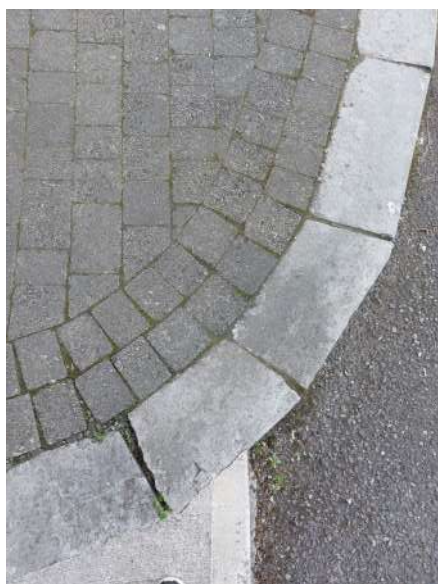
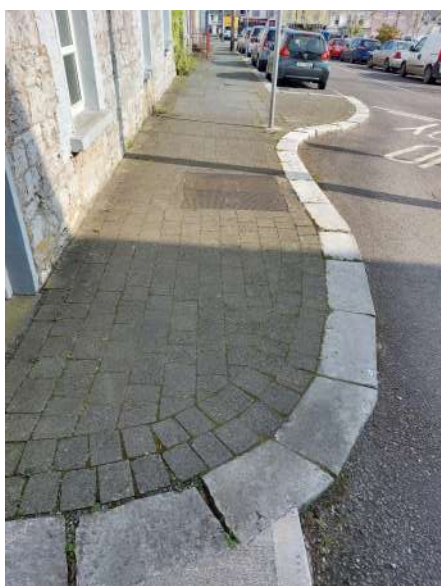
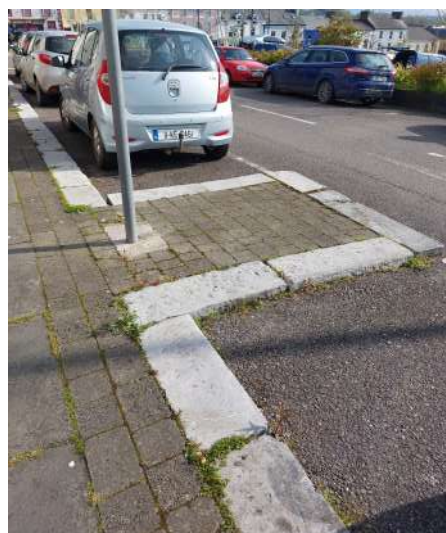
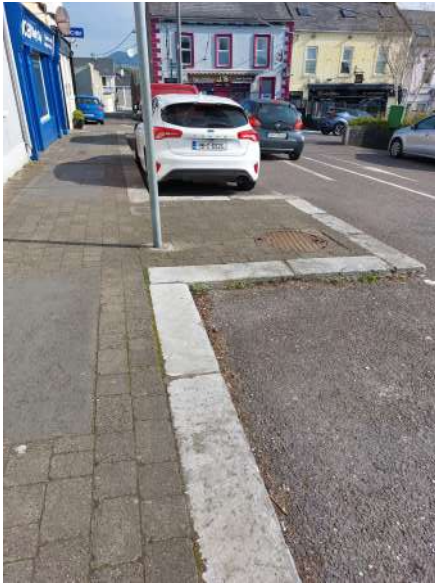
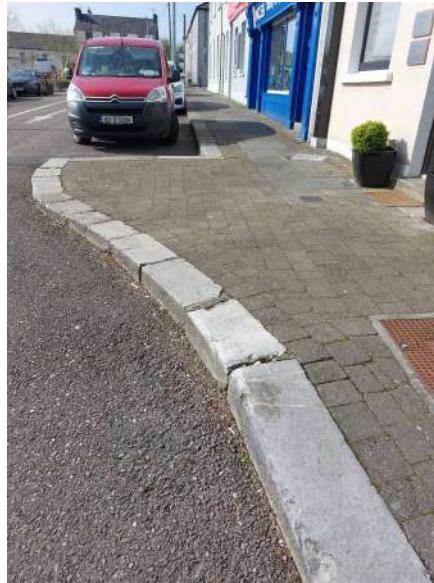
Reference 1

Description: This historic kerbing is approximately 300mm wide and matches the historic kerbing found in King Street. However, the kerb has been re-laid in this position at some point in the history of the square, with it being arranged to form parking bays to the east end of the square.

1S Section of kerb to the west side of the square to the south of the intersection with King Street. In good condition generally.

1R Section of kerb to the west side of the square to the north of the intersection with King Street. In good condition generally.

Physical Impact: The laying of the new paths/ paving/ road surfaces will be in directly adjacent to the kerbs and there is a risk of damage to the historic fabric

- A detailed design for the paving should be provided as part of the next phase of works. This should include details of the proposed new strips which are suitable for use in this historic context and highlight elements of original fabric being retained/ reused as part of the design
- Care should be taken to ensure that every possible care is taken to avoid damaging the steps in the process of paving the street. A method statement for undertaking these works should be taken out in due course.

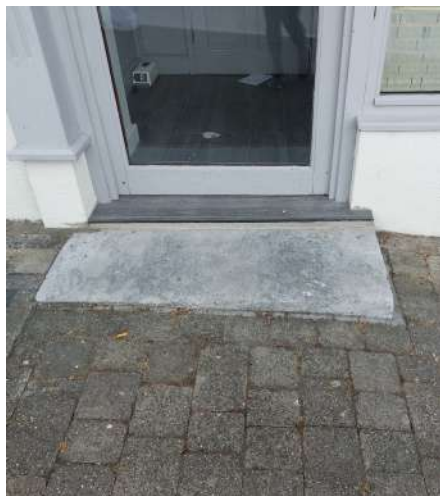
Reference 4

Physical Impact: The laying of the new paths/ paving will be in directly adjacent to the historic fabric, and there is a risk of damage to the stone threshold

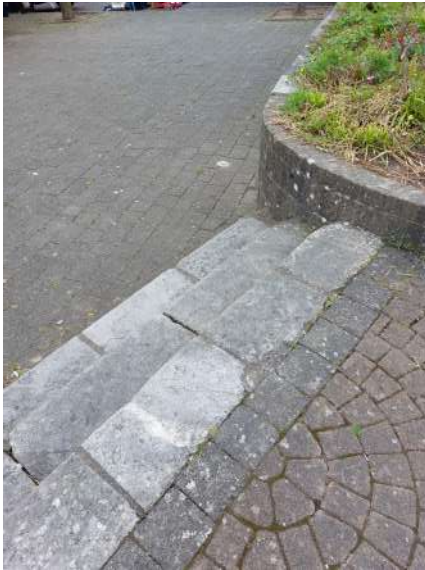
Reference 18

Limestone Steps

18C Centrally located curved limestone steps. It is not clear when these steps date from, but they do not appear in early photos of the square and appear to be a relatively modern addition. It is possible that the limestone present came from historic fabric in the earlier streetscape. In good condition generally.

18 D 3no. Shallow limestone steps along the south side of the square. In good condition generally.

- The limestone from the central steps should be incorporated as part of the detailed paving design in the next stage of work.
- Care should be taken to ensure that every possible care is taken to avoid damaging the thresholds in the process of paving the street. A method statement for undertaking these works should be provided in due course.

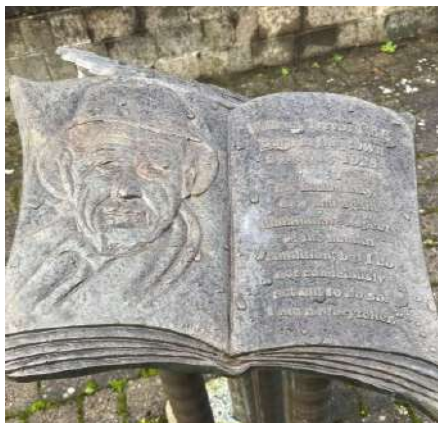
Reference 19

William Trevor Monument

Metal sculpture to the writer William Trevor, in good condition generally.

- Care should be taken to ensure that every possible care is taken to avoid damaging sculpture in the process of moving it. A method statement for undertaking these works should be provided in due course.

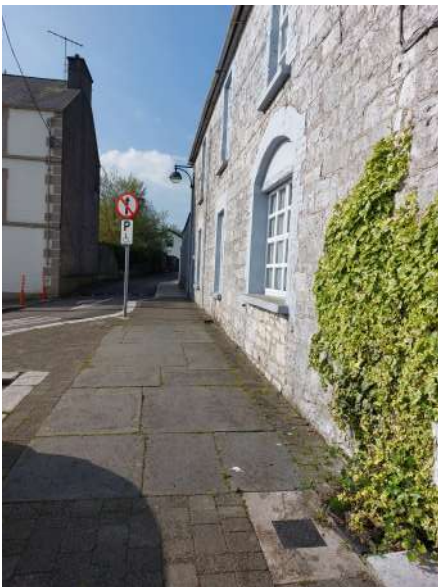
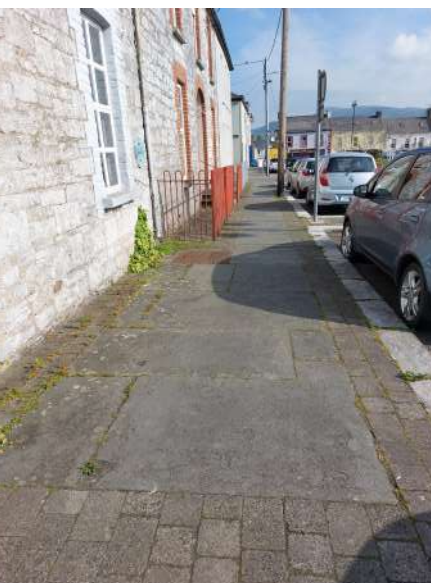
21A

21A: Sections of paving to the west side of the square to the south of the intersection with King Street. The paving is divided into two sections, with small concretes pavers adjacent to the slabs. They are in good condition generally, although some cracking visible towards the south end.

- A detailed design for the paving should be provided as part of the next phase of works. This should include details of the proposed new strips which are suitable for use in this historic context and highlight elements of original fabric being retained/ reused as part of the design
- Care should be taken to ensure that every possible care is taken to avoid damaging the paving as part of the proposed works. A method statement for undertaking these works should be provided in due course.

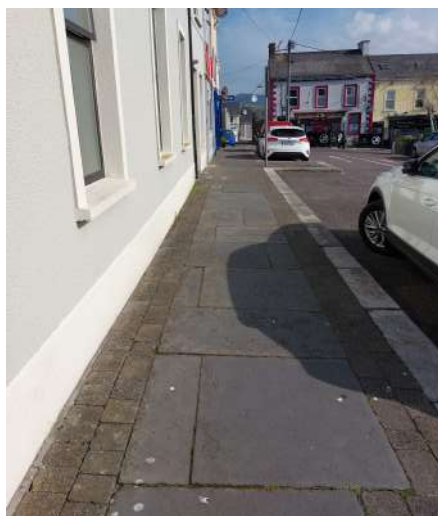
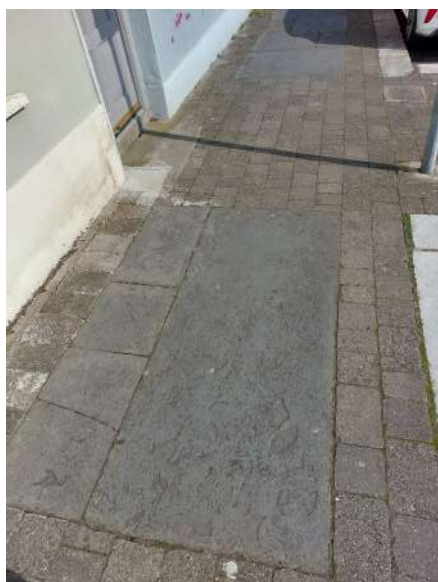
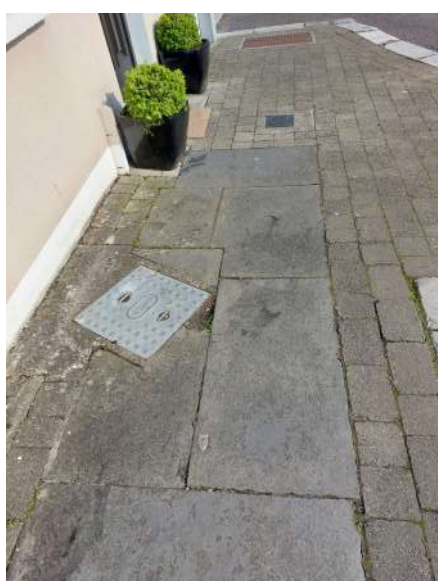
21B

21B: Sections of paving to the west side of the square to the north of the intersection with King Street. The paving is divided into four sections, with small concretes pavers adjacent to the slabs. They are in good condition generally.
