**Mitchelstown Public Realm Design,
Mitchelstown, Co. Cork
Archaeological Impact Assessment**

Client: Cork County Council

Report Date: 22nd February 2023

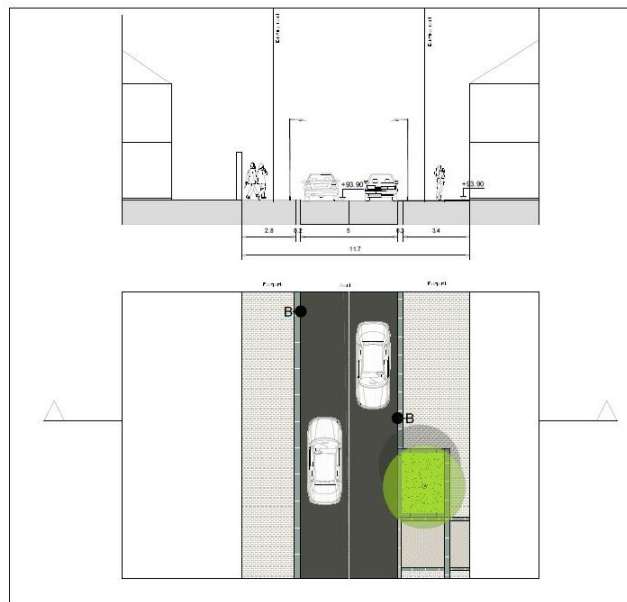
Figure 12: Kings Street Proposed Development Sections

NEW Section A kings Street

NEW Section B kings Street

King Street (Figure 11 & 12): King Street runs along an east west axis from New Market Square to George's Street. The street looks out to Market Square to the east, behind which is the Courthouse with the Spire of the church visible above. The hills behind this form a backdrop to this planned vista.

Reduction in the width of the carriageway is proposed to 5m. This would permit safe cycling in the street. (dmurs compliant) and create a cycle connection to New Market Square. Adequate space for parking is proposed and finished with pavement materials. Narrow beds of 0.5m wide could be created to allow for planting. Residents could be encouraged to refurbish their houses with funds to promote a consistent pallet of colour. It is proposed to add trees to one side of the street to the scale of the street and not block the historic vista. It is proposed to retain the historical parts of the pavement and reuse them in the design. Overhead wiring is to be undergrounded and new lighting poles fitting the scale of the street are to be proposed on one side of the street.

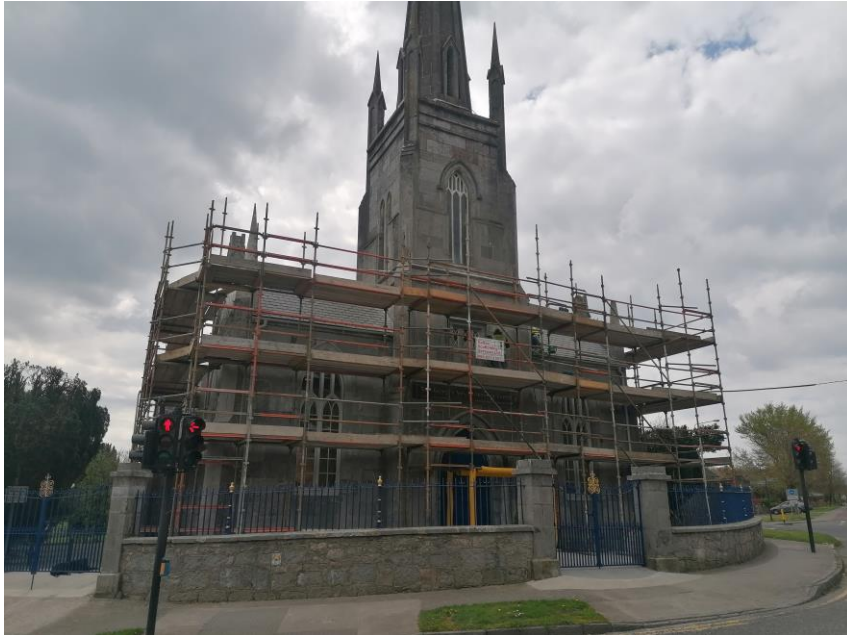
Plate 3: Church of Ireland Church (CO019-028002) undergoing restoration

Church of Ireland Church (CO019-028002) built in 1801 by the Countess of Kingston, located at the southernmost end of George St was undergoing restoration at the time of the visit (Plate 3). Opposite the church the demesne wall, measuring over 2m high was noted lining George St and continuing westward down Kildorrery Road. One of the original gateways and a pedestrian entrance (both disused) were noted in this area with dressed stone caps, pillars and surrounds (Plate 4).

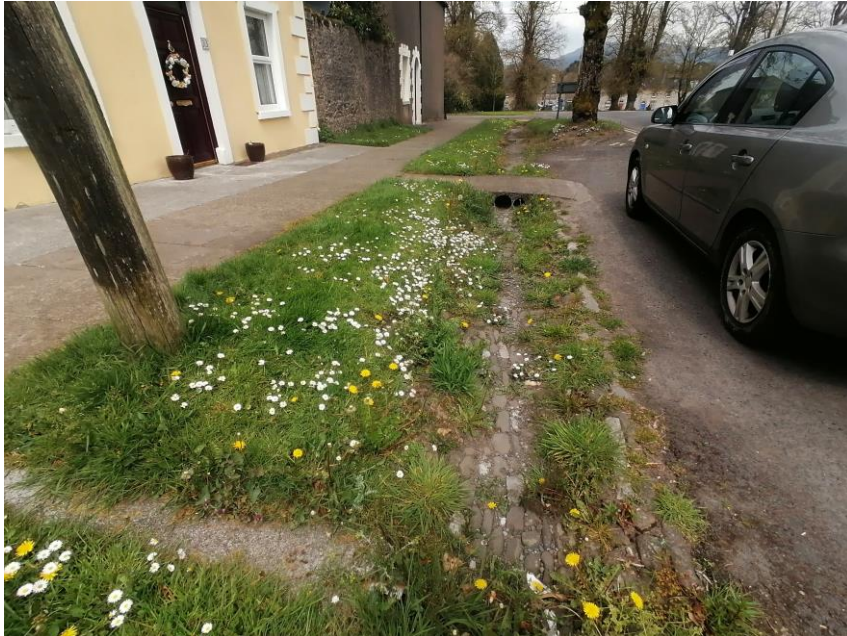
Plate 7: Original Street features such as cobbled drain and kerbing

As George St. approaches Kings Square many of the original street features, such as cobbled drains and kerbs can be seen (Plate 7). Kings Square itself is a beautiful, large open area with substantial private dwellings on the southern side and smaller 'alms houses' on the northern side. Many of these houses are not in use and are in a bad state of repair (Plate 8-10).

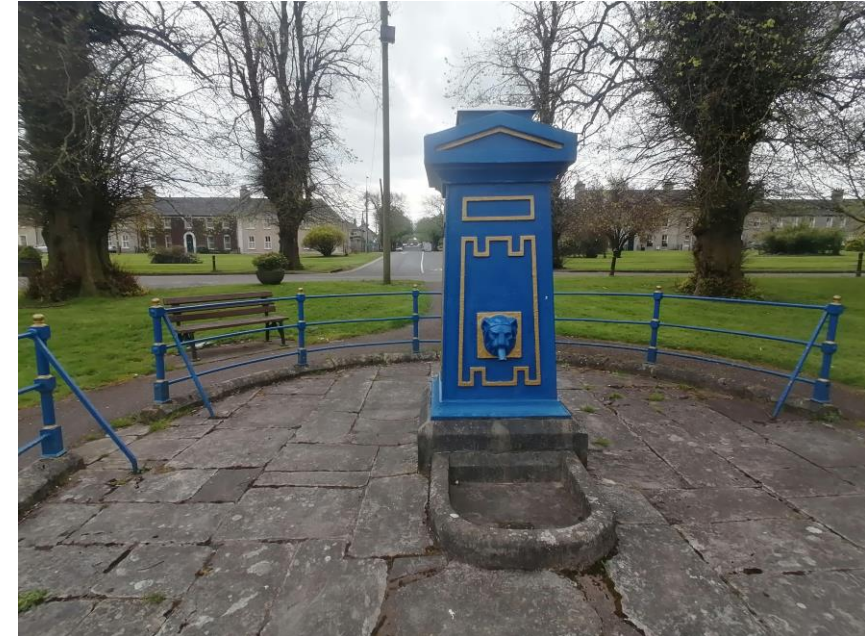
Plate 12: Original water fountain

The original water foundation still stands in the centre of Kings Square (NIAH Reg. No. 20818039). This would have provided clean drinking water for the inhabitants of the square and surrounding areas (Plate 12). There were many areas across the town where original features were built into the modern streetscape such as the original sign for Robert Street and footpath drains and street kerbing (Plate 13 & 14).

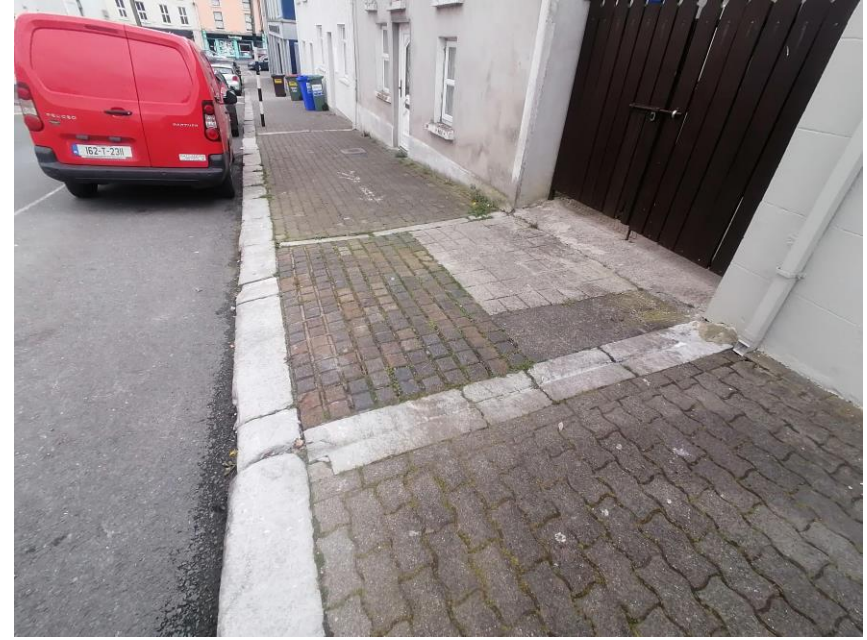
Plate 14: Original path drains and path kerbing
