# N25 Little Island Pedestrian and Cyclist Bridge

Environmental Impact  
Assessment Report

Volume 4  
Appendices

September 2023

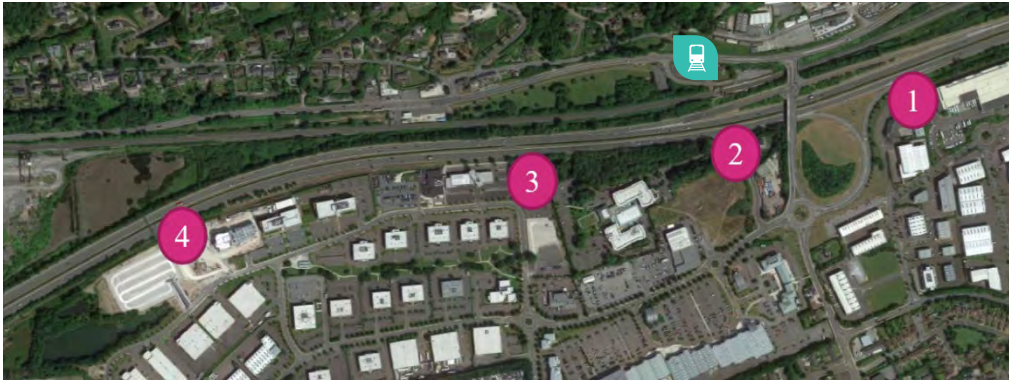
Figure 2: Potential New Bridge Landing Points Considered

As part of the LISTI project, an initial examination of 4 potential bridge landing locations were identified and examined. These 4 locations are identified in Figure 2 below.

Initial examination based on walking catchment and location resulted in two of these options to be removed at an early stage, namely locations 1 and 4. In order for either of these locations to be viable, it was determined that it would require a relocation of the Little Island Train Station. Cork County Council held initial discussions with Iarnród Éireann (IÉ), during which the feasibility of relocating the station was discussed. IÉ indicated that it could be feasible to relocate the station, hence options 1 and 4 were considered. However, when comparing the pros and cons of relocating the train station against retaining its current location, it was considered that a relocation of the station would not provide sufficient benefits to justify the capital expenditure at this time. Therefore, Options 1 and 4 have not been considered further in this feasibility report.

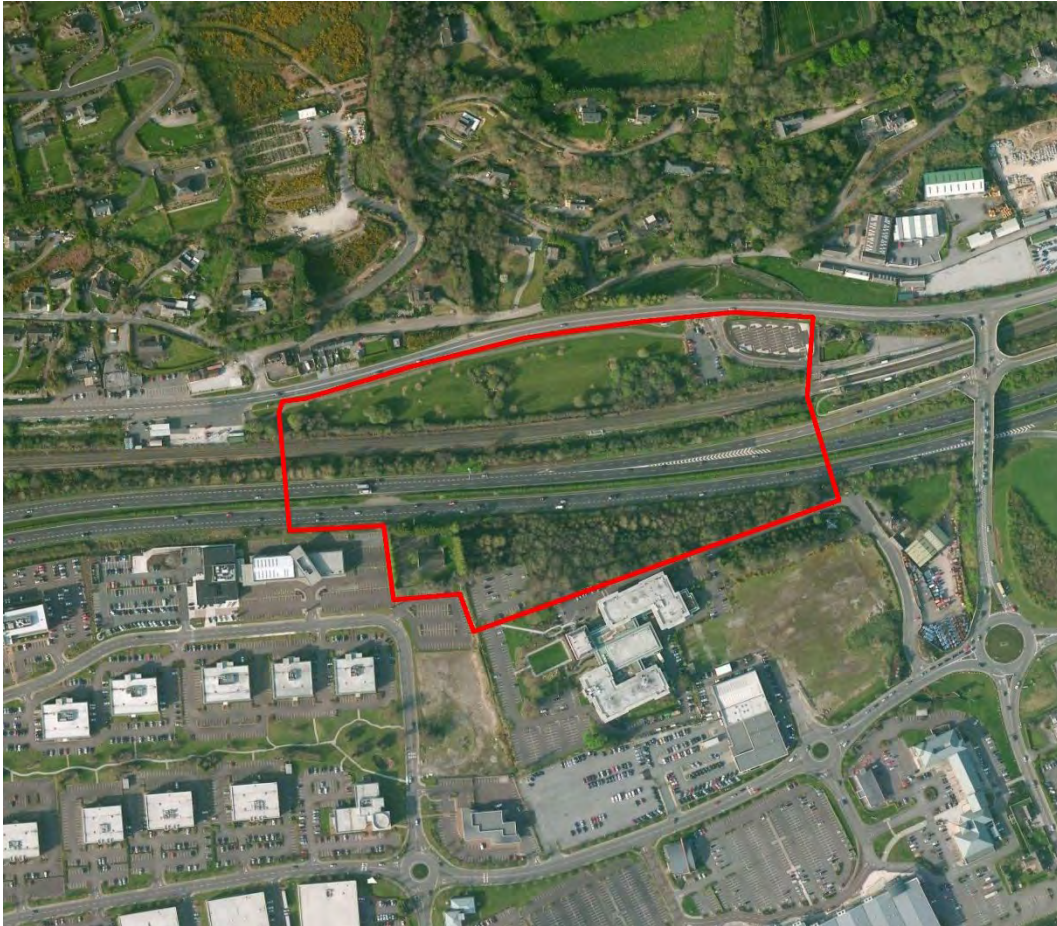
Figure 6: Feasibility Study Area © Bing Maps

The feasibility study area for the proposed bridge crossing is illustrated in Figure 6 below. This area encompasses landing points 2 and 3 as discussed in Section 4 and the three alignment options presented in Section 5.3.

The study area is bounded by the Glounthaune Road (former N25) to the north of the existing train station and extends between the train station to the east and a petrol filling station to the west on the northern side of the N25 road and existing Cork to Midleton railway.

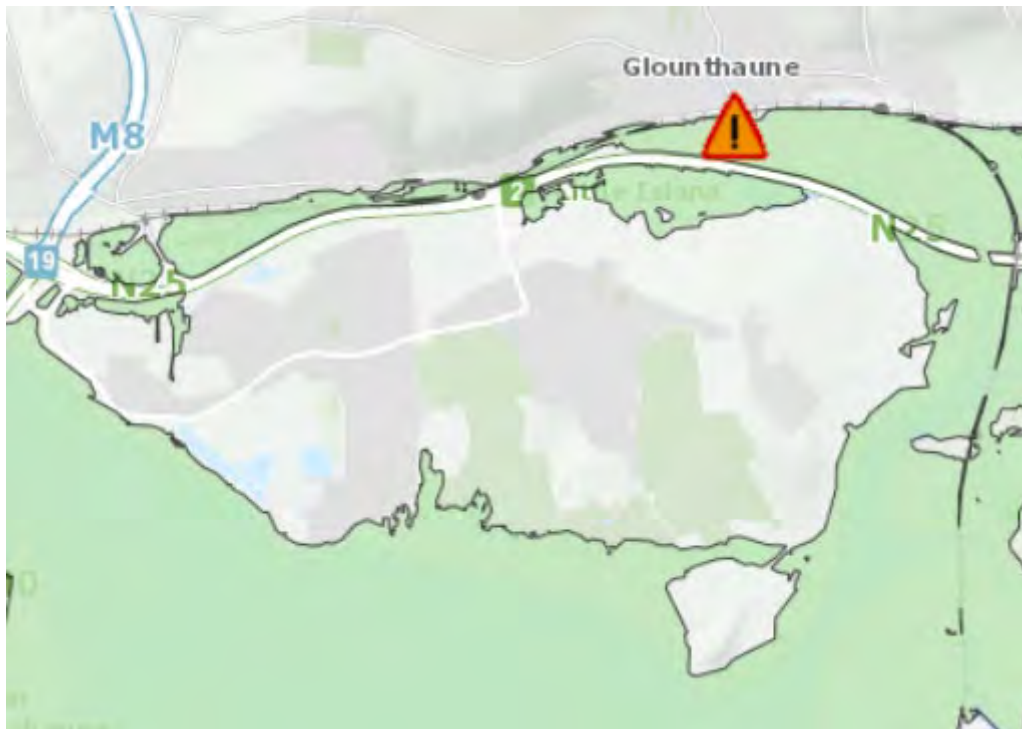
Figure 9 Current Flood Risk Extent and Past Flood Events (Source: <https://www.floodinfo.ie/map/floodmaps/> accessed December 2020)

The website <https://www.floodinfo.ie/map/floodmaps/> provides information on past flood events and current flood risk. Figure 9 shows an extract from this website for the study area. The low-lying land to the north of the railway is currently at risk to flooding. The closest recorded past flood event, indicated by the yellow triangle on Figure 9, was to the east of the study area.

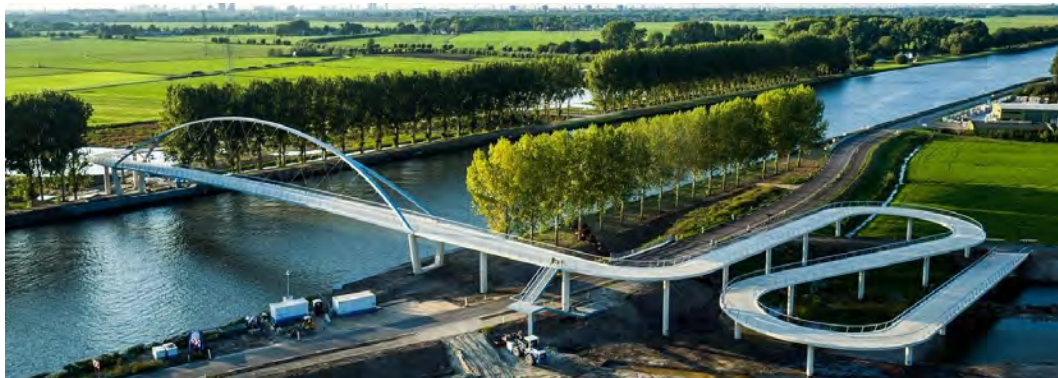
Figure 12 Example Elegant Bridge Ramp Design

The support structure for these ramps will need to be minimal in size to mitigate the effect on the surrounding environment and animal habitats and be aesthetically pleasing to minimise visual impact of the structure. See Figure 12 and Figure 13 below comparing an elegant approach ramp to a standard approach ramp.

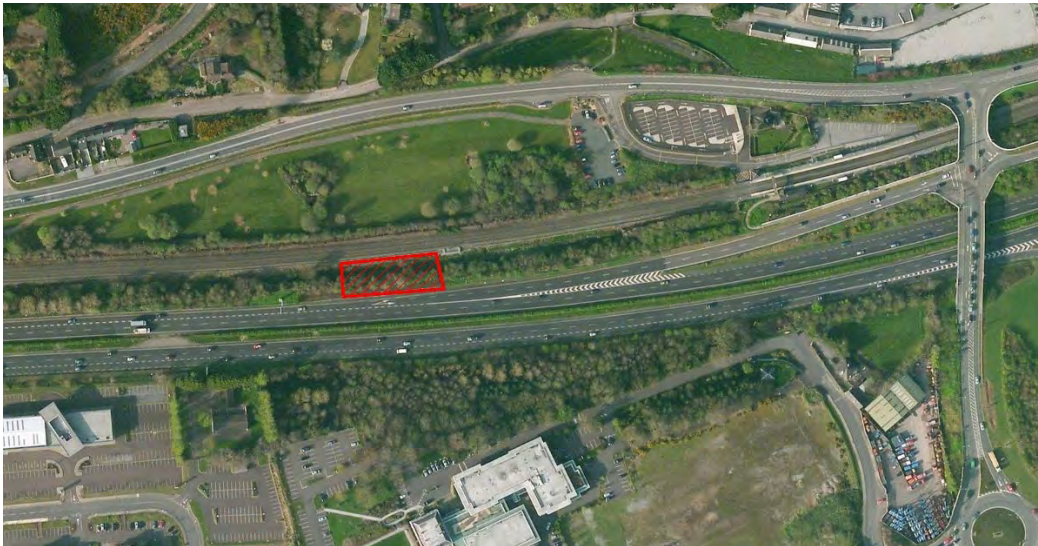
Figure 14: Land between Railway and N25 Road

The ability to construct a foundation on the land located between the N25 primary road and existing railway will also be a significant factor on the bridge form. Figure 14 shows the area of land that is potentially available for the construction of an intermediate pier based on the preferred bridge alignment option.

The ability to construct in this area will turn a single span bridge into a bridge composed of two segments of shorter spans. These shorter spans involve less construction materials being used for the bridge superstructure and therefore are slendrer than the single span option. This will aid in all bridge options but more so the below deck structures as a shallower superstructure will reduce the height of the approach ramps.

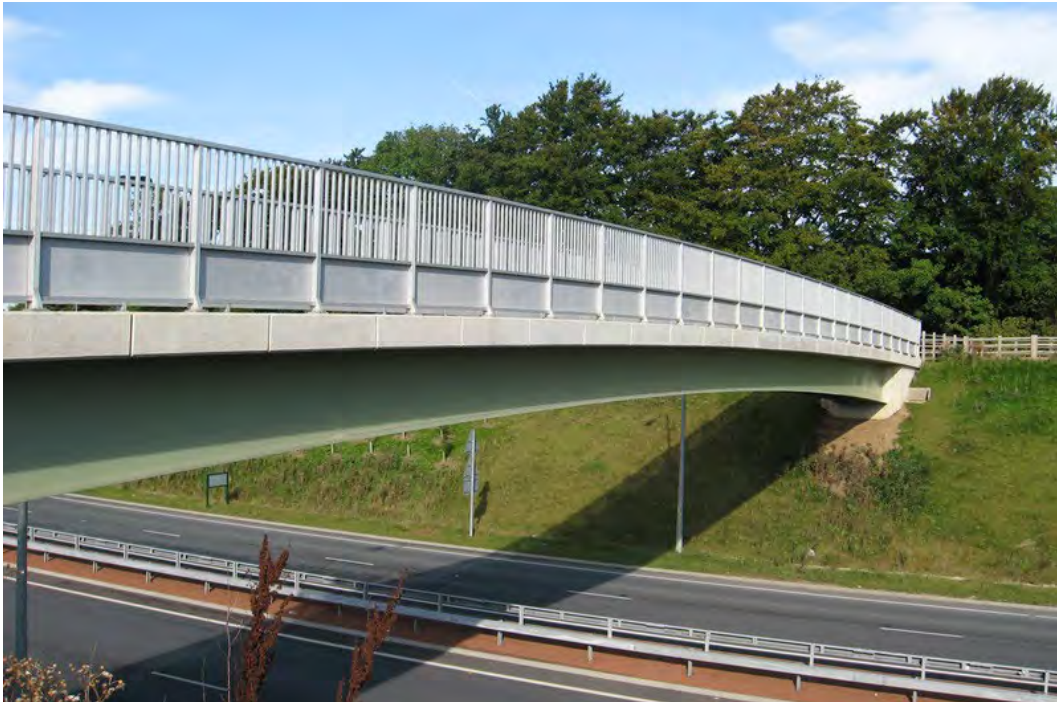
Figure 15: Double Span Through Girder

The supporting structure of a through girder bridge consists of a steel or concrete girder supporting the deck. The girders themselves are the primary support for the deck and are responsible for transferring the load down to the foundations. Material type, shape, and weight all affect how much weight a beam can hold and the depth of the girder itself.

Given the relatively flat terrain, an above deck structure appears to be most advantageous in limiting the extent of ramping. Therefore, it is recommended that the through girder option (Option 1) is not considered further.

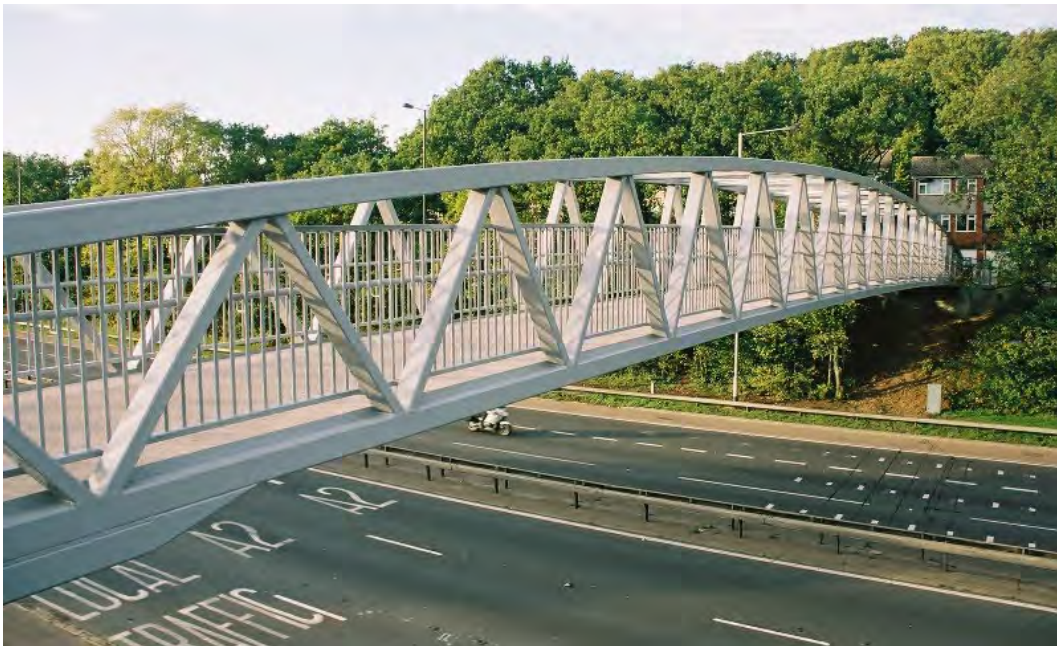
Figure 16: Single Span Through Girder – A2 Midhurst Warren Truss, UK

Half-through steel bridges are a common solution for pedestrian and cycleway bridges. The footway/cycleway is relatively narrow and a stiffened steel plate deck can easily span between the main beams on each side.

For the single span option, a truss depth in the region of 2.5m to 3m is feasible with all of the structure above deck and the handrail incorporated into the structure itself as shown in Figure 16.

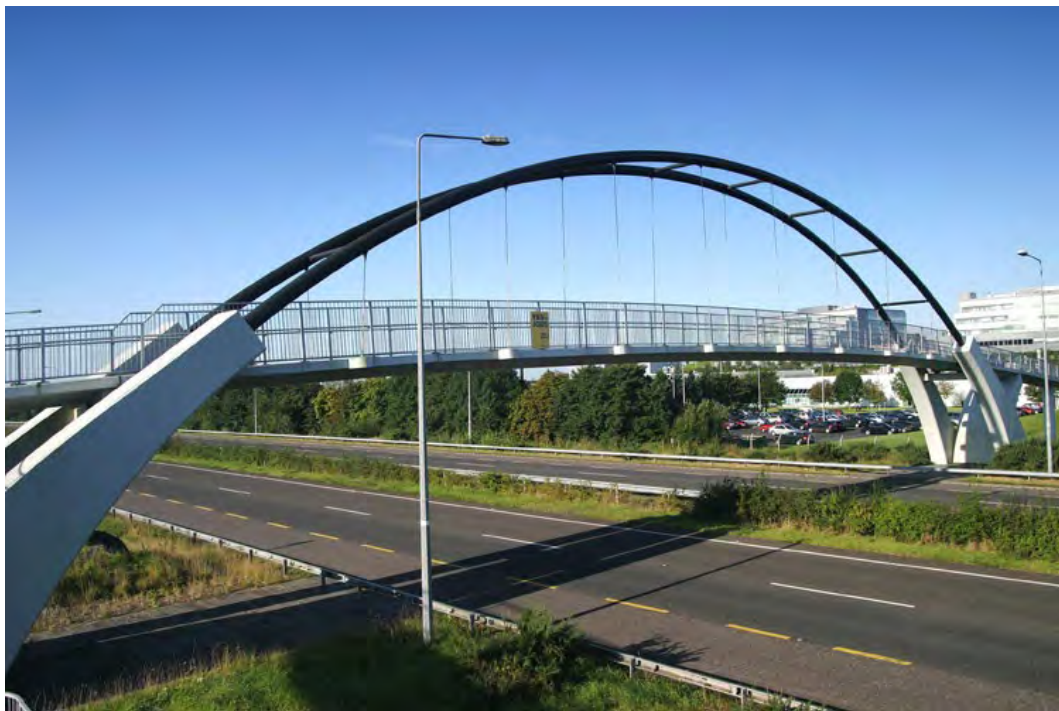
Figure 17: Shouldered Tied Arch Bridge Example – N19 Co. Clare

A tied arch bridge (also called bowstring-arch) is a type of bridge that has an arch on each side of the deck of which its outward direction horizontal forces are tied together by a chord tying the arch ends, usually the deck itself. The deck itself is then hung by vertical tie beams connected to the arches support the deck from above.

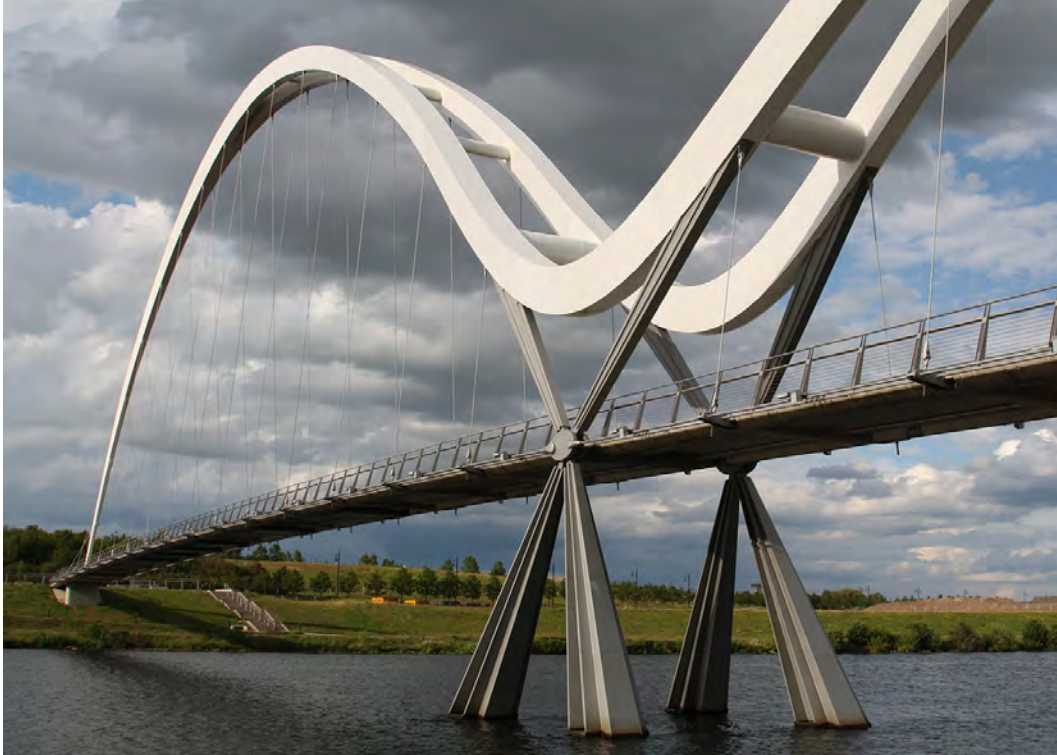
Figure 18: Double Span Tied Arch Bridge Example – Infinity Footbridge, Stockton-on-Tees, UK

Multi-span continuous tied arches are also a potential option with the 30m – 65m span ratios supported by two arches of varying span and height. In this example the continuous deck spans over the support tying the arches together.

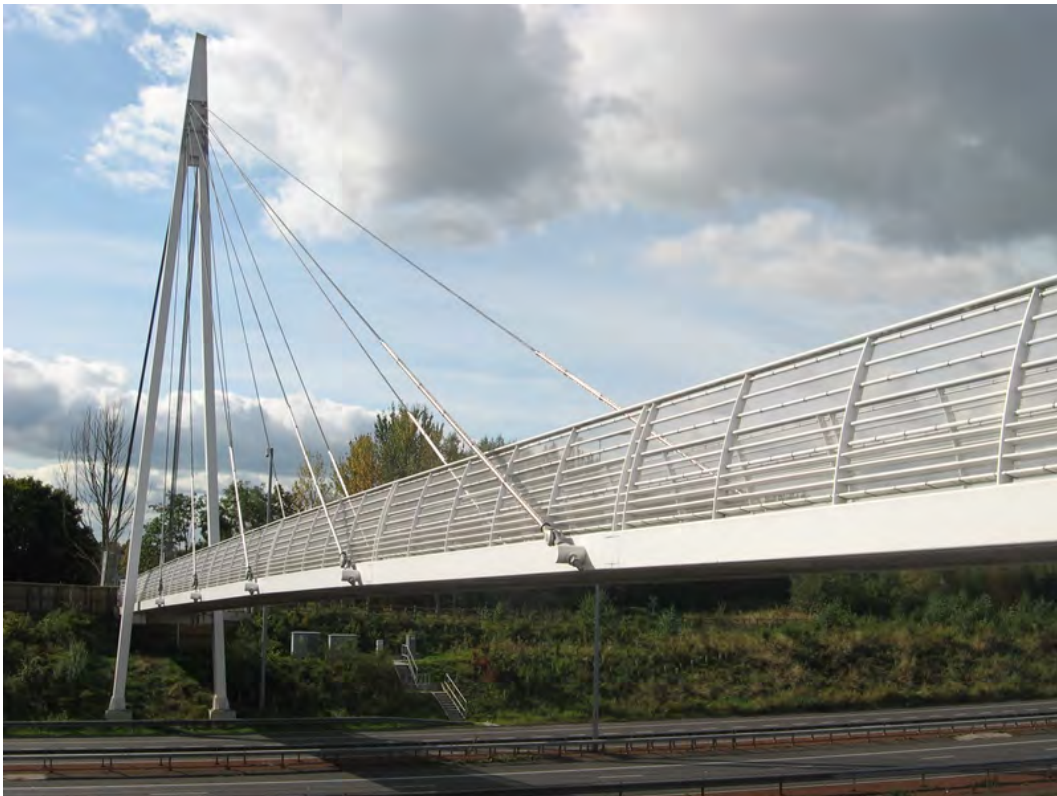
Figure 19 Cable Stayed Bridge Example

A cable-stayed bridge has one or more towers from which cables support the bridge deck. A distinctive feature are the cables or stays, which run directly from the tower to the deck, normally forming a fan-like pattern or a series of parallel lines.

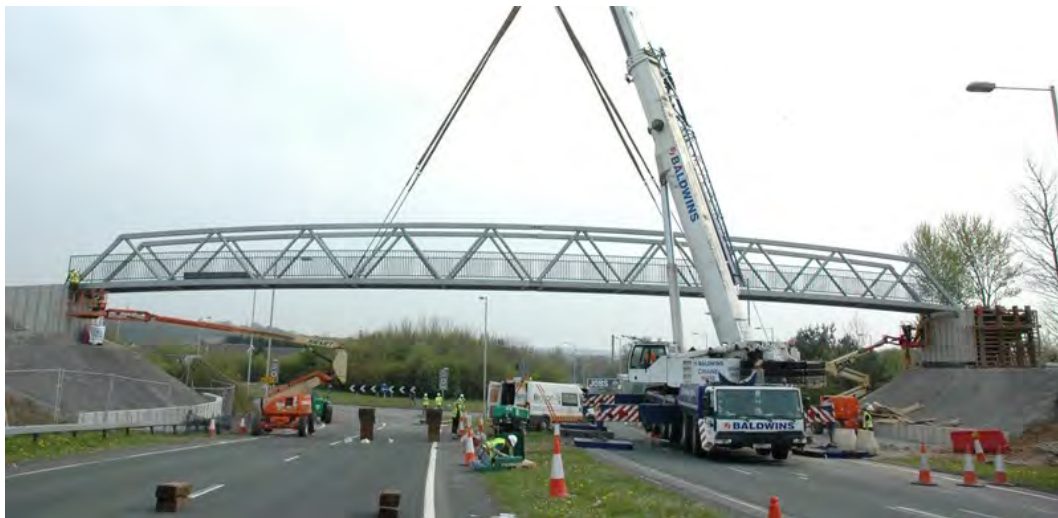
Figure 20: Bridge Erection during Road Closure

For Options 1, 2, 3, 4 and potentially Option 5 final erection would be carried out using one or two large mobile cranes during a night time road closure as shown in Figure 20.

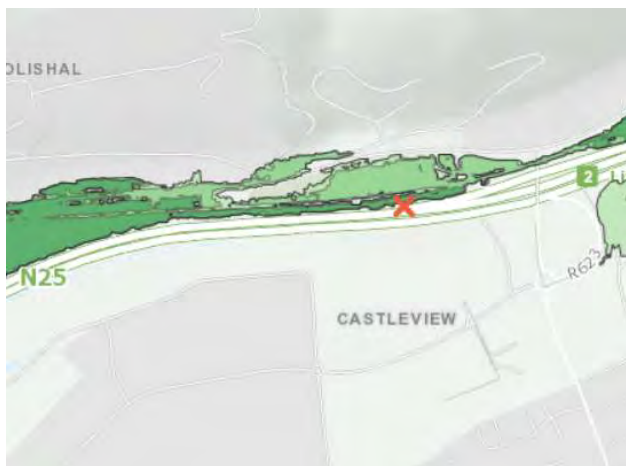
**Figure 4.1: Screenshot from floodinfo.ie showing extent of potential coastal flooding at location of proposed alignment**

The website floodinfo.ie provides flood maps which show a medium probability of coastal flooding in the northern park area and the lower areas surrounding the Irish Rail track at the location of the preferred alignment. Consideration shall be given to this in the options assessment and preliminary design of the preferred option. Consideration shall also be given to the mix of embankment vs elevated structure in areas at risk of flooding to minimise the maintenance liability for components in this area. Further consideration will be given to flood risk in the Environmental Impact Assessment.

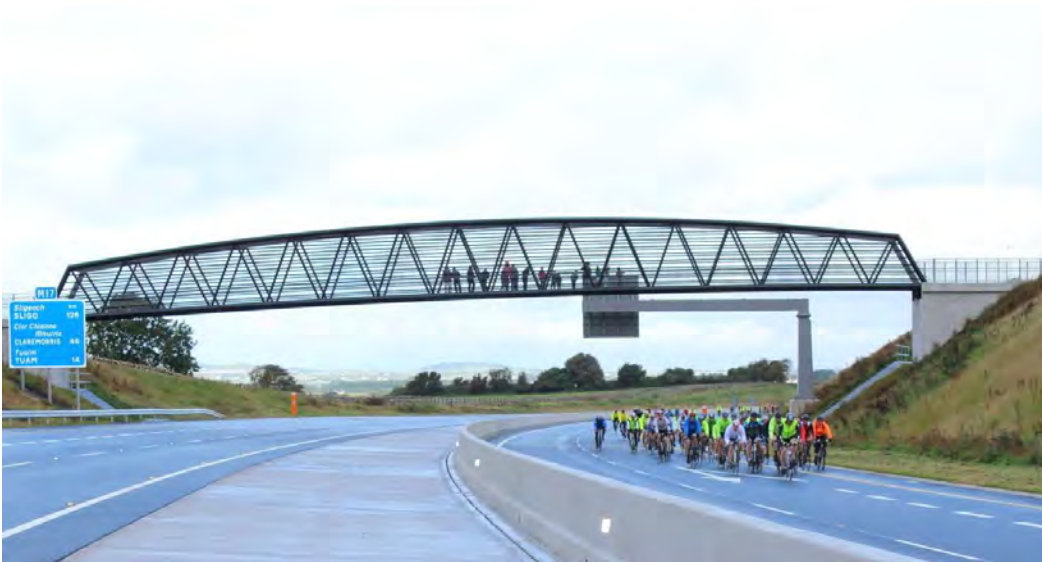
**Figure 4.3: Example of through truss pedestrian and cycle bridge**

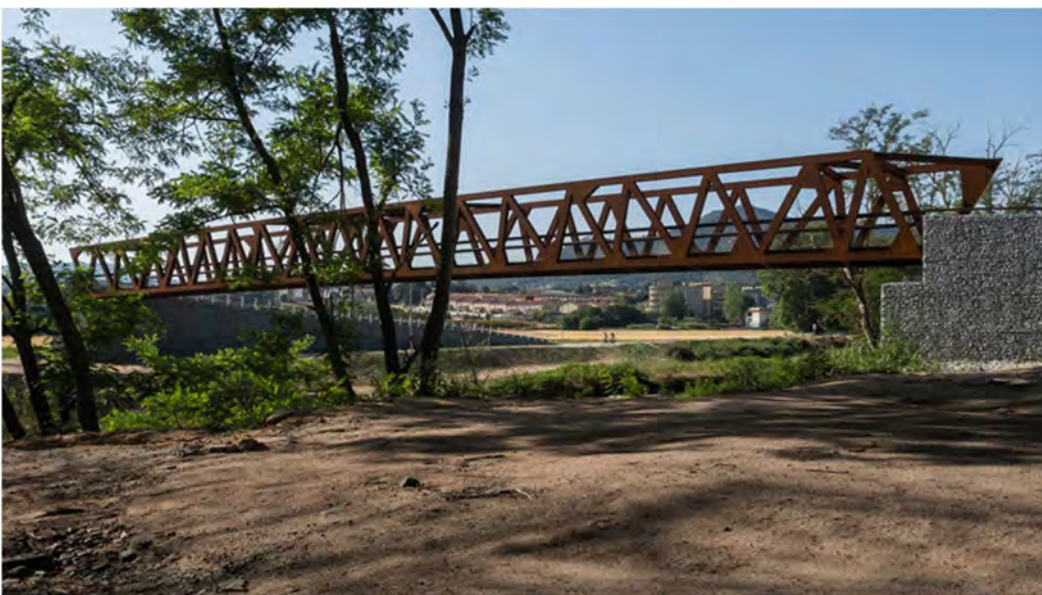
**Figure 4.4: Example of through truss pedestrian and cycle bridge of higher aesthetic (note weathering steel not expected applicable for this project, architectural option would be painted steel)**

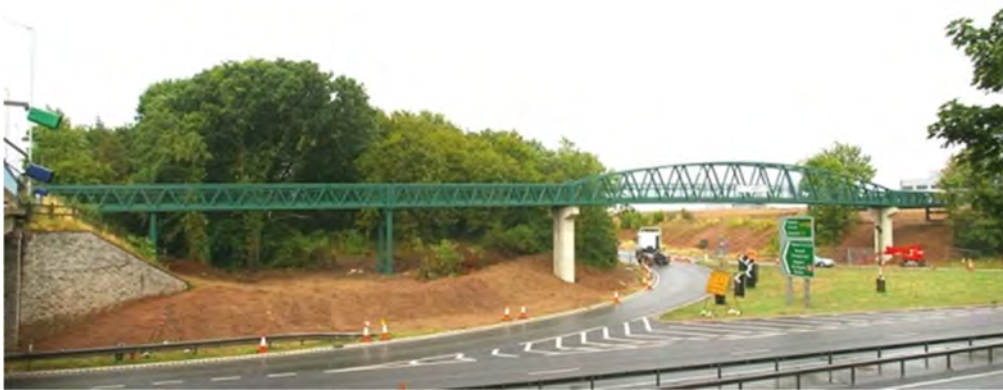
**Figure 4.6: Example of multiple span through truss footbridge structure**

Structural option 2 consists of a 2-span steel through truss structure crossing the N25 and the Irish Rail line in separate spans. The structures shown in Figure 4.5 are arched Howe truss structures. The spans of these structures will be approximately 50m (N25) and 30m (Irish Rail). The steel structures would be of painted steel construction. Weathering steel is not suitable as the location is close to the ocean. Figure 4.6 and Figure 4.7 give an indicative example of a similar structures.

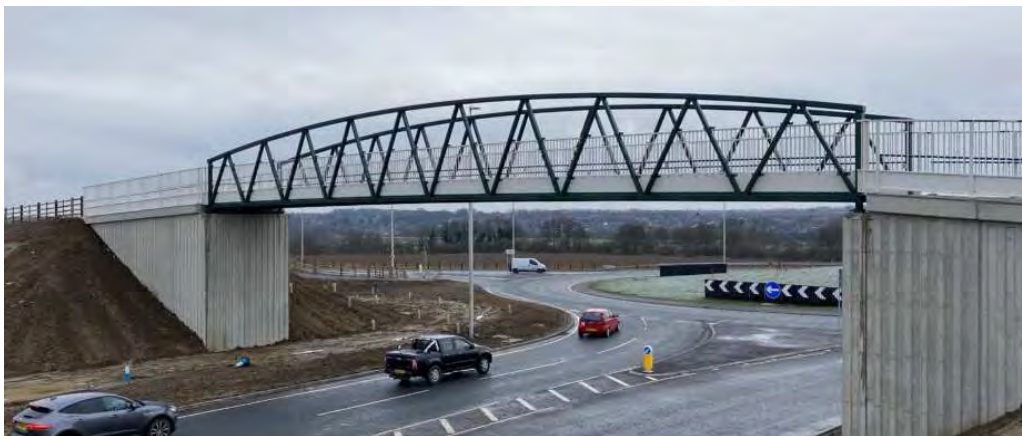
**Figure 4.7: Example of shorter span steel through truss over road**

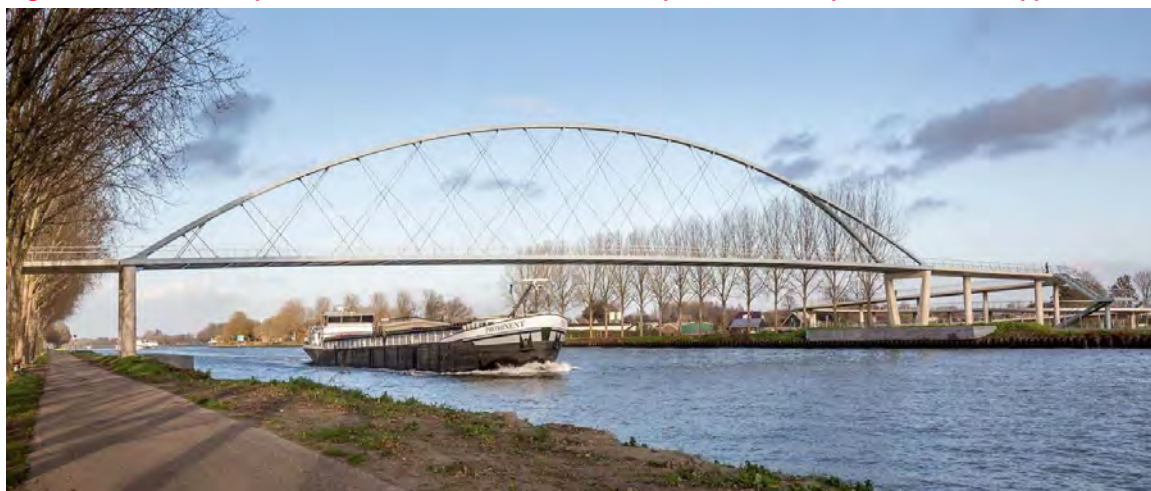
**Figure 4.9: Example of steel network arch pedestrian and cycle bridge with concrete deck**

Structural option 3 consists of a single span steel network arch structure over the N25 and a 2-span precast segmental portal frame structure over the Irish Rail track and adjacent land to the south. Both a steel deck and a concrete deck can be considered for this option should it be selected. A steel deck would be more lightweight however a concrete deck would help to maintain the aesthetic link to the Irish Rail span and would reduce maintenance requirements. The spans of these structures will be approximately 50m (N25) and 2x15m (Irish Rail). The steel structures would be of painted steel construction. Weathering steel is not suitable as the location is close to the ocean. Figure 4.9 and Figure 4.10 give an indicative example of a similar structures.

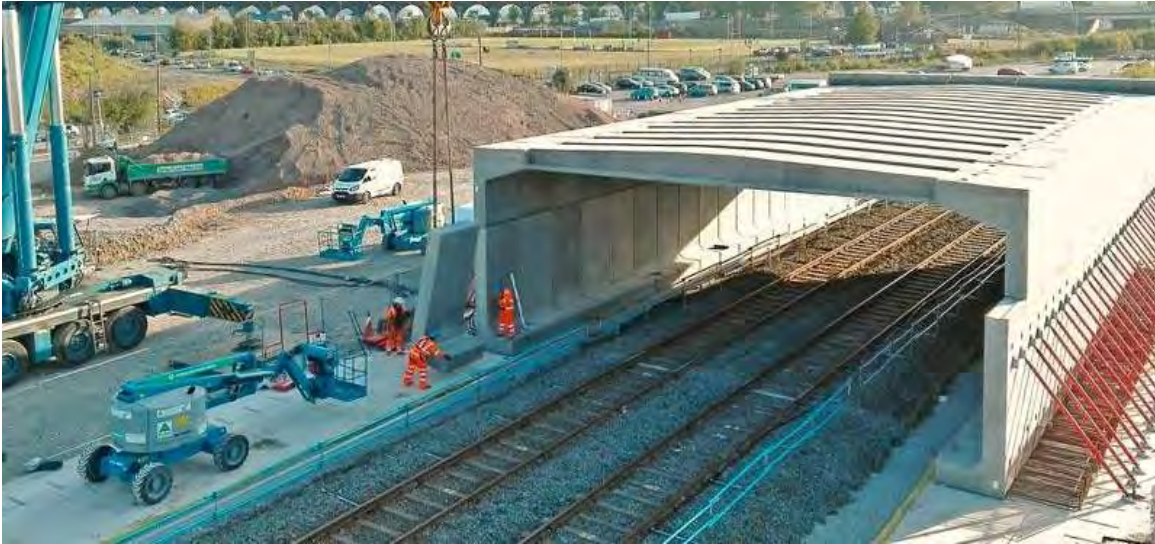
**Figure 4.10: Example of segmental precast reinforced concrete porta frame structure over rail**

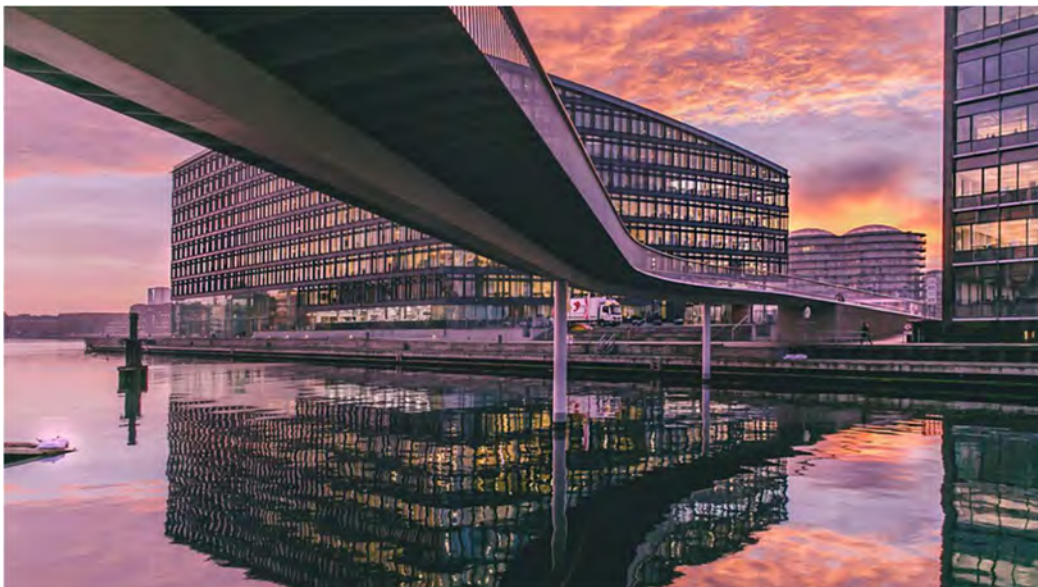
**Figure 4.12: Example of steel elevated ramp/cycleway structure with spine beam and monopiles/columns**

A spine beam structure with single piers for the northern elevated ramp section and a more economical edge beam design with 2 column piers and crossheads for the southern ramp sections. See Figure 4.11 for indicative cross sections of both structural forms. Both options would allow for a consistent deck aesthetic for the user.

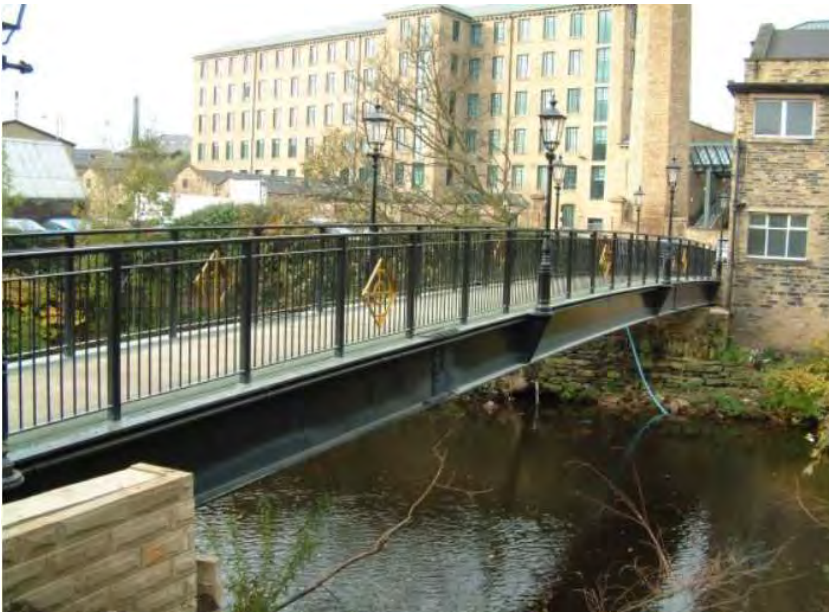
**Figure 4.13: Steel edge beam bridge**

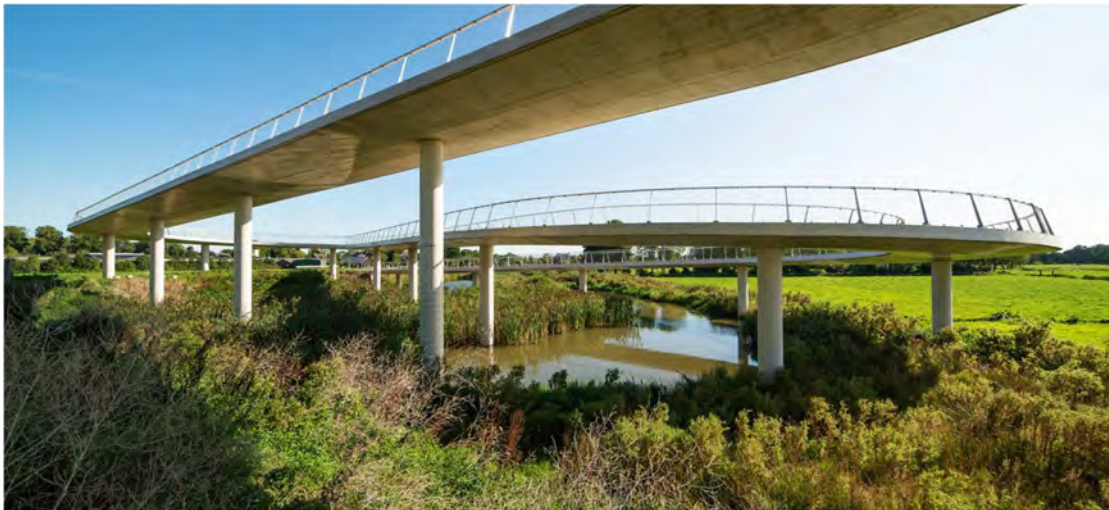
Figure 4.15: Example of reinforced concrete elevated ramp structure with monopiles/columns (northern approach ramp)

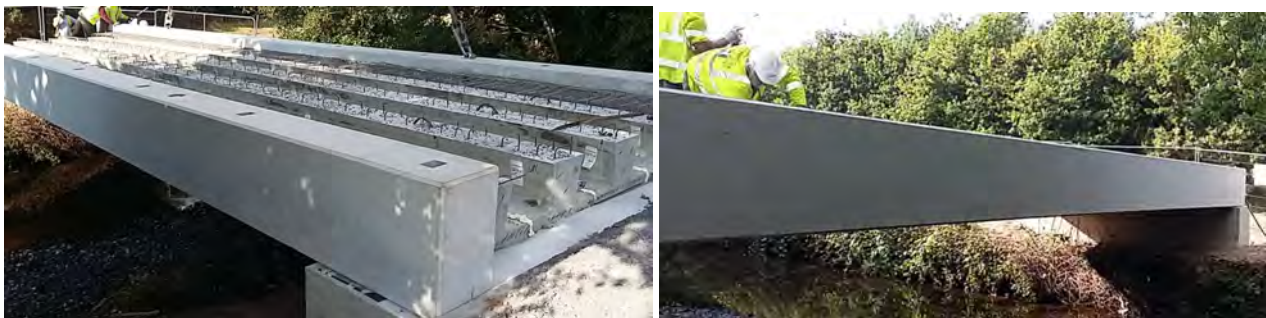
Figure 4.16: Economical precast prestressed concrete bridge beam option for approach ramp elevated structure (southern approach ramp)

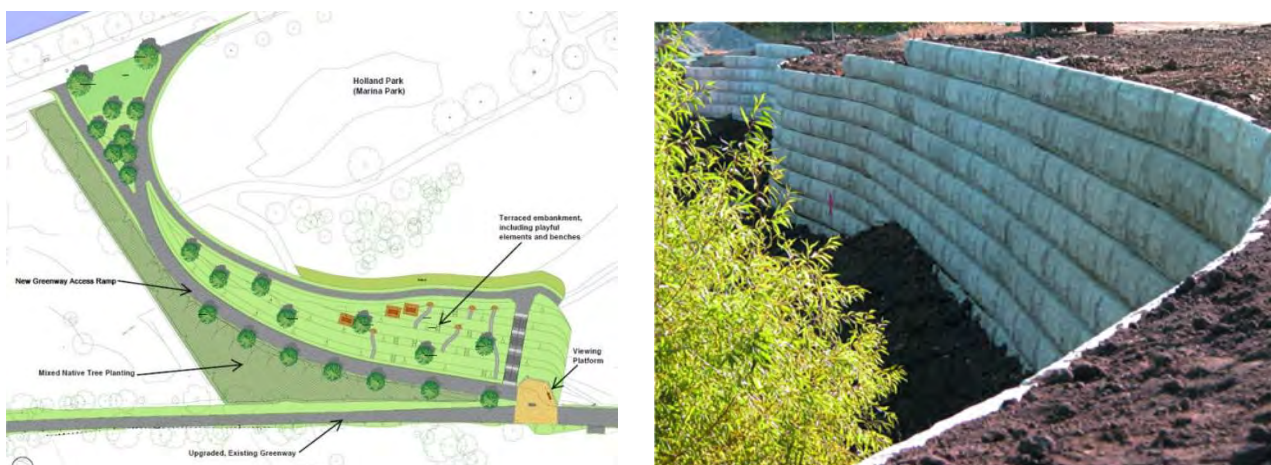
**Figure 4.17: Example of landscaped ramp (left) and soil reinforcement retaining wall (right)**

Figure 4.17 gives an example of a landscaping proposal used to blend an approach ramp for the Blackrock Greenway in Cork into the surrounding landscape. Proposals similar to this will be developed further during preliminary design for the tie in point of the ramp on the northern approach.

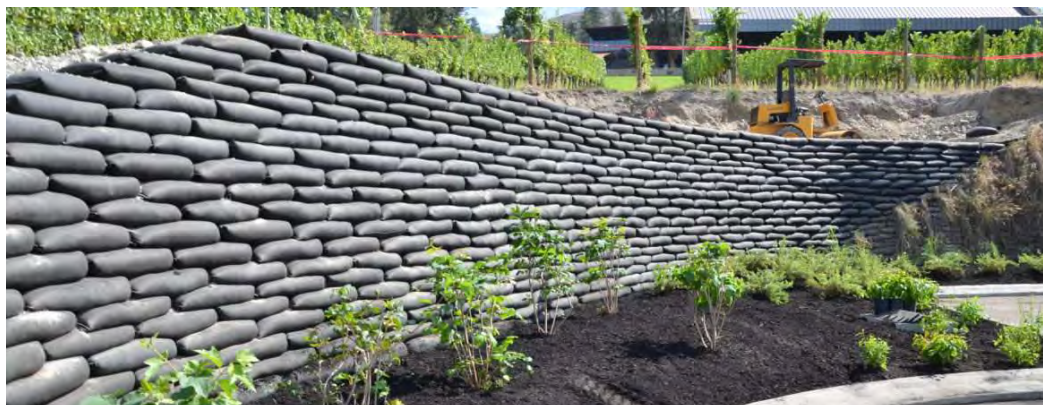
**Figure 4.18: Vegetated green wall retaining solution, prior to vegetation growth**

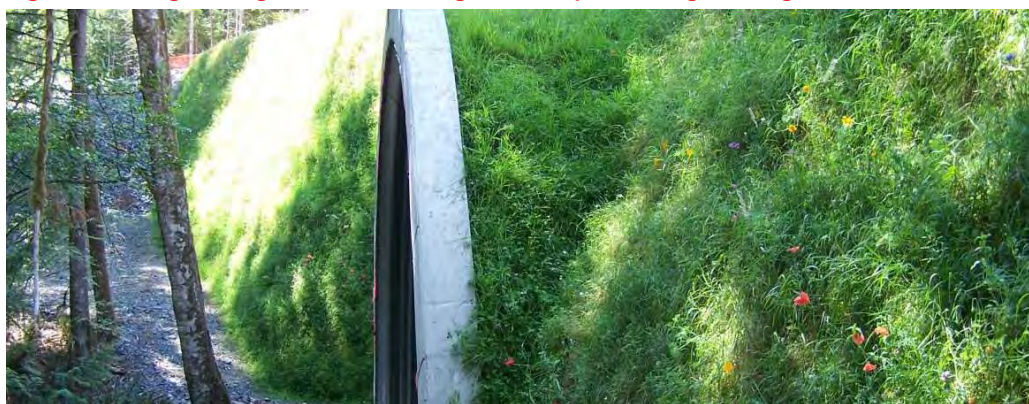
**Figure 4.19: Vegetated green wall retaining solution, following vegetation growth**

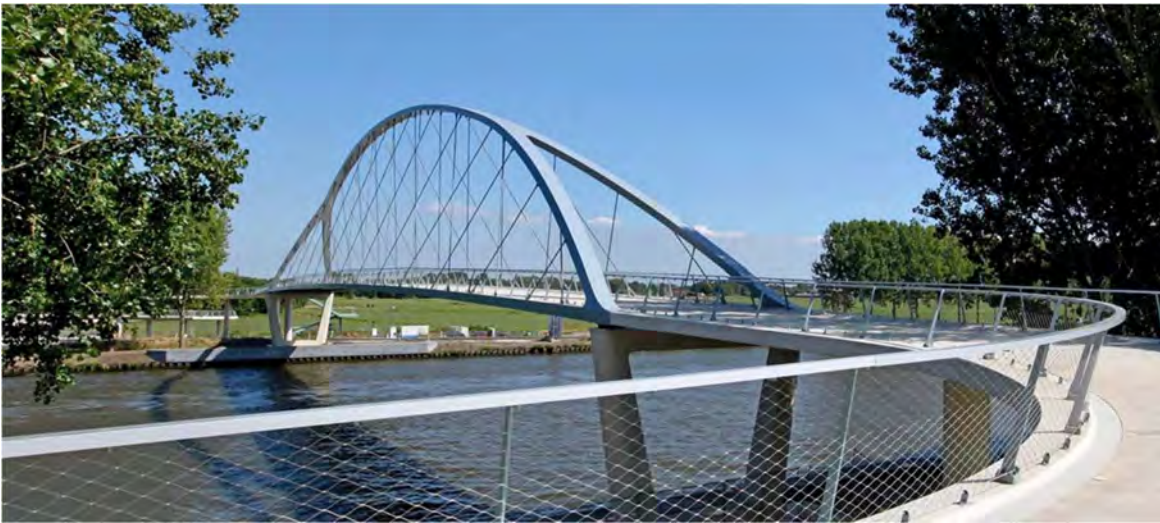
Figure 16.4: Example of network arch structure with concrete deck

The proposed N25 span structural form will consist of a steel network arch structure with a reinforced concrete deck to ensure a consistent design aesthetic is maintained with the reinforced concrete decks provided on the approach ramps and Irish Rail span.

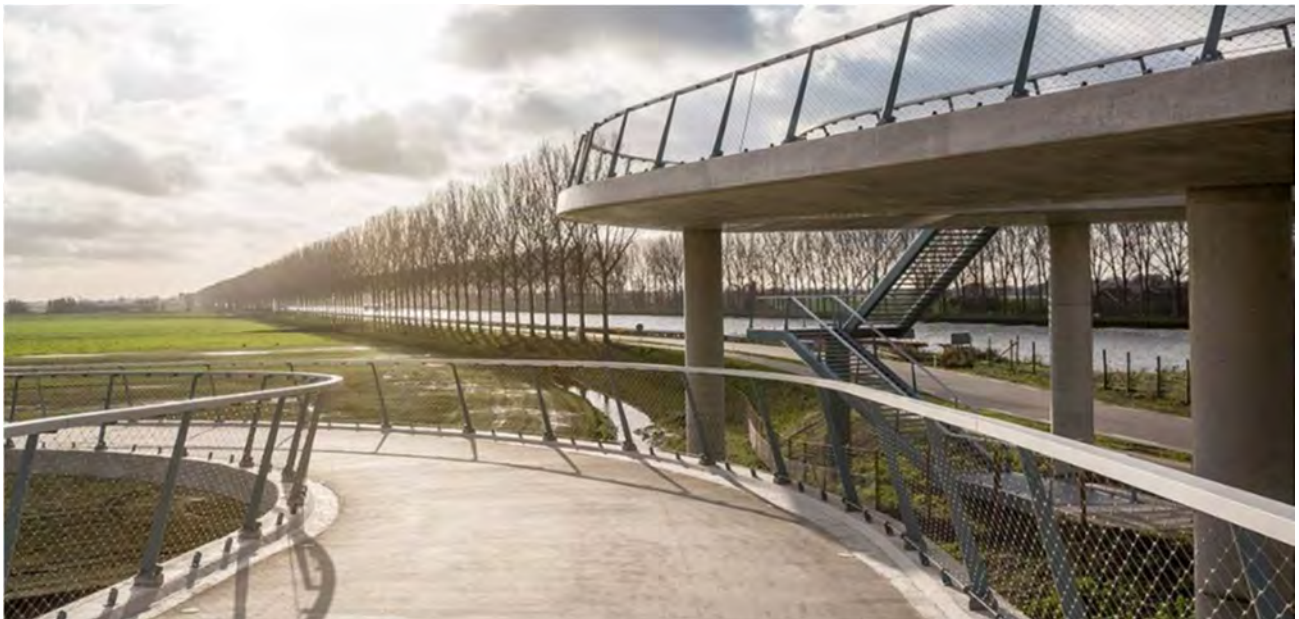
**Figure 16.8: Parapet type with vertical post and rail and steel mesh infill**

For the N25 span and the approach ramps and steps several parapet types are possible. 1.4m high parapets will be required on these spans. The parapet type to be used will be confirmed at the next phase in consultation with CCC, TII and Irish Rail. Two types of parapets under consideration (outside of Irish Rail span) are post and rail with steel wire mesh infill (Figure 16.8) & vertical post infill at closely spaced centres (Figure 16.9).

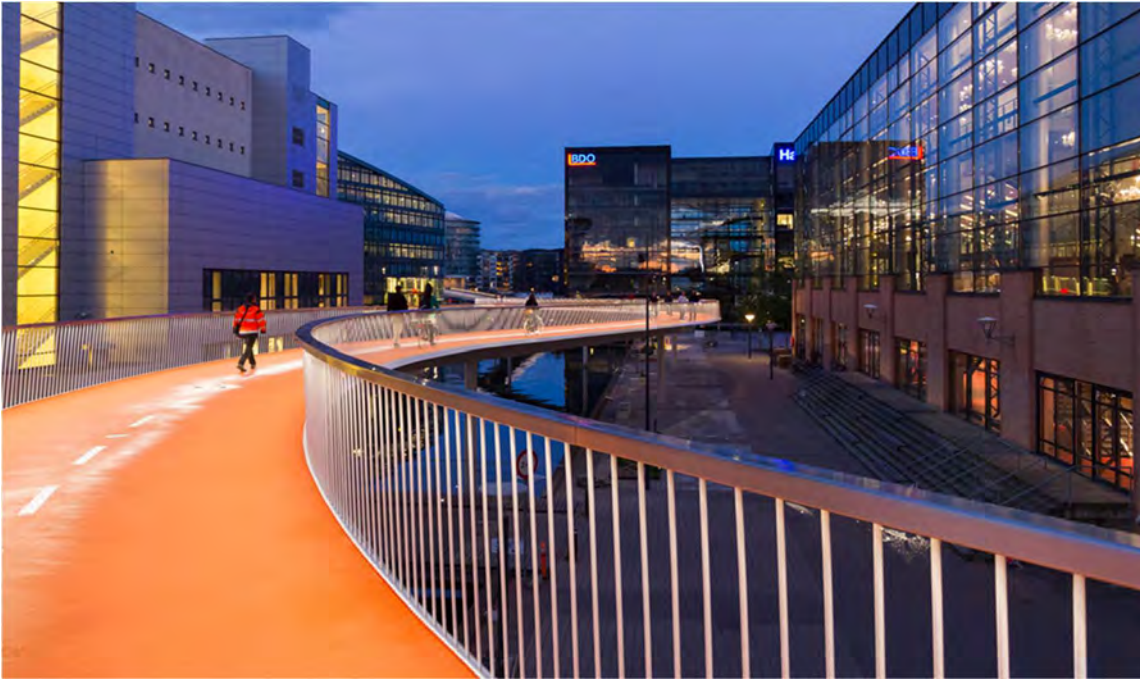
**Figure 16.9: Parapet type with vertical parapet infill**

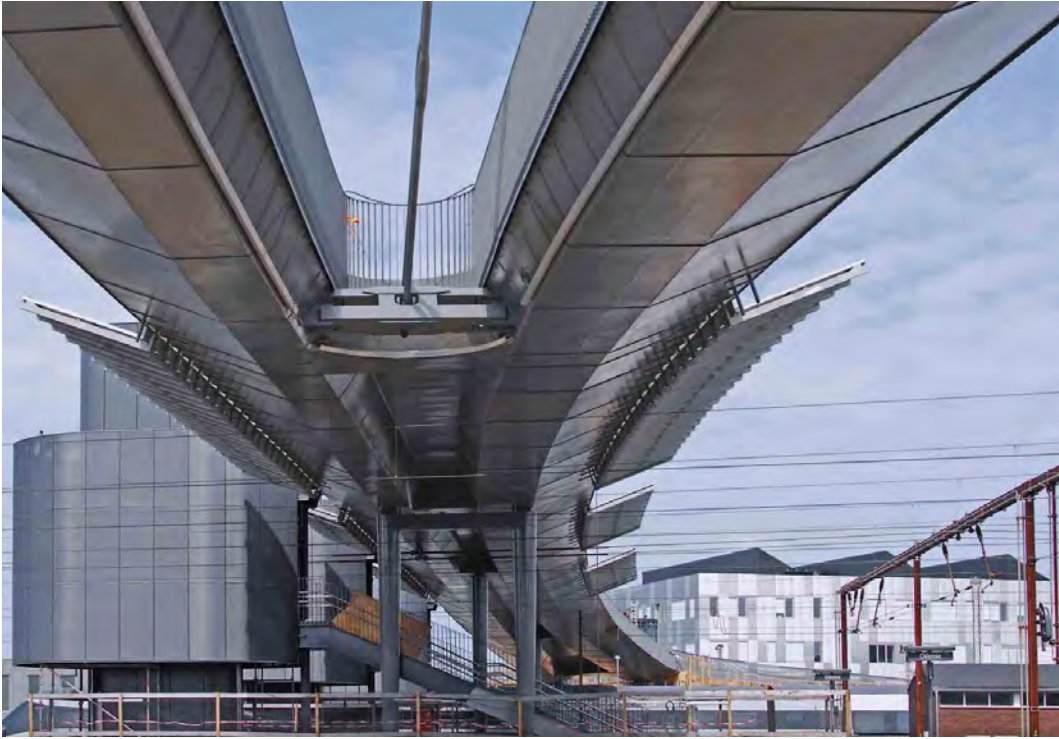
**Figure 11 Example of under bridge screening on new pedestrian and cycle bridge in Odense, Denmark with 1.2m high parapets with vertical bar infill**

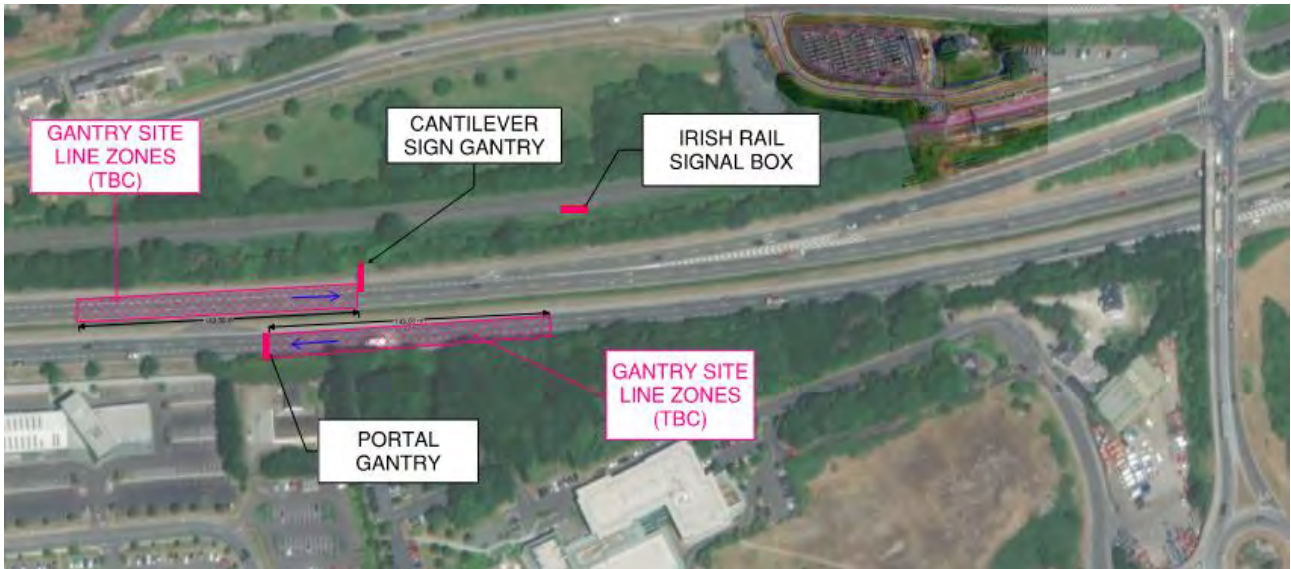
**Figure 2.5: N25 Gantries Locations and site line zones & Irish Rail signal location**

To the West of the study area there are two new sign gantries over the N25. A cantilever gantry on the North and a portal gantry on the south. Further to initial discussions with TII a site line of absolute minimum 200m, but preferably 250m will be required to both gantries and signs. The proposed bridge structure cannot obscure this site line. See Figure 2.5, which gives an indicative set back required from both gantries. This offset will need to be confirmed and agreed with TII once road levels are confirmed by the topographical survey. If a bridge is too close to the gantry TII will likely require this gantry to be moved which will require the reconstruction of foundations etc. During the next stage of this project, preliminary design, the preferred alignment option will be reviewed further to ensure adequate recognition time for signs and legibility is not obscured in accordance with EN 12966.

At an early engagement meeting IÉ identified a signal box approximately at the location of alignment option 2 on the southern side. IÉ has verbally confirmed that this should not pose a constraint to the bridge alignment as it is located at a lower level and on the outside of the curve. The preferred alignment will need to be agreed with IÉ.

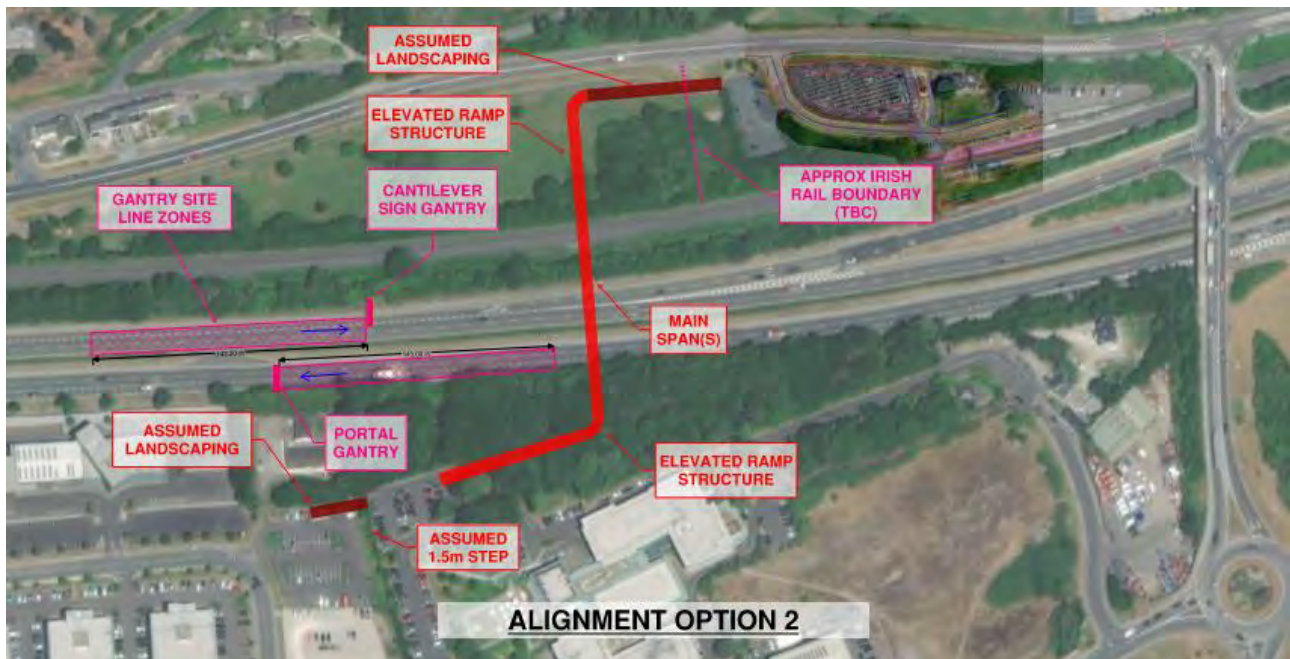
**Figure 2.9: Bridge Alignment Option 2**

Alignment Option 2 main crossing moves further to the east from the Little Island train station however, the landing point of the bridge is towards the hub of the Eastgate Business park. Due to the required length of ramps the northern approach ramp still lands close to the Little Island train station. Key considerations of this option are outlined below.

Based on the evaluation above of alignment options presented in this technical note, we recommend **Alignment Option 2** be taken forward as the preferred alignment option.
