# N25 Little Island Pedestrian and Cyclist Bridge

Environmental Impact  
Assessment Report

Volume 4  
Appendices

September 2023

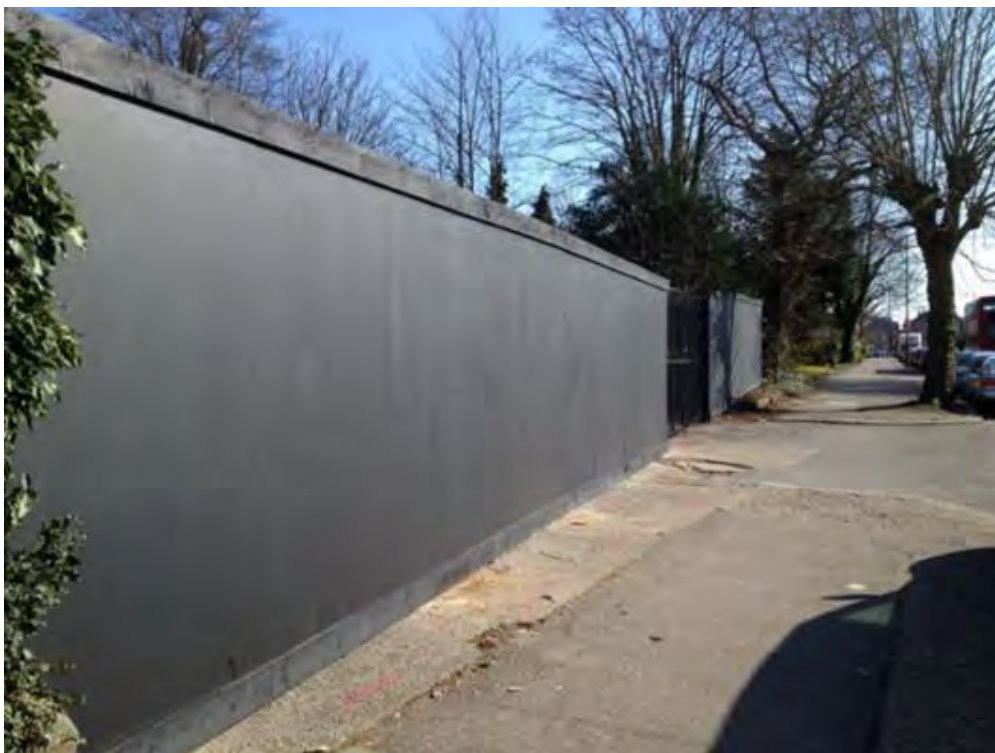
**Image 6: Example of suitable hoarding**

IBEX and / or Heras fencing, or alternate hoarding / fencing and the existing boundary may also be used in places. Controlled access points to the site, in the form of gates or doors, will be kept locked in any time that these areas are not monitored (e.g., outside working hours). The hoarding will be painted, well maintained and may contain graphics portraying project information.

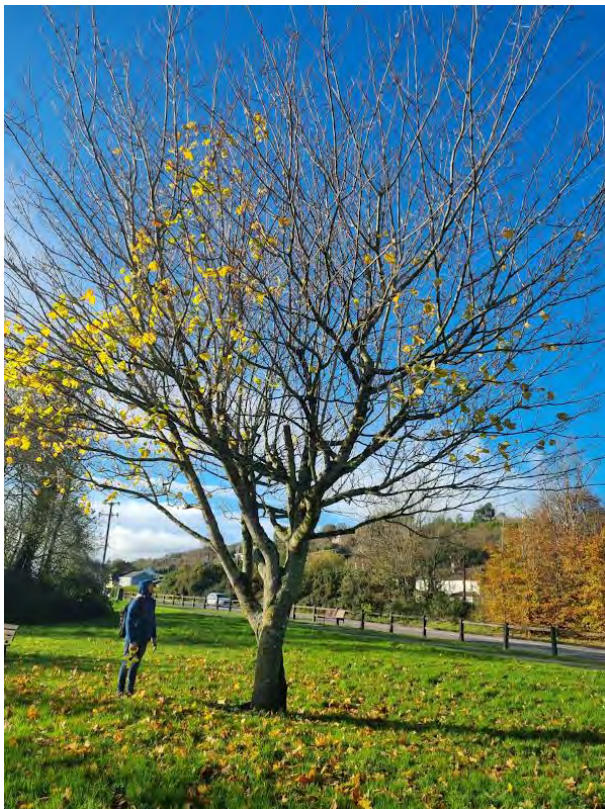
*Fig.3 Example of Site A's decurrent deciduous parkland trees*

- I. The open parkland area of Site A consists of 13 well-spaced decurrent deciduous trees (see *fig.3*), planted at equidistance from each other around the park/green, providing good visual diversity and amenity for pedestrians in Island Corporate Park. The seven (7) different species of trees, range in age from juvenile to mature and have moderately low maturing height (between 8-12m).

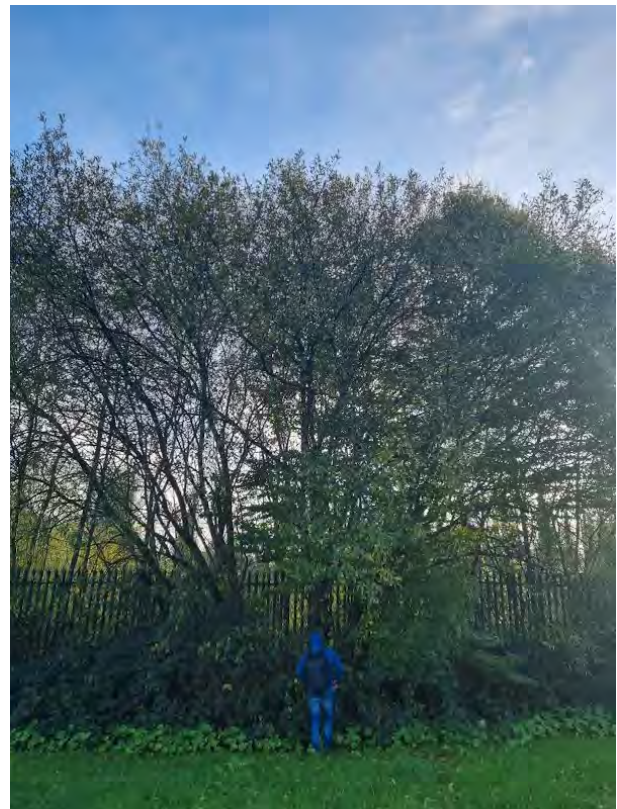
*Fig.4 Example of Site A's alder x grey willow x ash stands*

- III. Along the Southern fence-line of Site A between the park, the Irish Rail line, the N25 and around the carpark, are native groups of three (3) excurrent high canopy tree species with high maturing heights (>12m) (see *fig.4*). These alder (*Alnus*) x grey willow (*Salix cinerea*) x ash (*Fraxinus excelsior*) stands consist of around 398 trees, categorised in this report into 21 groups. In addition there are 6 groups of understory scrub species, including hazel (*Corylus*) and hawthorn (*Crataegus*) (*Perrin et al. 2008*).

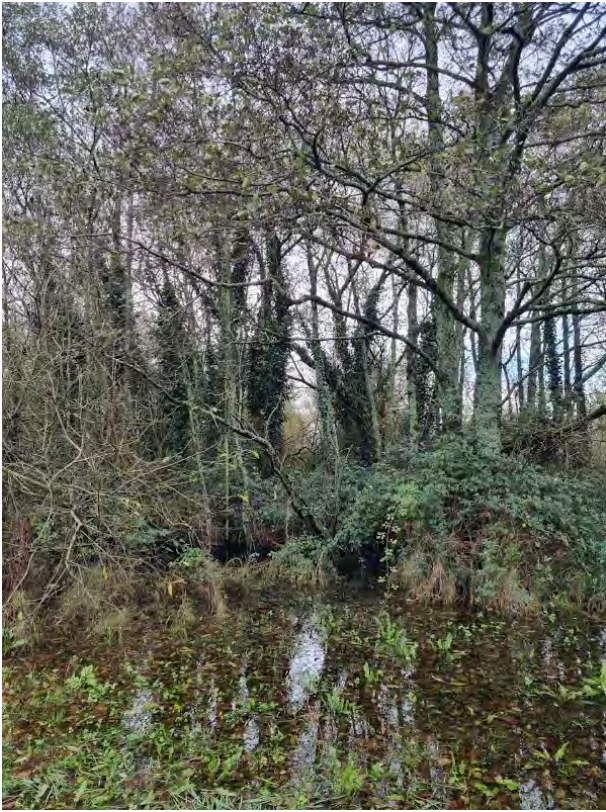
*Fig.5 One of Site A's protruding wetland areas*

- V. The two (2) protruding water-logged wetland areas on Site A (see *Fig.2*) are surrounded/populated by alder and grey willow boscage (see *fig.5*). The grey willows have partially submerged trunks (see *fig.6*) sending up numerous vertical stems into the canopies. The field layers beneath the grey willow boscage were unable to be identified due to the submerged conditions, however characteristically dominant bramble and ivy were observable.

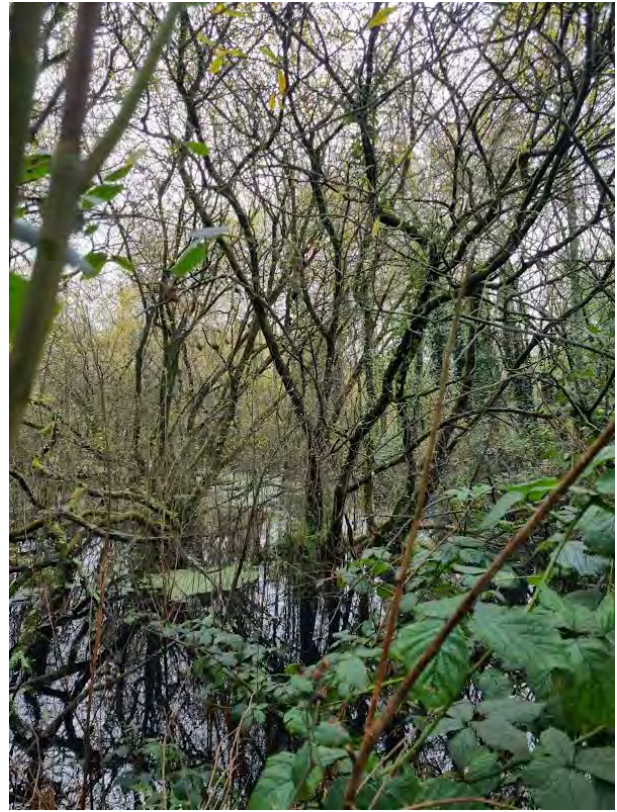
*Fig.6 Example of Site A's grey-willow boscaige with partially submerged trunks*

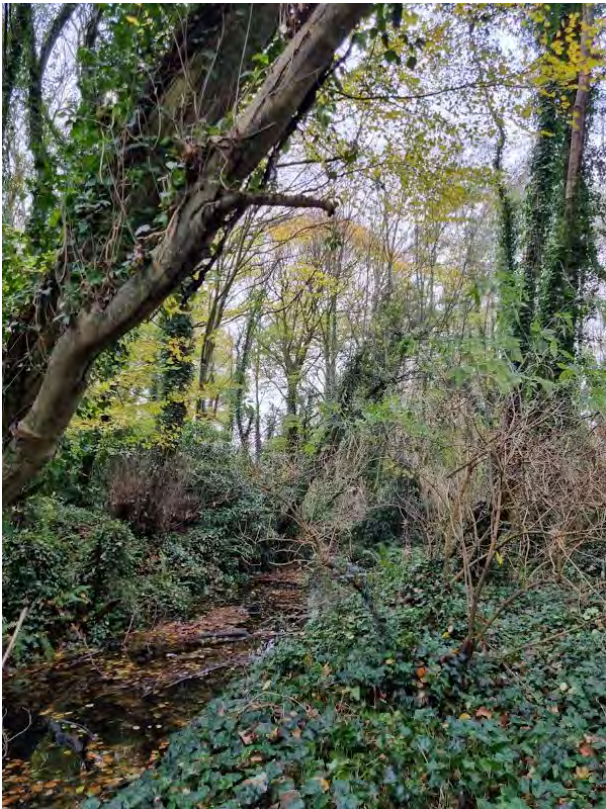
*Fig.7 Site B's deep stream running East-West between the deciduous and spruce x ash x alder woodlands*

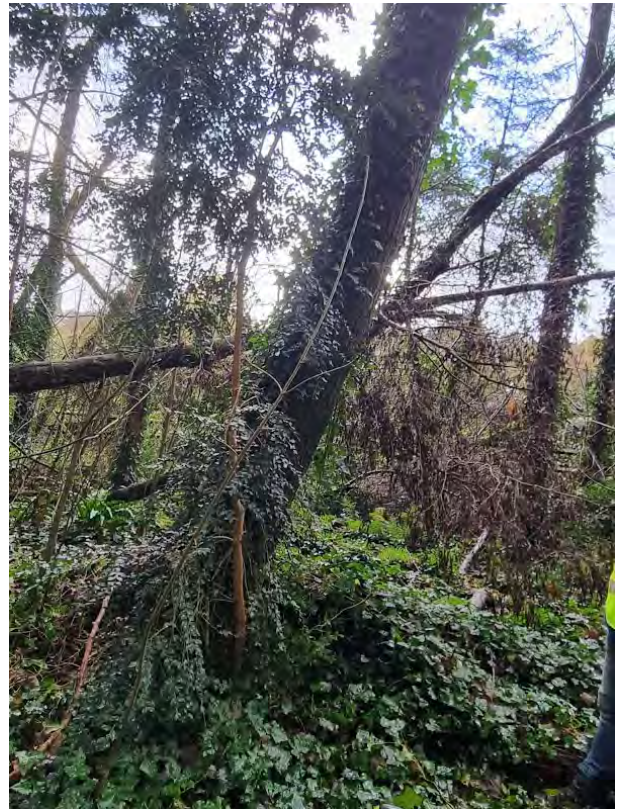
*Fig.8 Example of spruce x poplar x alder woodland with 21% of trees in dead/hazardous condition*

- III. Despite being planted, there appears to have been no woodland management in this area. Although woodlands are non-static entities that can usually be left without interference, the overall structure and composition of this woodland is poor; with 21% of the woodland classified as dead and/or hazardous (Byrnes, 2007b.) These trees have severe structural defects that are not remediable such that their failure is expected within 12 months (see fig.8). Only 2 alders (T713 and T714) have been categorised as high quality trees.

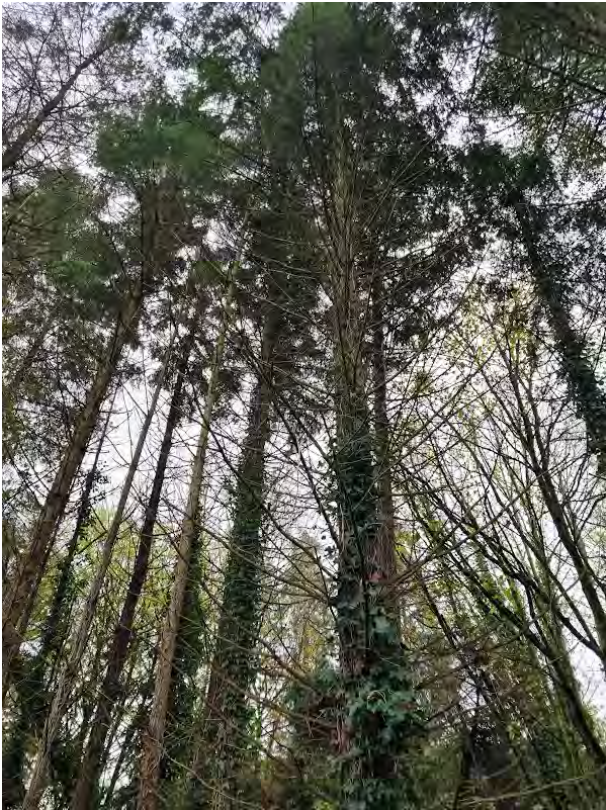
*Fig.9 Site B's dense-canopied spruce x poplar x alder woodland*

- II. The heavy shade-casting trees form a dense-canopied woodland, composed of blocks of similar size trees of varying age (from juvenile to mature) and condition (see fig.9). The species present are commonly found near streams, rivers and wetlands and play important roles in the dynamics of the riverine system (see fig.7). However despite their hydrological function, as a result of the shade the field layer is species-poor, dominated by ivy, broad leaved buckler-fern and hard fern (Forest Service, 2008).

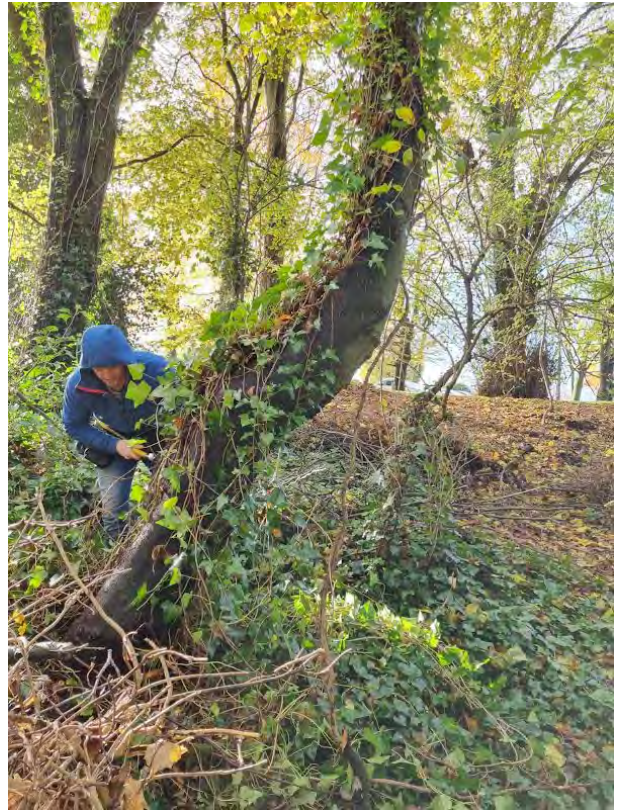
*Fig.10 Example of a Northerly phototropic kink in a main stem in Site 's deciduous woodland*

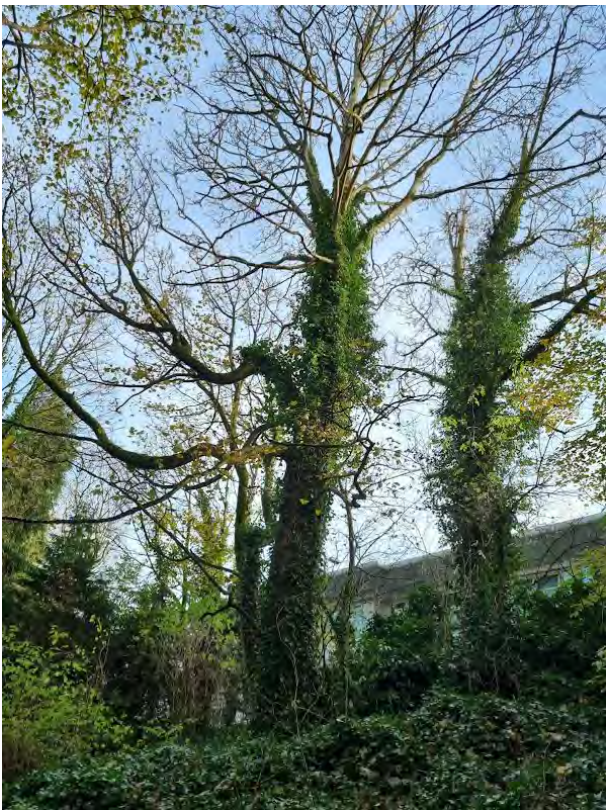
*Fig.11 Site B's veteran sycamore (T578) which requires specialised management programme*

- II. One veteran tree was identified during this survey, a sycamore opposite the Radisson Blu Hotel & Spa (numbered T578). Veteran trees are trees that are 'over-mature', trees that have surpassed maturity and are now 'veteran'. They are often of interest biologically and aesthetically. They are recognised by their impressive, unrestricted crown architecture, main stem girth, total size, and common presence of trunk hollows and/or cavities. Veteran trees are excellent examples of their species, and each requires a unique, specifically formulated care programme. See Appendix C for T578's recommended management strategy (see fig.11).

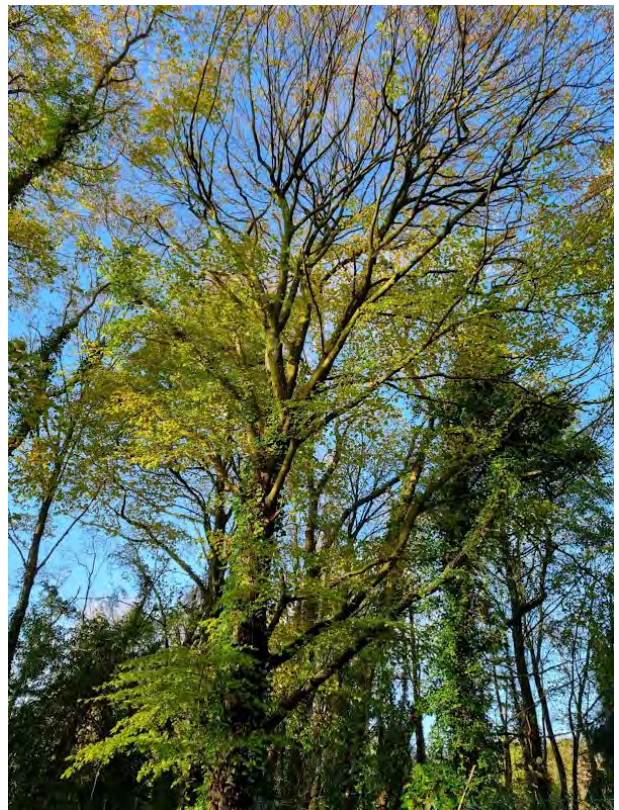
*Fig.12 An example of a Category A high retention value mature beech in Site B's deciduous woodland*

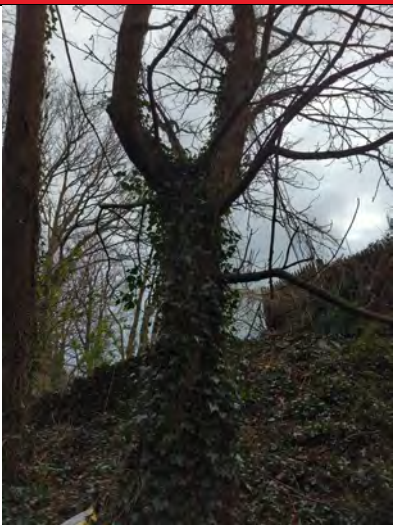
Tree Number	Description	Photograph	Potential roost value
T525	Mature dead Chestnut. Large tree with branching from 10 ft approx. Some moderately dense ivy with occasional high diameter stem. At the base ivy coverage above minimal. No significant cracks or crevices. Low potential due to dense Ivy.

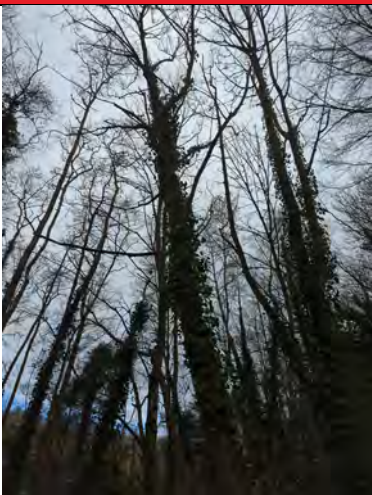
Tree Number	Description	Photograph	Potential root value
T517	Mature sycamore. Close to bank of drain one small branch at 8 ft. Ivy covering light extending close to crown. Low to negligible potential

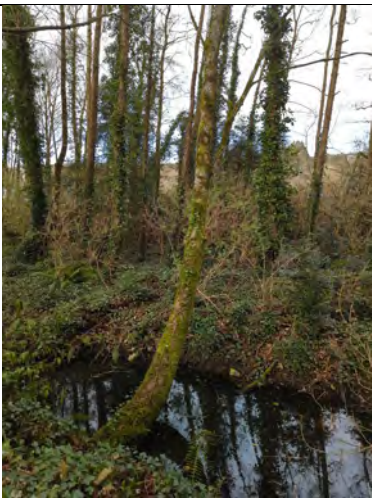
Low to negligible
T516	Mature Sycamore growing from bank extending over drain. Minimal ivy, one fork at approximately 20 ft smooth. No cracks or crevices. Negligible potential

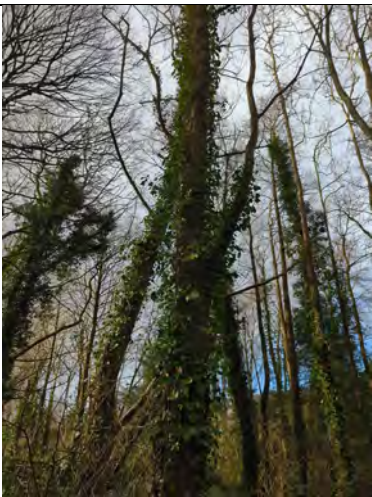
T515	Mature sycamore. Mature tree with fork at 15 ft approximately. Ivy covering is low and thinly spaced with lower diameter. No cracks or crevices. Low to negligible potential

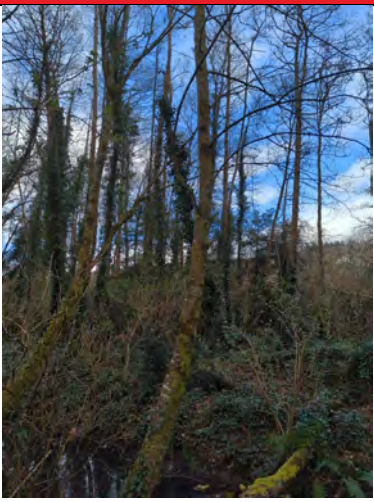
Tree Number	Description	Photograph	Potential root value
T514	Mature Sycamore. Going from bank at an angle out over drain. Minimal Ivy. No significant cracks or crevices negligible potential

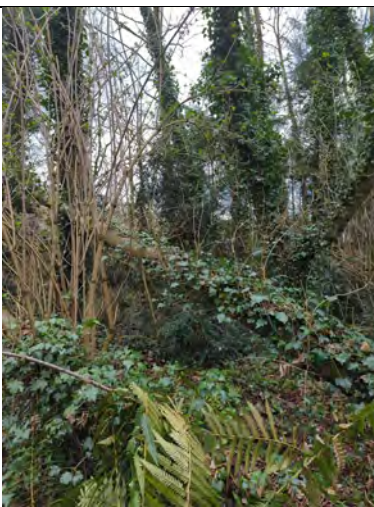
Negligible
T513	Mature Ash that has fallen over. ivy coverage low to moderate. Probably waterlogged leaning up against another tree. Negligible potential for beds

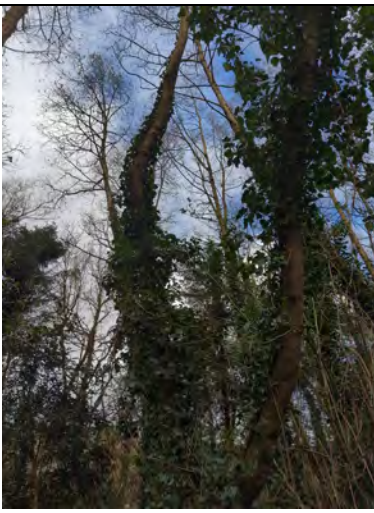
Negligible
T512	Mature Alder. Mature tree forked at 5 ft. Ivy coverage is low. Stems of relatively large diameter. No other significant side branches. No significant cracks or crevices. Low potential due primarily to some thicker ivy stems

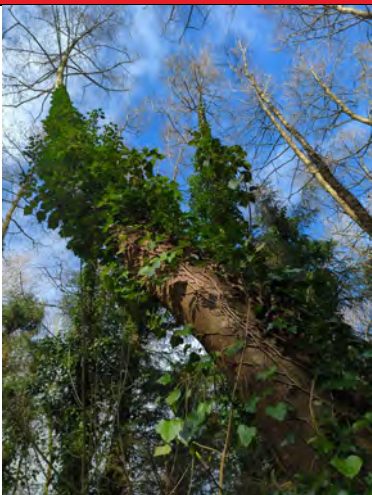
Tree Number	Description	Photograph	Potential roost value
T511	Mature Alder with mature ivy growing at quite an extreme angle. Ivy coverage is generally low. Ivy diameter stem low also no side branches. No significant cracks or crevices or loose bark. Fissures visible. Low to negligible potential

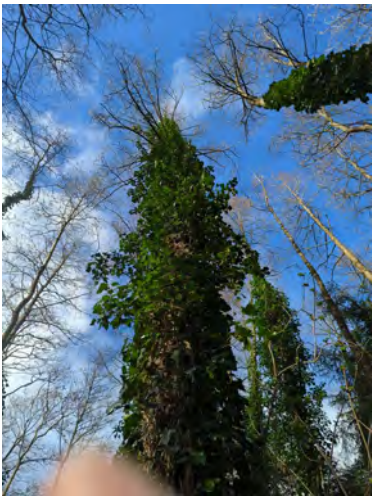
Low to negligible
T510	Mature Alder. Tall tree no side branches. Ivy extends from base to crown. Generally low diameter but some thicker areas. No significant cracks or crevices visible. Low potential for bats due primarily to ivy growth

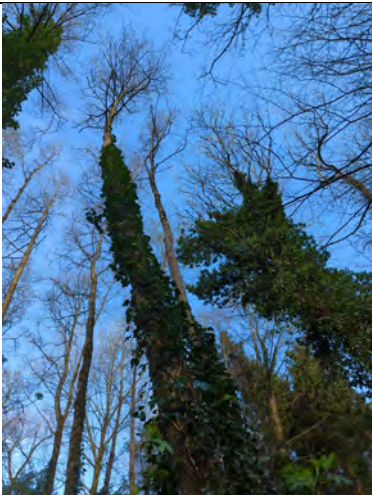
T509	Mature Alder. Forks into two bows from approximately 4 1/2 ft. Ivy coverage is low with stems of limited diameter. Crown poorly developed. No other significant side branches. Low to negligible potential for bats

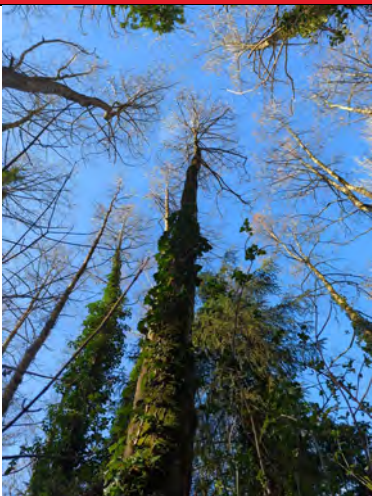
Tree Number	Description	Photograph	Potential roost value
T508	Mature Alder with ivy coverage very low. No significant cracks or crevices. Minor fissures in trunk. Low to negligible potential for bats

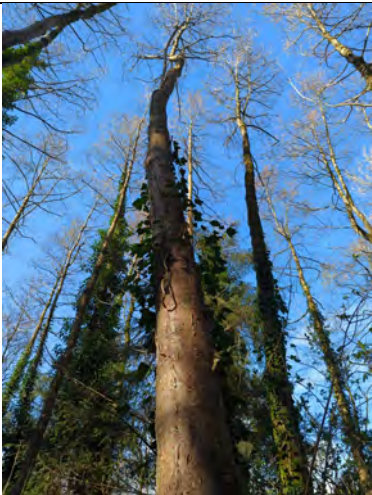
Low to negligible
T507	Mature Alder. Virtually no Ivy. No significant side branches. No significant crevices or cracks negligible potential

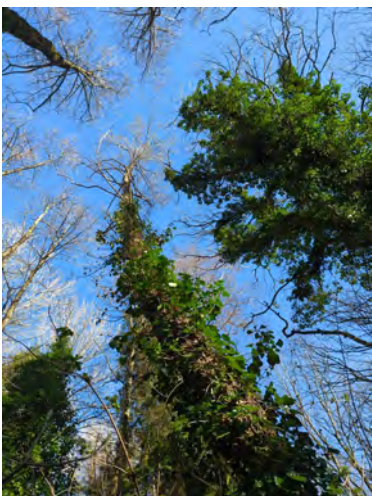
Negligible
T506	Mature Alder with no significant side bows. Ivy coverage is generally light. Stems low diameter, no significant cracks or crevices. Low to negligible potential

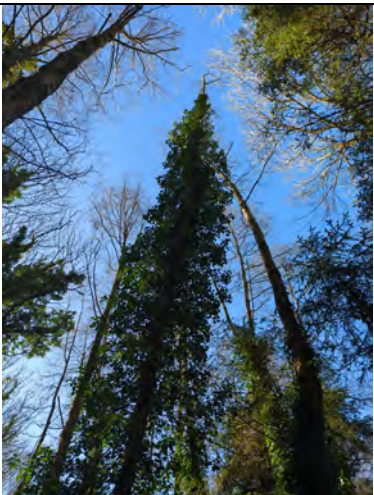
Low to negligible
T492	<p>Juvenile Alder. Relatively young tree with some mature growth of ivy. Stems are of high diameter but does not form dense growth. Ivy does extend to the top of the tree. No side bows. Low potential for bats</p>

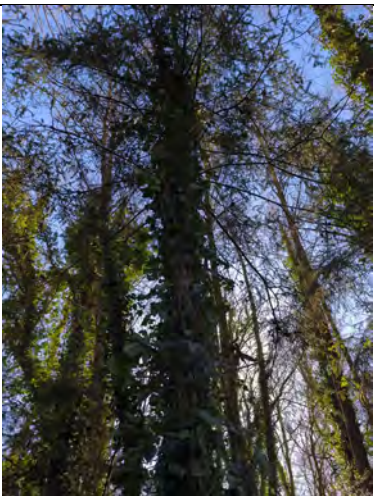
Low
T504	<p>Juvenile Sitka Spruce. Poor quality tree. Ivy cover low and stems of limited diameter. Negligible potential for bats</p>

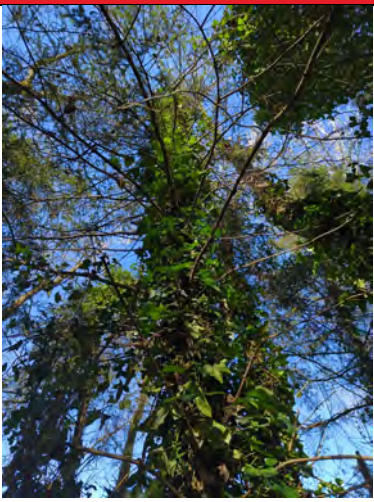
Tree Number	Description	Photograph	Potential roost value
T494	<p>Juvenile Sitka spruce with low ivy coverage. Immature tree. Diameter of ivy which extends from base to crown low. Negligible potential</p>

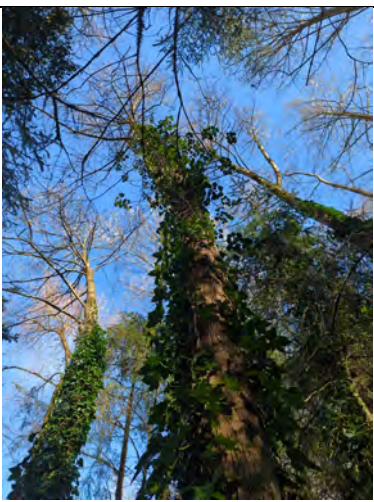
Negligible
T503	<p>Mature Alder. Tall tree with no significant side bows. Crown limited. Ivy cover low and stems of Ivy are limited diameter. No significant cracks or crevices noted. Low to negligible</p>

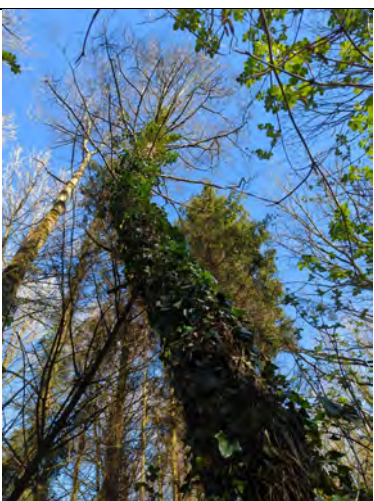
Low to negligible
T488	<p>Mature Alder. Large mature Alder leaning slightly. Ivy moderate to crown from base. Diameter of ivy stems not large but growth relatively dense. No significant side bows no significant cracks or crevices. Low potential</p>

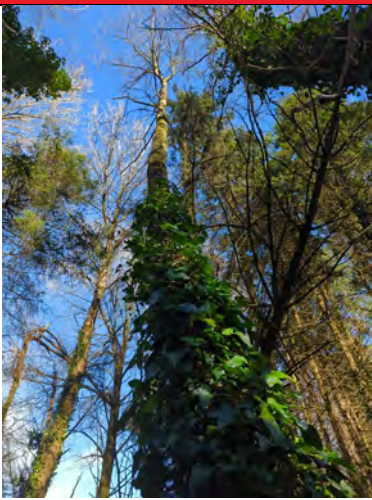
Tree Number	Description	Photograph	Potential roost value
T489	Mature Alder. Tall single stemmed tree with light ivy growth in lower section. Diameter of ivy is low. No significant crack so crevices. Low to negligible potential

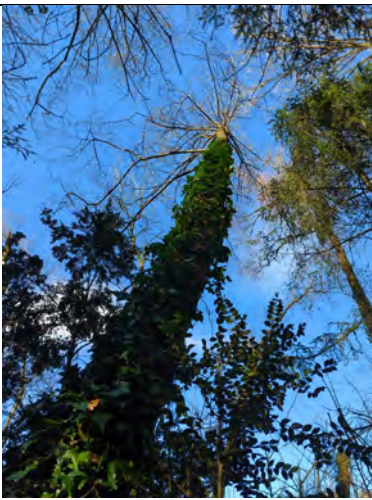
Low to negligible
T502	Mature Goat Willow. Tall mature tree with ivy growth on lower section. Growth of ivy is not dense and stem diameter is low. No significant side bows. Low to negligible potential

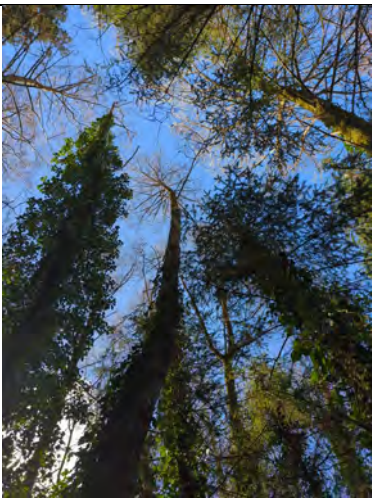
Low to negligible
T493	Mature Alder. Mature tree single stems to top. No significant side. Light ivy coverage with low. Low to negligible potential

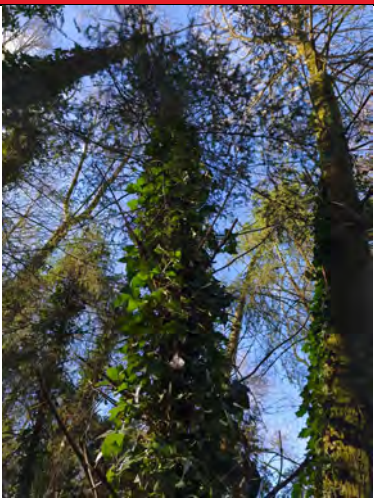
Tree Number	Description	Photograph	Potential roost value
T495	Juvenile spruce with moderate covering of ivy. Stems of ivy of lower diameter. Low to negligible potential.

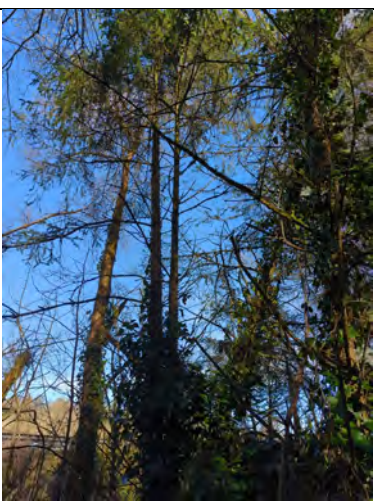
Low to negligible
G29/T497 JUV SPRUCE	Small group of immature spruce ivy growth very light. Negligible potential

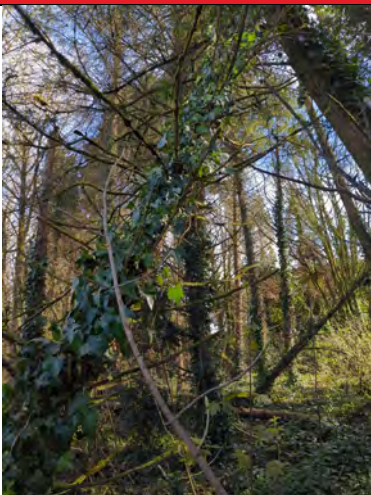
Tree Number	Description	Photograph	Potential roost value
T498	<p>Juvenile spruce. Falling at an angle light. Coverage of Ivy thin diameter. Negligible potential for bats</p>

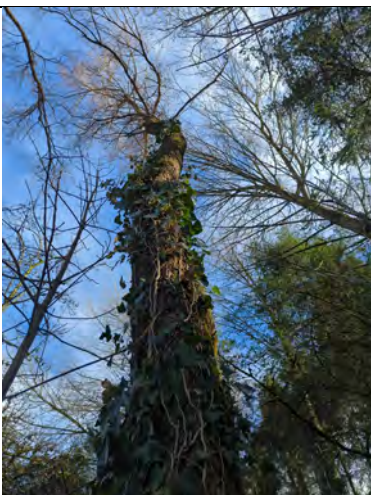
Negligible
T499	<p>Goat Willow. Mature tree one bow at 20 ft. Cracked but hanging on at an angle. Ivy coverage very low. Low potential for bats</p>

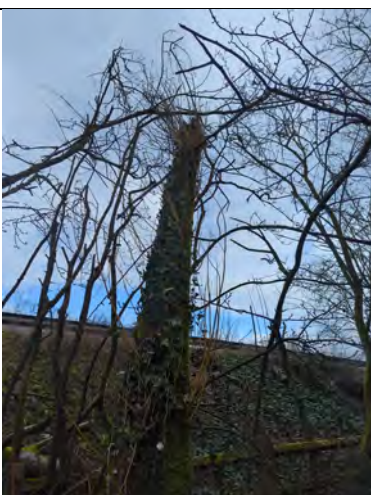
Low
T500	<p>Goat Willow. Mature tree I that's been trimmed in the past. Some very young regrowth from the stem. Low ivy coverage. Low to negligible</p>

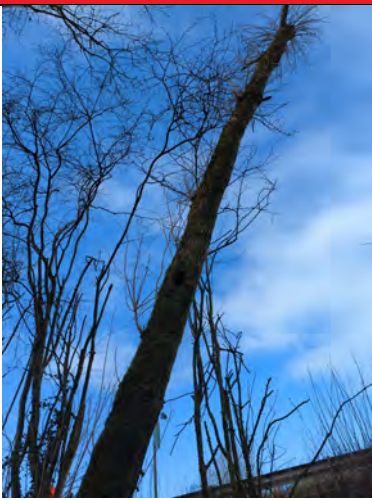
Tree Number	Description	Photograph	Potential roost value
T501	<p>Mature goat willow single stem has been trimmed in the past. Some young regrowth. Hollowing tree at 15 ft. Low potential for bats</p>

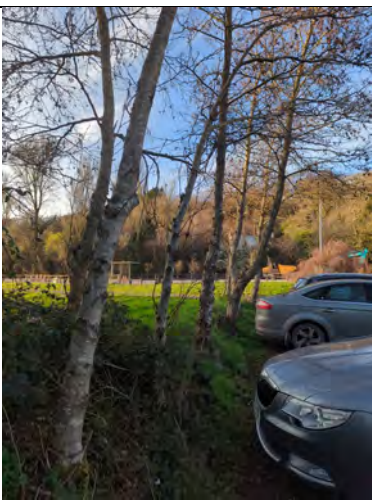
Low
G19/T441	<p>Grey willow by six multi stemmed within existing planted area.. No significant cracks or crevices.</p>

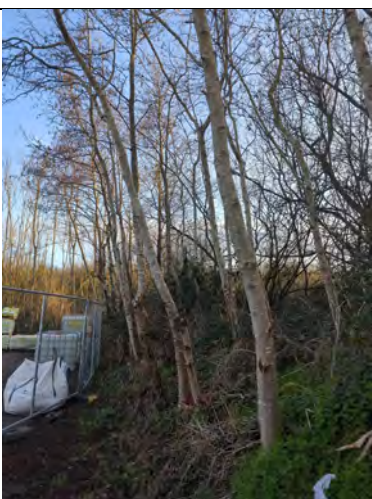
Negligible
G17/T439	<p>Alder x 46 semi-mature Immature closely spaced. No complexity or cracks or crevices. No suitability for bats. Negligible potential</p>

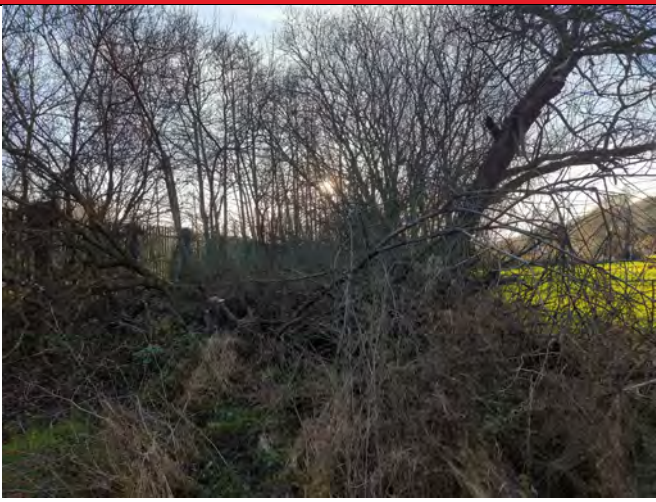
Tree Number	Description	Photograph	Potential roost value
G12/T443	Group of collapsed willows relatively old. Some broken bows. Some loose bark but no significant cracks or crevices. 5-6 trees. Some growing outside the railing, some growing the drainage ditch and the railway

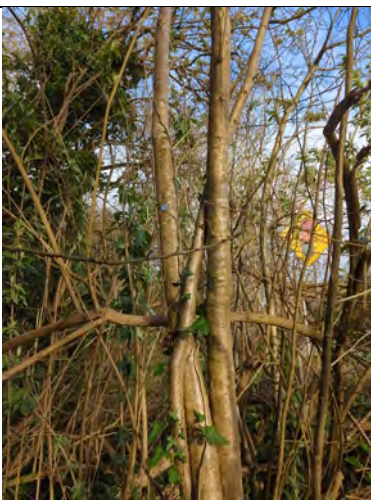
Low to negligible
G25/T448	Hazel Young probably planted as part of the road scheme. Multi-stemmed immature. No significant Ivy. Negligible potential for bats

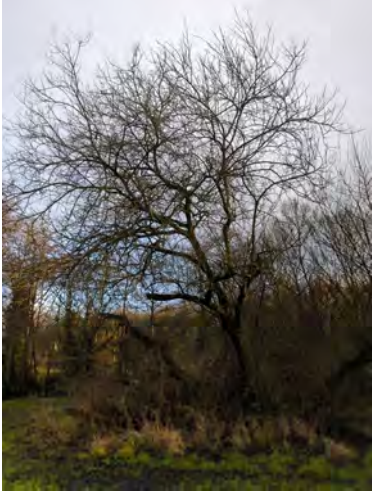
Tree Number	Description	Photograph	Potential roost value
433	Willow. Mature, multi-stemmed broken boughs have been damaged in the past has also been trimmed back. Low potential for bats

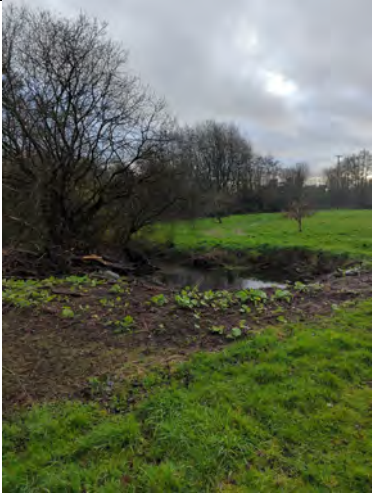
Low
436	Willow. Previously on corner of woodland appears to have been removed. Small oak 432 visible in background

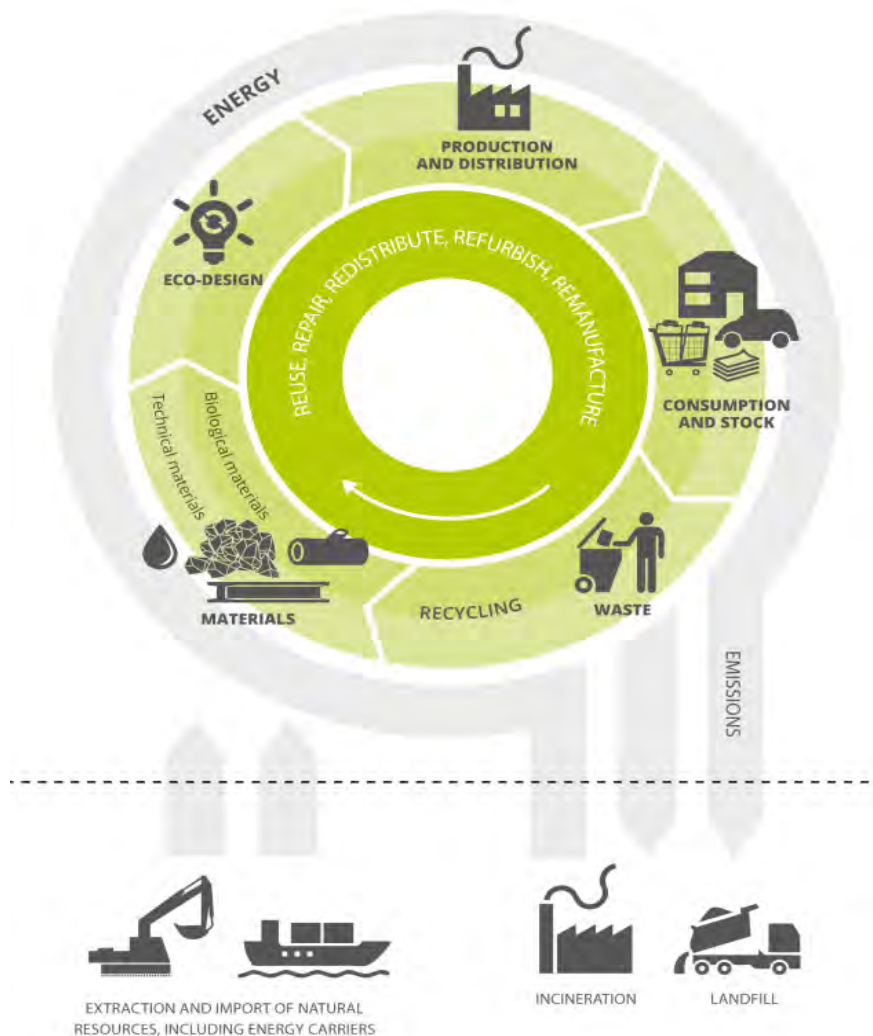
**Image 1: A simplified model of the circular economy for materials and energy (European Environment Agency, 2016)**

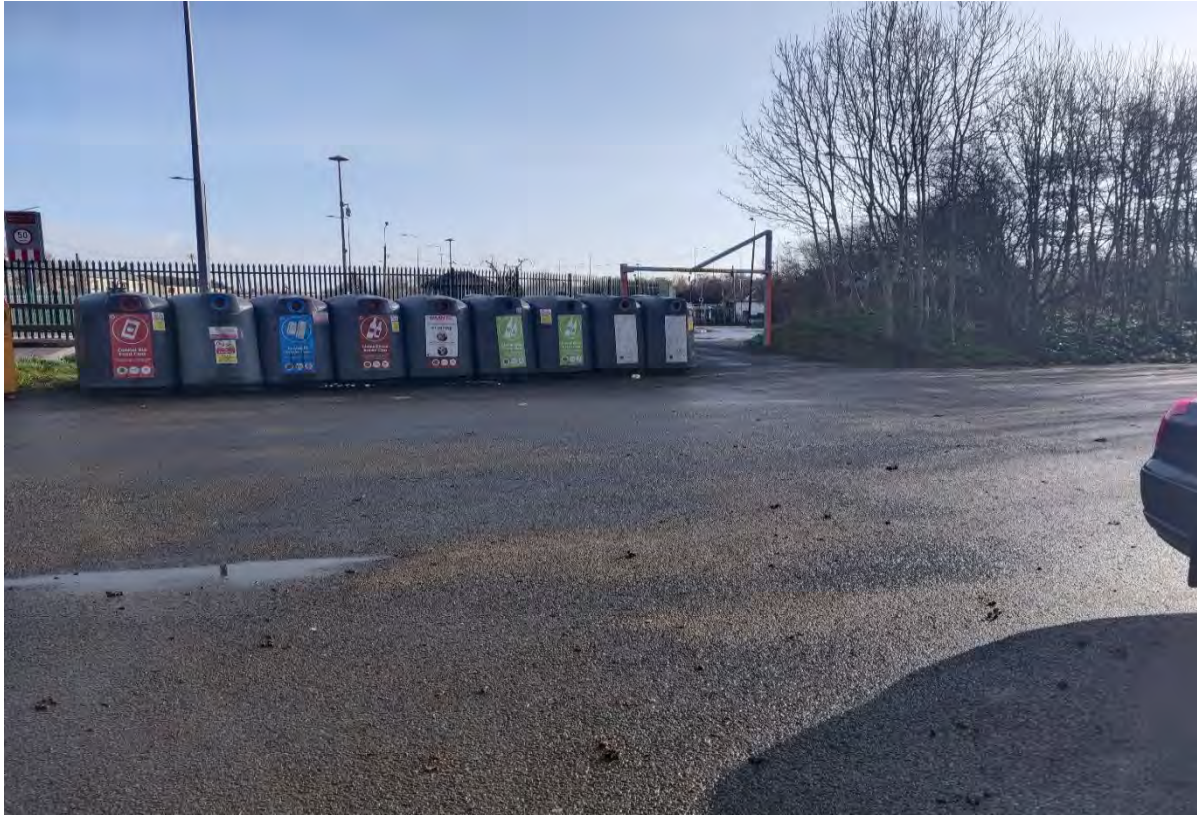
Photo ID	Caption	Date taken	Coordinates (ITM)
Figure_01	Hard standing area in north eastern portion of the site.	17/02/2022	575433, 572929

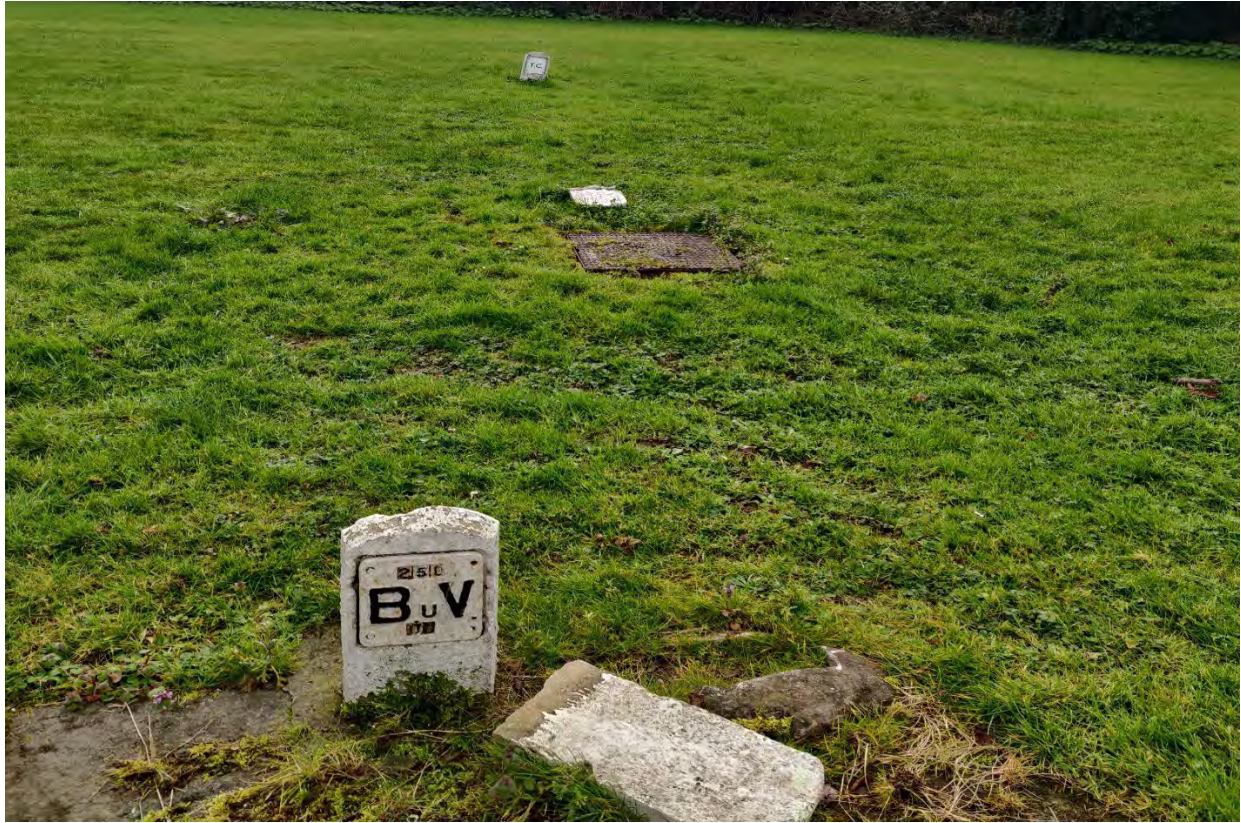
Photo ID	Caption	Date taken	Coordinates (ITM)
Figure_02	Subsurface services located to the west of the Proposed Development.	17/02/2022	575243, 572900

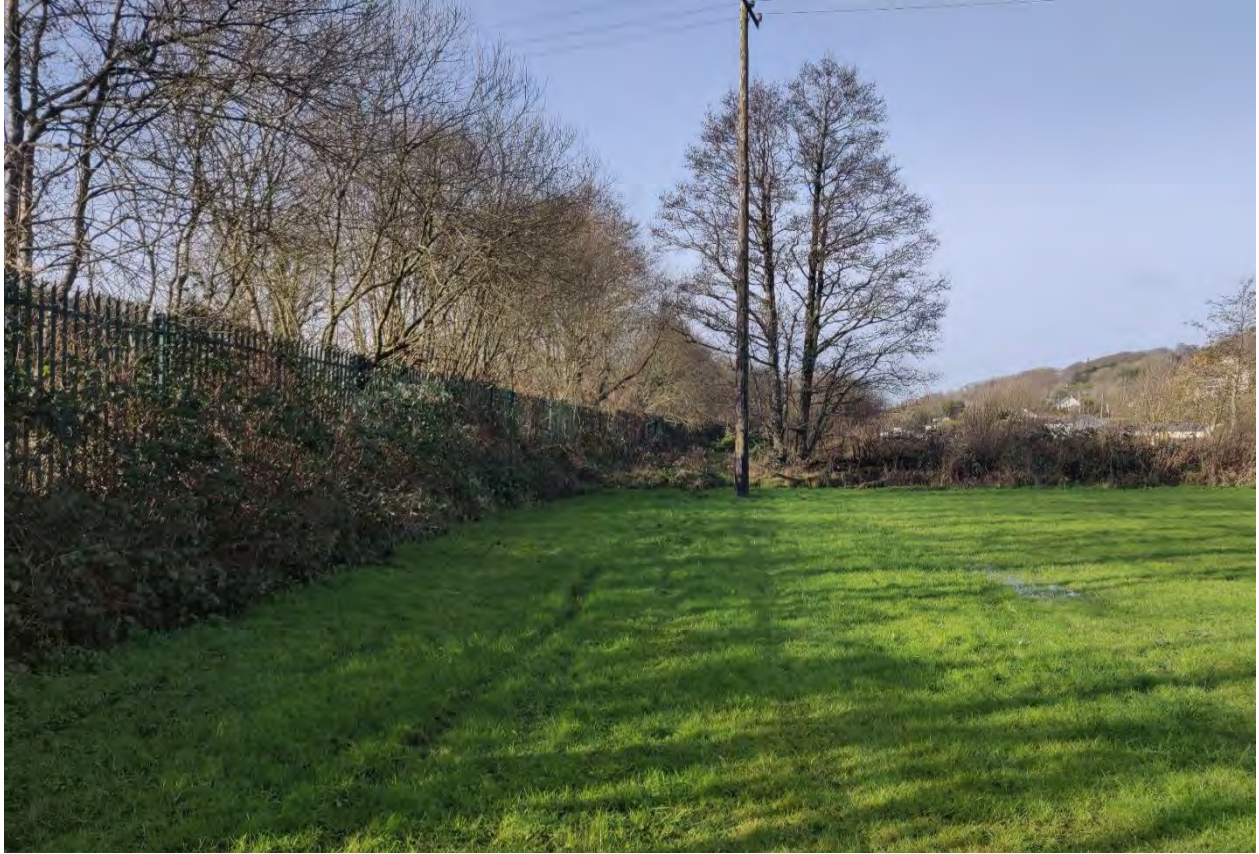
Photo ID	Caption	Date taken	Coordinates (ITM)
Figure_03	Overhead power lines along the northwest site boundary. Surface water ponding also encountered.	17/02/2022	575348, 572884

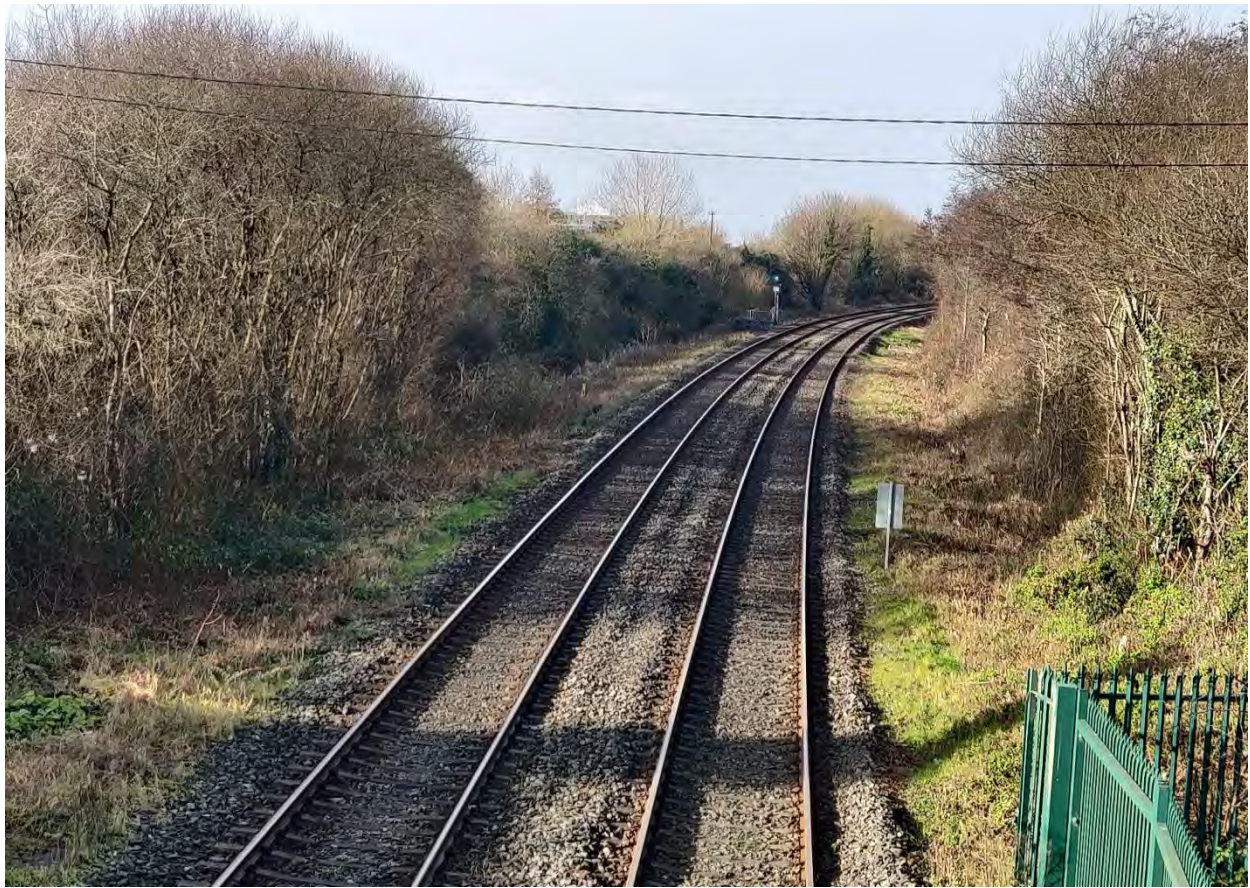
Photo ID	Caption	Date taken	Coordinates (ITM)
Figure_04	Railway line with several overhead power line crossings.	17/02/2022	575547, 572893

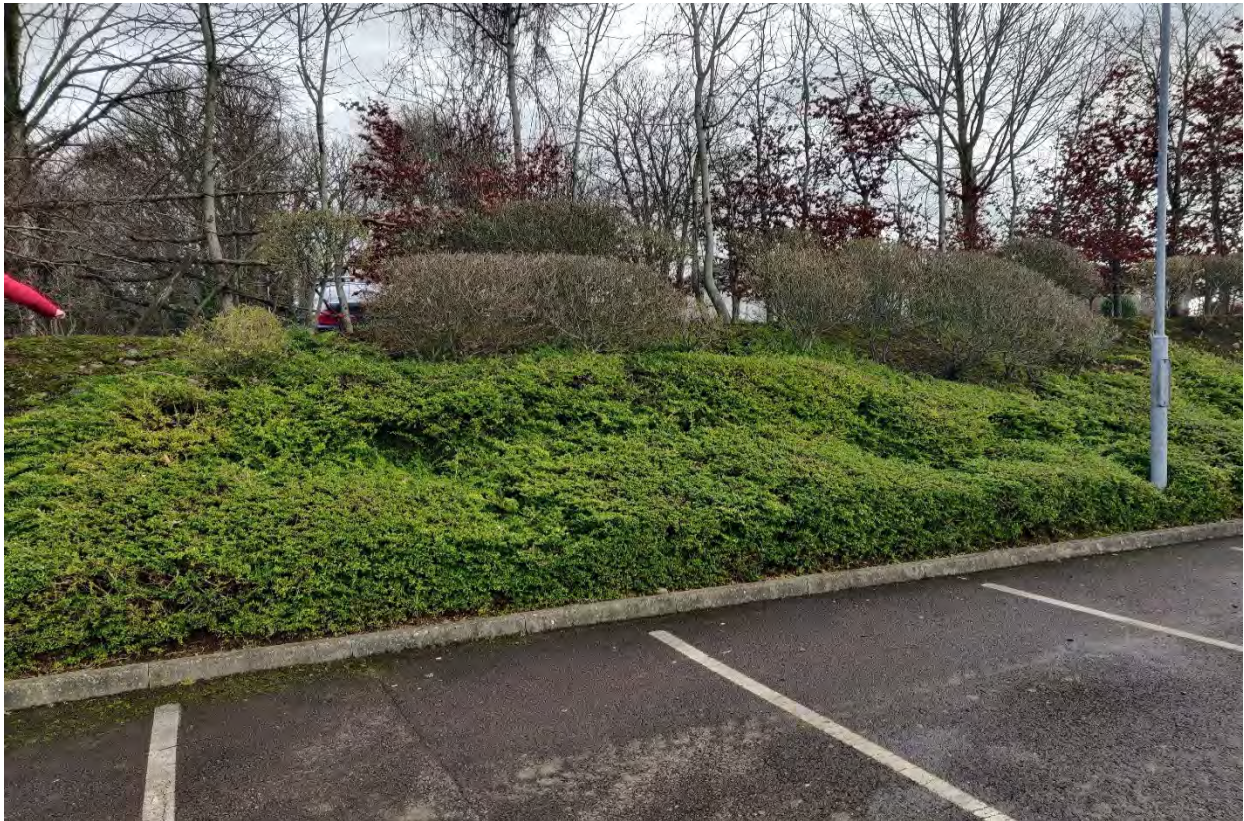
Photo ID	Caption	Date taken	Coordinates (ITM)
Figure_05	Level change between car parks south of the N25 carriageway.	17/02/2022	575244, 572720

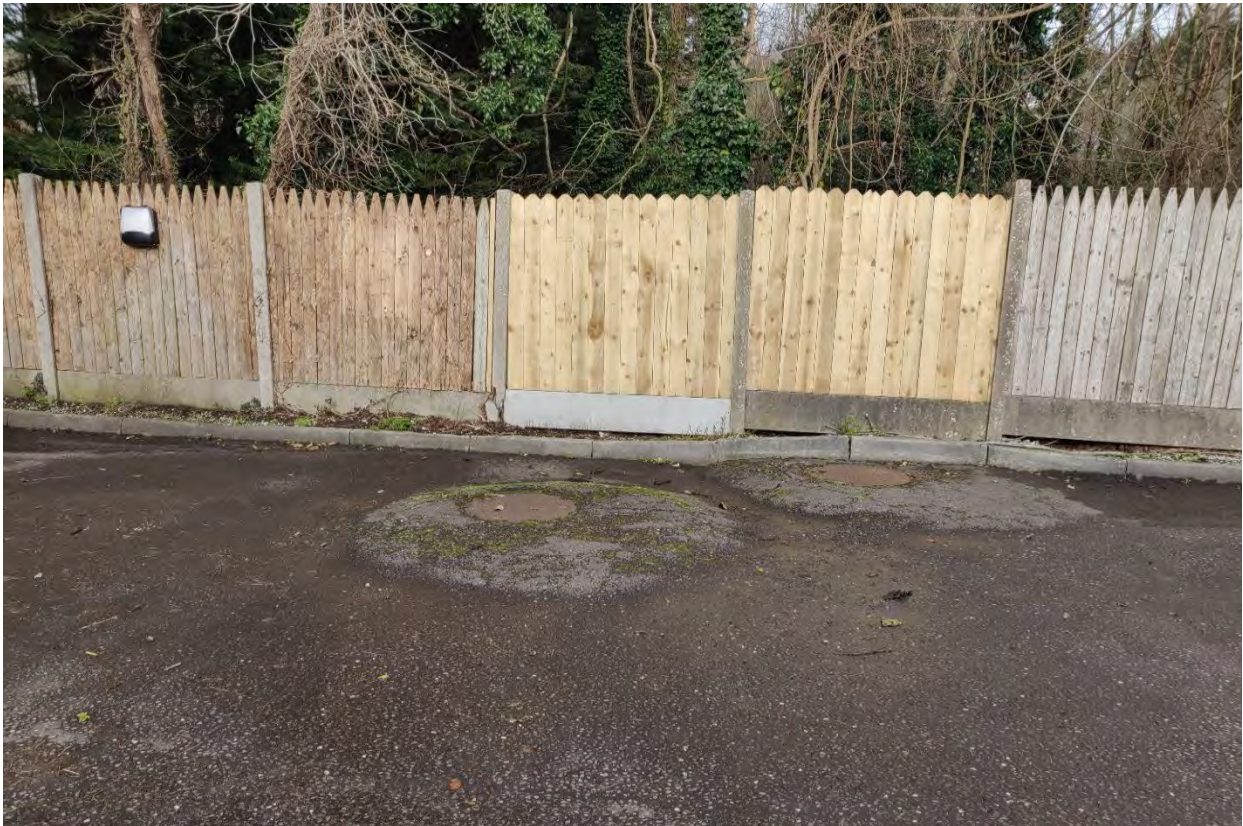
Photo ID	Caption	Date taken	Coordinates (ITM)
Figure_06	Settlement of hardstanding areas in southern section of the site.	17/02/2022	575260, 572730
