# N25 Little Island Pedestrian and Cyclist Bridge

Environmental Impact  
Assessment Report

Volume 4  
Appendices

September 2023

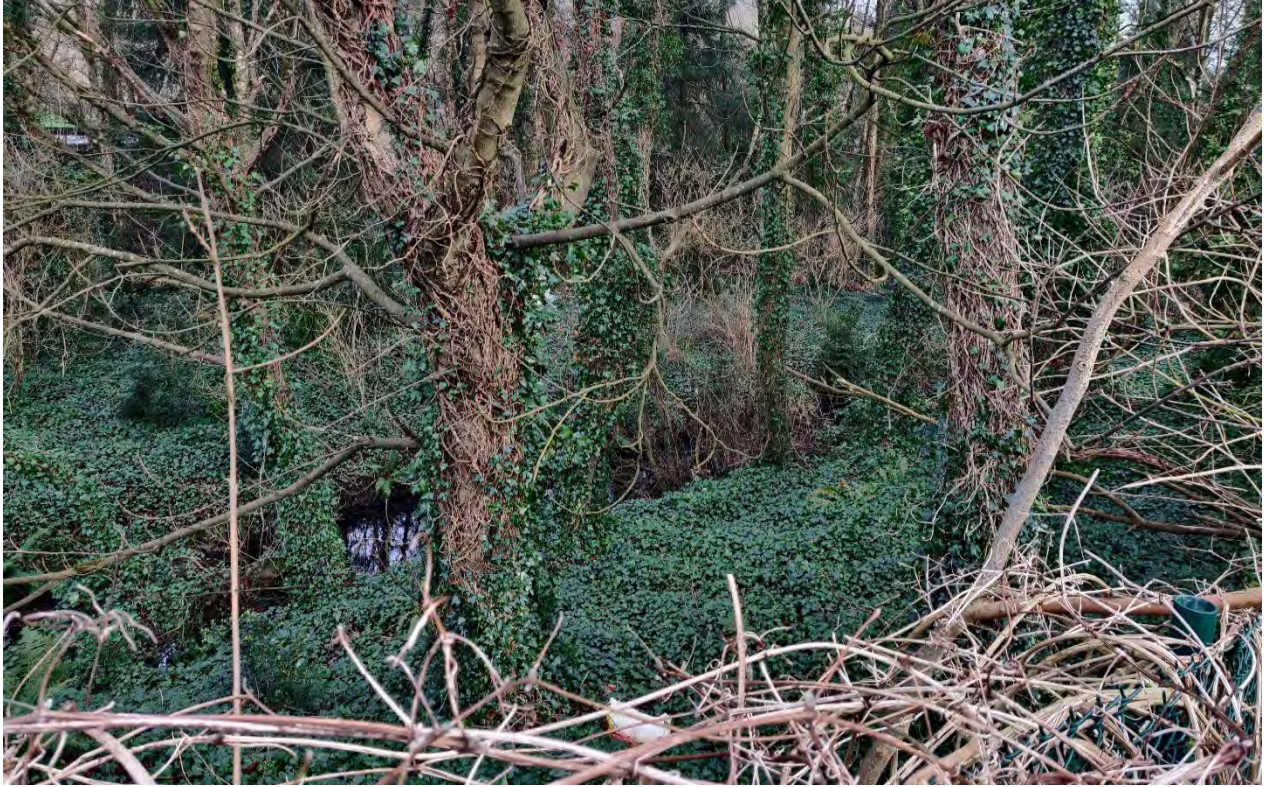
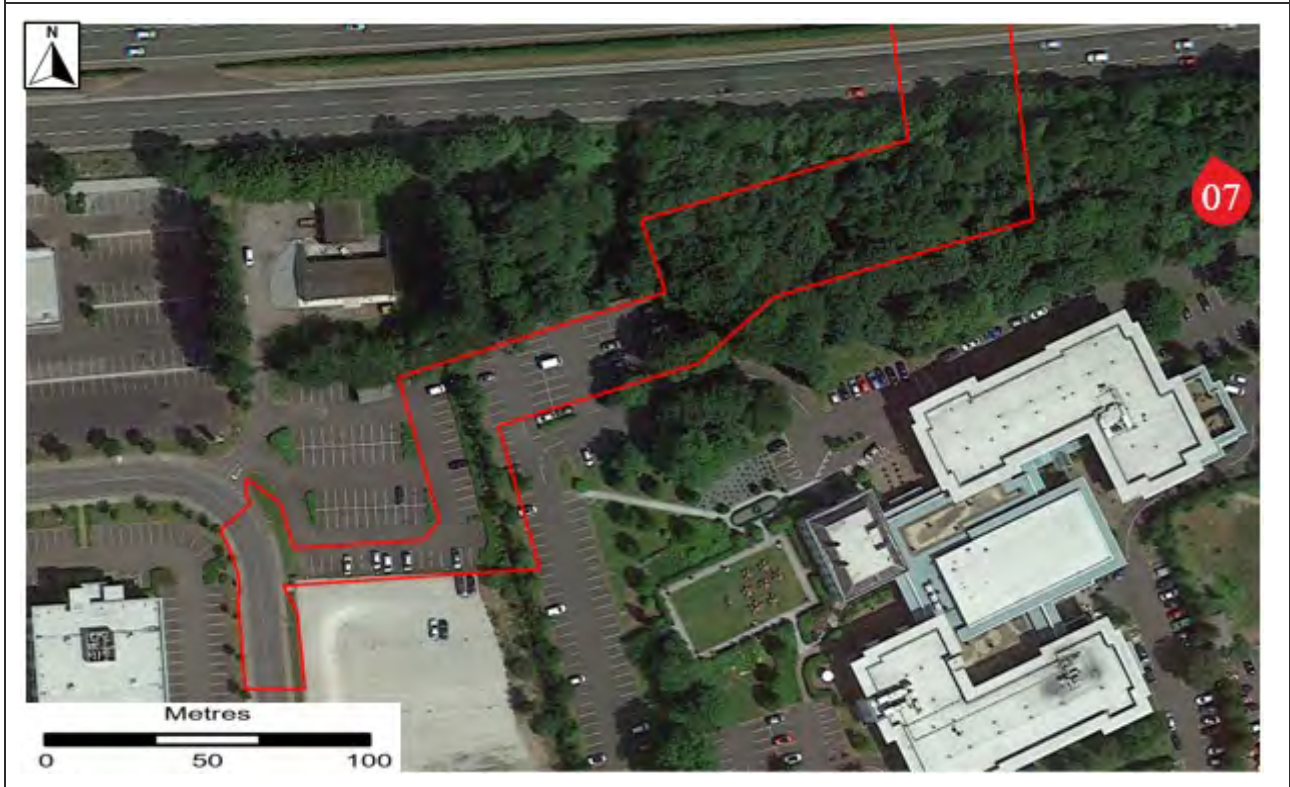
Photo ID	Caption	Date taken	Coordinates (ITM)
Figure_07	Open surface water drainage ditch to the south of the N25 carriageway.	17/02/2022	575440, 572762

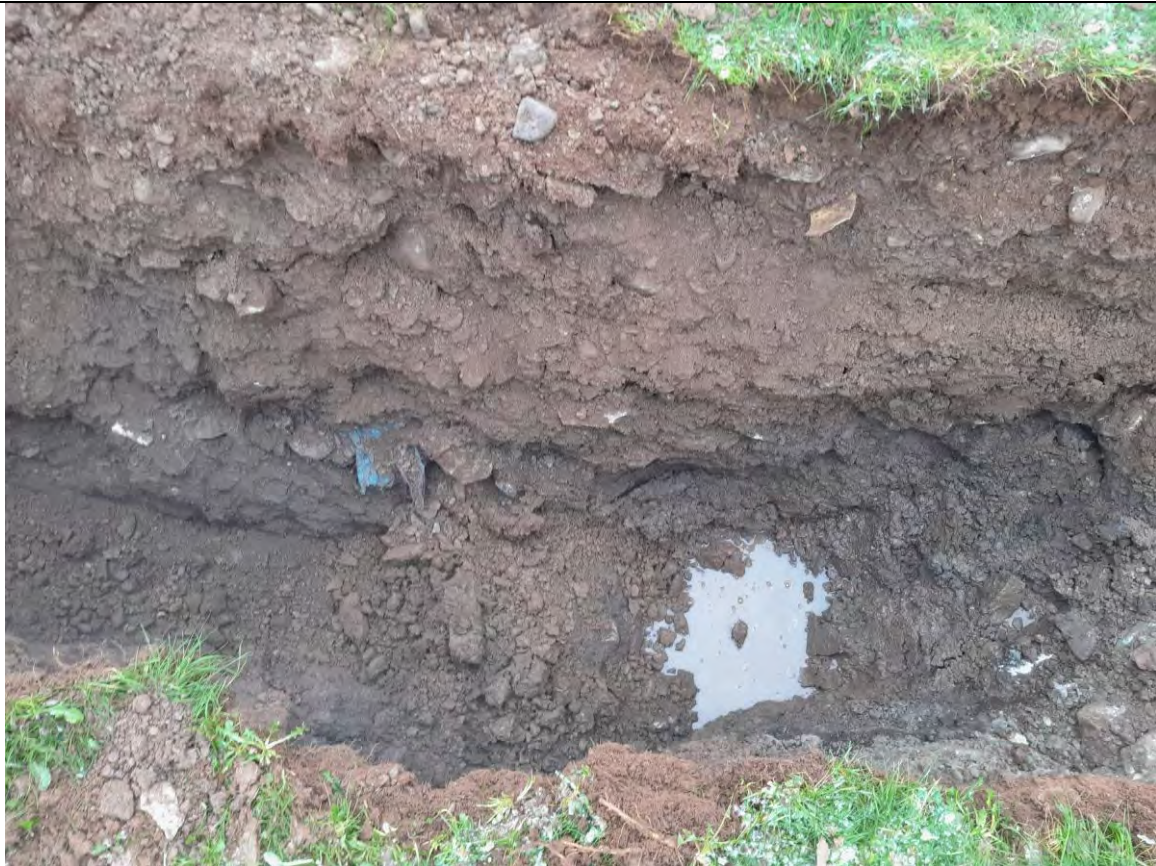
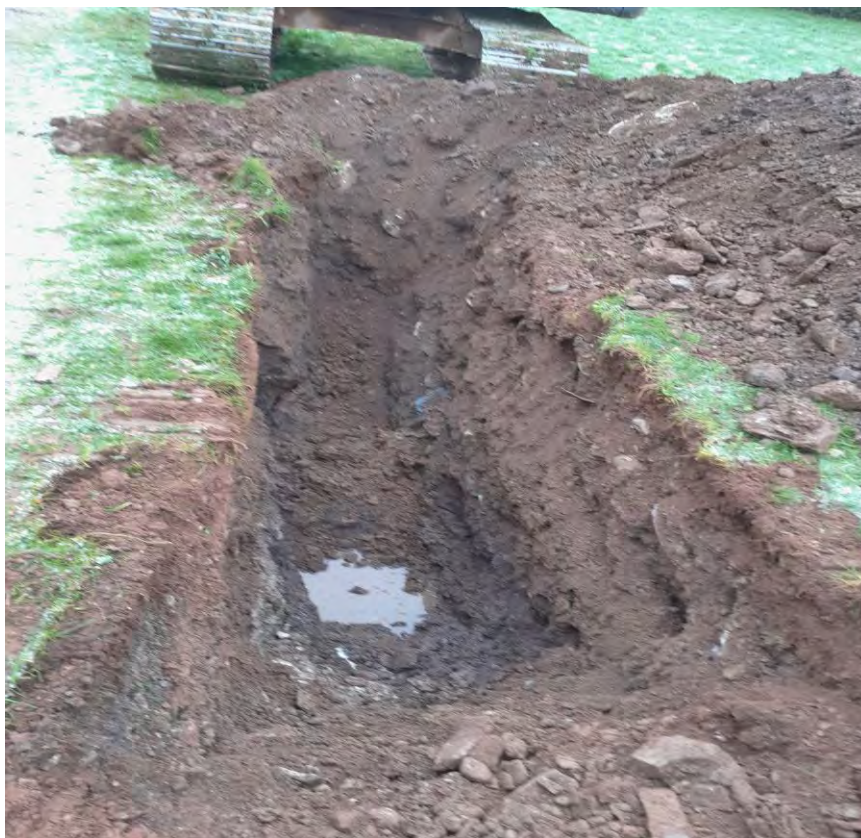
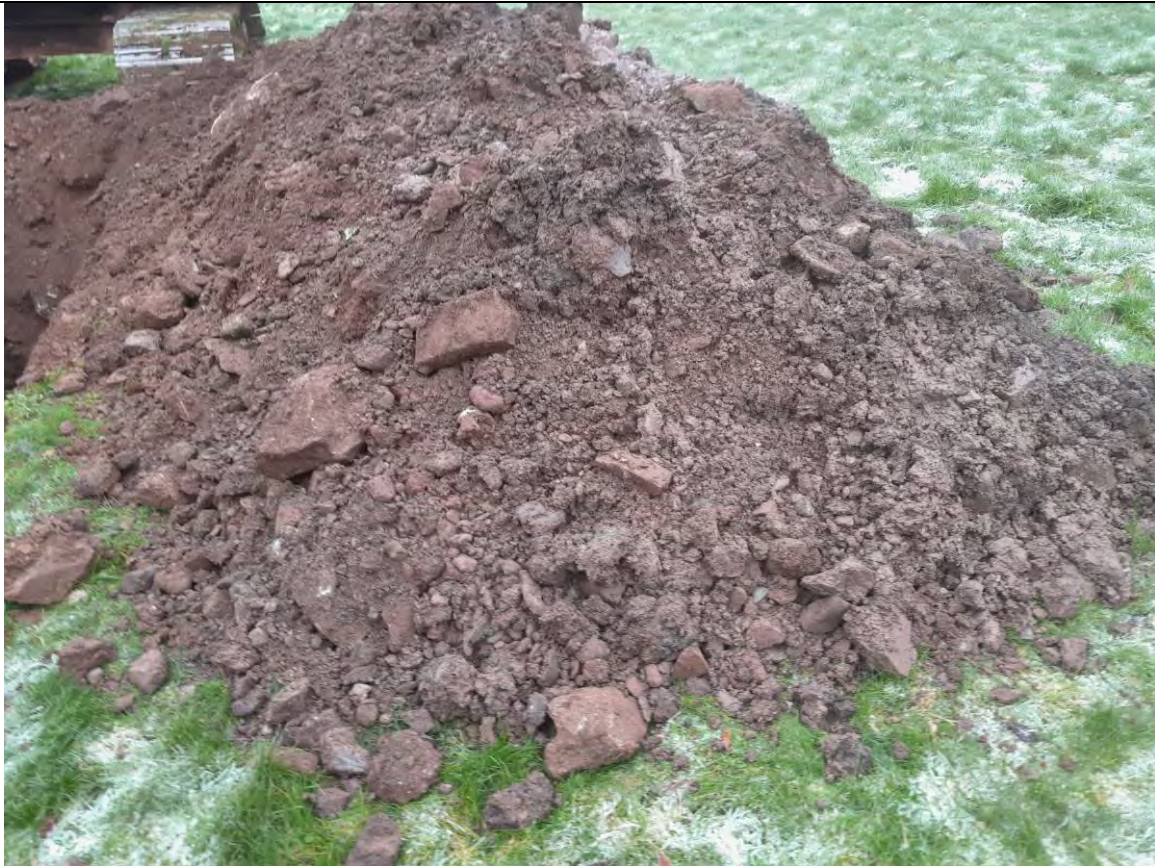
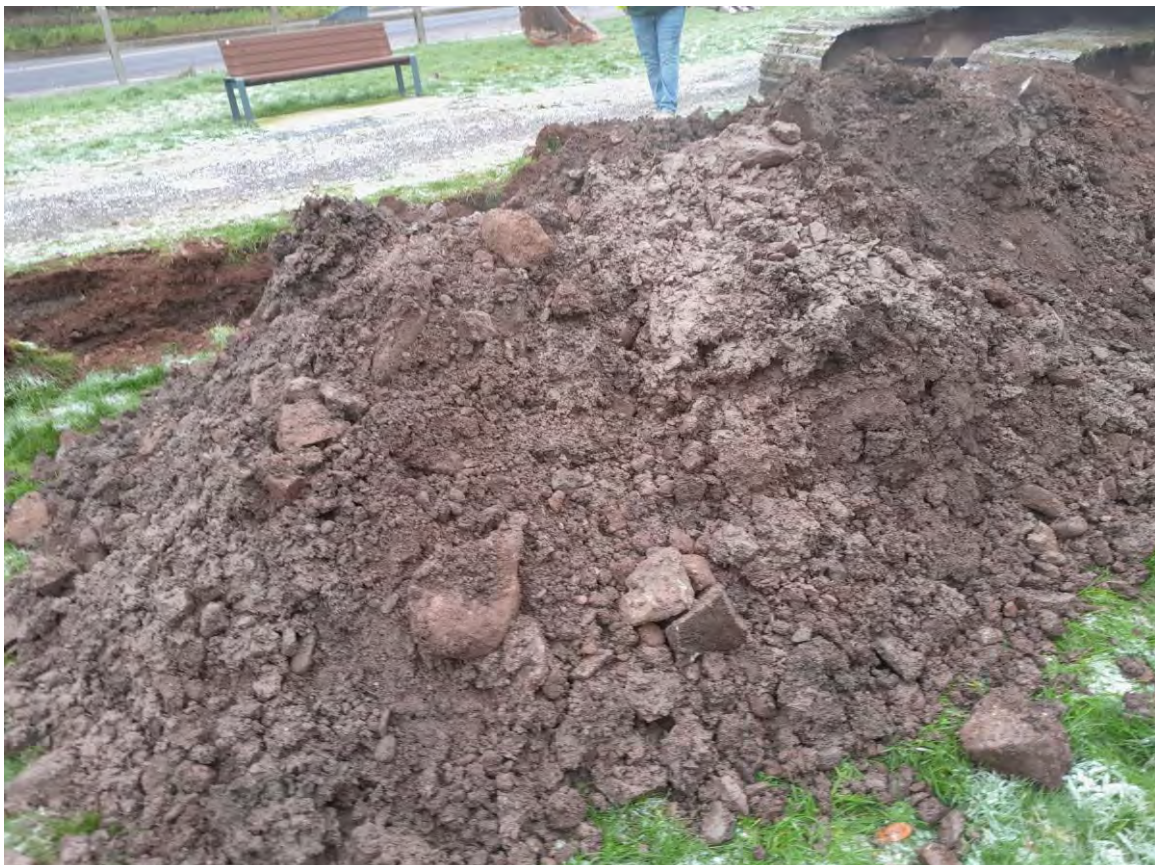
**TP01**

Plate Bearing Test  
 Test Number: PLT TP01  
 Depth: 1 m bgl  
 Bedding Material: Sand  
 Date: 12/12/2022  
 Ground Conditions: (Made Ground) Silty sandy GRAVEL with high cobble content.  
 Seating Load: 0.75t/ 25kPa  
 Plate Diameter: 450 mm  
 Plate Area: 0.1589625 m<sup>2</sup>

Load to Achieve 1.25mm of Settlement: 17 kPa  
 Subgrade Modulus (MN/m<sup>2</sup>/m) k<sub>750</sub>: 9  
 Estimated CBR (NRA DMRB HD25-26 3.62) 0.4 %  
 Plate scaling factor 0.64  
 Plate rigidity factor 1.00  
 Estimated failure load Δh 0.1R - kPa  
 Estimated undrained shear strength - kPa

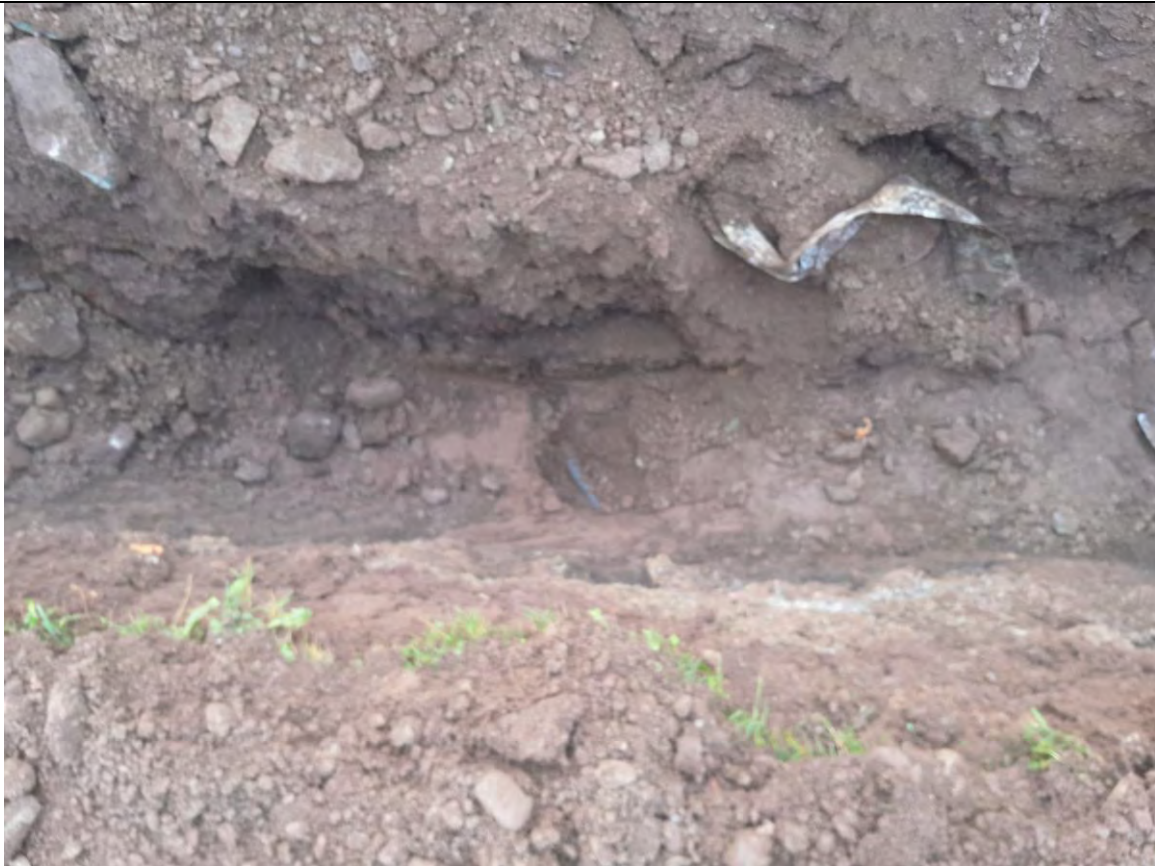
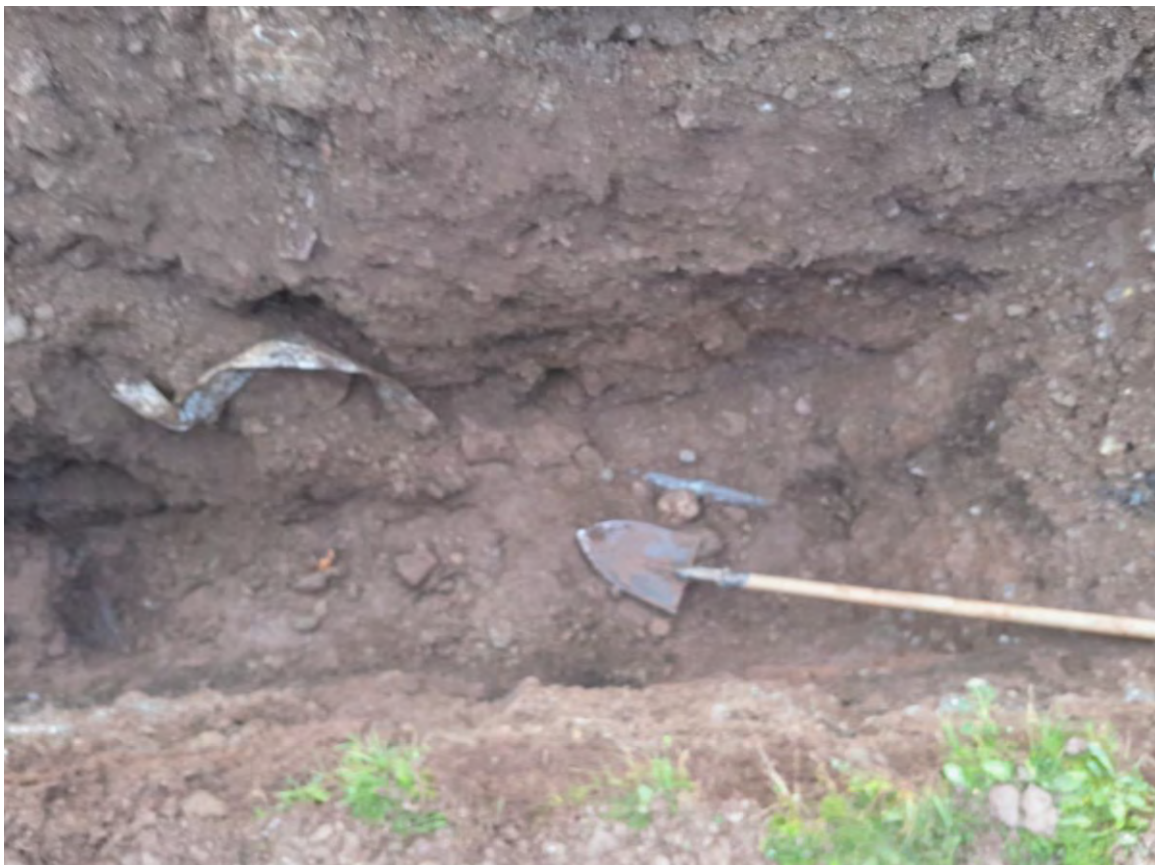
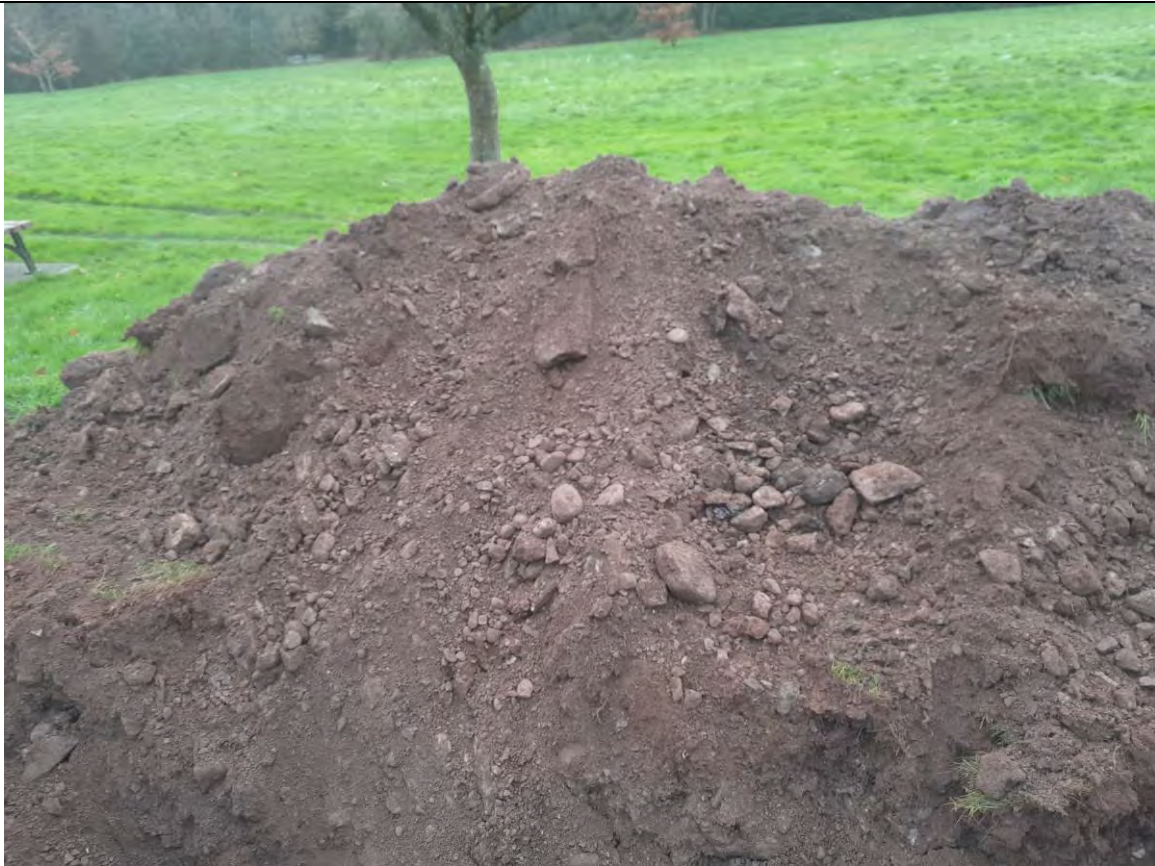
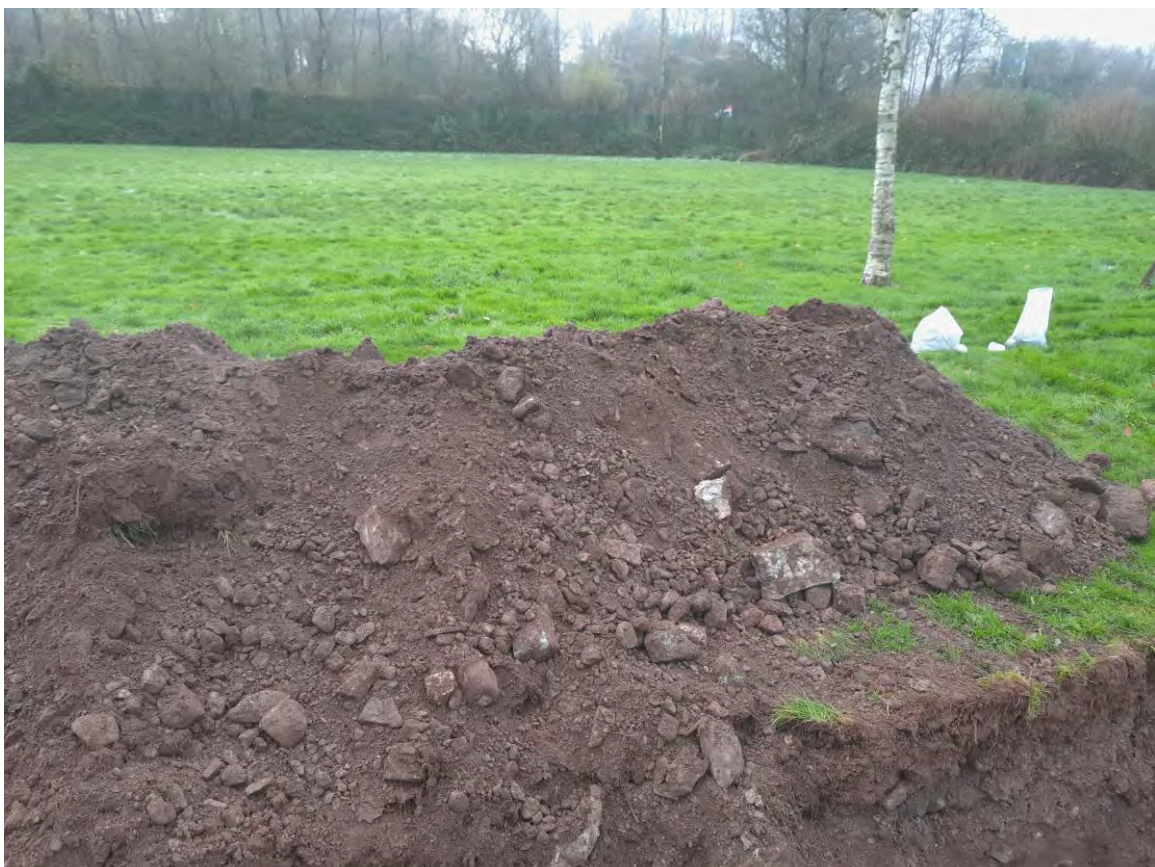
TP02

Plate Bearing Test  
 Test Number: 1  
 Depth: 0.5m m bgl  
 Bedding Material: Sand  
 Date: 12/12/2022  
 Ground Conditions: (Made Ground) Slightly sandy gravelly SILT with high cobble content.  
 Seating Load: 0.75t/ 25kPa  
 Plate Diameter: 450 mm  
 Plate Area: 0.1589625 m<sup>2</sup>

Load to Achieve 1.25mm of Settlement: 31 kPa  
 Subgrade Modulus (MN/m<sup>2</sup>/m) k<sub>750</sub>: 16  
 Estimated CBR (NRA DMRB HD25-26 3.62) 1.2 %  
 Plate scaling factor 0.64  
 Plate rigidity factor 1.00  
 Estimated failure load Δh 0.1R - kPa  
 Estimated undrained shear strength - kPa

**Remarks:** Trial pit terminated at 1.20m bgl, services found.

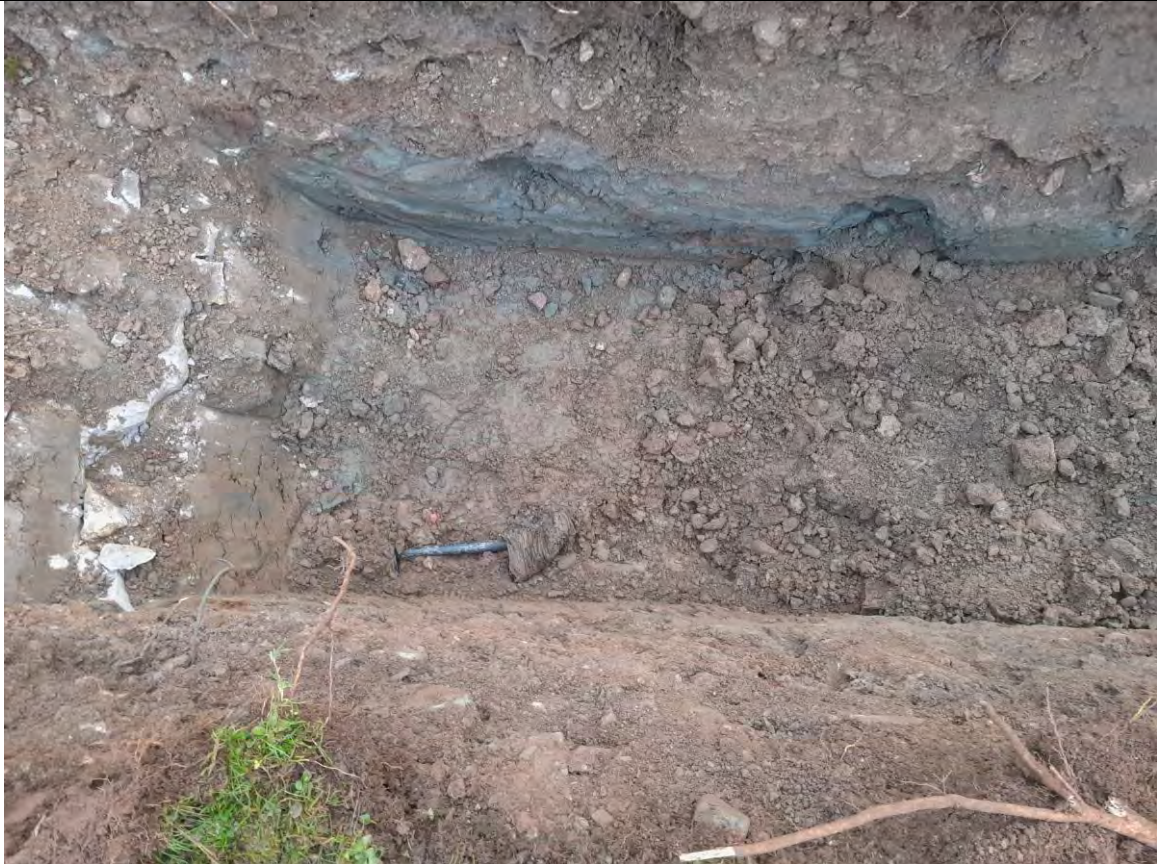
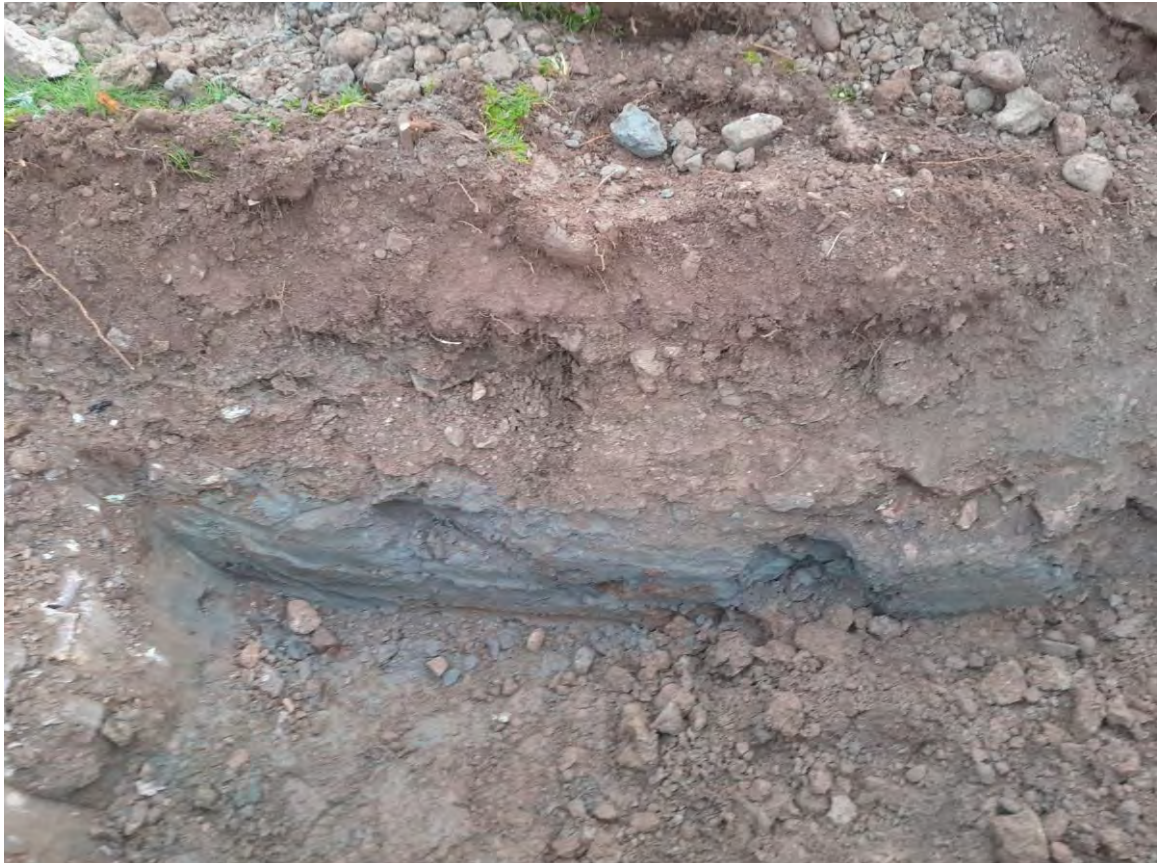
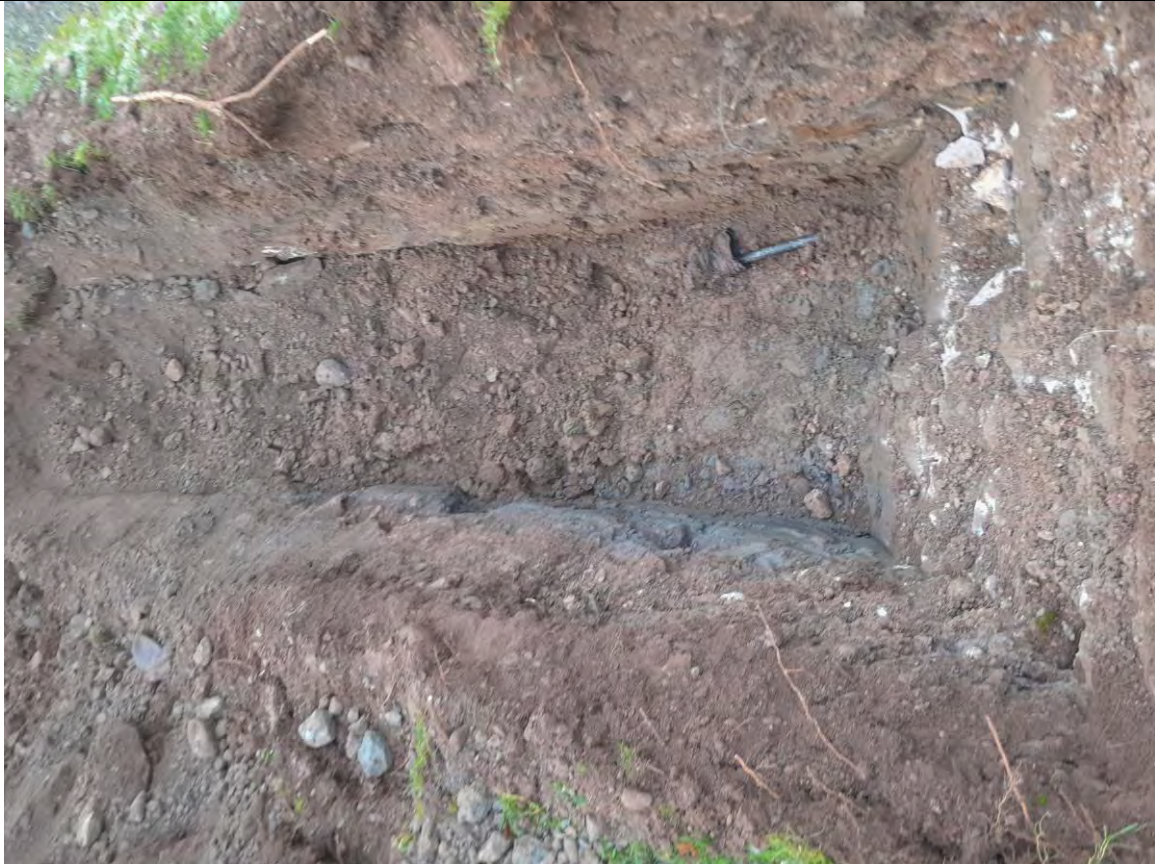
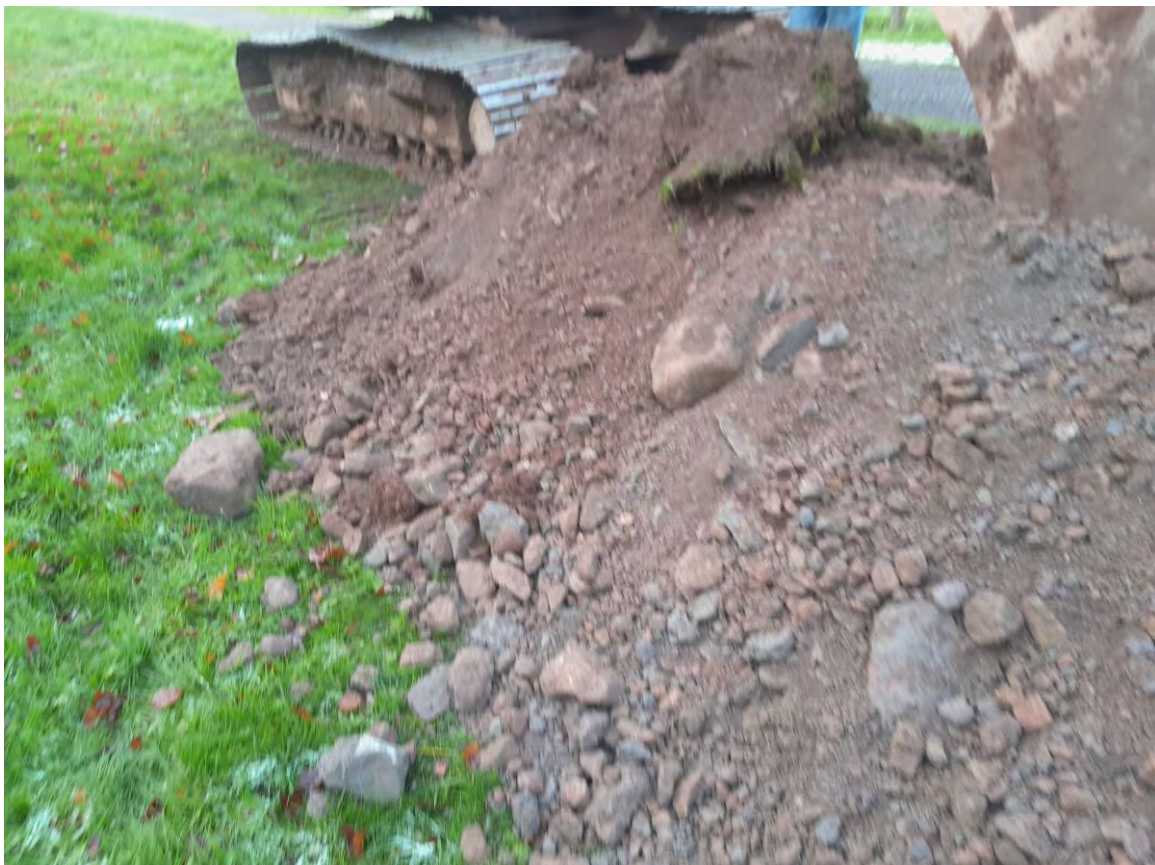
<p><b>Number:</b> TP03</p>	<p><b>Project</b> Little Island/ N25 Pedestrian &amp; Cycle Bridge <b>Project No</b> P22156 <b>Engineer</b> Arup</p>	
----------------------------	--	--

DATUM COORDINATES: EASTING: 575181.54 NORTHING: 572888.69 LEVEL: 3.16mAOD		TRIAL PIT NUMBER: <b>TP03</b>
KEY: DATUM: X		JOB NAME: N25 Pedestrian & Cycle Bridge
TRIAL PIT DIMENSIONS: LENGTH: 3.50m WIDTH: 1.00m DEPTH: 1.20m		JOB NUMBER: P22156
STRATA SHOWN ON DETAILED LOG		
DRAWN BY: G.C.	DATE: 14/12/2022	DRAWING NUMBER: P22156-TP03
LOGGED BY: R.S.	DATE: 12/12/2022	
SCALE: AS STATED	APPROVED: GH

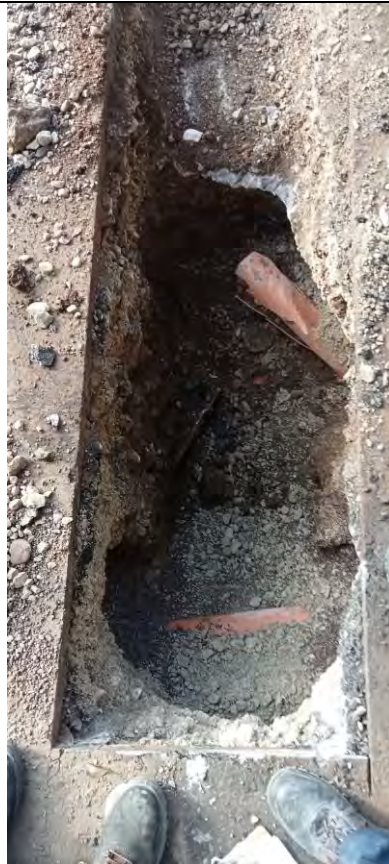
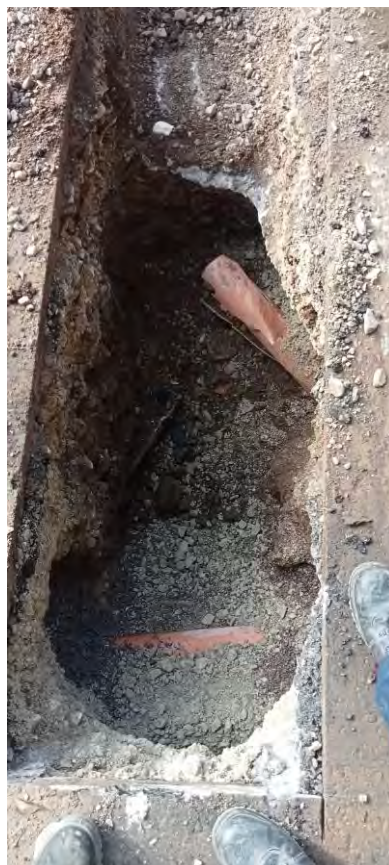
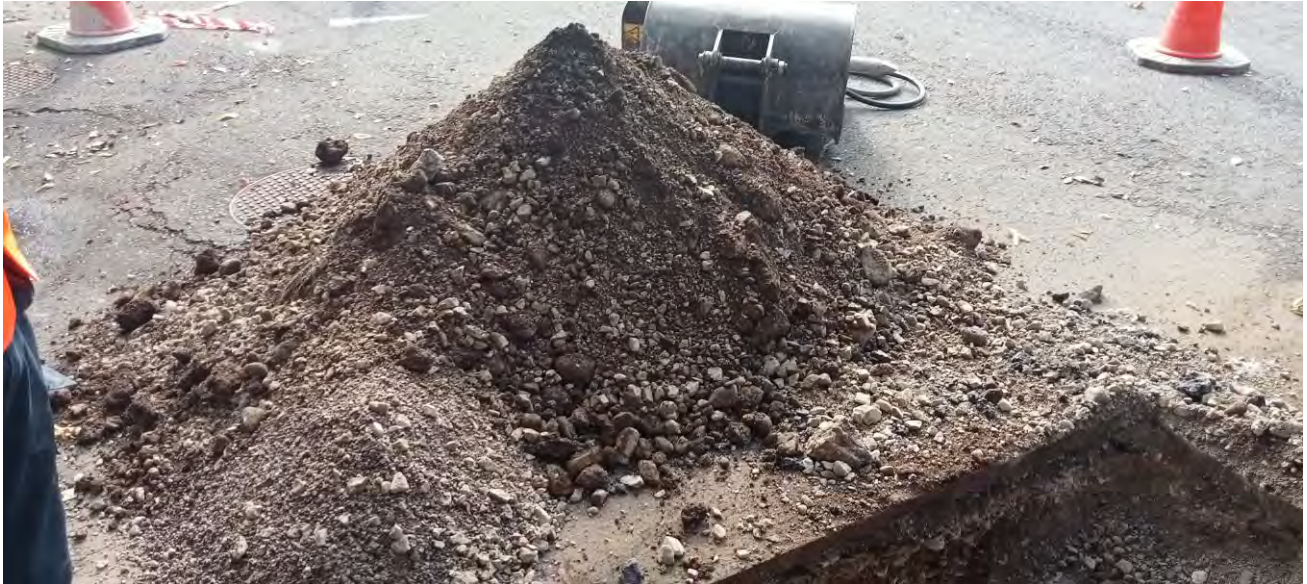
**TP04**

Water Strike & Backfill	Samples & In Situ Testing			Depth (m)	Level (m OD)	Legend	Stratum Description
	Depth (m)	Type	Results				
	0.10	B		0.10	4.82		Bituminous surfacing
	0.10	ES					(MADE GROUND) Clause 804 or similar.
	0.10 - 1.10	ENV					
				1.10	3.82		0.80m: Water main and broken pipe.
							End of Pit at 1.100m

DATUM COORDINATES: EASTING: 575256.58 NORTHING: 572732.37 LEVEL: 4.921mAOD		TRIAL PIT NUMBER: <b>TP04</b>
KEY: DATUM: X		JOB NAME: N25 Pedestrian & Cycle Bridge
TRIAL PIT DIMENSIONS: LENGTH: 3.20m WIDTH: 0.65m DEPTH: 1.10m		JOB NUMBER: P22156
STRATA SHOWN ON DETAILED LOG		
DRAWN BY: G.C.	DATE: 06/07/2023	DRAWING NUMBER: P22156-TP04
LOGGED BY: M.M.	DATE: 29/06/2023	
SCALE: AS STATED	APPROVED: GH

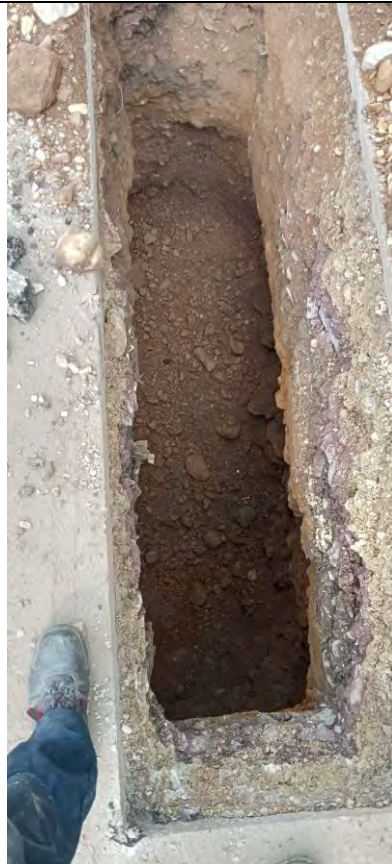
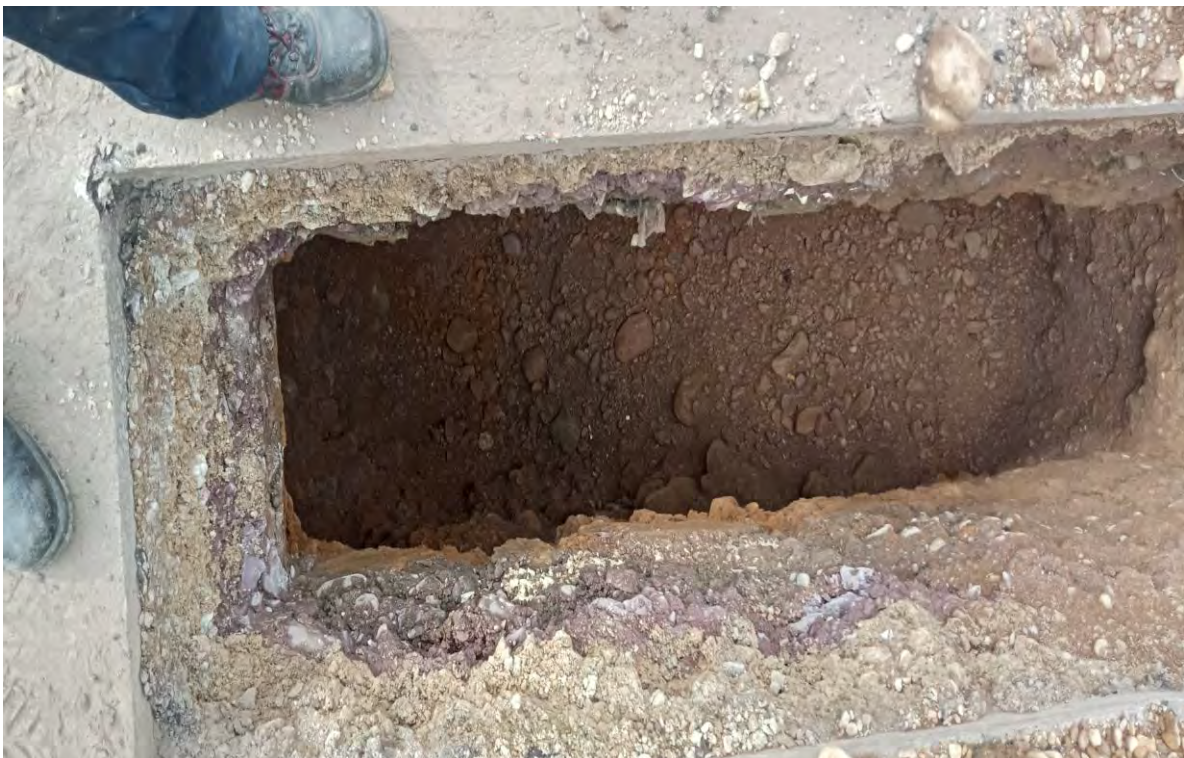
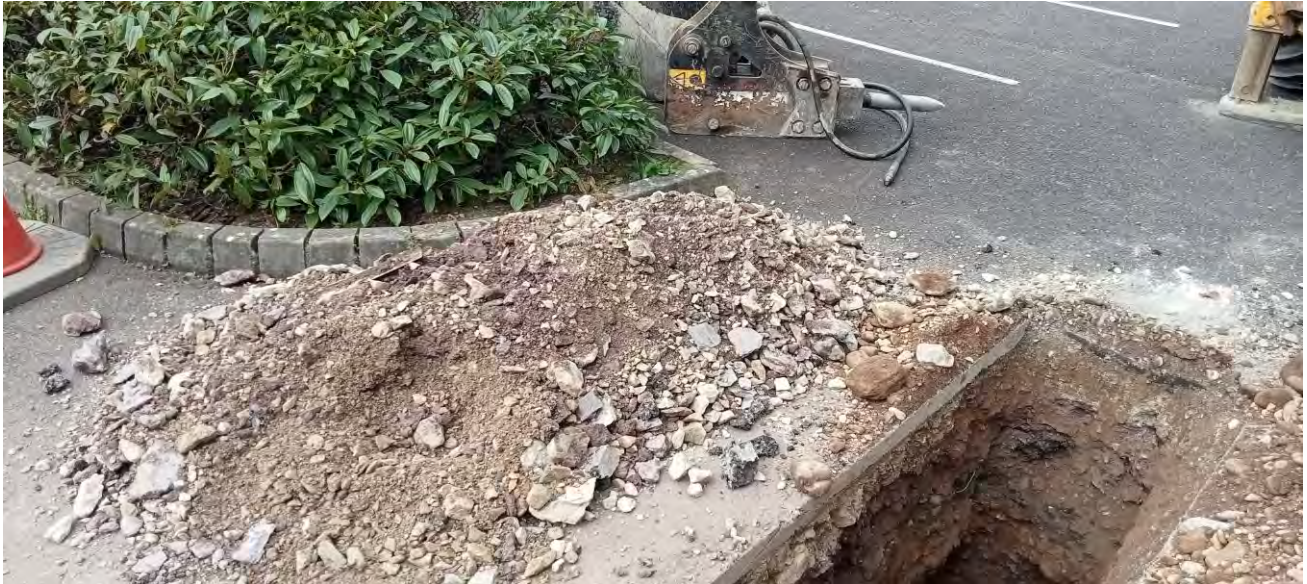
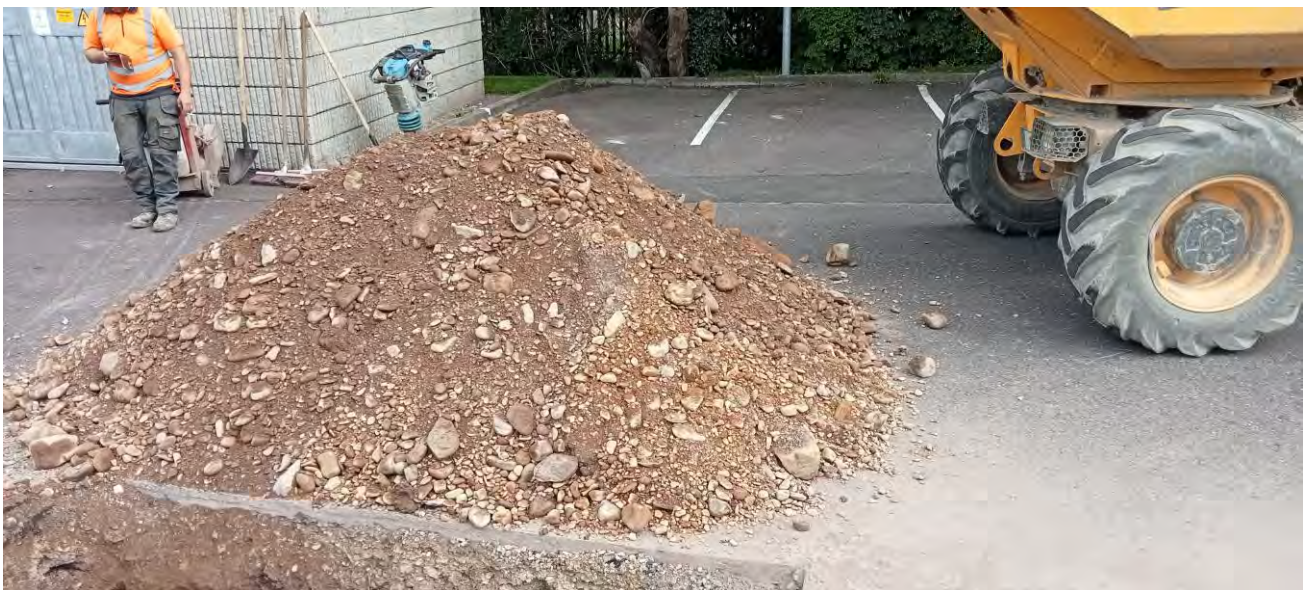
**TP05**

DATUM COORDINATES: EASTING: 575235.79 NORTHING: 572716.09 LEVEL: 3.801mAOD		TRIAL PIT NUMBER: <b>TP05</b>
KEY: DATUM: X		JOB NAME: N25 Pedestrian & Cycle Bridge
TRIAL PIT DIMENSIONS: LENGTH: 2.40m WIDTH: 0.70m DEPTH: 2.30m		JOB NUMBER: P22156
STRATA SHOWN ON DETAILED LOG		
DRAWN BY: G.C.	DATE: 19/07/2022	DRAWING NUMBER: P22156-TP05
LOGGED BY: M.M.	DATE: 29/06/2022	
SCALE: AS STATED	APPROVED: GH	REVISION: D01

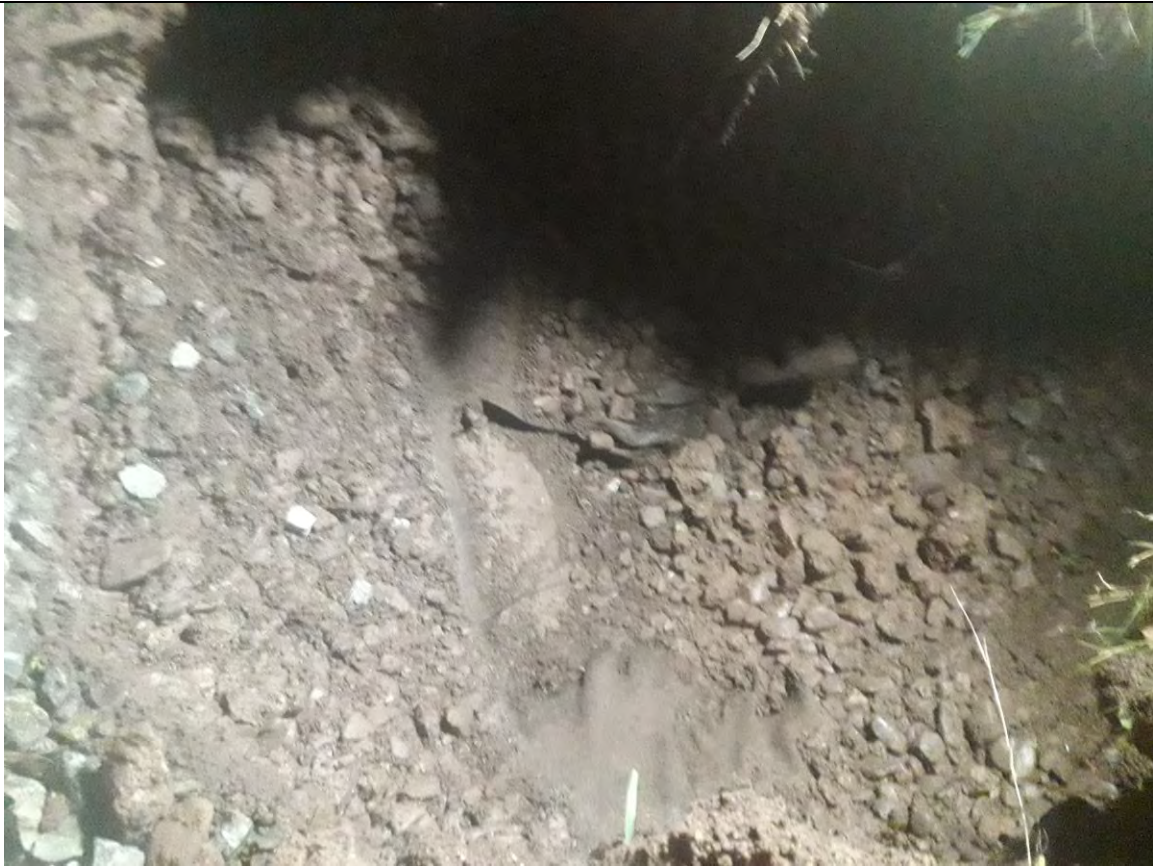
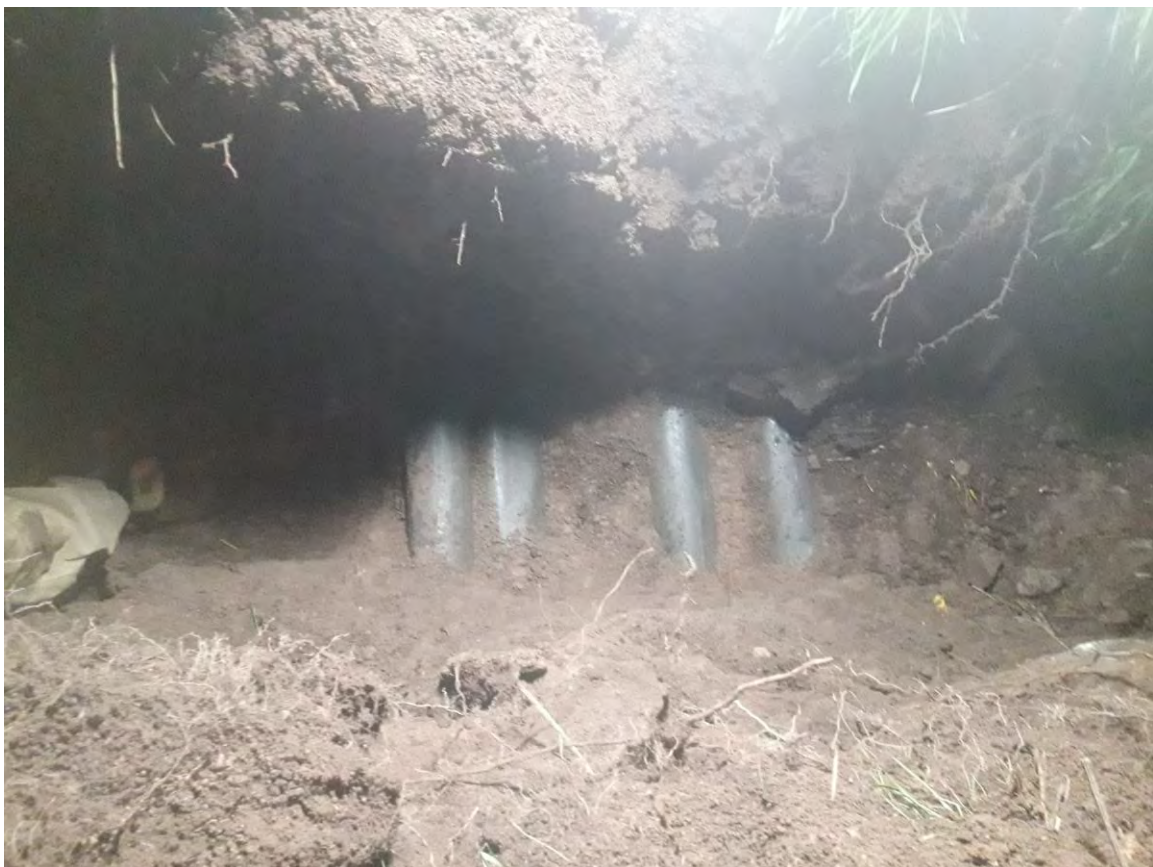
**ST913**

DATUM COORDINATES: EASTING: 575227.8 NORTHING: 575797.0 LEVEL: 3.618mAOD		SLIT TRENCH NUMBER: <h1>ST913</h1>
KEY: DATUM: X		JOB NAME: <b>N40 / Dunkettle Interchange Upgrade Scheme</b>
SLIT TRENCH DIMENSIONS: LENGTH: 6.50m WIDTH: 0.80m DEPTH: 1.50m		JOB NUMBER: <b>P19248</b>
STRATA SHOWN ON DETAILED LOG		
DRAWN BY: G.C.	DATE: 10/01/2020	DRAWING NUMBER: <b>P19248-ST913</b>
LOGGED BY: D.McC.	DATE: 07/01/2020	
SCALE: AS ST9ATED	APPROVED: GH
