# N25 Little Island Pedestrian and Cyclist Bridge

Environmental Impact  
Assessment Report

Volume 4  
Appendices

September 2023

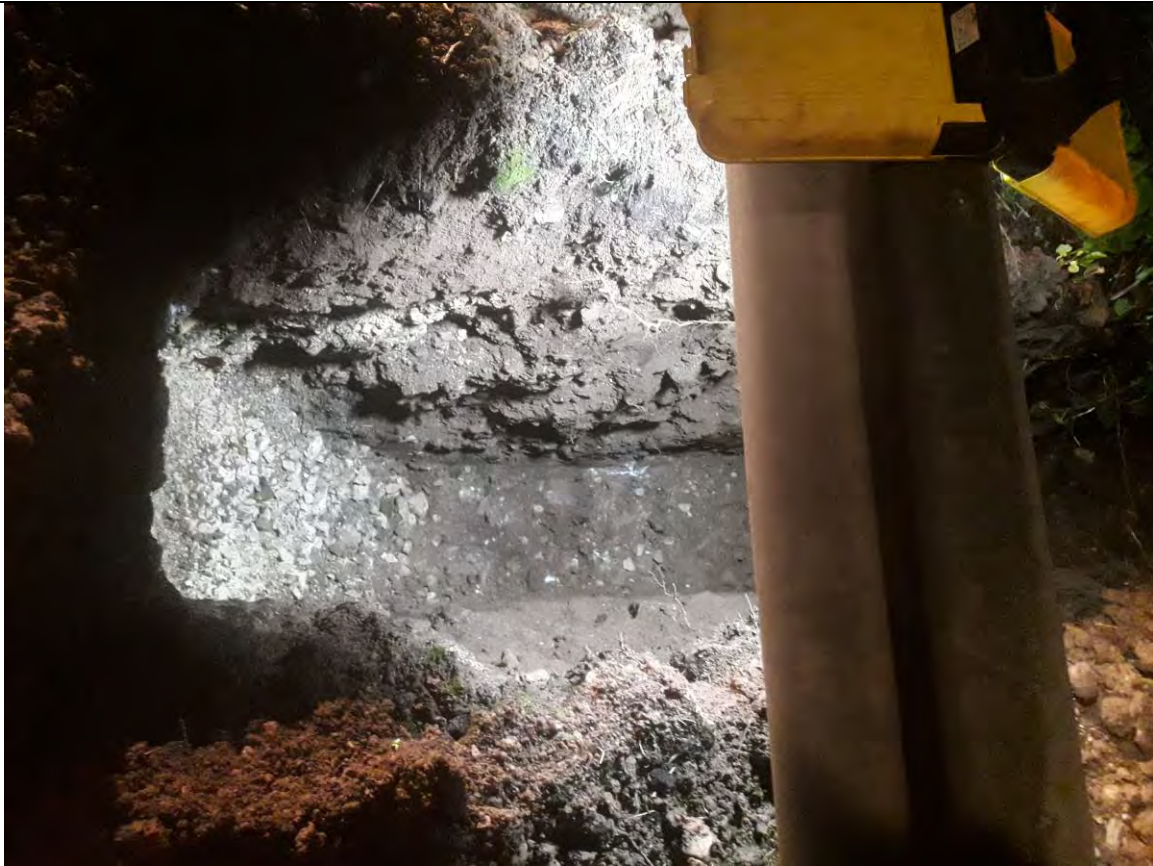
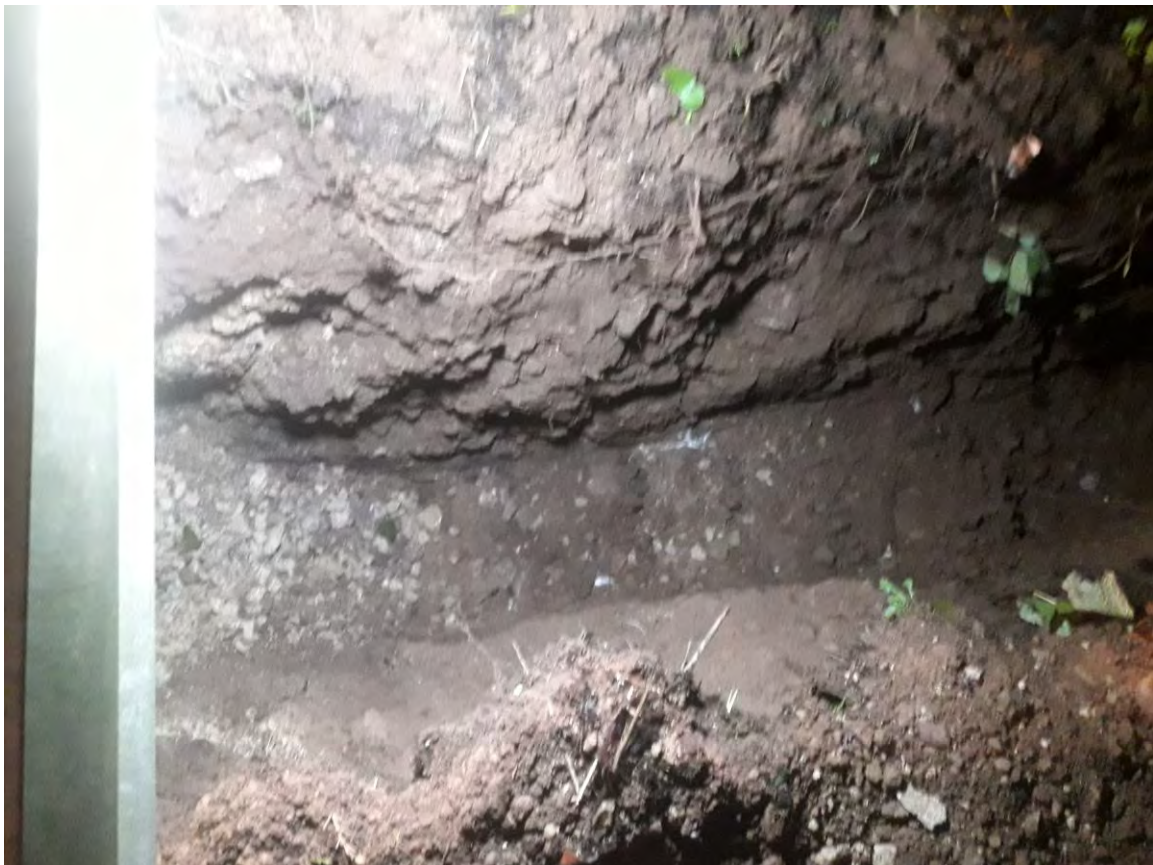
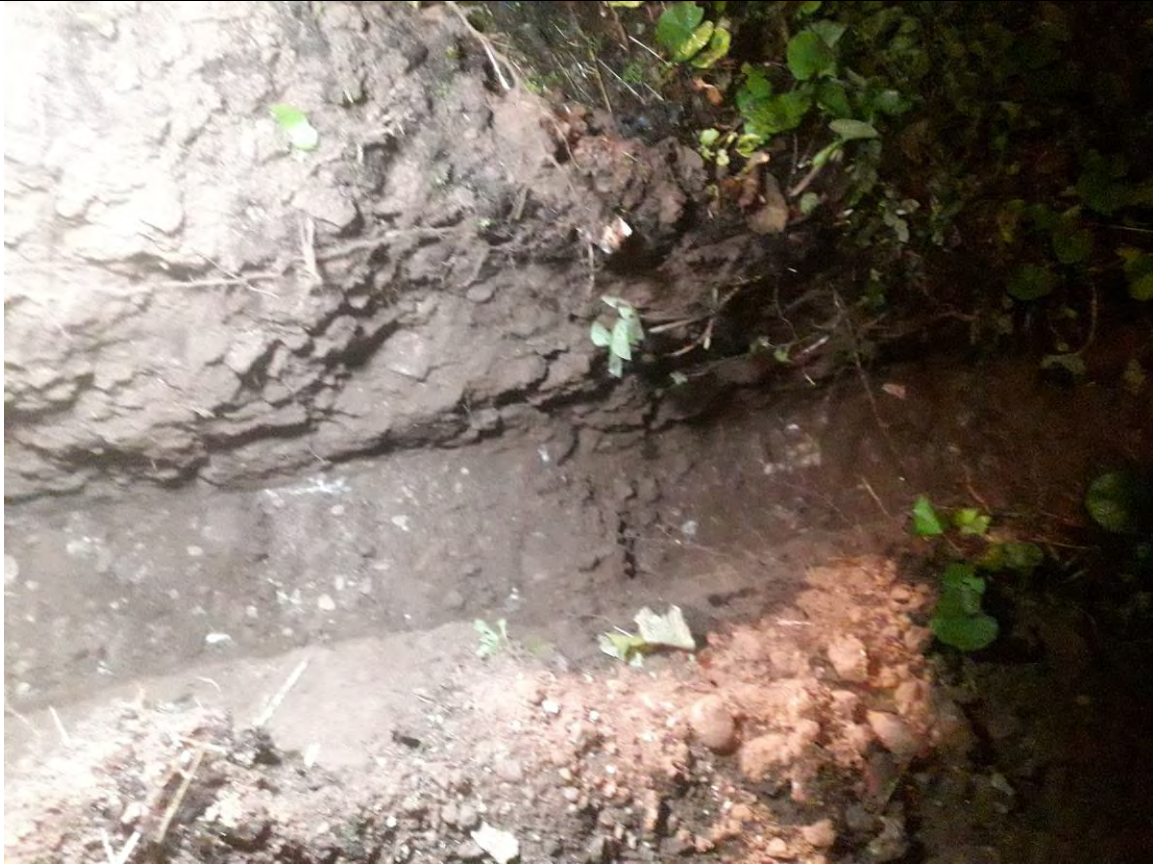
**ST914**

DATUM COORDINATES: EASTING: 575226.1 NORTHING: 572784.1 LEVEL: 3.986mAOD		SLIT TRENCH NUMBER: <h1>ST914</h1>
KEY: DATUM: X		JOB NAME: N40 / Dunkettle Interchange Upgrade Scheme
SLIT TRENCH DIMENSIONS: LENGTH: 4.60m WIDTH: 0.70m DEPTH: 1.50m		JOB NUMBER: P19248
STRATA SHOWN ON DETAILED LOG		
DRAWN BY: G.C.	DATE: 09/01/2020	DRAWING NUMBER: P19248-ST914
LOGGED BY: D.McC.	DATE: 06/01/2020	
SCALE: AS ST9ATED	APPROVED: GH

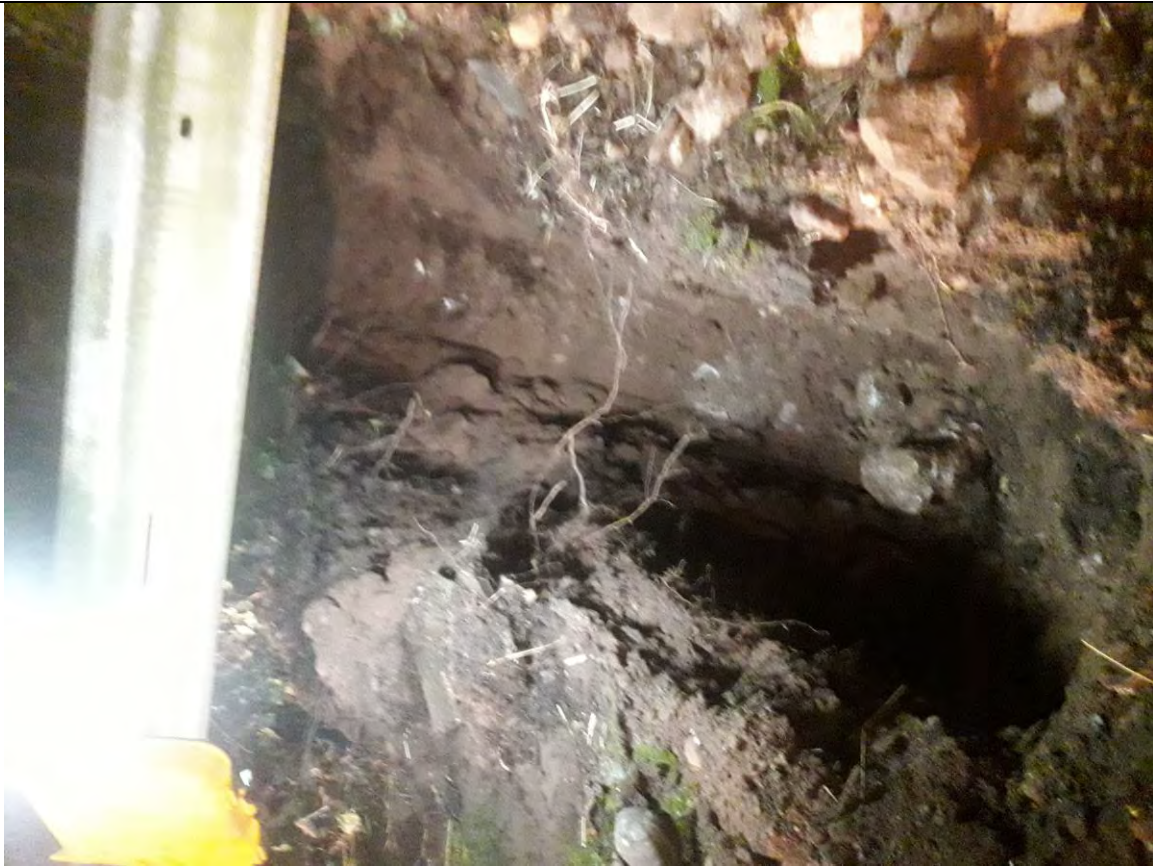
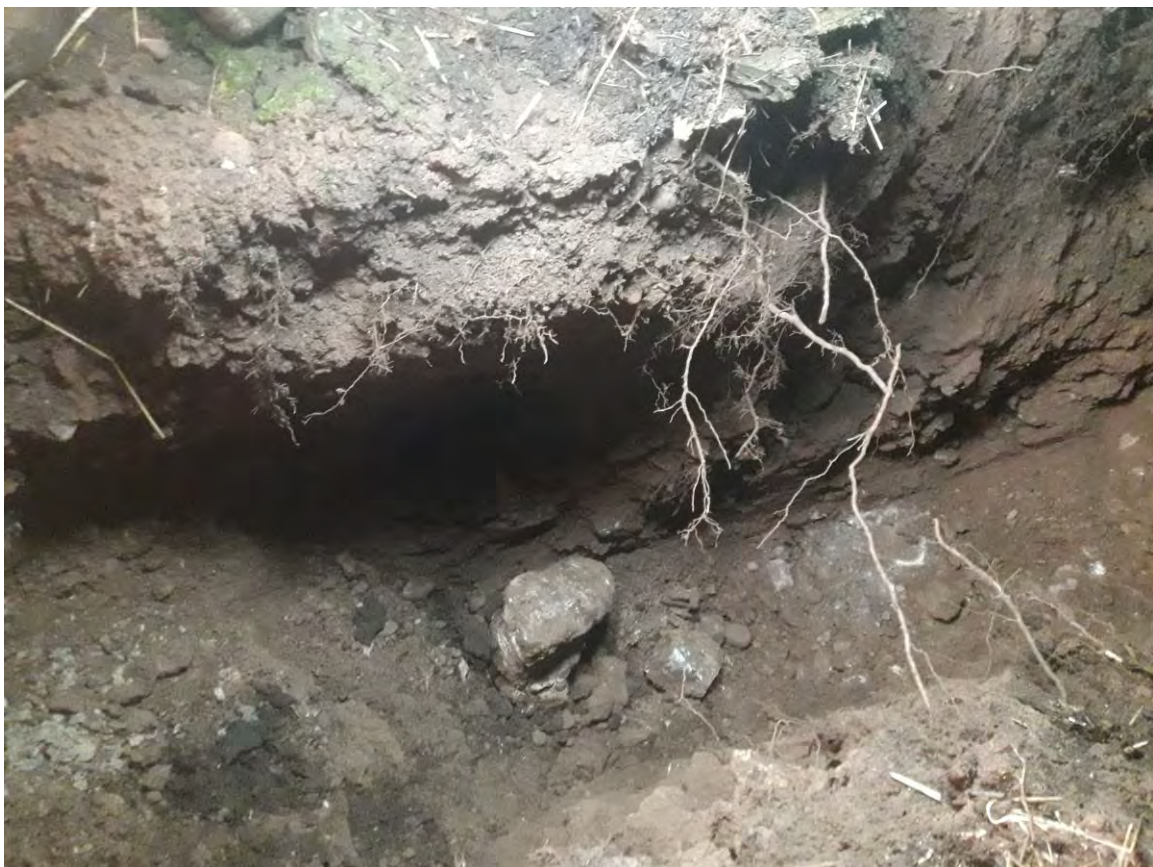
**ST915**

DATUM COORDINATES: EASTING: 575460.7 NORTHING: 572801.9 LEVEL: 4.122mAOD		SLIT TRENCH NUMBER: <b>ST915</b>
KEY: DATUM: X		JOB NAME: N40 / Dunkettle Interchange Upgrade Scheme
SLIT TRENCH DIMENSIONS: LENGTH: 3.30m WIDTH: 0.60m DEPTH: 1.30m		JOB NUMBER: P19248
STRATA SHOWN ON DETAILED LOG		
DRAWN BY: G.C.	DATE: 09/01/2020	DRAWING NUMBER: P19248-ST915
LOGGED BY: D.McC.	DATE: 06/01/2020	
SCALE: AS ST9ATED	APPROVED: GH

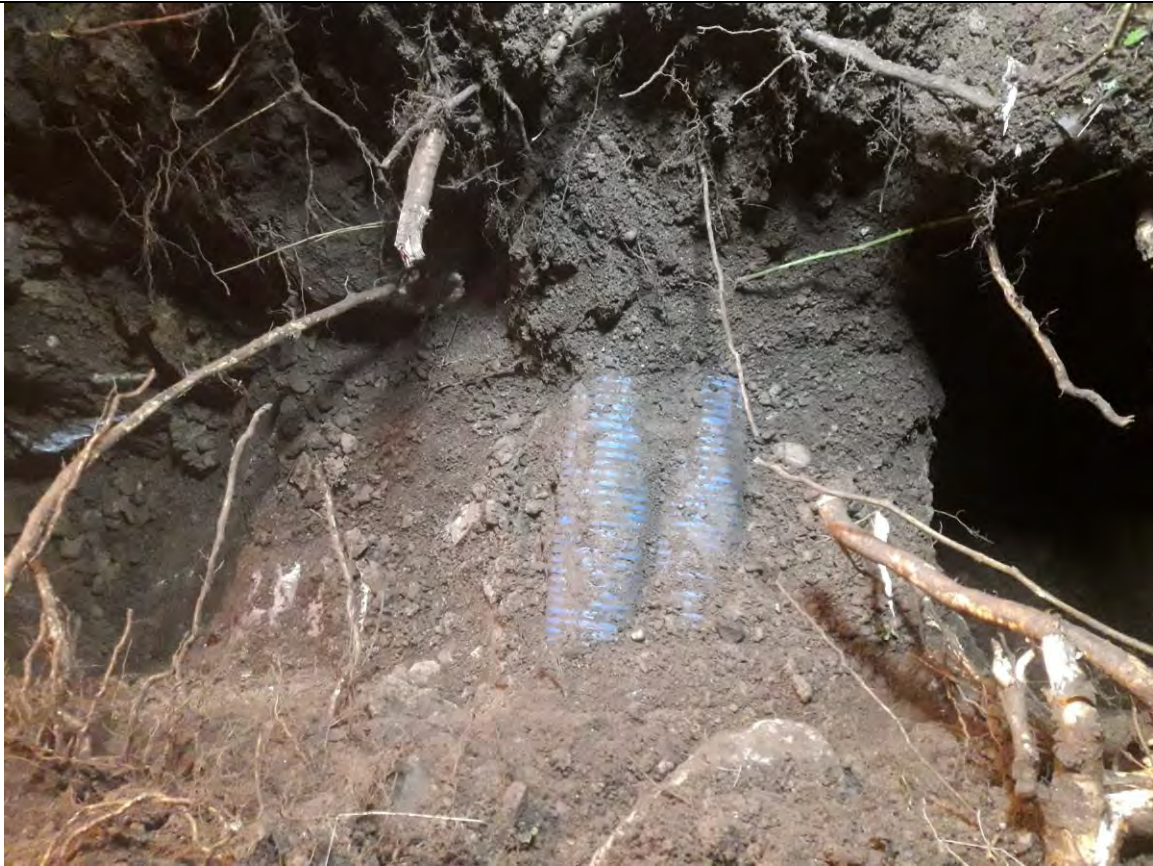
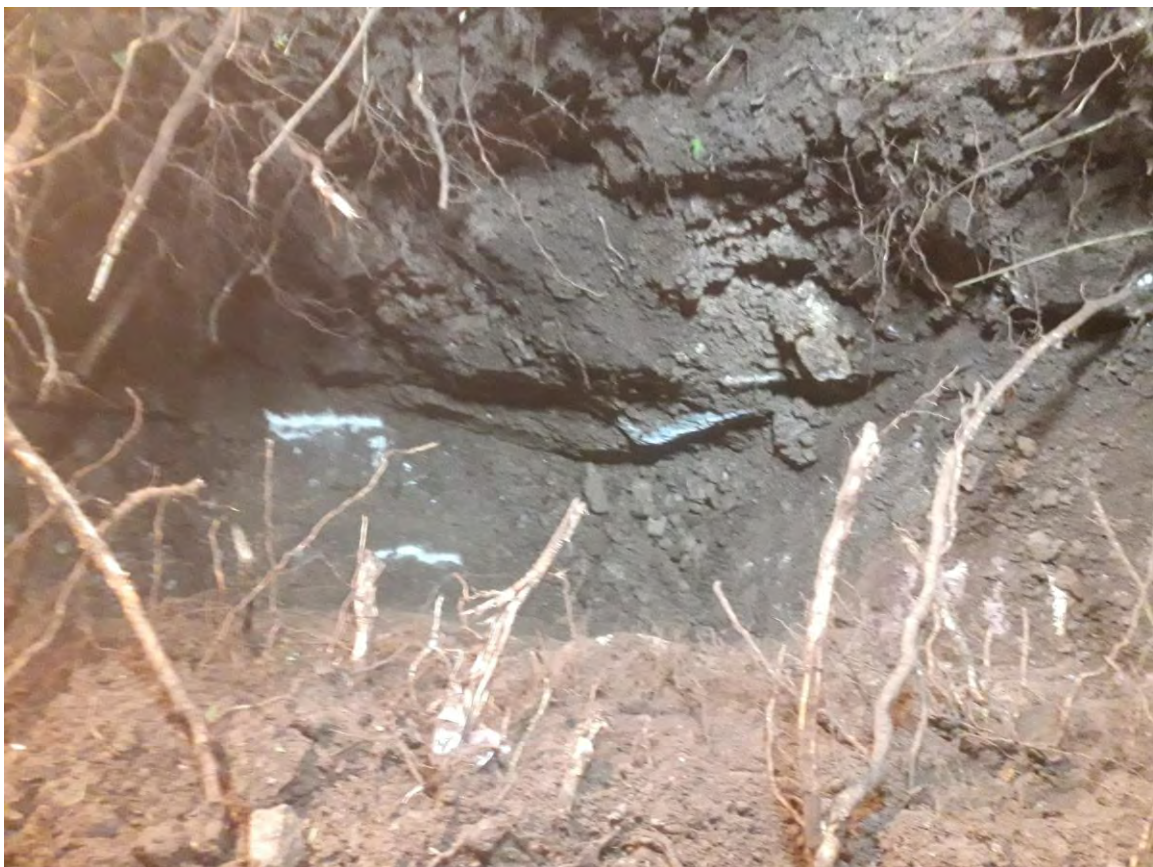
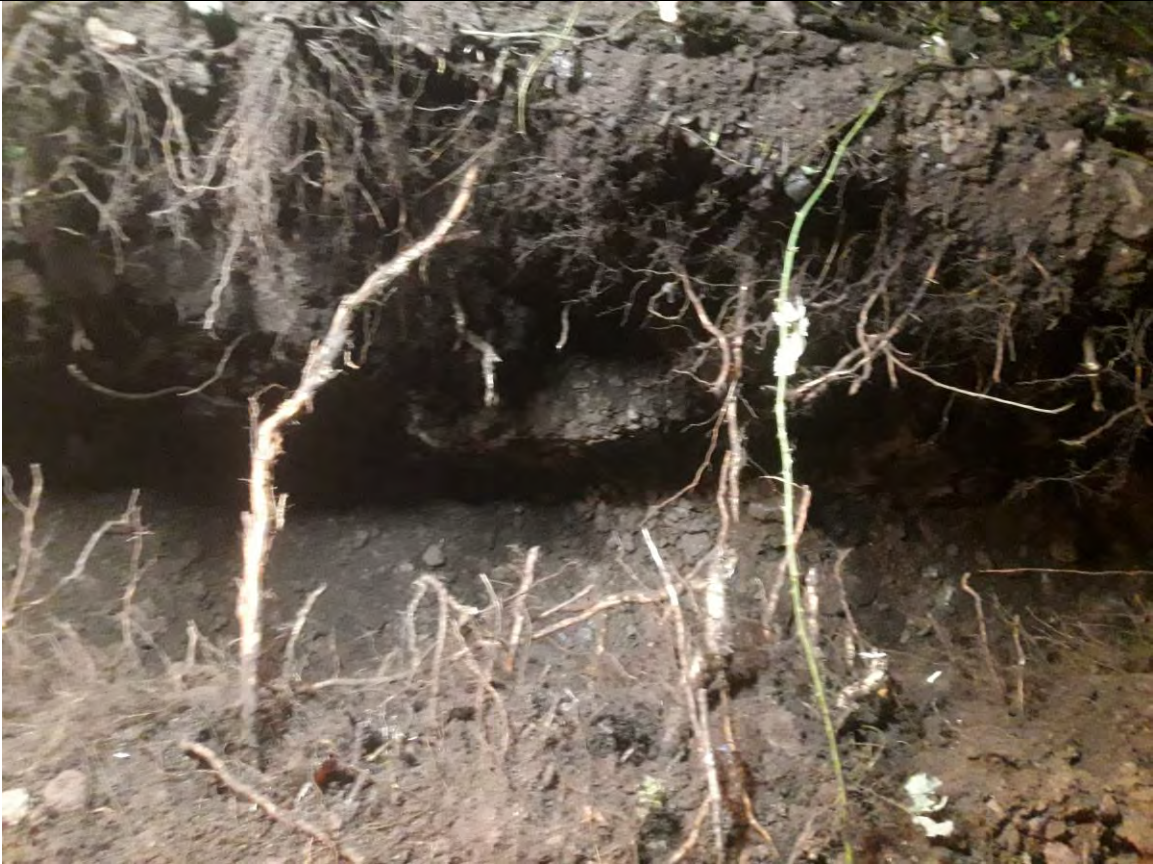
<b>Number:</b> ST916	<b>Project</b> Dunkettle Advance ITS Works <b>Project No</b> P19248 <b>Engineer</b> Atkins	
----------------------	--	--

DATUM COORDINATES: EASTING: 575616.5 NORTHING: 572828.4 LEVEL: 4.076mAOD		SLIT TRENCH NUMBER: <b>ST916</b>
KEY: DATUM: X		JOB NAME: N40 / Dunkettle Interchange Upgrade Scheme
SLIT TRENCH DIMENSIONS: LENGTH: 6.90m WIDTH: 0.60m DEPTH: 1.40m		JOB NUMBER: P19248
STRATA SHOWN ON DETAILED LOG		
DRAWN BY: G.C.	DATE: 10/01/2020	DRAWING NUMBER: P19248-ST916
LOGGED BY: D.McC.	DATE: 06/01/2020	
SCALE: AS ST9ATED	APPROVED: GH

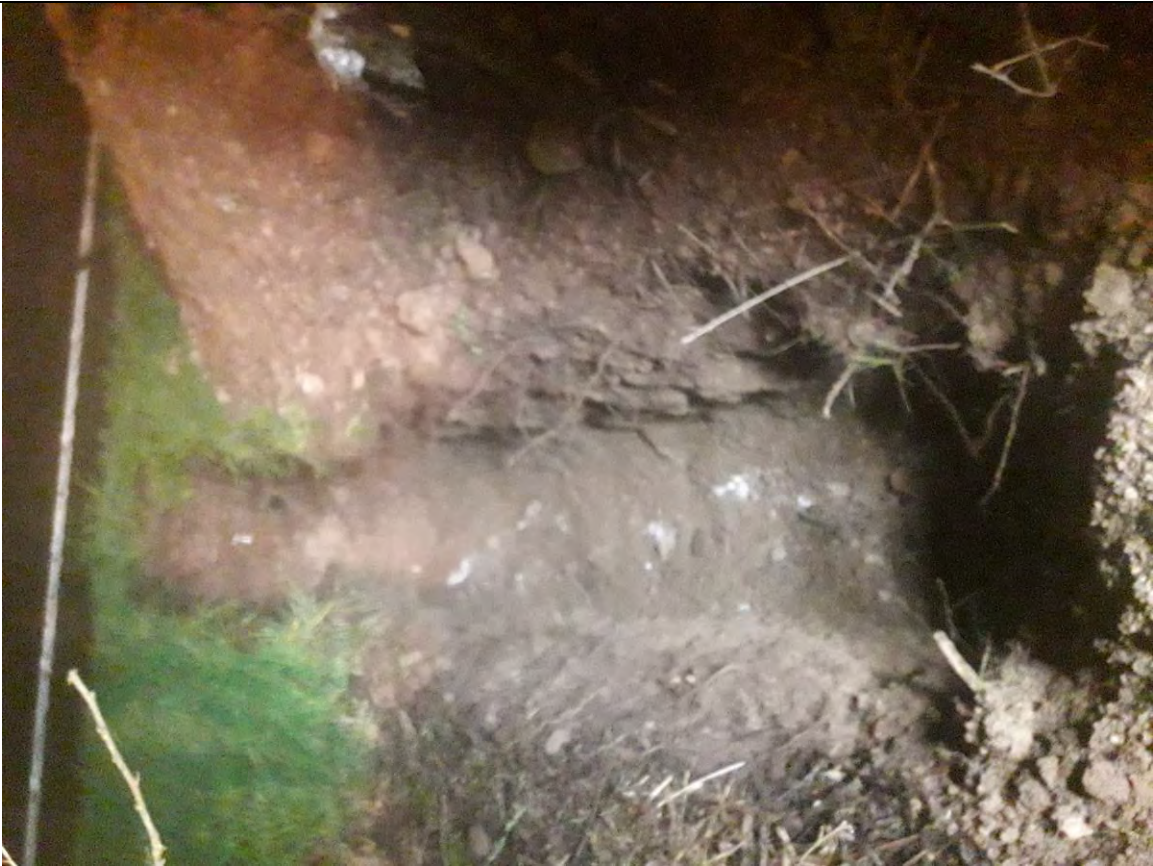
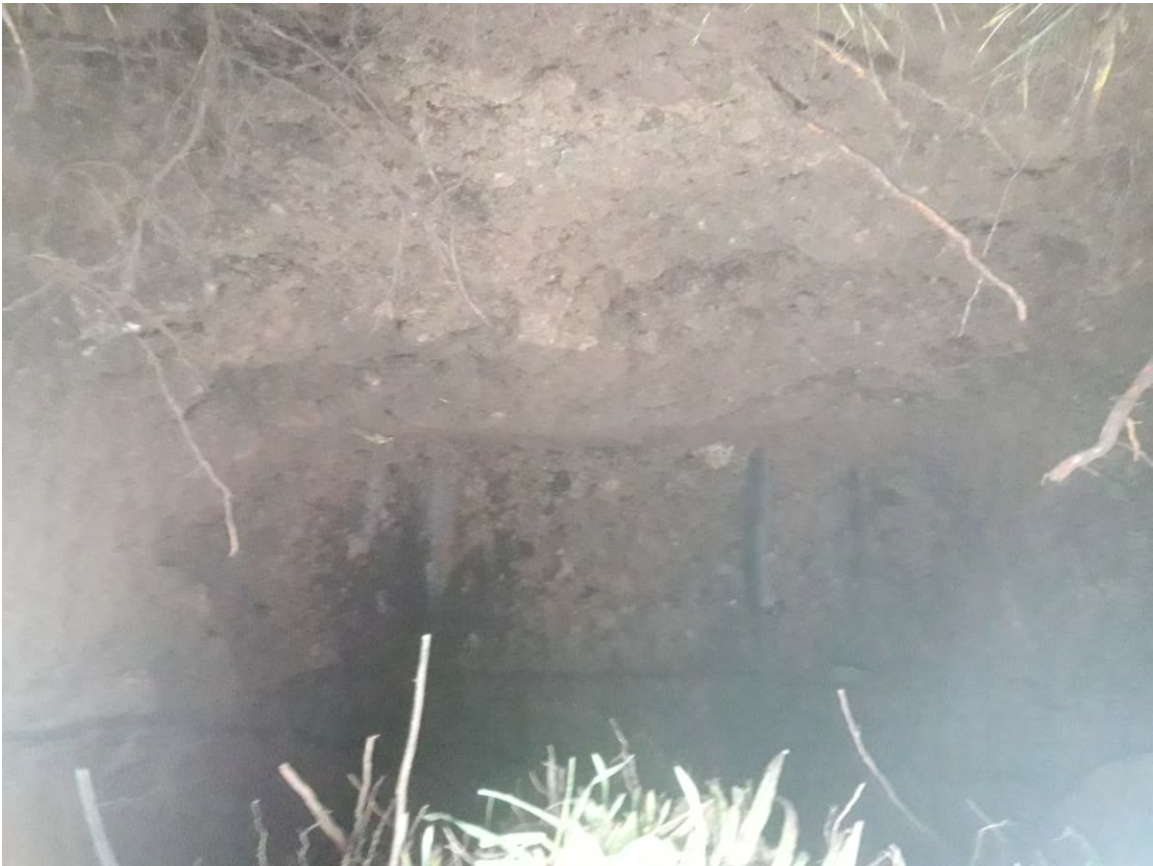
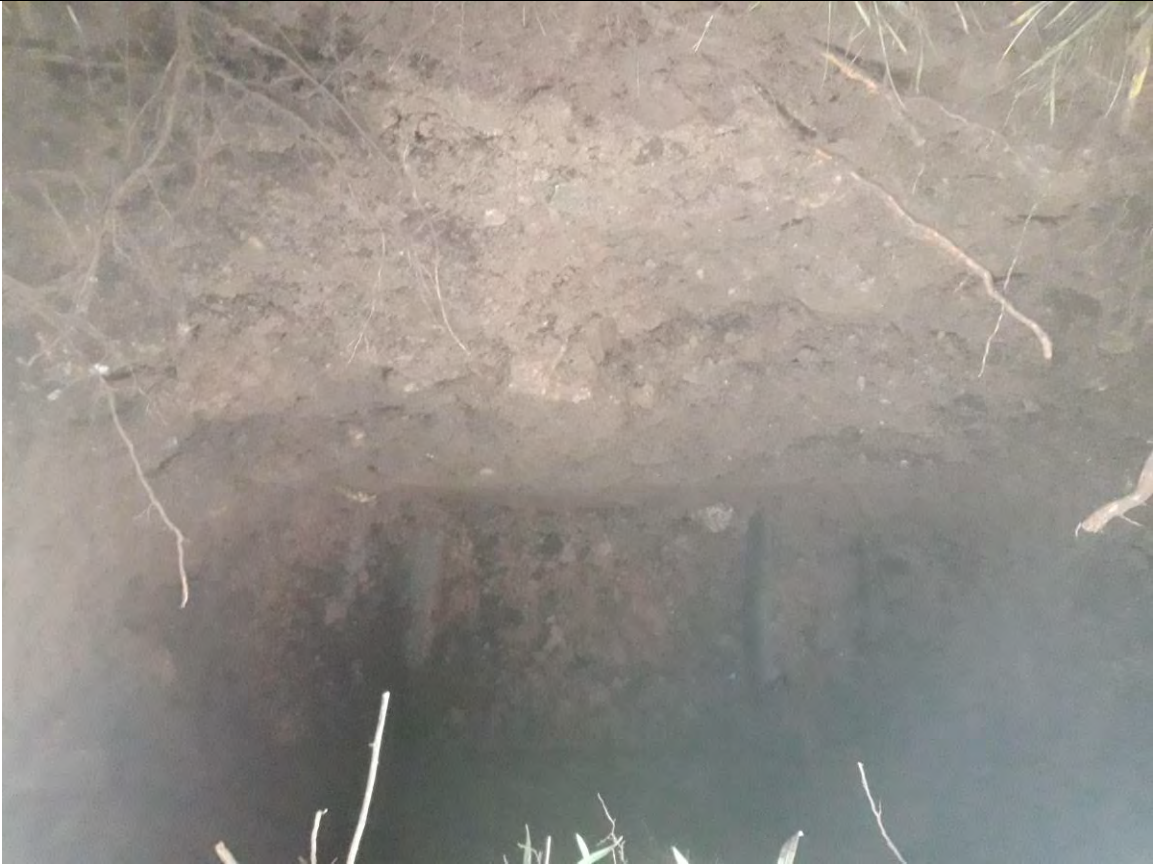
<p><b>Number:</b> ST917</p>	<p><b>Project</b> Dunkettle Advance ITS Works <b>Project No</b> P19248 <b>Engineer</b> Atkins</p>	
-----------------------------	---	--

DATUM COORDINATES: EASTING: 575725.3 NORTHING: 572874.0 LEVEL: 3.448m AOD		SLIT TRENCH NUMBER: <b>ST917</b>
KEY: DATUM: X		JOB NAME: N40 / Dunkettle Interchange Upgrade Scheme
SLIT TRENCH DIMENSIONS: LENGTH: 7.40m WIDTH: 0.60m DEPTH: 1.40m		JOB NUMBER: P19248
STRATA SHOWN ON DETAILED LOG		
DRAWN BY: G.C.	DATE: 10/01/2020	DRAWING NUMBER: P19248-ST917
LOGGED BY: D.McC.	DATE: 07/01/2020	
SCALE: AS ST9ATED	APPROVED: GH

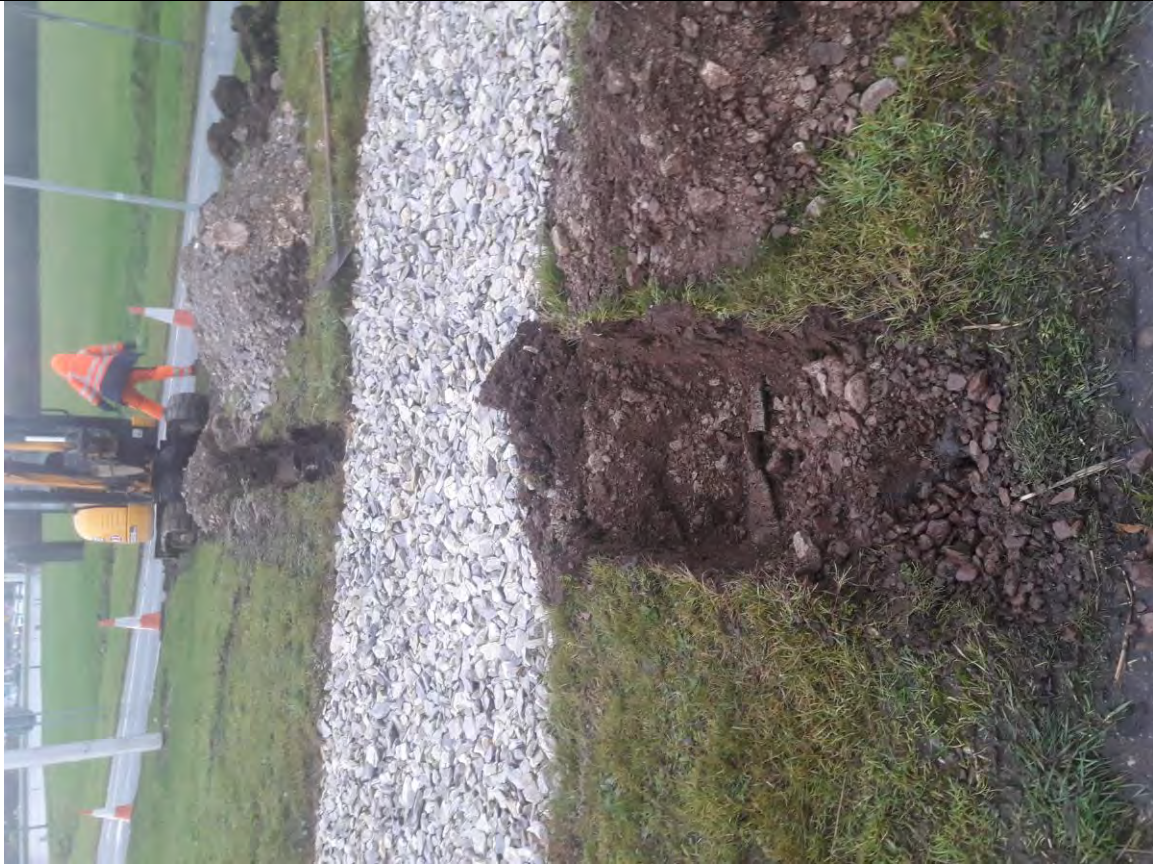
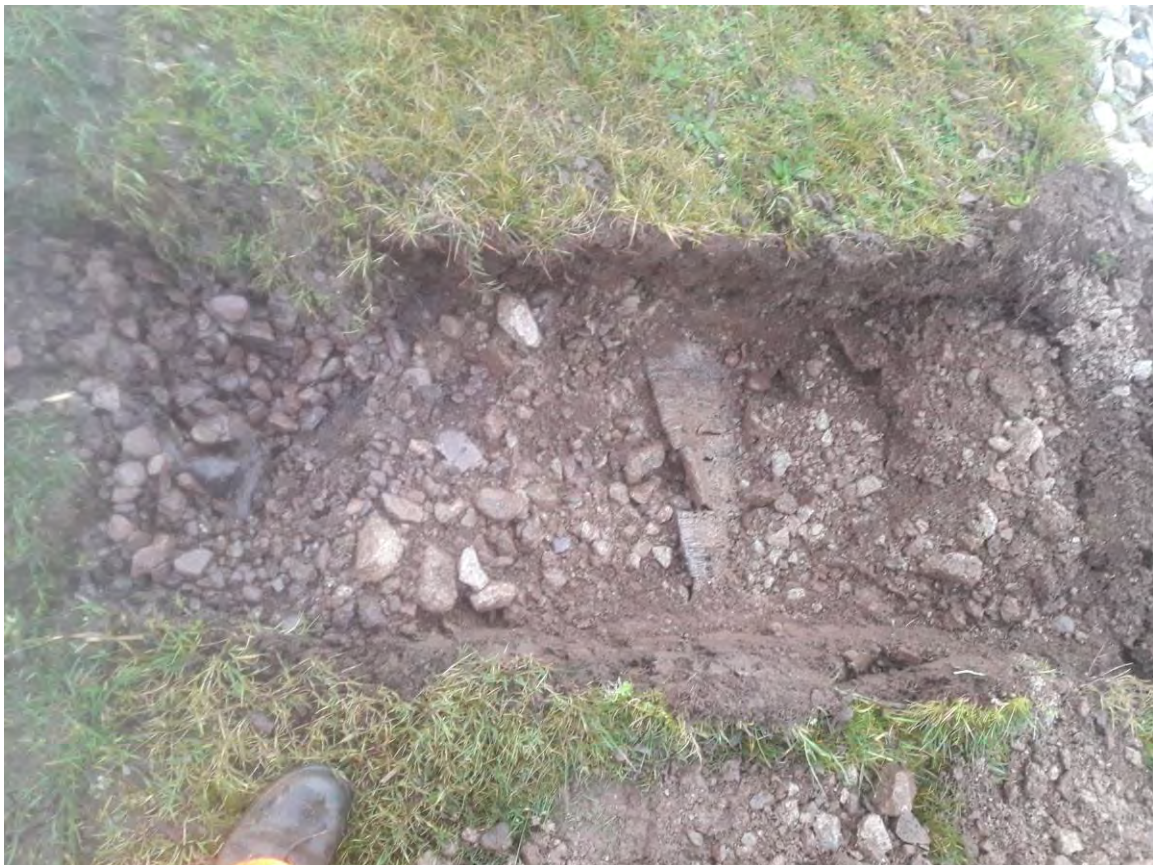
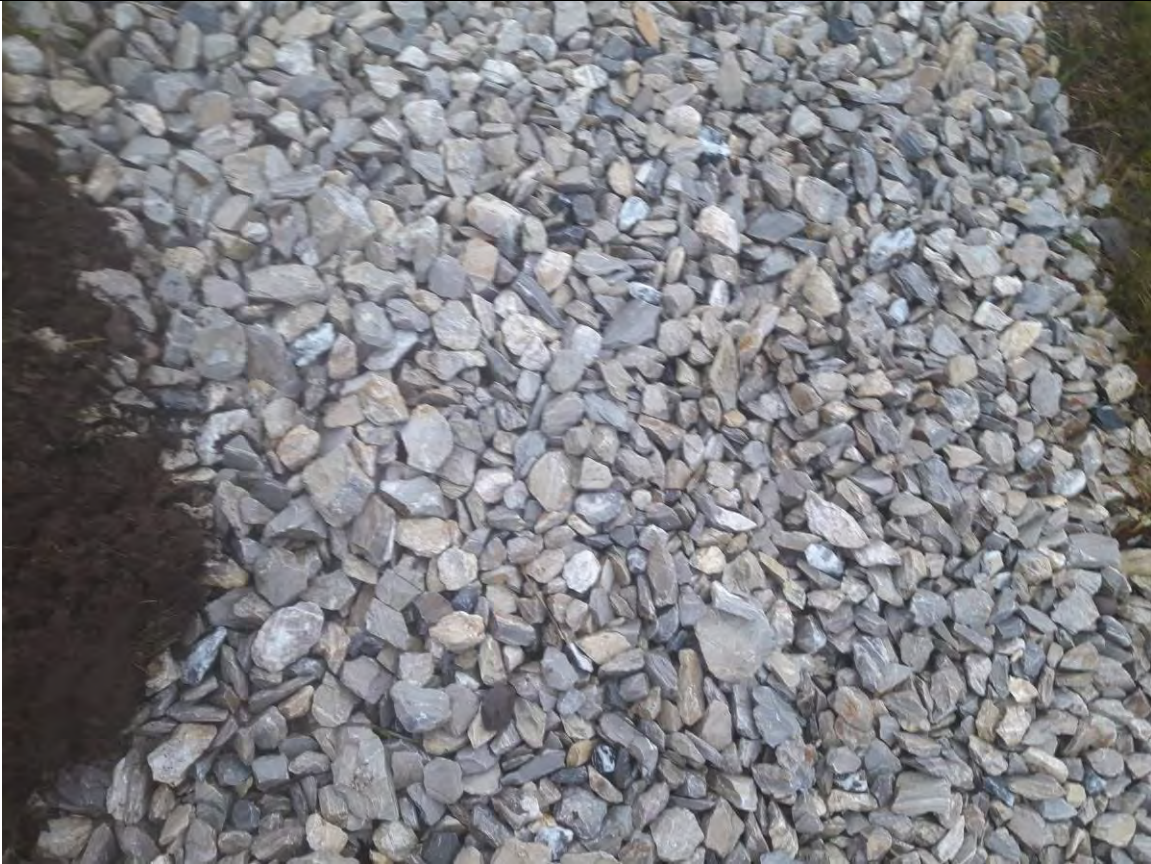
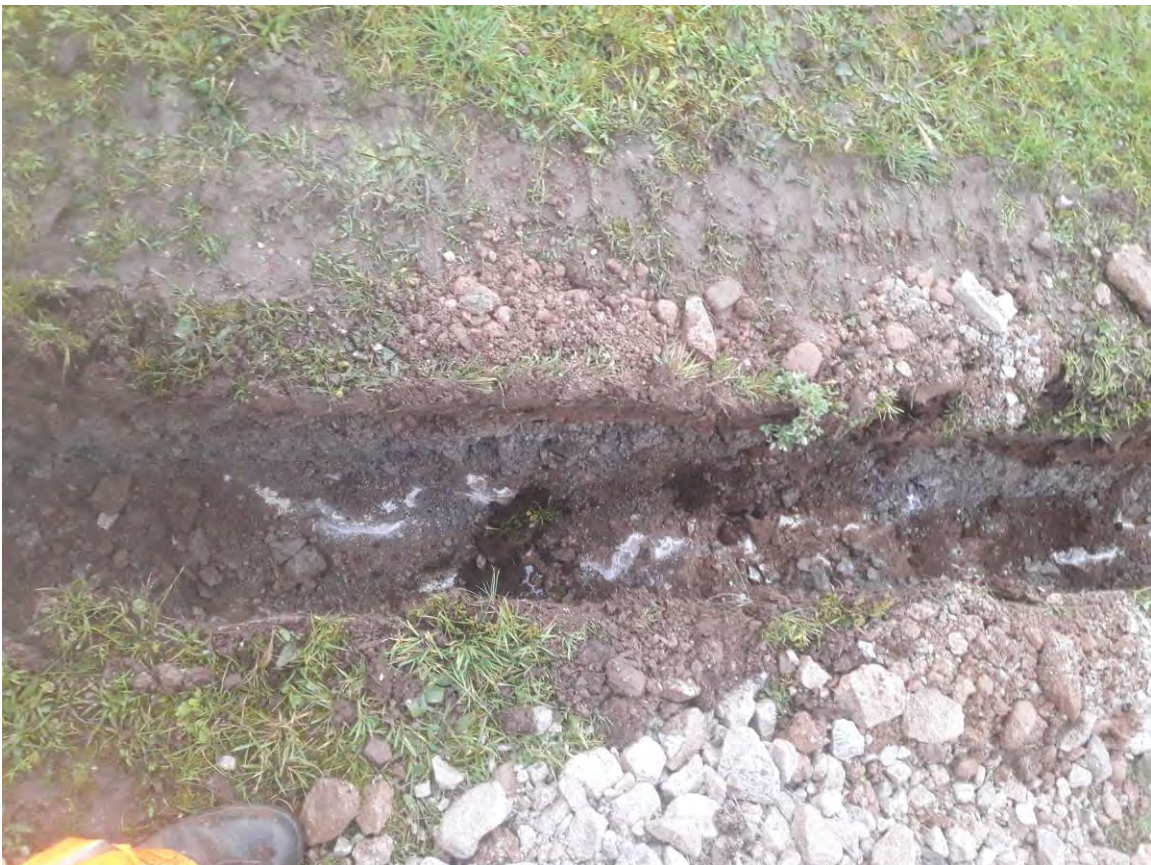
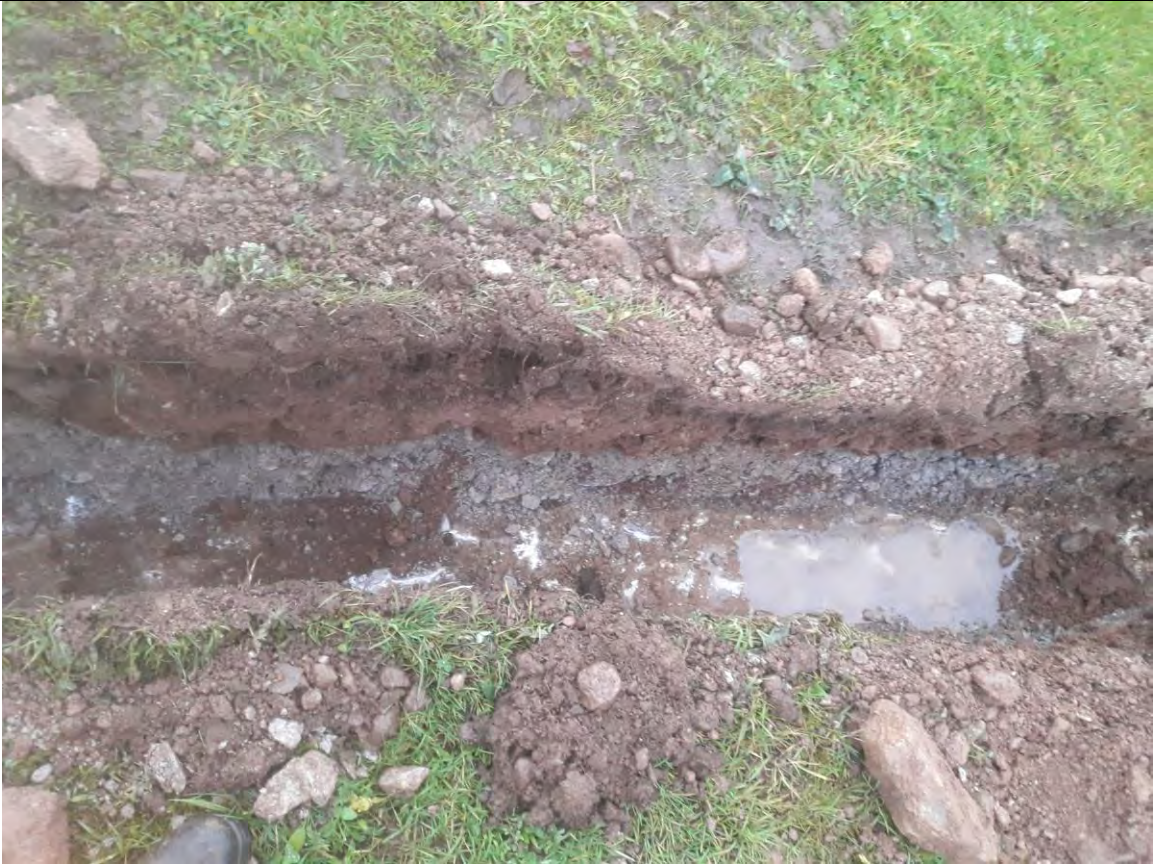
**ST918**

DATUM COORDINATES: EASTING: 575730.8 NORTHING: 572863.7 LEVEL: 3.595mAOD		SLIT TRENCH NUMBER: <h1>ST918</h1>
KEY: DATUM: X		JOB NAME: N40 / Dunkettle Interchange Upgrade Scheme
SLIT TRENCH DIMENSIONS: LENGTH: 9.50m WIDTH: 0.60m DEPTH: 0.60m		JOB NUMBER: P19248
STRATA SHOWN ON DETAILED LOG		
DRAWN BY: G.C.	DATE: 07/01/2020	DRAWING NUMBER: P19248-ST918
LOGGED BY: D.McC.	DATE: 19/12/2019	
SCALE: AS ST9ATED	APPROVED: GH
