Carrigaline Cycle/Pedestrian
Track - Phase 1
(Section B)

Stage 1 Road Safety Audit

Document Ref:	P23056-PMCE-XX-XX-RP-SA-RSA-3_ZZ_02
----------------------	--

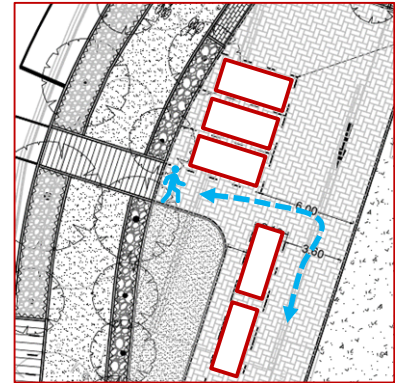
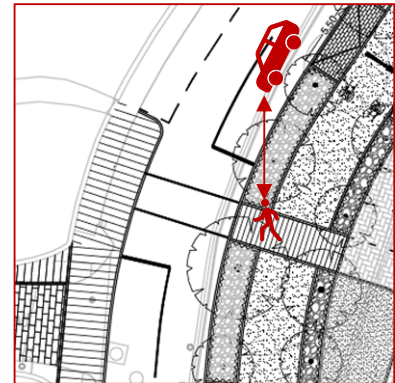
Location: Drawing no. 281905-UM-SB-ML-DR-CH-00012

Summary: Unclear what type of pedestrian crossing is proposed, and insufficient forward visibility towards the crossing for approaching drivers.

It is unclear what type of crossing (e.g. Zebra, Pelican, Toucan, etc.) is proposed on Strand Road north of its junction with Glen Road. Forward visibility towards signals or Belisha beacons may be restricted by the horizontal alignment to the north of the crossing and by the row of trees at the edge of the footpath.

Should a driver's visibility to a pedestrian (or cyclist) waiting at the crossing be restricted there is a risk of drivers overshooting the stop line and colliding with vulnerable road users.

Ensure sufficient inter-visibility is provided between drivers & pedestrians waiting to cross. Additionally, undertake an assessment of the demands in this area to determine the most appropriate form of crossing.

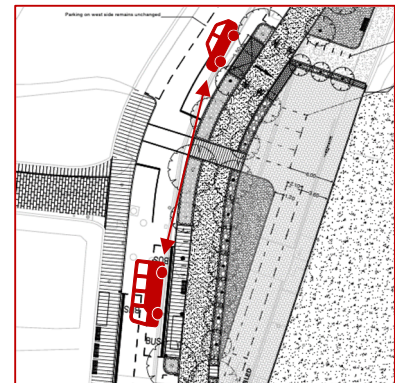
Location: Drawing no. 281905-UM-SB-ML-DR-CH-00012

Summary: Bus stop provided directly after horizontal curve.

The southbound bus stop on Strand Road has been indicated directly after a horizontal curve. A stationary bus may not be seen by southbound drivers travelling around the bend due to the restrictions to visibility splayed posed by the horizontal alignment, the trees and roadside furniture, leading to rear-end-shunt collisions.

Review visibility at this location, and if required, the bus stop should be relocated.

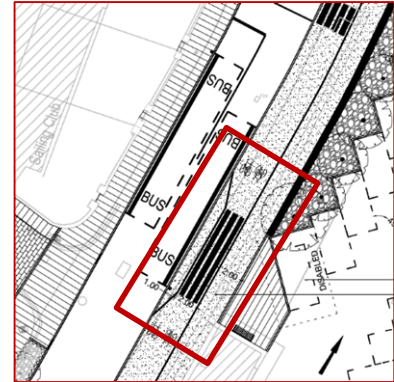
Location: Drawing no. 281905-UM-SB-ML-DR-CH-00013

Summary: Bus Stop layout may increase the risk of pedestrian/cyclist collisions.

The proposed works include shared use facilities for pedestrians and cyclists, however in the location of the southbound bus stop, the cyclist and pedestrian facilities are locally segregated. The segregated facilities demand several elements to operate such as tactile paving arrangements, and traffic signs as the facility transitions between the different cross sections. As these demands occur within a limited section of the scheme, the RSA Team is concerned that the segregated facilities will lead to confusion and the introduction of conflict points between road users.

Furthermore, the cycle track is narrowed at the proposed bus stop, with cyclists required to continue through a narrow channel where pedestrians will be waiting for the bus, or bus passengers will be disembarking. This will bring cyclists and pedestrians into direct conflict, and may lead to pedestrian/cyclist collisions, particularly where visually impaired pedestrians are using the bus stop. This problem will likely be exacerbated by the growth of battery powered bicycles and scooters, where users can travel at, and maintain, high speeds on the cycle track.

The layout should be simplified to remove the need for complex cross sectional transitions and conflict zones presented in the current design.

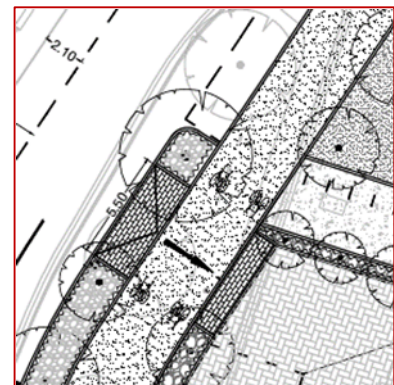
Location: Drawing no. 281905-UM-SB-ML-DR-CH-00012 & Drawing no. 281905-UM-SB-ML-DR-CH-00013

Summary: Inter-visibility between road users and oncoming vehicles might be obscured at both carpark accesses.

Trees, parallel parking, and other street furniture may reduce visibility for motorists entering/exiting the two carparks. Insufficient visibility may lead to unsafe entering/exiting manoeuvres resulting in side-on collisions and vehicle/pedestrian collisions.

Adequate inter-visibility should be available for all manoeuvres likely to be undertaken at the carpark accesses.

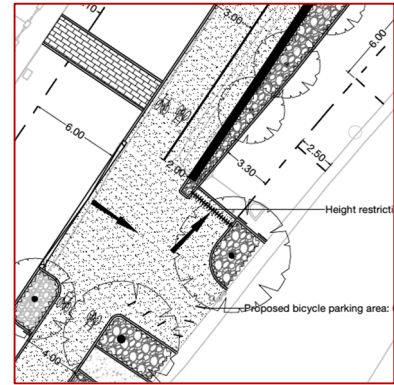
Location: Drawing no. 281905-UM-SB-ML-DR-CH-00012 & Drawing no. 281905-UM-SB-ML-DR-CH-00013

Summary: Swept path analysis within the carparks has not been provided to the Audit Team and it is therefore unclear if all vehicles can safely complete turning manoeuvres within the extents of their traffic lane.

Information regarding the swept path analysis of vehicles entering/exiting the two carparks has not been provided to the Audit Team. It is unclear if the revised road layout at the carpark accesses will accommodate the swept path of all vehicles, particularly cars towing boats, entering and exiting the carpark areas.

If vehicles cannot complete turning manoeuvres within the carriageway extents there is a risk of kerb strikes, collisions with other road users or collisions with items of roadside furniture.

Ensure the swept path of all vehicles can safely enter/exit the carparks.

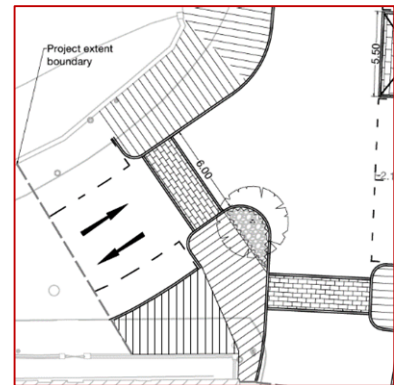
Location: Drawing no. 281905-UM-SB-ML-DR-CH-00012 & Drawing no. 281905-UM-SB-ML-DR-CH-00013

Summary: No junction control or priority type has been indicated at junctions within the scheme extents.

The junction control (stop, yield etc.) at the junctions and carpark accesses within the proposed scheme has not been indicated. It is therefore unclear who has priority at these junctions.

This could result in driver confusion and hesitation leading to collisions should drivers assume that they have priority over vehicles in adjacent roads leading to low speed collisions and material damage.

Ensure the junction control at all junctions is clear and that drivers are sufficiently advised of the priority.

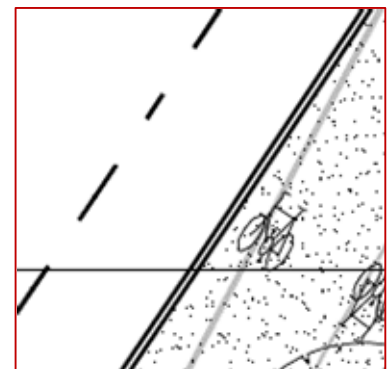
Location: Drawing no. 281905-UM-SB-ML-DR-CH-00012 & Drawing no. 281905-UM-SB-ML-DR-CH-00013

Summary: The proximity of the proposed parallel parking and the adjacent cyclists/pedestrian facilities may result in vehicle doors opening into the cyclists/pedestrian facilities presenting an obstacle for cyclists.

Parallel parking is proposed directly adjacent the cyclist/pedestrian facilities on the eastern side of Strand Road with a kerb indicated between the parking and the pedestrian/cyclist facilities. The proximity of the parking bays to the pedestrian/cyclist facilities may result in a vehicle door opening into the cyclist/pedestrian facilities and presenting an obstacle to cyclists resulting in personal injury collisions.

A buffer zone should be provided between the cyclist/pedestrian facilities and the parking bays.

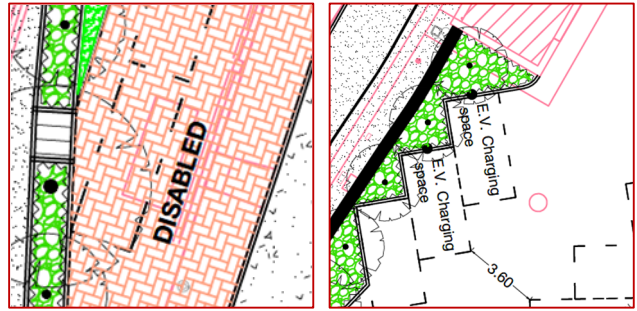
- 4.1 Most of the proposed parking spaces within the carpark appear to have similar dimensions, which do not appear to make allowance for EV parking space requirements. There is a risk, therefore, that carparking spaces intended to accommodate mobility impaired and EV parking will be insufficient sized.

Sufficient space should be provided at the proposed mobility impaired and EV parking spaces in accordance with the Traffic Signs Manual.

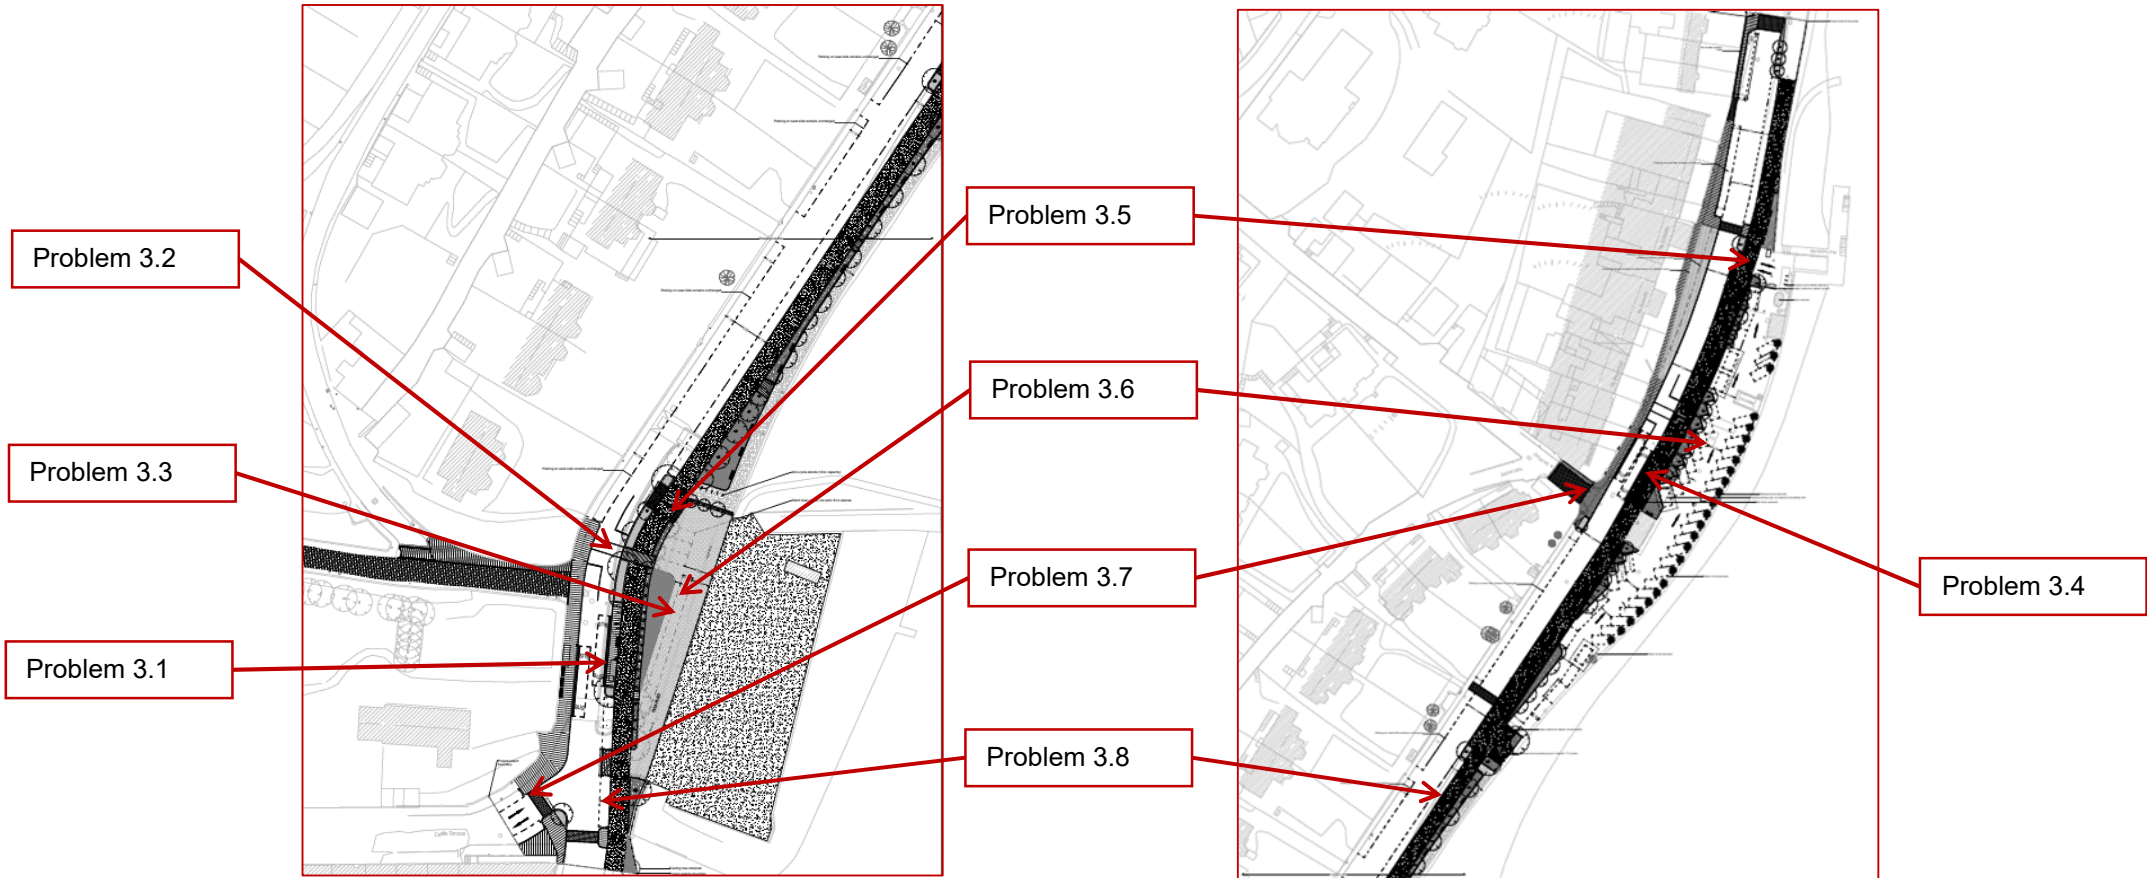
Appendix D – Problem Locations

Where problems are relevant to specific locations these are shown on drawing extracts within the main body of the report and their locations are shown in Appendix D. Where problems are general to the proposals sample drawing extracts are within the main body of the report, where considered necessary.
