Appropriate Assessment Screening for Ardcahan Bridge, Co. Cork

Prepared by Triturus Environmental Ltd. for Fehily Timoney and Company

July 2023

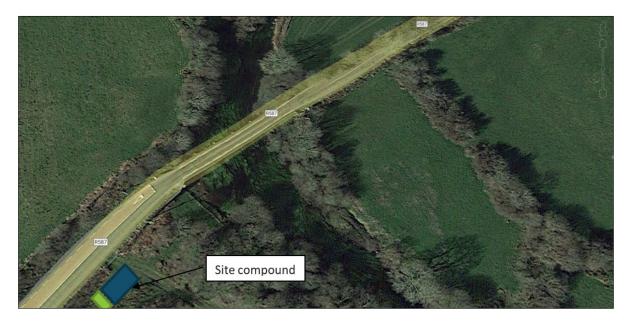
Figure 3.1 Site compound location south west of Ardcahan Bridge

During the construction phase, it will be necessary to provide temporary facilities for construction personnel. This project will have 1 no. temporary compound located near the entrance to the site which will include welfare facilities. The location of the temporary site compound is proposed to be set back c. 30m from the south west corner of the bridge, as shown in Figure 3 1. The temporary compound shall be constructed with crushed rock aggregate hard standings with low dust content. Temporary facilities will be removed, and the lands reinstated upon completion of the construction phase.

The site compound is located in agricultural land inside the Bandon River SAC (see Figure 2-1).

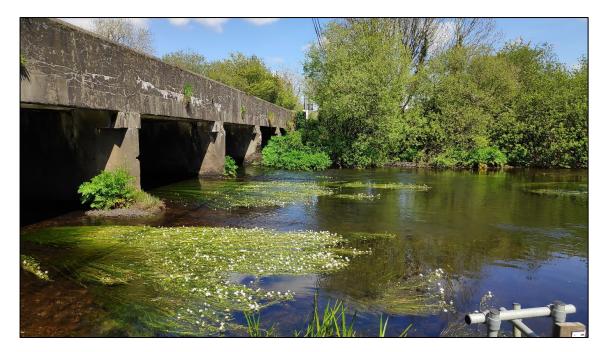
Plate 4.1 Representative image of the Bandon River immediately downstream of the Ardcahan Bridge (facing downstream) showing floating river vegetation communities in flower.

The Ardcahan Bridge is a six-arch structure with each spanning approx. 5-6m located approximately 3km north of Dunmanway, Co. Cork. The bridge is located on the upper Bandon River (20B02), within the River Bandon SAC (002171) on the R587 road, directly downstream of the Bandon River/Caha River (20C01) confluence. The Bandon River at this location is approx. 25m wide and averaging 0.3-0.5m deep. The bridge is situated within a rural landscape dominated by improved agricultural grassland (GA1). The land use classification for the surrounding area of the bridge site, as defined by the CORINE 2018 land cover dataset, is agricultural pasture (231) with coniferous forest (312) present upstream near the Caha River confluence. The area is underlain by Green-grey sandstone & purple siltstone based on examination of available Geological Survey of Ireland data.
