# Natura Impact Statement for Ardcahan Bridge, Co. Cork

Prepared by Triturus Environmental Ltd. for Fehily Timoney and Company

**August 2023**

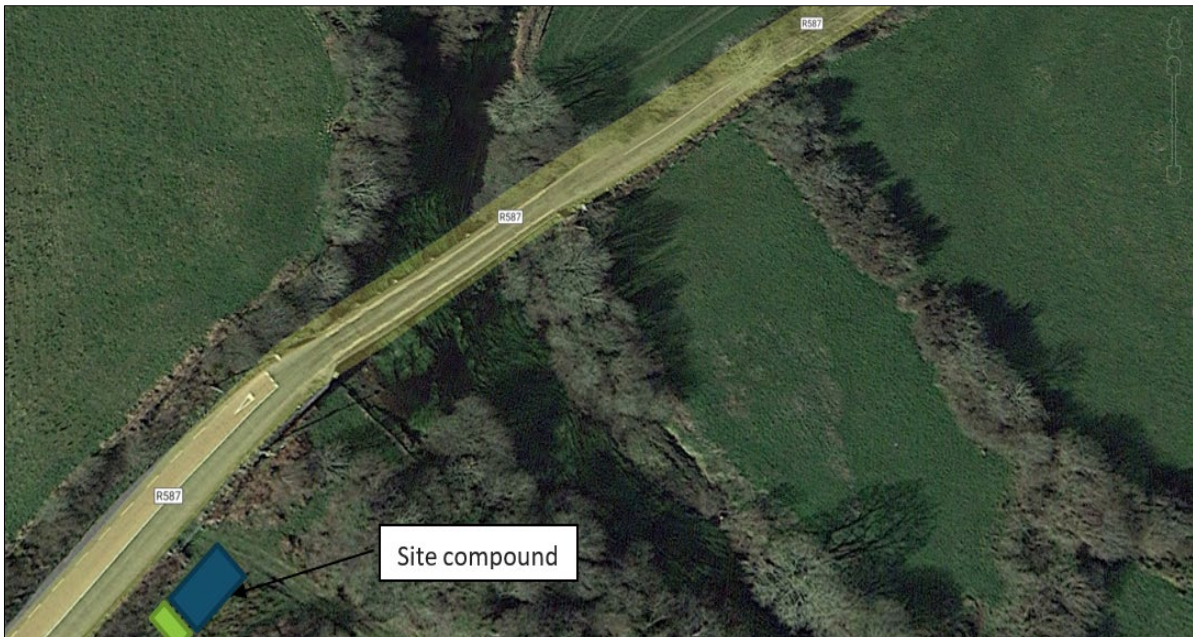
**Figure 2.1** Site compound location south west of Ardcahan Bridge

During the construction phase, it will be necessary to provide temporary facilities for construction personnel. This project will have 1 no. temporary compound located near the entrance to the site which will include welfare facilities. The location of the temporary site compound is proposed to be set back c. 30m from the south west corner of the bridge, as shown in Figure 3 1. The temporary compound shall be constructed with crushed rock aggregate hard standings with low dust content. Temporary facilities will be removed, and the lands reinstated upon completion of the construction phase.

The site compound is located in agricultural land within the Bandon River SAC (see Figure 2-1).

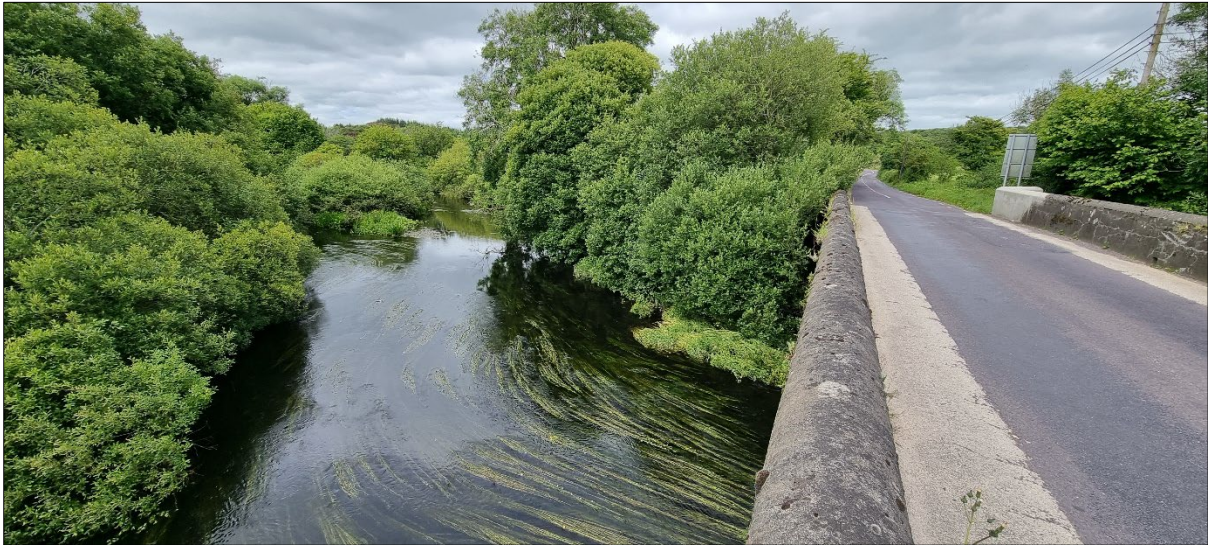
Plate 3.1 Representative image of the River Bandon upstream of Ardcahan Bridge

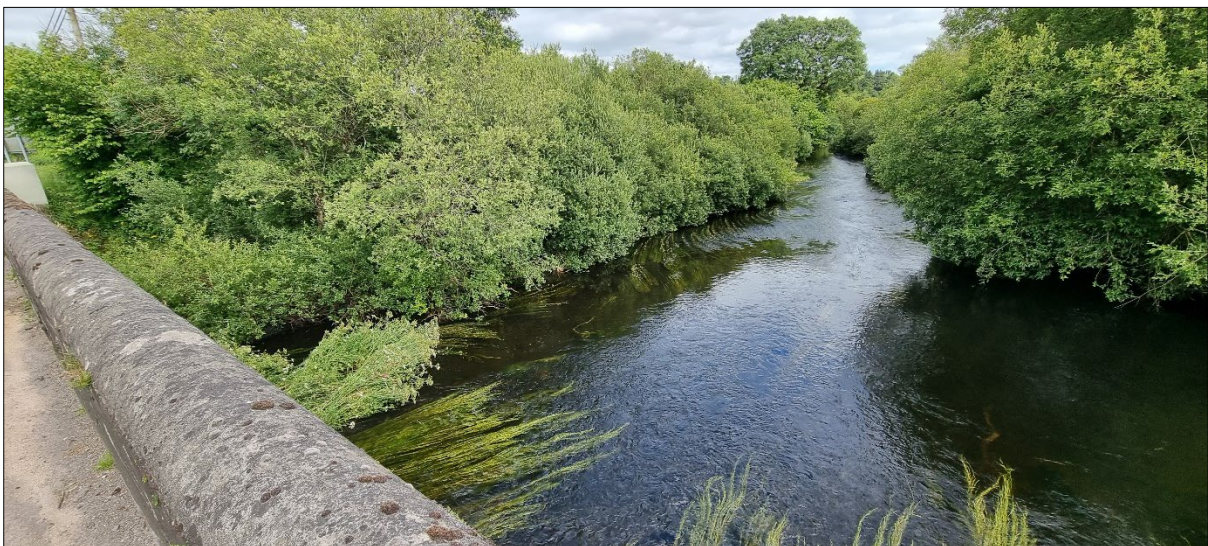
Plate 3.2 Representative image of the River Bandon downstream of Ardcahan Bridge

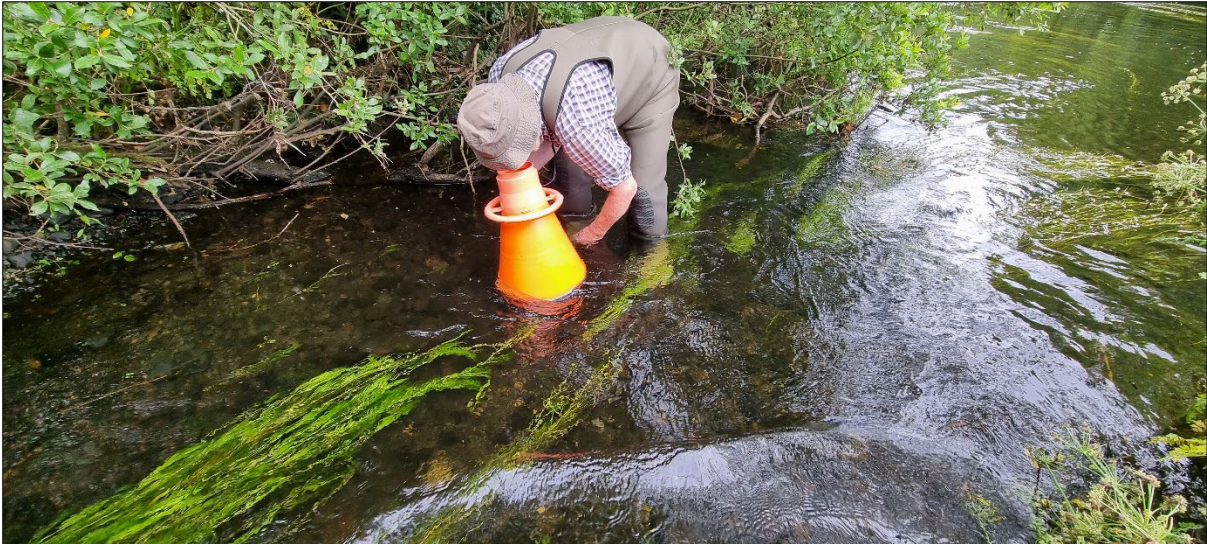
**Plate 3.3** Pascal Sweeney conducting pearl mussel surveys in the vicinity of the bridge structure

Stage I and Stage II freshwater pearl mussel surveys covering a larger section of the Bandon River up and down stream of the bridge were completed under NPWS licence C165/2019 on 11<sup>th</sup> and 12<sup>th</sup> July 2019 in bright weather, with good underwater visibility and under base flow conditions (Triturus, 2019a).
