Proposed Residential Development at Broomfield West Td., Midleton, Co. Cork

Archaeological Testing Report (Final) – Part 2

Excavation Licence No. 24E1156 X

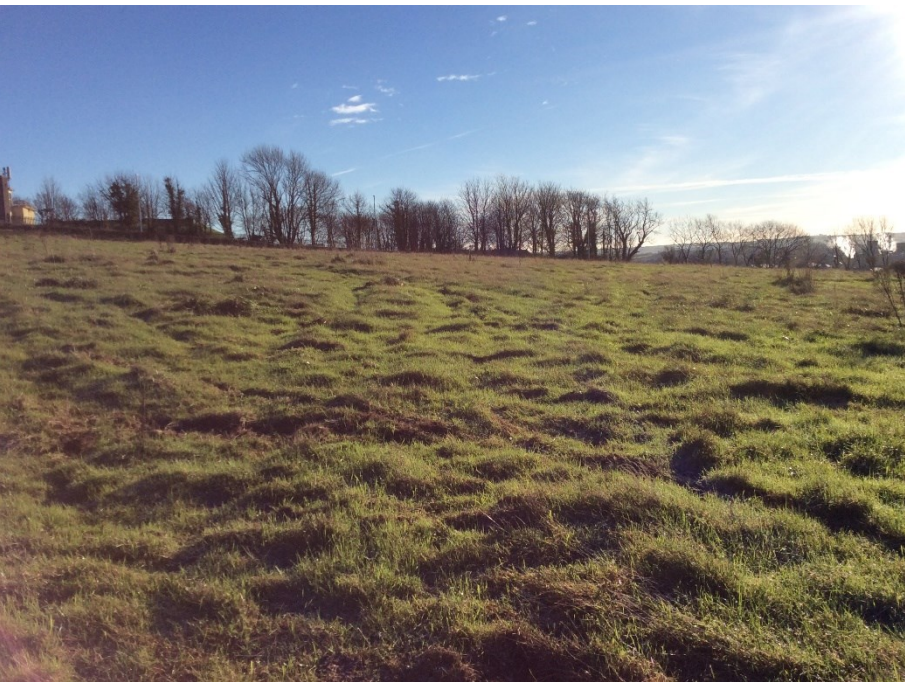
Plate 1: Proposed development site prior to excavation of test trenches, looking SE.

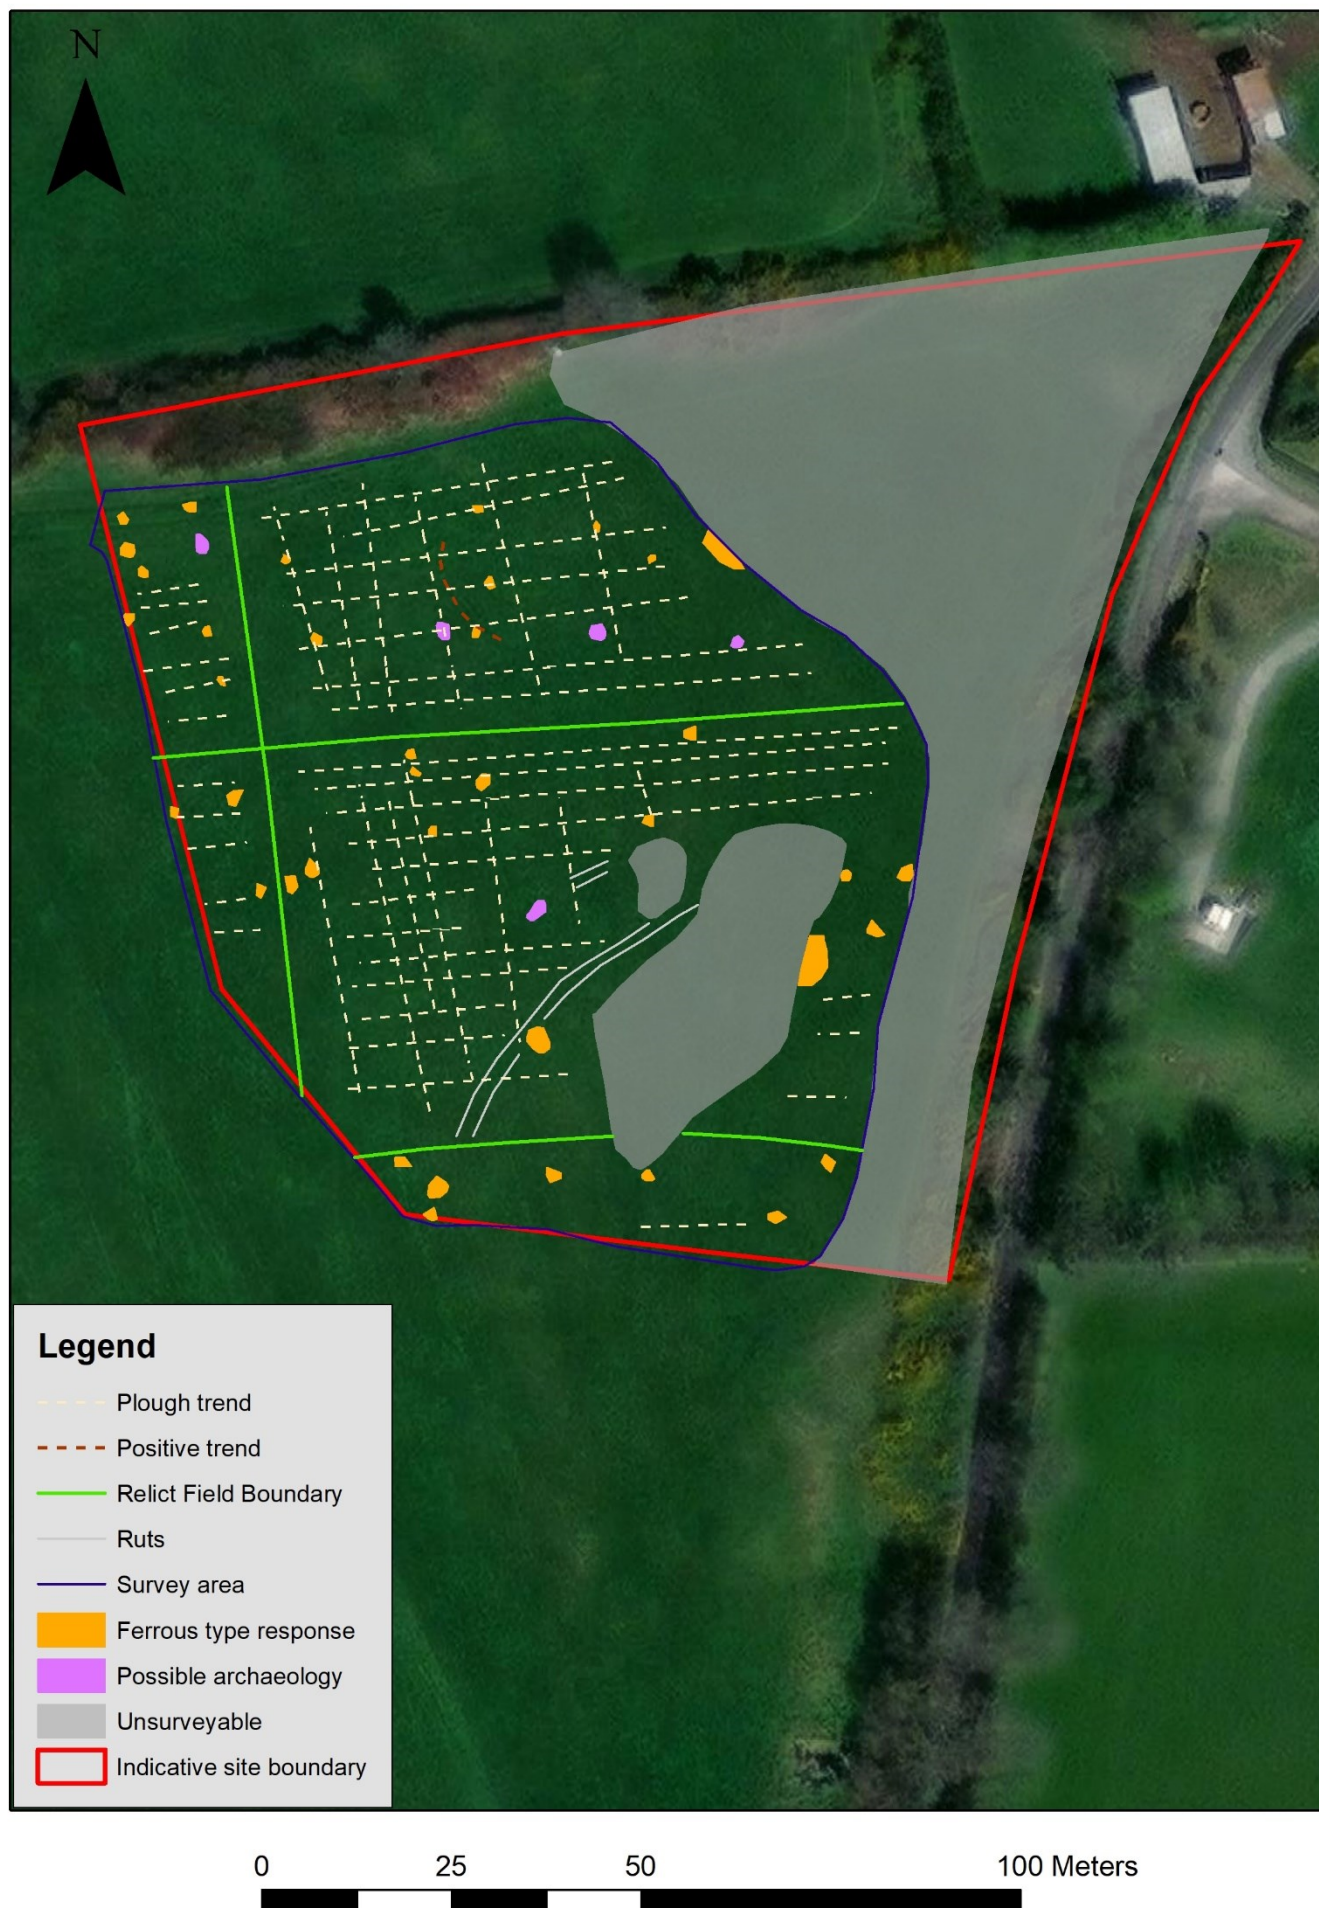
Figure 3: Geophysical survey results on aerial background (see geophysical survey report (Dowling, 2024) for further detail and interpretation).

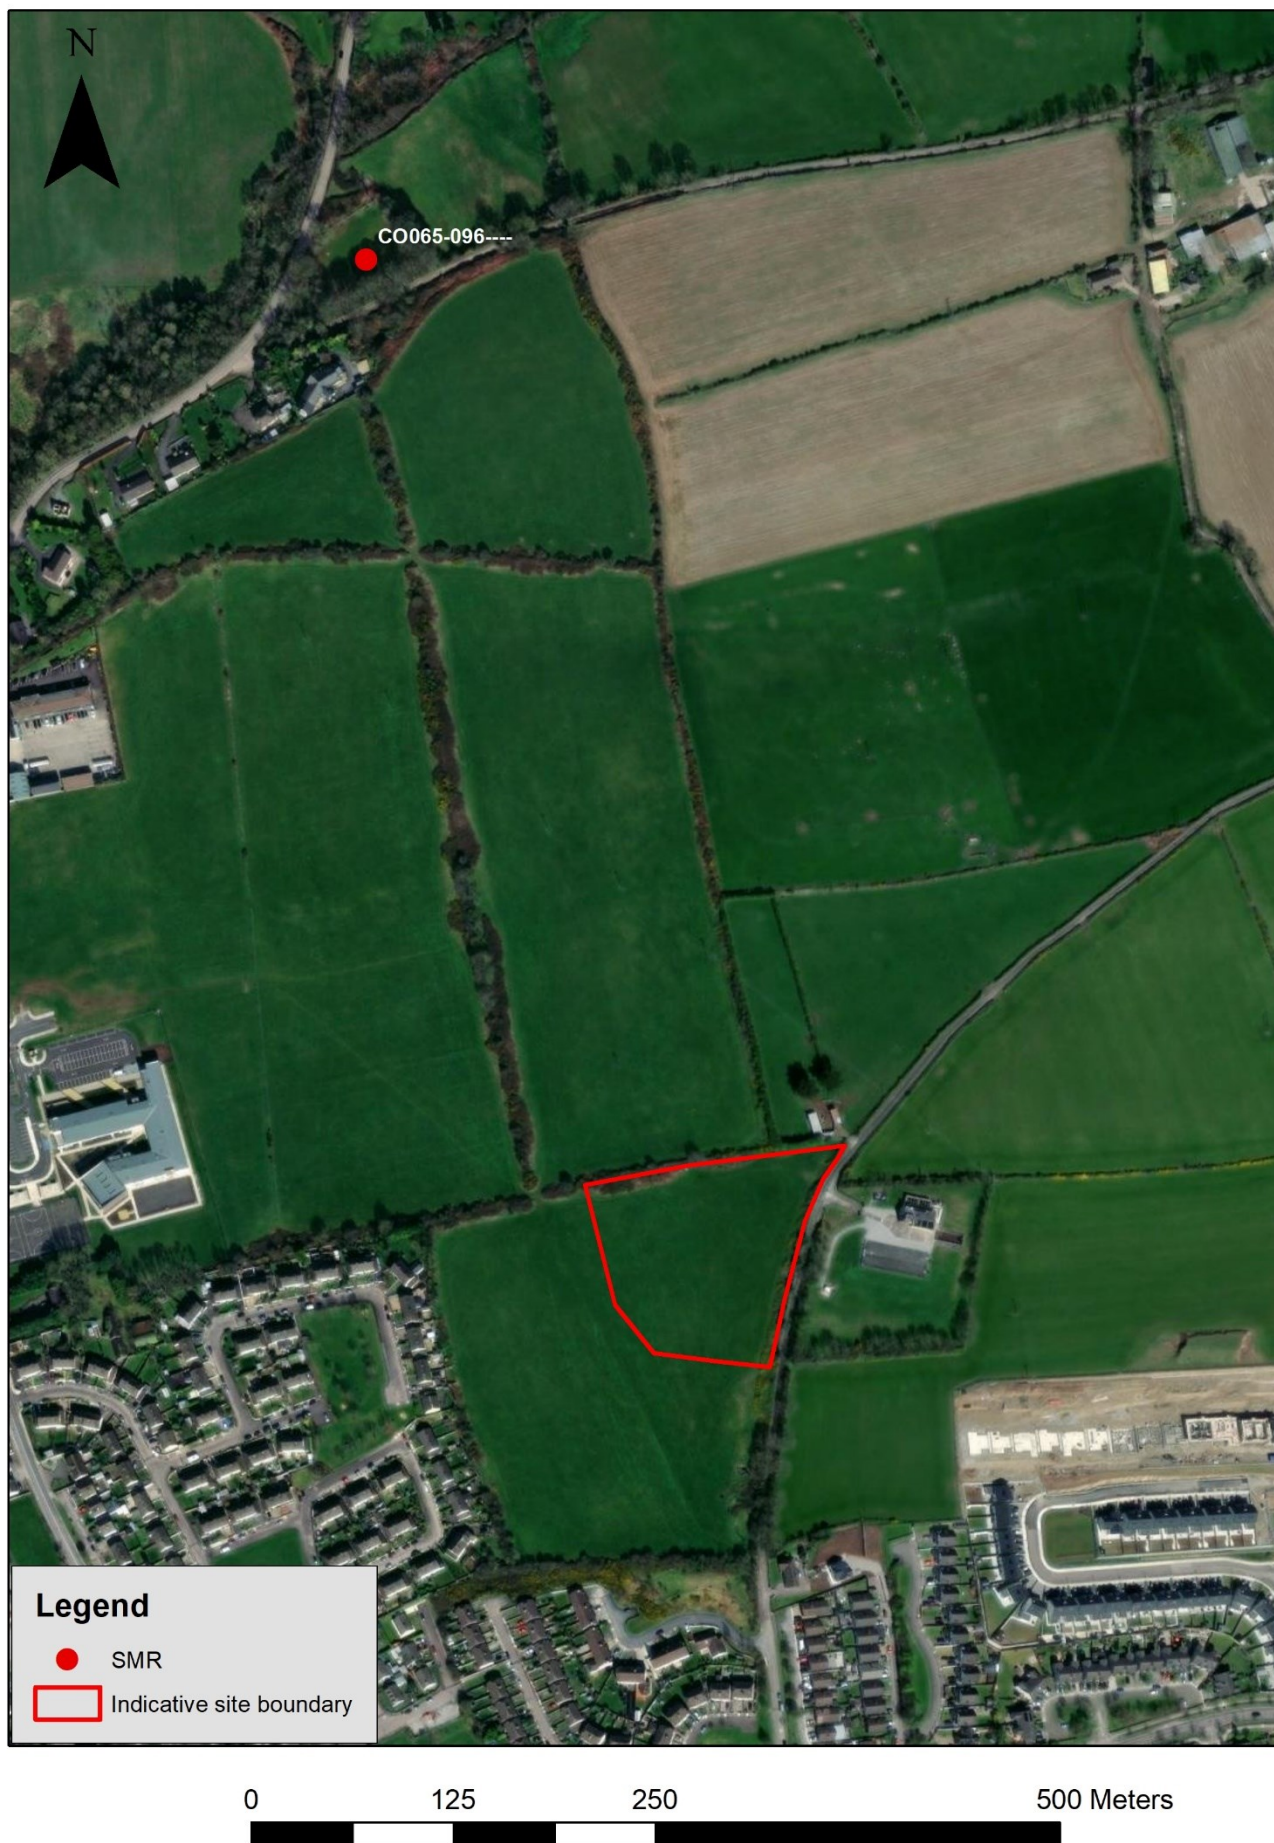
Figure 4: Indicative development boundary in relation to nearest recorded monument CO065-096----.

The proposed development site does not contain any recorded monuments nor is it located within the ZoN for any monuments. The nearest recorded monument is located over 600m to the north and comprises a graveyard CO065-096---- (Figure 4).

A description of the monument is not currently available, however, the graveyard is indicated on the second edition 25-inch OS map as a rectangular area which is named 'Union Burial Ground'.

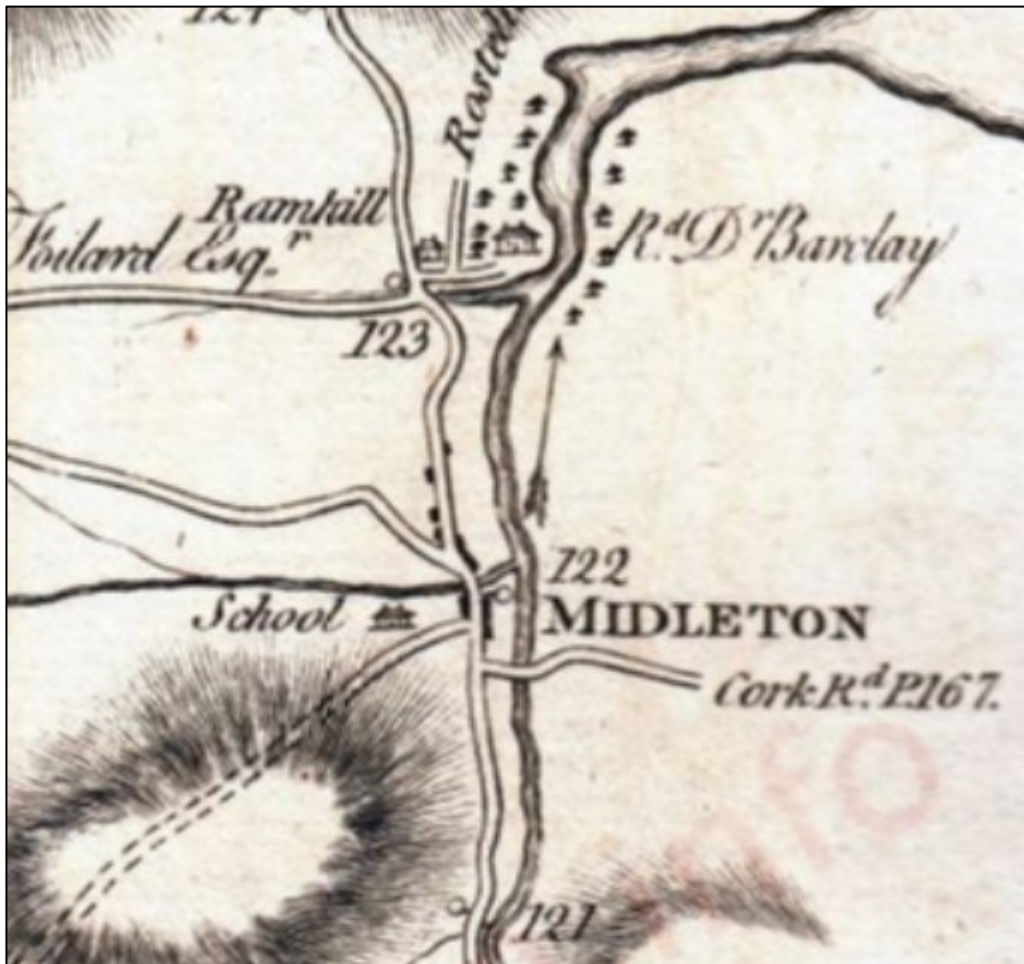
Figure 5: Extract from Taylor and Skinners Road Map 126 - Road from Dublin to Midleton and Cloyne and to Castle Martyr (1777) showing Midleton.

Taylor and Skinner's Road map (1777) names Midleton on the road from Dublin to Midleton and Cloyne and to Castlemartyr but provides little detail of the town (Figure 5).

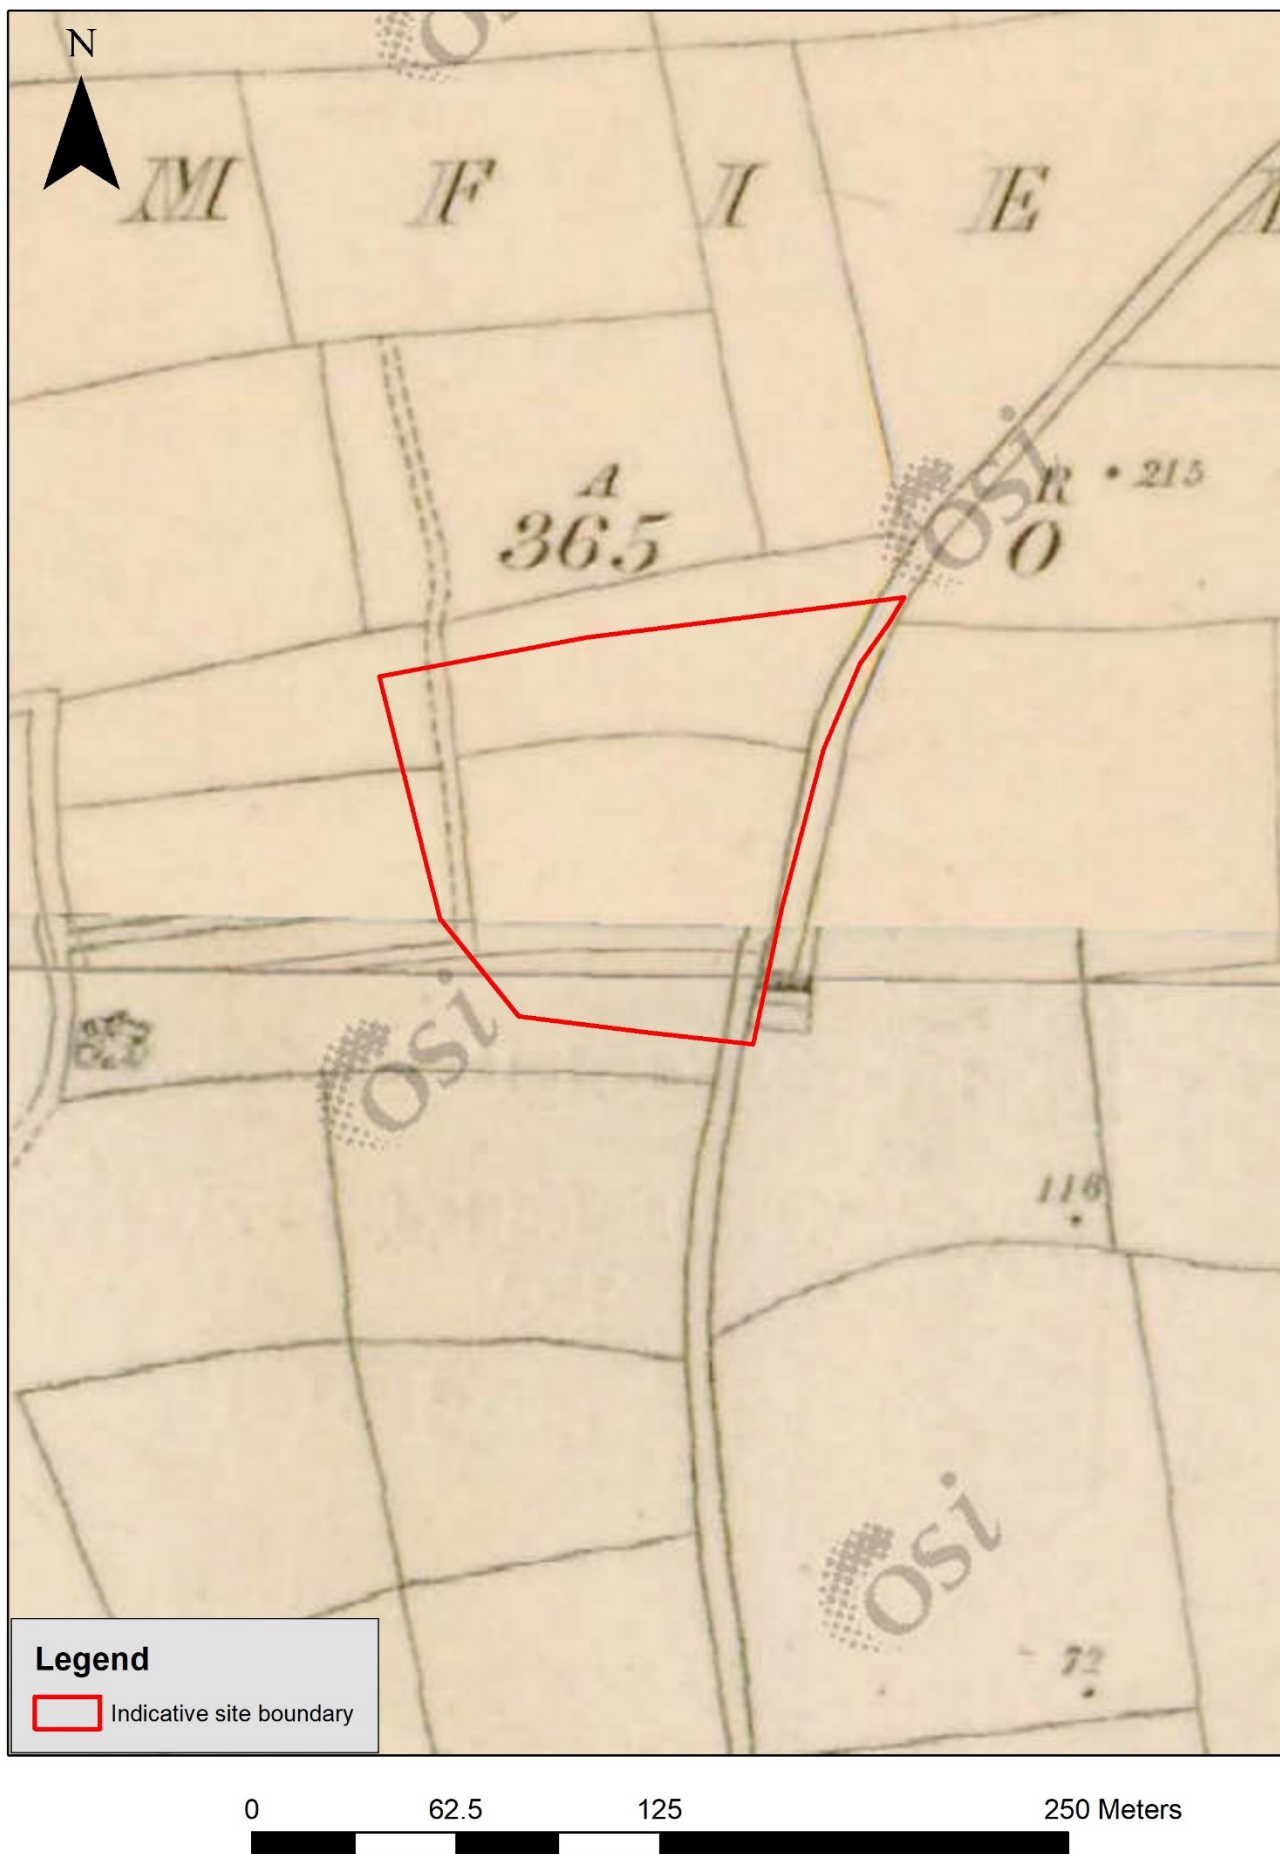
Figure 6: Proposed development site as depicted on the first edition (1829-41) OS map. Note overlay discrepancy.

The first edition (1829-41) 6-inch OS map depicts the proposed development site as a sub-rectangular field divided in two by an E/W orientated boundary. A north-south orientated track and associated boundaries extends close to the west side of the field (Figure 6). By the time of the second edition (1897-1913) 25-inch OS map the track at the west was not depicted and the field boundary dividing the field in two was no longer indicated. A field boundary is shown at the south end of the site (Figure 7) and was detected in both the geophysical survey and the test trenches.

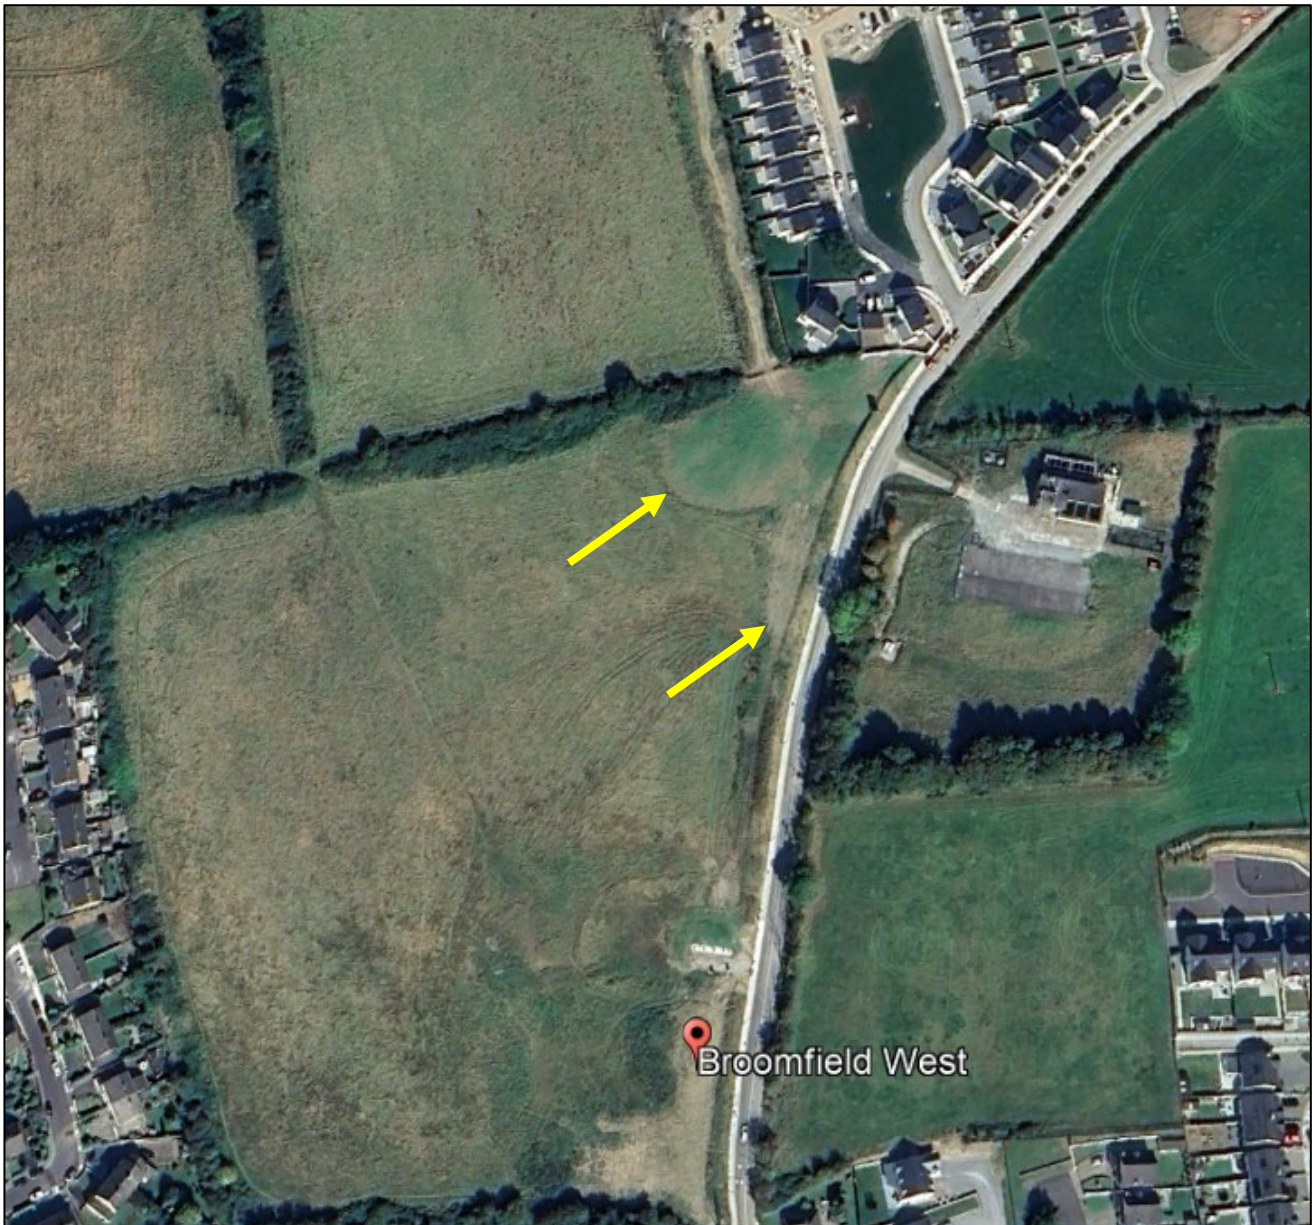
Recent ground disturbance took place within the north-east side of the proposed development site and along the eastern boundary adjacent to the public road. From a review of the available aerial maps and the results of the test trenching it would appear that topsoil was previously removed from the north-east portion of the proposed development site and this area was also infilled with modern material. A modern storm drain is also located in the north-east corner of the site and extends down further to the south outside of this proposed development site.

Figure 8: Extract from Google Earth 2024 imagery showing ground disturbance at north-east and east side of the proposed development site. .

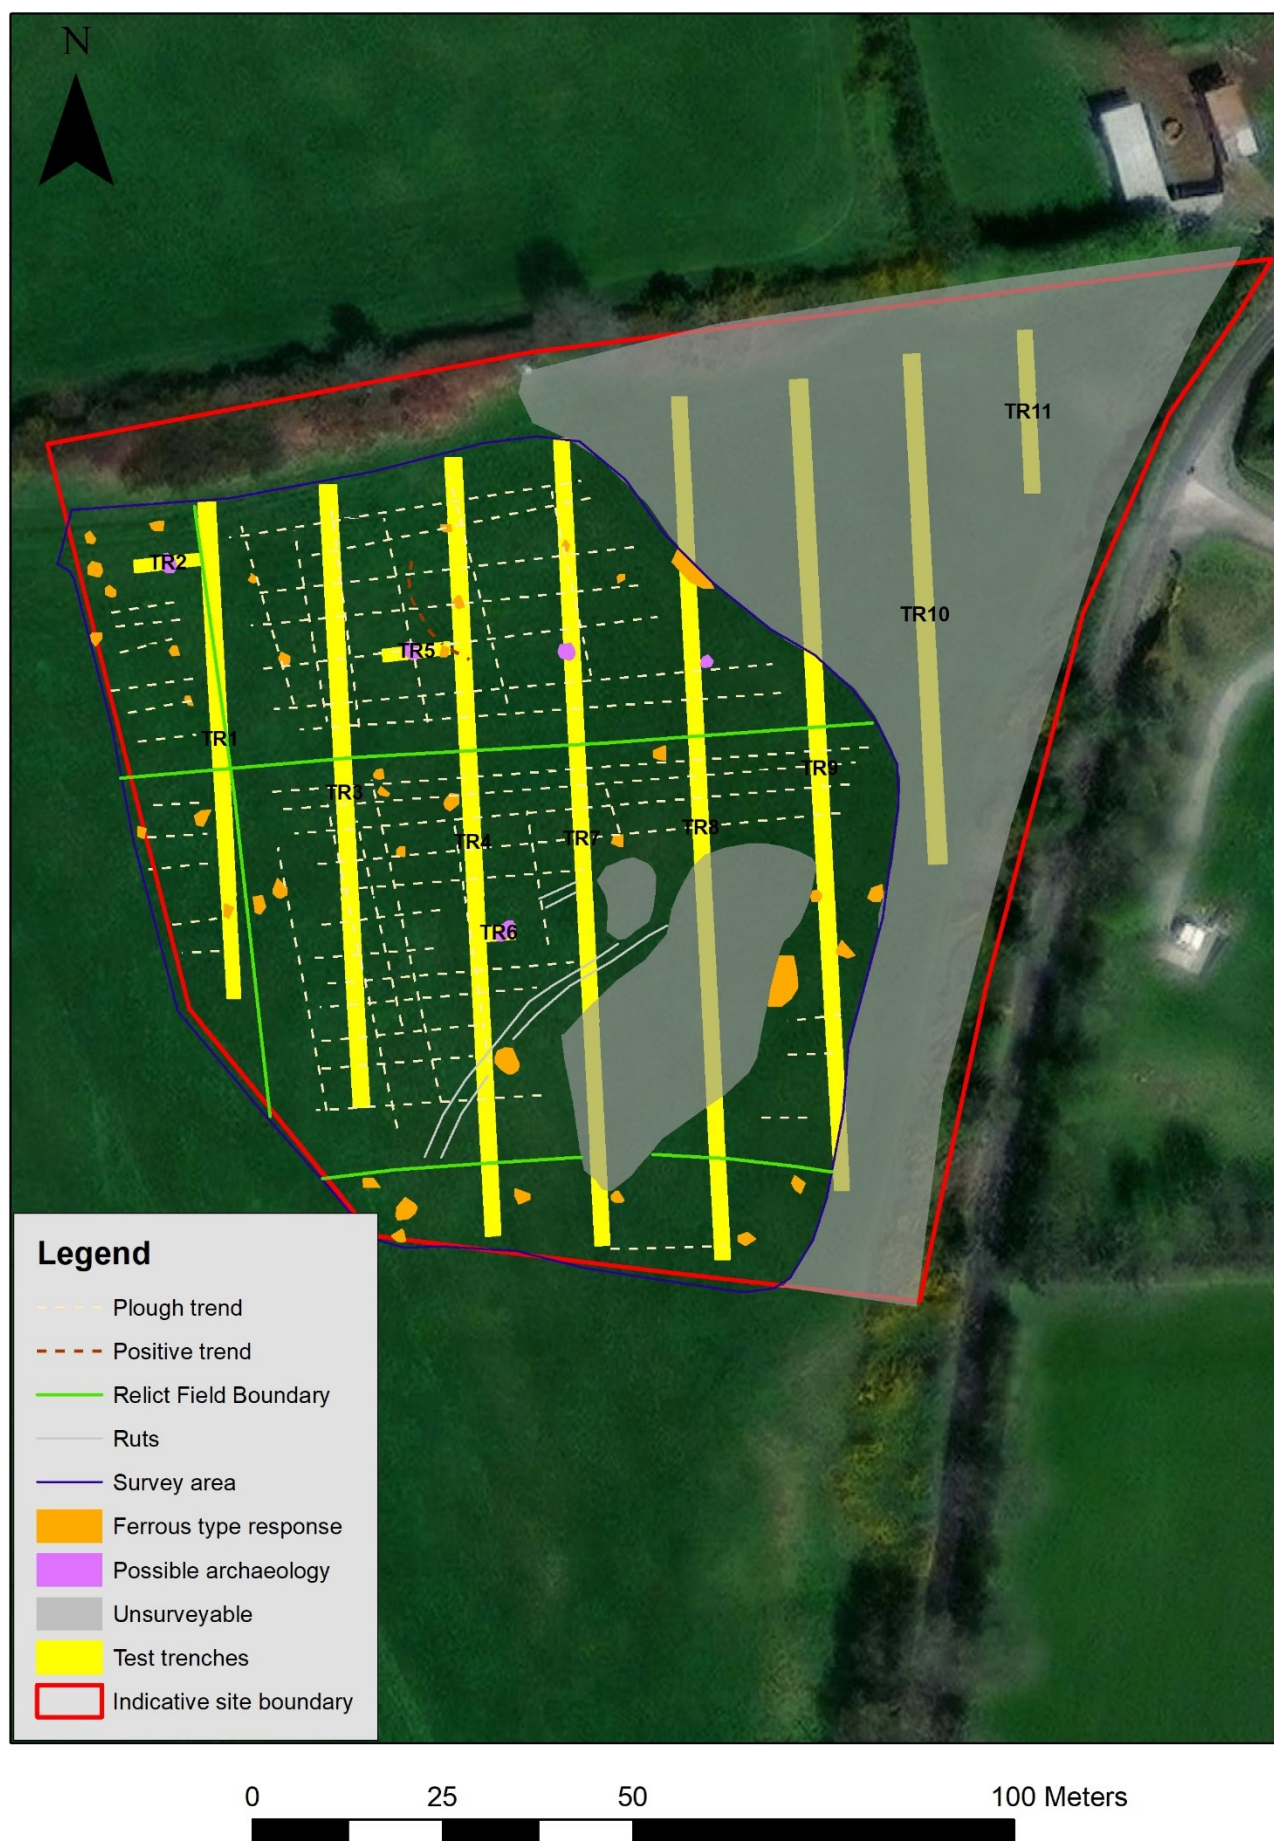
Figure 9: Trench layout in relation to results of geophysical survey.

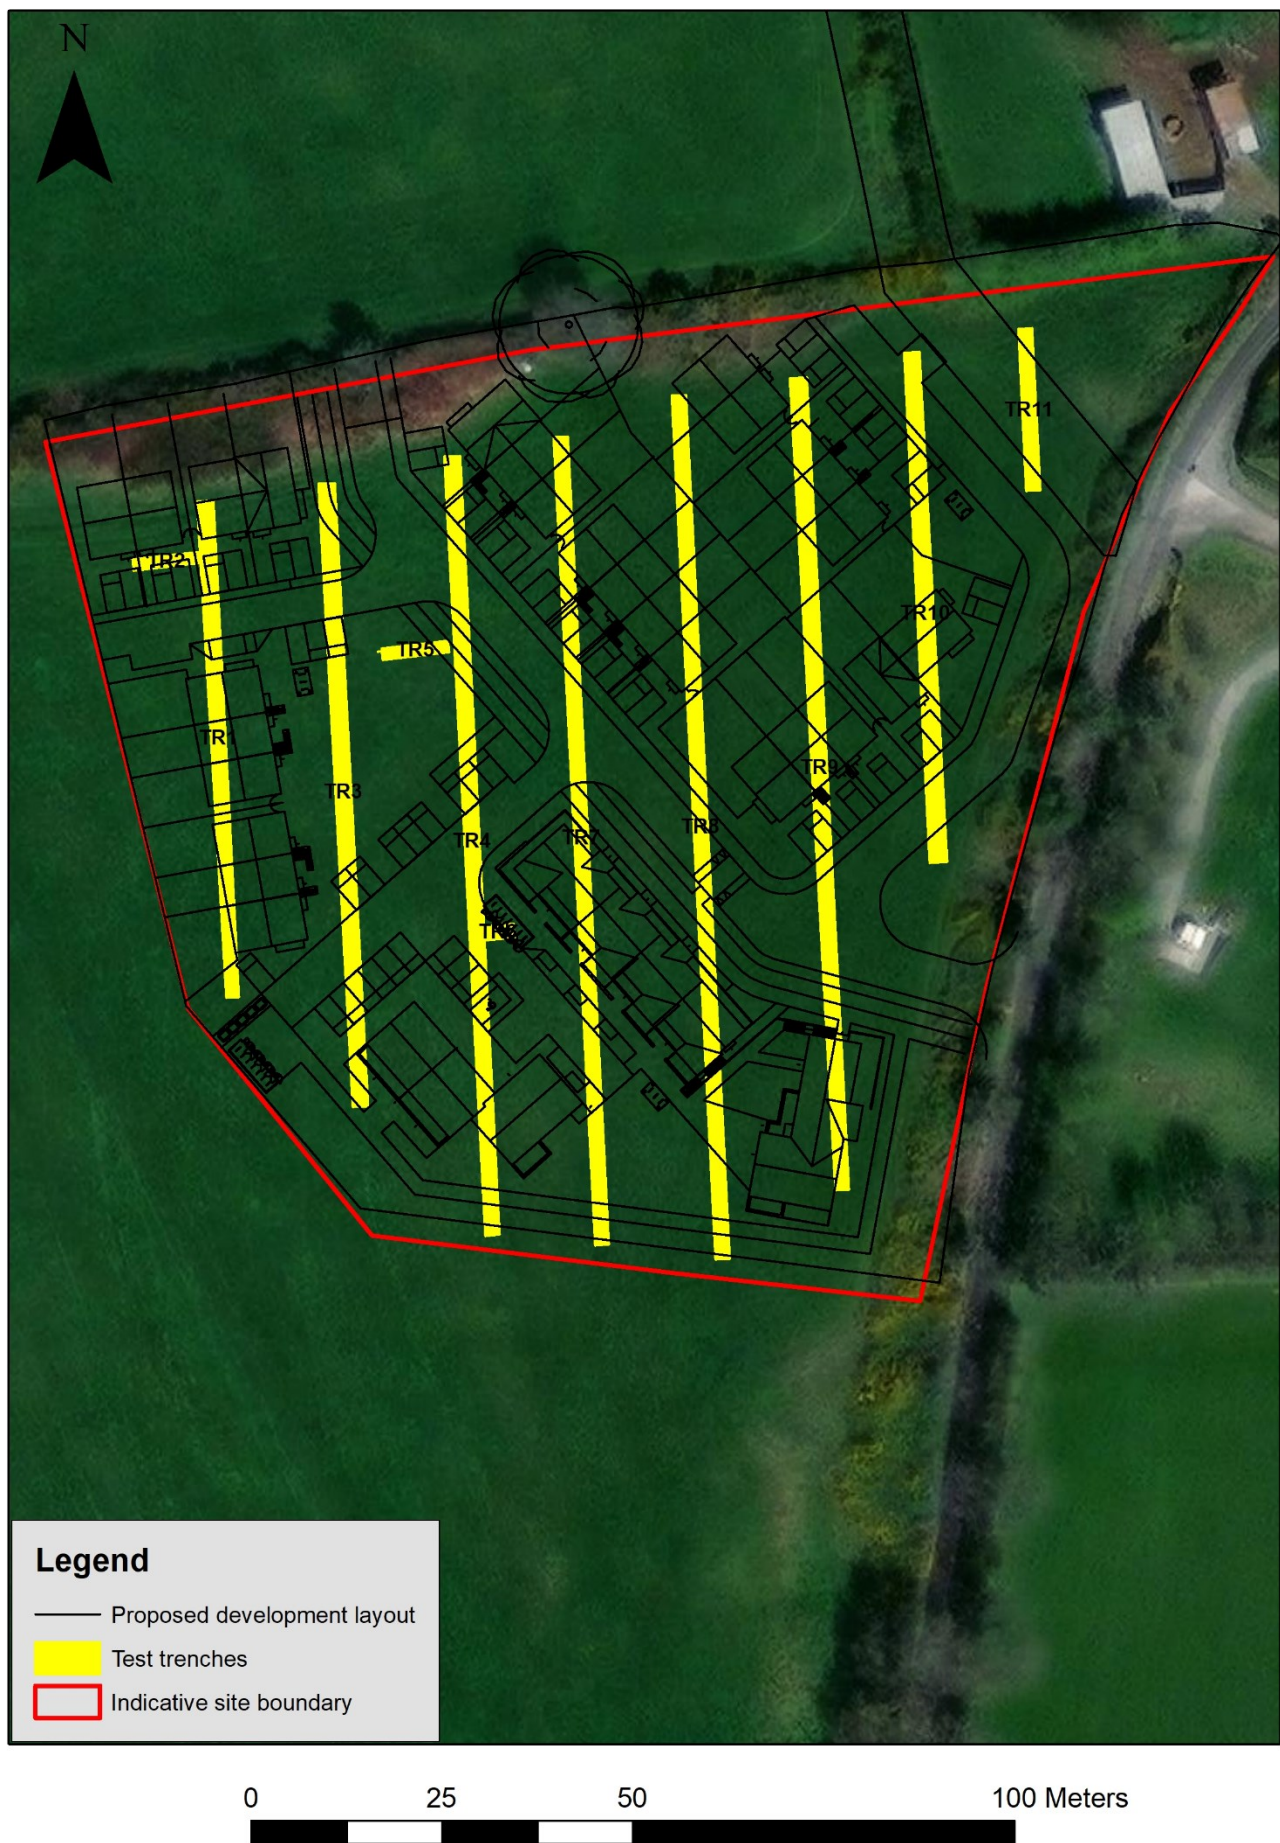
Figure 10: Trench layout and proposed development layout.

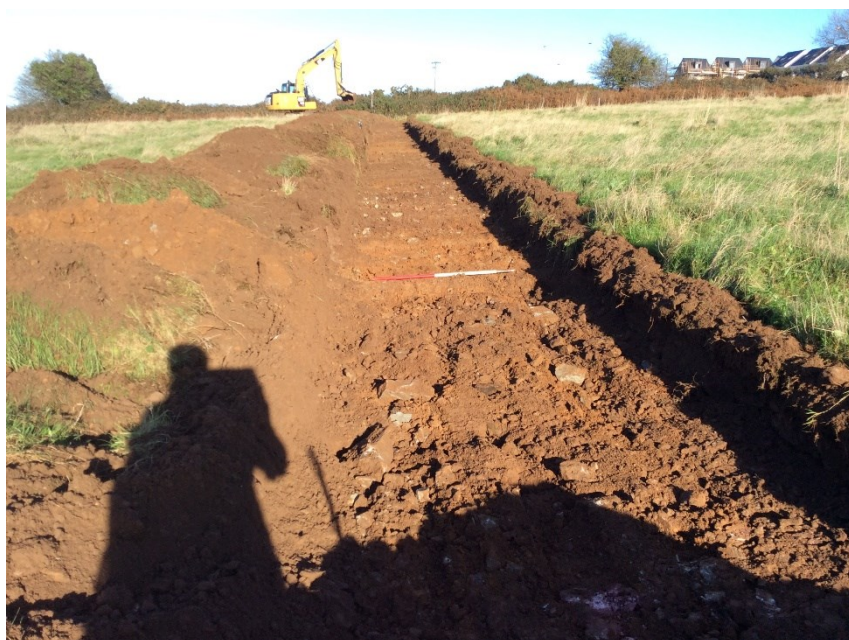
Trench 1 was excavated at the west of the site. The stratigraphy comprised 0.3m-0.35m of sod and loose topsoil over a loose stoney orange subsoil. A relict field boundary indicated on the first edition 6-inch OS map extends along the length of much of the trench. Boulders were apparent in the subsoil in places which coupled with loose stone made the trench base uneven. No archaeological finds or features were uncovered.

Plate 2: Trench 1, looking N.

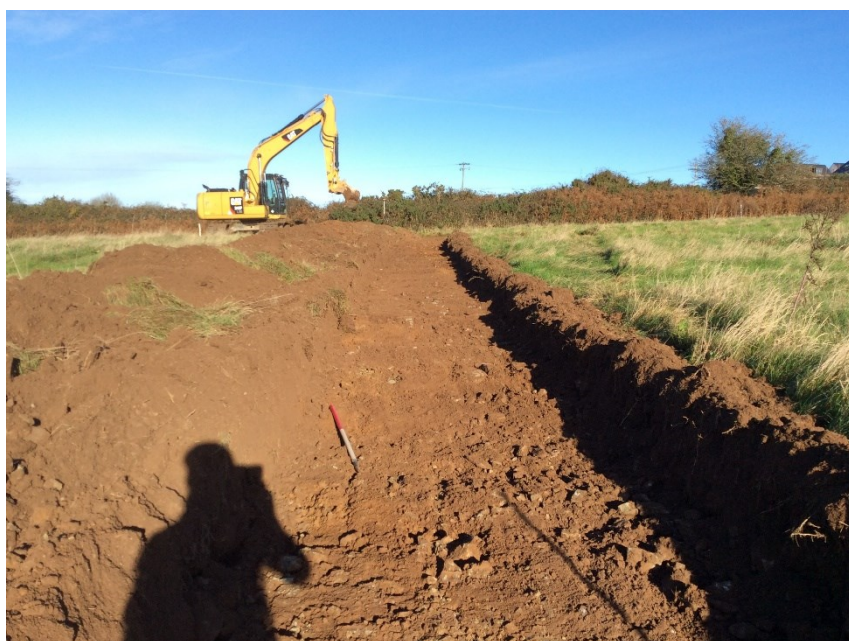
Plate 3: Relict field boundary towards north end of Trench 1, looking N.

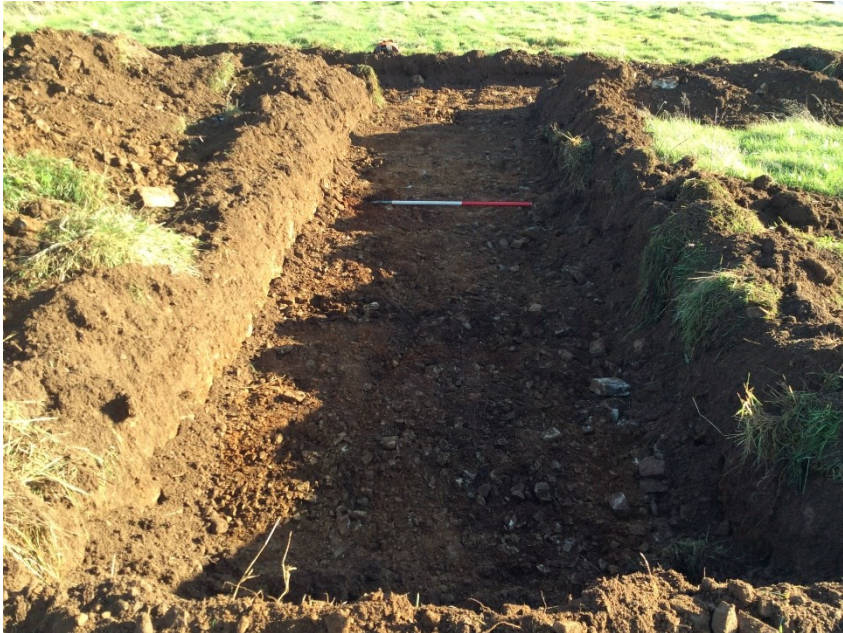
Trench 2 was a short trench excavated perpendicular to trench 1 over a geophysical anomaly interpreted in the geophysical survey report as possible archaeology (unnumbered). The stratigraphy comprised 0.35m of sod and loose topsoil over a varied orange-brown stoney subsoil. No potential feature was uncovered in the trench in the area of the geophysical anomaly.

Plate 4: Trench 2, looking E.

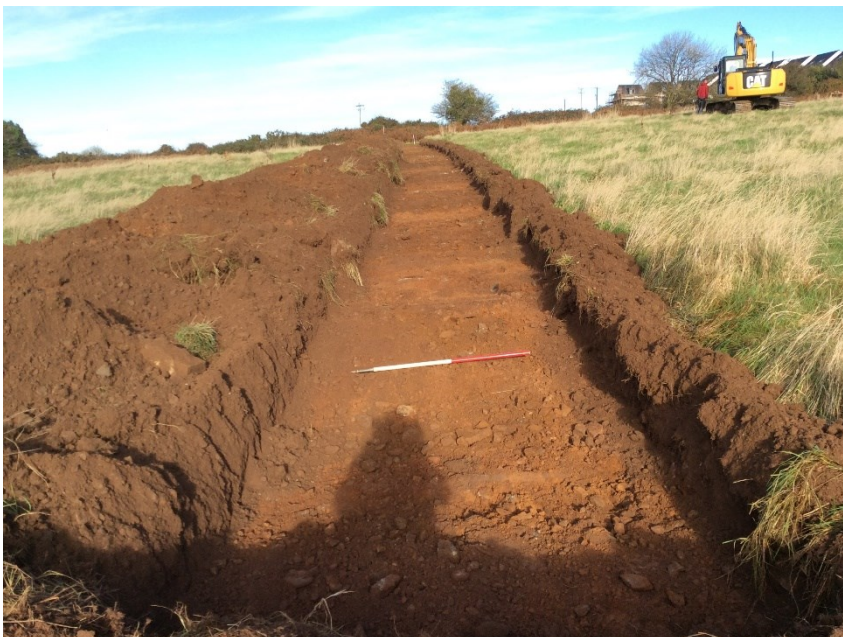
Trench 3 was excavated to the east of trench 1. The stratigraphy noted was similar to the previous trenches and consisted of c. 0.35m-0.4m of sod and topsoil over a stoney orange brown subsoil. Plough furrows cross the trench at regular intervals and bedrock or large boulders were present towards the south end of the trench. No archaeological finds or features were uncovered.

Plate 5: Trench 3, looking N.

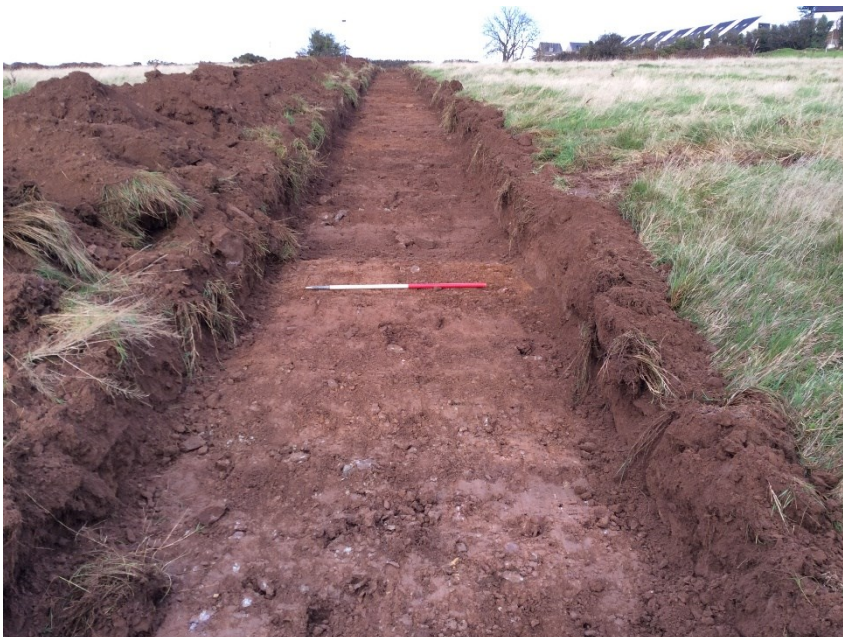
Trench 4 was a long trench excavated to the east of Trench 3. The stratigraphy here was similar to the previous trenches however the subsoil was slightly less stoney. Regular plough activity was apparent crossing the trench and a relict field boundary indicated on the second edition 25-inch OS map was exposed at the south end of the trench. It measured c. 4.9m in width N/S.

Plate 7: South end of Trench 4 with relict field boundary in middle ground.

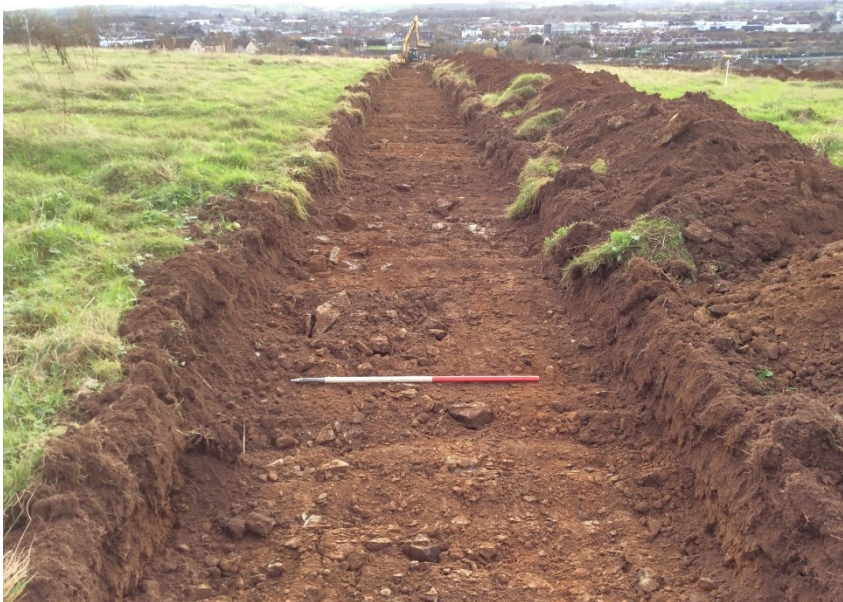
Plate 8: Trench 4, looking S.

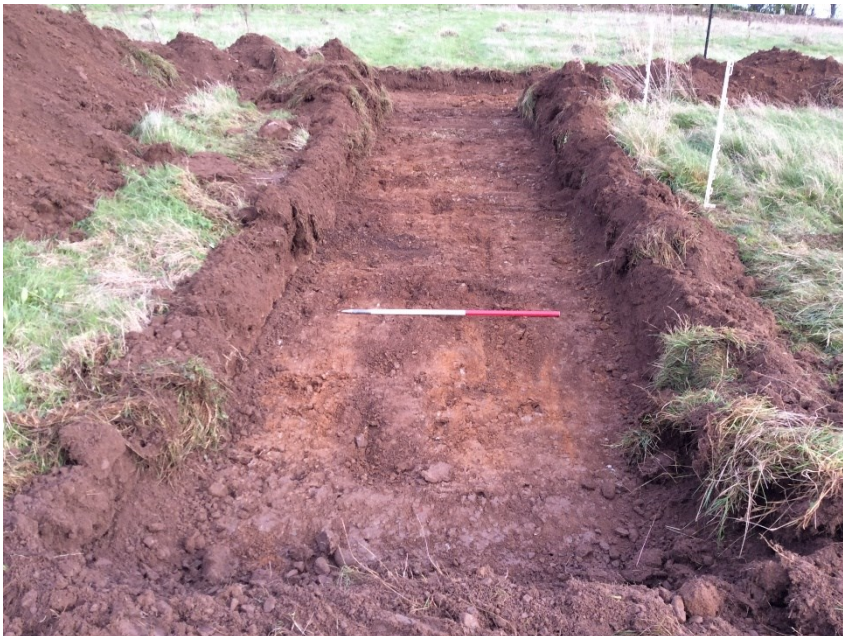
Trench 5 comprised a short trench excavated perpendicular to trench 4 towards the north end of same. The trench was located over an unnumbered geophysical anomaly interpreted as possible archaeology. The stratigraphy comprised 0.35m of sod and topsoil over a stoney orange brown subsoil with patches of smaller stones as well as larger boulders. Burnt root activity was present in the area of the geophysical anomaly. Charcoal was observed going under the subsoil and therefore is most likely the result of root activity/burning. Plough activity was also evident. No archaeological finds or features were uncovered.

Plate 9: Trench 5, looking E.

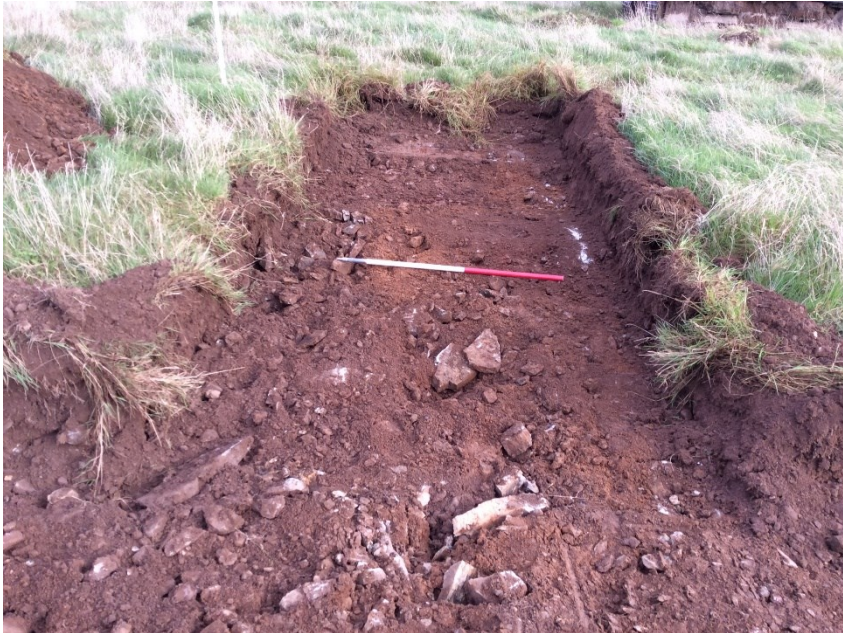
Trench 6 was a short trench excavated perpendicular to trench 4 over another unnumbered geophysical anomaly interpreted as possible archaeology. The same stratigraphy as the previous trenches was apparent here over a very stoney subsoil with loose stone and boulders exposed. Burnt root activity was also apparent and is likely to correspond to the geophysical anomaly. No archaeological finds or features were uncovered.

Plate 10: Trench 6, looking E.

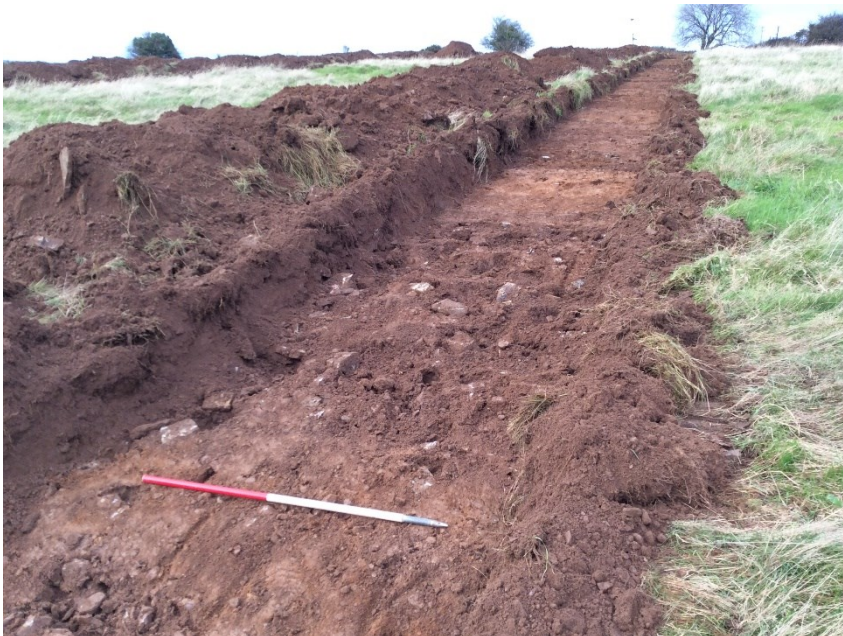
Trench 7 comprised a long trench located to the east of trench 4. An area of oxidized natural and burnt root activity was noted in the area of another geophysical anomaly towards the north end of the trench. Again the charcoal was observed going under the subsoil which is indicative of root activity. The stratigraphy in the trench comprised c. 0.35m of sod and topsoil over an orange brown subsoil, which became stoney towards the south. Plough furrows also crossed the trench at regular intervals. The E/W orientated relict field boundary exposed in Trench 4 was also exposed at the south end of this trench. It measured c. 4.2m in width N/S.

Plate 11: Relict field boundary at south end of Trench 7, looking NW.

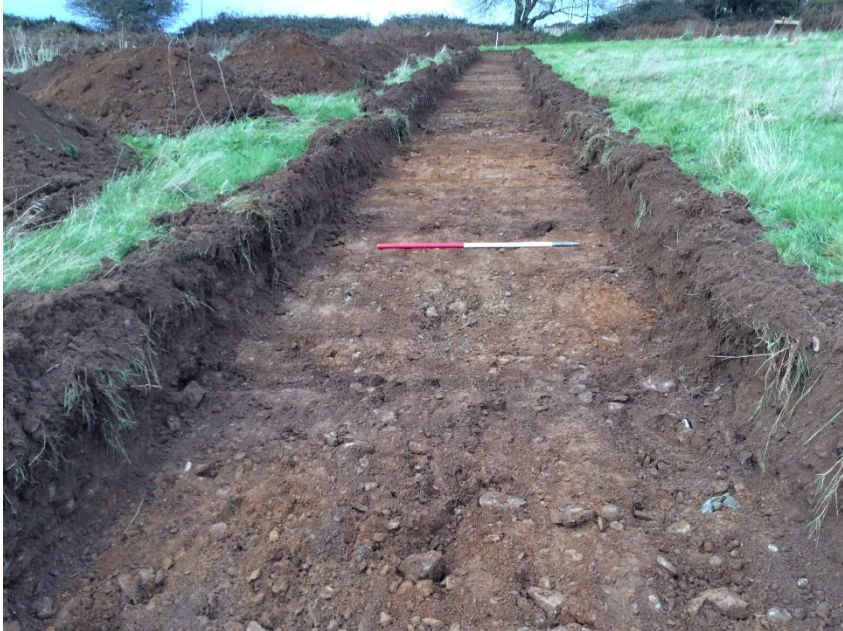
Plate 12: North end of Trench 7, looking N.

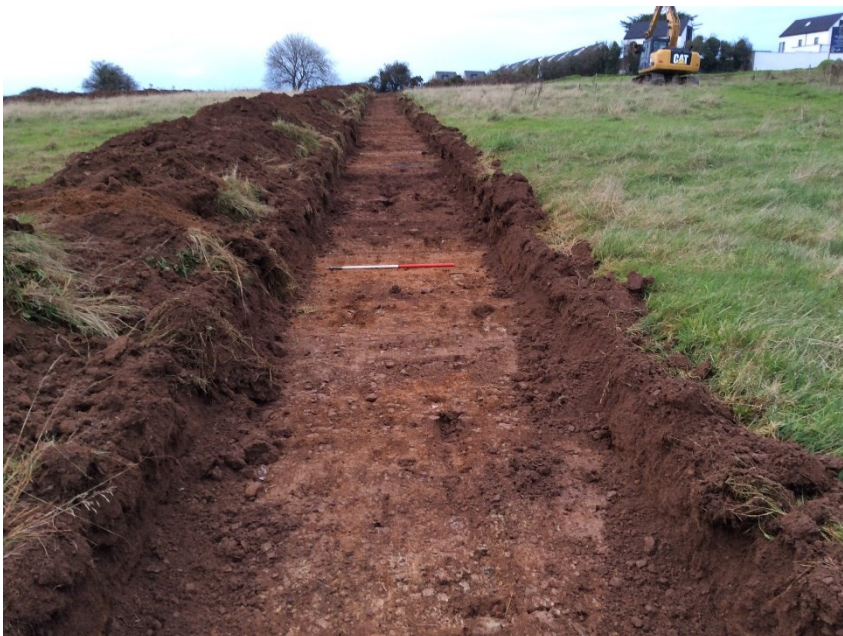
Trench 8 was a long trench located to the east of trench 7. The same stratigraphy was noted here as the previous trenches. The ground at the north end of the trench was disturbed as a result of recent ground works carried out in this area, however the subsoil appeared to be intact and did not appear to have been reduced. The relict field boundary was again exposed at the south end of the trench and measured c. 4.1m in width N/S. A plough furrow with burning was located immediately to the north of the field boundary. It was manually investigated which showed it to be shallow measuring only c 0.07m deep. It was filled with a loose brown topsoil like material under which was a lens of charcoal and some oxidisation at the base. No archaeological finds or features were uncovered.

Plate 13: Trench 8, looking N. Relict field boundary in middle ground.
