Proposed Residential Development at Broomfield West Td., Midleton, Co. Cork

Archaeological Testing Report (Final) – Part 2

Excavation Licence No. 24E1156 X

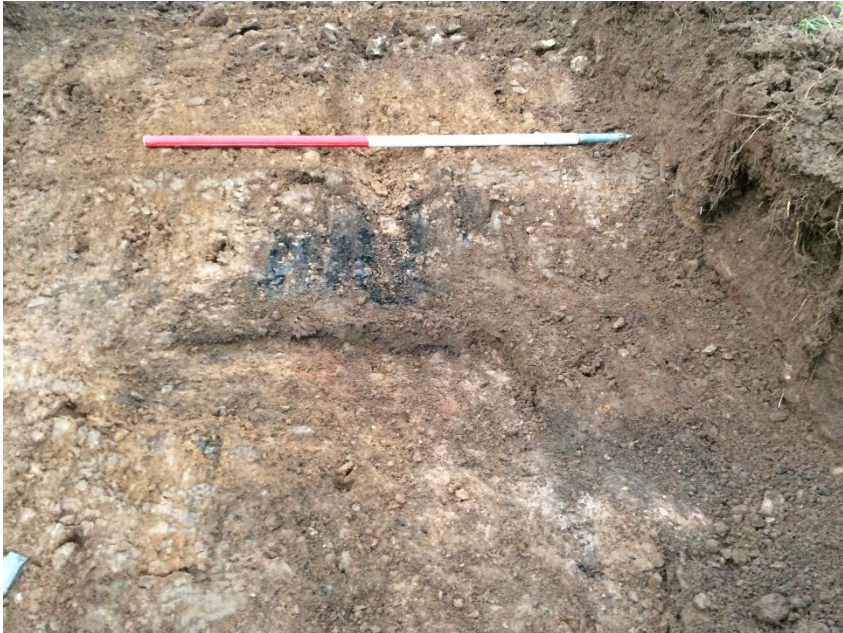
Plate 14: Plough furrow with charcoal and burning after investigation, looking N.

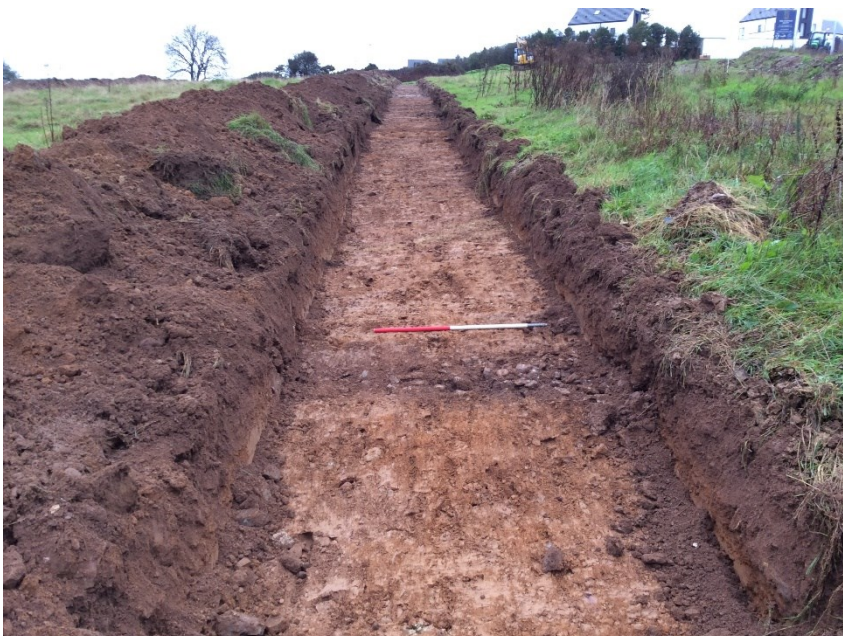
Trench 9 comprised a long trench located to the east of trench 8. Modern disturbance was apparent at the north end of the trench and appeared to be a large area infilled with 804 and stone. Further to the south the stratigraphy comprised 0.35m-0.4m of sod and topsoil over a stoney orange subsoil. A narrow stoney linear feature was exposed at the south end of the trench. A section was manually excavated across it showing it to be filled with a loose, mid-brown stoney material only 0.05m in thickness. The cut was very shallow and broad (c. 0.85m in width N/S) and therefore is likely to represent the remains of a plough furrow or similar feature of agricultural origin. The field boundary exposed in Trenches 4, 7 and 8 was not exposed in this trench. No archaeological finds or features were uncovered.

Plate 15: Trench 9, looking N. Stoney linear feature in foreground.

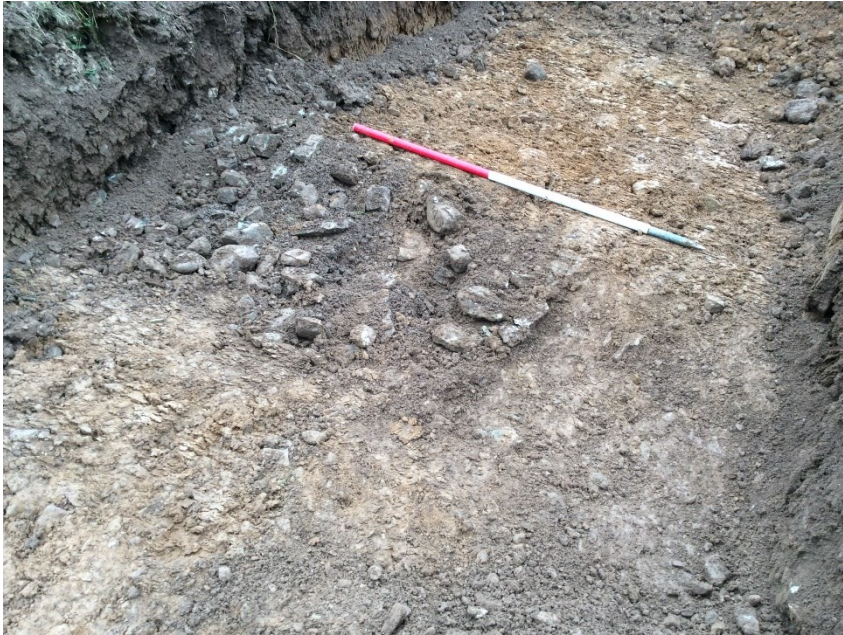
Plate 16: Stoney linear feature in Trench 9 after manual investigation, looking SSE.

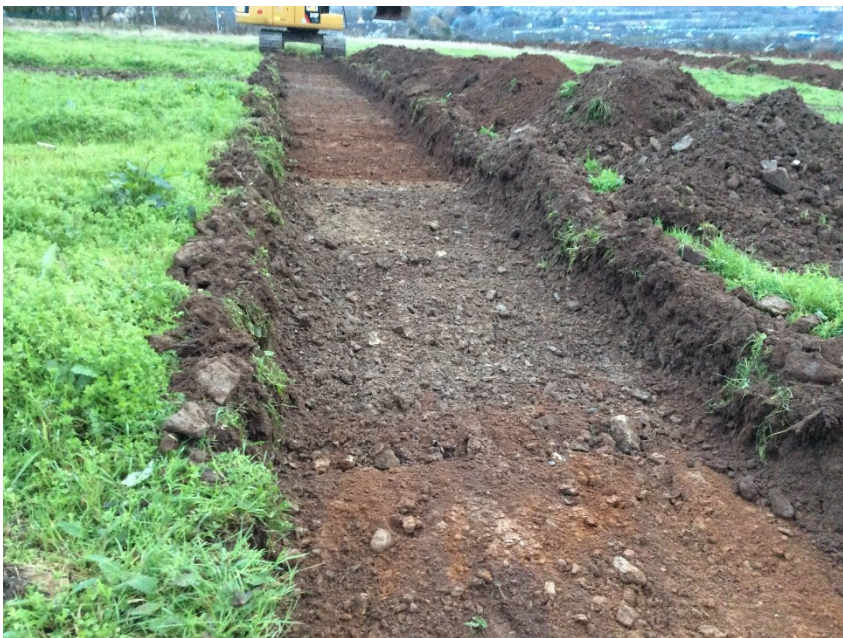
Plate 17: Modern disturbance at north end of Trench 9, looking SW.

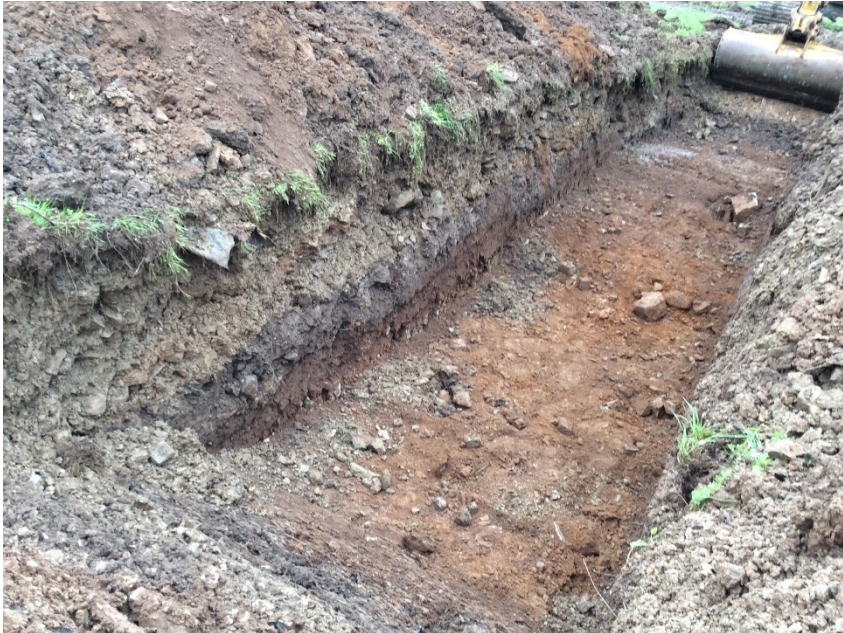
Trench 10 was excavated to the east of trench 9. Modern disturbance was apparent throughout the entire length of the trench to varying depths. At the north end of the trench there was a significant depth of infilled material overlying buried topsoil. Here the trench depth was c. 1.2-1.5m at its deepest and the stratigraphy comprised c. 0.8m of light coloured earth and stone infill over c. 0.4m of buried dark brown soil which in turn overlay the original buried topsoil. Orange subsoil was exposed at the base of trench which could not be entered due to depth and instability of the trench sides. Less infill was present as the trench progressed to the south but then increased again at the south end of the trench where modern infill c 0.85m in thickness overlay a disturbed topsoil. The topsoil then petered out and the infill directly overlay the orange subsoil with no in situ topsoil present. No archaeological finds or features were uncovered.

Plate 18: Significant depth of infilled material at the north end of Trench 10, looking SE.

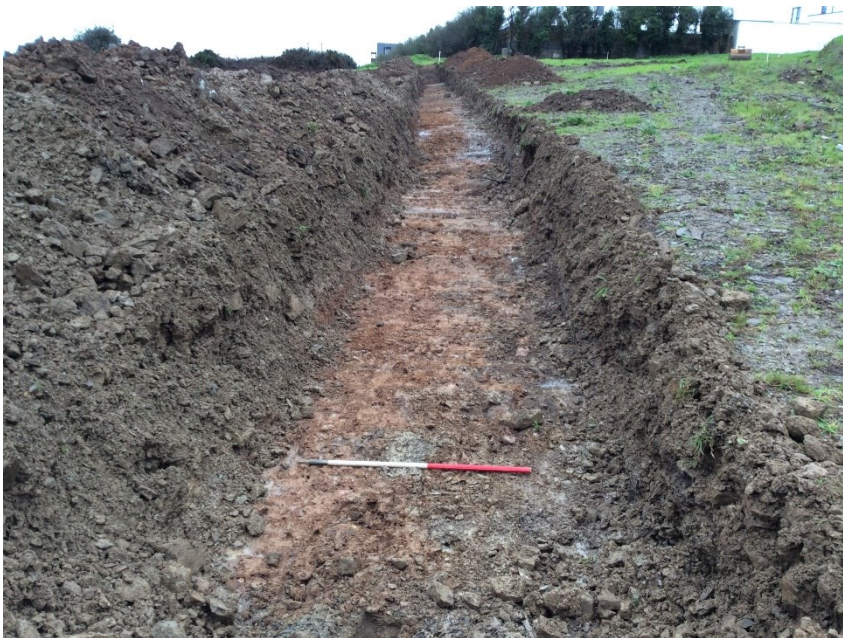
Plate 19: Trench 10, looking N.

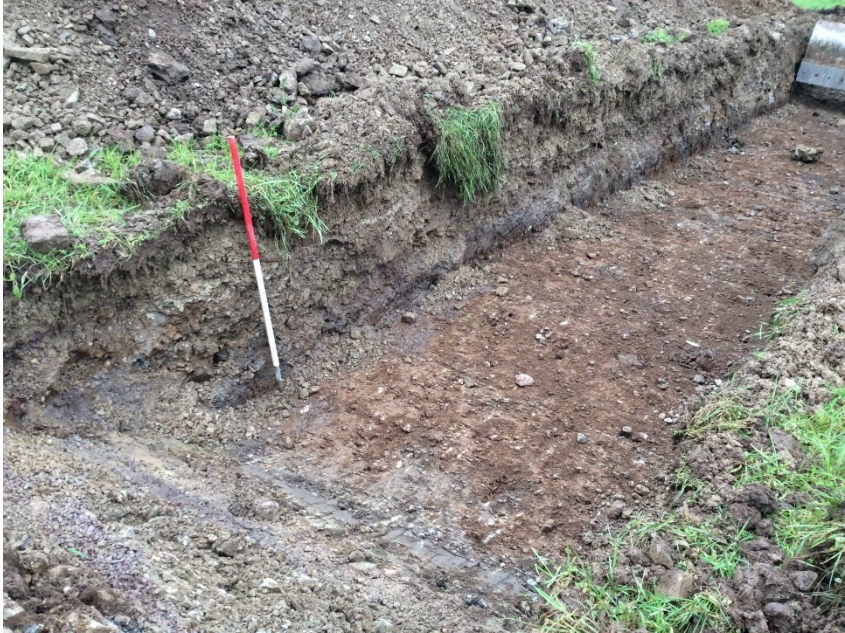
Trench 11 was excavated to the east of Trench 10 at the north-east side of the proposed development site. Modern disturbance was again apparent here throughout the trench length. The stratigraphy at the north end of the trench comprised 0.75m of compacted modern stone infill with a thin sod layer on top. This overlay a thin, probably compressed, layer of in situ topsoil which overlay the orange subsoil. A trench for a modern storm drain crossed the trench in a NW/SE direction and an associated manhole is located to the west of the trench. To the south of the storm drain the in situ topsoil petered out and the modern infill (thickness 0.8m-0.9m) directly overlay the subsoil. No archaeological finds or features were uncovered.

Plate 20: North end of Trench 11 showing infilled material, looking SE.

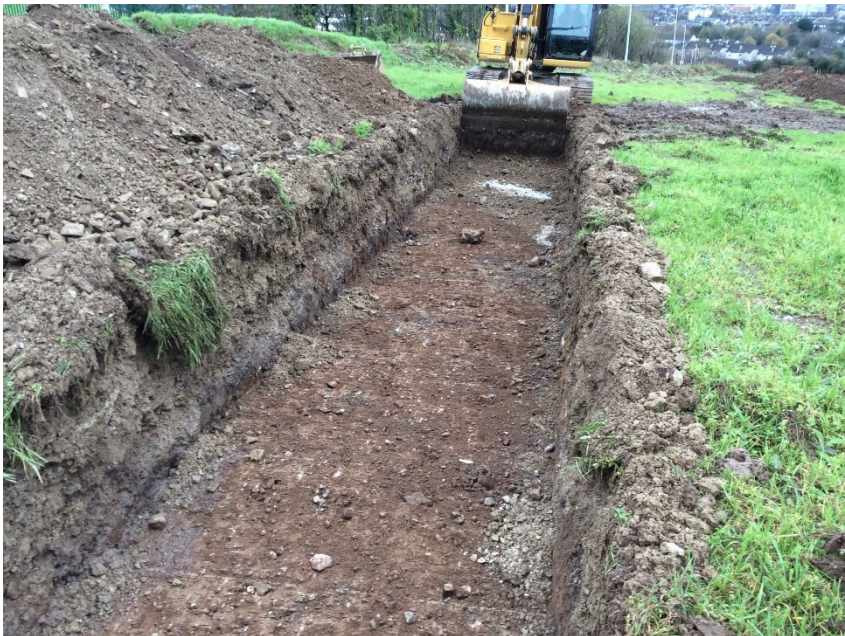
Plate 21: Trench 11 looking S with trench for modern storm drain being uncovered by the machine.

Modern disturbance was also evident within the proposed development area, in particular at the east and north-east where a significant depth of infilled material is present and a modern storm drain extends through the site.

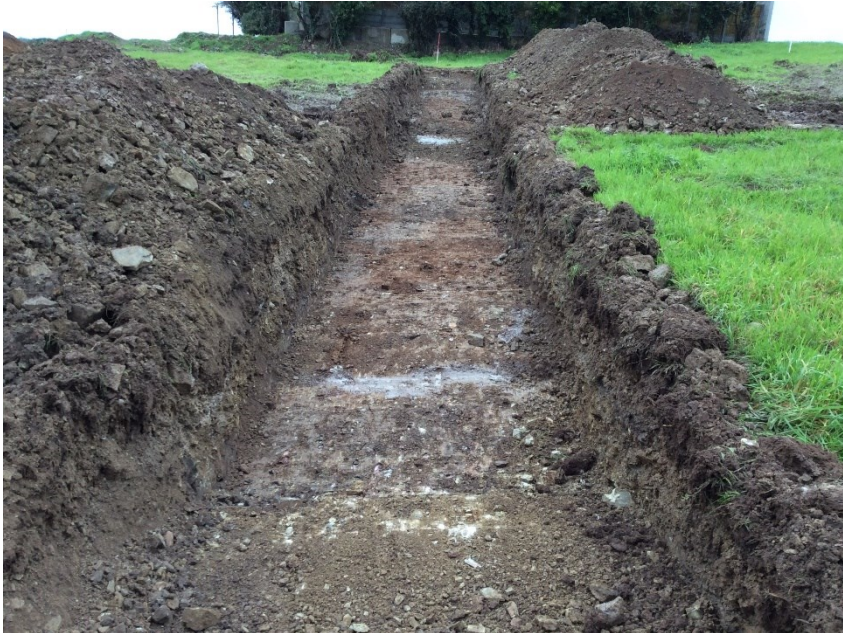
Plate 22: Trench 11, looking N.
