# Architectural Heritage Impact Assessment

for  
St.Coleman's Church Macroom  
Former Church of Ireland  
Community Hub Project

Prepared by Mary O'Brien,  
Architects Department  
09.12.2021

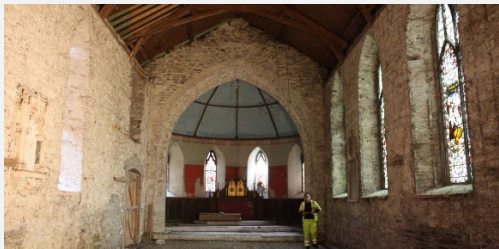
<p>Main nave space looking east</p>	Main Nave Space	<p>This space will remain as a pure open space, linked to the apse.</p> <p>The existing concrete floors will be retained to avoid and further fabric disturbance, with provisions allowed for underfloor heating within a polished screed throughout the ground floor. The internal walls will be repointed where necessary with lime mortar and all the walls will receive a lime wash finish.</p>	Low	Agree finishes with conservation officer at detail design stage.
<p>2</p>

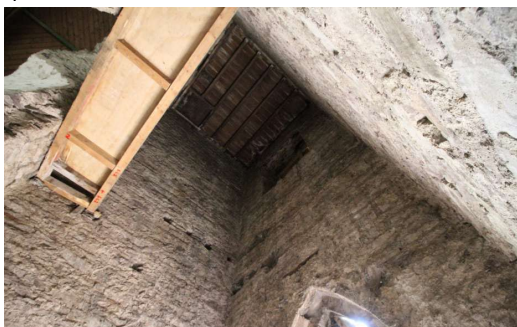
<p>View from the ground looking up to roof of tower</p>	Tower	<p>Currently empty and void of vertical circulation, the proposal seeks to install a winding stair in a footprint that echoes the geometry of the previous stairs (based on the 1989 survey drawings). The stair landings will be utilised to create balcony viewing areas internally and externally; the first offering a connected view into the main nave space; the second offering views of the surrounding areas from the upper tower windows to the north, east, south and west.</p>	Low	<p>Agree finishes with conservation officer at detail design stage.</p> <p>Use skilled trades with appropriate training.</p>
<p>5</p>

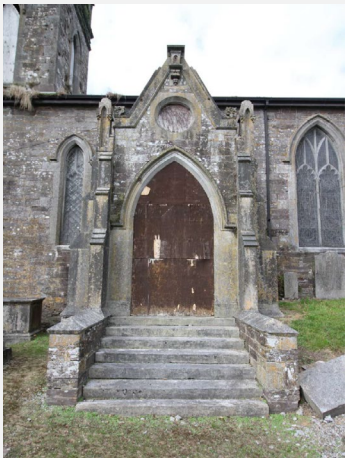
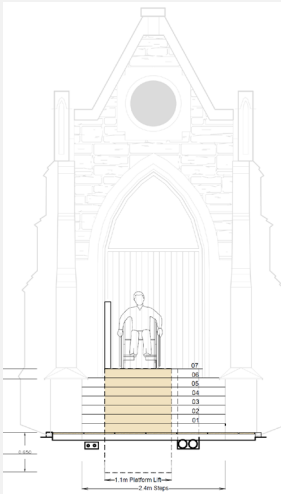
<p>Porch - Universally Accessible Entrance</p>	<p>The local authority has an onus to ensure that all public buildings are accessible by all. All existing access routes to the church are either elevated and access via stairs or cannot be navigated to by a less-abled person due to the terrain and vertical obstacles of the burial ground.</p> <p>There is an opportunity to form a new entrance in the existing porch by way of a fully integrated concealed platform lift to allow for level threshold access by less-abled or disabled persons. The geometry of the steps will require the entire section of steps will need to be removed. Due to its required and the work's proximity to burials, this item has been studied by an independent archaeologist - please refer to the archaeological report accompanying this report.</p>	<p>High</p>	<p>The removed steps will be reused to clad the new platform steps.</p> <p>Treatment of fabric will be agreed with conservation officer at detail design stage.</p>

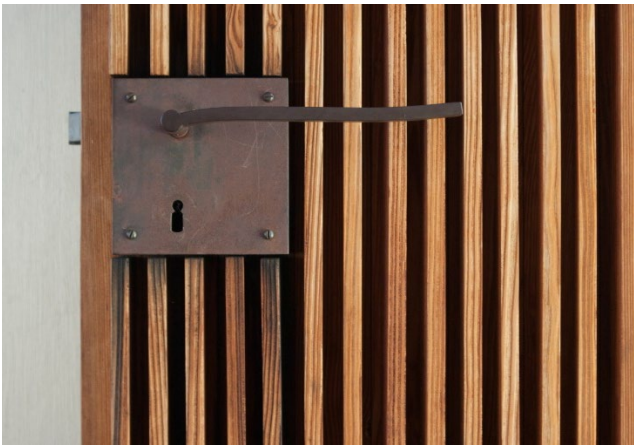
<p>Design intent for the new lobby door and for new doors required to south and west entrances</p>	<p>Porch - Universally Accessible Entrance</p>	<p>The location of the existing door will need to be pushed back in to the existing porch, forming an external lobby in order to accommodate a level landing for the wheelchair user.</p> <p>The new door will be contemporary but timeless in style using vertical timber slat language with high-quality ironmongery.</p>	<p>Medium</p>	<p>The external lobby will be sensitively formed using stone heads and cut stone reveals.</p> <p>Treatment of fabric will be agreed with conservation officer at detail design stage.</p>

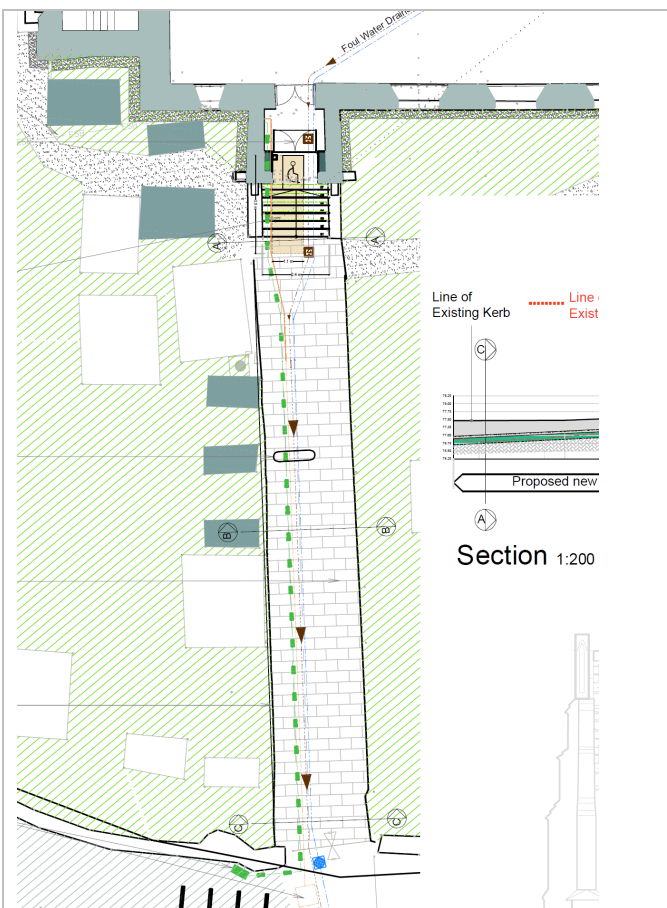
<p>General External Works – connections, RWOs, lead flashings</p>	<p>Attempts appear to have been made at the time of the construction of the rear extension to connect a foul drainage system to the east. A CCTV drains survey is required.</p> <p>Archaeological input has been sought to inform the route of foul and storm connections. Please refer to archaeological report in relation to this element.</p> <p>Refer to architectural drawings.</p> <p>The intention is to finish this new pathway in natural irish stone paving.</p>	<p>High</p>	<p>Agree methodology prior to commencement.</p> <p>Drains survey of existing is required but expected to be defective and partially complete.</p> <p>Route has been designed with minimal disturbance in mind.</p>

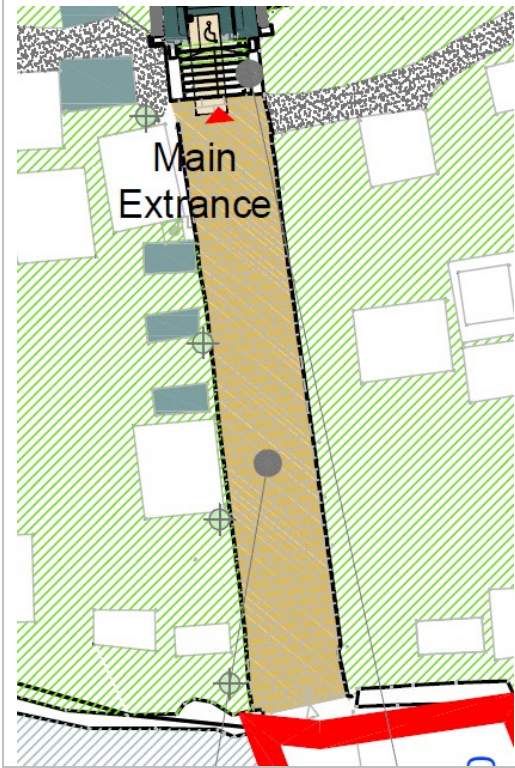
<p>General External Works - connections, RWOs, lead flashings</p>	<p>Lighting will be required on approach to the building and it is also proposed to softly light up the building via discreet uplighters, with emergency lighting to the east also. Please refer to the architectural drawings for locations.</p>	<p>Low</p>	<p>Minimal design lighting features to be selected.</p> <p>Selection of finishes will be agreed with conservation officer at detail design stage.</p>
--	---	---	------------	---
