Gallanes Amenity Area (Phase 2)

Road Safety Audit Stage 1/2

**OCTOBER 2021**

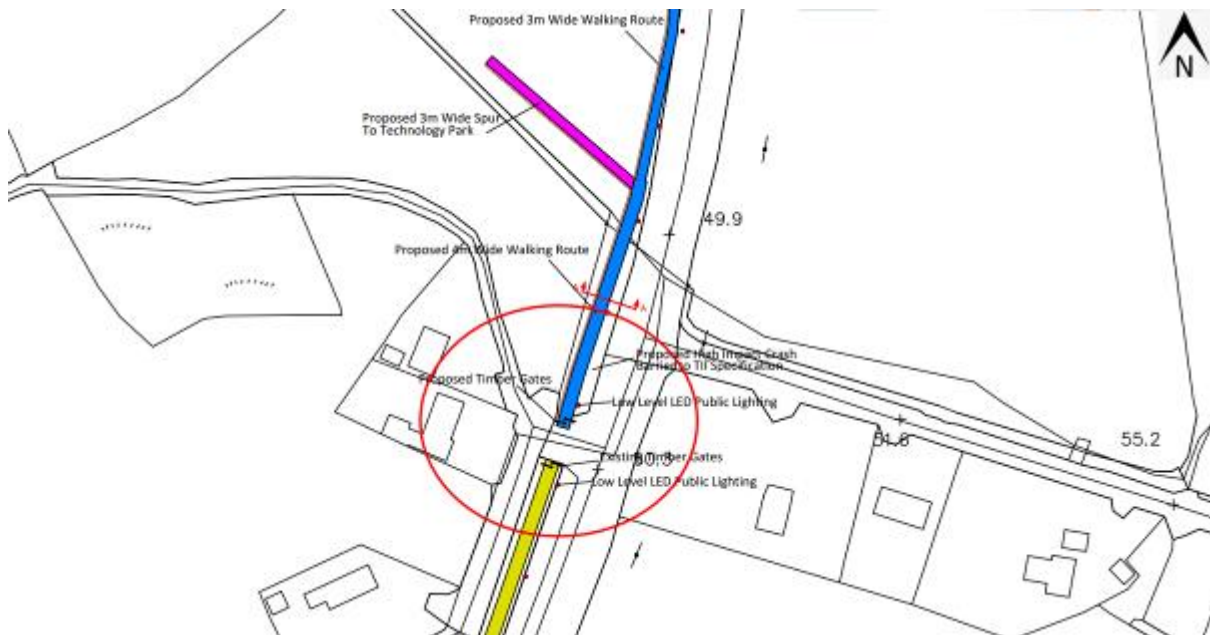
**Figure 3.1 Audit location**

Visibility splays at the amenity walk tie in location are limited by its proximity to existing roadside parking. Failure to provide appropriate visibility at the junction may lead to collisions between passing vehicles and vehicles exiting the junction. See Photos A1 and A2 in Appendix A.

It is unclear if the proposed lighting is adequate to properly light the tie in location across the existing residential junction entrance. Failure to adequately illuminate the proposed junction may lead to collisions involving vehicles and pedestrian amenity walkers.

The proposed lighting column locations look to be positioned on the road carriageway between audit assessment locations 3 and 4 (the connection with the amenity walk and the connection across the L4032 local road). Failure to provide appropriate column offsets locations may lead to collisions involving passing vehicles.

No pedestrian priority connection to the nearby urban footpath network is provided from the proposed pedestrian entry/exit access, with no pedestrian crossing shown in the vicinity. Failure to provide appropriate pedestrian crossing facilities may lead to collisions involving vehicles and pedestrians travelling to/from this pedestrian route.

It is unclear from the layouts what boundary treatment is proposed along the section of amenity walkway that runs adjacent to the Business Park. Failure to provide appropriate boundary treatment provision may lead to trip/fall hazards to pedestrians travelling to/from this pedestrian route.

The proposed layouts do not show tactile paving at the proposed pedestrian crossing location. Failure to provide appropriate tactile paving may lead to visually impaired/vulnerable users walking onto the road carriageway. This could lead to collisions between vehicles and vulnerable users at this location. See Photos A3 and A4 in Appendix A.

Provide appropriate junction tactile paving on both sides of the junction.

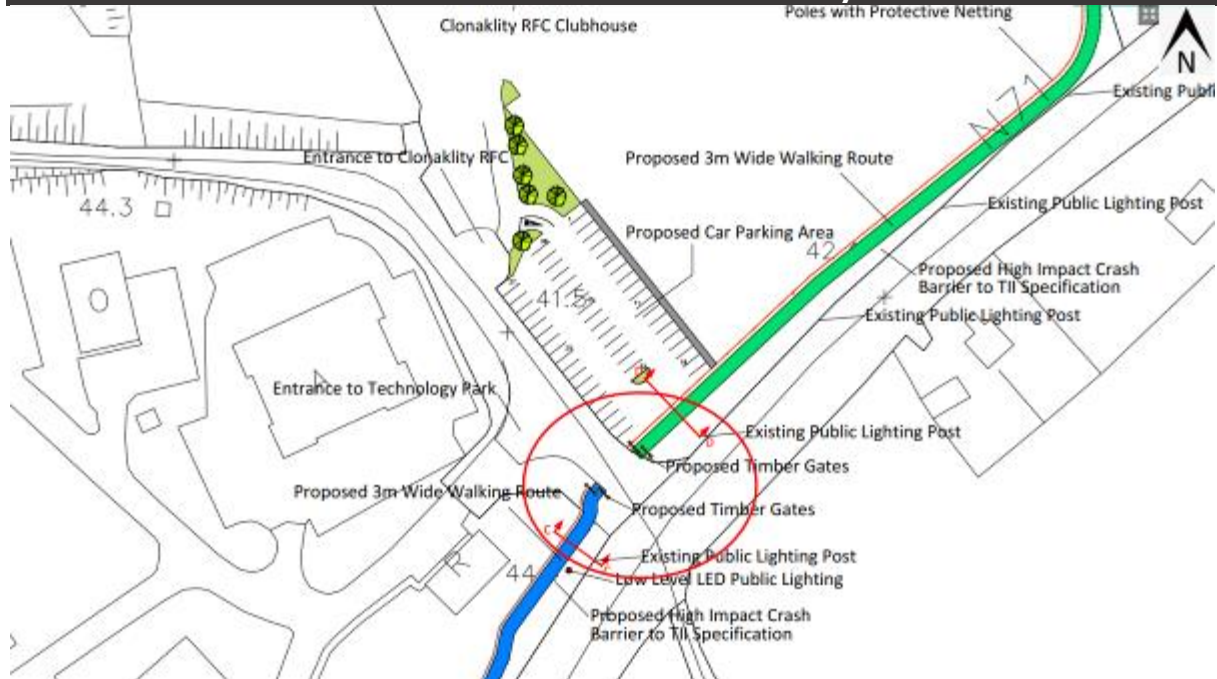
**Figure 4.1 Audit location**

Existing visibility splays at the N71 junction should not be hindered by any pedestrian crossing proposals. Failure to provide appropriate visibility at the junction may lead to collisions between passing vehicles and vehicles exiting the junction. See Photos A3 and A4 in Appendix A.

It is unclear if the proposed lighting is adequate to properly light the tie in location across the existing junction entrance. Failure to adequately illuminate the proposed junction may lead to collisions involving vehicles and pedestrian amenity walkers.

It is unclear if the existing lighting columns as shown in the layouts are to remain in their current locations or are to be repositioned to account for the new amenity walkway. Failure to provide appropriate column offset locations may lead to collisions involving passing vehicles.

Provide appropriate junction tactile paving on both sides of the junction.
