Cobh Town Hall

Roger Casement Square, Ringmeen, Cobh, Co.Cork.

Conservation Report - Heritage Impact Assessment:

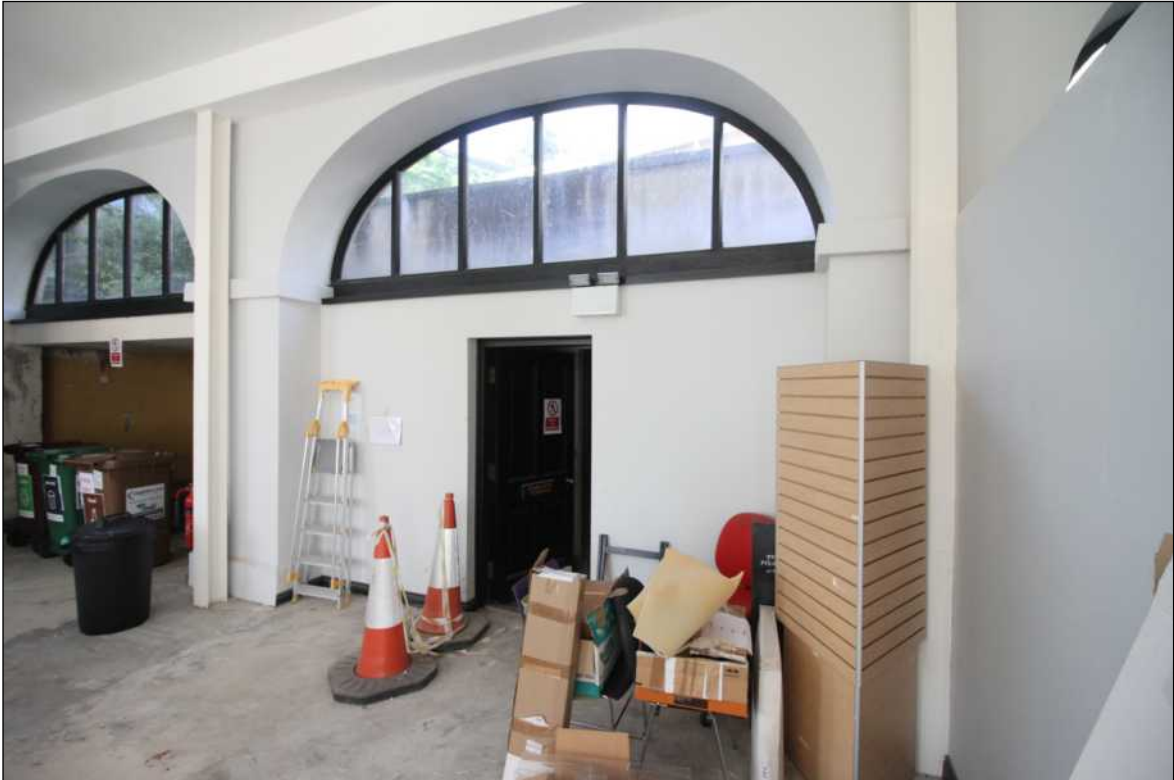
• Fig 61. Room 9. Rear flat North roofed rooms under arches.

The rear flat roofs are clearly in need of attention, as illustrated above. Much of the trouble is likely to stem from blocked outlets and build up of 'greenery' on the roof. It is assumed this roof is being replaced and as such less of a concern.

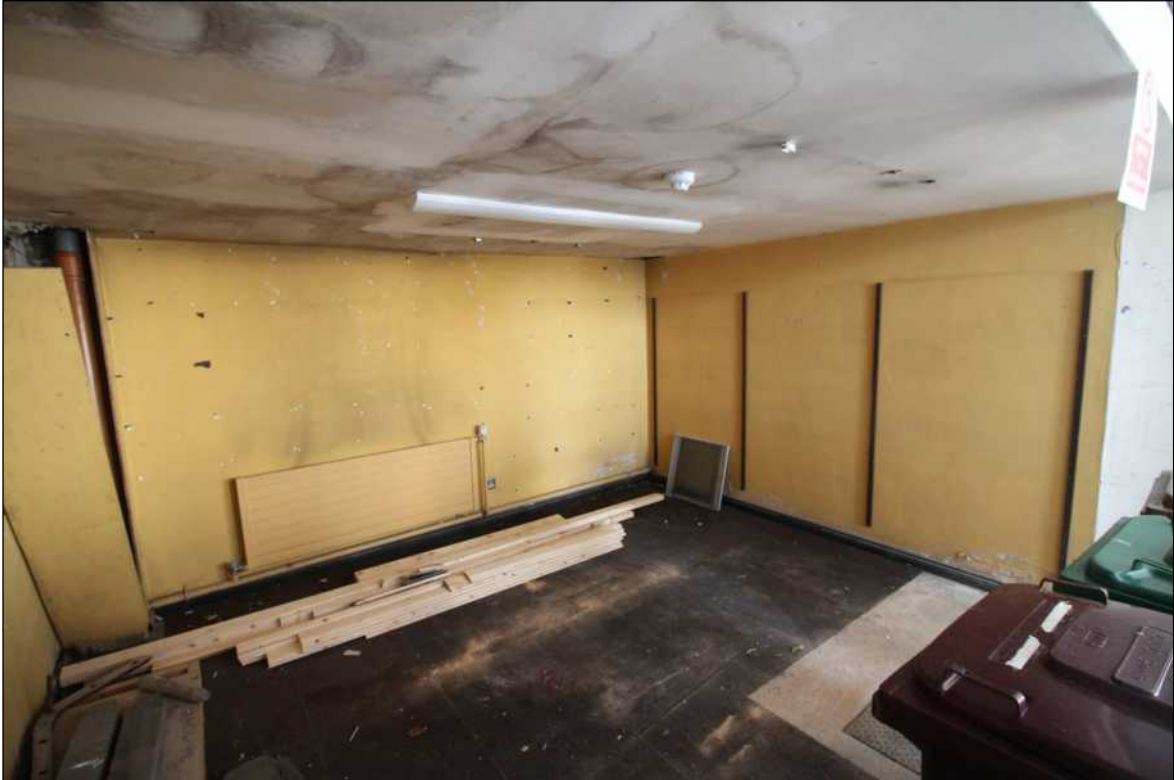
• Fig 62. Room 10. Rear flat North roofed rooms.

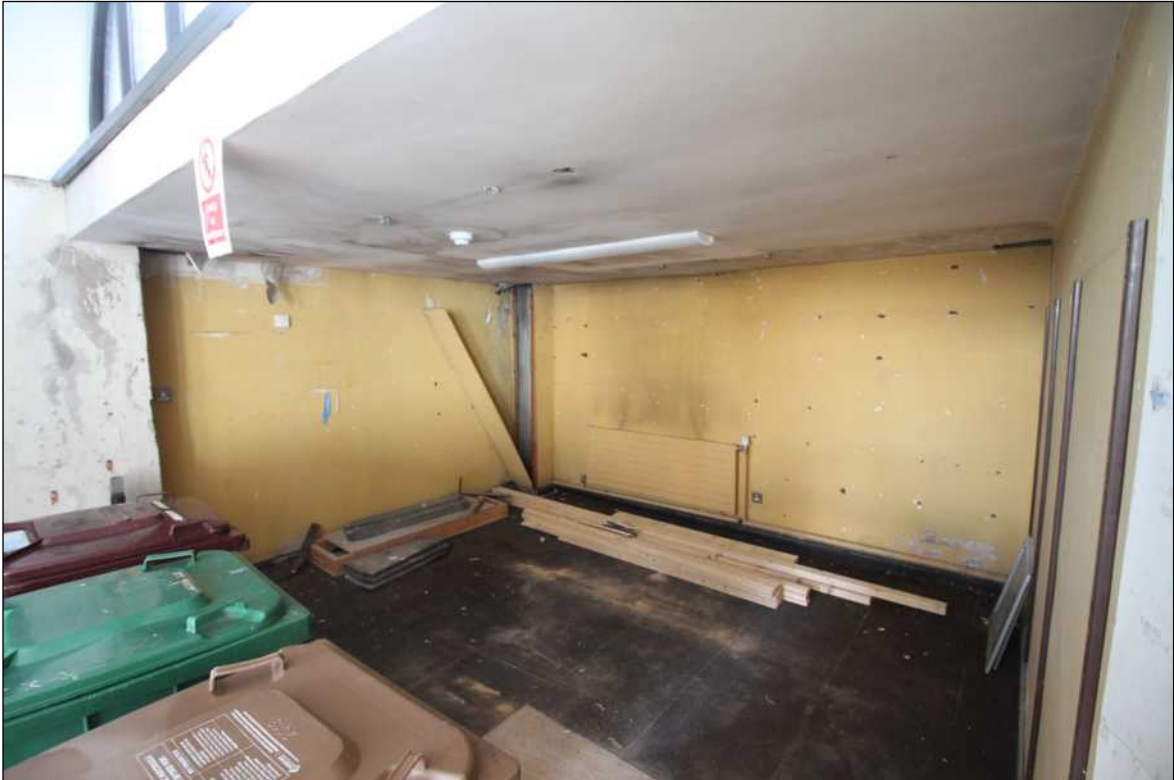
• Fig 63. Room 10. Rear flat North roofed rooms.

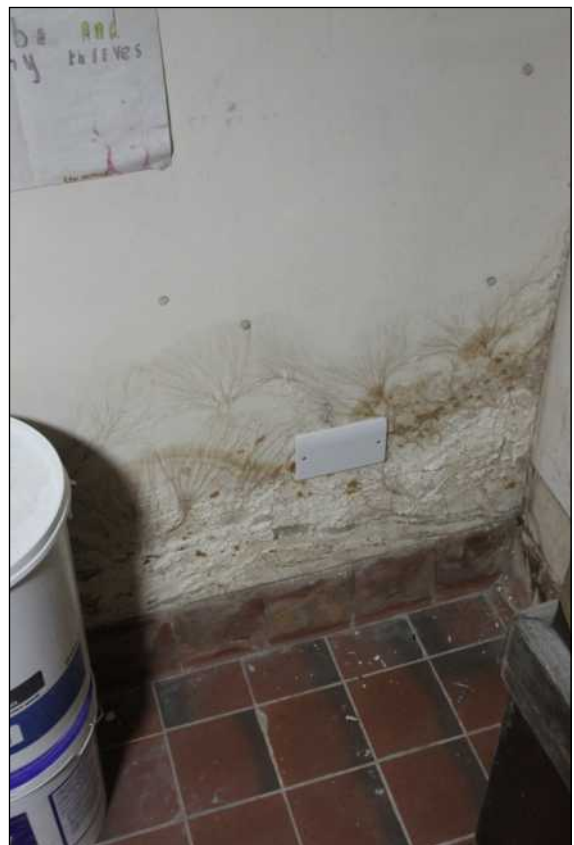
Fig 69. Damp issues in rear rooms.

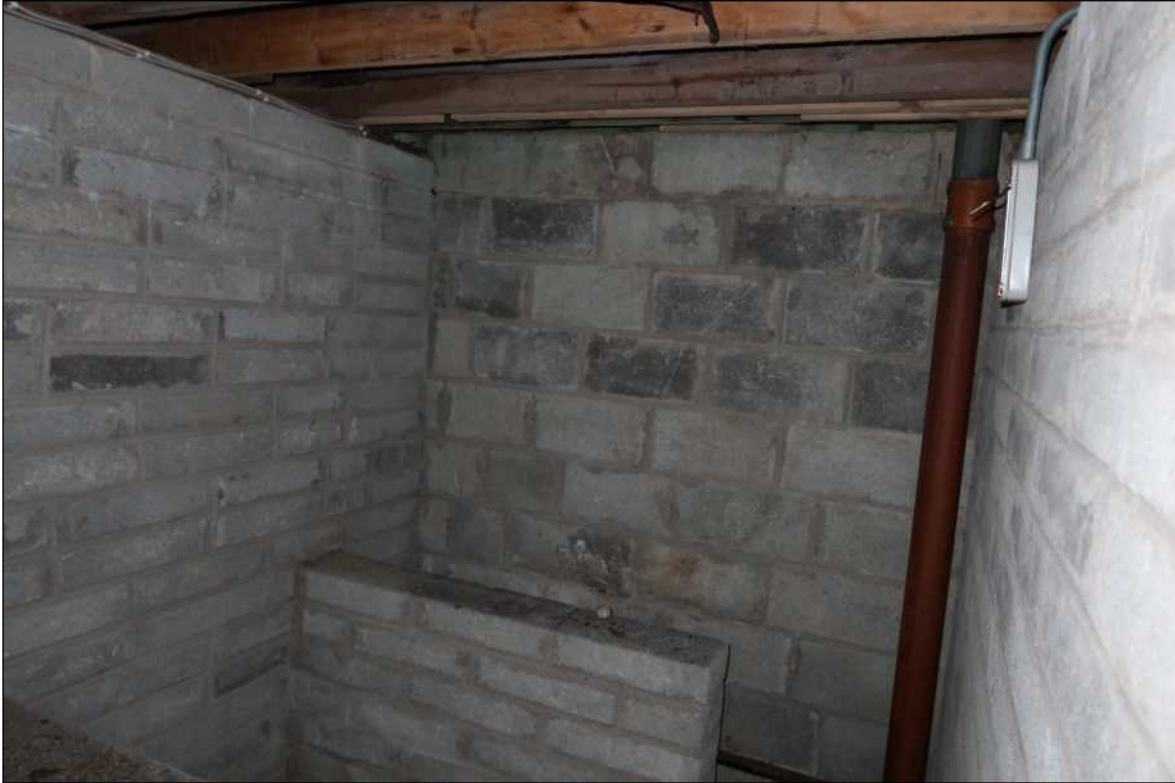
• Fig 70. Room 11. Rear North flat roofed rooms .
