the working hub | Charleville Court and Market House

## Charleville Court and Market House

### Conservation Feasibility Study

12th February 2021

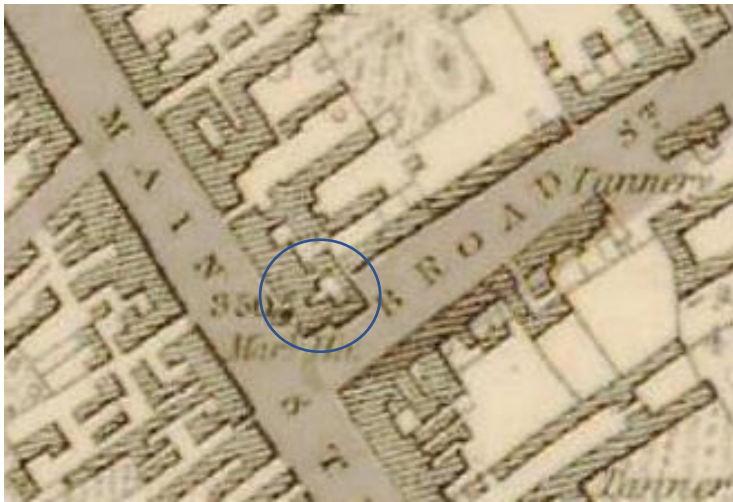
Figure 2: First edition OS map, surveyed 1841

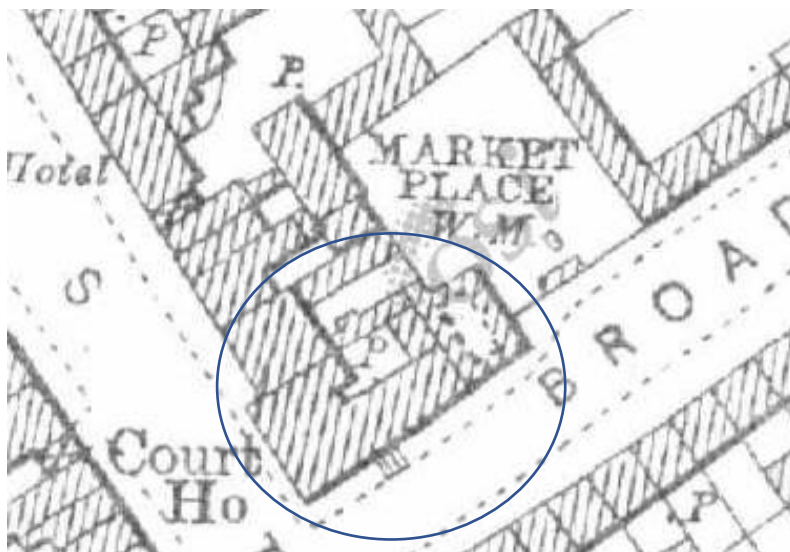
Figure 3: Large scale OS map, 1903

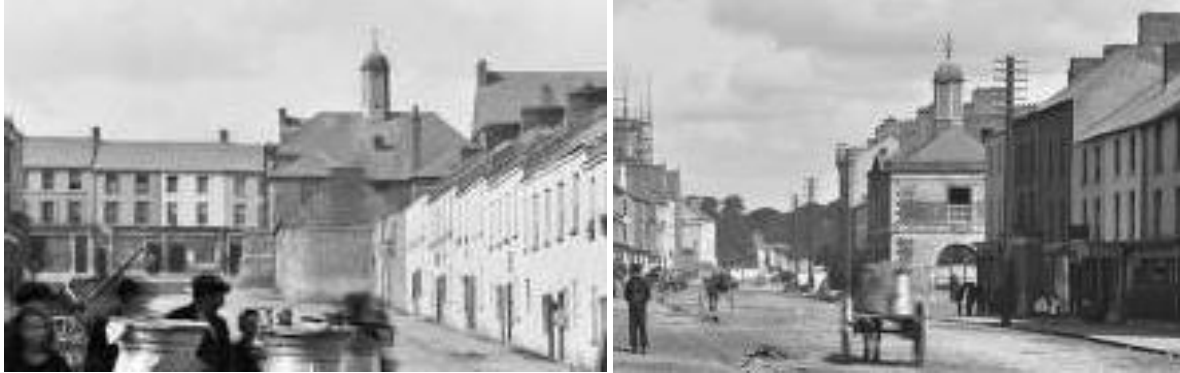
Figure 4: Photographs from the NLI's Lawrence Collection, dated c. 1880-1900, showing the cupola on the building in place

Late nineteenth-century photographs show the survival up to that stage of a striking, tall cupola, topped by a weather-vane. The cupola appears to have been removed in the latter half of the 20<sup>th</sup> century. These photographs also provide evidence of the original, or at least early, multi-pane timber sash windows to the side elevation of the market house.

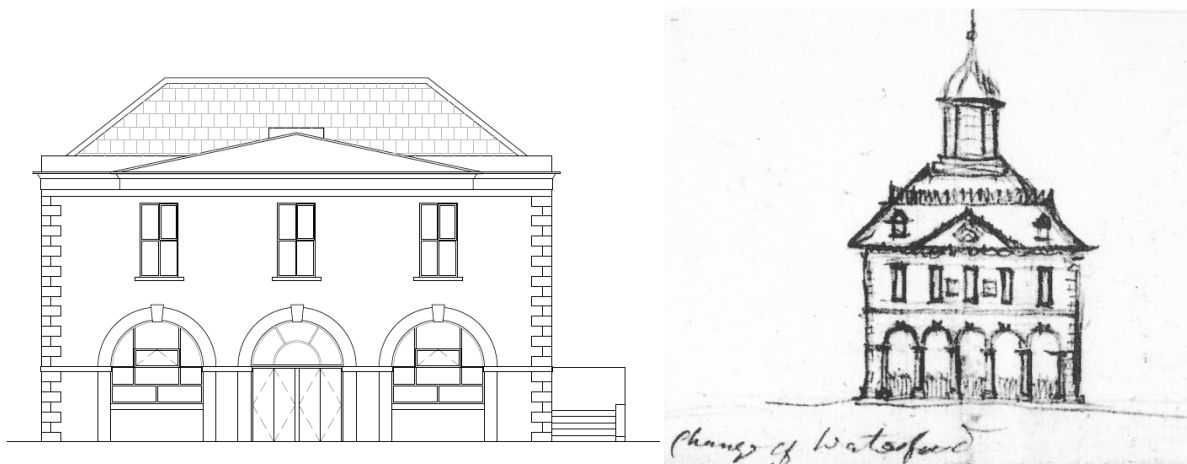
Figure 5: Comparative drawings of Charleville Court and Market House in its present form, left, and a 1715 sketch by Thomas Wright of Waterford Exchange, right

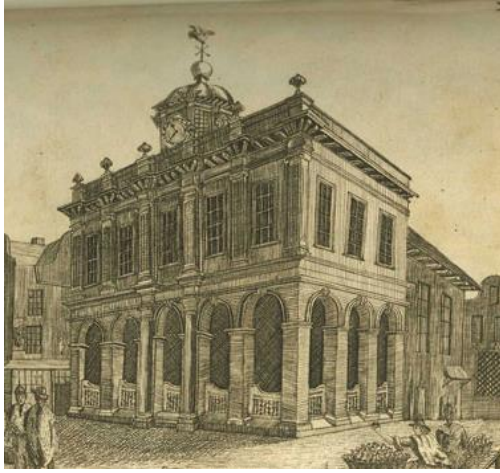
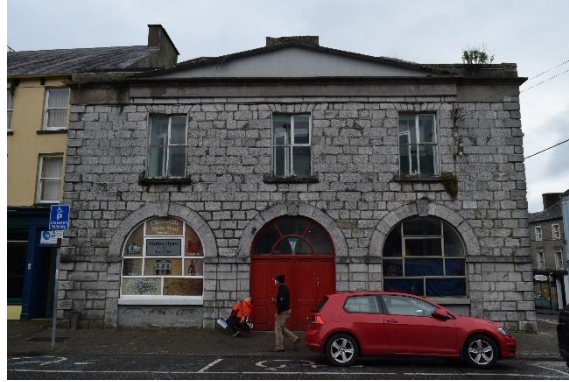
*Figure 6: The Exchange building that stood in Cork, built c. 1705-10, left, with Charleville Court and Market house (right)*

Although described by Samuel Lewis in the 19<sup>th</sup> century as a small, plain building, the design of Charleville Court and Market House was very characteristic of the typical early 18<sup>th</sup> century market house or exchange building, which would have had an open arcaded ground floor. As in Antrim, for example, at Charleville an external stone stair led to the courthouse located above the market house. These buildings had a formality of design and construction that was intended to set them apart from other urban buildings. Tall cupolas further distinguished their civic presence, as in Cork.
