CORK COUNTY BRIDGE REHABILITATION SERVICES: ARDCAHAN BRIDGE

Ecological Appraisal Report

Prepared for:
Cork County Council

Date: August 2023

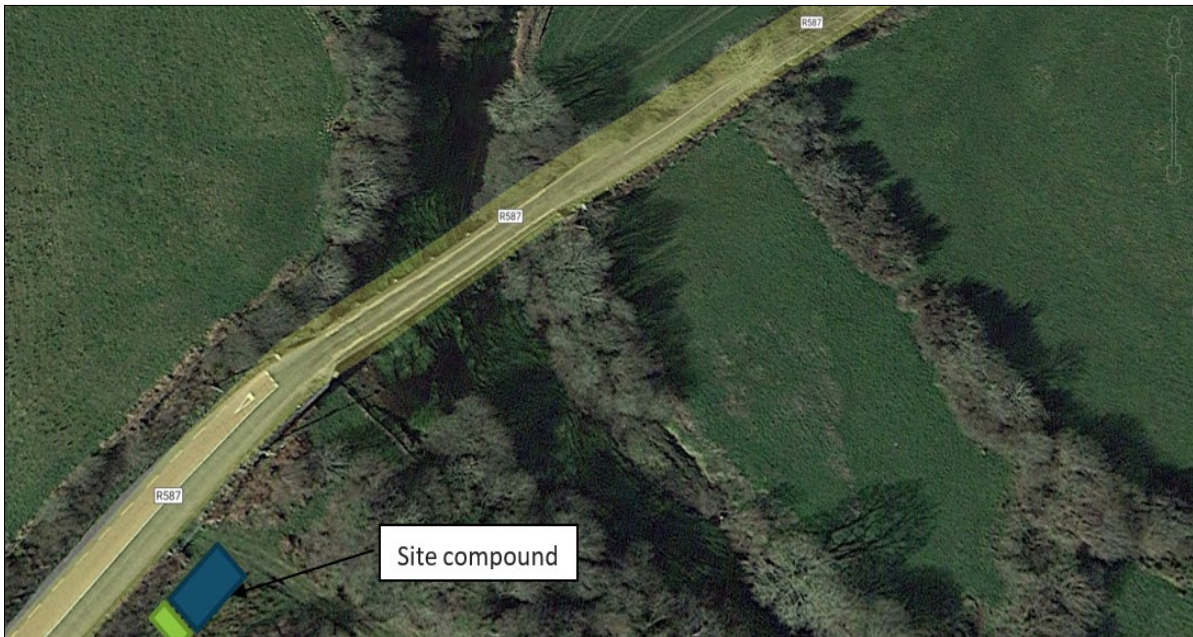
Figure 4-1: Site compound location south-west of Ardcahan Bridge

The site compound is located in agricultural land within the Bandon River SAC (see Figure 4-1).

During the construction phase, it will be necessary to provide temporary facilities for construction personnel. This project will have 1 no. temporary compound located near the entrance to the site which will include welfare facilities. The location of the temporary site compound is proposed to be set back c. 30m from the south west corner of the bridge, as shown in Figure 3 1. The temporary compound shall be constructed with crushed rock aggregate hard standings with low dust content. Temporary facilities will be removed, and the lands reinstated upon completion of the construction phase.

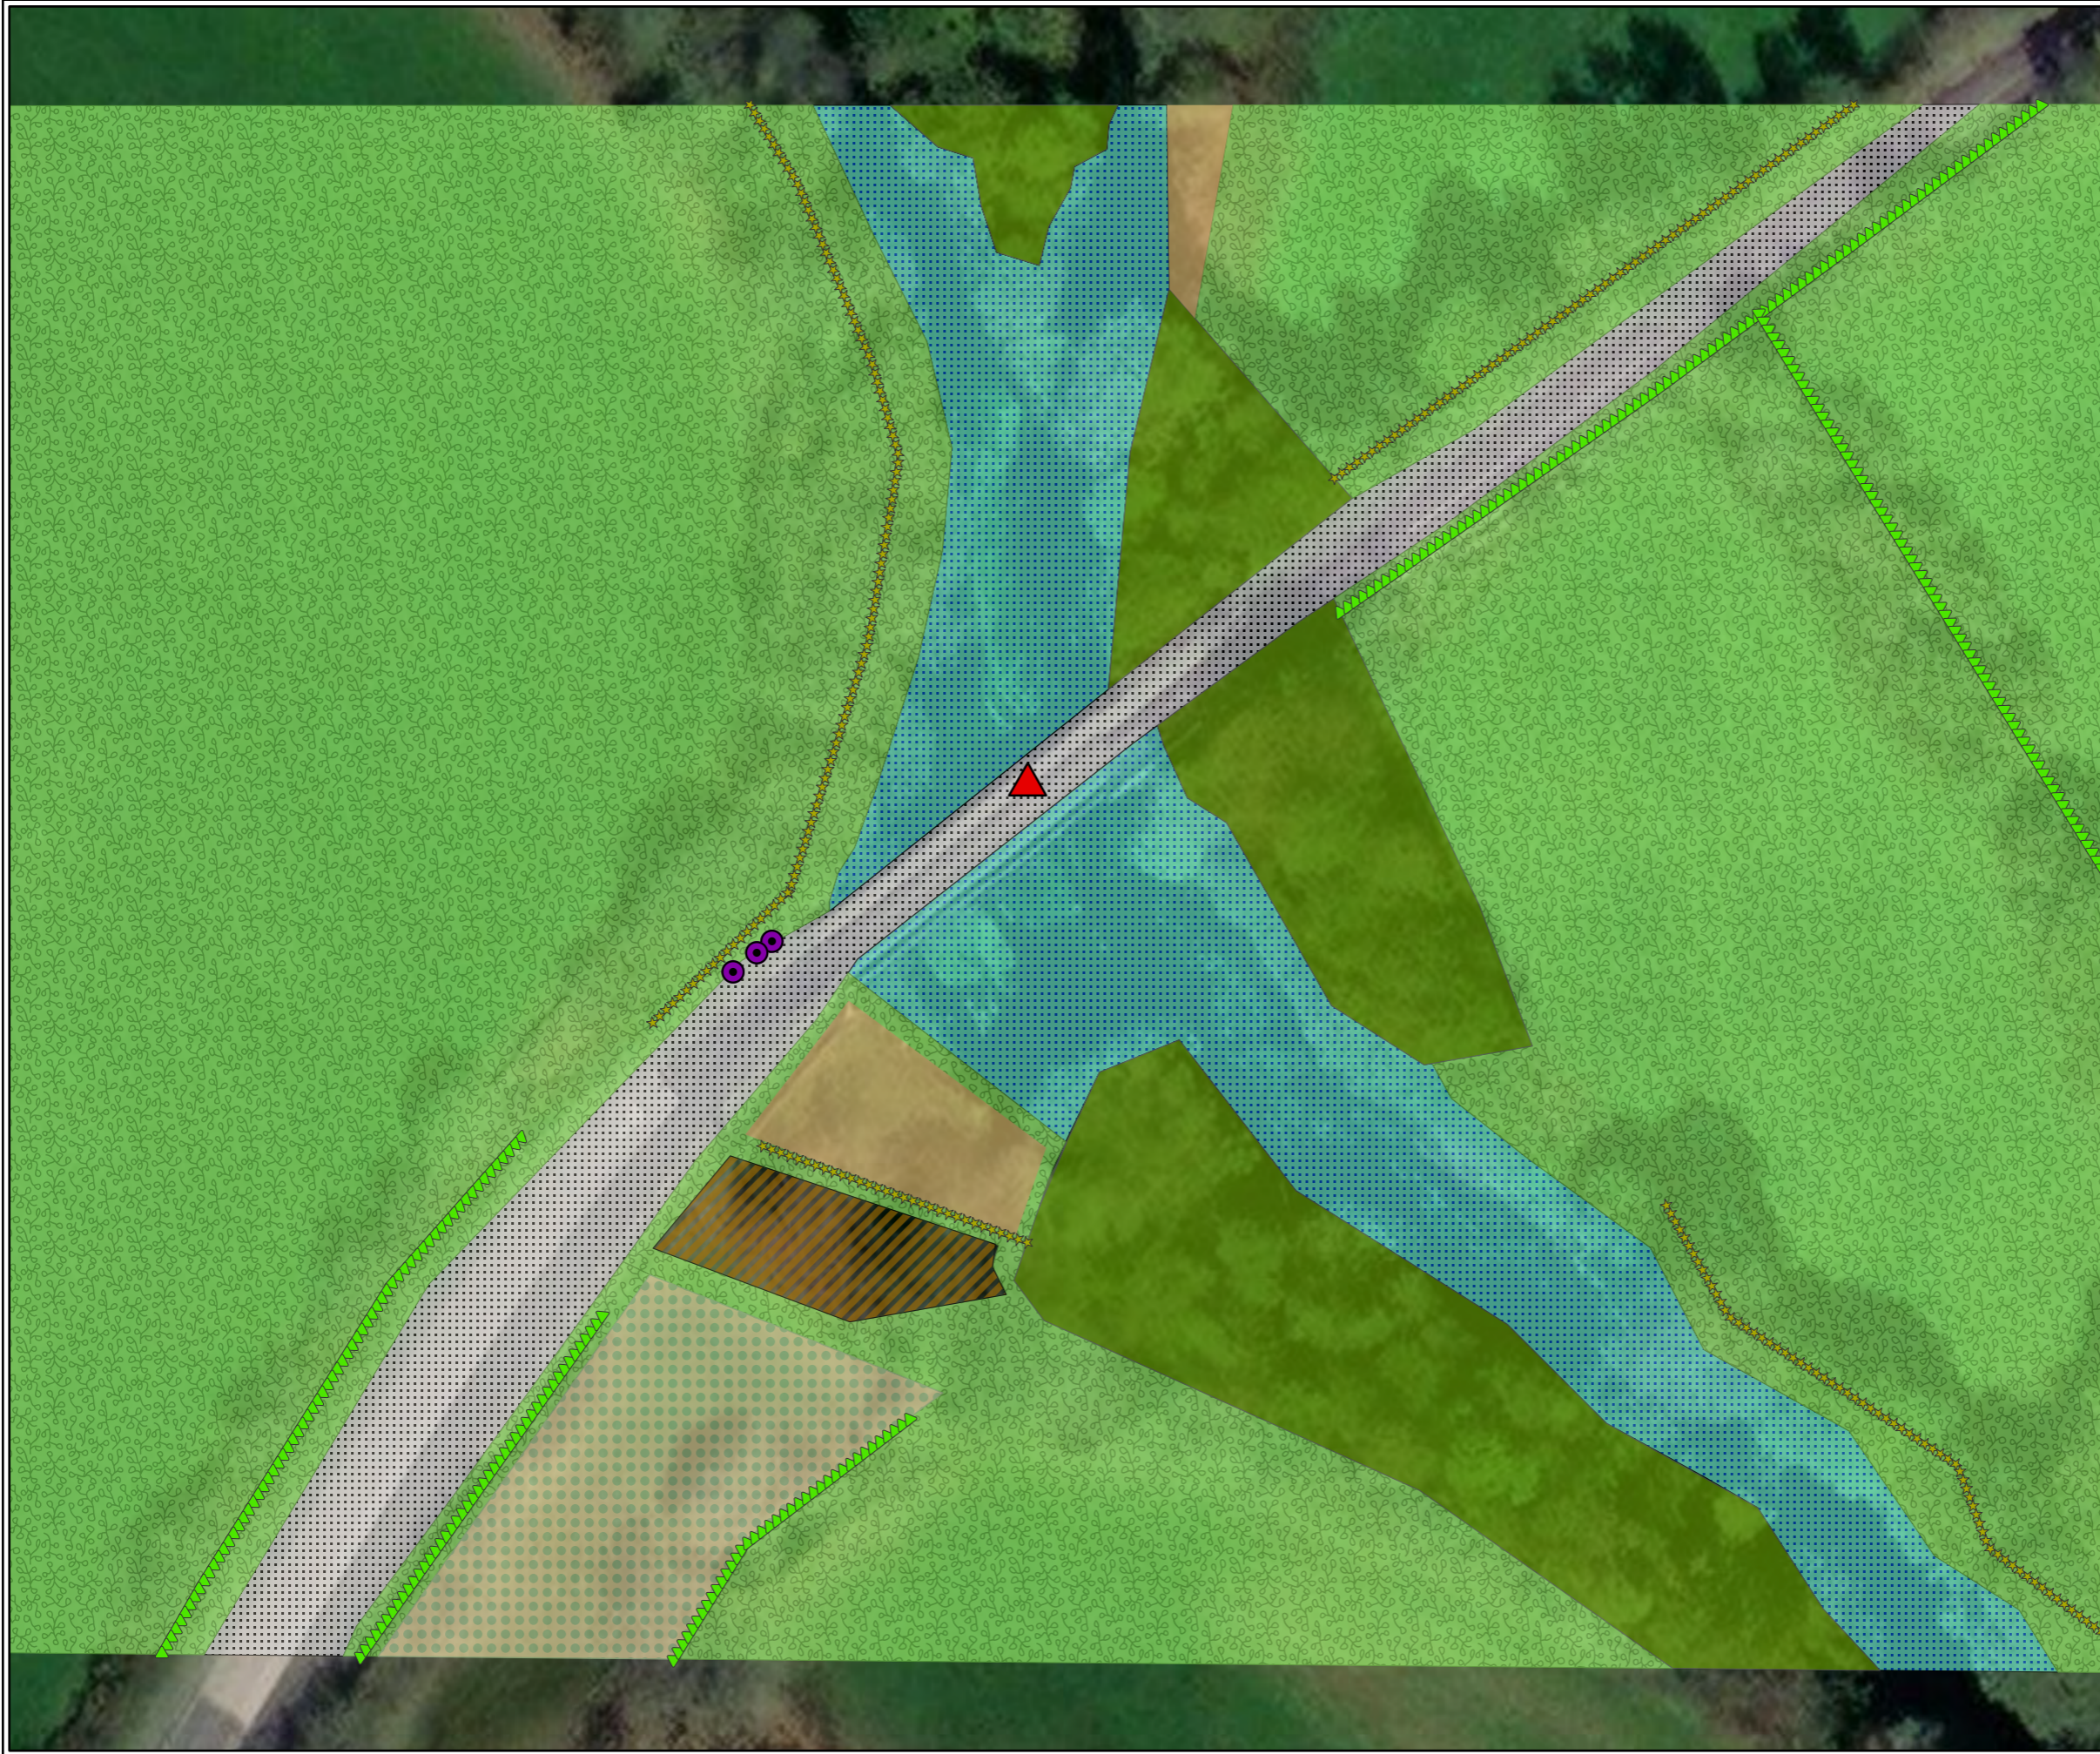
TITLE:	
Habitat Map and Invasive Species	
PROJECT:	
Ardcahan Bridge Rehabilitation	
FIGURE NO: 5-1	
CLIENT: Cork County Council	
SCALE: 1:500	REVISION: 0
DATE: 21/07/2023	PAGE SIZE: A3

- Legend**
- Ardcahan Bridge
 - Winter Heliotrope
- Habitat Polygon Code, Description**
- BL3, Buildings and Artificial Surfaces
 - FW2, Depositing / Lowland Rivers
 - GA1, Improved Agricultural Grassland
 - GS4/GS2, Wet Grassland/Dry Meadows and Grassy Verges Mosaic
 - HD1, Dense Bracken
 - WN5, Riparian Woodland
 - WS1, Scrub
- Habitat Line Code, Description**
- WL1, Hedgerows
 - WL2, Treelines

There are ten habitat types at and around the bridge (Figure 2):

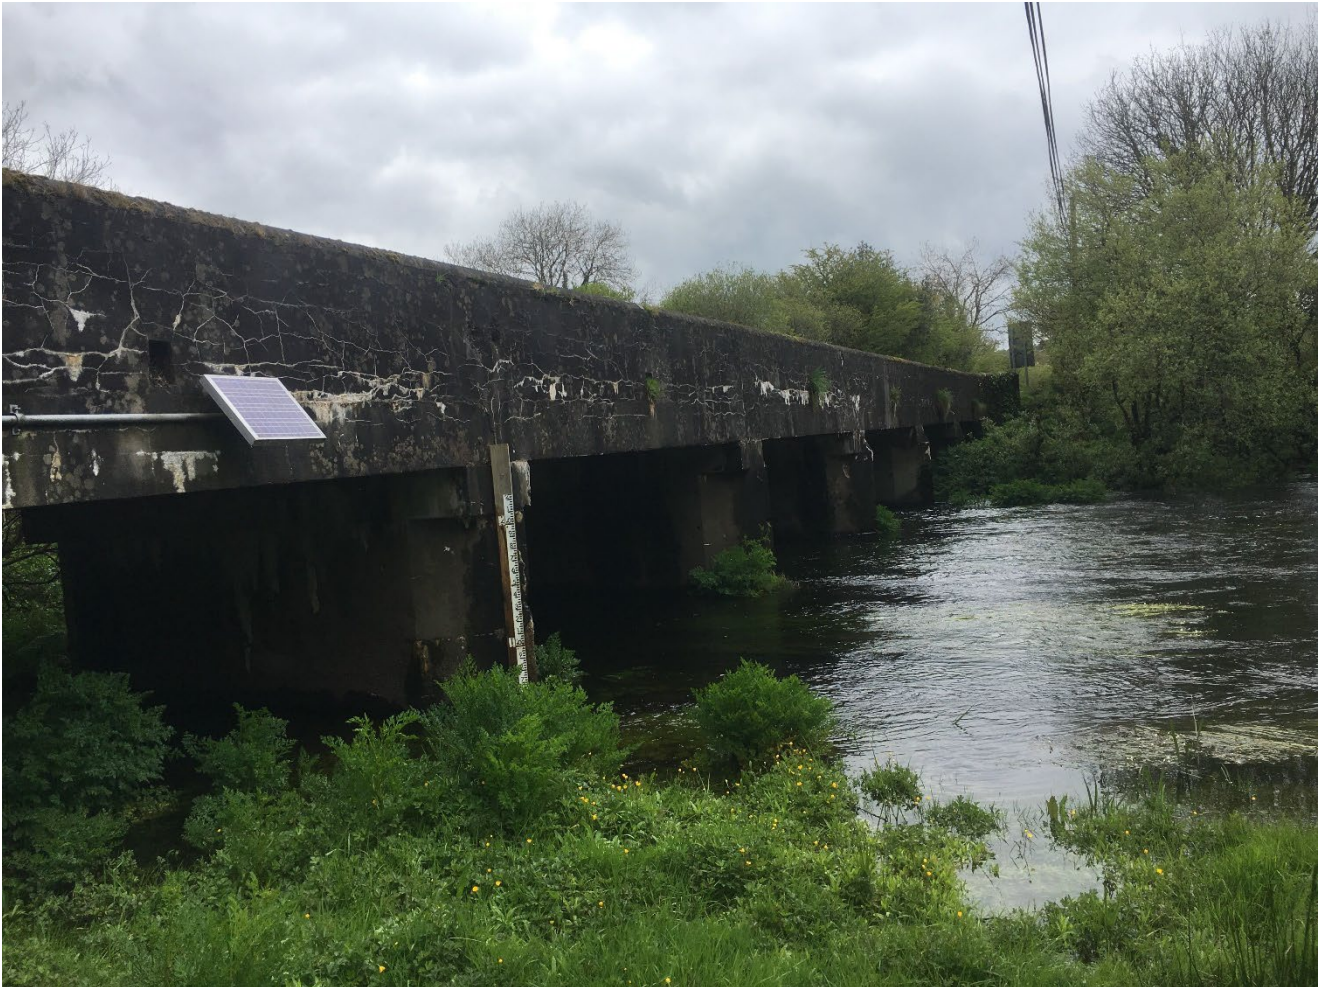
Figure 1: Depositing/Lowland Rivers (FW2), Buildings and Artificial Surfaces (BL3), Treelines (WL2)

Depositing/lowland rivers habitat type is found in the river that the Ardcahan bridge spans. Note the instream vegetation. Buildings and artificial surfaces is represented by the bridge itself. Also visible in the photo are treelines.

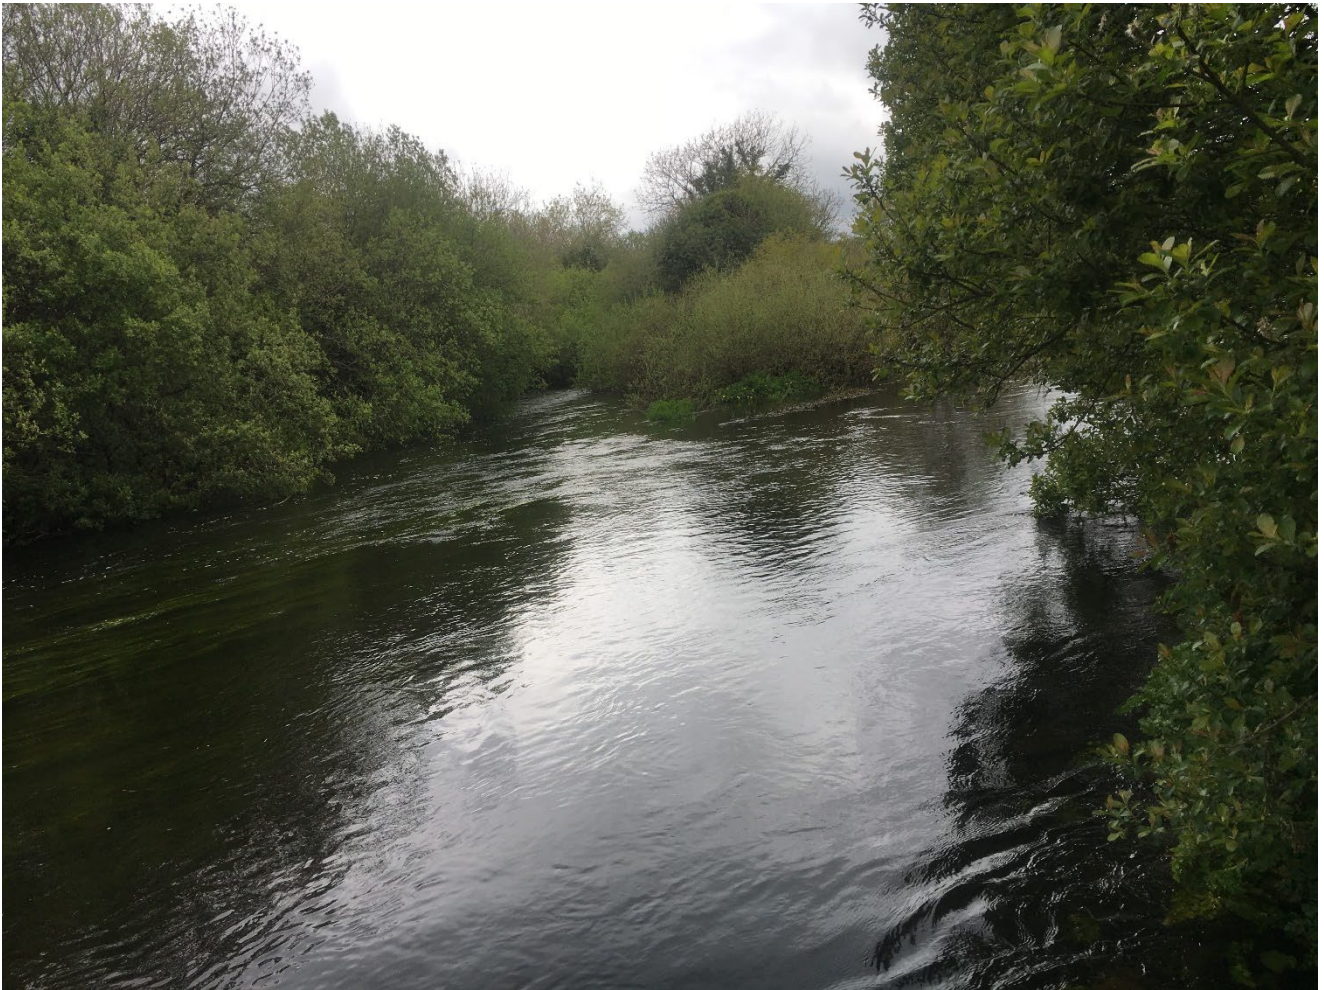
Figure 2: Depositing/Lowland Rivers (FW2) and Riparian Woodland (WN5)

Depositing/lowland rivers makes up the River Bandon that Ardcahan bridge spans. Also present are patches of riparian woodland (edges of which seen here).

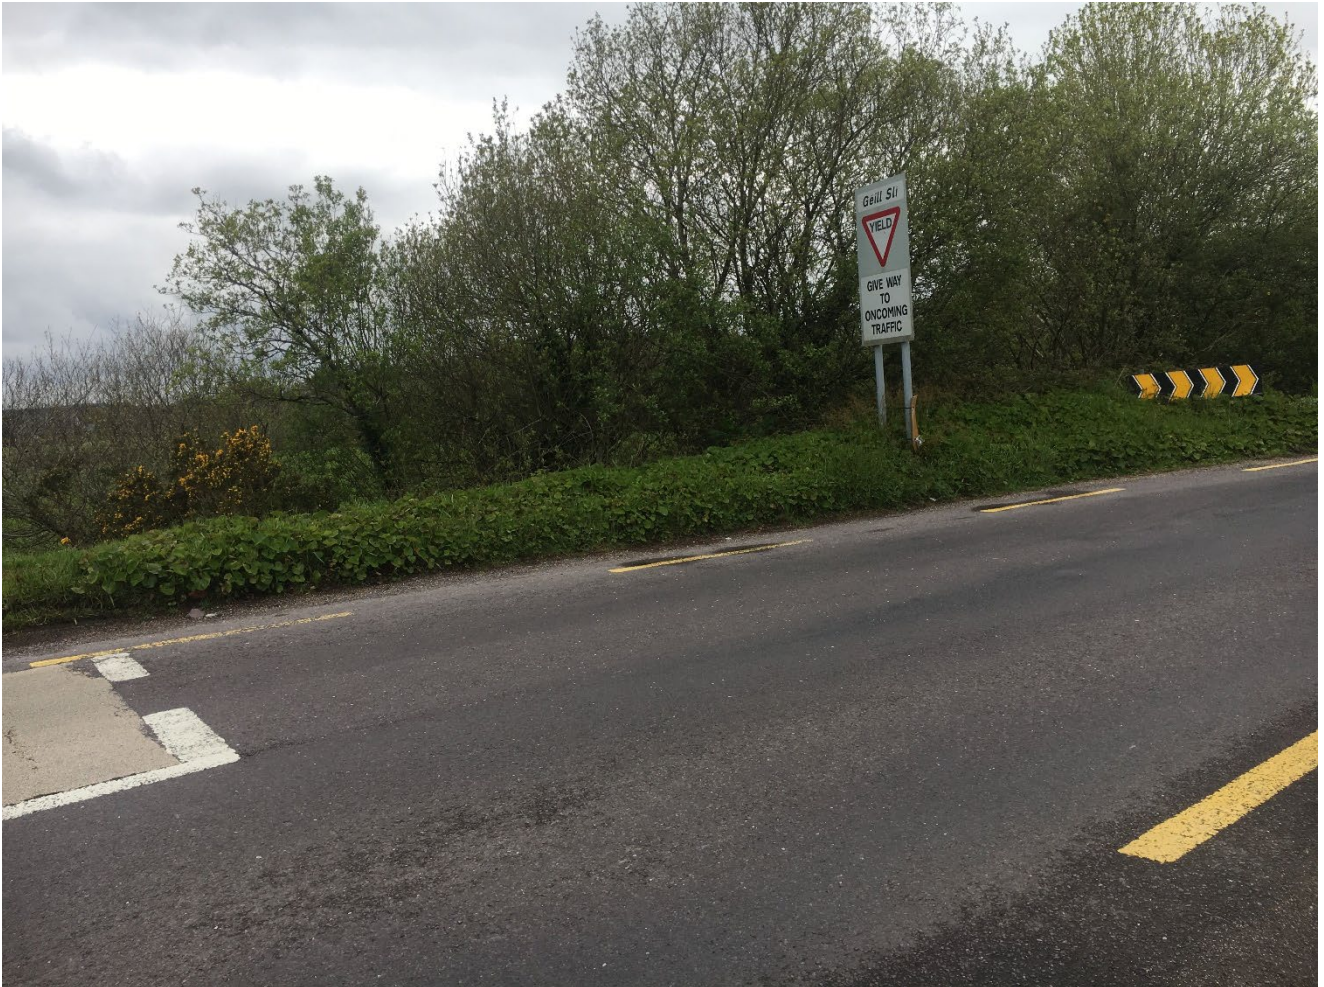
Figure 3: Dry Meadows and Grassy Verges (GS2), Hedgerows (WL1) and Buildings and Artificial Surfaces (BL3)

Buildings and artificial surfaces include the road that crosses the bridge. Hedgerows can also be seen along the edge of the road. Dry meadows and grassy verges are present alongside the road. Note also the presence of winter heliotrope in this picture.

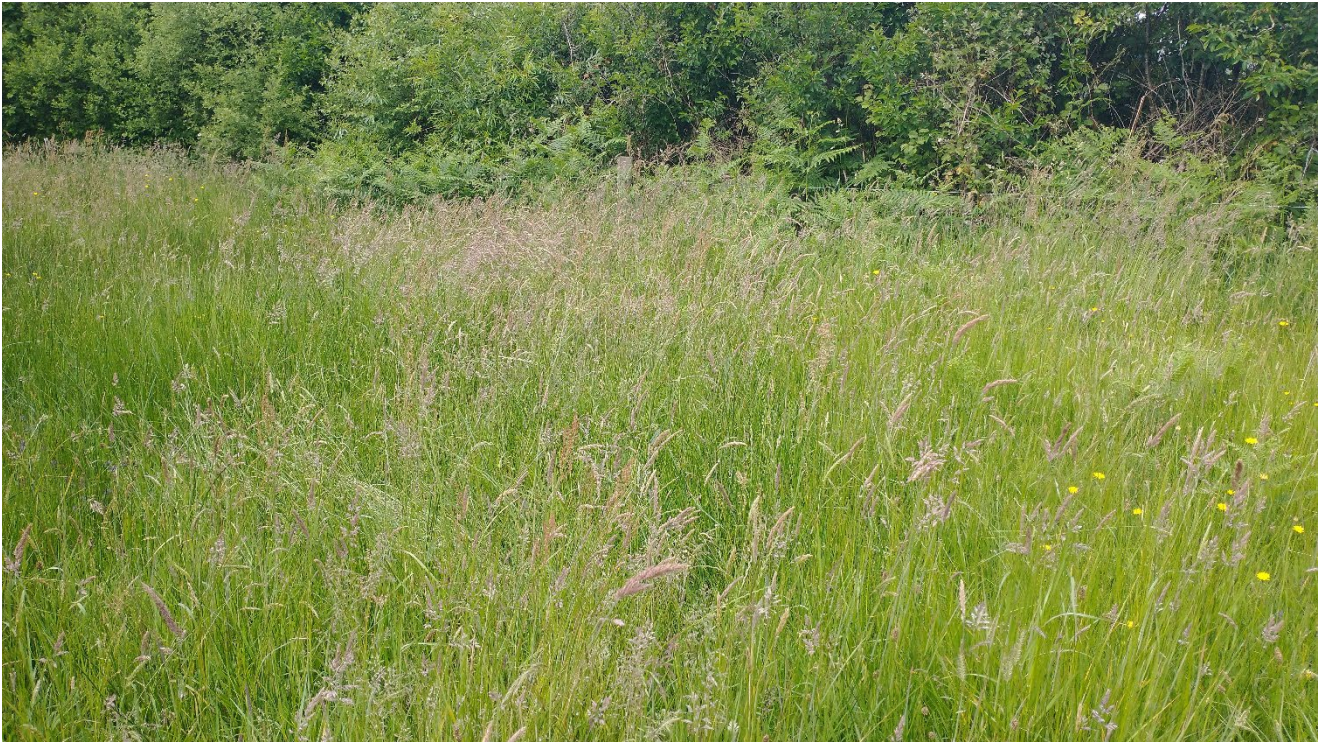
Figure 4: Wet grassland/ Dry calcareous and neutral grassland Mosaic (GS4/GS2)

A mosaic of wet grassland / dry calcareous and neutral grassland (GS4/GS2) habitat is present in the field south-west of the bridge where the proposed site compound is located. Species indicative of wet conditions include Yorkshire fog (*Holcus lanatus*), ragged robin (*Silene flos-cuculi*) and rushes (*Juncus Spp.*), while the presence of selfheal (*Prunella vulgaris*), cat's ear (*Hypochaeris radicata*) and crested dog's tail (*Cynosurus cristatus*) are indicative of calcareous/neutral conditions. This is likely to be due to the presence of alluvial soils closer to the river which would differ in their makeup from the more acidic soils which would be characteristic of the surrounding upland areas. This habitat does not have links with any Annex 1 habitat type.

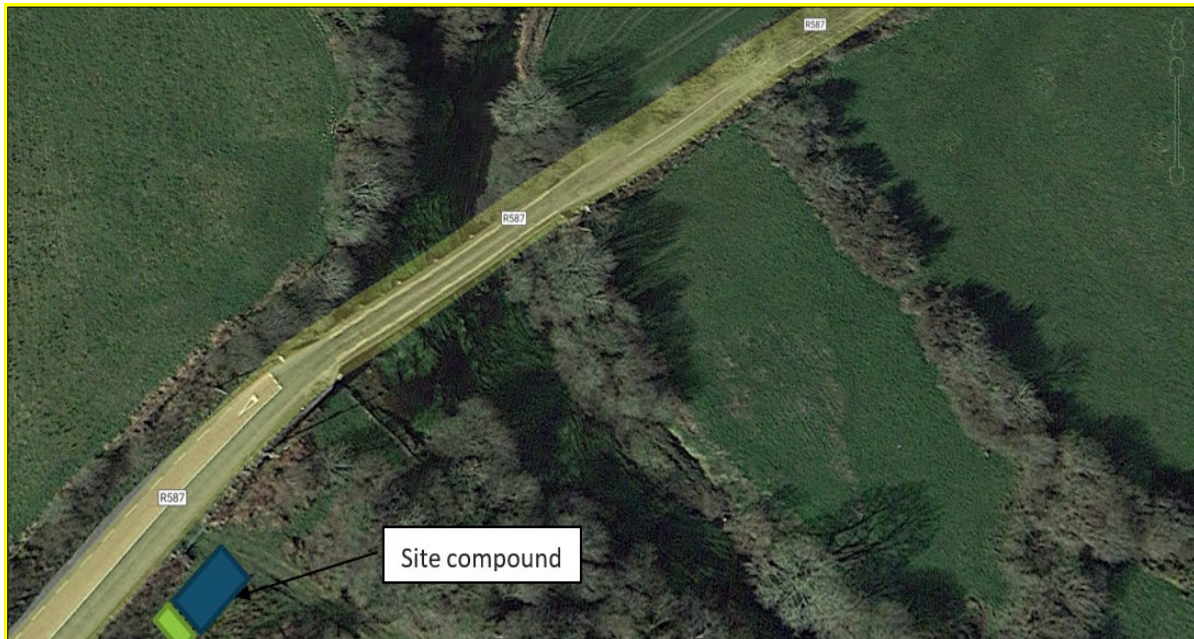
Figure 1.1: Site compound location south-west of Ardcahan Bridge

The site compound is located in agricultural land within the Bandon River SAC (see Figure 1.1).

During the construction phase, it will be necessary to provide temporary facilities for construction personnel. This project will have 1 no. temporary compound located near the entrance to the site which will include welfare facilities. The location of the temporary site compound is proposed to be set back c. 30m from the south west corner of the bridge, as shown in Figure 3 1. The temporary compound shall be constructed with crushed rock aggregate hard standings with low dust content. Temporary facilities will be removed, and the lands reinstated upon completion of the construction phase.

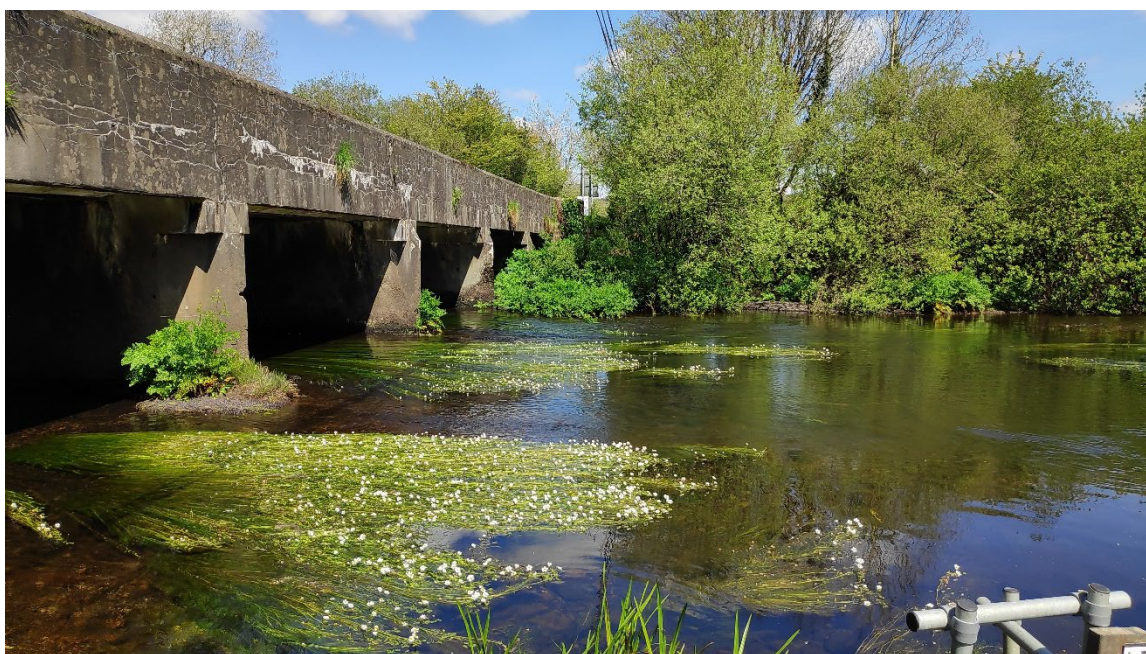
Plate 3.3 Representative image of site 3 at Ardcahan Bridge on the River Bandon near Dunmanway, Co. Cork

The bridge apron at Ardcahan was comprised mainly of a historical cobbled base with good moss and liverwort growth (*Fontanalis* and *Porella* spp.). Four of the seven arches contained flowing water while three had dry arches at the time of survey. Good salmonid nursery habitat was located in the fast-flowing water flowing over the cobbled bed of bridge abutments but limited pearl mussel habitat was present under the bridge structure. Ardcahan Bridge featured good fish passage with no evident obstructions. Several otter signs (i.e. spraints) were recorded under or in the vicinity of the bridge (see Table 3.4).

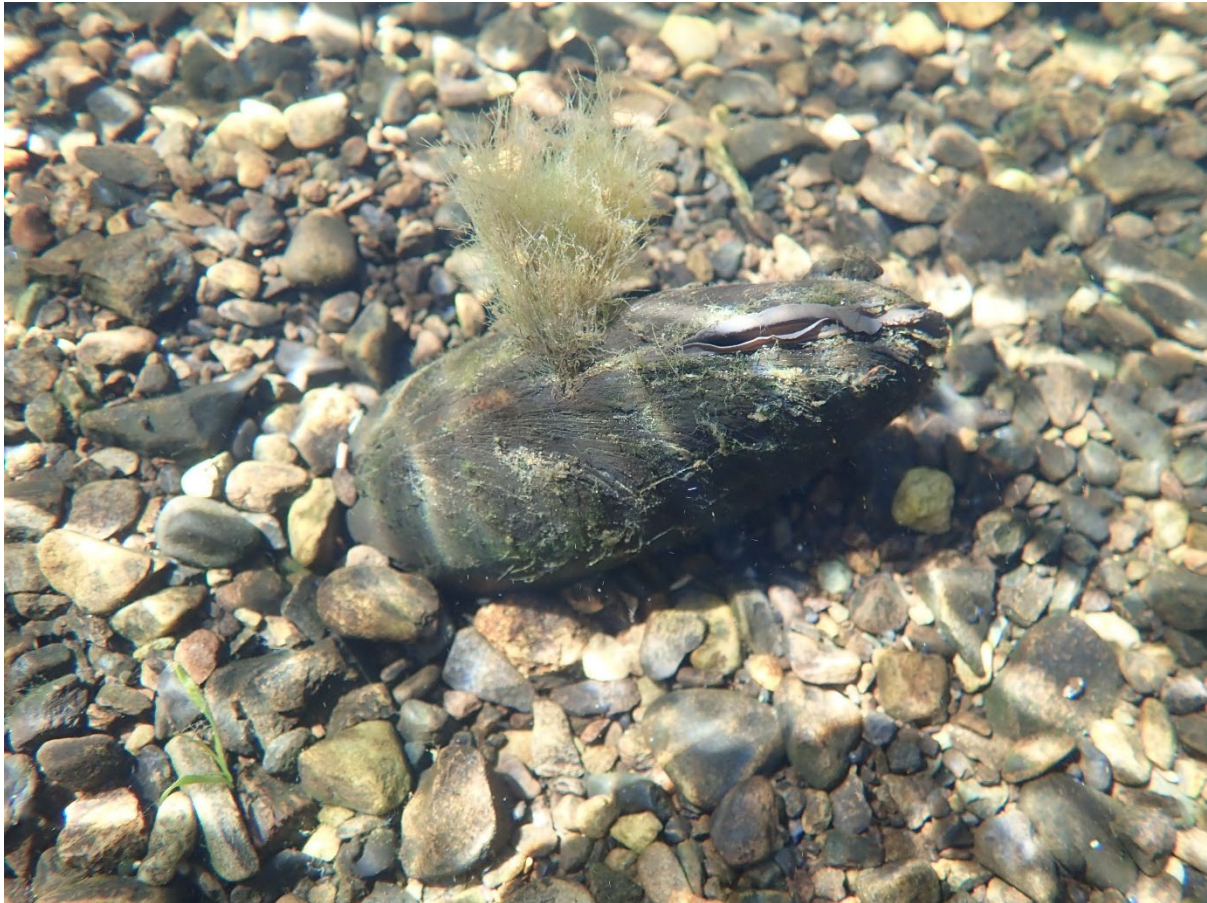
Plate 3.1 Adult pearl mussel present in semi-stable gravel and cobble matrix approx. 5m downstream of Ardcahan Bridge

Suitability for pearl mussel was good throughout much of Section B given the presence of unbedded yet stable cobbles. The higher flow rate helped keep the bed cleaner (despite some silt plumes underfoot) than downstream, slower-energy areas. A total of $n=87$ live and one dead mussel were recorded in Section B (Table 3.1).

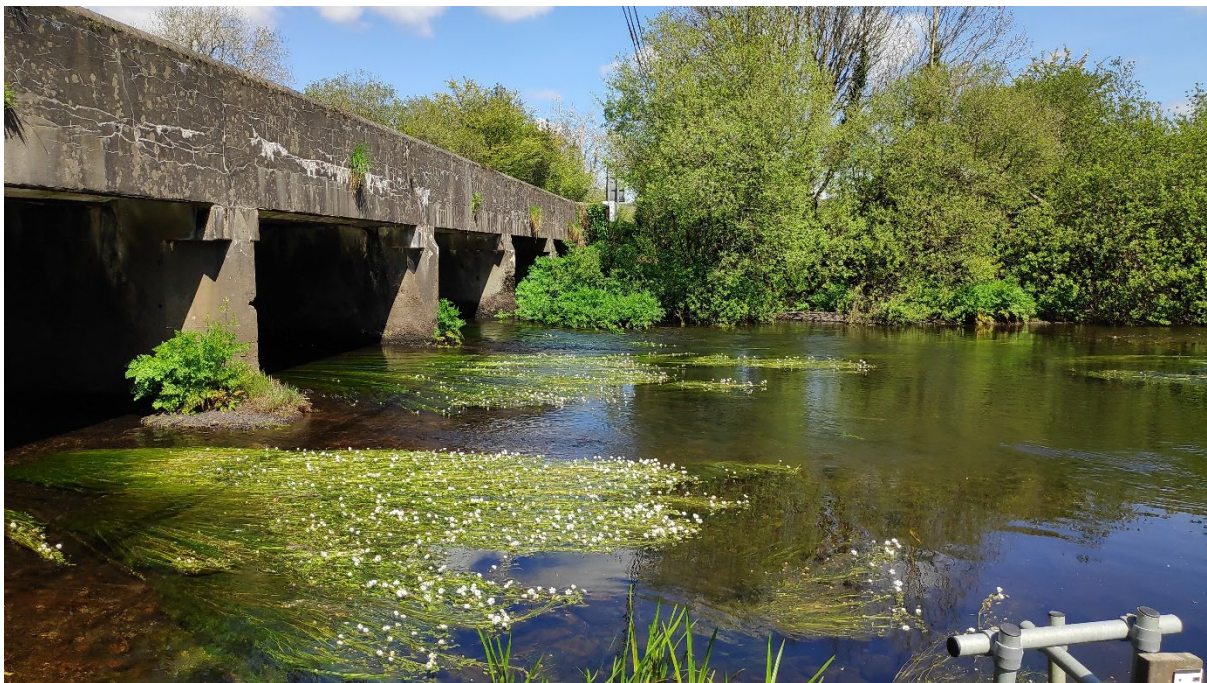
Plate 3.2 Section D immediately downstream of Ardcahan Bridge

Immediately downstream of Ardcahan Bridge the river featured a semi-natural profile, 25m wide and averaging 0.3-0.5m deep. Deeper pools to >1m were present locally. Fast riffle and shallow glide habitat predominated with extensive beds of stream water crowfoot covering 30-40% surface area. Siltation was heavy locally along the west bank of the River Bandon but largely confined to marginal pool areas where small clusters of mussels were living in very poor conditions (high algae and silt cover). Overall, the predominant cobble and coarse gravel substrata were of good quality in faster flowing glide and riffle areas (i.e. clean, unbedded) downstream of the bridge apron. However, relatively high filamentous algal cover was evident as per other downstream survey sections (approx. 40%). Localised beds of hemlock water dropwort (*Oenanthe crocata*) grew on gravel shoals. In deeper pool areas with silt deposition (south bank), small beds of branched bur-reed & water plantain were present. Some small patches of Canadian pondweed (*Elodea canadensis*) were present in marginal slacks which supported silt accumulations. The riparian zone was dominated by low lying grey willow vegetation which corresponds well to wet willow woodland habitat. Section B offered excellent nursery for juvenile salmonids. The evident proliferation of species such as minnow (*Phoxinus phoxinus*) and stone loach (*Barbatula barbatula*) is further indicative of nutrient enrichment (O’Brian et al., 2019).

Section D provided some good pearl mussel habitat and supported several clusters of pearl mussels, albeit sedimentation and enrichment were impacting the population (Table 3.1). A total of $n=92$ mussels were recorded. All were alive although approx. 20% were partially covered in sediment and or filamentous algae.

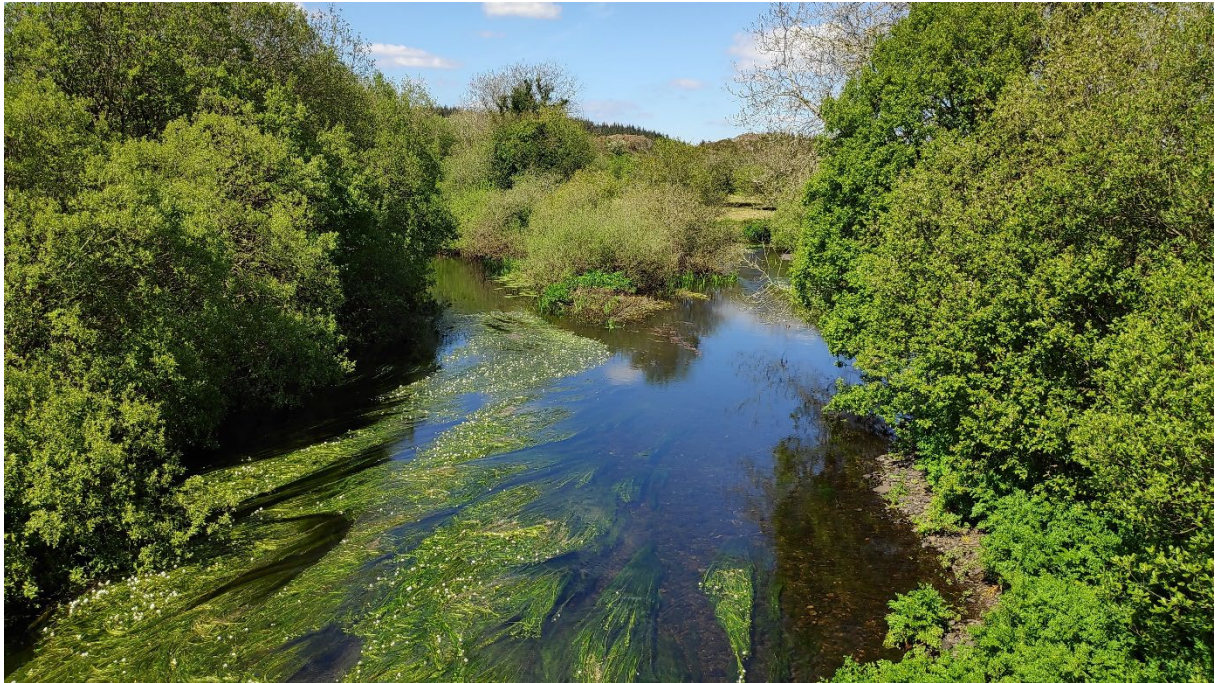
Plate 3.3 Section G upstream of Ardcahan Bridge (on left River Bandon, on right River Caha)

Section G the River Bandon retained a semi-natural profile (as downstream) in a 15-20m wide channel. Upstream of the Bandon-Caha confluence (approx. 35m upstream of Ardcahan Bridge), the respective river channels narrowed to 10-12m. The habitat was dominated by deep glide throughout (averaging 0.5-0.7m), with depths of >1.2m present in the Bandon channel upstream of the confluence. Localised pool was present also. Substrata comprised primarily small boulder and cobble with coarse gravels. Silt accumulations were more prevalent in the Bandon channel upstream of the confluence and at the confluence itself. Growth of macrophytes was relatively high and was dominated by stream water crowfoot (up to 40% surface area) with localised beds of hemlock water drop on exposed cobble shoals. Spiked water milfoil was present but rare and mixed with crowfoot vegetation. Localised broad-leaved pondweed (*Potamogeton natans*), water plantain and bog bean (*Menyanthes trifoliata*) were present at the river confluence. The Bandon channel also supported localised yellow lily and branched bur-reed upstream of the confluence. The channel was bordered by mature willow treelines with ash on both banks. The section offered some good salmonid nursery habitat but more so in the way of adult holding habitat.

Section G provided poorer pearl mussel habitat overall, which improved moving upstream into the Caha River. The majority of the pearl mussels recorded were along the west bank under crowfoot vegetation and or upstream of the Caha River confluence in shaded cobble and gravel. A total of $n=62$ live mussels were recorded, with five empty shells identified (Table 3.1).
