St. Colemans Church,

Macroom,
Co. Cork.

Structural and Condition report :

Macroom Church Of Ireland,

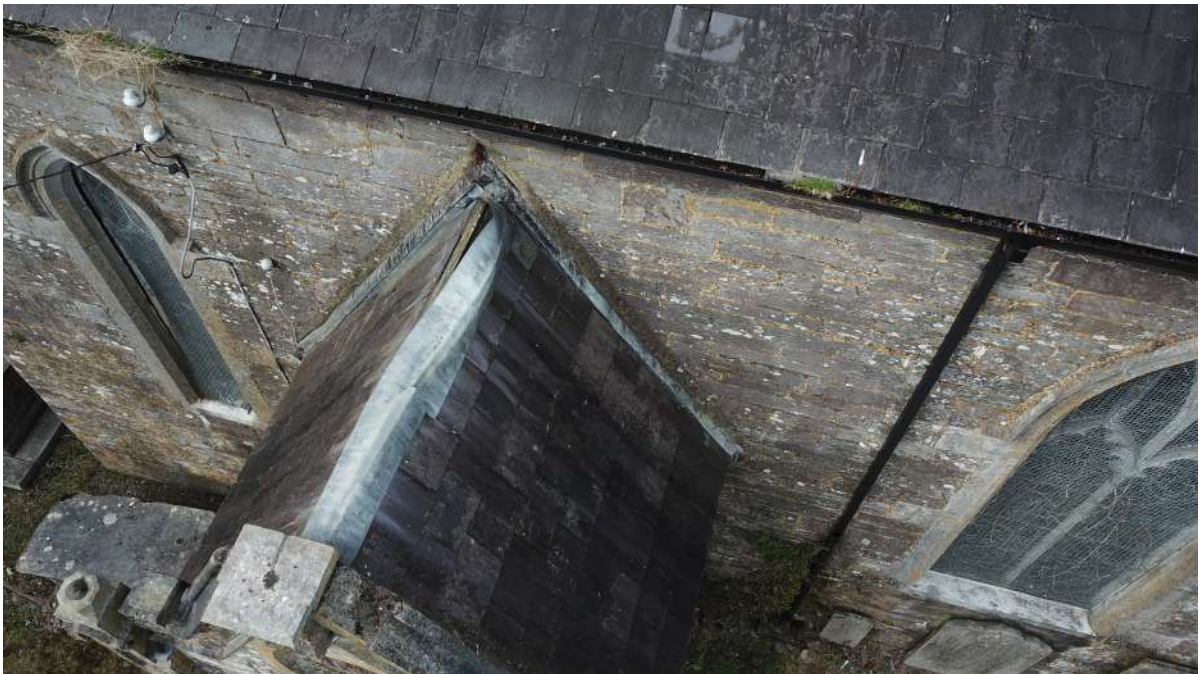
• Fig 19. Entrance porch roof.

Natural slates were used in the re-roofing and possibly an element of salvage of slates from the original roof. Slates appear basically sound across the roof generally, but there are certainly some slipped slates and some flashings in need of attention. Ridge flashings/ tiles to rear annex roof are missing and lead ridge flashing to entrance porch needs urgent attention.

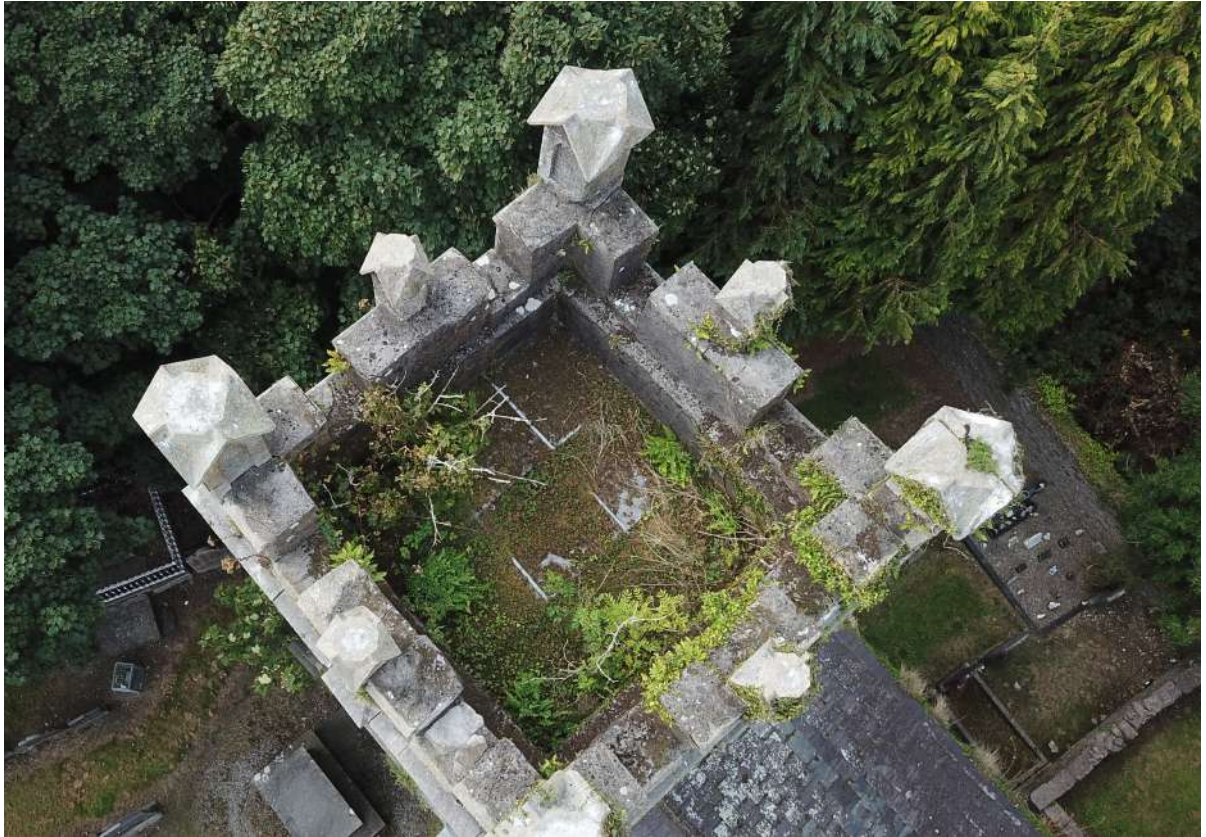
• Fig 24. Tower roof from above.

The roof of the tower of the Church also appears to have been addressed as part of the rest of the roof works. It looks like this may have had a lead roof repair at the time? Much sand cement mortar and render has been put on the upper level of the tower and it is possible that this may have been a part of creating a 'ring beam' to support the Castellations at the roof level.

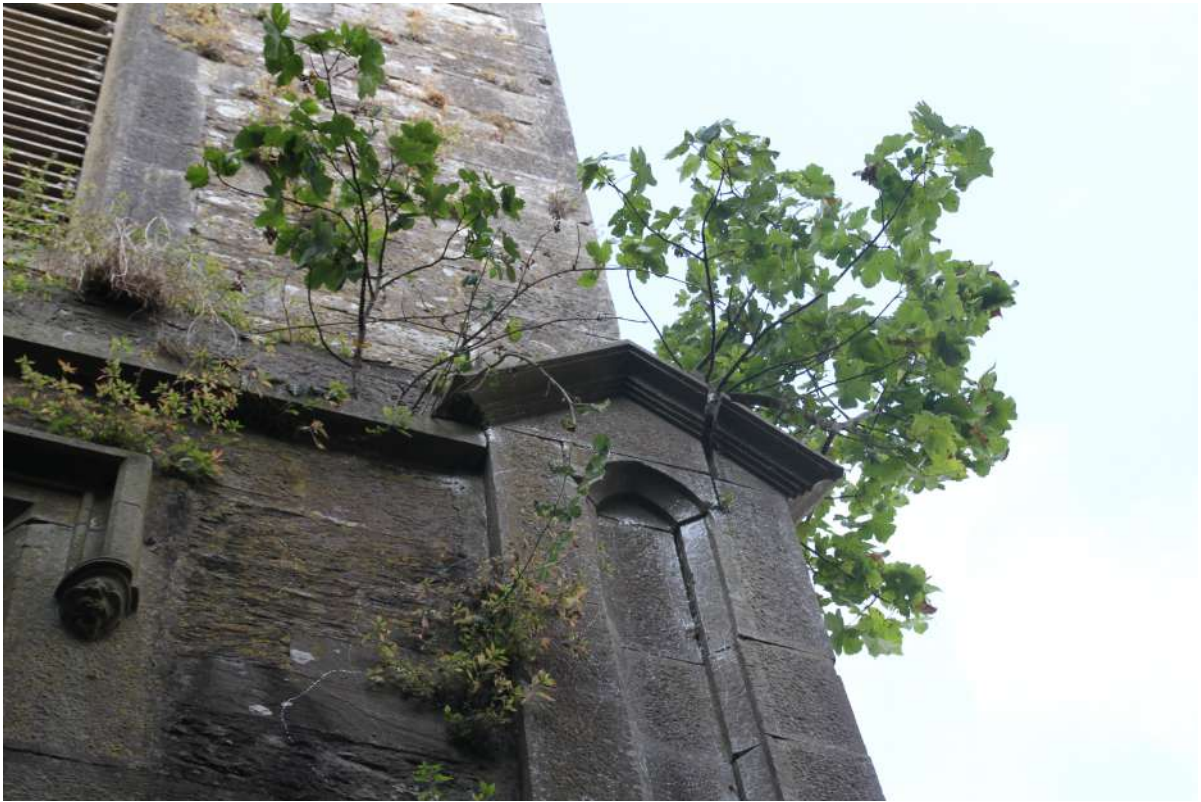
• Fig 27. Tower vegetation/ growth.

There are finely tooled limestone blocking buttresses to tower corners, having helmed coping and trefoil-headed panels. The level of growth in the tower indicates the amount of pointing required and moisture retention resulting from same.

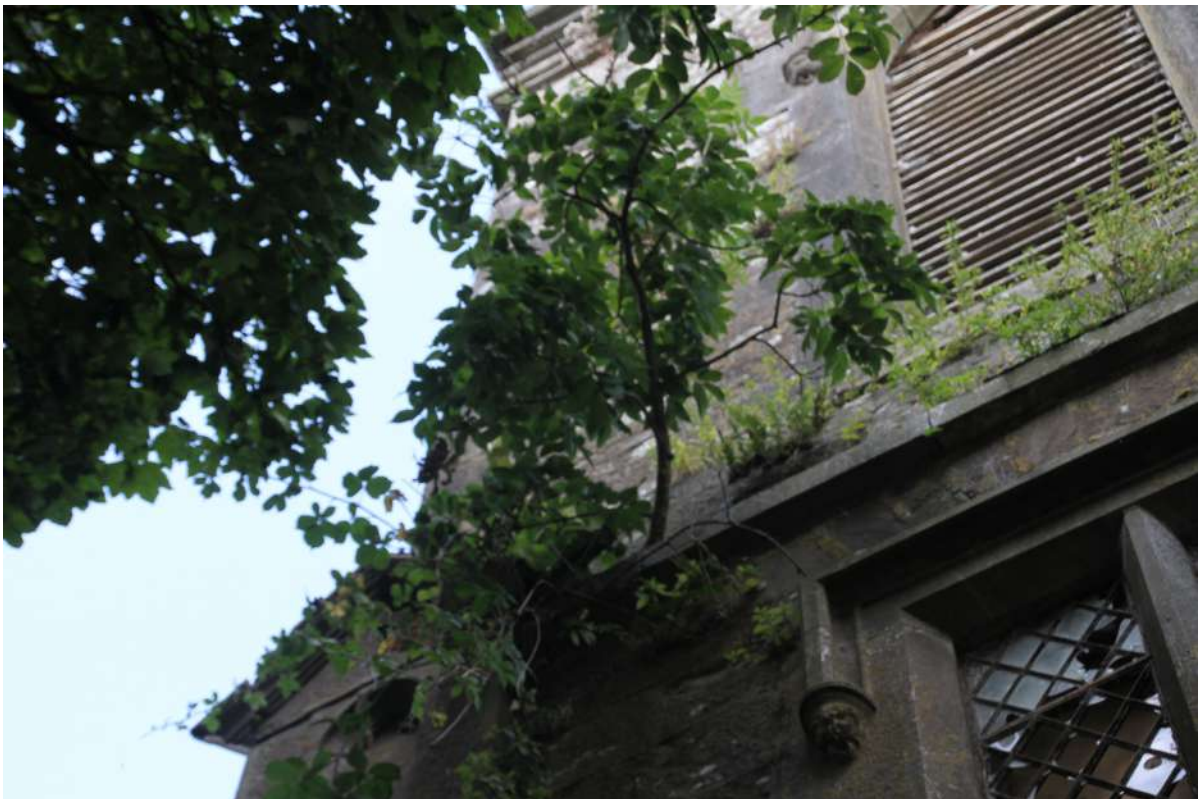
• Fig 28. Tower vegetation/ growth.

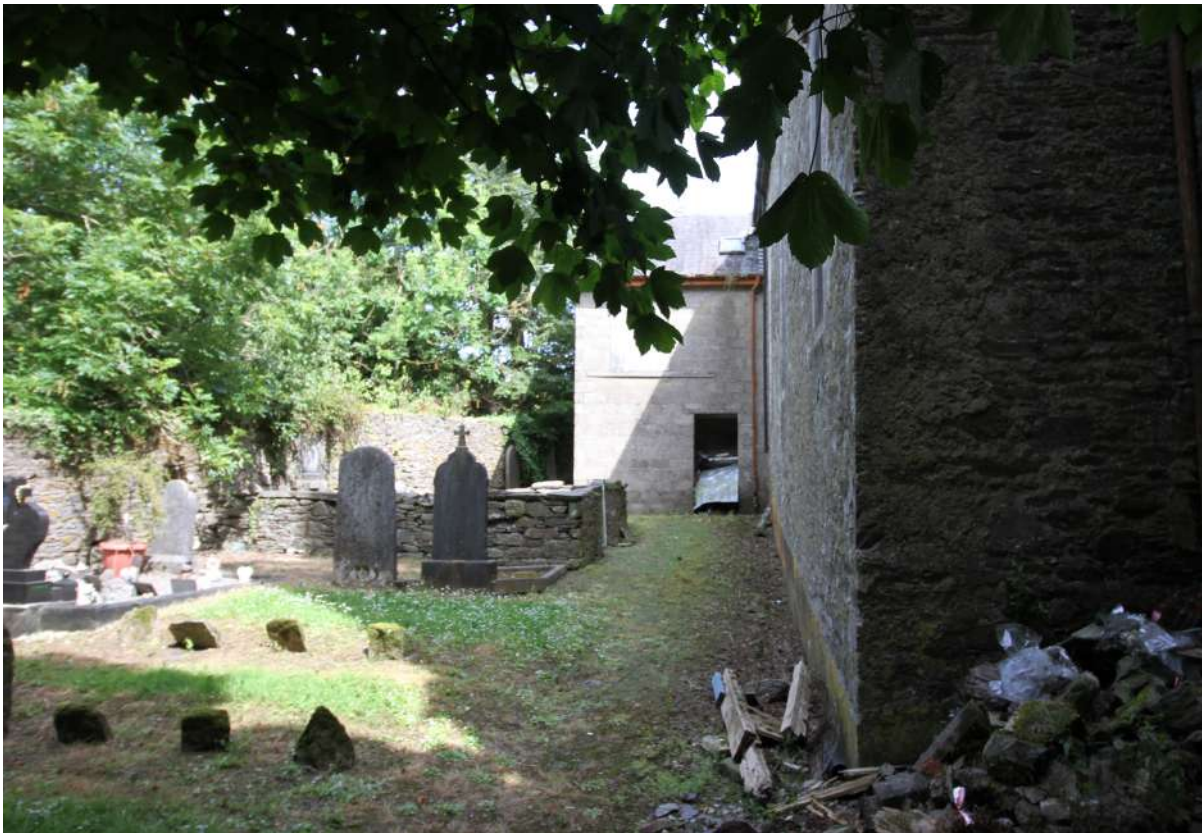
• Fig 31. Rear North elevation with partially completed annex ahead.

A concrete (cement based) plinth band has been introduced at the bottom of the rear (North) wall of the Church and may have been added relatively recently. This tends to make it harder for moisture travelling down the wall to escape, and has the opposite effect and drives rising dampness further up into the building. This should be removed in a few areas and wall examined behind. The objective should be its total removal.

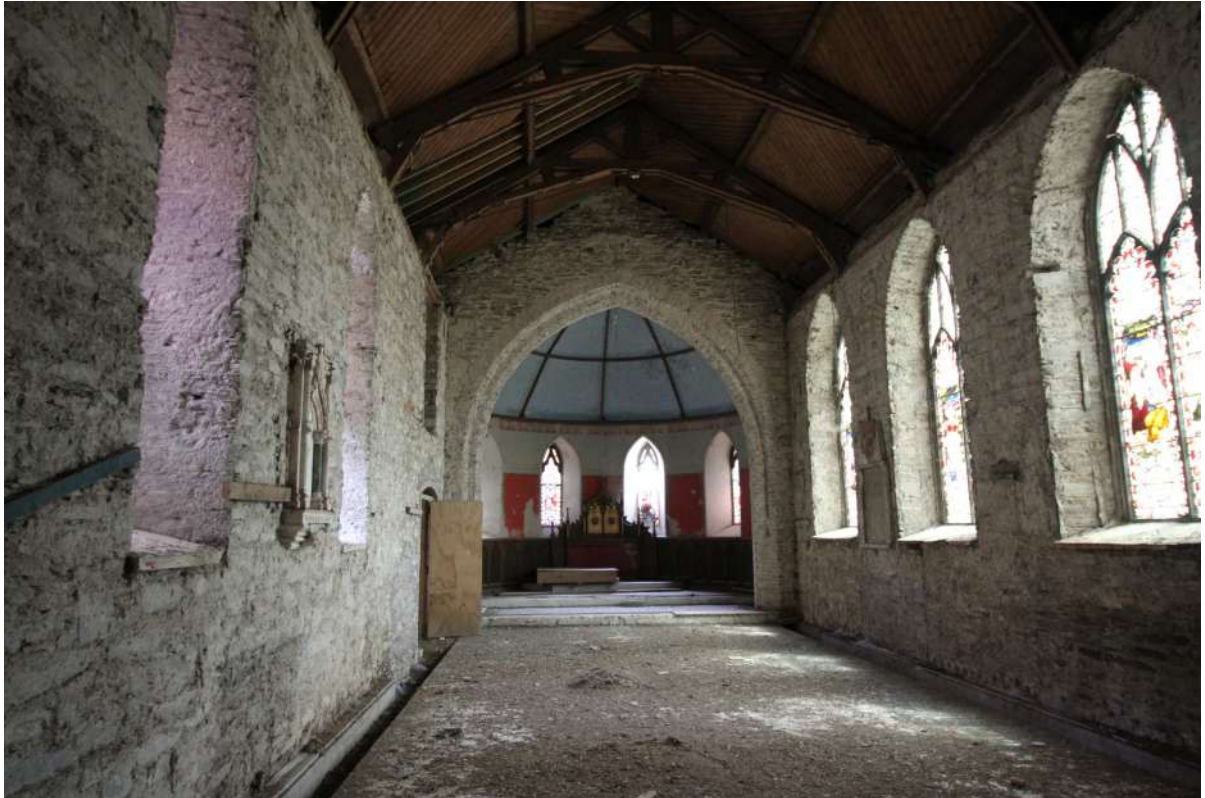
• Fig 40. Interior looking to Alter (East).

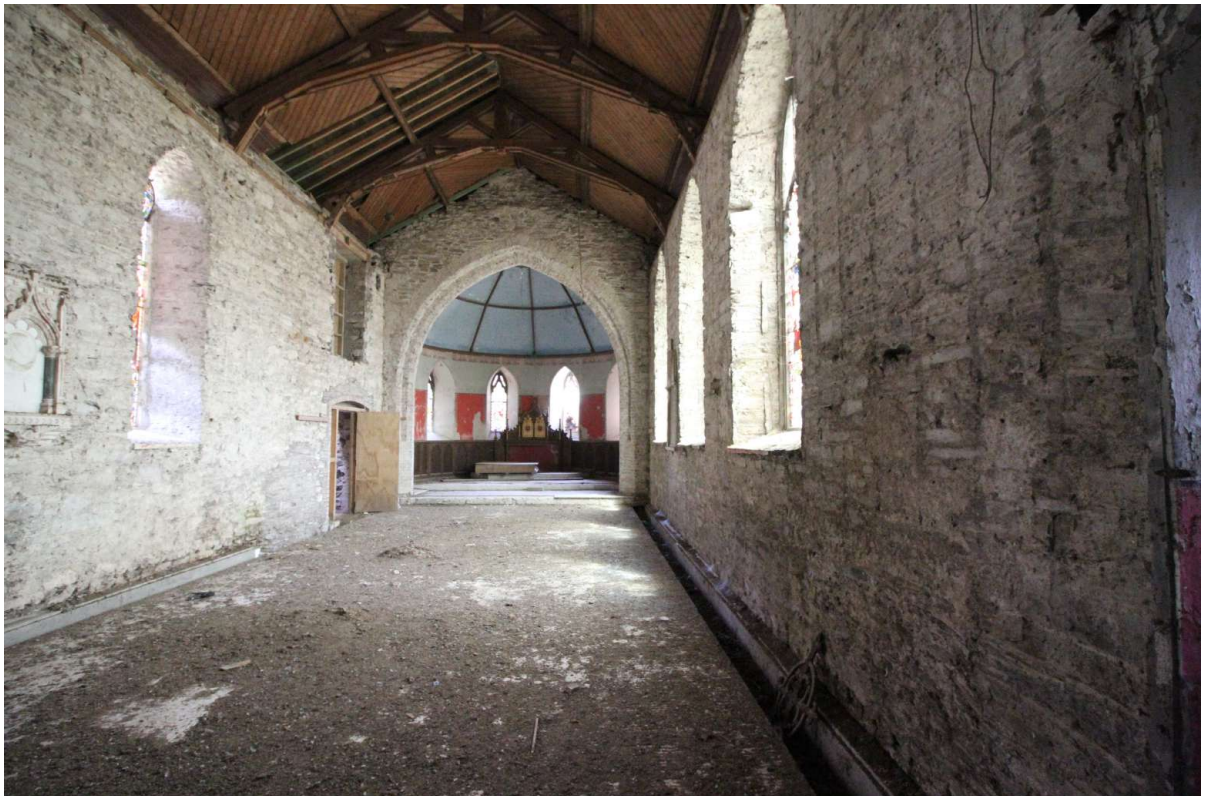
• Fig 41. Interior looking to Alter (East).

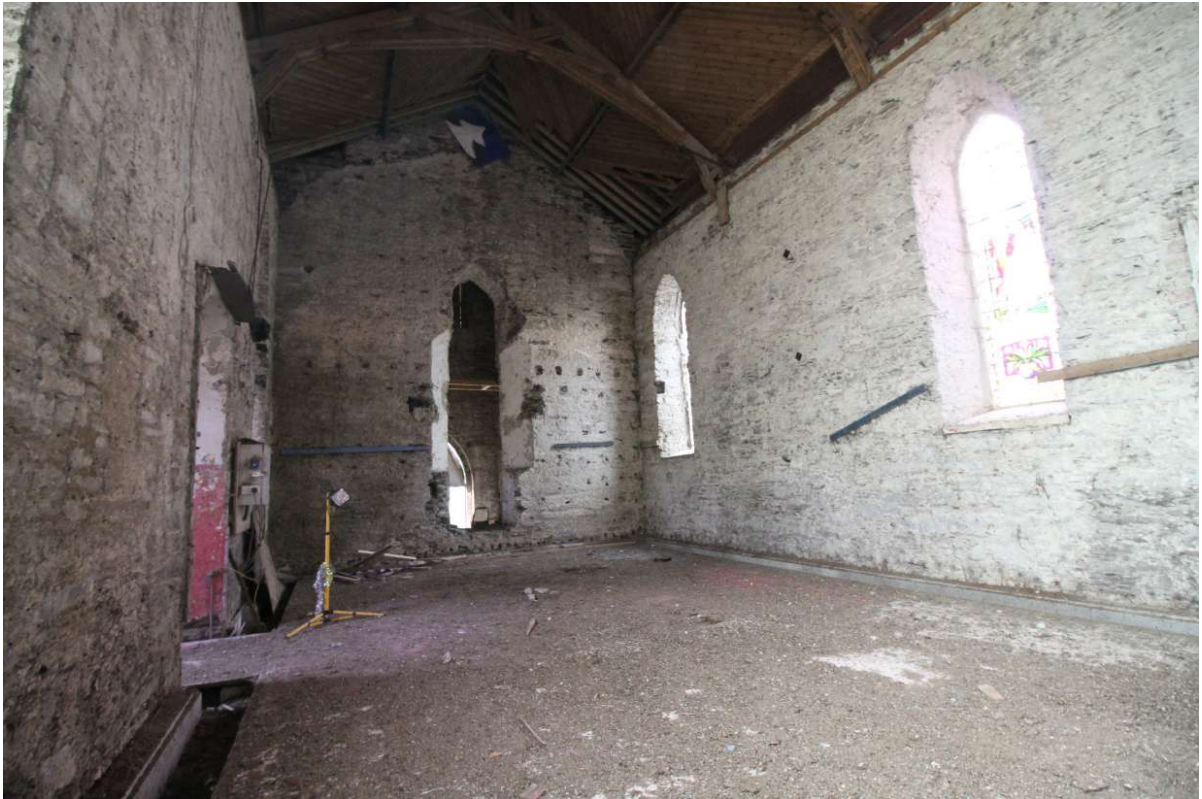
• Fig 42. Interior looking towards tower (West).

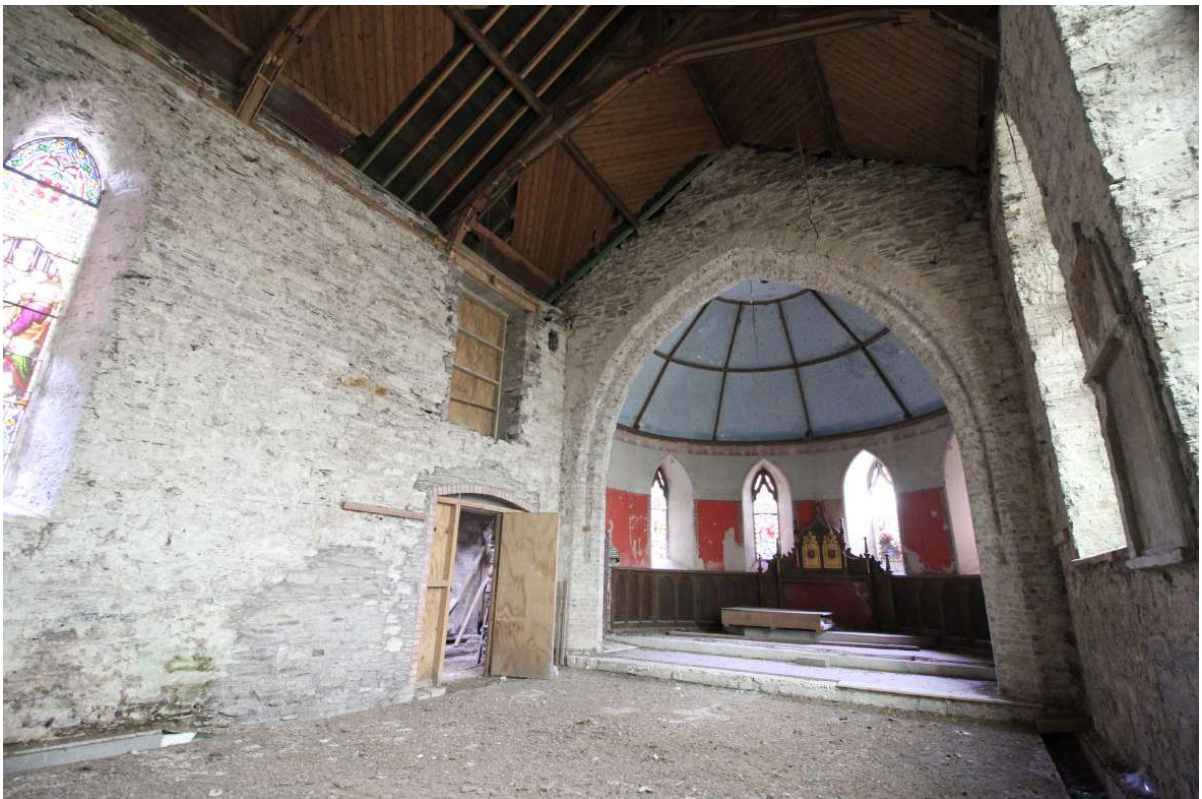
• Fig 43. Interior looking to Alter and new entrance made to link to rear annex, with mezzanine access above.

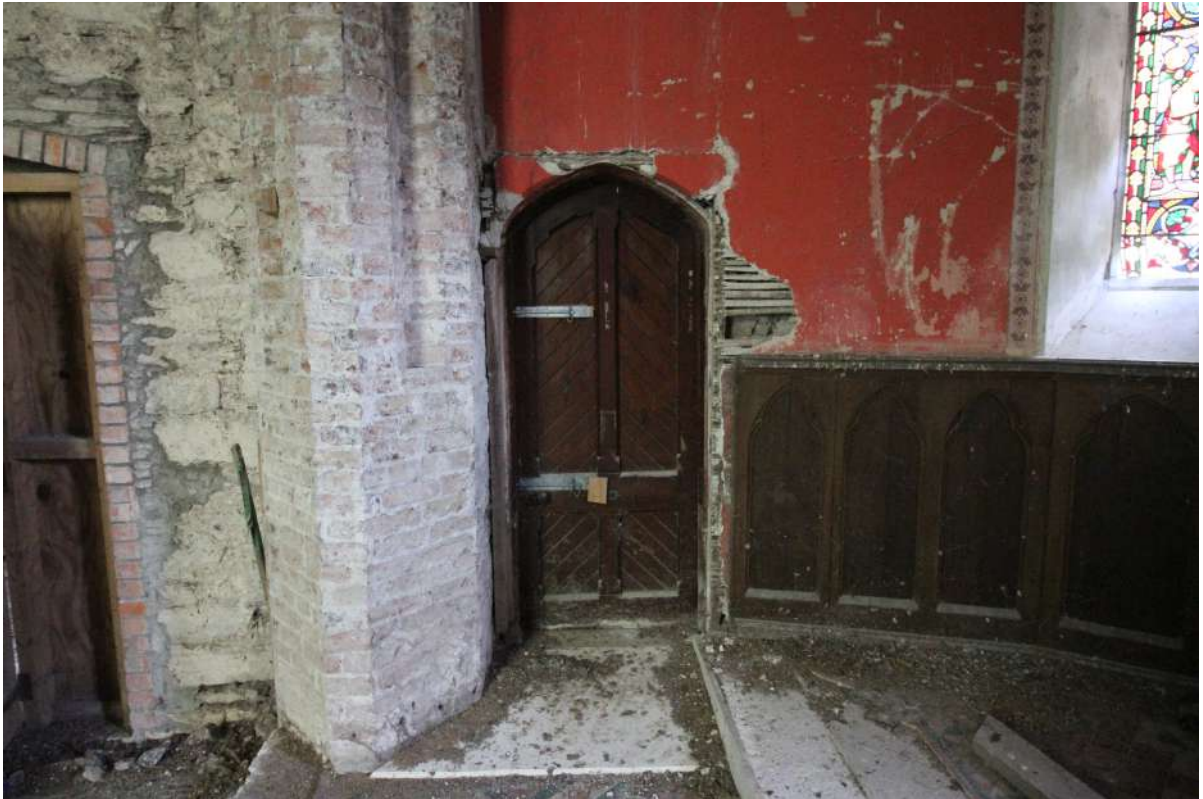
• Fig 44. View from Alter to door original lobby to Sacristy. Now access to annex.

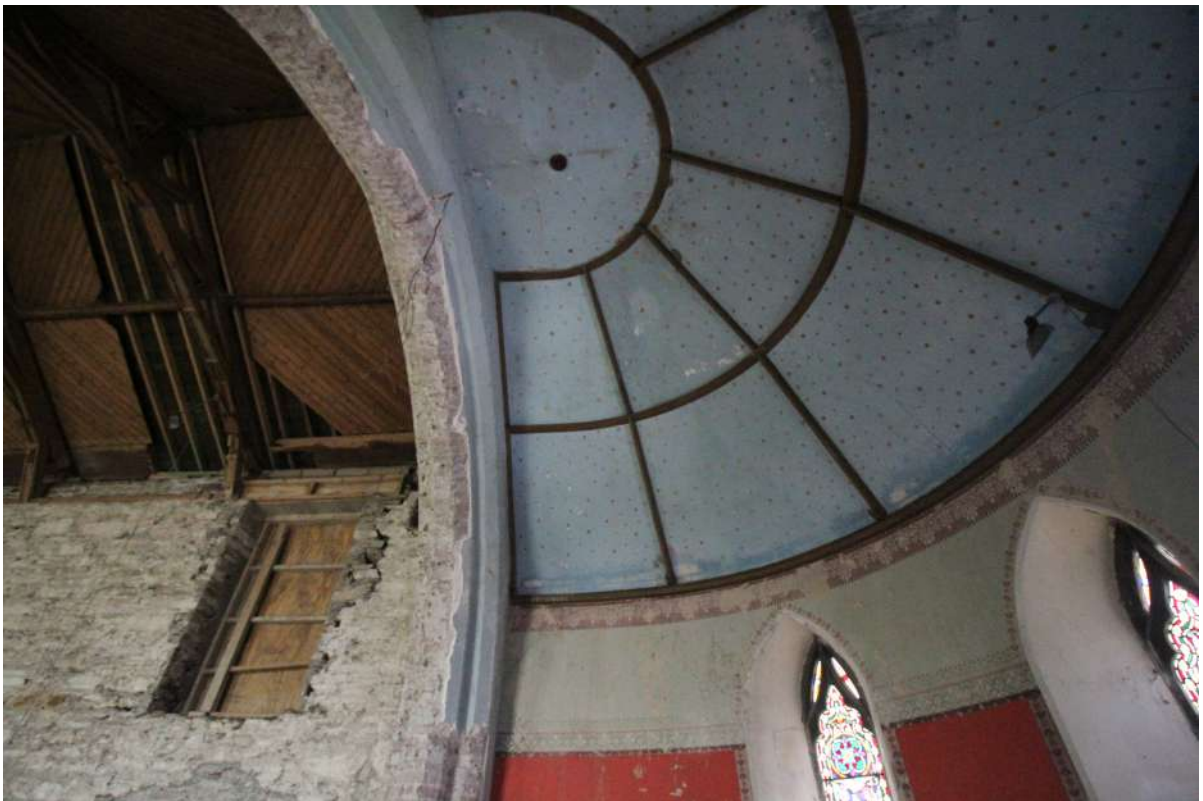
• Fig 45. View above same location as above (fig 44).

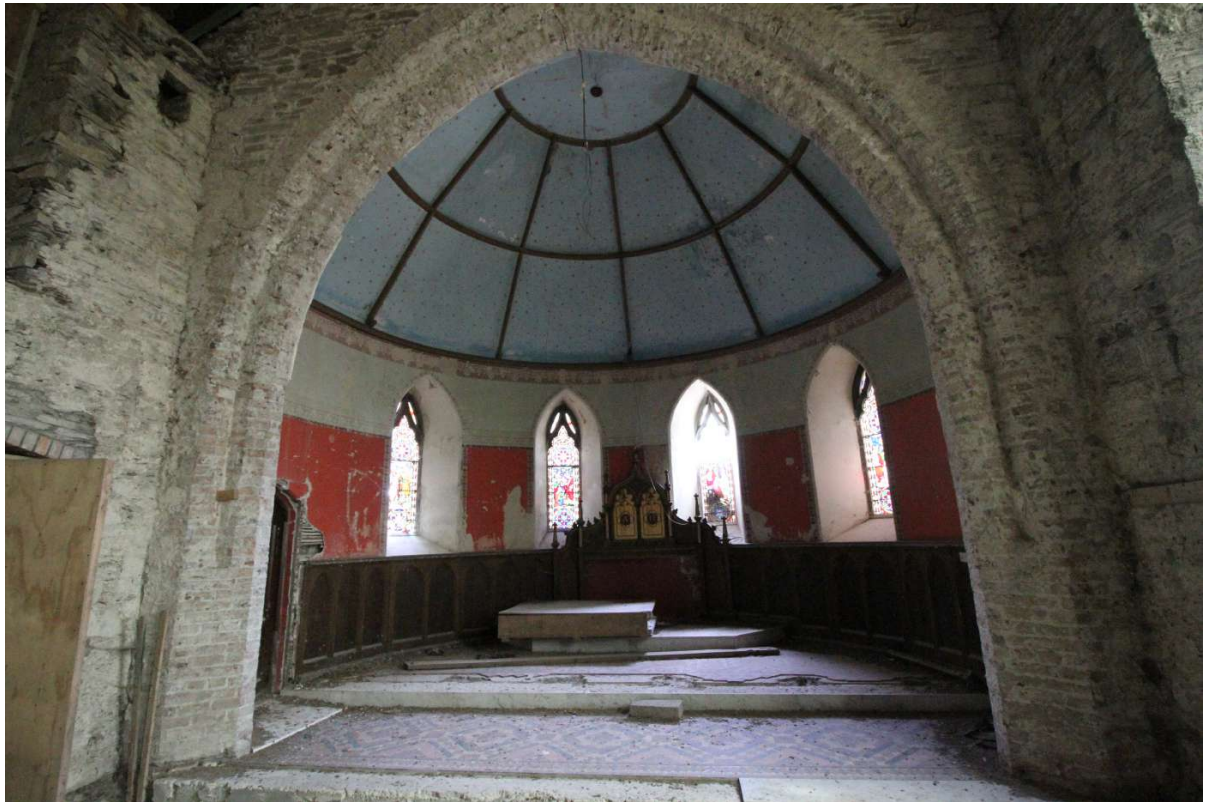
• Fig 46. View towards altar.

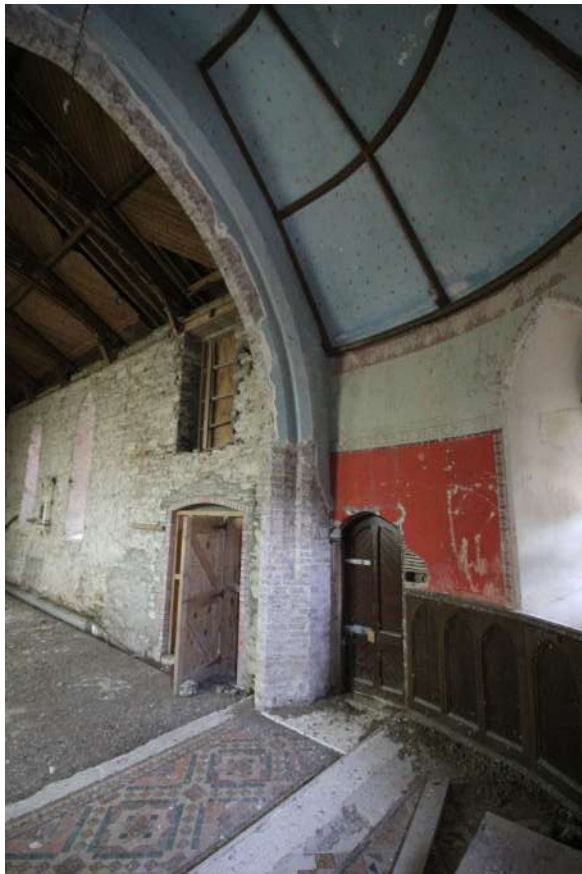
• Fig 47. Access to Annex from altar.

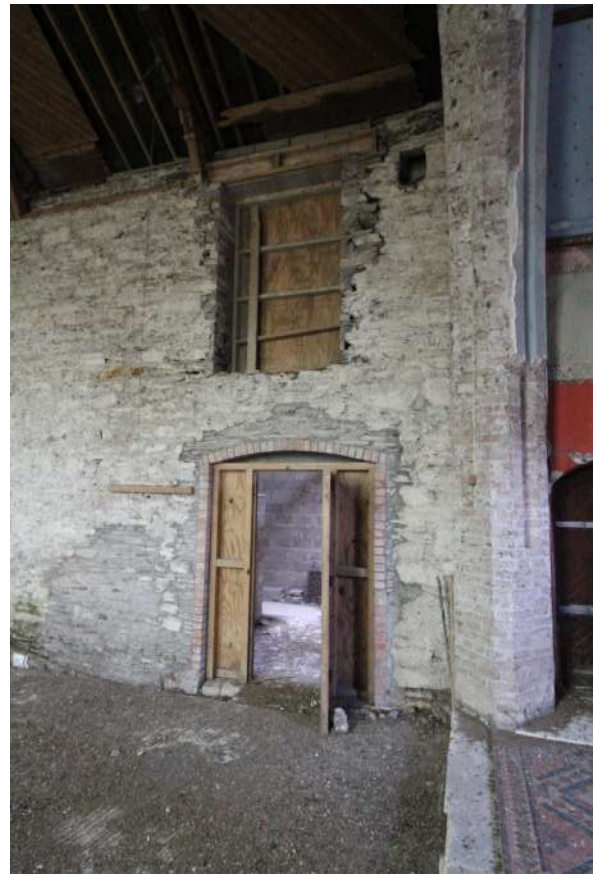
• Fig 48. Access to Annex from in front of altar.

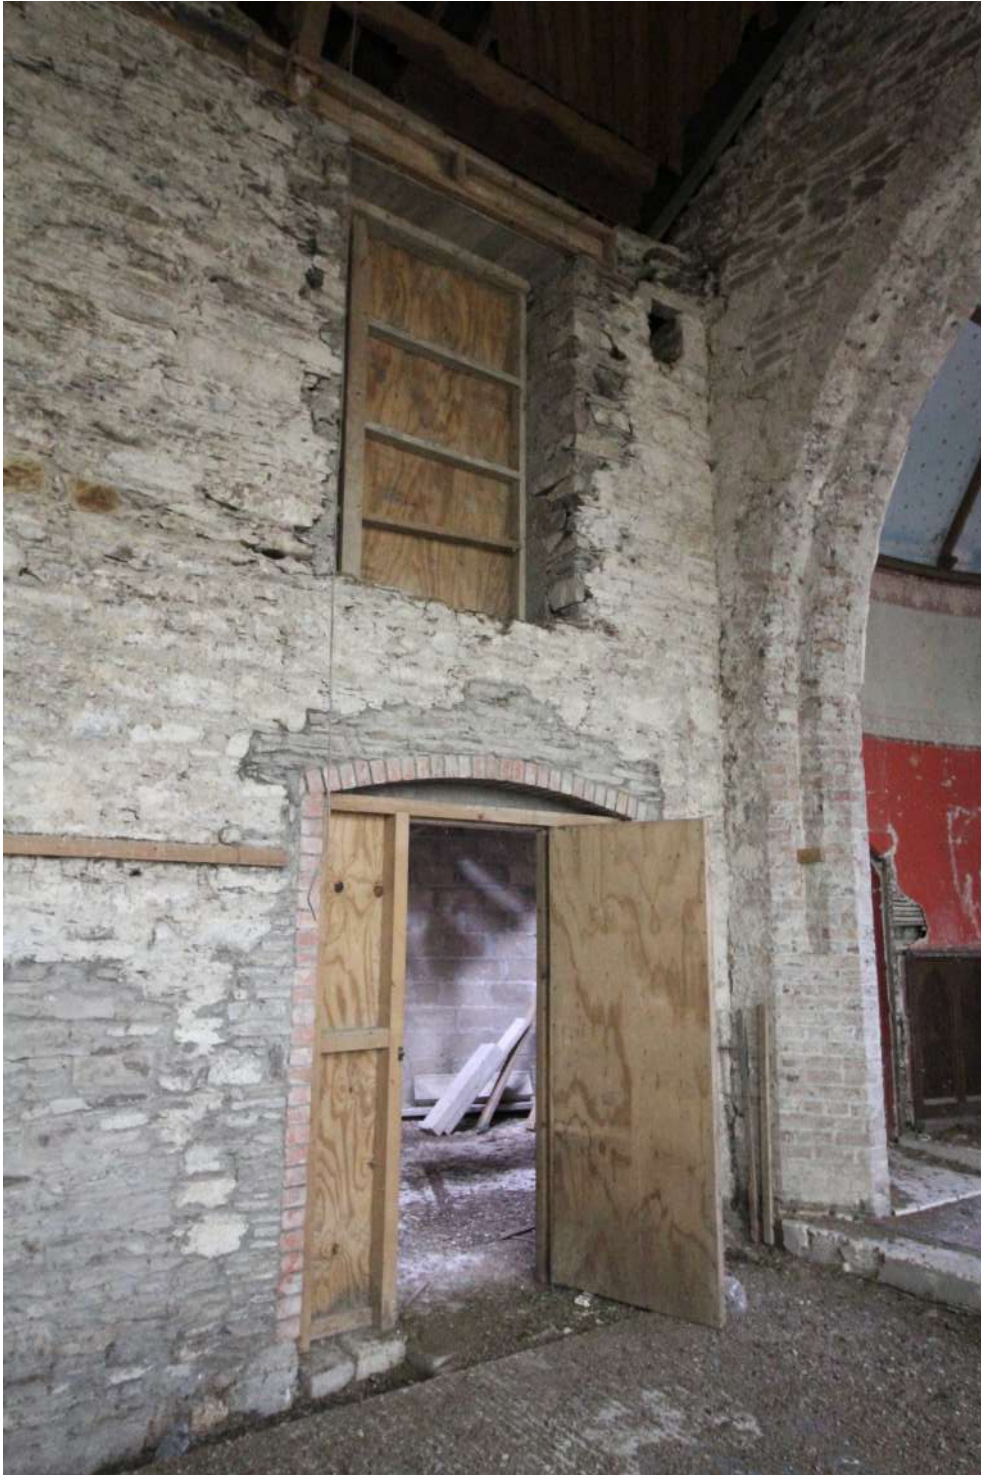
• Fig 49. New opes formed in North wall forming access to Annex.

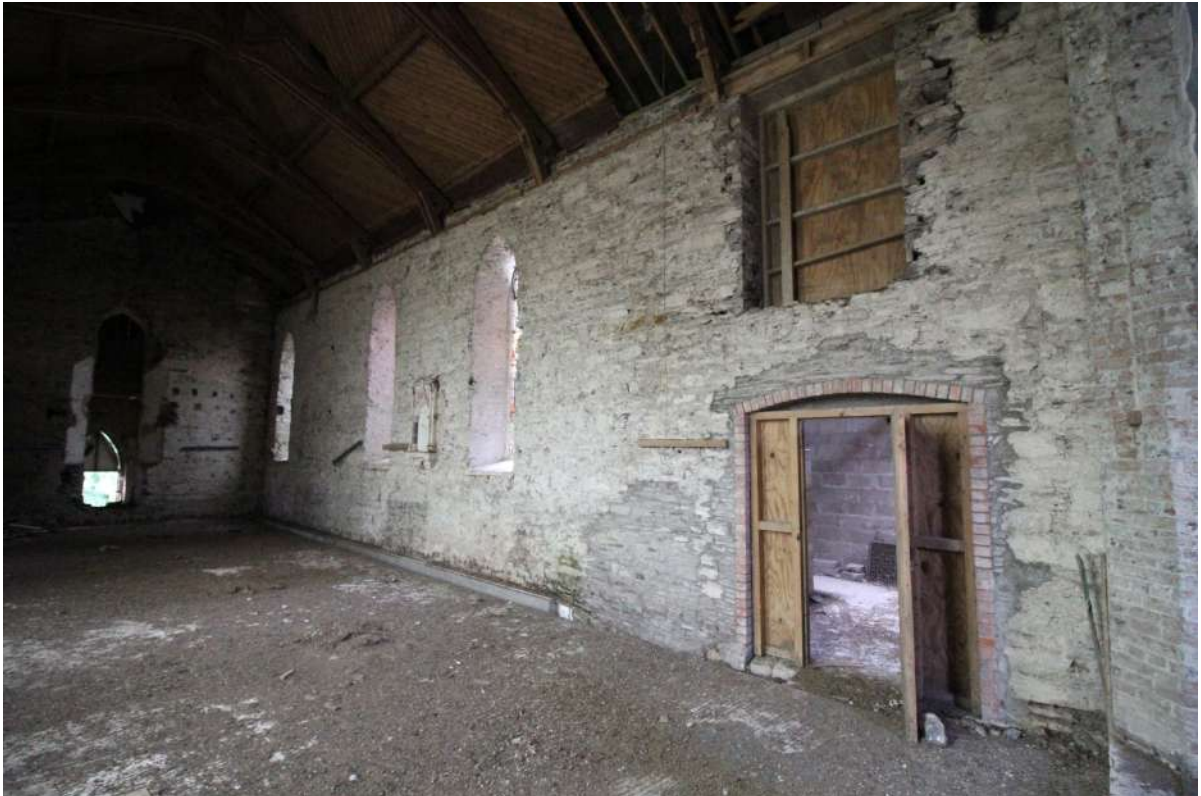
• Fig 50. Inner North wall with stripped plaster and new opes.

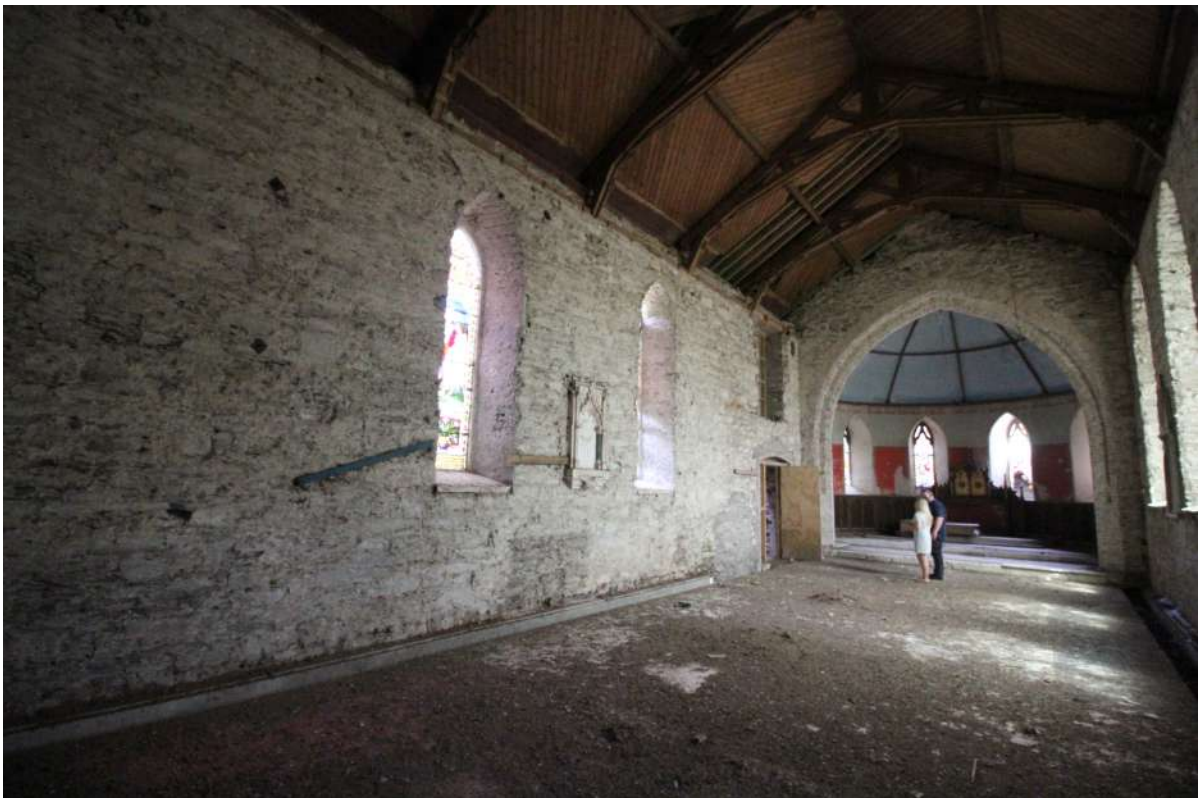
• Fig 51. Inner North wall with stripped plaster and new opes.

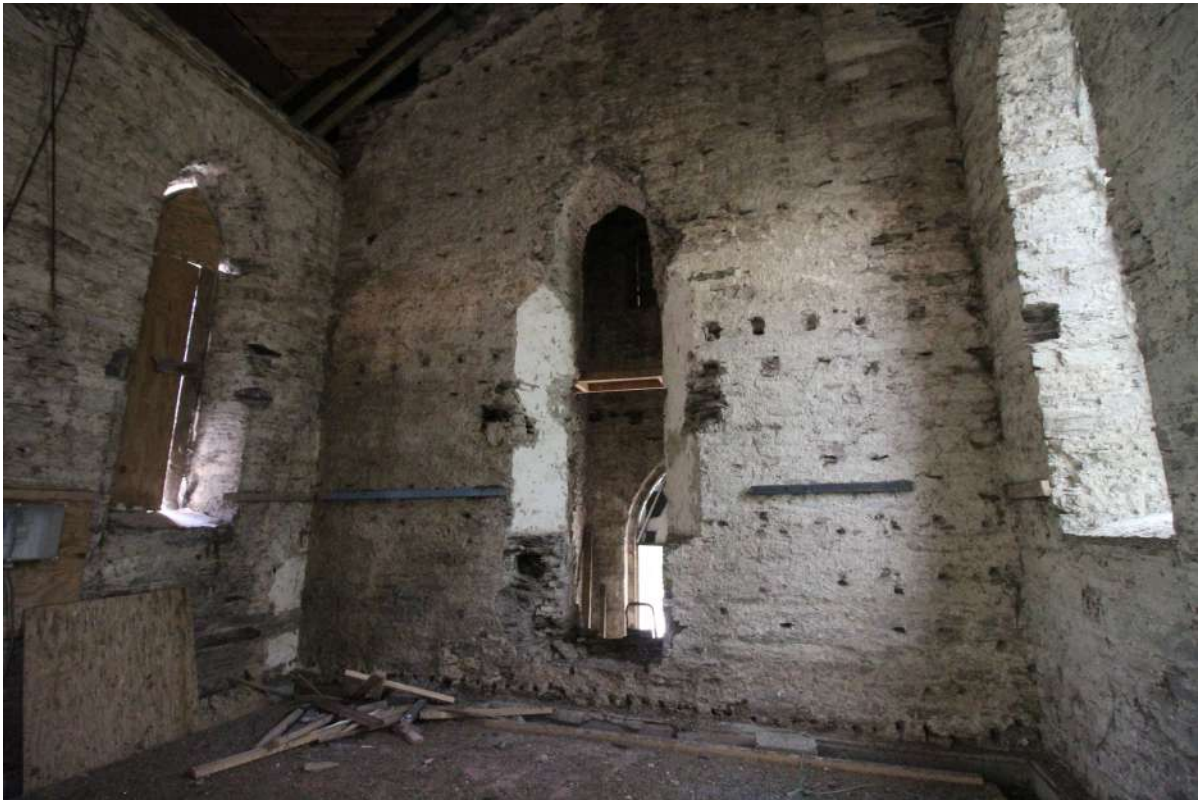
• Fig 52. Rear Western wall in church with access to tower.

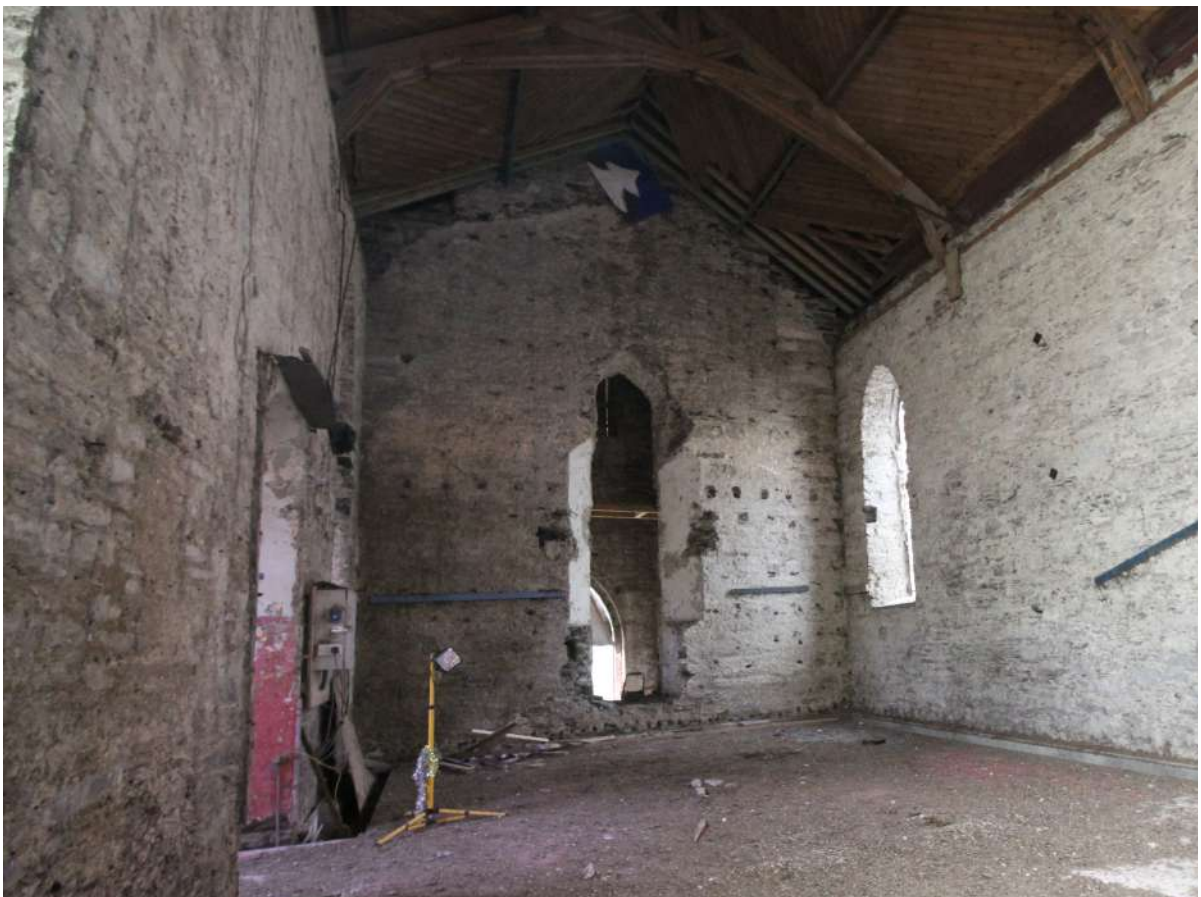
• Fig 53. Rear Western wall in church with access to tower, and front entrance on left.

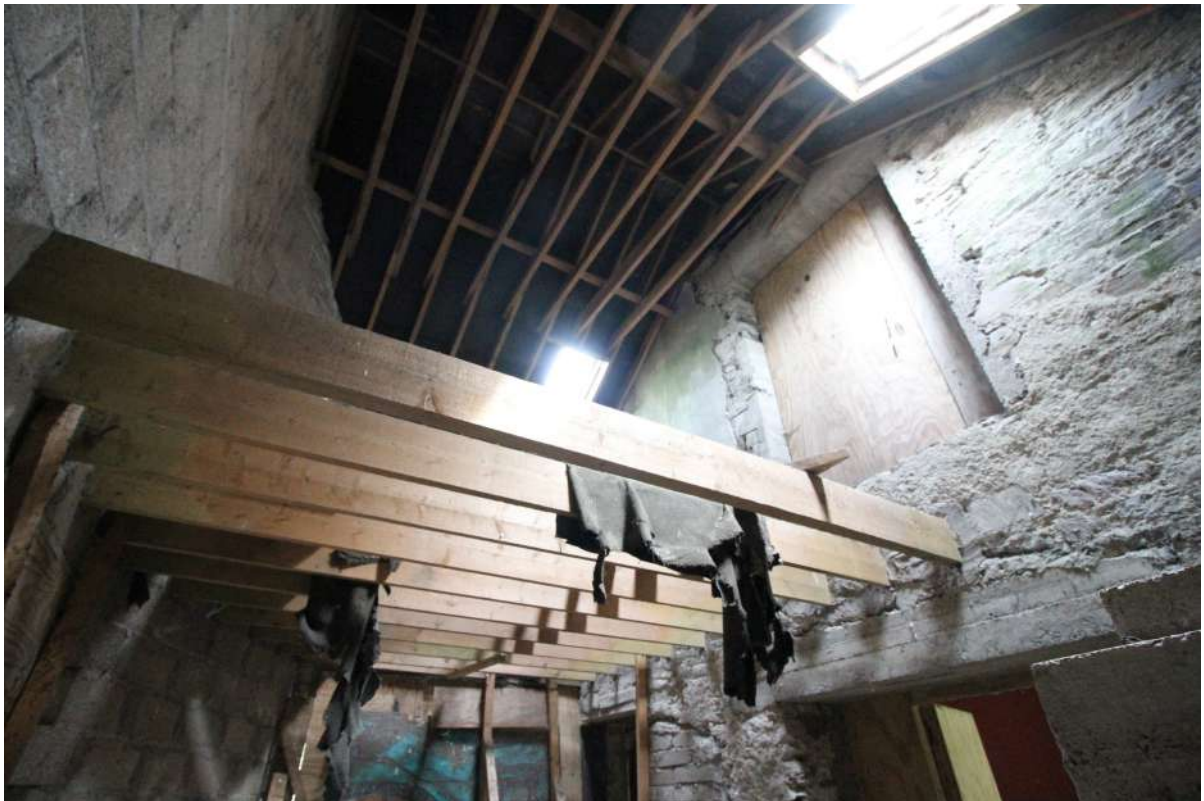
• Fig 54. Partially completed Annex building with mezzanine access landing.

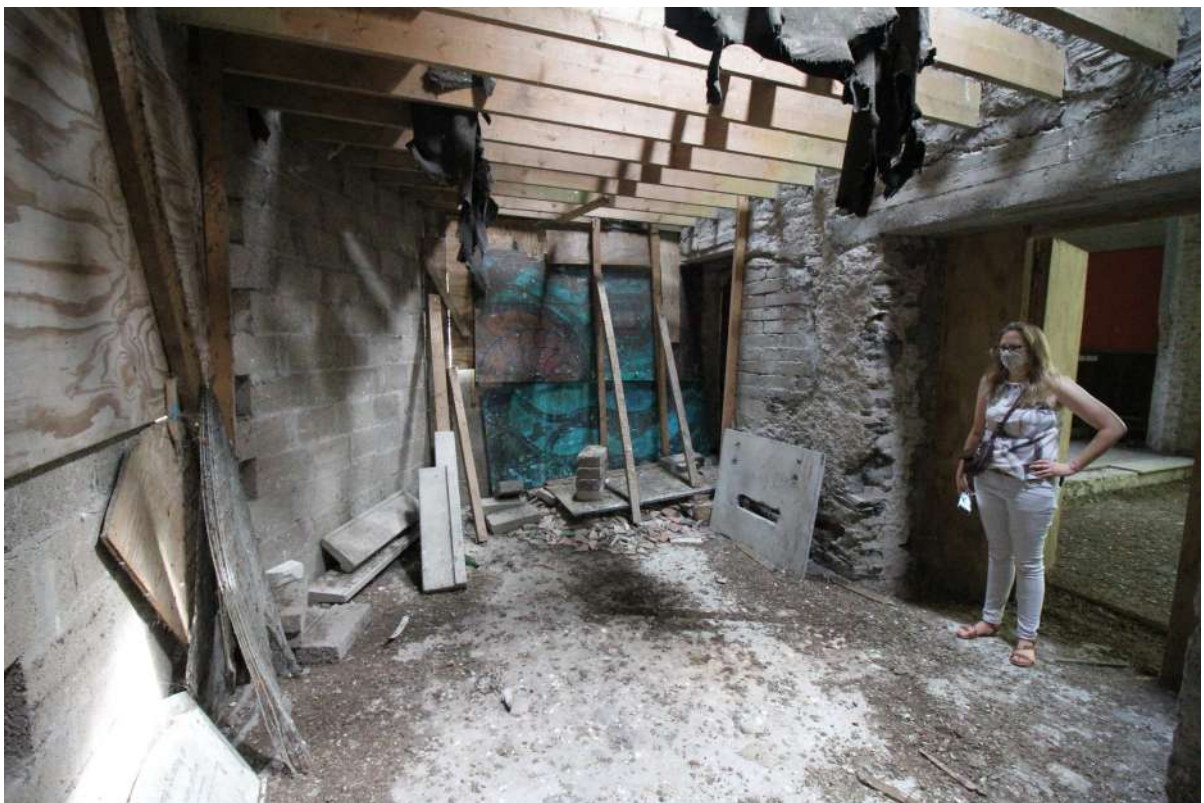
• Fig 54. Partially completed Annex building looking East.

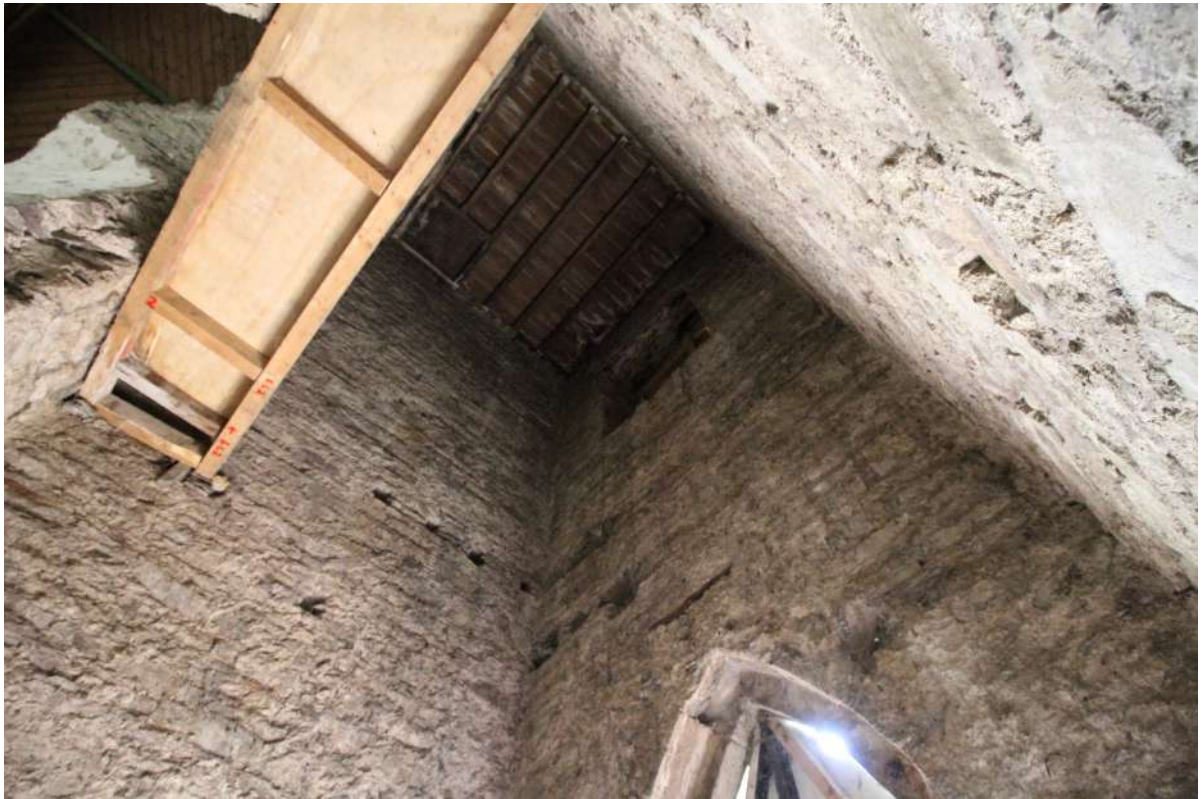
• Fig 55. View up inside tower.

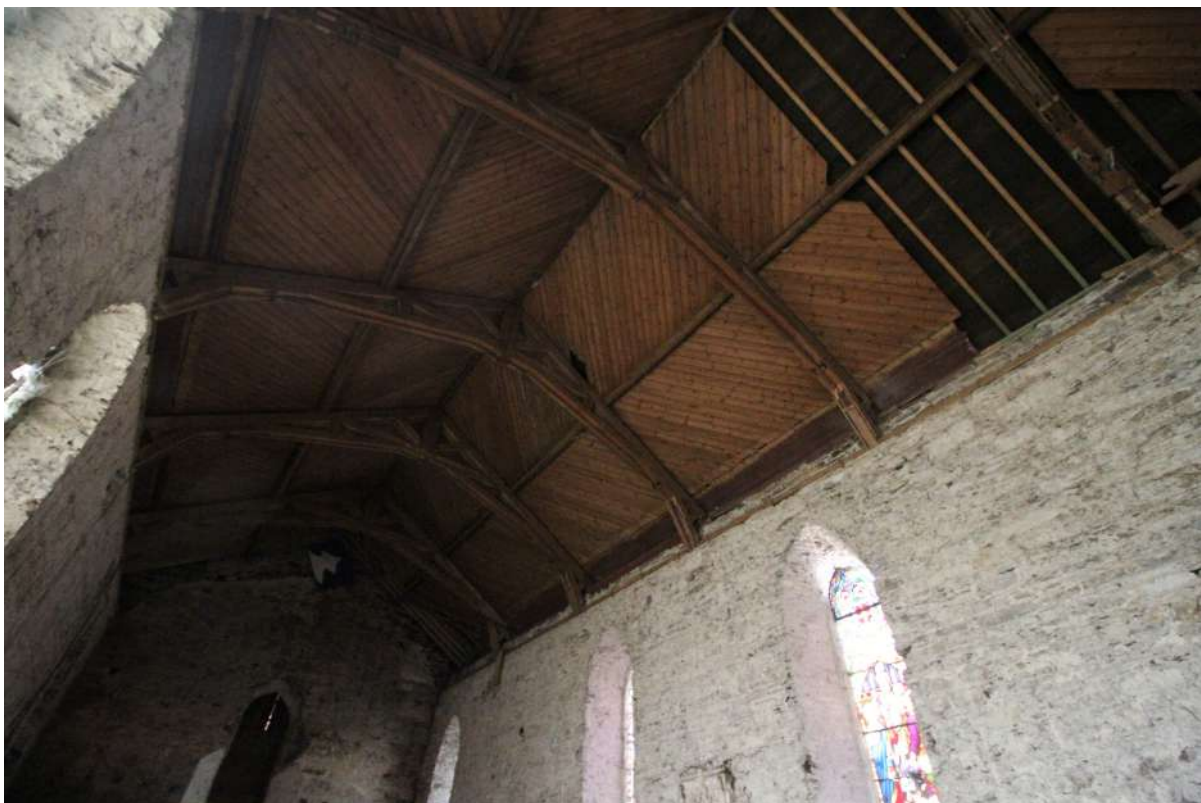
• Fig 56. Panelled ceiling and exposed roof trusses.

Roof/ Ceiling: The roof trusses will need closer inspection once access can be arranged. The unusual structure of the trusses is to the original Design, indicated in sketch (RCB Library) from c1868
