St. Colemans Church,

Macroom,
Co. Cork.

Structural and Condition report :

Macroom Church Of Ireland,

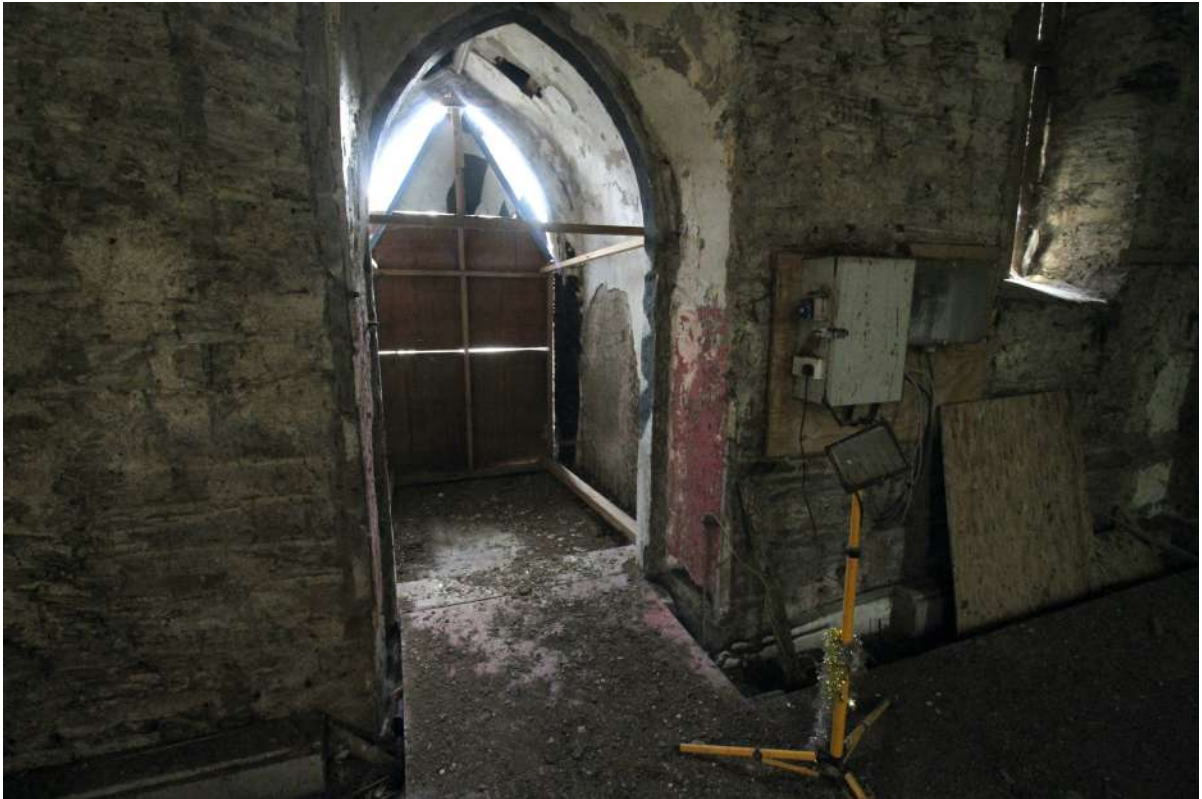
• Fig 57. Looking South through entrance lobby.

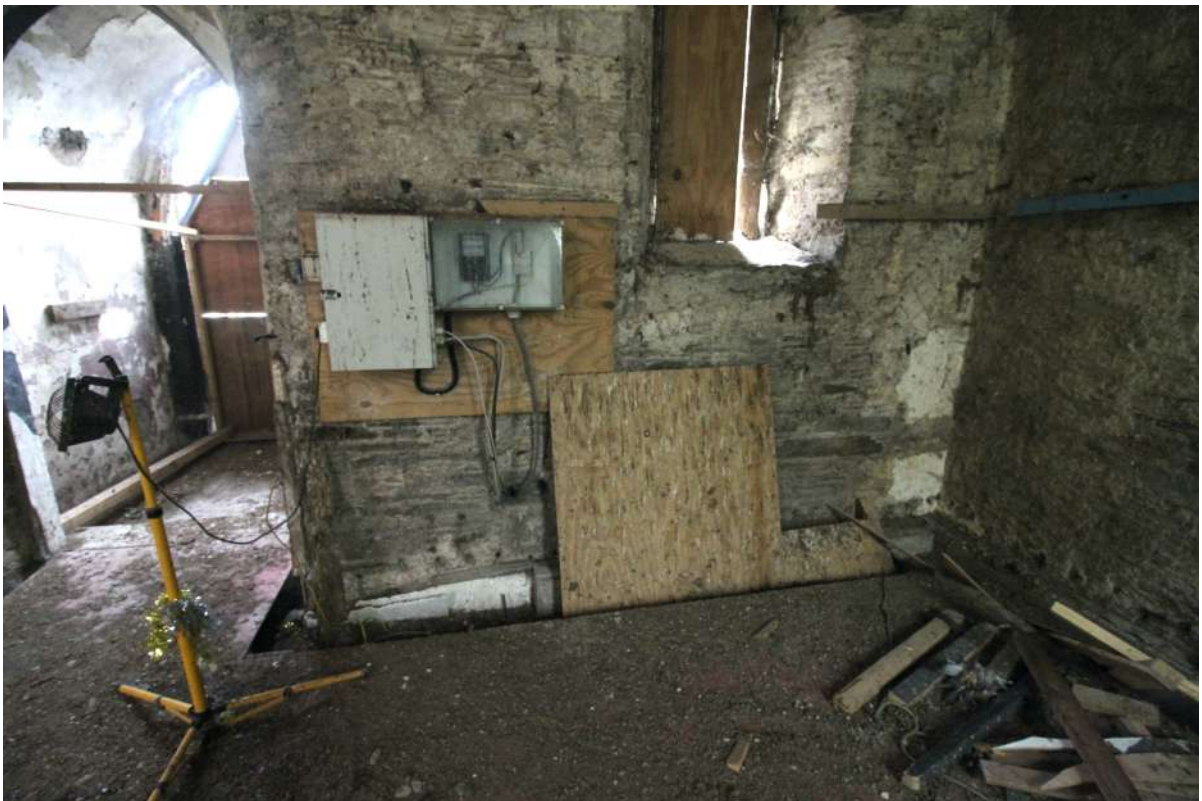
• Fig 58. Looking South alongside entrance lobby, with temporary ESB supply panel.

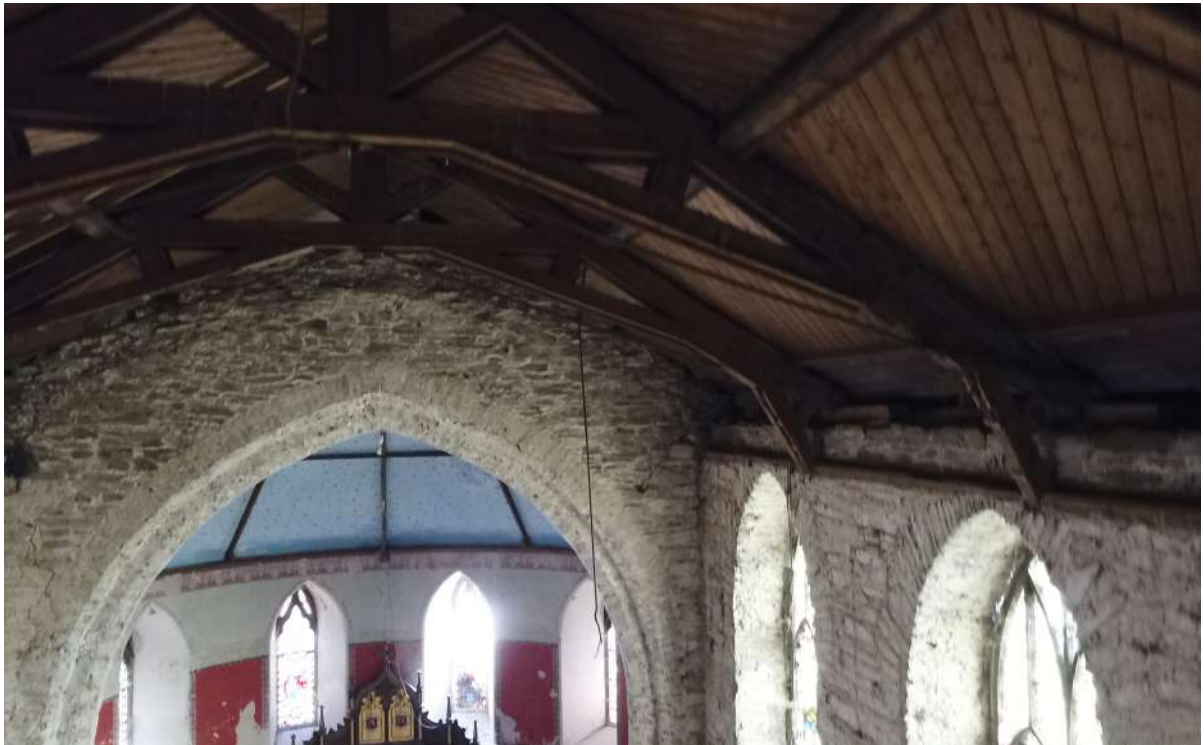
• Fig 59. Roof underside and arch over altar.

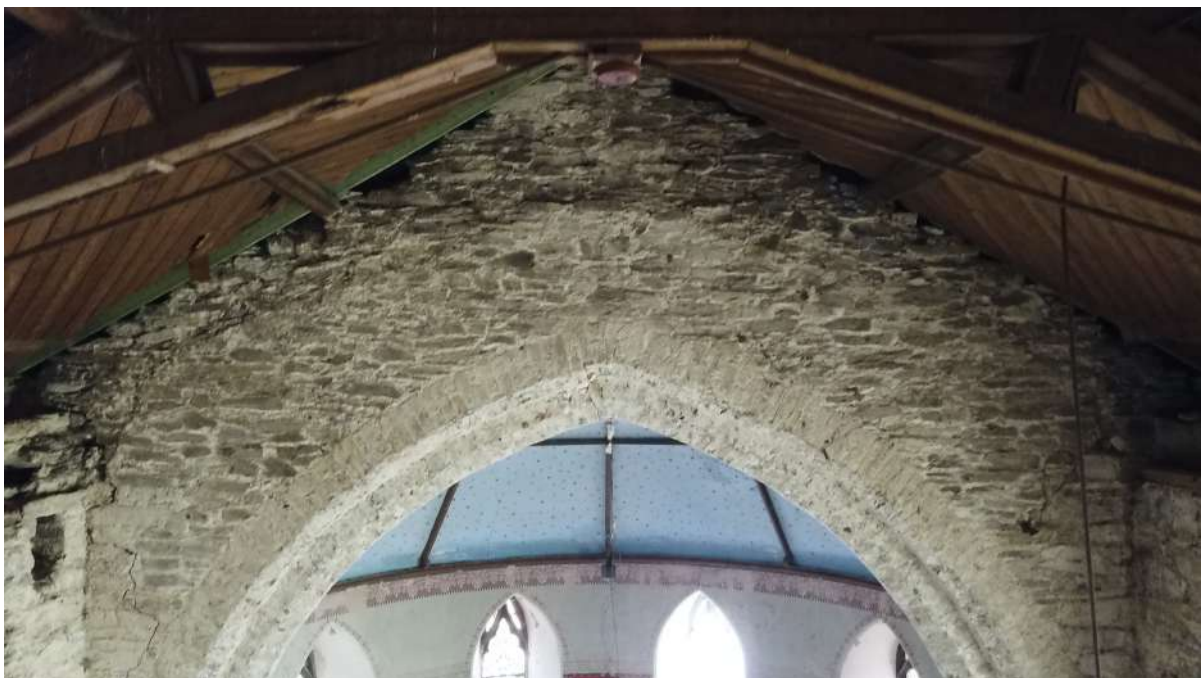
• Fig 60. Roof underside and arch over altar, with signs of movement to left and mid span.

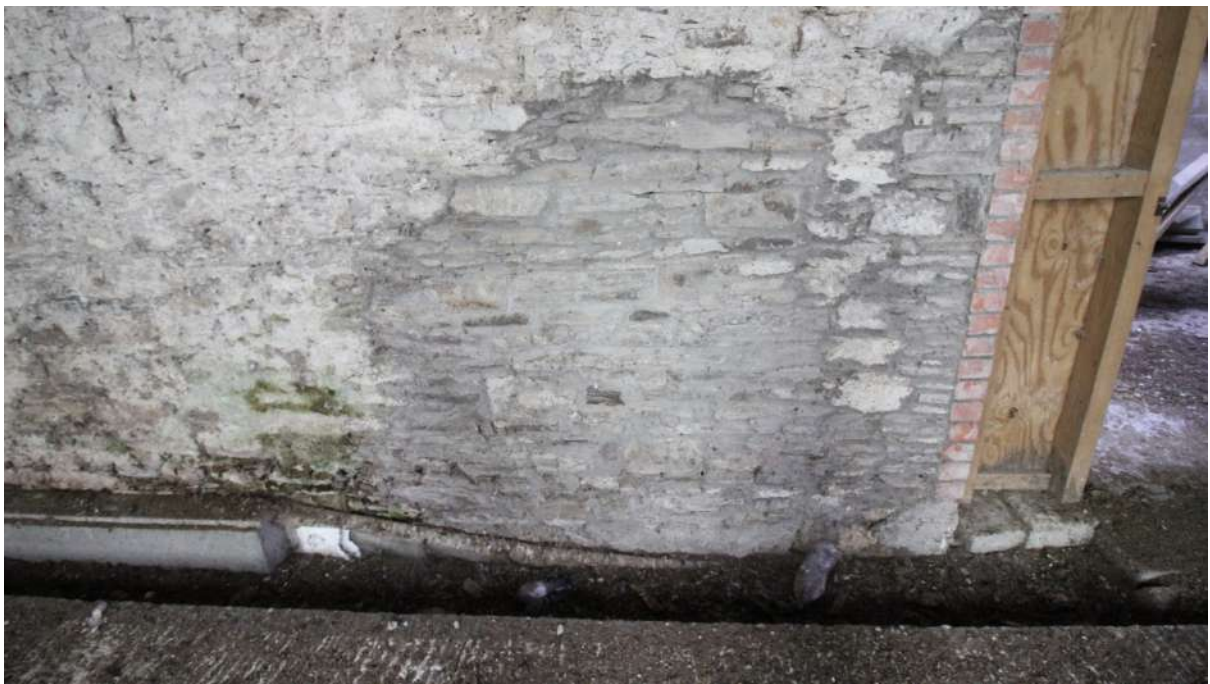
• Fig 62. Perimeter 'duct' left around new RC floor around church. Indication of some minimal insulation.
