Cobh Town Hall

Roger Casement Square, Ringmeen, Cobh, Co.Cork.

Conservation Report - Heritage Impact Assessment:

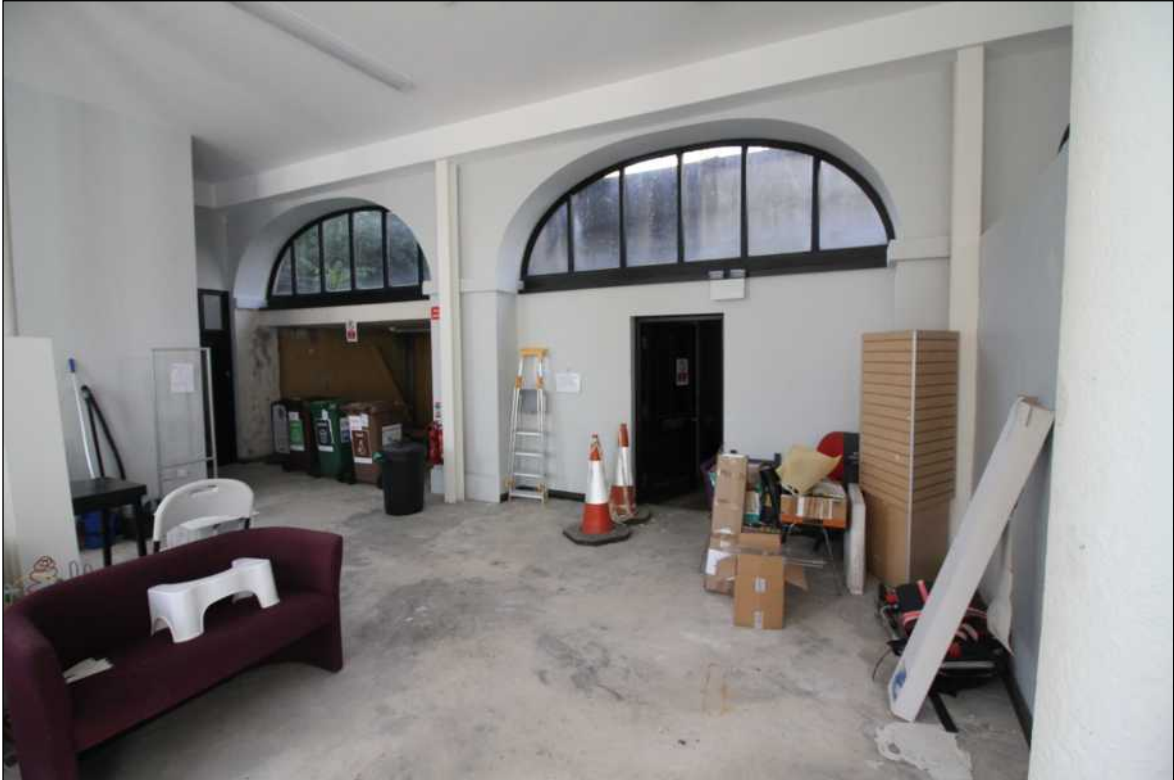
• Fig 60. Room 9. Rear flat North roofed rooms under arches.

The rear flat roofs are clearly in need of attention, as illustrated above. Much of the trouble is likely to stem from blocked outlets and build up of 'greenery' on the roof. It is assumed this roof is being replaced and as such less of a concern.

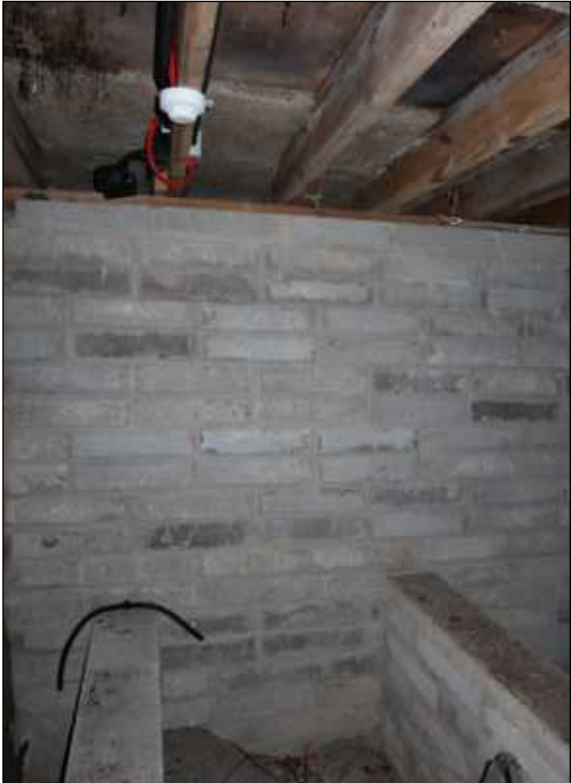
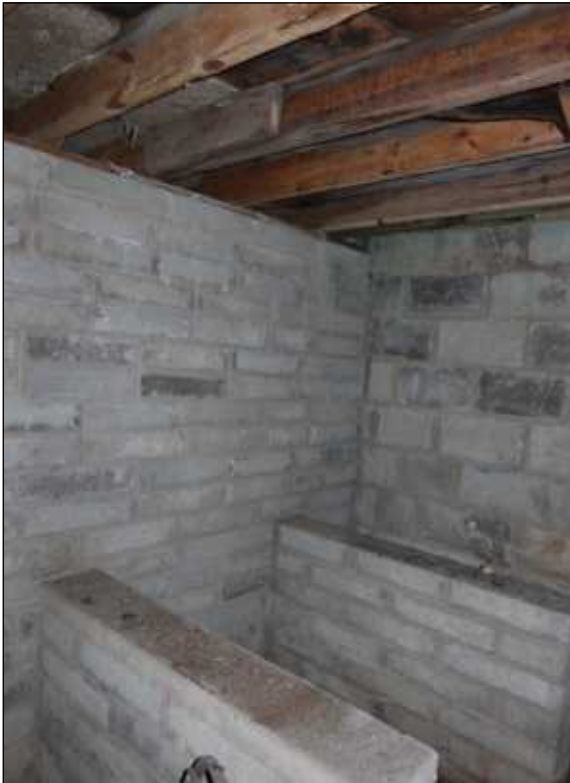
• Fig 71 & 72. Rear North flat roofed rooms. Room 1.

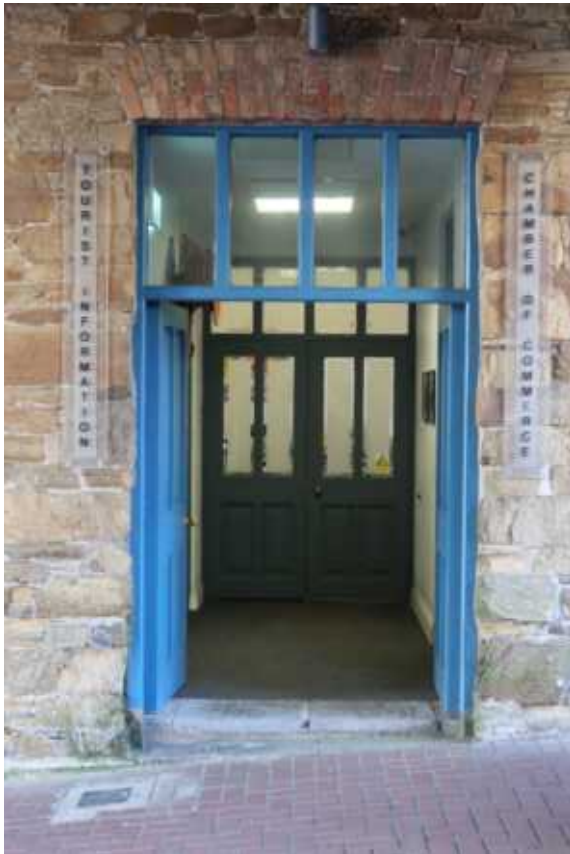
The library has been made accessible by a detail at door step that facilitates the access. The same has not been done at the tourist office side, and it would be worth trying to address this in the same way, to ensure visitor/ guest access.

• Fig. 84. Tourist office entry step.

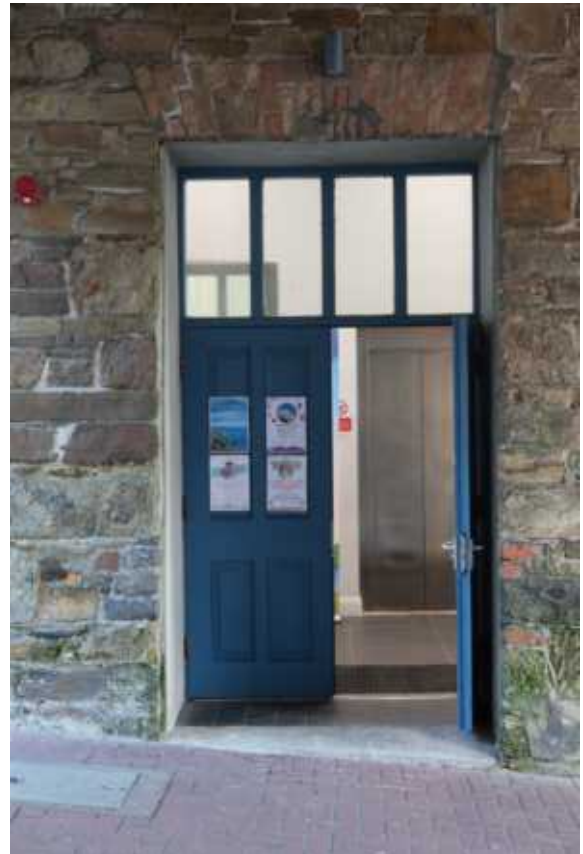
• Fig. 85. Library ramped entry step.
